Your Ref: Honda Engine
(number K20A5824485)
Our Ref : CI/TP20002162/D

INSPECTION REPORT OF A HONDA ENGINE WITH NUMBER K20A5824485

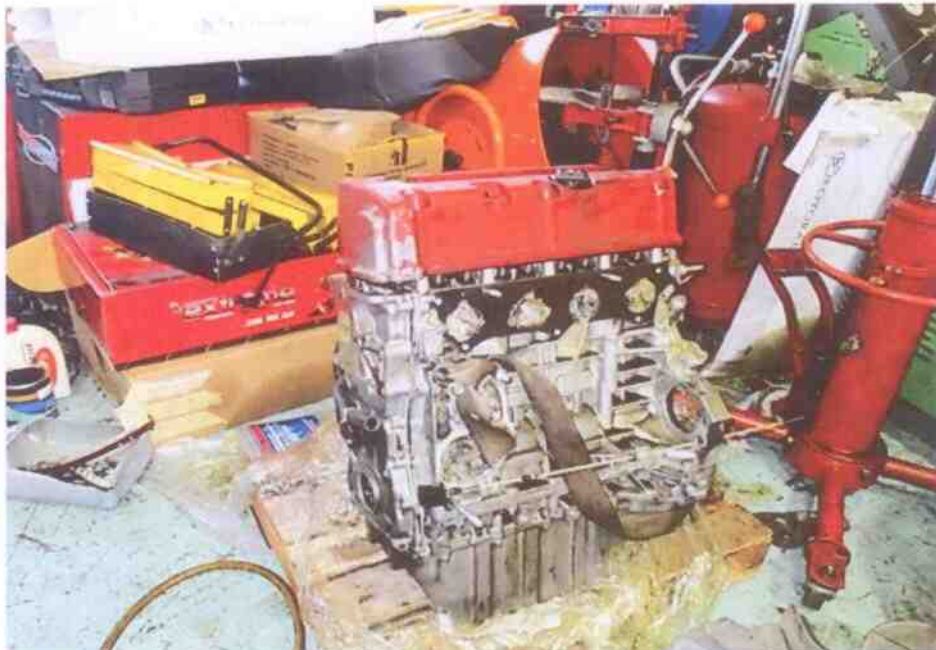
Photo 1 shows a general view of the Honda engine that I had inspected. The Honda engine was observed to be a used engine and was not fitted on any motor car. It was also observed to be a complete assembly with all mechanical parts still intact, within the engine housing.

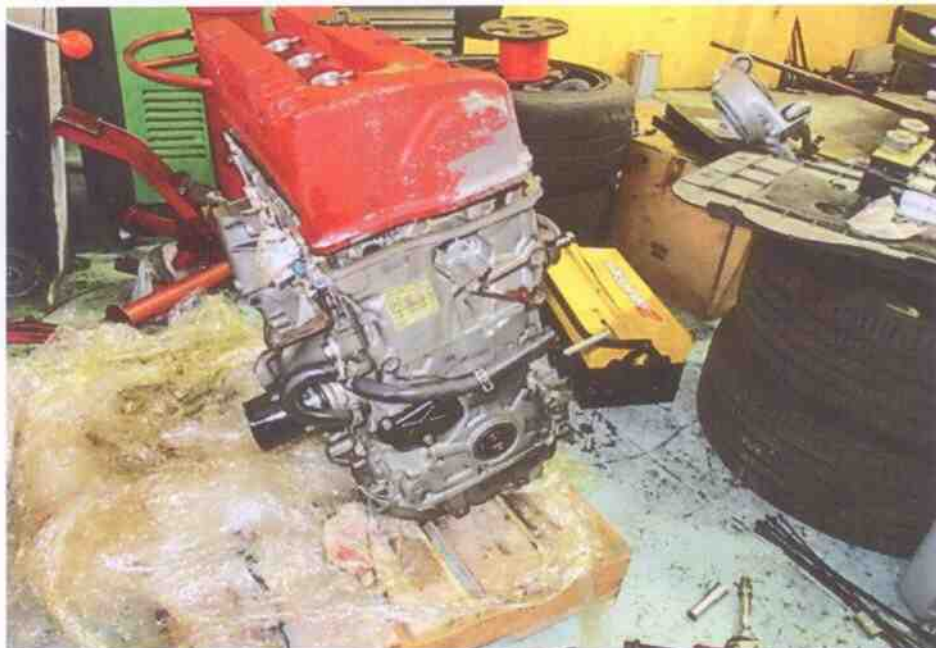
Photo 2 shows a general view of the Honda engine that I had inspected. My visual examination of the engine housing revealed the housing to be of serviceable/satisfactory condition. There was no crack and/or hole observed on the engine housing.

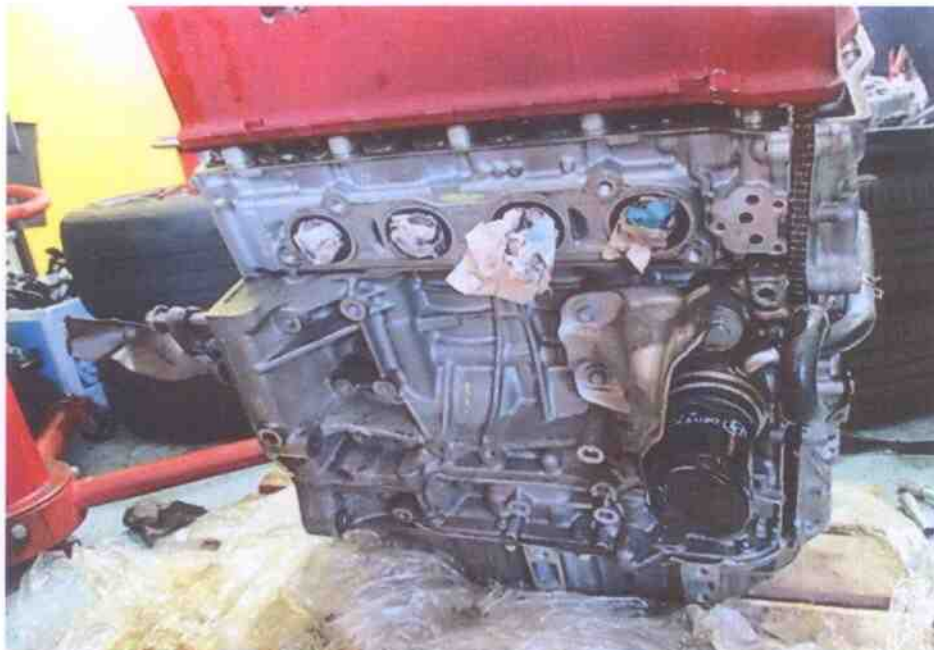
Photo 3 shows a closer view of the Honda engine that I had inspected. My visual examination of the engine housing revealed the housing to be of serviceable/satisfactory condition. There was no crack and/or hole observed on the engine housing.

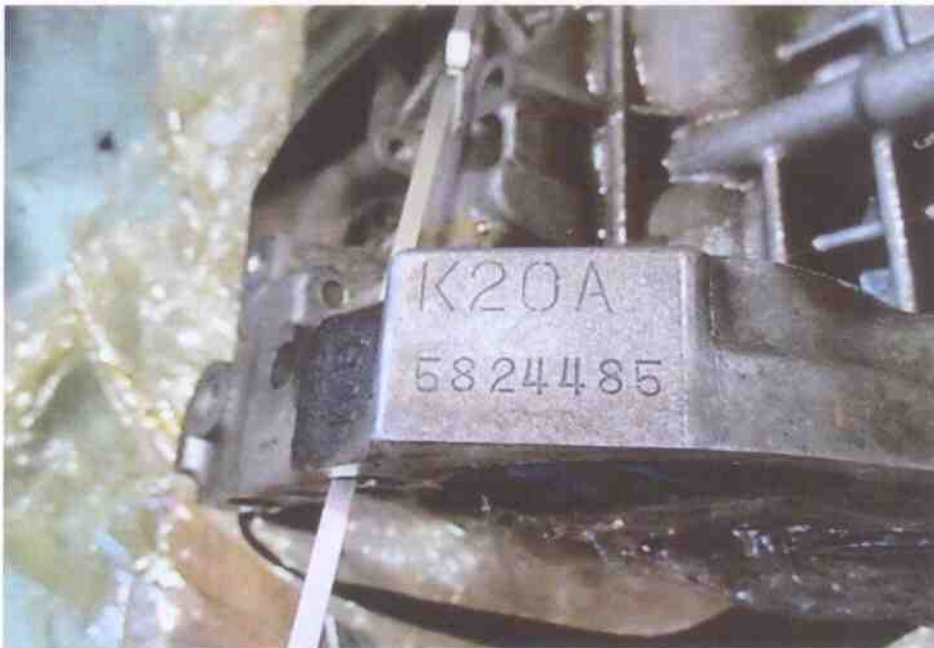
Photo 4 shows the engine number engraved on the housing of the Honda engine that I had inspected. The engine number was K20A5824485.

14. In summary, the Honda engine that I had inspected was a Honda K20A model engine. The engine number engraved on the housing of this Honda engine was K20A5824485. The engine displacement of the Honda engine is 1998cc as per the technical specification.

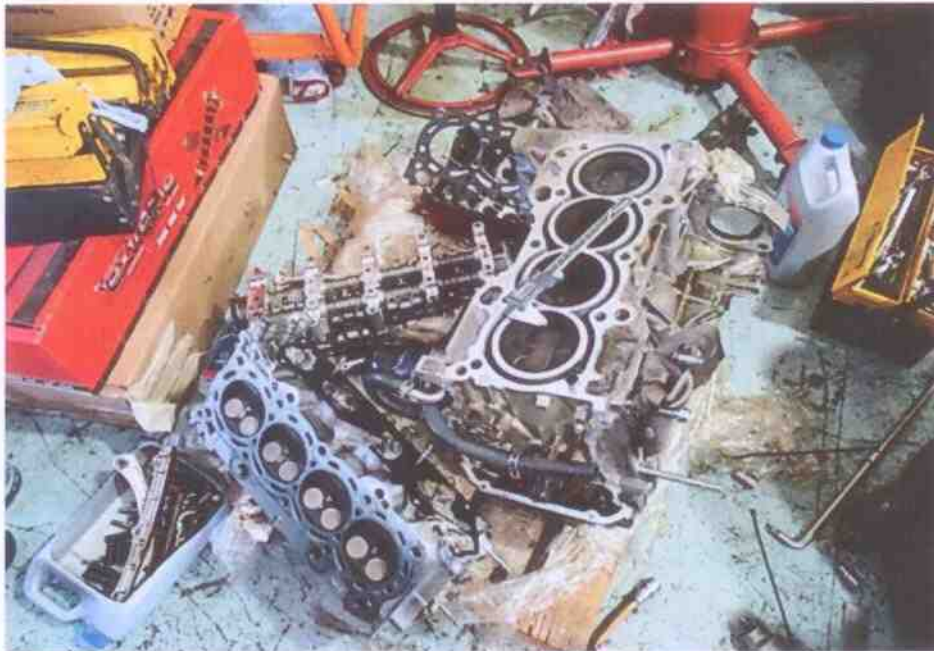
Photo 5 shows the top block of the Honda engine separated from its bottom block. This was to enable me to carry out measurements of its cylinders, in particular the bore and stroke measurements of each cylinder, which typically can be used to determine the engine displacement or more commonly referred to as engine cc.

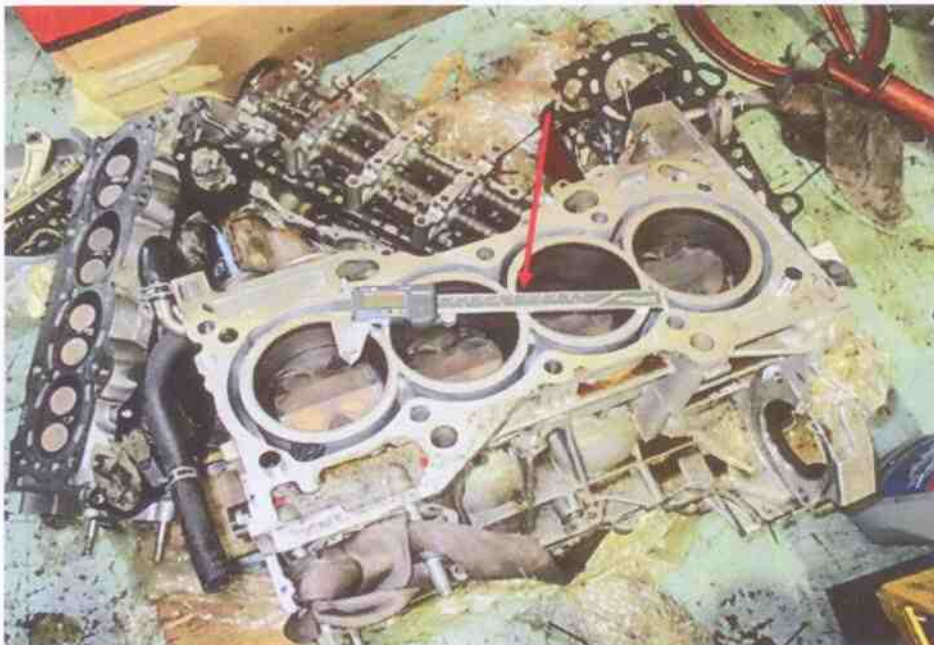
Photo 6 shows the bottom block of the Honda engine and the digital Vernier Caliper (arrowed) that was used to measure the bore and stroke measurements of each cylinder, which typically can be used to determine the engine displacement or more commonly referred to as engine cc. The digital Vernier Caliper was calibrated before the start of the measurements.

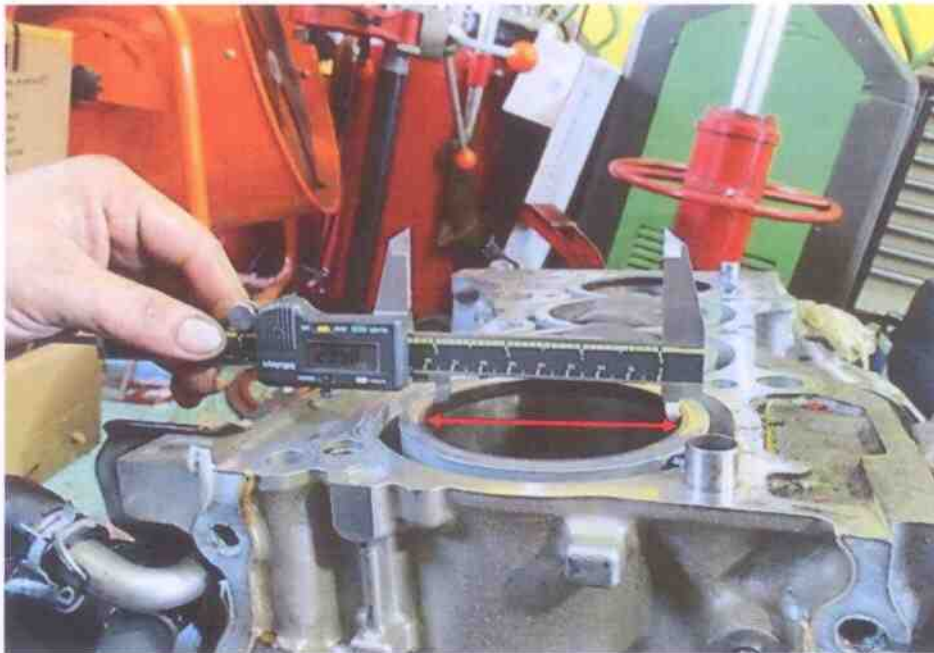
Photo 7 shows measurement being carried out to the bore (arrowed) of cylinder 1 of the Honda engine. The measurements were carried out using a digital Vernier Caliper that was calibrated before the start of the measurements.

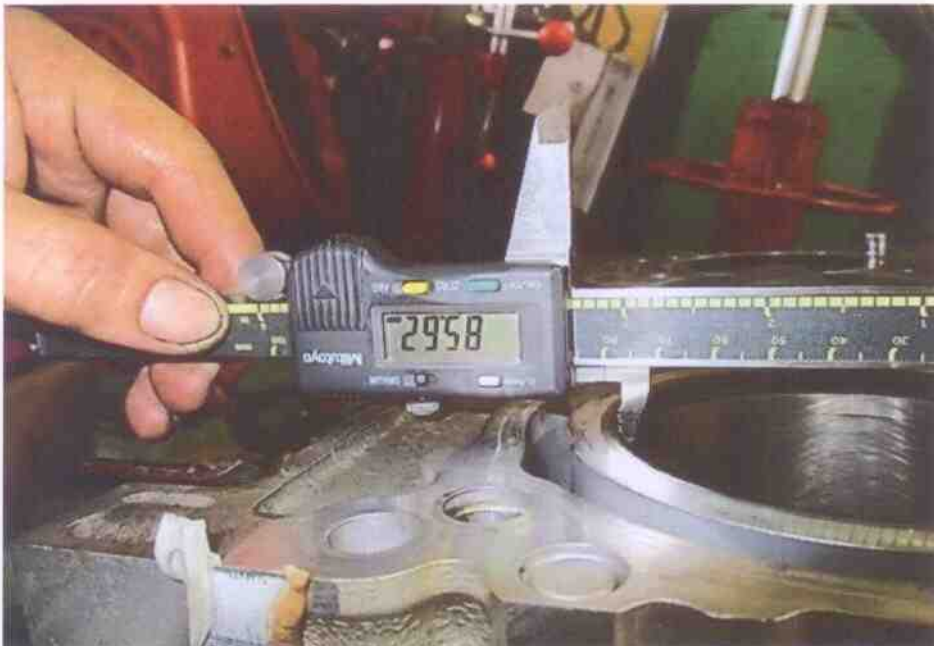
| | Bore (mm) | Stroke (mm) |
|---|---|---|
| Cylinder 1 | 85.62 | 85.63 |

Photo 8 shows the bore measurement of cylinder 1, which was recorded to be 85.62mm.

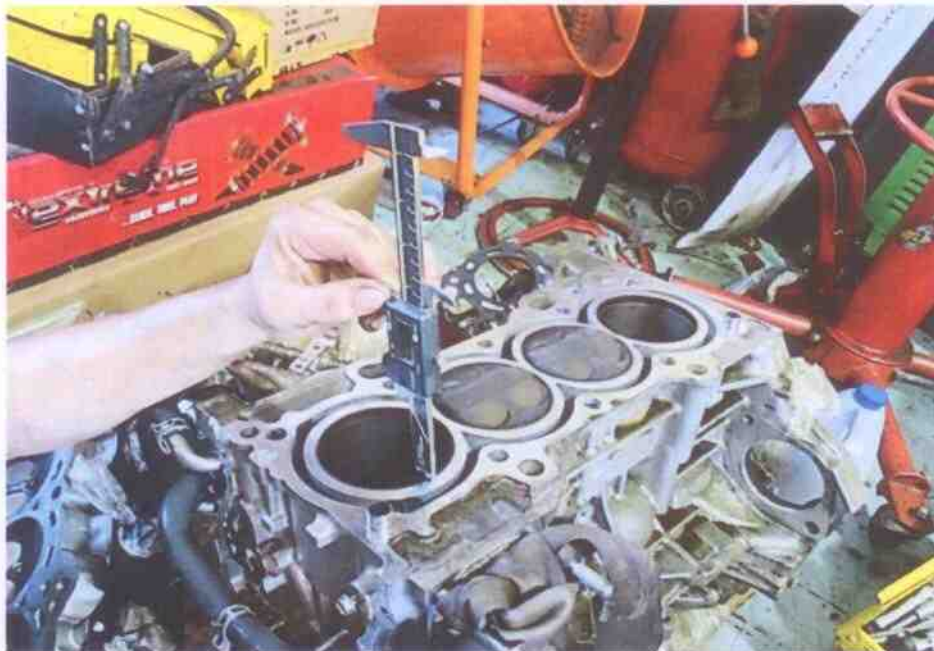
Photo 9 shows measurement being carried out to the stroke of cylinder 1 of the Honda engine. The bore and stroke measurements of the Honda engine were carried out using a digital Vernier Caliper.

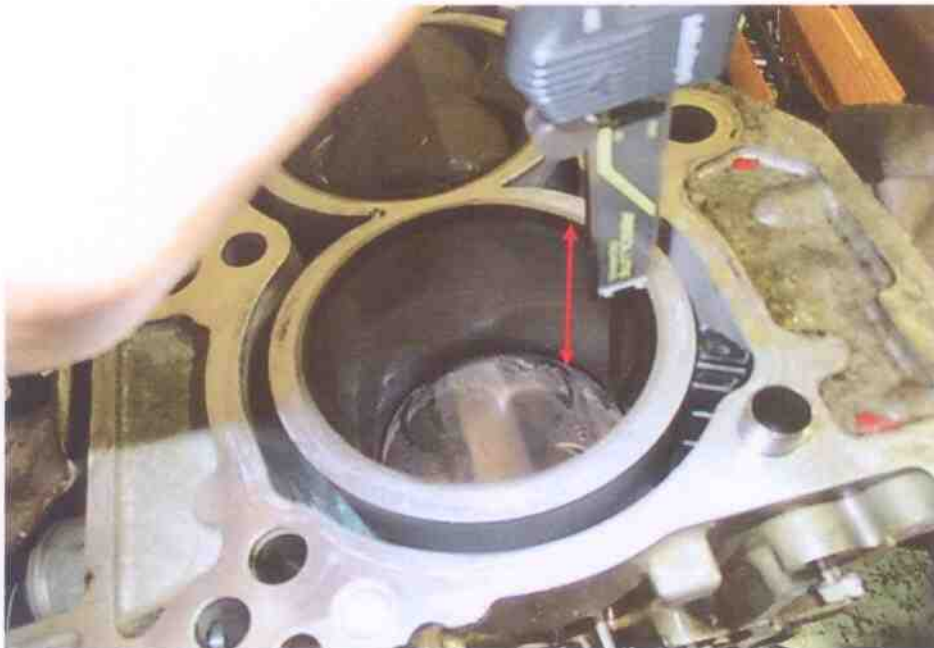
Photo 10 shows measurement being carried out to the stroke (arrowed) of cylinder 1 of the Honda engine. The bore and stroke measurements of the Honda engine were carried out using a digital Vernier Caliper that was calibrated before the start of the measurements,

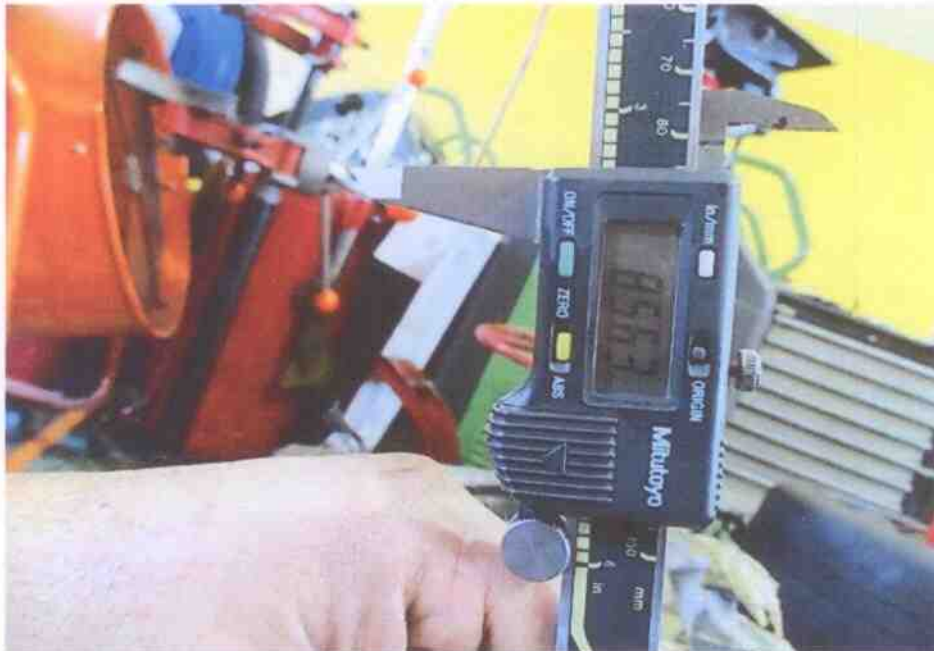
Photo 11 shows the stroke measurement of cylinder 1, which was recorded to be 85.63mm.

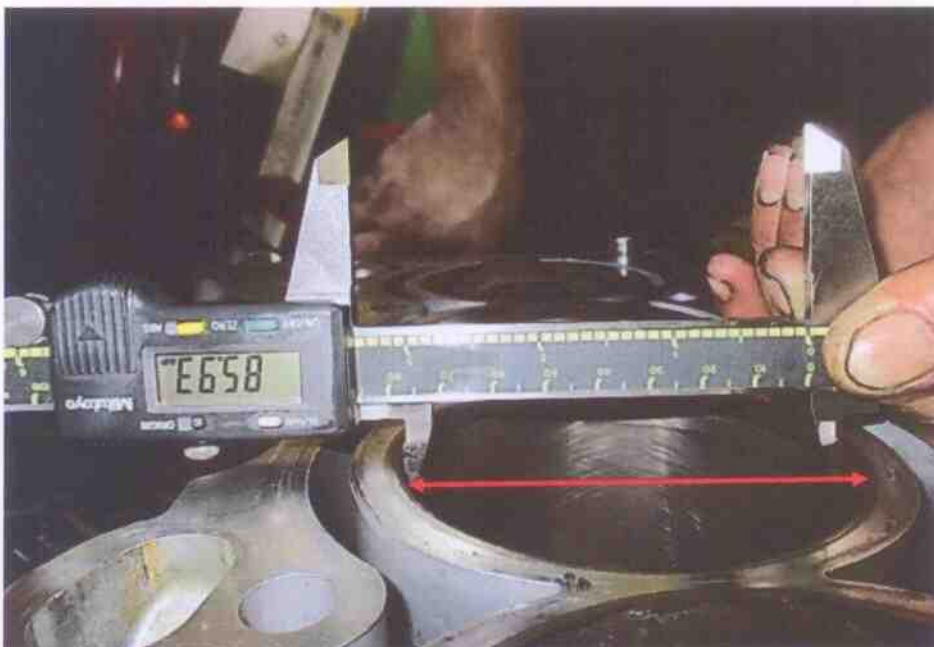
| | Bore (mm) | Stroke (mm) |
|---|---|---|
| Cylinder 2 | 85.93 | 85.88 |

Photo 12 shows measurement being carried out to the bore (arrowed) of cylinder 2 of the Honda engine. The bore measurement of cylinder 2 was recorded to be 85.93mm.

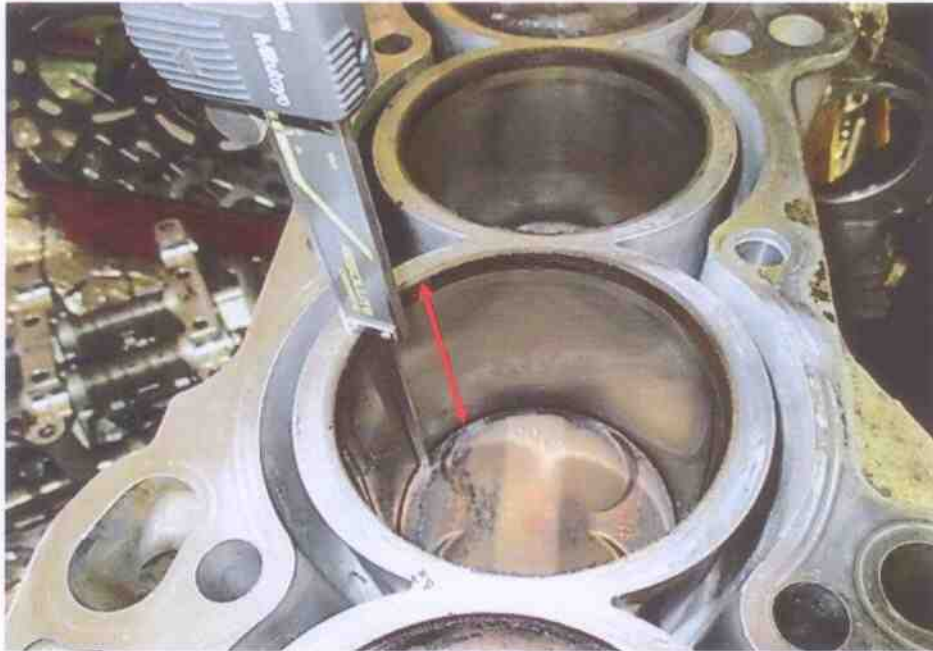
Photo 13 shows measurement of the stroke (arrowed) for cylinder 2 of the Honda engine that I had inspected.

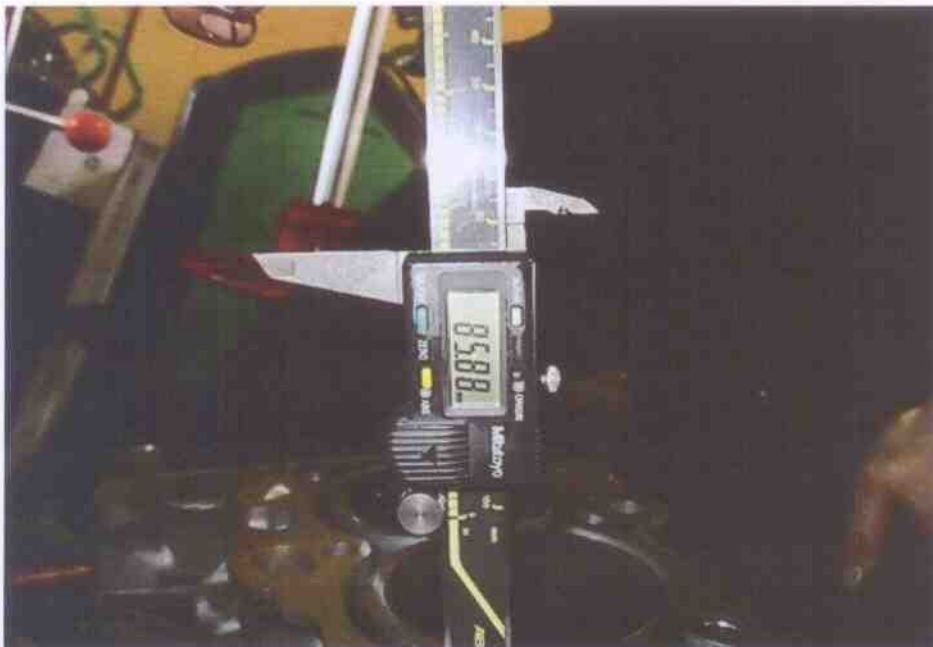
Photo 14 shows the stroke measurement of cylinder 2, which was recorded to be 85.88mm.

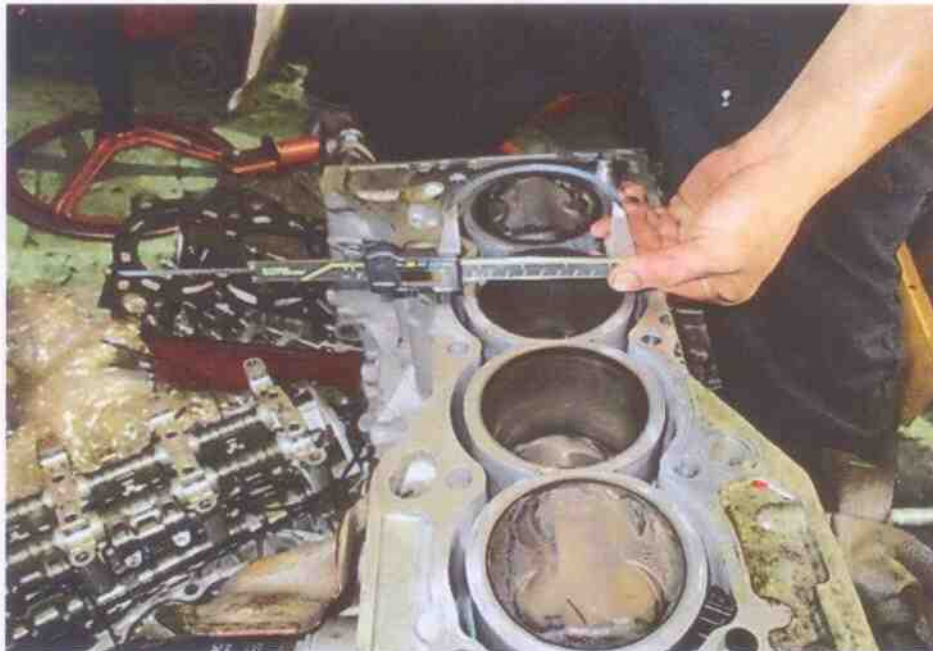
Photo 15 shows measurement being carried out to the bore of cylinder 3 of the Honda engine. The bore and stroke measurements of the Honda engine were carried out using a digital Vernier Caliper.

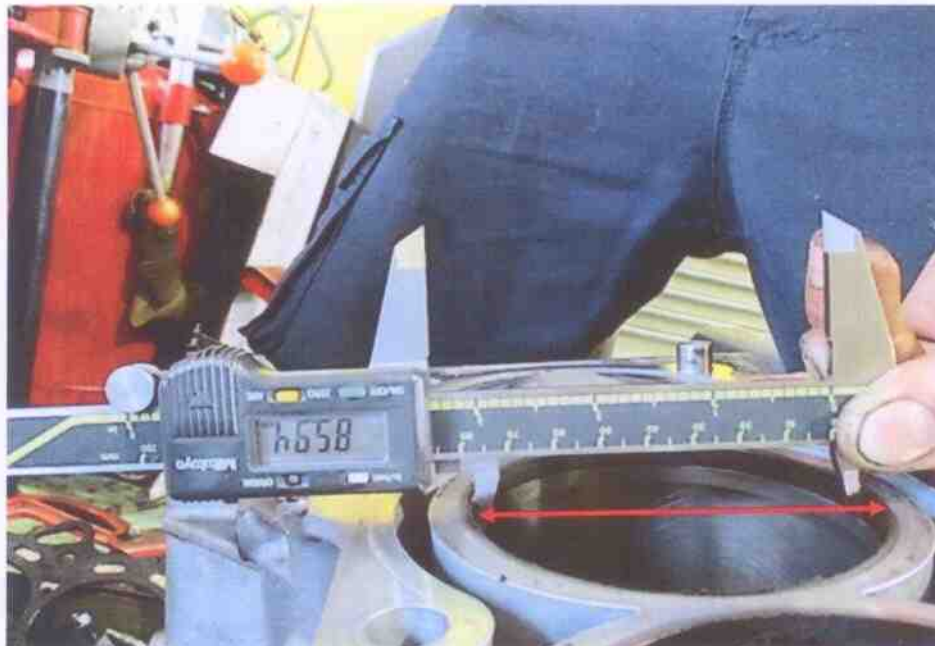
| | Bore (mm) | Stroke (mm) |
|---|---|---|
| Cylinder 3 | 85.94 | 85.77 |

Photo 16 shows measurement being carried out to the bore (arrowed) of cylinder 3 of the Honda engine. The bore measurement of cylinder 3 was recorded to be 85.94mm.

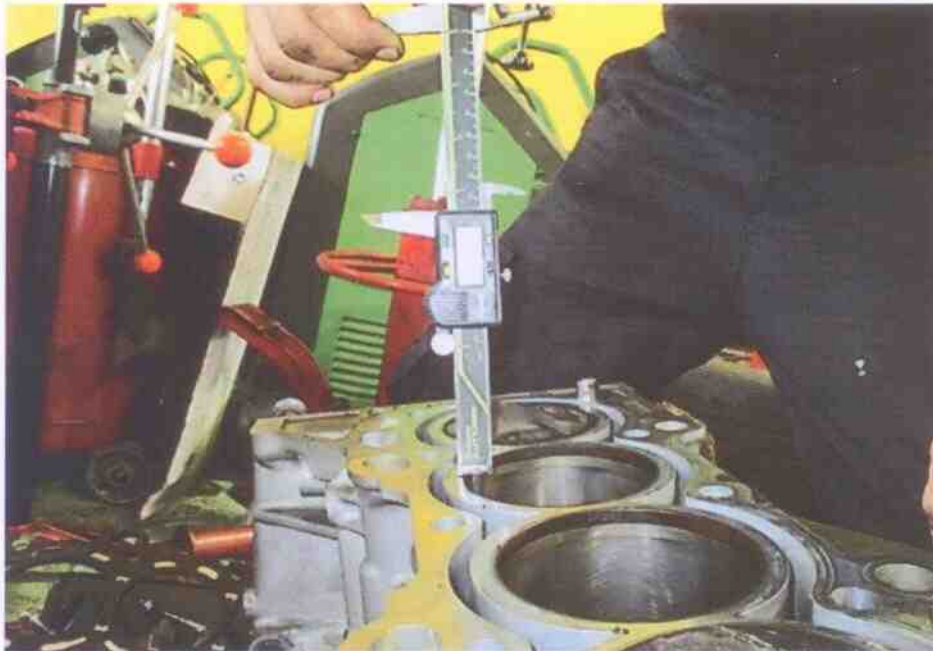
Photo 17 shows measurement of the stroke for cylinder 3 of the Honda engine that I had inspected. The bore and stroke measurements of the Honda engine were carried out using a digital Vernier Caliper that was calibrated before the start of measurements.

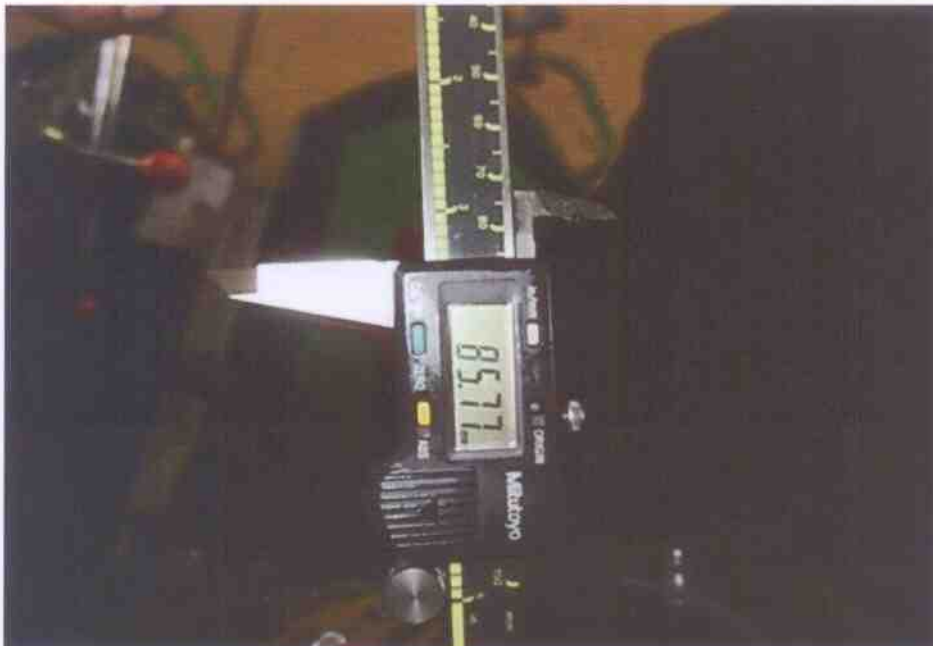
Photo 18 shows the stroke measurement of cylinder 3, which was recorded to be 85.77mm.

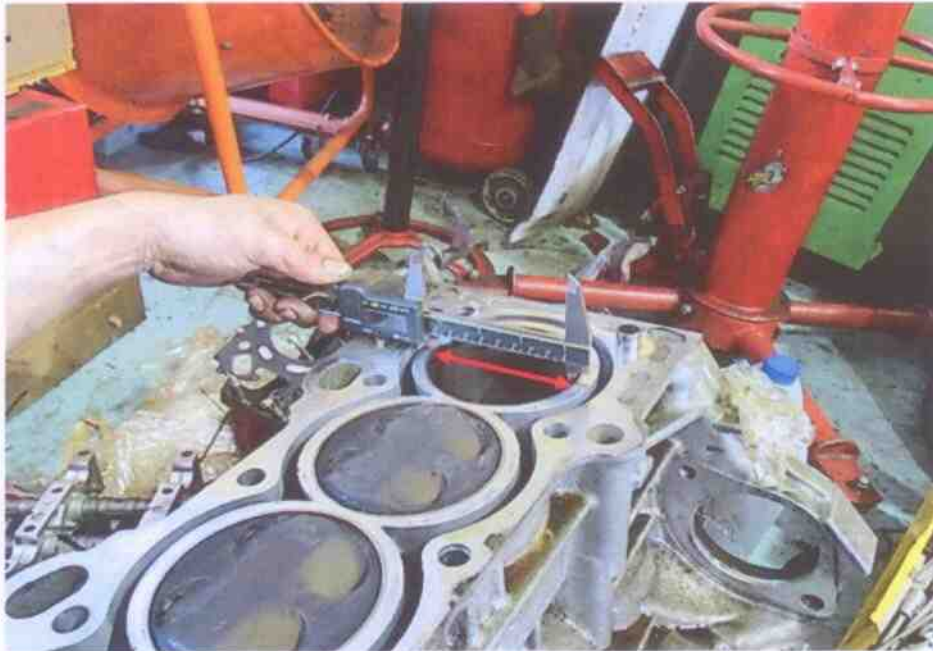
Photo 19 shows measurement being carried out to the bore (arrowed) of cylinder 4 of the Honda engine. The bore and stroke measurements of the Honda engine were carried out using a digital Vernier Caliper.

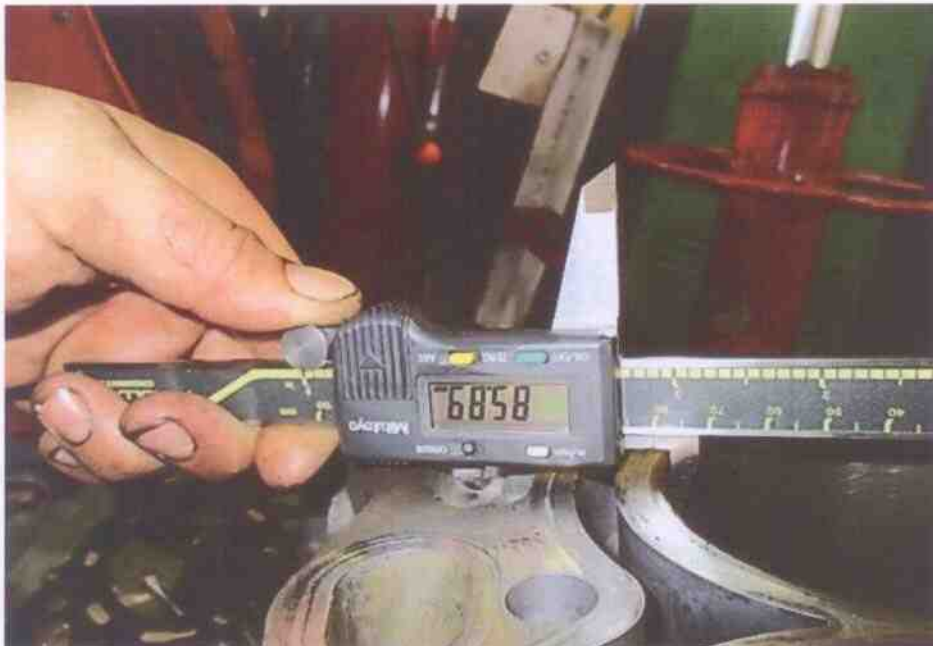
| | Bore (mm) | Stroke (mm) |
|---|---|---|
| Cylinder 4 | 85.89 | 85.84 |

Photo 20 shows the bore measurement of cylinder 4, which was recorded to be 85.89mm.

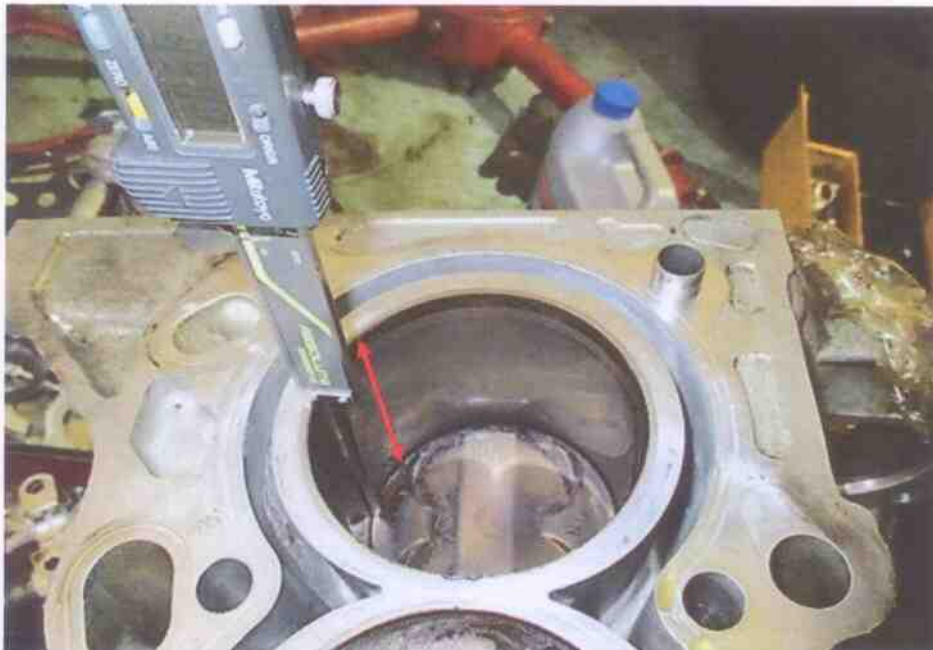
Photo 21 shows measurement being carried out to the stroke (arrowed) of cylinder 4 of the Honda engine. The bore and stroke measurements of the Honda engine were carried out using a digital Vernier Caliper that was calibrated prior to the start of measurements.

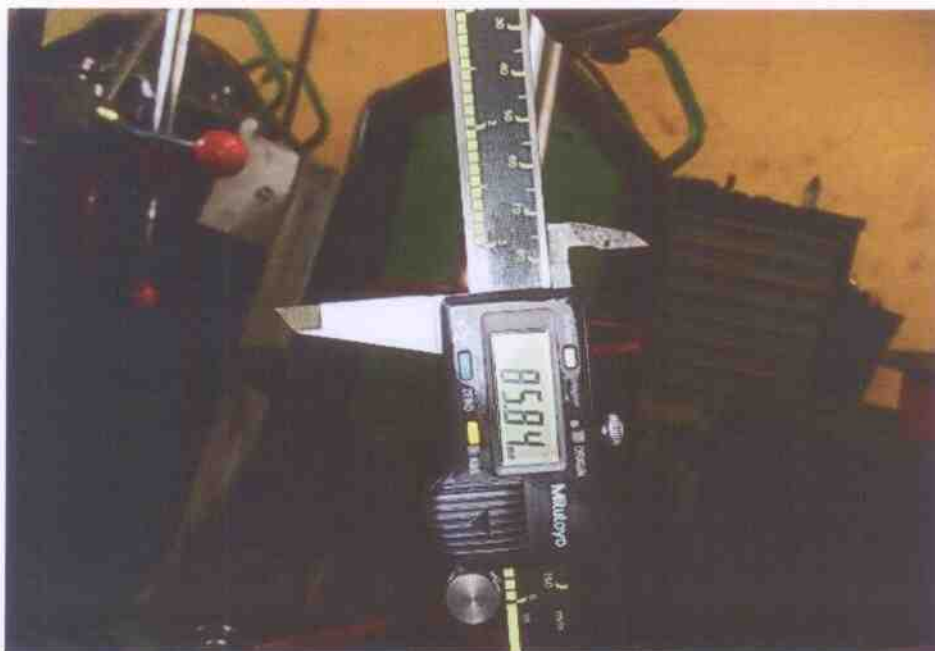
Photo 22 shows the stroke measurement of cylinder 4, which was recorded to be 85.84mm.
