07 February 2020

(number K20A5824485)

Our Ref: CI/TP20002162/D

INSPECTION REPORT OF A HONDA ENGINE WITH NUMBER K20A5824485

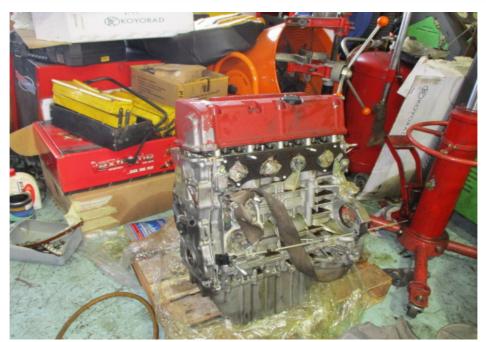
Photo 1 shows a general view of the Honda engine that I had inspected. The Honda engine was observed to be a used engine and was not fitted on any motor car. It was also observed to be a complete assembly with all mechanical parts still intact, within the engine housing.

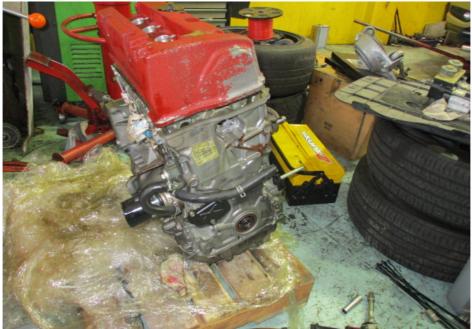
Photo 2 shows a general view of the Honda engine that I had inspected. My visual examination of the engine housing revealed the housing to be of serviceable/satisfactory condition. There was no crack and/or hole observed on the engine housing.

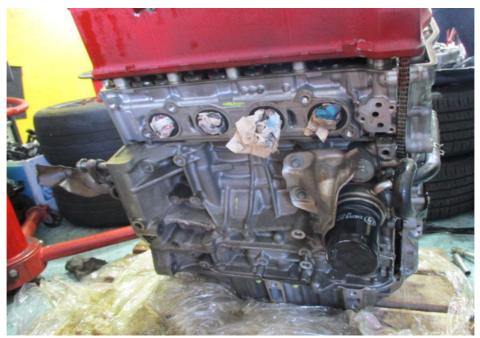
Photo 3 shows a closer view of the Honda engine that I had inspected. My visual examination of the engine housing revealed the housing to be of serviceable/satisfactory condition. There was no crack and/or hole observed on the engine housing.

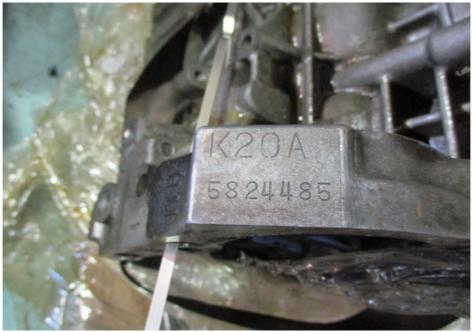
Photo 4 shows the engine number engraved on the housing of the Honda engine that I had inspected. The engine number was K20A5824485.

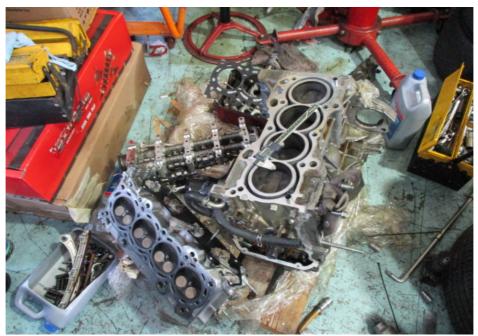
Photo 5 shows the top block of the Honda engine separated from its bottom block. This was to enable me to carry out measurements of its cylinders, in particular the bore and stroke measurements of each cylinder, which typically can be used to determine the engine displacement or more commonly referred to as engine cc.

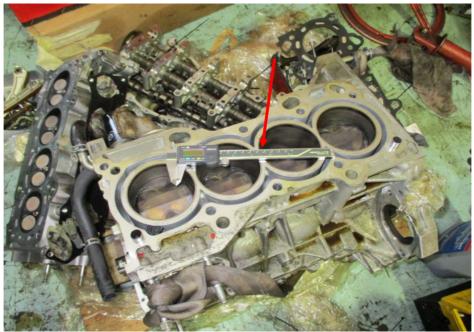
Photo 6 shows the bottom block of the Honda engine and the digital Vernier Caliper (arrowed) that was used to measure the bore and stroke measurements of each cylinder, which typically can be used to determine the engine displacement or more commonly referred to as engine cc. The digital Vernier Caliper was calibrated before the start of the measurements.

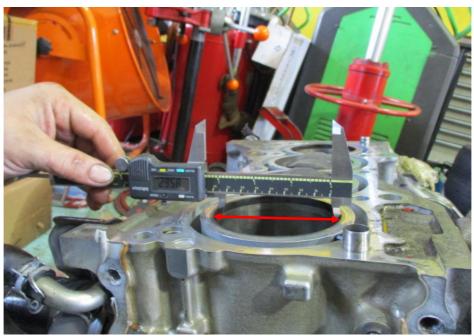
Photo 7 shows measurement being carried out to the bore (arrowed) of cylinder 1 of the Honda engine. The measurements were carried out using a digital Vernier Caliper that was calibrated before the start of the measurements.

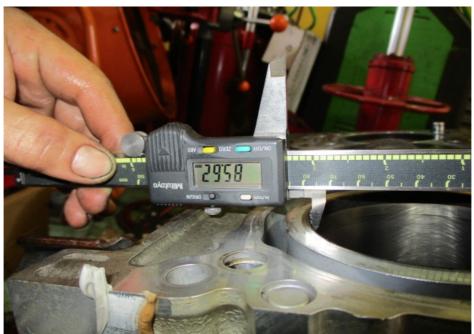
Photo 8 shows the bore measurement of cylinder 1, which was recorded to be 85.62mm.

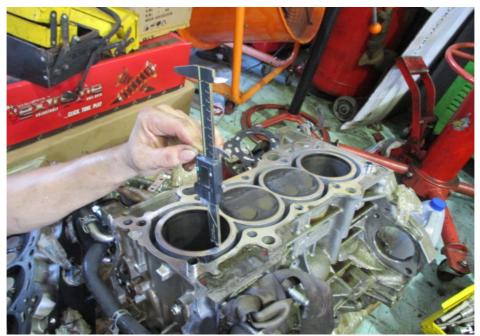
Photo 9 shows measurement being carried out to the stroke of cylinder 1 of the Honda engine. The bore and stroke measurements of the Honda engine were carried out using a digital Vernier Caliper.

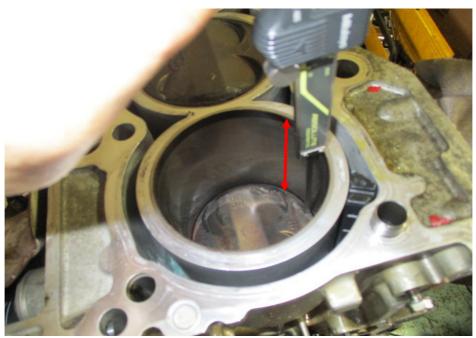
Photo 10 shows measurement being carried out to the stroke (arrowed) of cylinder 1 of the Honda engine. The bore and stroke measurements of the Honda engine were carried out using a digital Vernier Caliper that was calibrated before the start of the measurements,

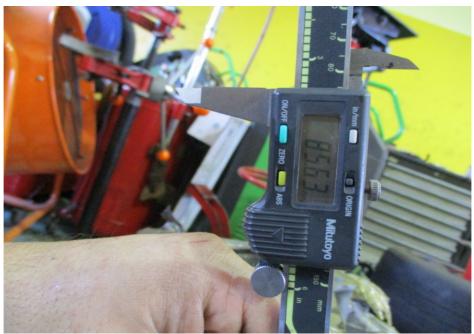
Photo 11 shows the stroke measurement of cylinder 1, which was recorded to be 85.63mm.

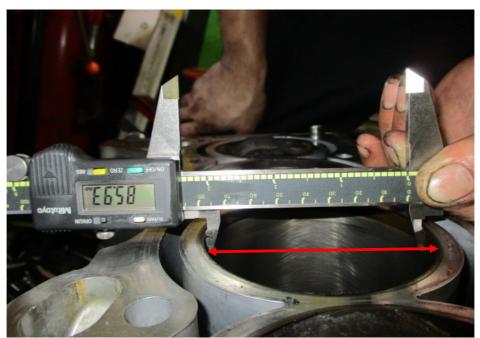
Photo 12 shows measurement being carried out to the bore (arrowed) of cylinder 2 of the Honda engine. The bore measurement of cylinder 2 was recorded to be 85.93mm.

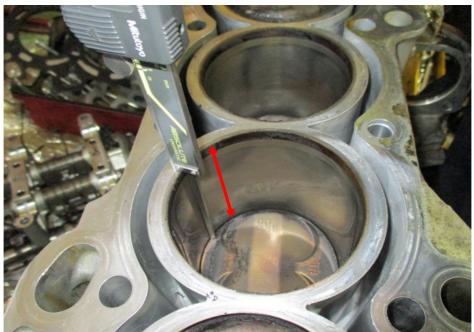
Photo 13 shows measurement of the stroke (arrowed) for cylinder 2 of the Honda engine that I had inspected.

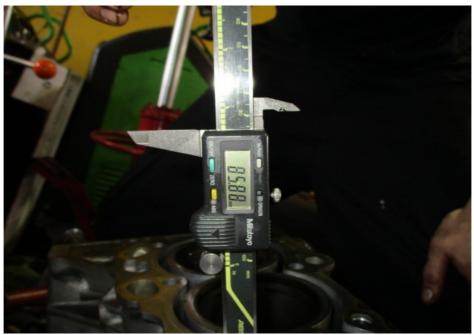
Photo 14 shows the stroke measurement of cylinder 2, which was recorded to be 85.88mm.

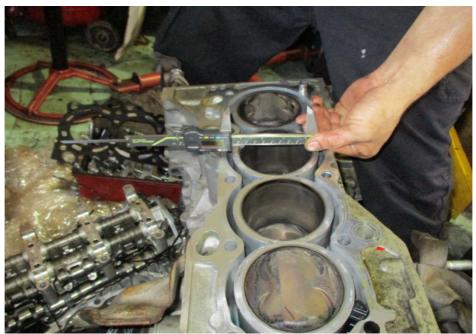
Photo 15 shows measurement being carried out to the bore of cylinder 3 of the Honda engine. The bore and stroke measurements of the Honda engine were carried out using a digital Vernier Caliper.

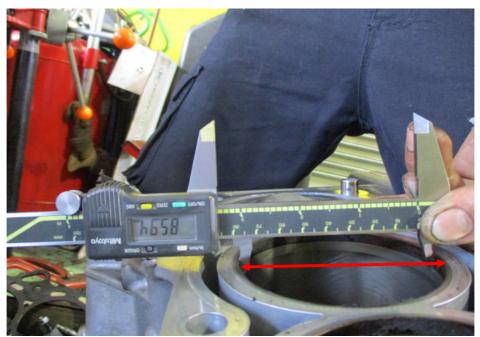
Photo 16 shows measurement being carried out to the bore (arrowed) of cylinder 3 of the Honda engine. The bore measurement of cylinder 3 was recorded to be 85.94mm.

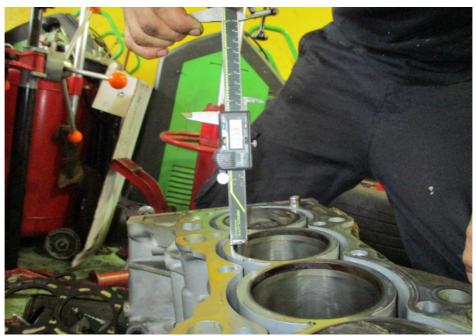
Photo 17 shows measurement of the stroke for cylinder 3 of the Honda engine that I had inspected. The bore and stroke measurements of the Honda engine were carried out using a digital Vernier Caliper that was calibrated before the start of measurements.

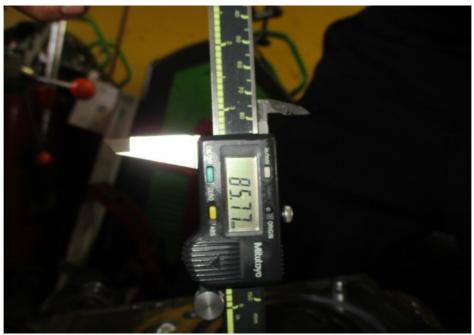
Photo 18 shows the stroke measurement of cylinder 3, which was recorded to be 85.77mm.

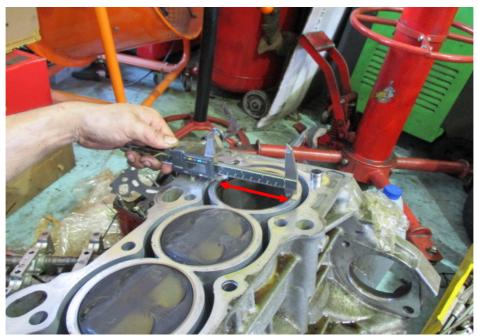
Photo 19 shows measurement being carried out to the bore (arrowed) of cylinder 4 of the Honda engine. The bore and stroke measurements of the Honda engine were carried out using a digital Vernier Caliper.

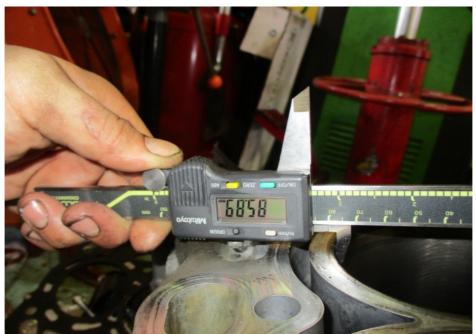
Photo 20 shows the bore measurement of cylinder 4, which was recorded to be 85.89mm.

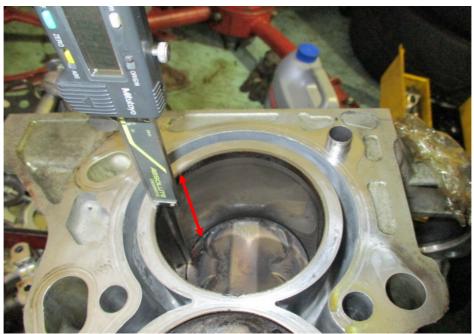
Photo 21 shows measurement being carried out to the stroke (arrowed) of cylinder 4 of the Honda engine. The bore and stroke measurements of the Honda engine were carried out using a digital Vernier Caliper that was calibrated prior to the start of measurements.

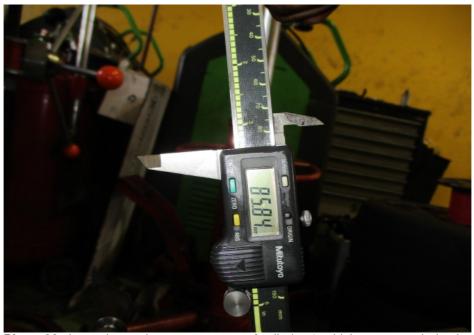
Photo 22 shows the stroke measurement of cylinder 4, which was recorded to be 85.84mm.
