LKK Auto Consultants Pte Ltd

ADJUSTMENT ON REPAIR COST FOR VEHICLE NO. SLV 2075M

PHOTOGRAPHS FOR VEHICLE NO. SLV 2075M

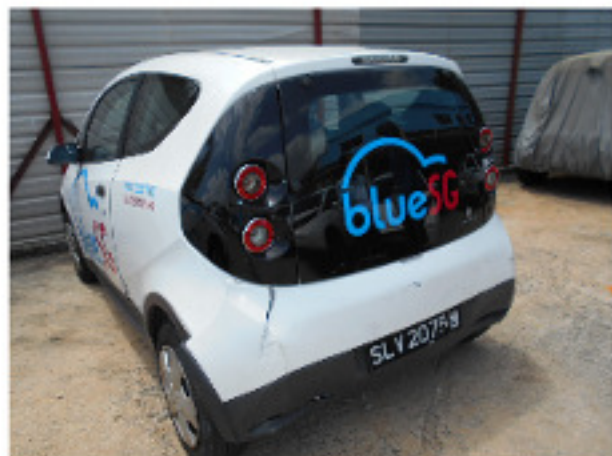
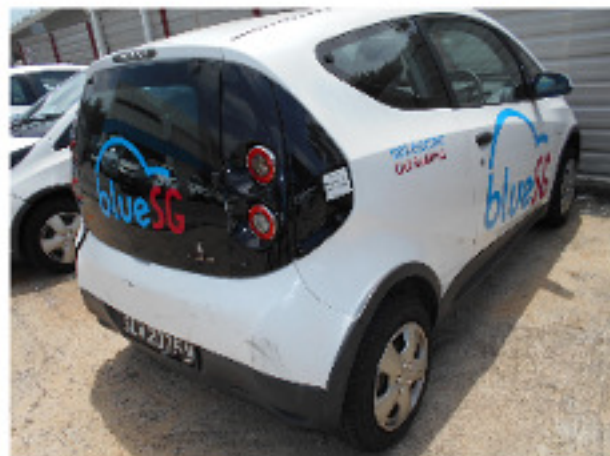
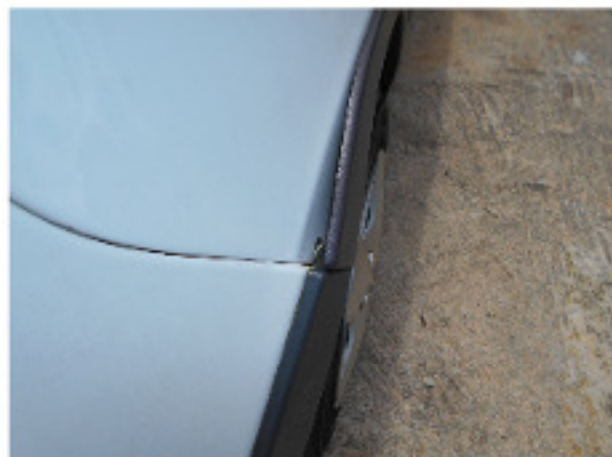
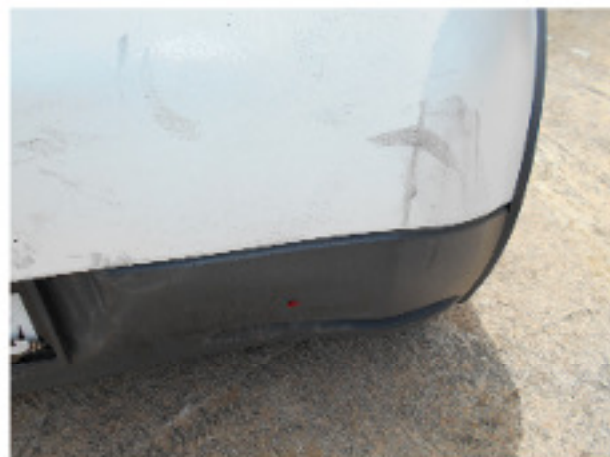
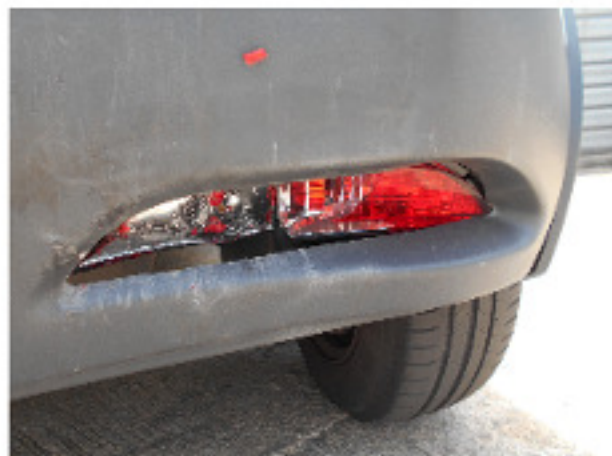
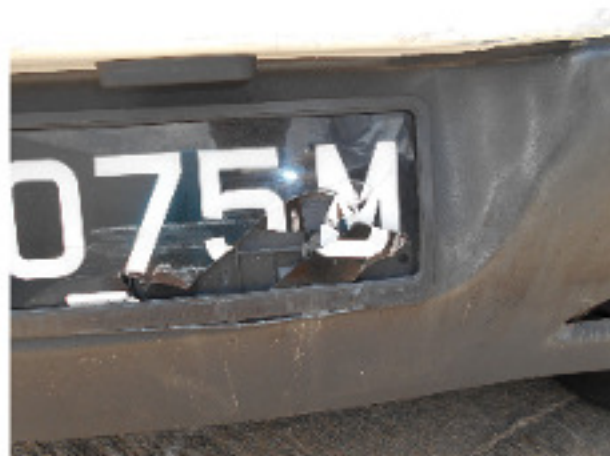
INSPECTION

THE VEHICLE SUSTAINED DAMAGES AT THE FRONT AND REAR PORTION. DAMAGES SEE DETAILS.
--
