LKK Auto Consultants Pte Ltd

Vehicle No. SH 6008Y
Insured Veh. PA 9335E
Claim No. SNM20D200706
Policy No. DMB1SN1913791900
Accident Date 04/02/2020
Inspection Date 06/02/2020

ADJUSTMENT ON REPAIR COST FOR VEHICLE NO. SH 6008Y

PHOTOGRAPHS FOR VEHICLE NO. SH 6008Y

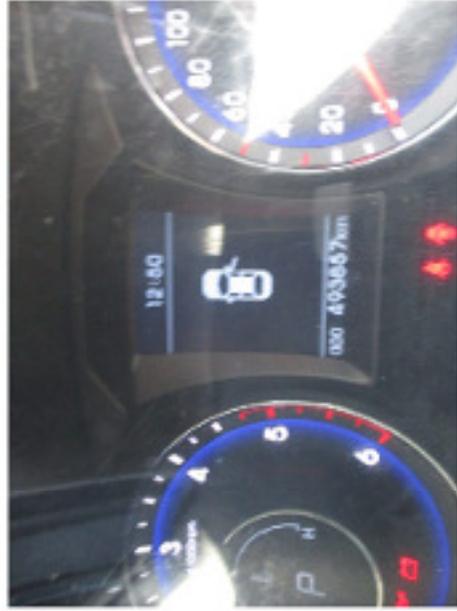
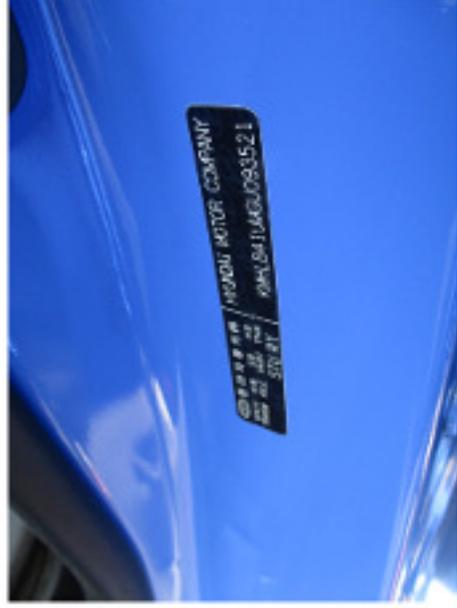
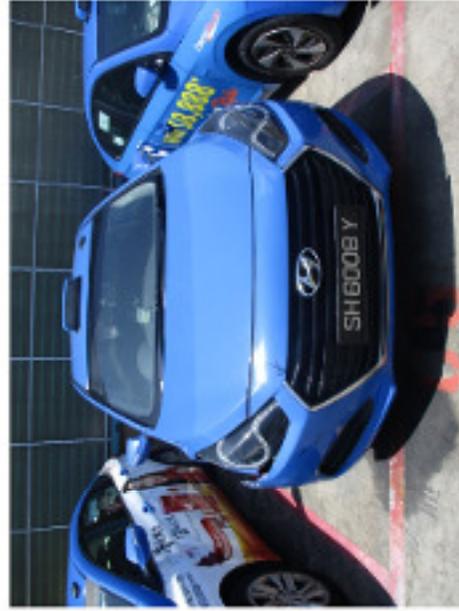
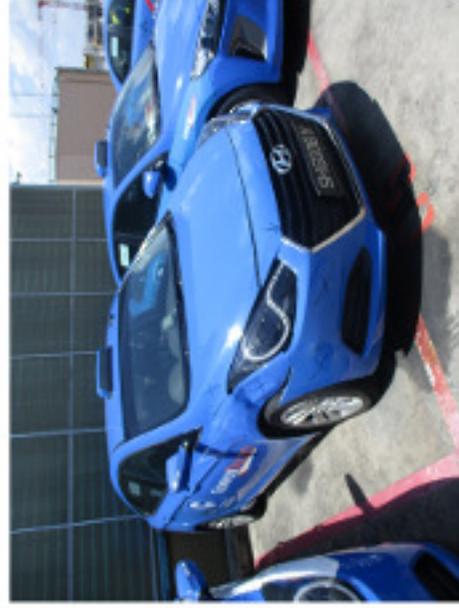
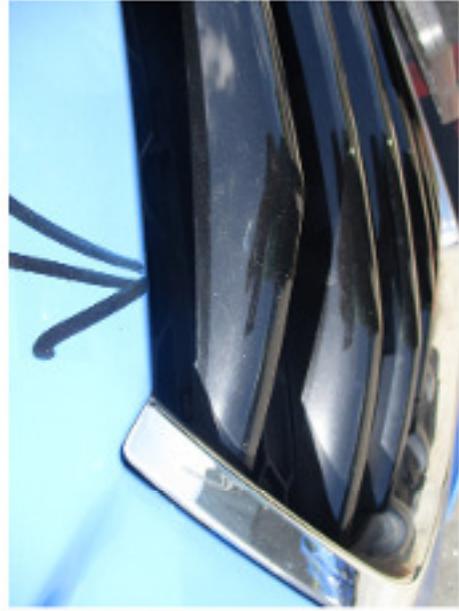
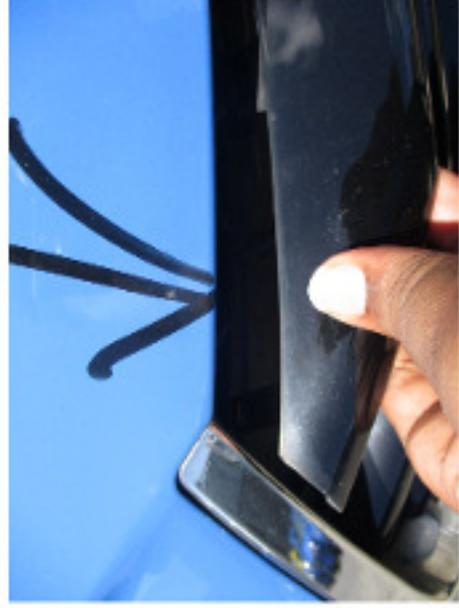
INSPECTION

THE VEHICLE SUSTAINED DAMAGES AT THE O/S FRONT AND FRONT PORTION.
DAMAGES SEE DETAILS.
