GBE 9563H - NM/CTI 20002059/114 D.O.A - 05/02/2020

GBE 4092 - CS/CTI 20002228/121473 DM - 05/02/2020

Vehicle Model: DOBLO CARGO MAXI 1.6 MTJ AMT  
GLAZE

## VEHICLE DAMAGE INSPECTION REPORT

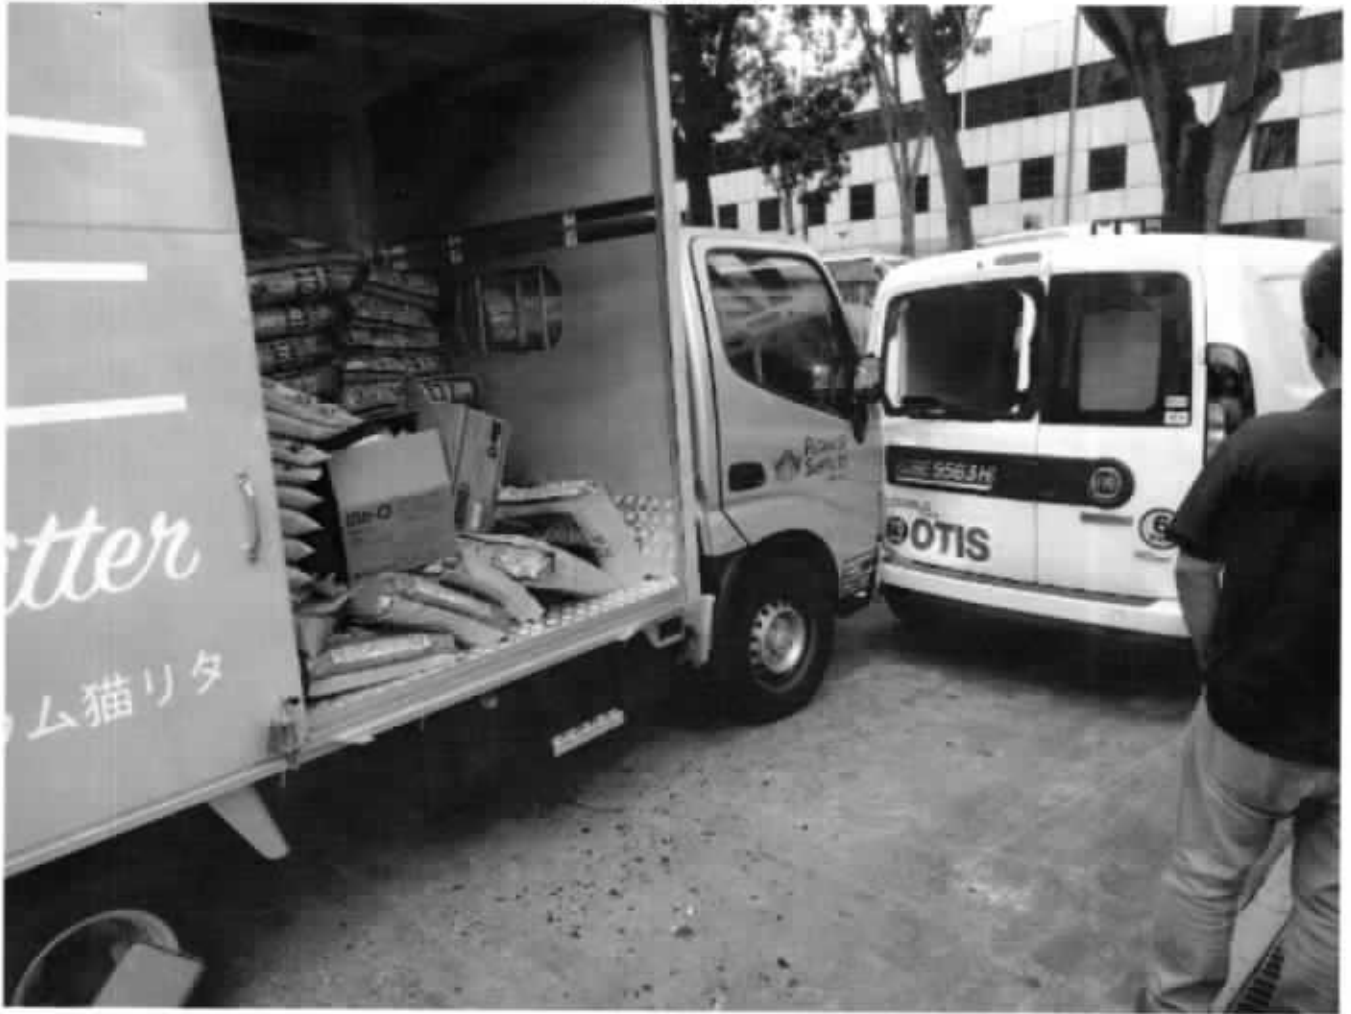
Accident Photo

Tyre Size: F: 195/60R16  
 R:  
 BS / DUN / EXNOVA / GY / FS / LIZA / MIC / OHTSU PIP / SUMI /  
 TOYO / YOKO or  
 Front 6 Rear 6  
 R/Bal. mm R/Bal. mm  
 L/Bal. mm L/Bal. mm  
 D.O.A. 5/12/20 D.O.I. 10/12/20  
 Survey held at  
 Des. of Damages: Frt / Rear / O/S / N/S / U/C / Rooftop or  
 Rear & R.L. &  
 The O/S / Chassis frame / Body Structure affected due to collision.

ON 5 FEB 2022 AT 1510HRS, I PARKED MY VEHICLE GBE9563H AT 4 CLEMENTI LOOP CAR PARK. AFTER I FINISHED MY WORK, I RETURNED BACK TO MY VEHICLE. REALISED THAT VEHICLE GBK409Z HAS COLLIDED ONTO MY VEHICLE AT REAR PORTION. BECAUSE OF THE COLLISION MY VEHICLE MOVED FORWARD AND COLLIDED ONTO THE FENCE. REAR PORTION OF MY VEHICLE C-GBK409Z ALSO COLLIDED ONTO VEHICLE GBF2437E WHICH IS PARKED ON LEFT OF MY VEHICLE. VEHICLE GBK409Z WAS PARKED AT THE SLOPE. SO THE VEHICLE MOVED OUT FROM THE SLOPE AND COLLIDED ONTO MY VEHICLE AT REAR PORTION. MY VEHICLE REAR MIRROR, UNDERCARRIAGE WERE DAMAGED. THERE WAS OIL LEAKAGE FROM BELOW MY VEHICLE. NOBODY WAS INJURED.
