Your Ref: S0M02FPS
Our Ref : CS/ASM20002344/N

13 February 2020

**TECHNICAL INVESTIGATION REPORT OF FIRE INCIDENT INVOLVING THE
INSURED VEHICLE SJK 4681G ON 7 FEBRUARY 2020**

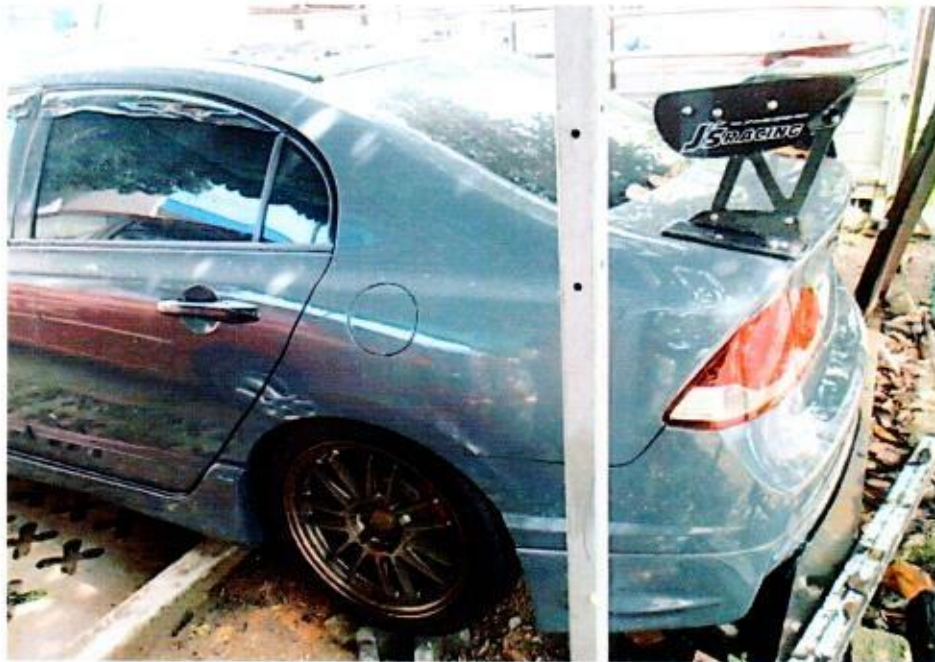
Photo 1 shows the rear left view of the Insured Vehicle. The rear portion of the Insured Vehicle was observed to be relatively unaffected by the fire.

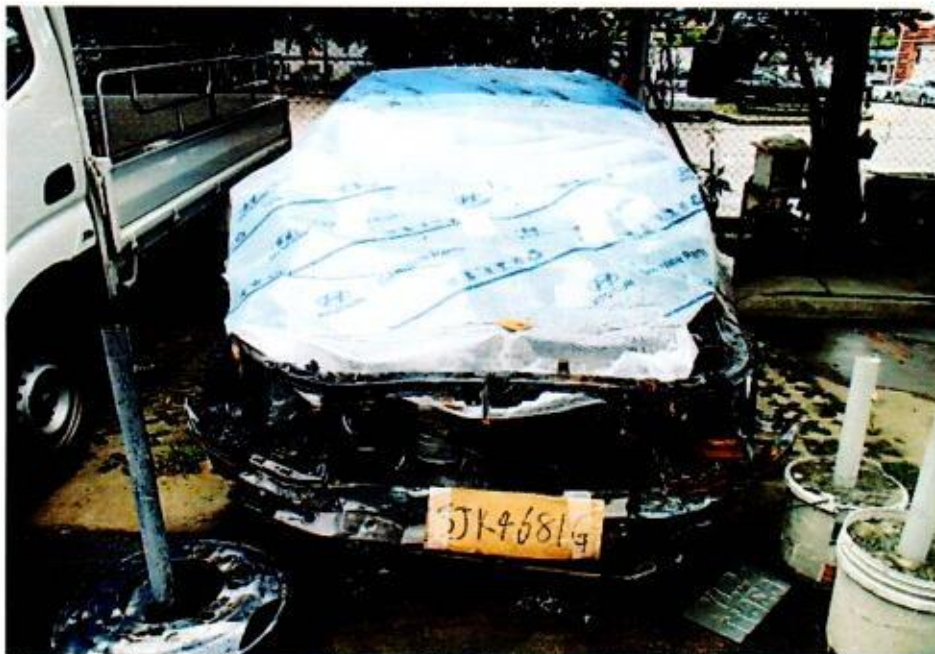
Photo 2 shows the general view of the frontal portion of the Insured Vehicle at the time of our inspection. The exterior body of the Insured Vehicle had sustained visible fire damage. This included its front windscreen, front bonnet, front bumper, front bumper reinforcement panel, headlights and side panels.

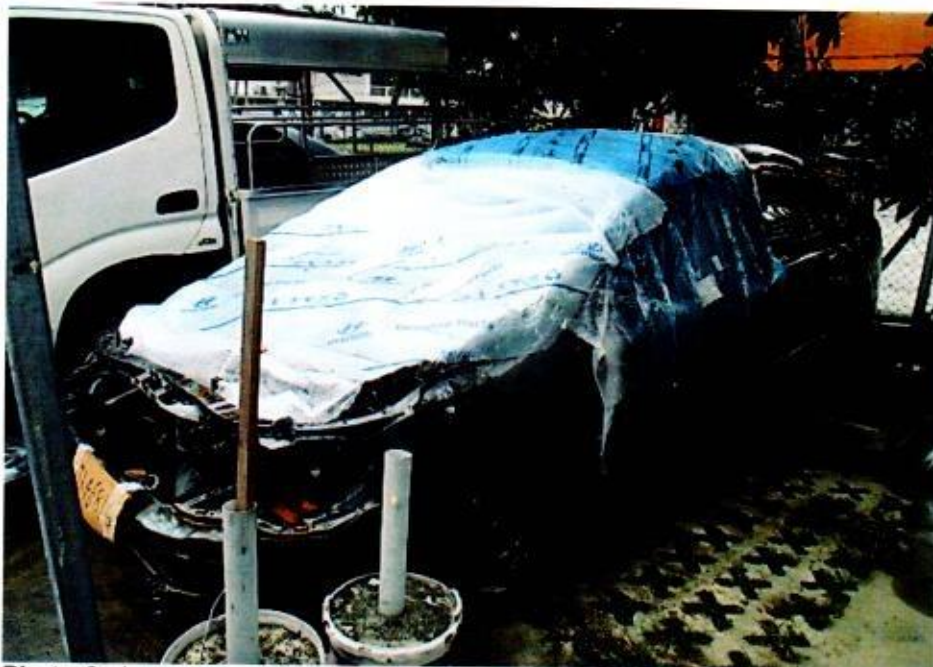
Photo 3 shows the general view of the left portion of the Insured Vehicle at the time of our inspection. The exterior body of the Insured Vehicle had sustained visible fire damage. This included its front windscreen, front bonnet, left headlight, front bumper and left front panel.

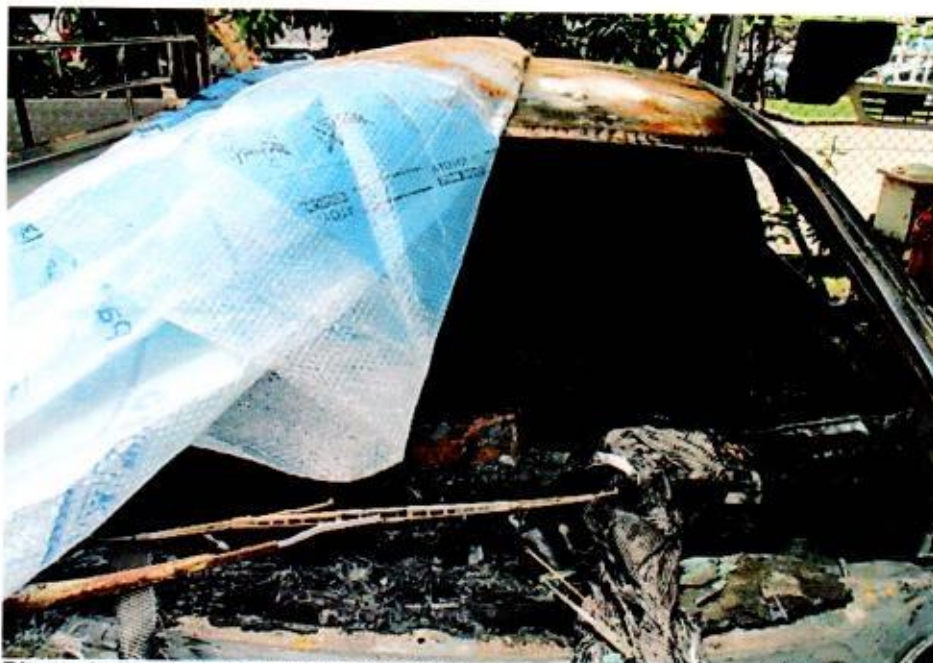
Photo 4 shows a closer view of the front windscreen of the Insured Vehicle at the time of our inspection. The front windscreen had sustained extensive fire damage.

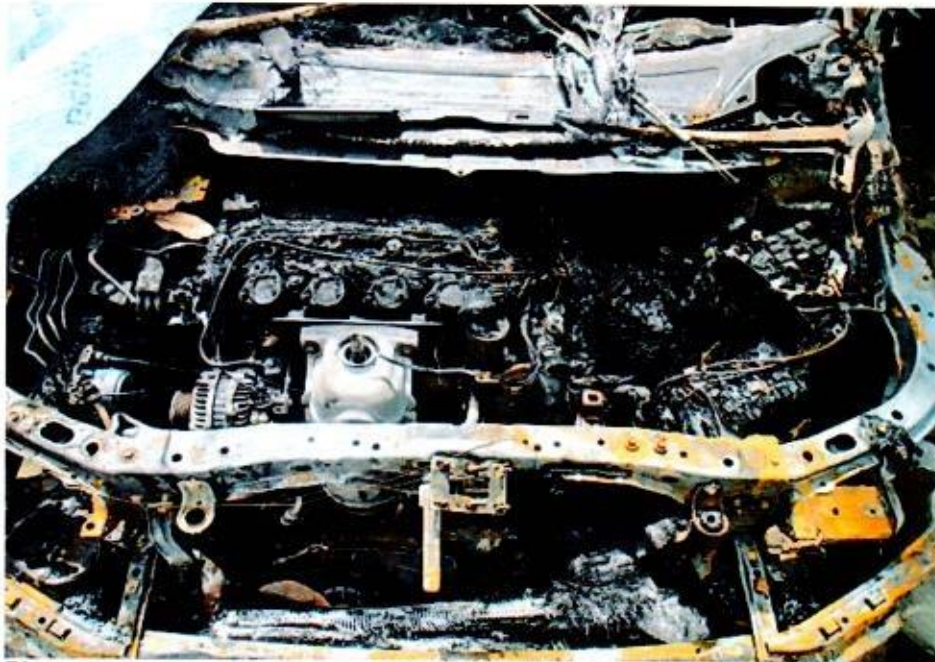
Photo 5 shows a general view of the engine compartment of the Insured Vehicle at the time of our inspection. Most of the components inside the engine compartment were found to be severely burnt and/or melted as a result of the fire.

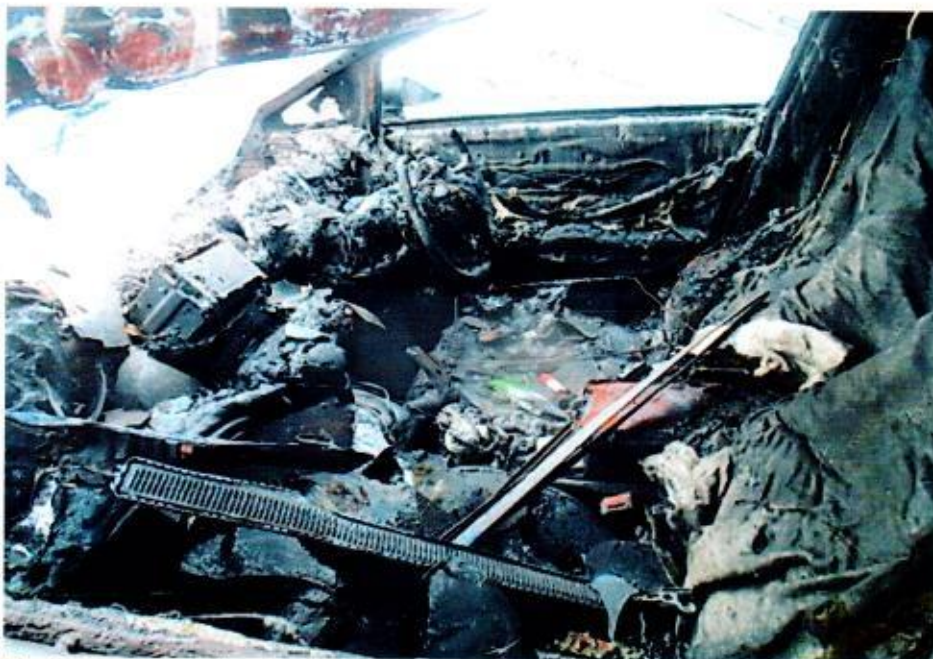
Photo 6 shows the interior compartment of the Insured Vehicle, which was observed to be seriously affected by the fire.

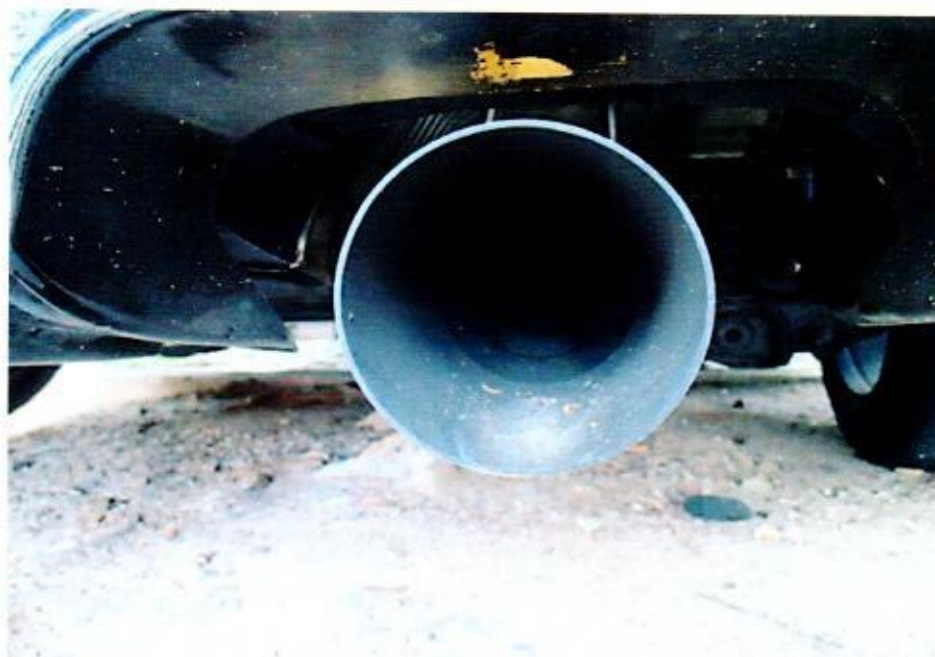
Photo 7 shows a front view of the non-standard rear exhaust muffler that was found to be fitted on the Insured Vehicle at the time of our inspection.

32. Although the aftermarket alloy rims and rear exhaust muffler fitted on the Insured Vehicle were not the standard type for the Insured Vehicle, we are of the view that these parts did not cause and/or contribute to the fire incident.

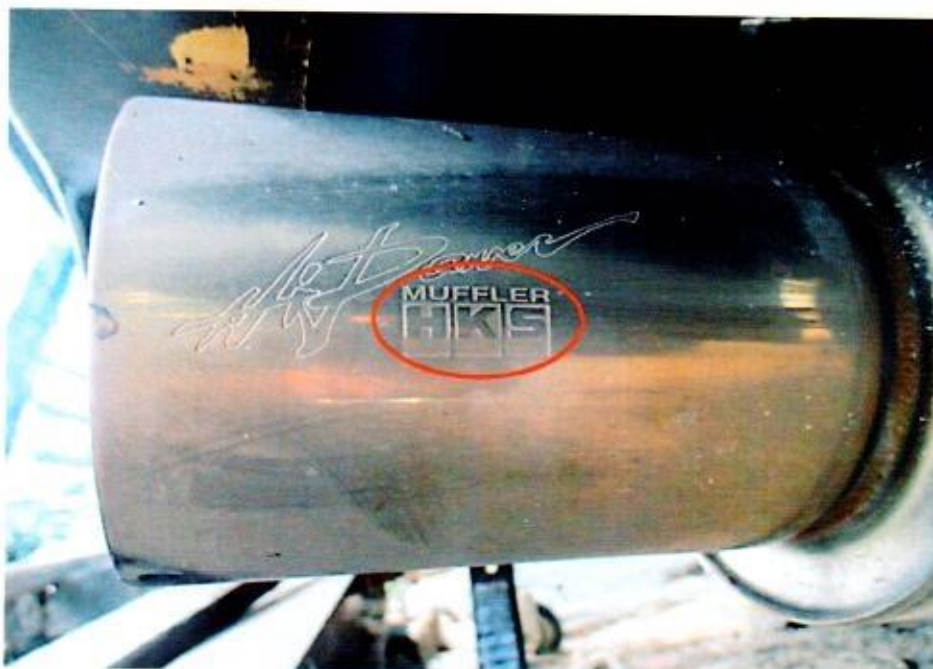
Photo 8 shows a close up right side view of the non-standard rear exhaust muffler that was found to be fitted on the Insured Vehicle at the time of our inspection. The brand of the rear exhaust muffler was 'HKS' (circled).

31. We found the Insured Vehicle to be fitted with a non- standard rear exhaust muffler and non-standard tyre rims (17 inch alloy rims). The abovementioned rims do not require prior approval from LTA however the non-standard rear exhaust muffler would require prior approval from LTA. Mr Foo has provided documents to prove that the non-standard rear exhaust muffler has been approved by the LTA.

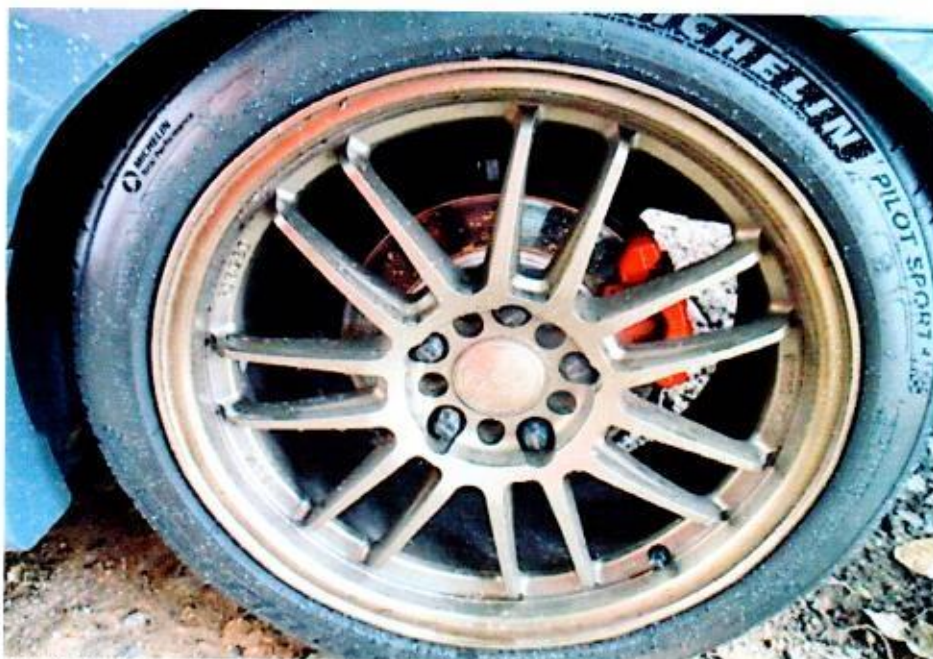
Photo 9 shows the non-standard rim found to be fitted on the Insured Vehicle at the time of our inspection. The 17- inch alloy rims fitted on the Insured Vehicle were not the standard type for the Insured Vehicle.

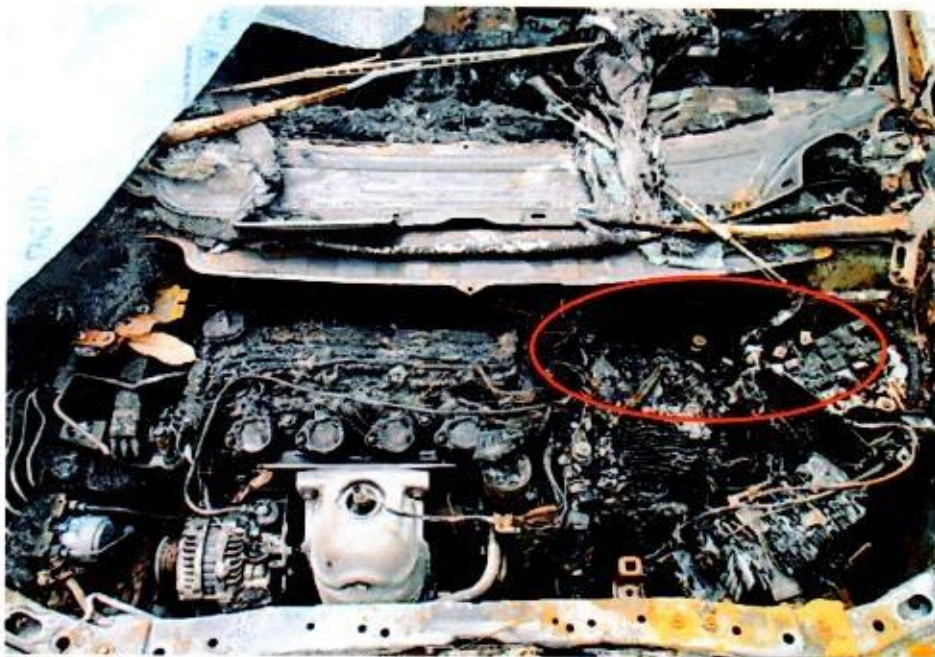
8. For this particular case, the fire appears to have originated within the engine compartment of the Insured Vehicle, somewhere around the rear left portion of the engine compartment. This can be determined from the greenish residue that was found on several stretches of burnt original factory fitted wirings mainly around the rear left portion of the engine compartment. The presence of greenish residue indicates internal heating of copper wires, a sign of an electrical short circuit occurring. The greenish residue is normally left behind from oxidation as a result of chemical reaction involving the copper wires. These physical evidences would appear to suggest that the cause of fire to the Insured Vehicle could have possibly been due to electrical in nature. See photos 10 – 12 below.

Photo 10 shows the burnt wirings around the rear left portion of the engine compartment which is near to the vicinity where the fire to the Insured Vehicle had likely started (circled).

29. Having investigated and technically analysed the damages to the Insured Vehicle, we are of the view that the cause of fire to the Insured Vehicle was of electrical in nature. For this particular case, the fire had originated along the wirings inside the engine compartment, somewhere around the rear left portion. The wirings were original factory wirings of the Insured Vehicle.

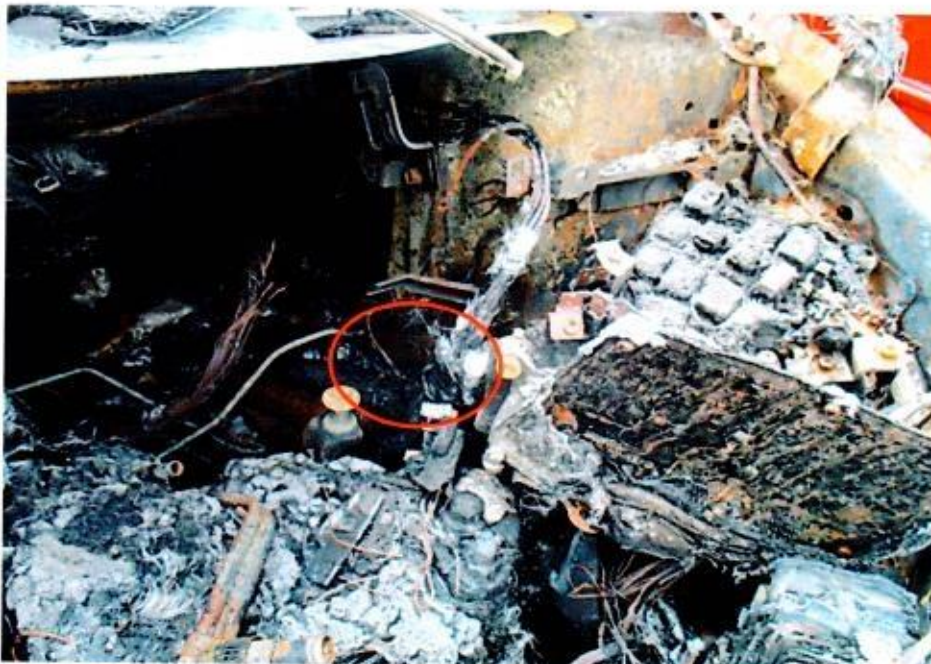
Photo 11 shows a closer view the greenish residue on several stretches of burnt wirings at the rear left portion of the engine compartment (circled), a sign of an electrical short circuit occurring. The greenish residue is normally left behind from oxidation as a result of chemical reaction involving the copper wires.

27. The possibility of the fire being due to electrical in nature would then seem more likely given that engine overheating and external factors would both seem unlikely. The fire being due to electrical nature is also supported by the condition of the wirings that were found in the engine compartment of the Insured Vehicle, which was earlier discussed in paragraph 8 above.

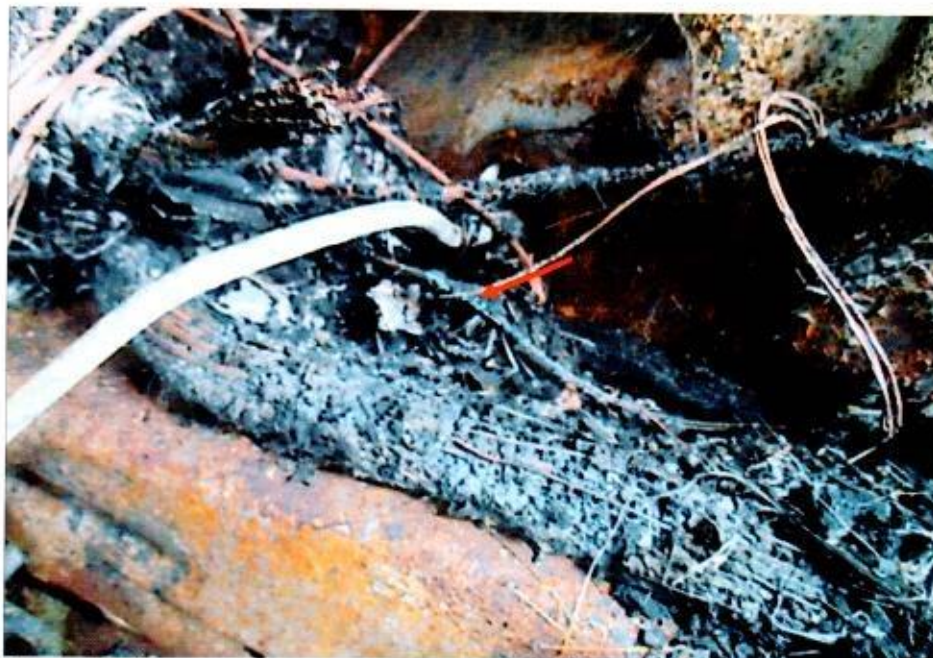
Photo 12 shows a close up view of the greenish residue on the wirings at the rear portion of the engine compartment (arrowed). The presence of such greenish residue suggests occurrence of an electrical short circuit.

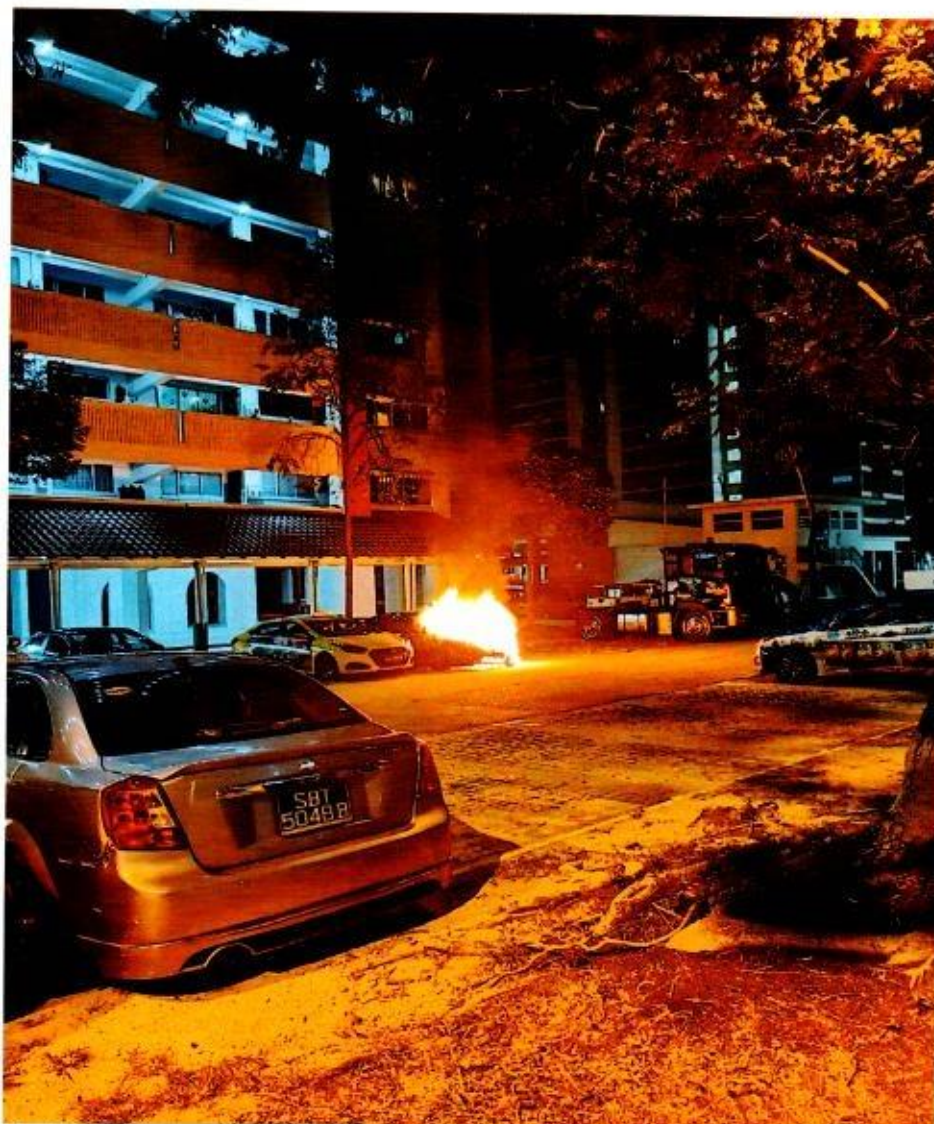
Photo 14 shows the Insured Vehicle on fire before the arrival of the SCDF. In general, the information that could be gathered from this photograph had corresponded to the events that were related to us by Mr Foo, which is there was a taxi parked on the right side of the Insured Vehicle when the fire broke out.

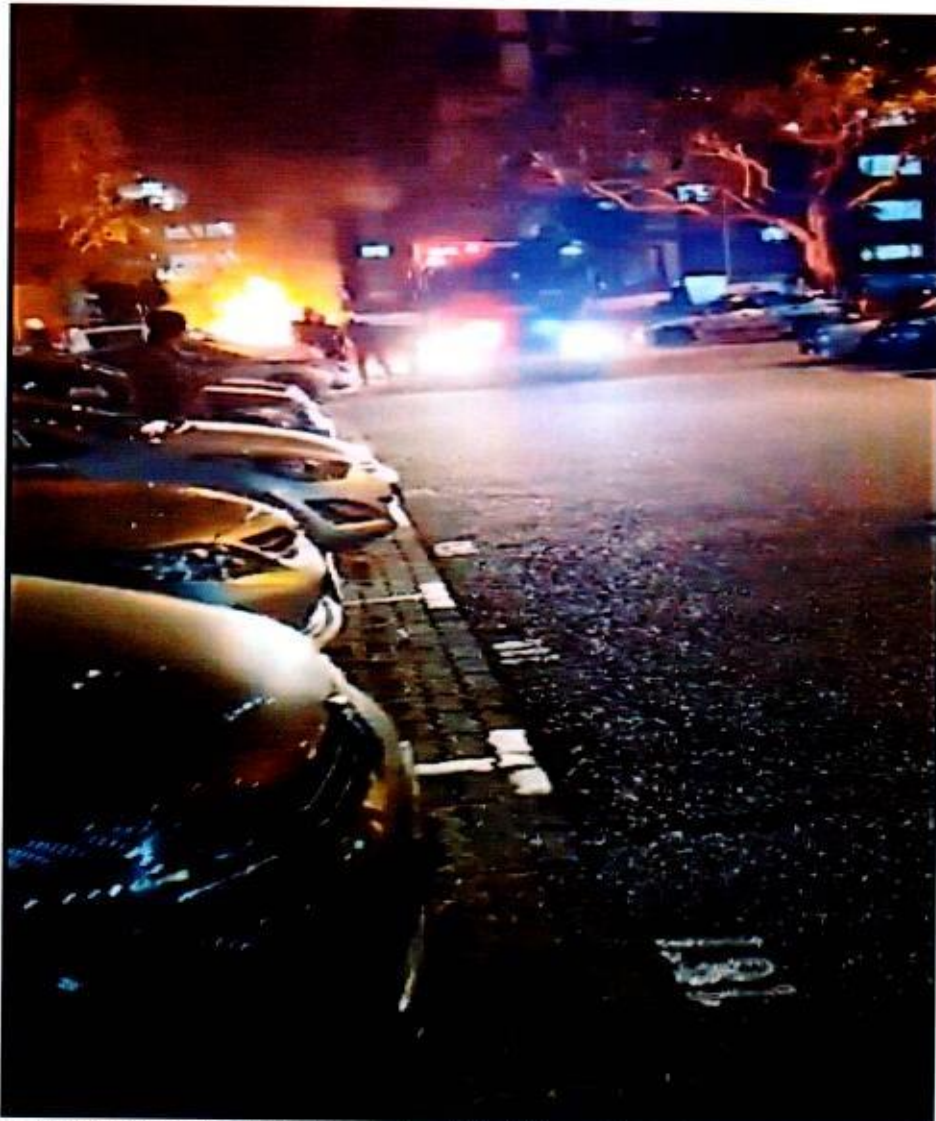
Photo 15 shows the SCDF's arrival and firefighters attempting to put out the fire.

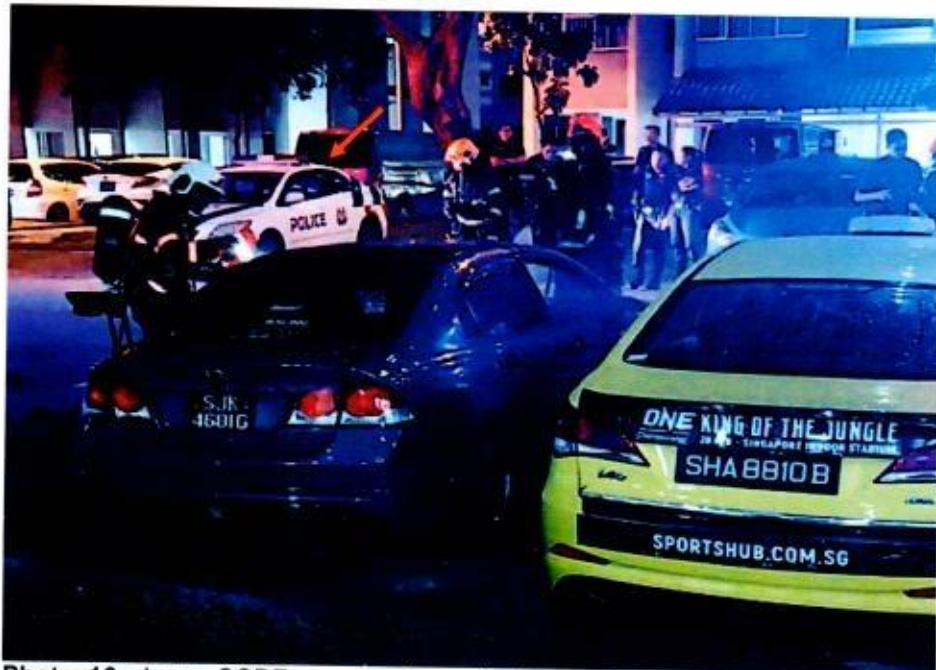
Photo 16 shows SCDF personnel conducting preliminary investigations as to how the fire to the Insured Vehicle had likely started. In general, the information that could be gathered from this photograph had corresponded to the events that were related to us by Mr Foo, which is police were also present at the incident scene (arrowed).

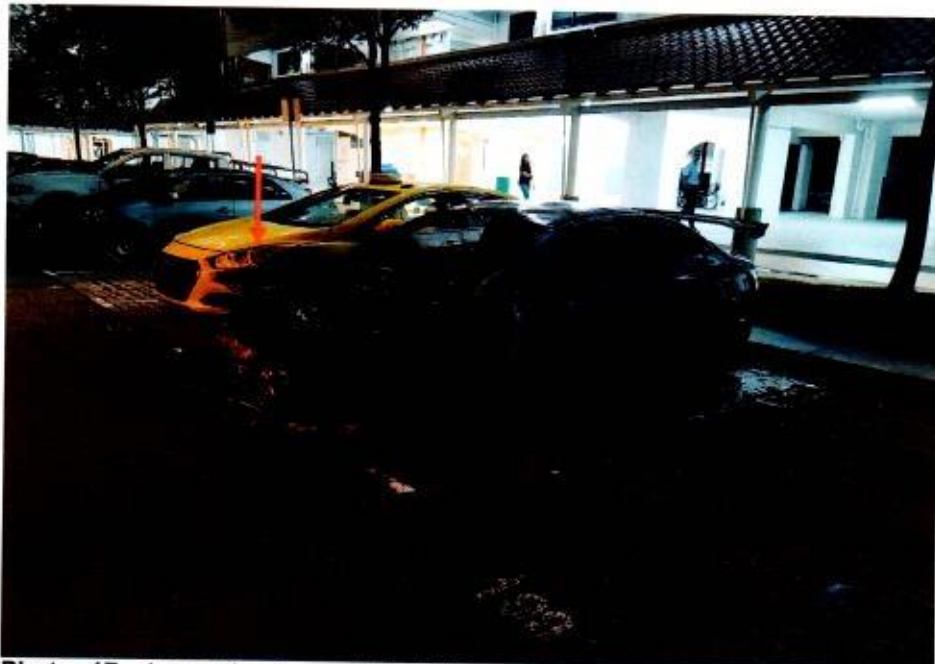
Photo 17 shows the Insured Vehicle and the taxi after the fire had been extinguished. The taxi had sustained consequential damage of heat nature to its front left side as a result of the fire (arrowed).

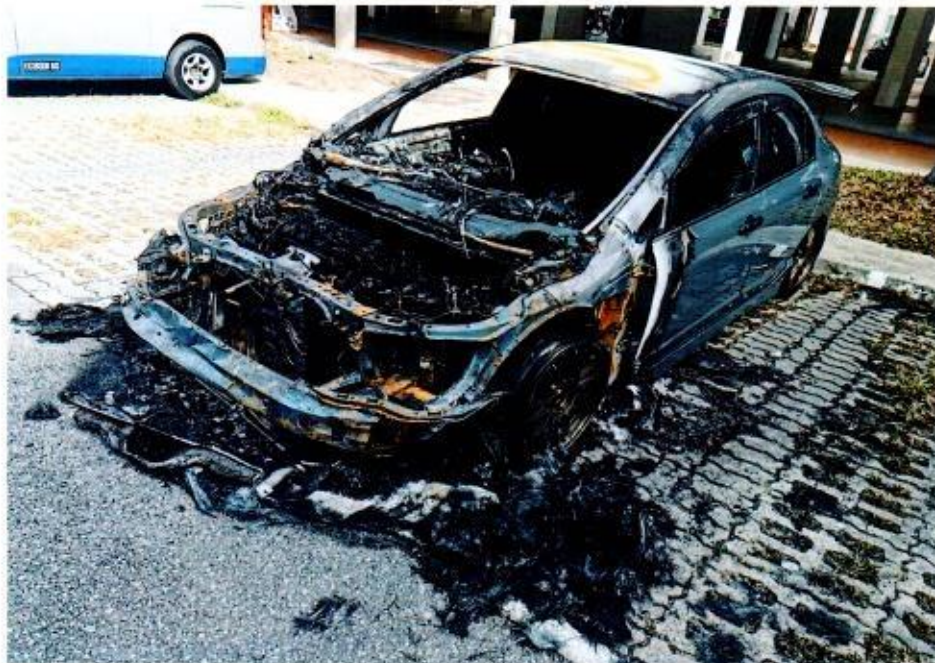
Photo 18 shows the Insured Vehicle at the incident scene after the fire was extinguished. The extent of damage indicates that the fire had started in the engine compartment.

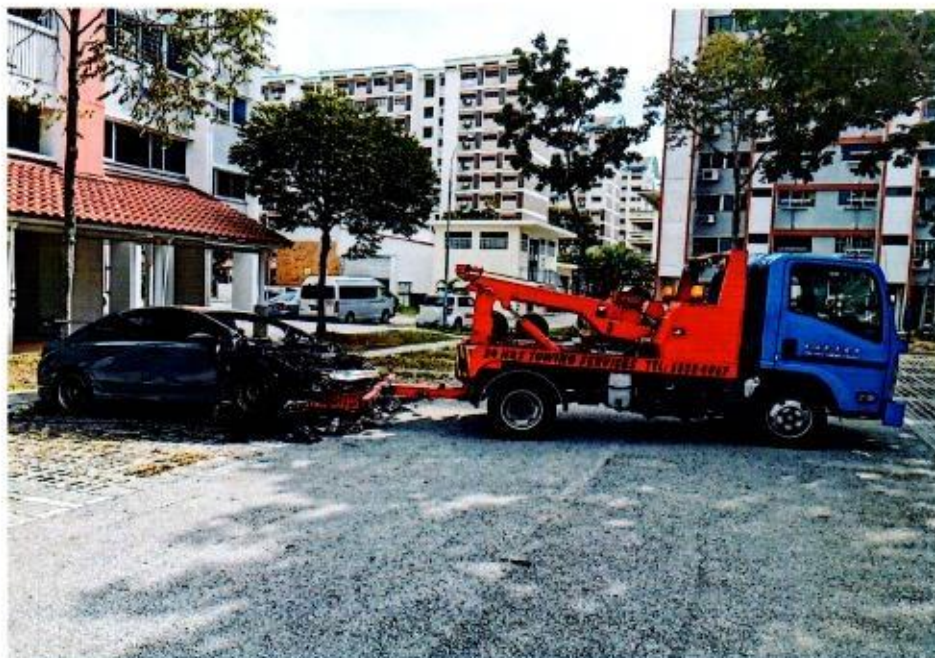
Photo 19 shows the Insured Vehicle being prepped to be towed away.
