Your Ref: C10005502/JM  
Our Ref : CS/AGI20002468/P

26<sup>th</sup> February 2020

**M/s Auto & General Insurance (Singapore) Pte. Ltd.**

**TECHNICAL INVESTIGATION REPORT OF FIRE INCIDENT INVOLVING THE INSURED VEHICLE SMA 1984U ON 06<sup>th</sup> FEBRUARY 2020**

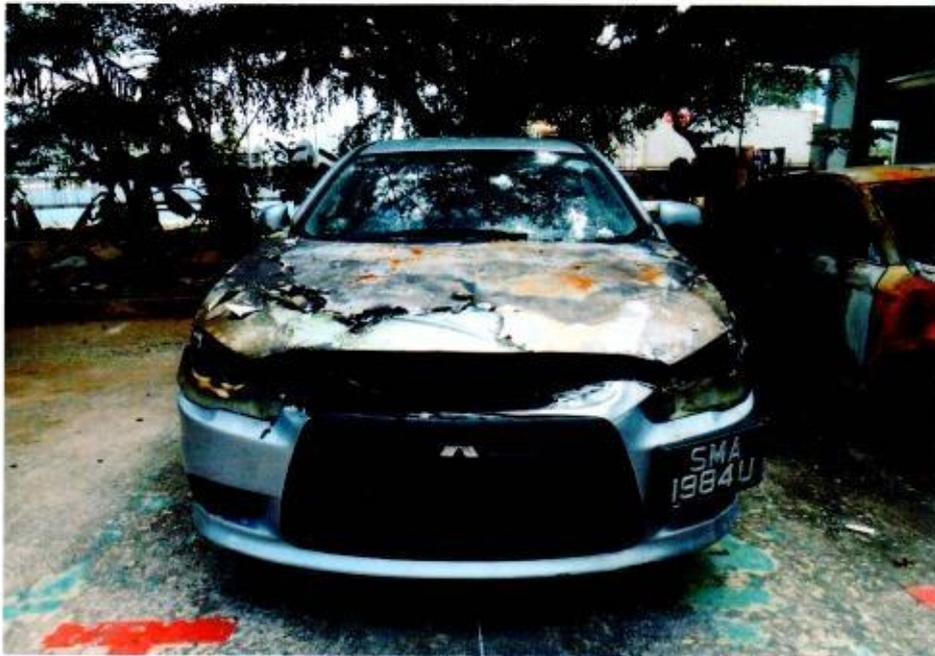
**Photo 1** shows the general view of the front portion of the Insured Vehicle at the time of our inspection. The fire damage to the Insured Vehicle was confined to its front right portion. Its front right headlamps, bonnet and whole of the engine compartment were also observed to sustain heat damage. This includes the timing cover, alternator, battery, Ecu, fuses box ABS pump and its wiring harness, are amongst the body parts that were found to have been affected as a result of the fire.

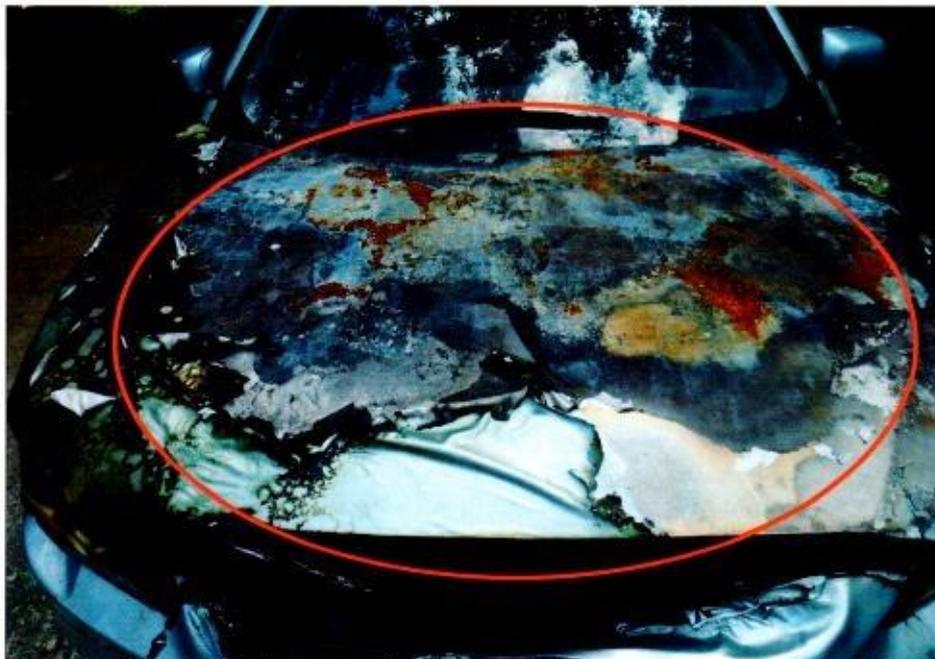
**Photo 2** shows the close up view of the front bonnet portion of the Insured Vehicle at the time of our inspection. The fire damage to the Insured Vehicle was confined to its front portion. As observed whitish burn marks (circled) on the surface are a result of exposure to prolonged heat intensity as a result of the fire.

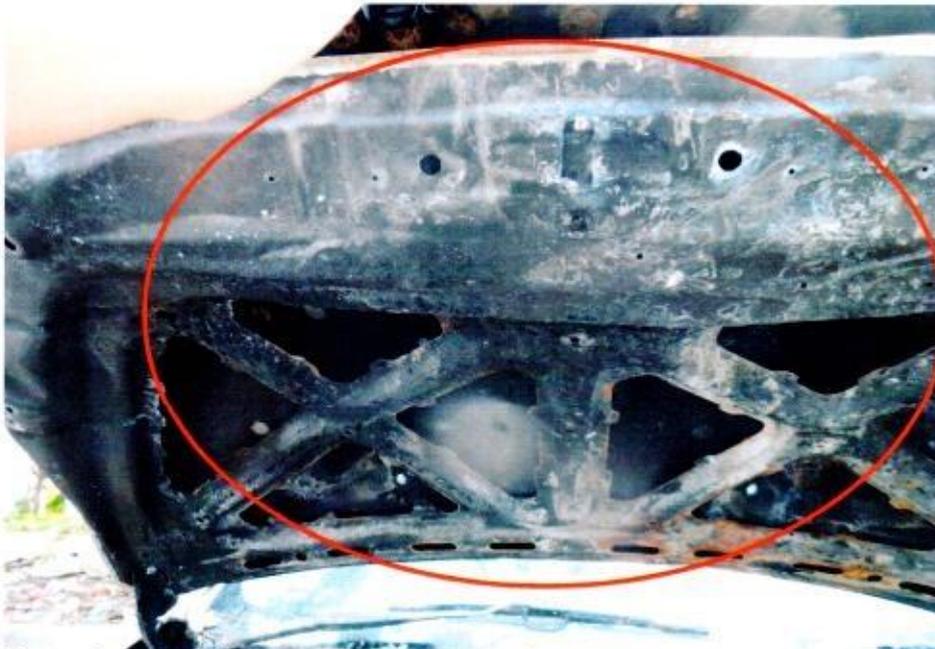
**Photo 3** shows the close up view of the front bonnet portion of the Insured Vehicle at the time of our inspection. The fire damage to the Insured Vehicle was confined to its front portion. As observed whitish burn marks (circled) on the surface are a result of exposure to prolonged heat intensity as a result of the fire.

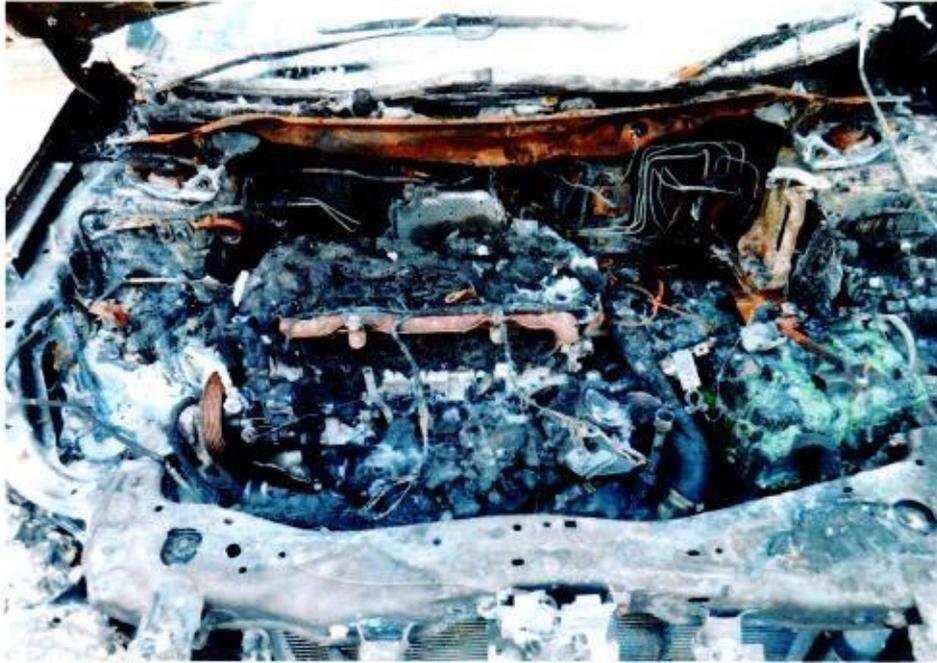
**Photo 4** shows the general view of the engine compartment of the Insured Vehicle at the time of our inspection. Its front headlights, timing cover, alternator, battery, Ecu, fuse box, ABS pump and its wiring harness, are amongst the body parts that were found to have been affected as a result of the fire.

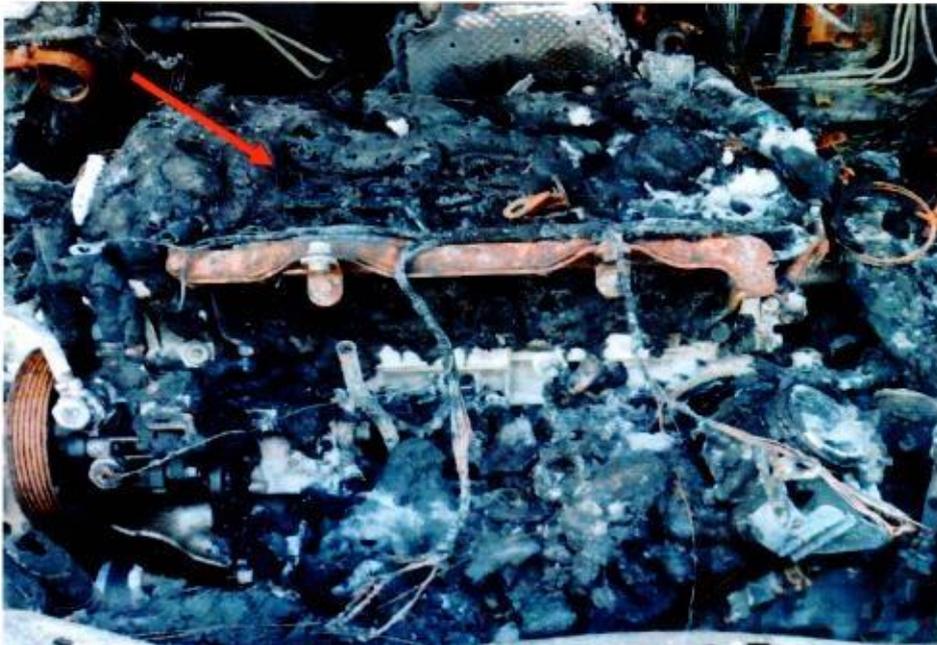
**Photo 5** shows the close up view of the front engine compartment portion of the Insured Vehicle at the time of our inspection. Its timing cover, (arrowed) was damaged as a result of the fire.

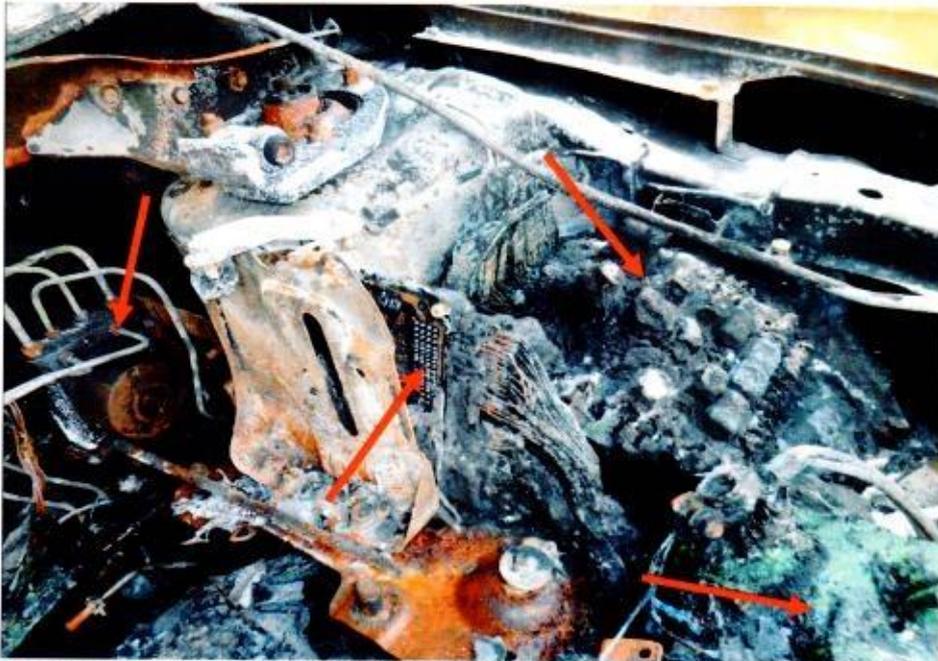
**Photo 6** shows the close up view of the front engine compartment portion of the Insured Vehicle at the time of our inspection. Its ABS pump, Ecu, fuse box and battery (arrowed) were damaged as a result of the fire.

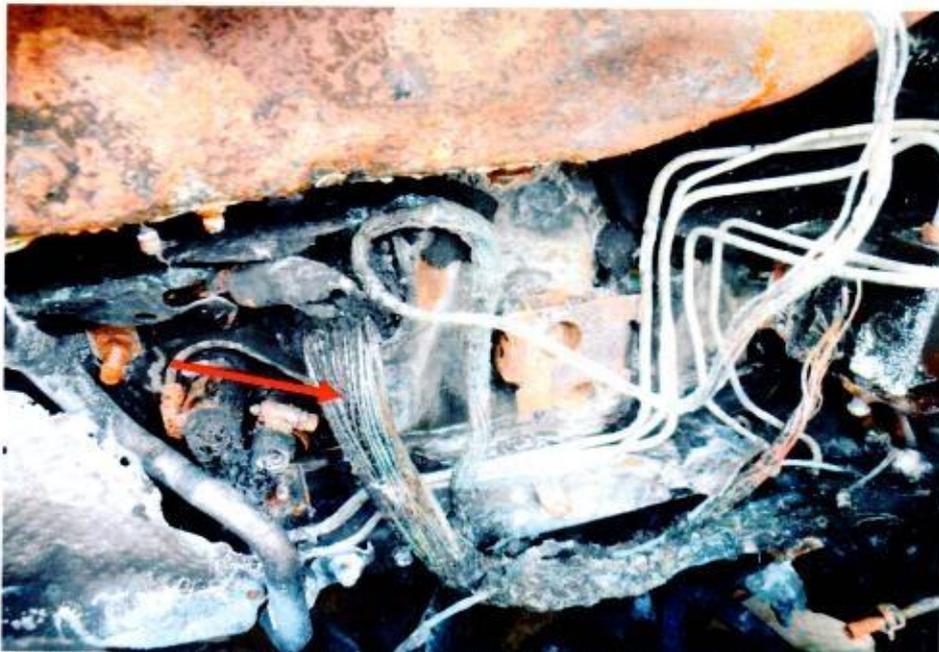
**Photo 7** shows the close up view of the front engine compartment portion of the Insured Vehicle at the time of our inspection. Its wiring harnesses (arrowed) were damaged as a result of the fire.

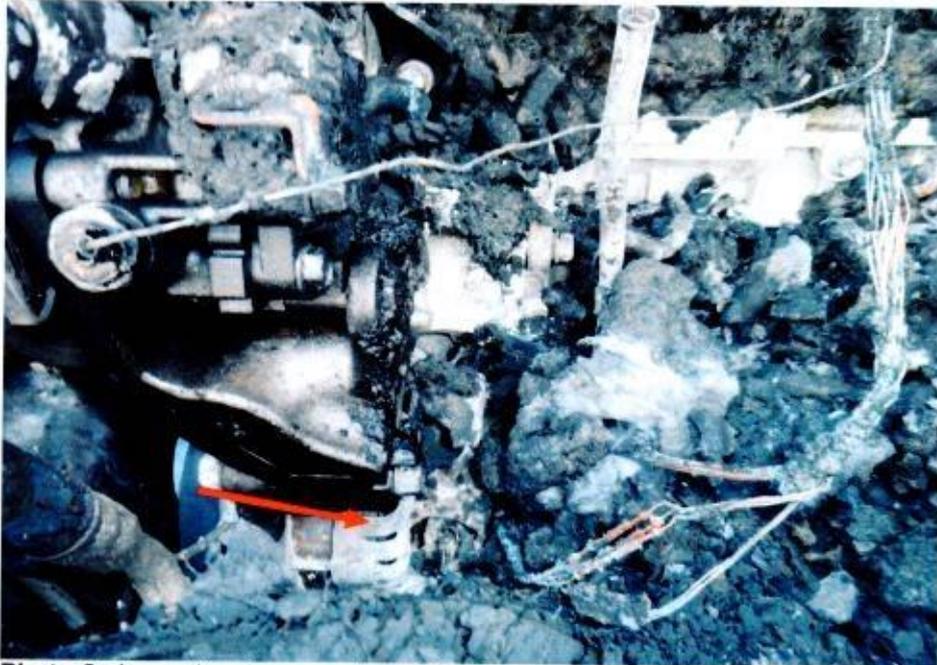
**Photo 8** shows the close up view of the front engine compartment portion of the Insured Vehicle at the time of our inspection. Its alternator (arrowed) was damaged as a result of the fire.

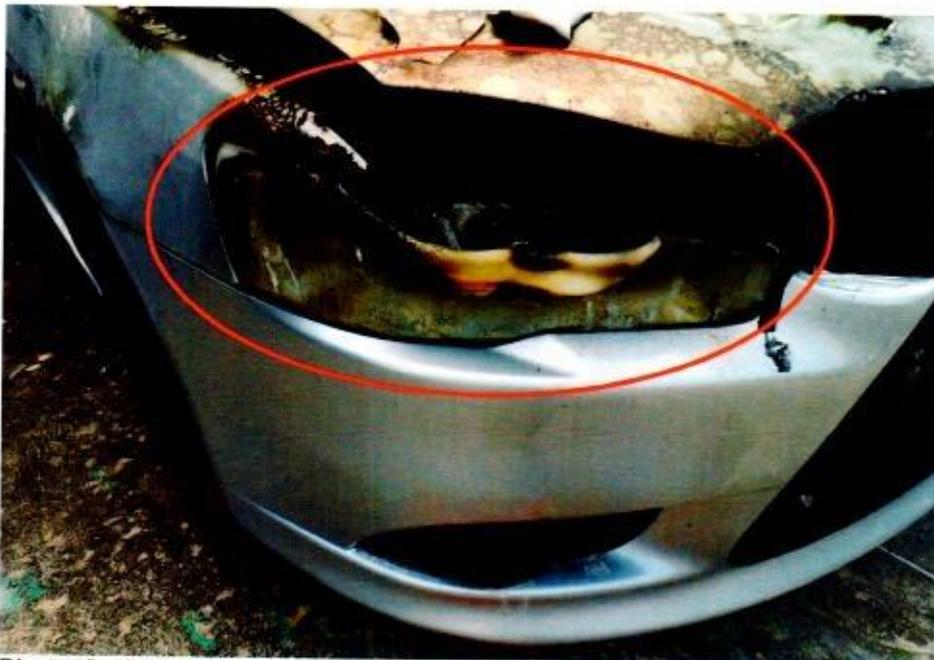
**Photo 9** shows the close up view of the front right head lamp portion of the Insured Vehicle at the time of our inspection. The whole of the head lamp including its housing and its wiring harness (circled) were damaged and melted down as a result of the fire.

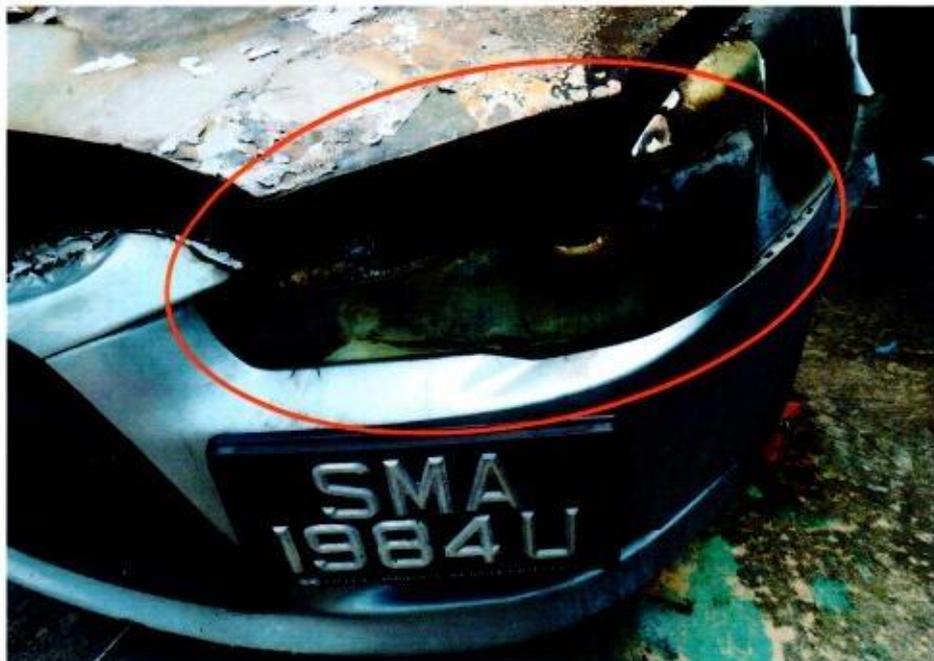
**Photo 10** shows the close up view of the front left head lamp portion of the Insured Vehicle at the time of our inspection. The whole of the head lamp including its housing and its wiring harness (circled) were damaged and melted down as a result of the fire.

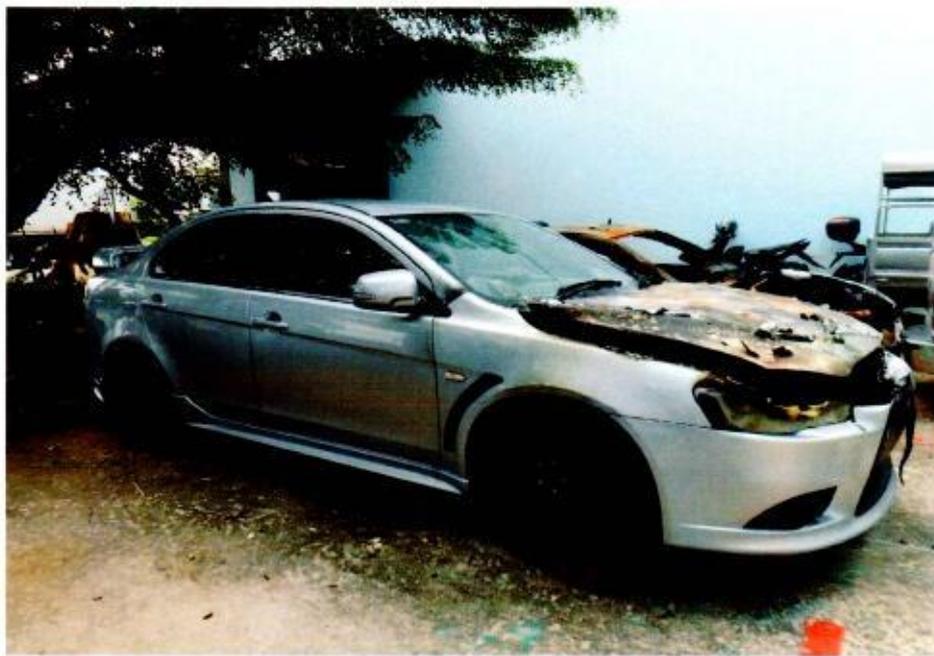
**Photo 11** shows the right rear portion of the Insured Vehicle, which was observed to be unaffected by the fire.

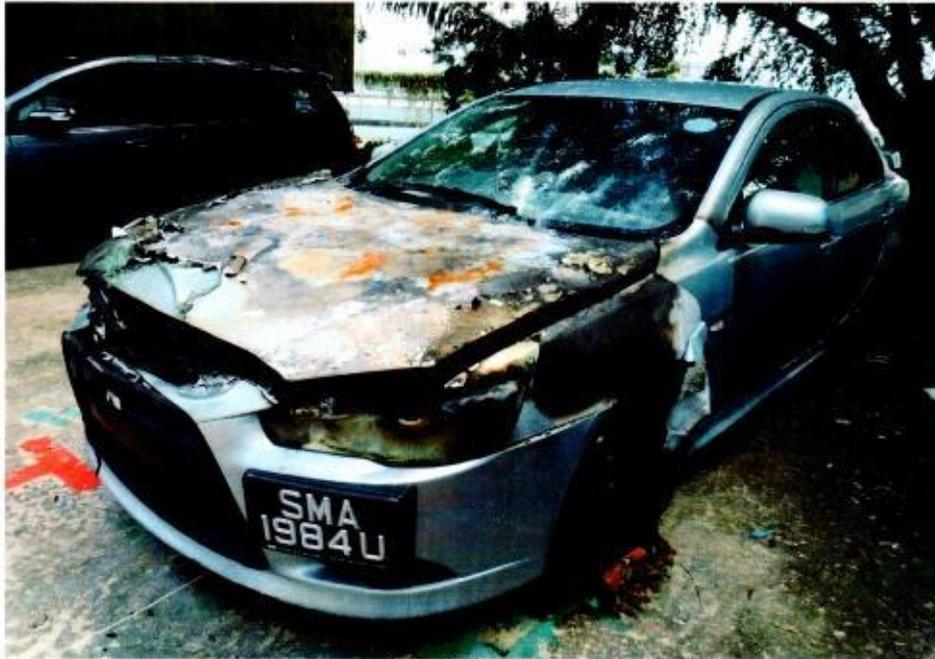
**Photo 12** shows the left rear portion of the Insured Vehicle, which was observed to be unaffected by the fire.

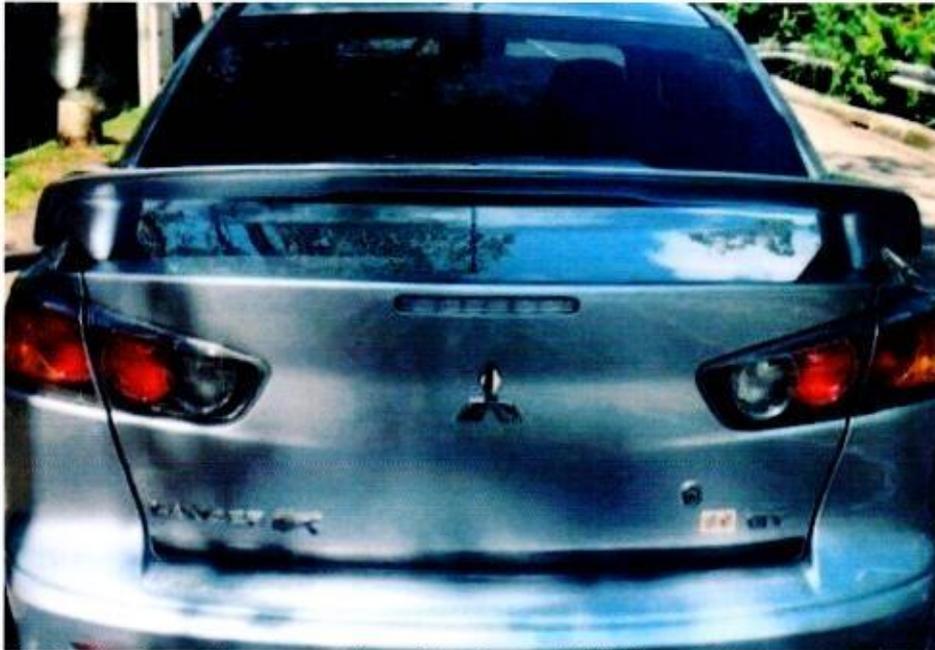
**Photo 13** shows the rear portion of the Insured Vehicle, which was observed to be unaffected by the fire.

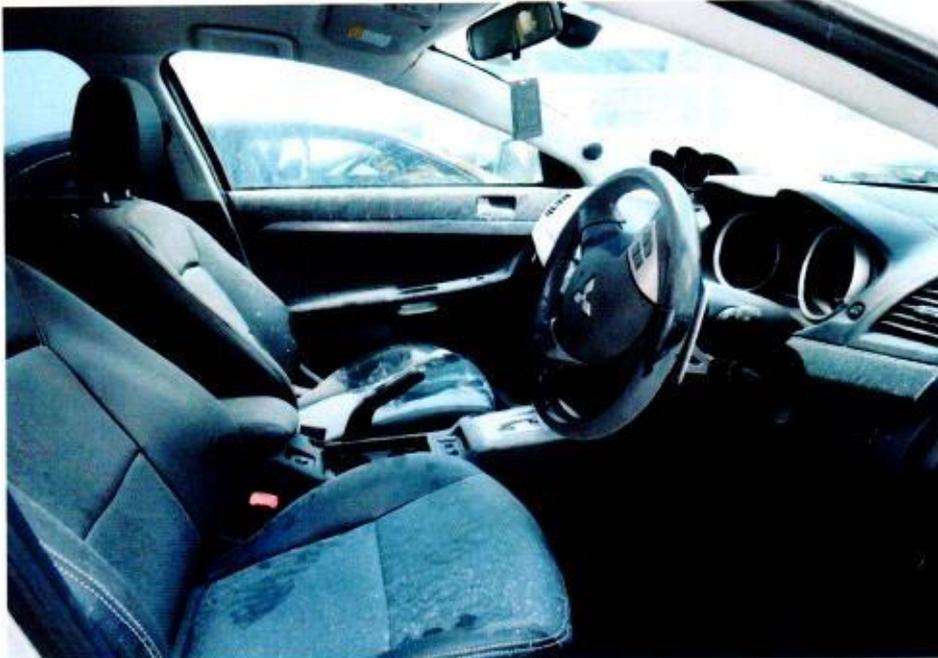
**Photo 14** shows the interior compartment of the Insured Vehicle, which was observed to be unaffected by the fire.

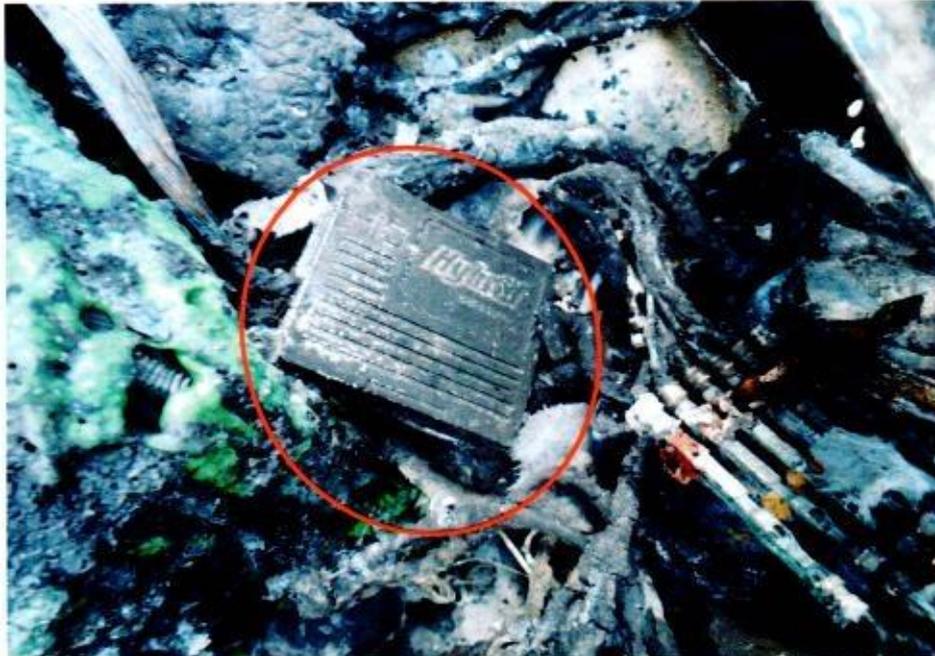
**Photo 15** shows the left aftermarket head lamp with High Intensity Discharged (HID) bulbs and external ballast (circled) of the Insured Vehicle, which was observed to be affected by the fire.

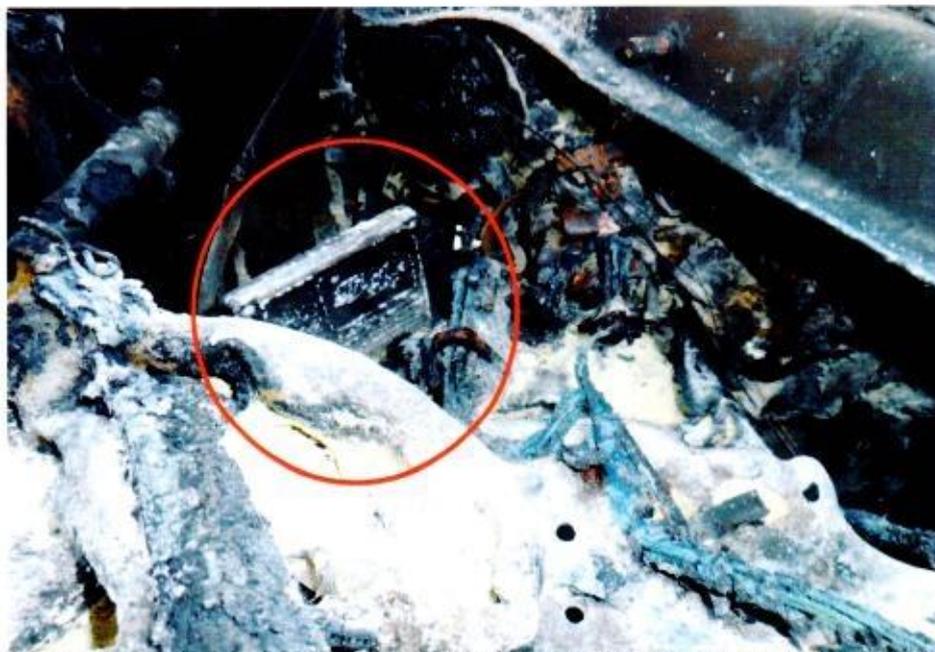
**Photo 16** shows the right aftermarket head lamp with High Intensity Discharged (HID) bulbs and external ballast (circled) of the Insured Vehicle, which was observed to be affected by the fire.

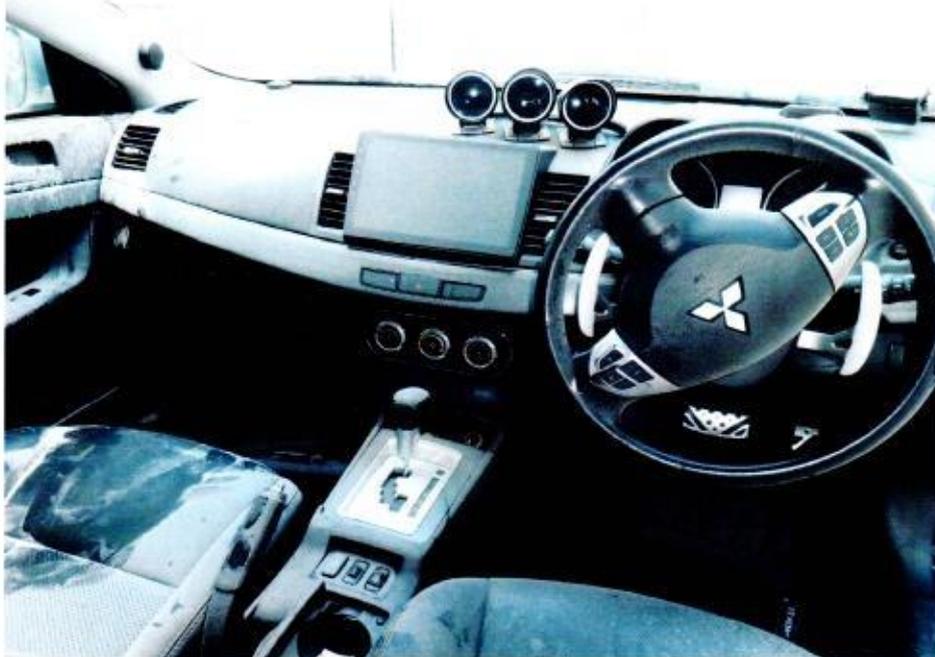
**Photo 17** shows the interior compartment of the Insured Vehicle. An aftermarket audio head unit with tweeters and external instrument gauges were fitted on the Insured Vehicle, which was observed to be unaffected by the fire.

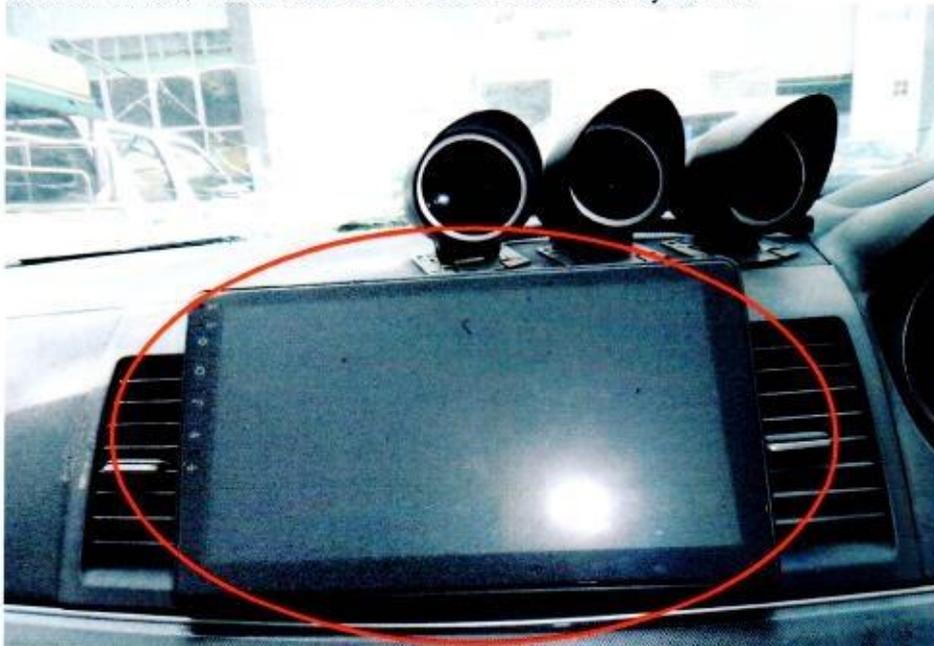
**Photo 18** shows the aftermarket audio head unit (arrowed) of the Insured Vehicle, which was observed to be unaffected by the fire.

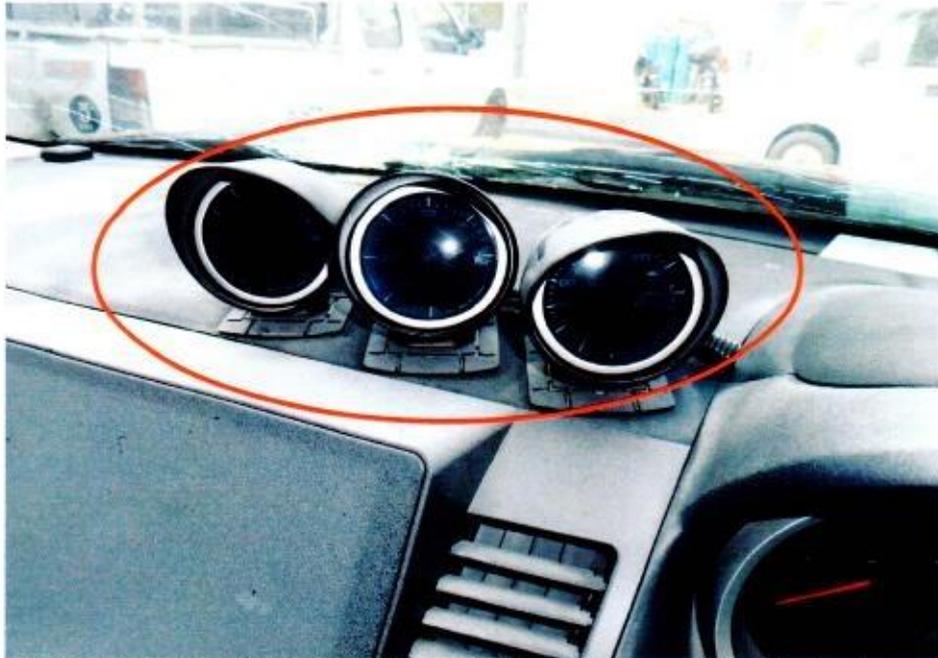
**Photo 19** shows aftermarket external instrument gauges fitted in the Insured Vehicle, which was observed to be unaffected by the fire.

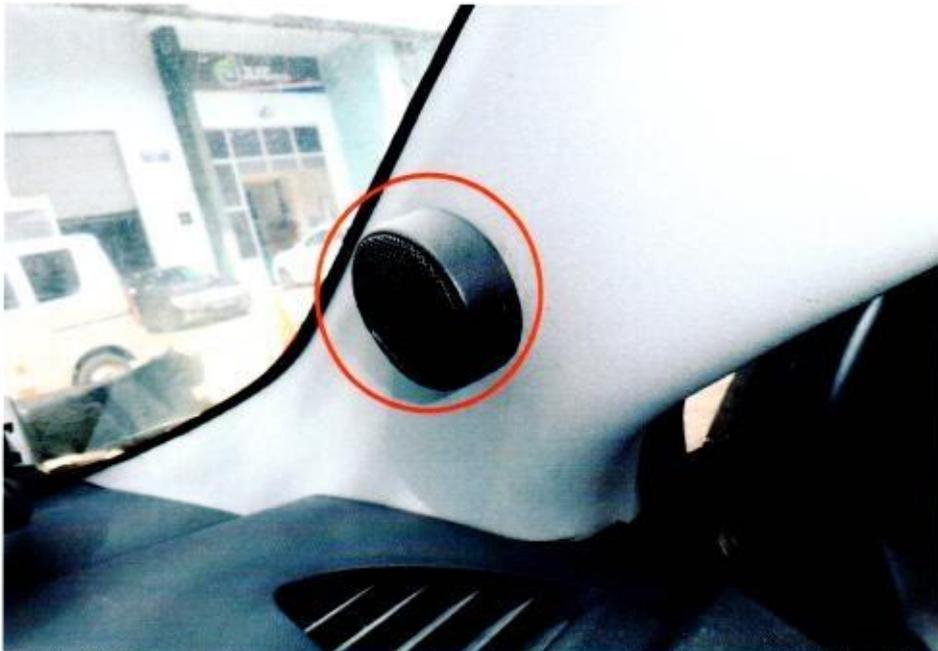
**Photo 20** shows aftermarket audio tweeters fitted in the Insured Vehicle, which was observed to be unaffected by the fire.

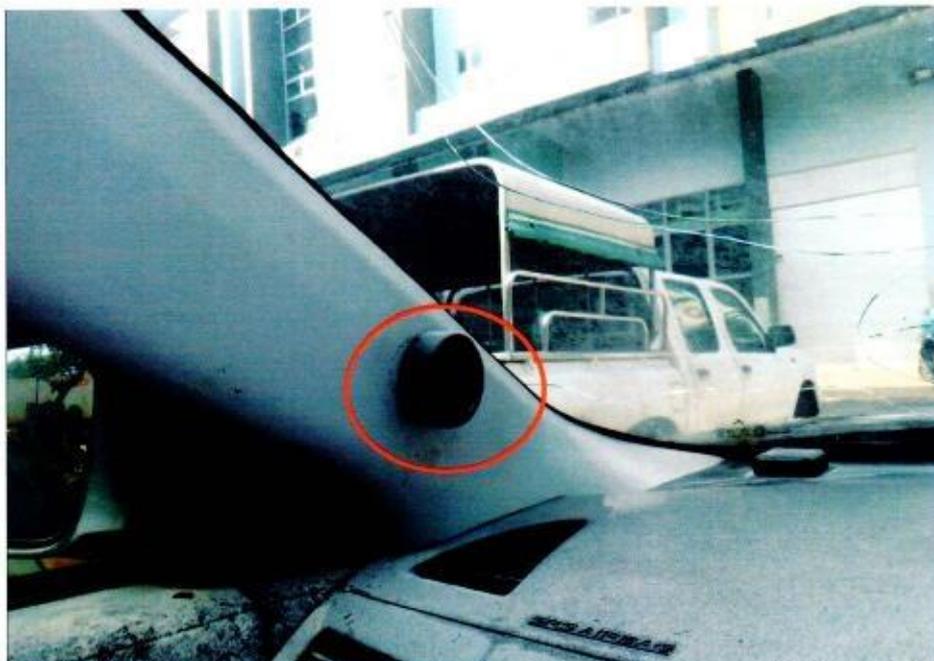
**Photo 21** shows aftermarket audio tweeters fitted in the Insured Vehicle, which was observed to be unaffected by the fire.

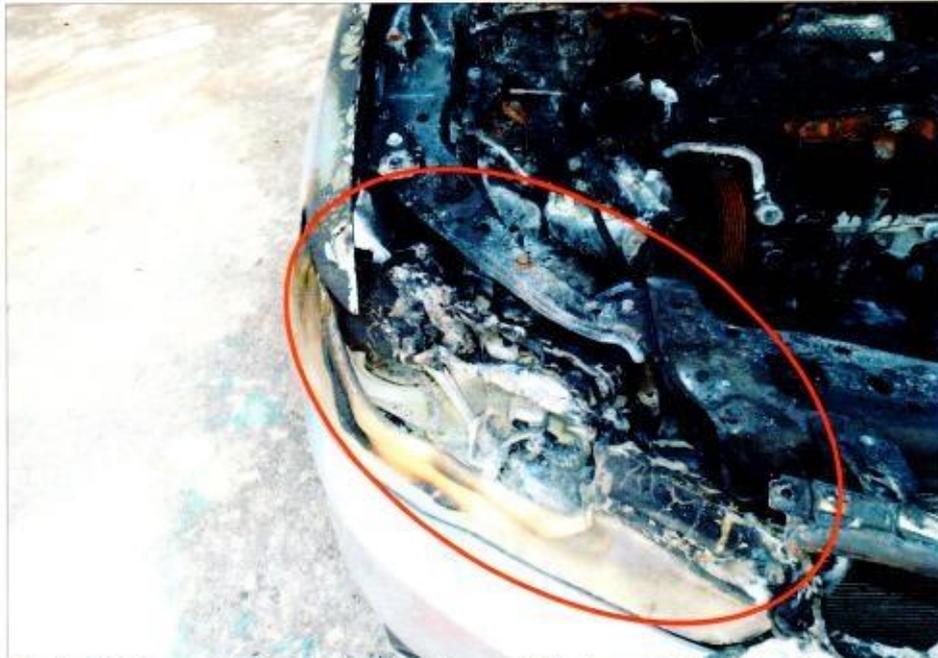
10. The whitish burn marks are a result of exposure to prolonged heat intensity. Rust would normally start to develop around these areas soon after a fire as prolonged exposure to high heat intensity usually causes steel/metal material body parts to be exposed to natural environmental condition. The rust that had developed on the metal brackets is an indication that the front right position of the Insured Vehicle had sustained exposure to prolonged high heat intensity. See photos 22 - 23 below.

**Photo 22** shows the front right headlamp of the Insured Vehicle, at the time of our inspection. Due to heat rises, the prolonged high heat intensity confined to this area caused high heat intensity burn marks (whitish burn marks) on the surface of the metal bracket of the Insured Vehicle. (circled) and the headlamp assembly and various components was observed to be melted from the high heat intensity

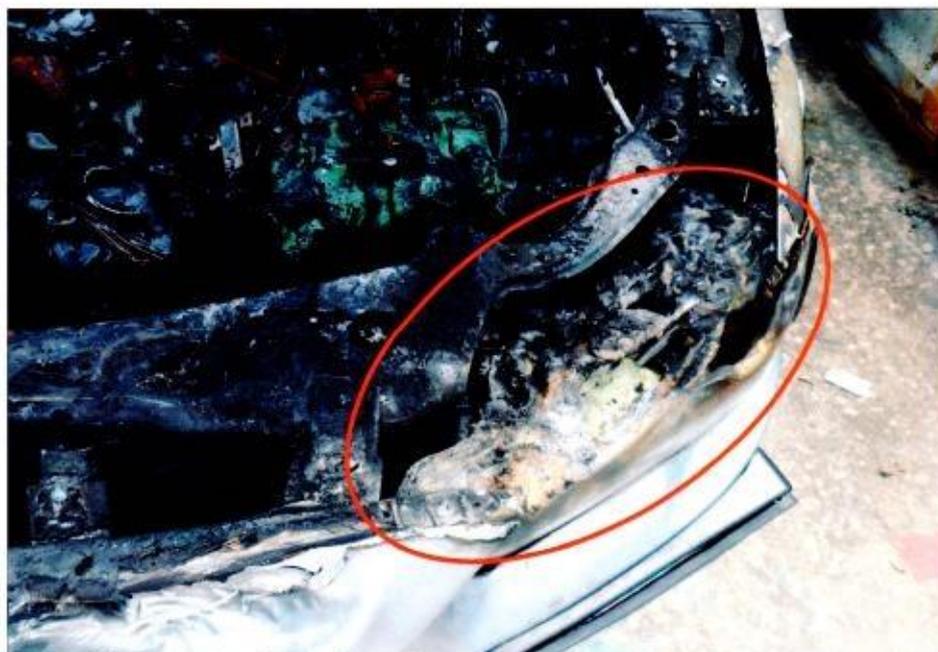
**Photo 23** shows the front left headlamp of the Insured Vehicle, at the time of our inspection. Due to heat rises, the prolonged high heat intensity confined to this area caused high heat intensity burn marks (whitish burn marks) on the surface of the metal bracket of the Insured Vehicle. (circled) and the headlamp assembly and various components was observed to be melted from the high heat intensity

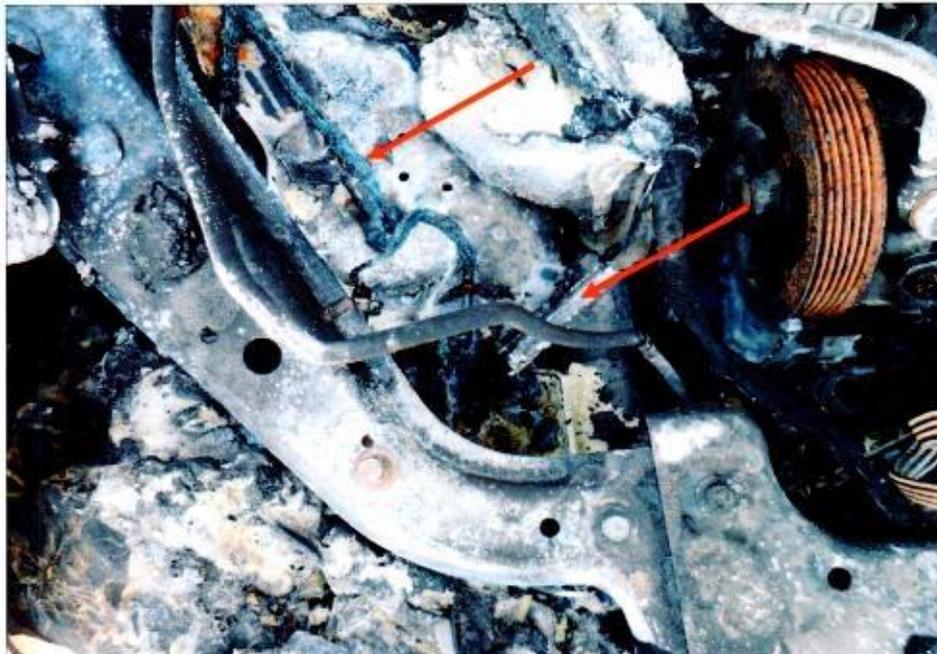
11. Upon closer examination to the both front headlamps of the Insured Vehicle which was where the fire had likely started, we had found traces of greenish residue on the wirings leading from the external ballast to the High intensity discharge blubs (HID). The external ballast wirings and HID bulbs were aftermarket and not factory fitted. The presence of greenish residue indicates internal heating of copper wires, a sign of an electrical short circuit occurring. The greenish residue is normally left behind from oxidation as a result of chemical reaction involving the copper wires. This physical evidence would then appear to suggest that the cause of fire to the Insured Vehicle could have possibly been due to electrical in nature. See photos 24 - 27 below.

**Photo 24** shows general view of the right headlamp wirings leading from the external ballast to the High intensity discharge blubs (HID). The external ballast wirings and HID bulbs were aftermarket and not factory fitted wirings (arrowed). The presence of greenish residue indicates internal heating of copper wires, a sign of an electrical short circuit occurring. The greenish residue is normally left behind from oxidation as a result of chemical reaction involving the copper wires.

25. Having investigated and technically analysed the damages of burnt nature to the Insured Vehicle, we are of the view that the cause of fire to the Insured Vehicle was of short circuit from the wirings of the non-original High intensity discharge (HID) headlight.
26. We did not find any evidence which had suggested that the cause of fire to the Insured Vehicle was due to poor maintenance and/or recurring electrical problem.
27. Our investigations had also revealed that at the time of writing this report, the manufacturer recall campaign in between 11<sup>th</sup> September 2014 – 25<sup>th</sup> January 2018 which had involved the Insured Vehicle did not possess a fire risk to the Insured Vehicle.

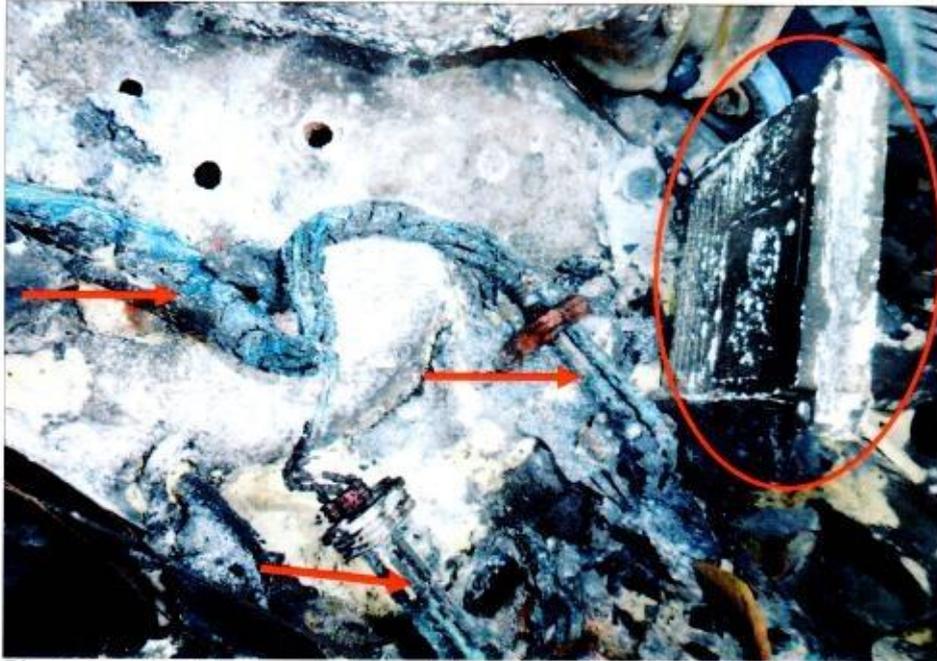
**Photo 25** shows the close up view of the right headlamp wirings leading from the external ballast (circled) to the High intensity discharge bulbs (HID) (arrowed). The external ballast wirings and HID bulbs were aftermarket and not factory fitted wirings. The presence of greenish residue indicates internal heating of copper wires, a sign of an electrical short circuit occurring. The greenish residue is normally left behind from oxidation as a result of chemical reaction involving the copper wires.

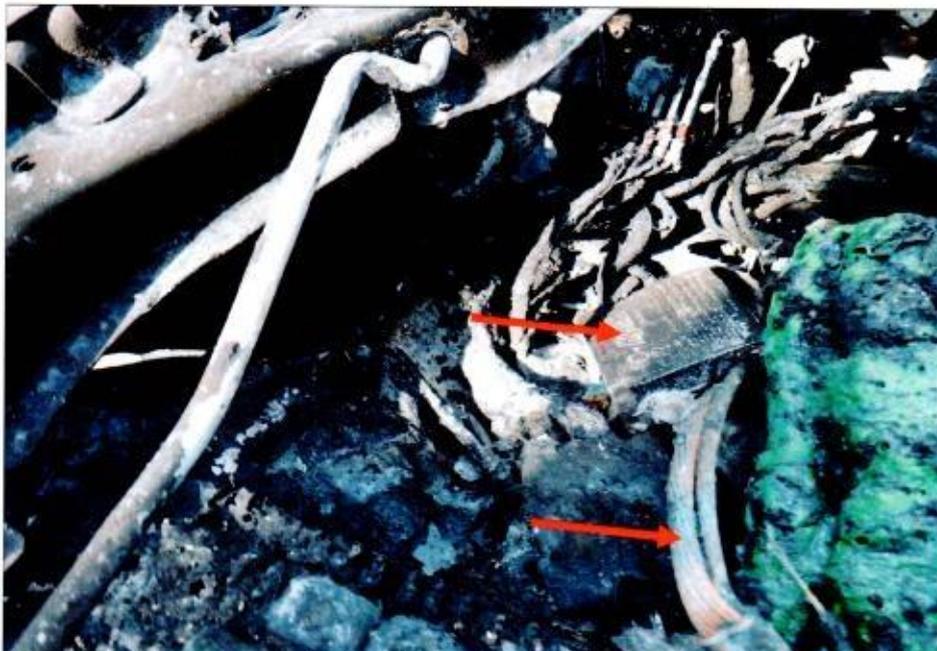
**Photo 26** shows general view of the left headlamp wirings leading from the external ballast to the High intensity discharge bulbs (HID). The external ballast wirings and HID bulbs were aftermarket and not factory fitted wirings (arrowed). The presence of greenish residue indicates internal heating of copper wires, a sign of an electrical short circuit occurring. The greenish residue is normally left behind from oxidation as a result of chemical reaction involving the copper wires.

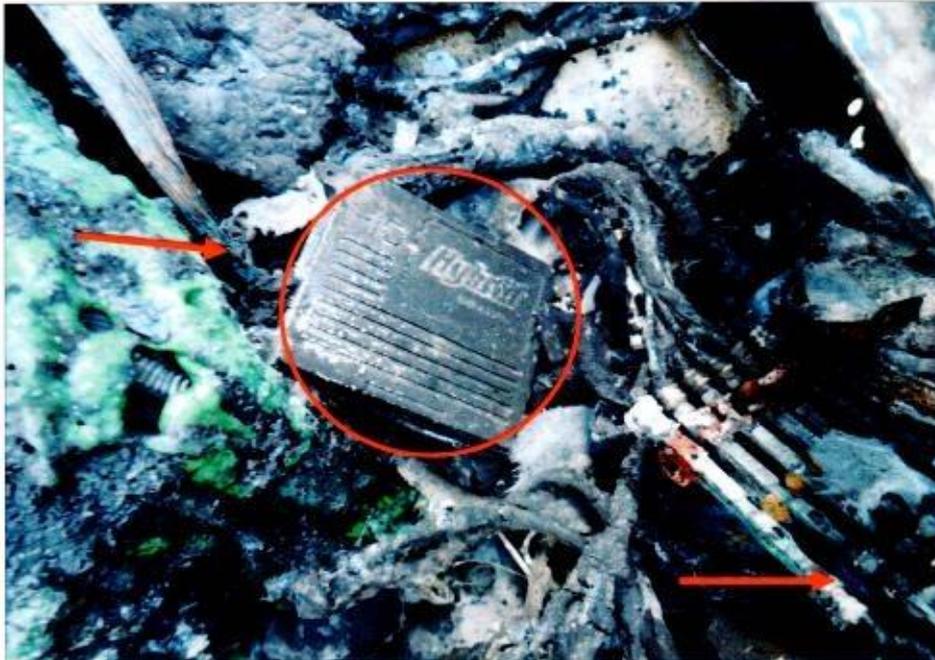
**Photo 27** shows the close up view of the left wirings leading from the external ballast (circled) to the High intensity discharge blubs (HID) (arrowed). The external ballast wirings and HID bulbs were aftermarket and not factory fitted wirings. The presence of greenish residue indicates internal heating of copper wires, a sign of an electrical short circuit occurring. The greenish residue is normally left behind from oxidation as a result of chemical reaction involving the copper wires.
