# LKK Auto Consultants Pte Ltd

| Affiliated to Federation Internationale Des Experts En Automobile | | | | |
|---|---|---|---|--|
| <b>1. Policy Particulars :- THIRD PARTY CLAIM</b> | | | | |

## ADJUSTMENT ON REPAIR COST FOR VEHICLE NO. SBT 3189R

### PHOTOGRAPHS FOR VEHICLE NO. SBT 3189R

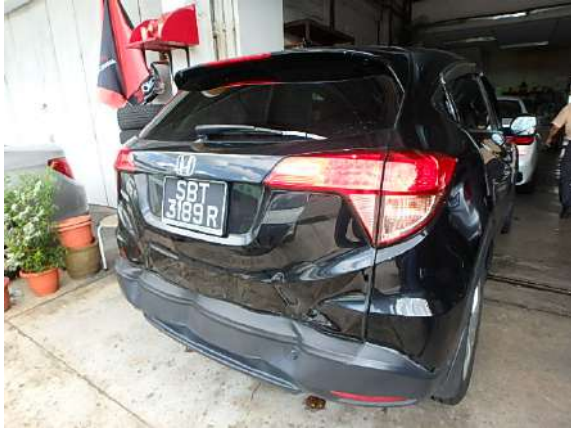
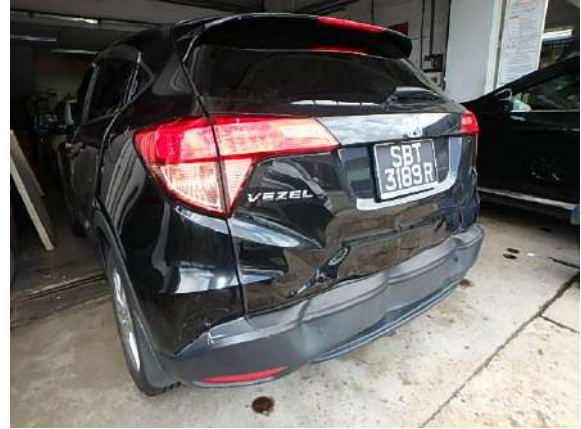
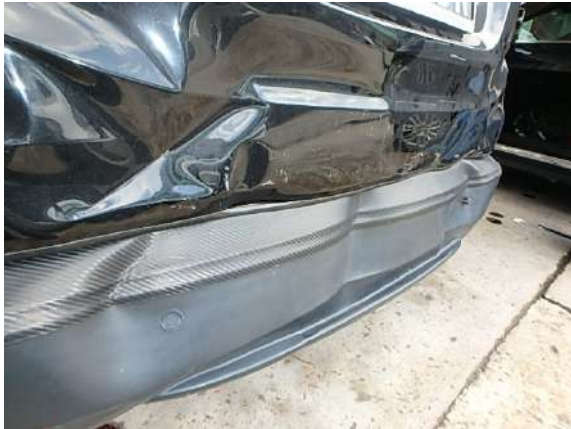
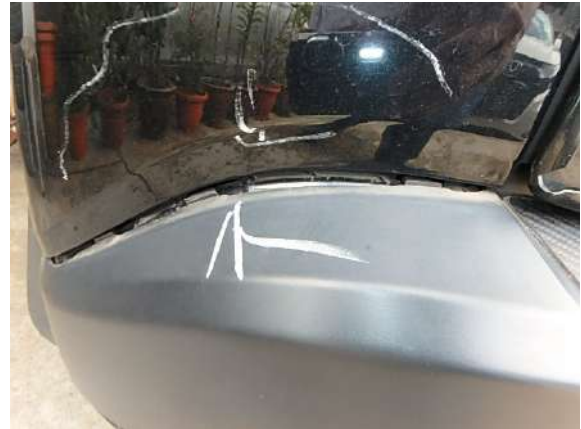
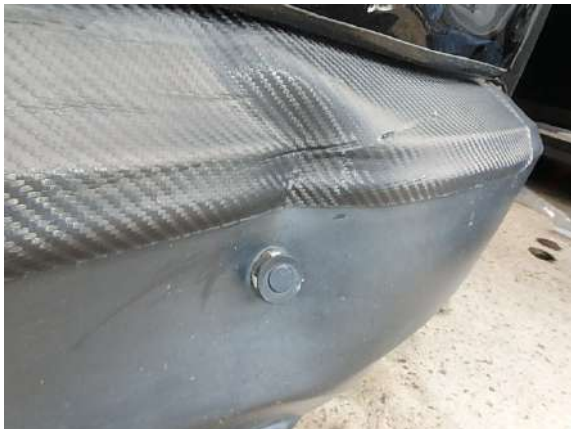
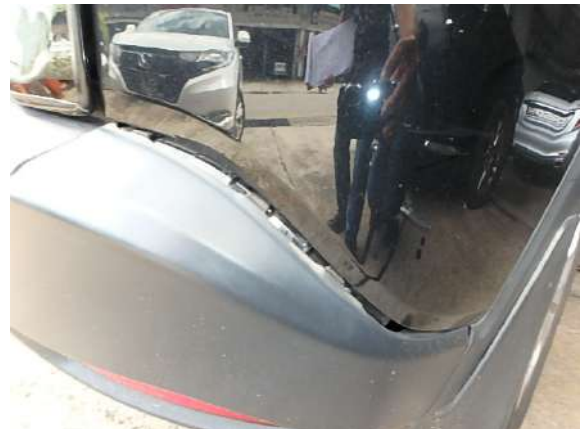
### INSPECTION

| Affiliated to Federation Internationale Des Experts En Automobile | | | | |
|---|---|---|---|--|
| THE VEHICLE SUSTAINED DAMAGES AT THE REAR PORTION.<br><br>DAMAGES SEE DETAILS. | | | | |
