LKK Auto Consultants Pte Ltd

1. Policy Particulars :- THIRD PARTY CLAIM				
	Insured Veh.	SHC 8416X	Veh. Inspected	SMM 5611G
	Policy No.	D-20094922MFSH	Coverage (\$)	0.00
	Claim No.	D20000957MFSH	Excess (\$)	0.00
	Assign From	CHRIS	Assign Date	13/02/2020

ADJUSTMENT ON REPAIR COST FOR VEHICLE NO. SMM 5611G

PHOTOGRAPHS FOR VEHICLE NO. SMM 5611G

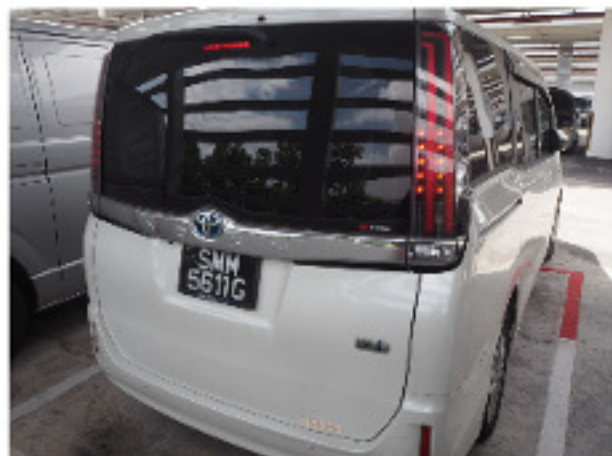
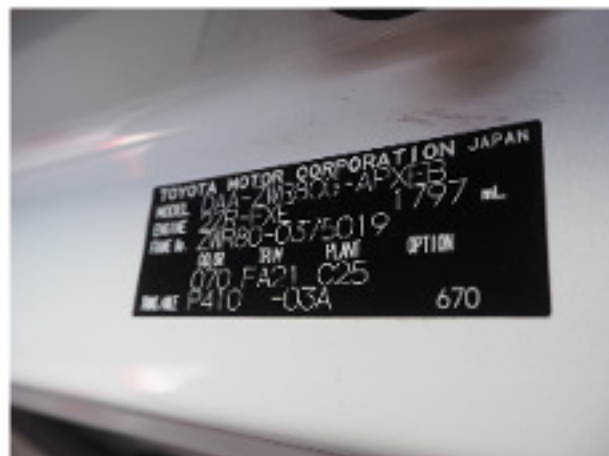
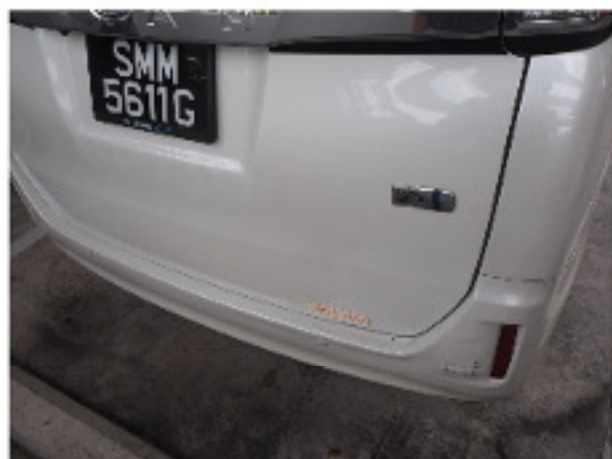
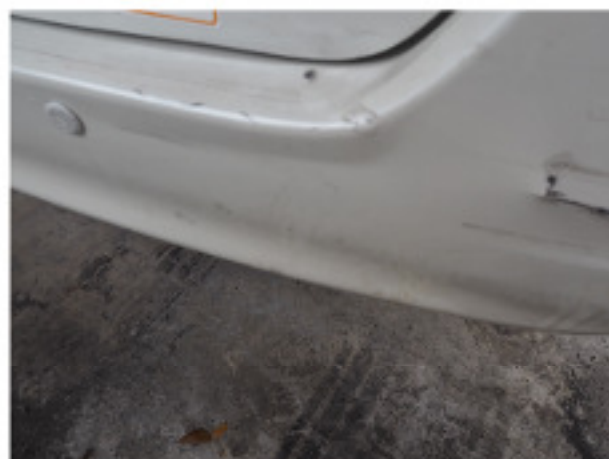
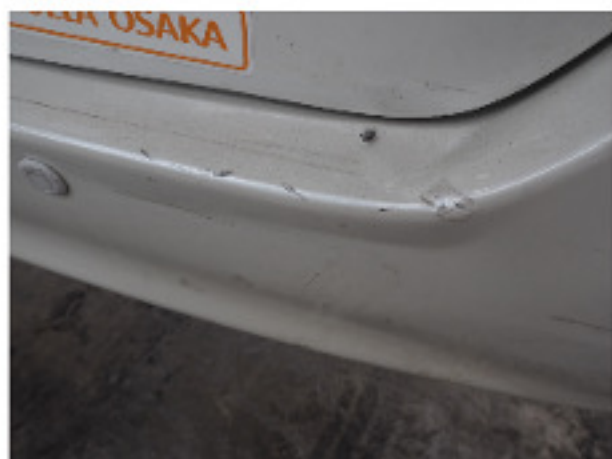
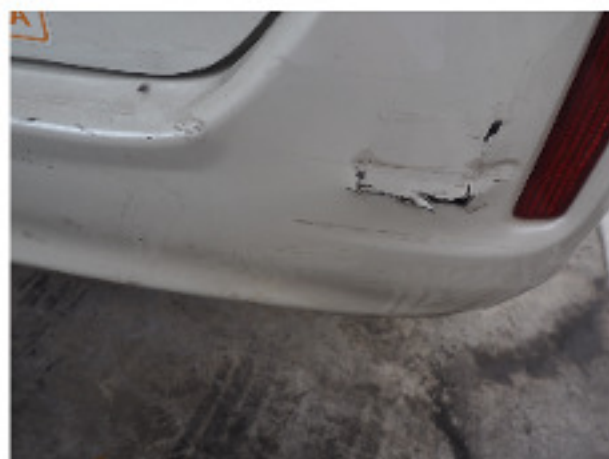
4. Description of Damages				
	THE VEHICLE SUSTAINED DAMAGES AT THE REAR PORTION. DAMAGES SEE DETAILS.			
5. General Information				
	Accident Date	10/02/2020	Inspection Date	19/02/2020
	Survey held at	N-51 AUTOMOTIVE PL 2 KAKI BUKIT AVE 2 #01-17 KAKI BUKIT AUTOHUB SINGAPORE 417921		
5a. Remarks				
	A)THE INSPECTION WAS CONDUCTED ON A"WITHOUT PREJUDICE" BASIS. B)IN ACCORDANCE TO YOUR INSTRUCTIONS, WE HAVE NOT AUTHORISED REPAIRS.			
5b. Estimate Days of Repair				
	ESTIMATED NORMAL PERIOD FOR REPAIR:		6 Working Days
