Vehicle No. GBF 2595G
Insured Veh. GBE 1849L
Claim No. SNM20D200827
Policy No. DMCVSN3064531900
Accident Date 12/02/2020
Inspection Date 14/02/2020

2. Vehicle Particulars & Condition				
Make & Model	FIAT DOBLO (M)	c.c	1248	
Engine No.	HIDDEN	Year of Reg.	2016	
Chassis No.	ZFA26300006C58109	Colour	WHITE	
Odometer	145916 KM	Steering	IN ORDER	
Brakes	IN ORDER	Modification	NIL	
General	GOOD

ADJUSTMENT ON REPAIR COST FOR VEHICLE NO. GBF 2595G

PHOTOGRAPHS FOR VEHICLE NO. GBF 2595G

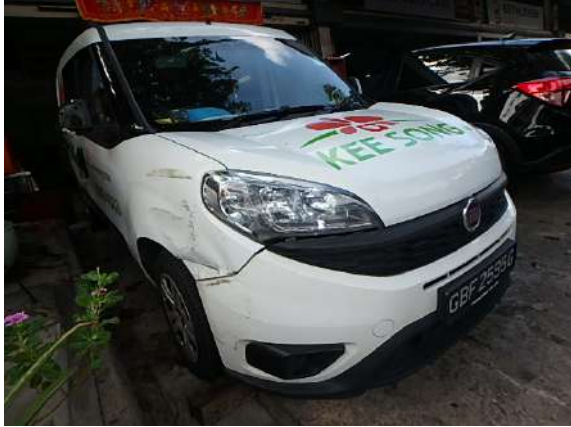
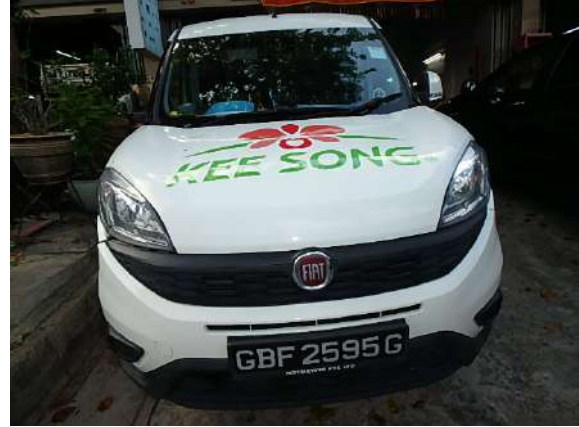
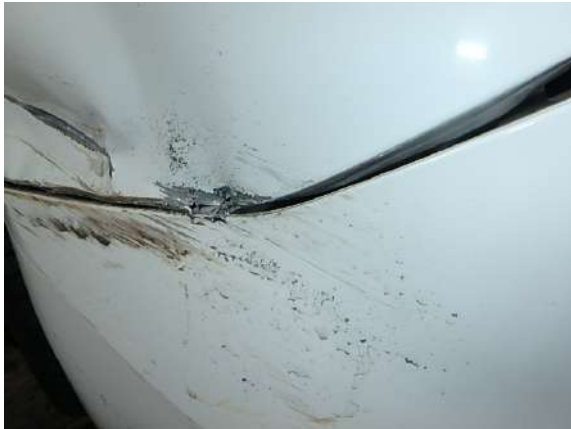
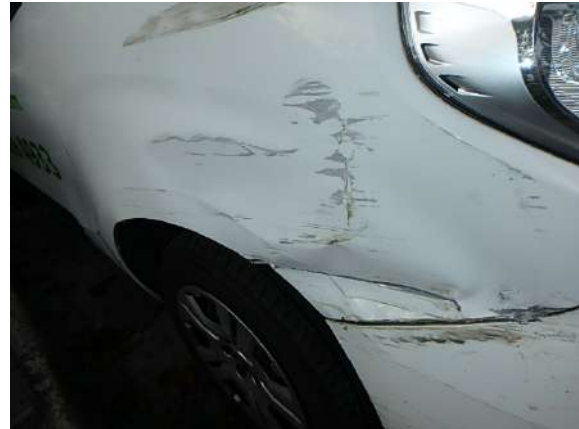
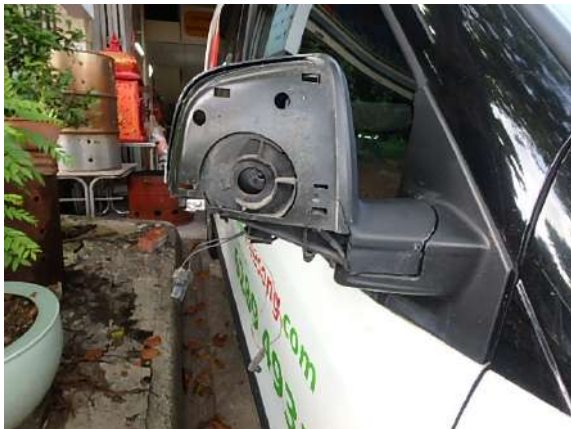
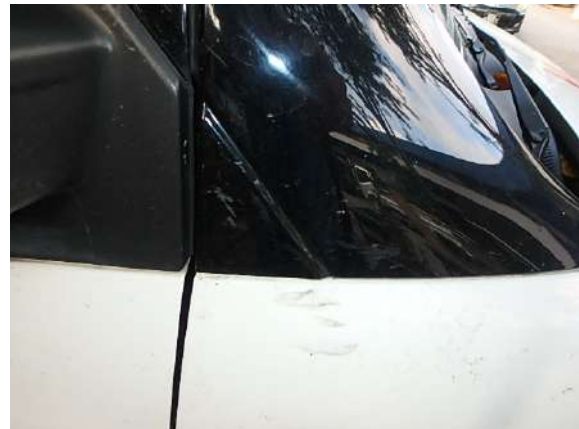
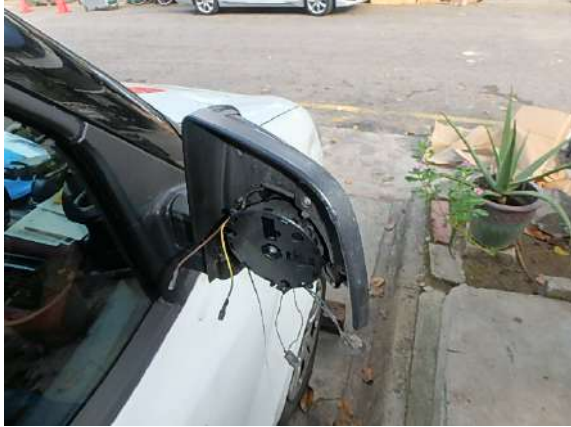
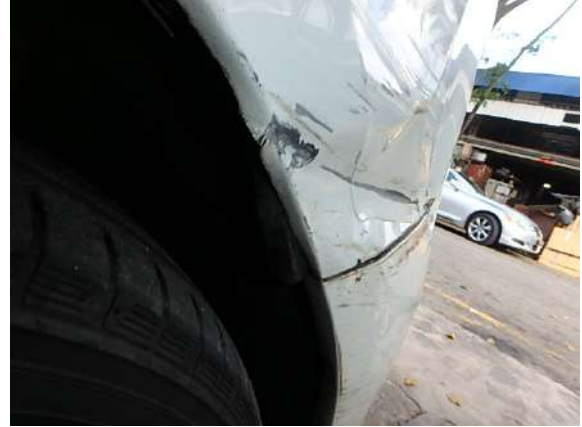
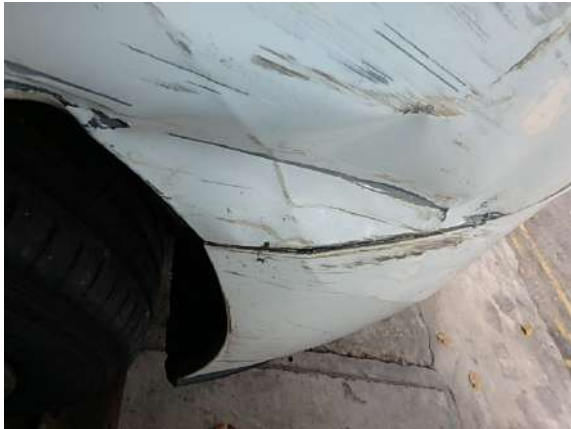
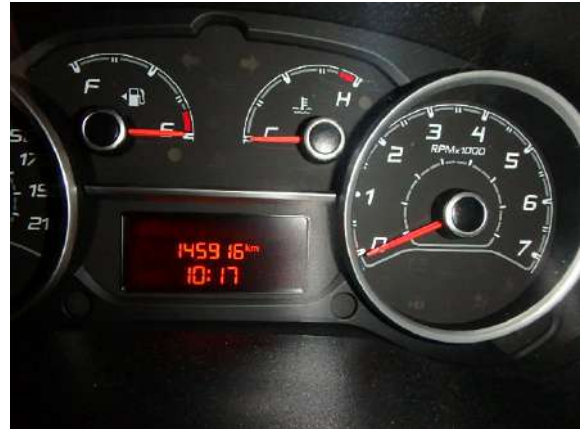
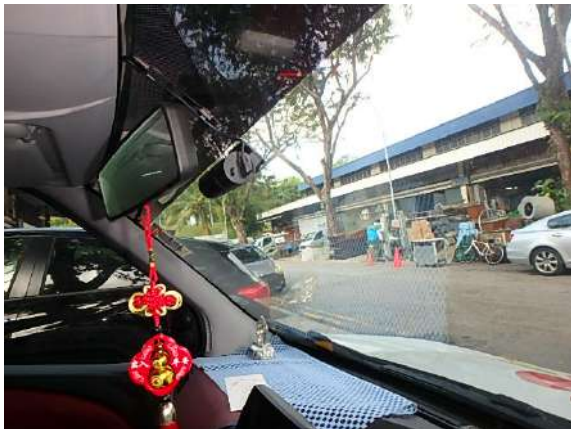
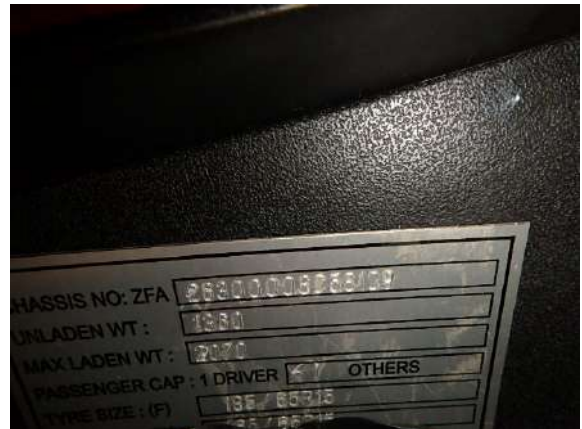
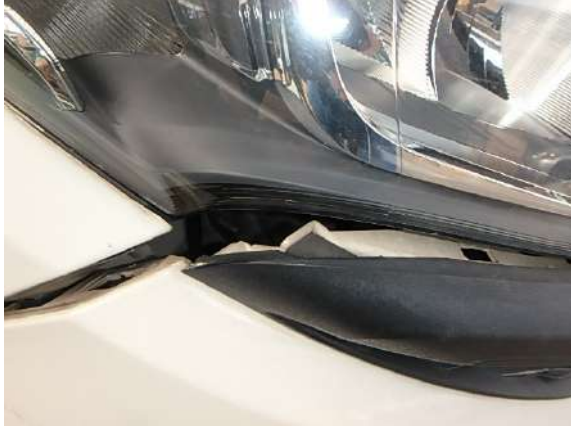
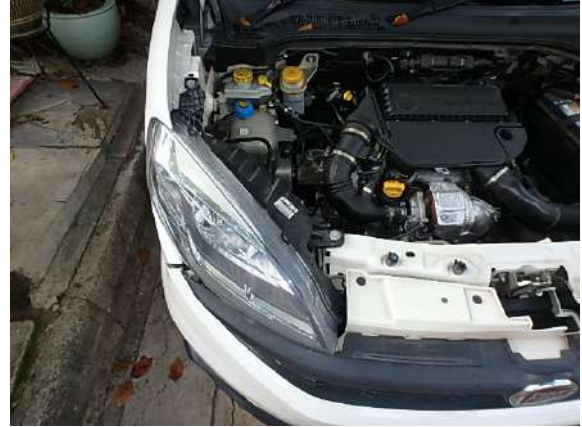
INSPECTION

4. Description of Damages				
THE VEHICLE SUSTAINED DAMAGES AT THE O/S FRONT PORTION. DAMAGES SEE DETAILS.				
5. General Information				
Accident Date	12/02/2020	Inspection Date	14/02/2020	
Survey held at	MOTORVIVA PTE LTD 10 TUAS AVENUE 18 SINGAPORE 638894			
5a. Remarks
