## LKK Auto Consultants Pte Ltd

### 1. Policy Particulars :- THIRD PARTY CLAIM

### ADJUSTMENT ON REPAIR COST FOR VEHICLE NO. SFB 7372Z

PHOTOGRAPHS FOR VEHICLE NO. SFB 7372Z

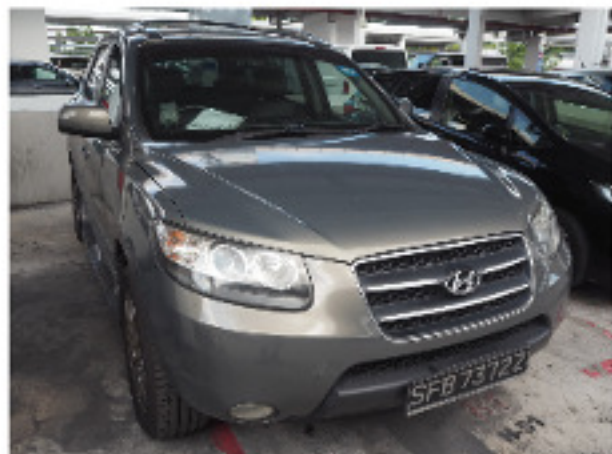
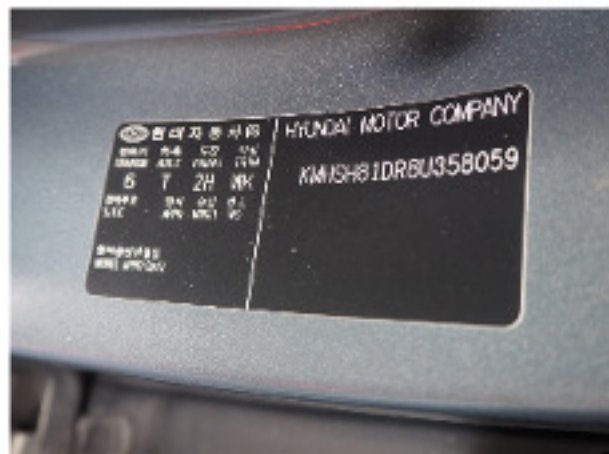
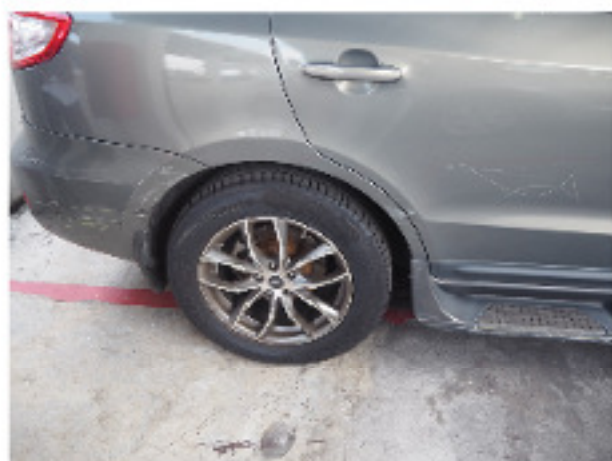
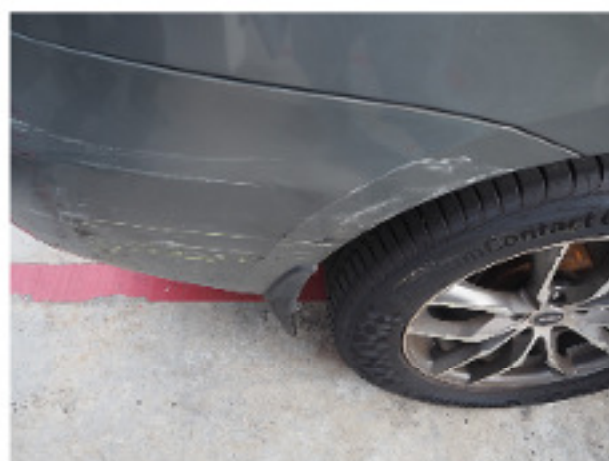
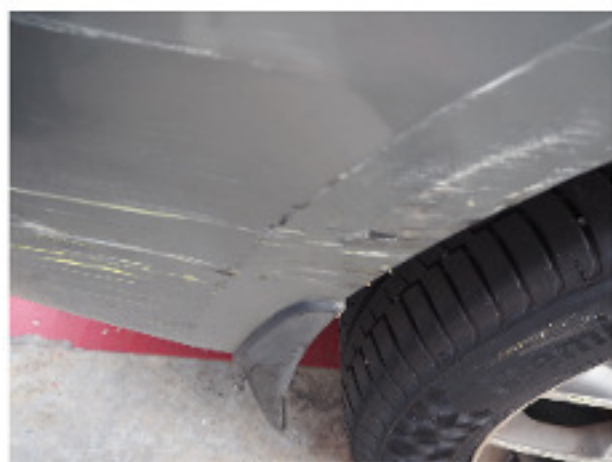
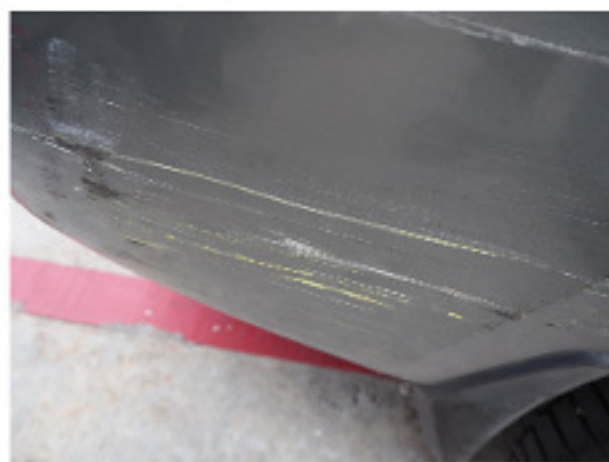
INSPECTION

| THE VEHICLE SUSTAINED DAMAGES AT THE O/S BODY.<br>DAMAGES SEE DETAILS. |
