LKK Auto Consultants Pte Ltd

Affiliated to Federation Internationale Des Experts En Automobile				
EQ INSURANCE COMPANY LTD		Ref : CC6/EQI20002856/Aga3q2		
5 MAXWELL ROAD #17-00 TOWER BLOCK MND COMPLEXSINGAPORE 069110		Date : 04-05-2020

ADJUSTMENT ON REPAIR COST FOR VEHICLE NO. GBE 152U

PHOTOGRAPHS FOR VEHICLE NO. GBE 152U

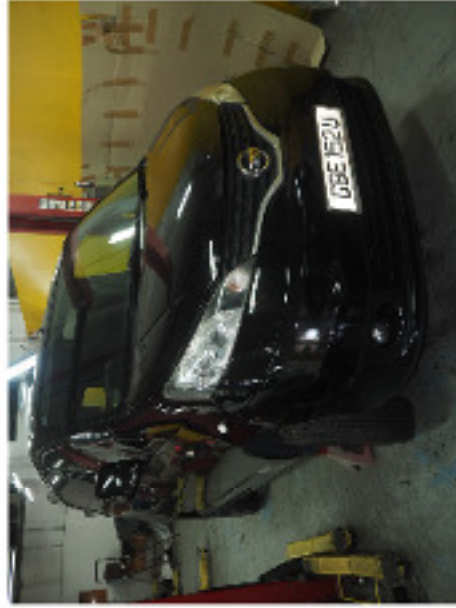
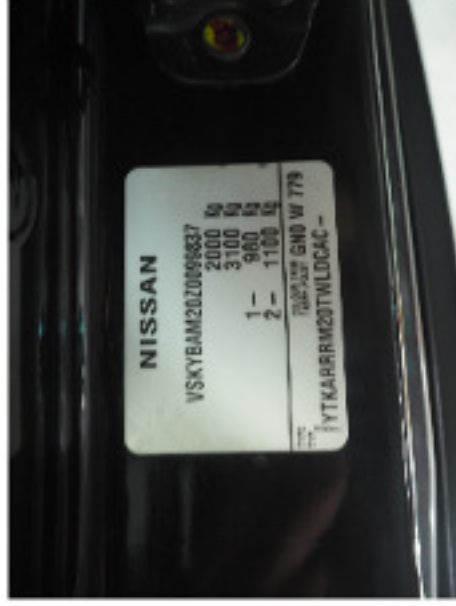
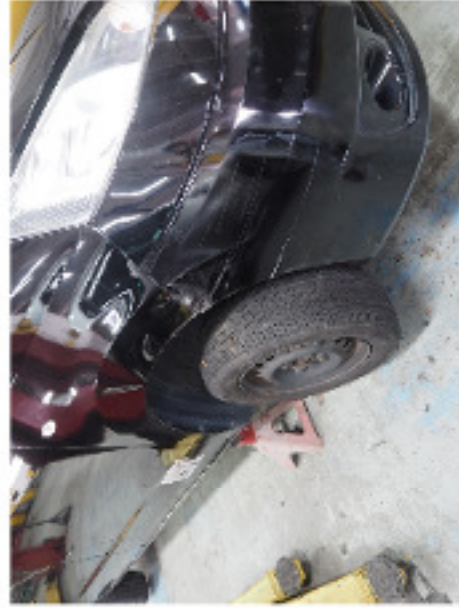
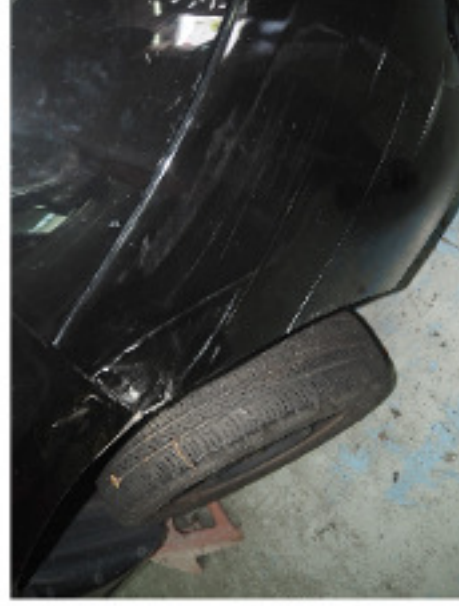
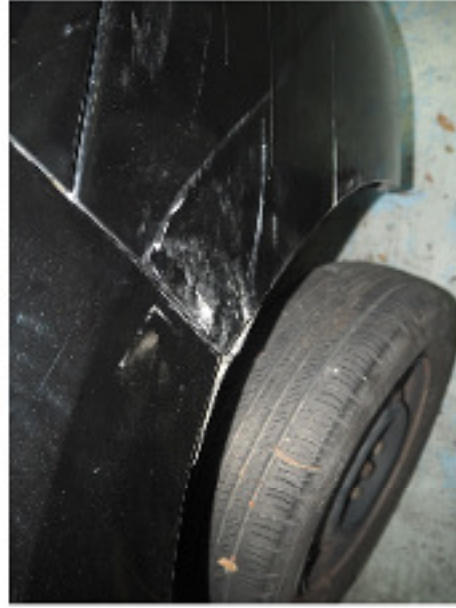
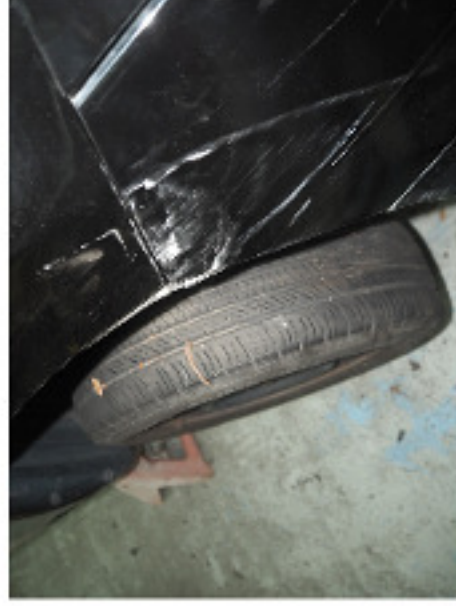
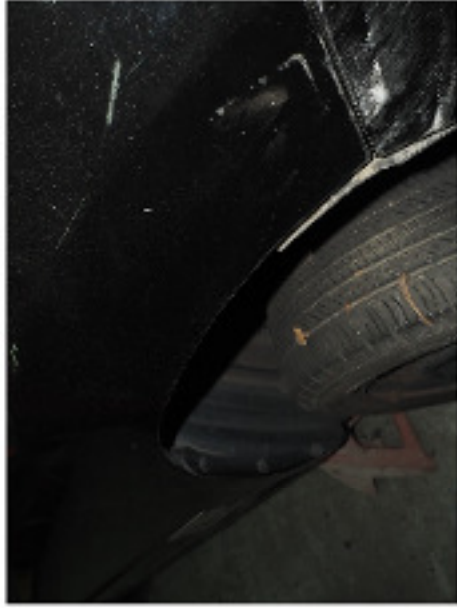
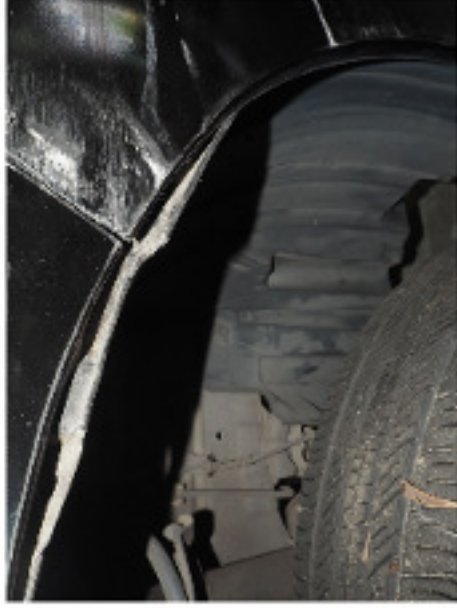
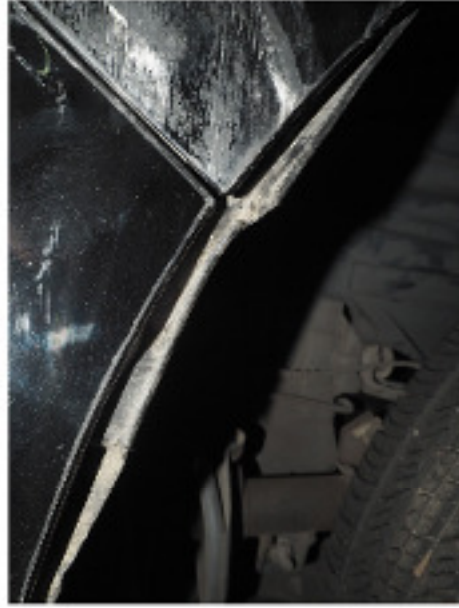
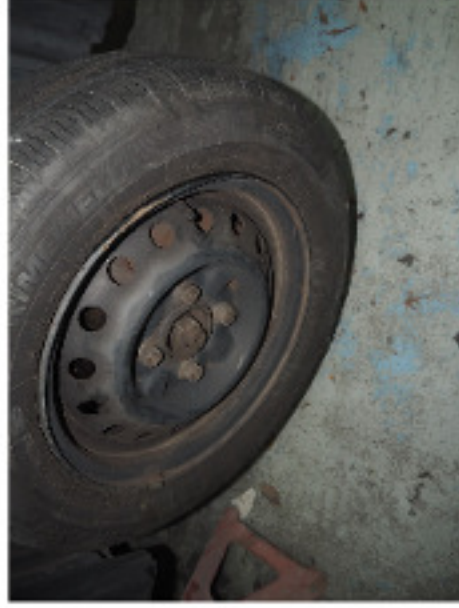
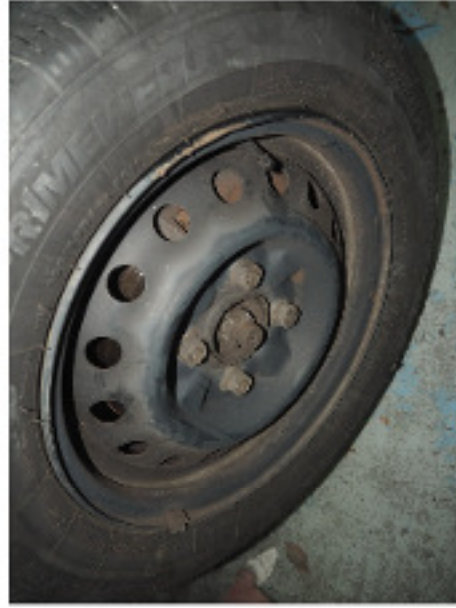
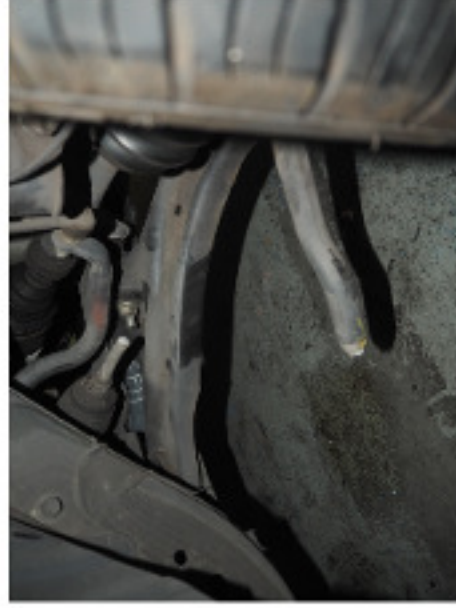
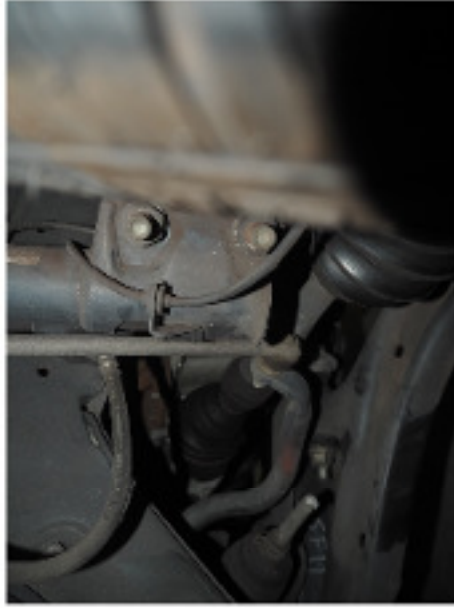
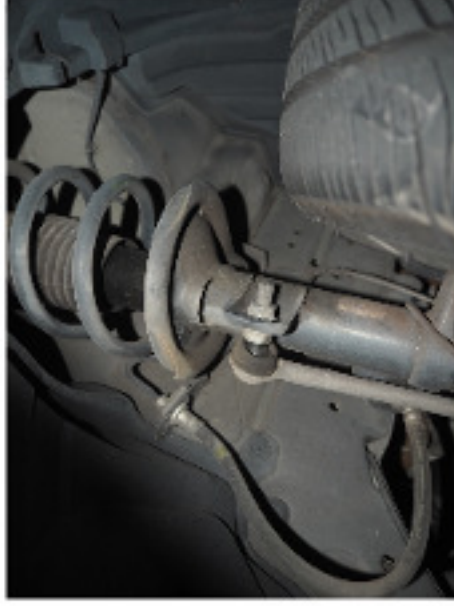
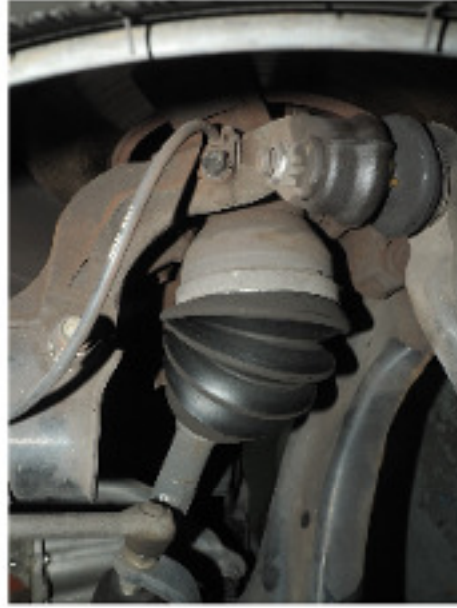
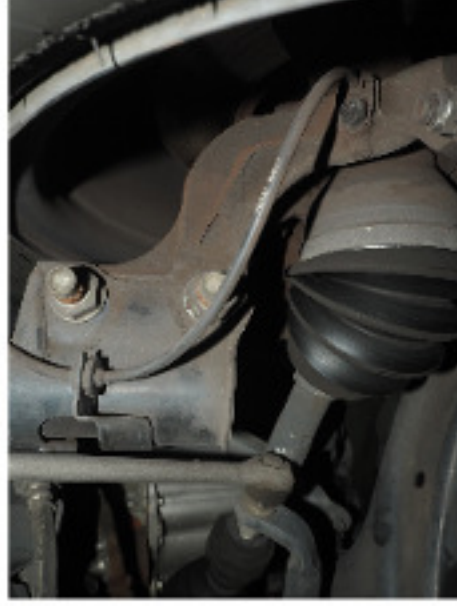
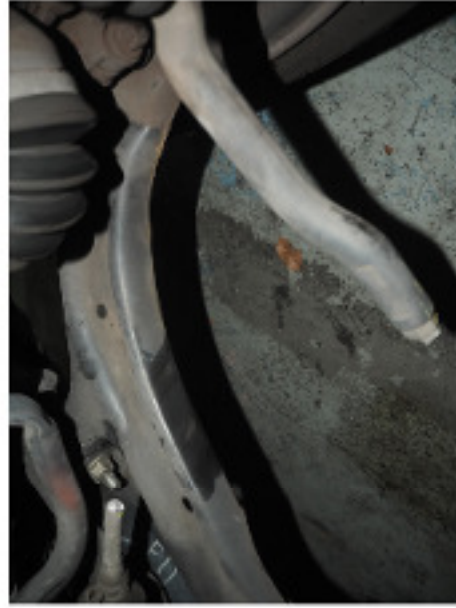
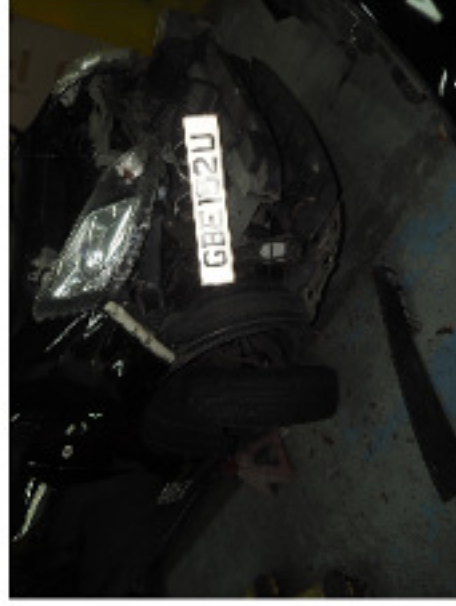
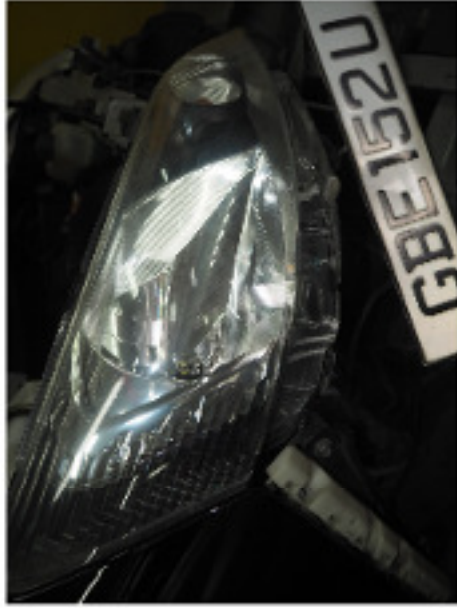
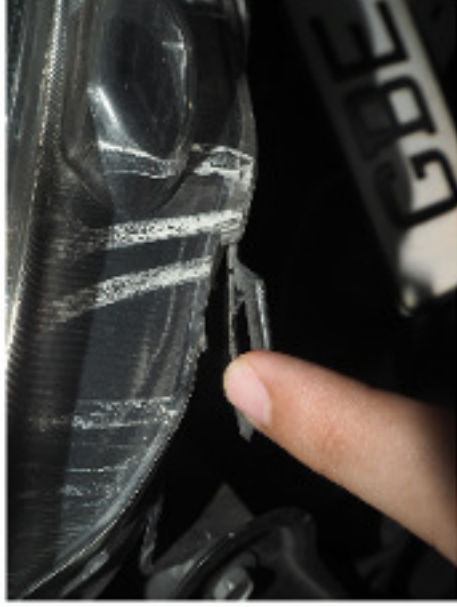
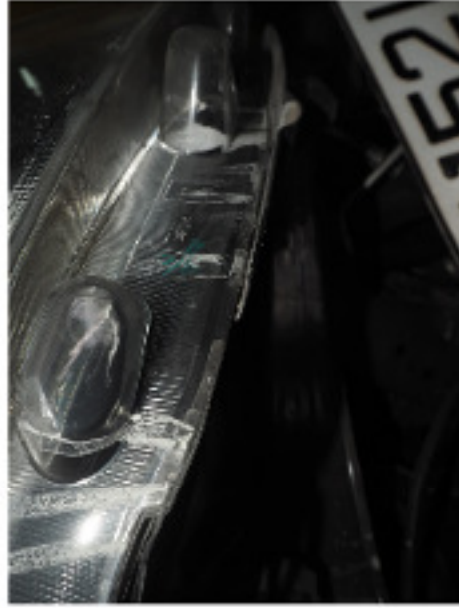
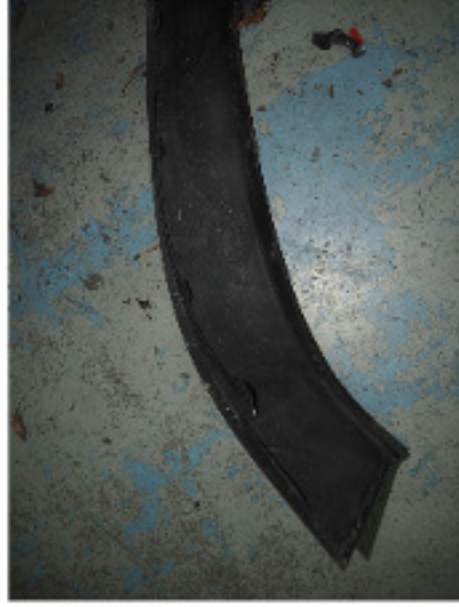
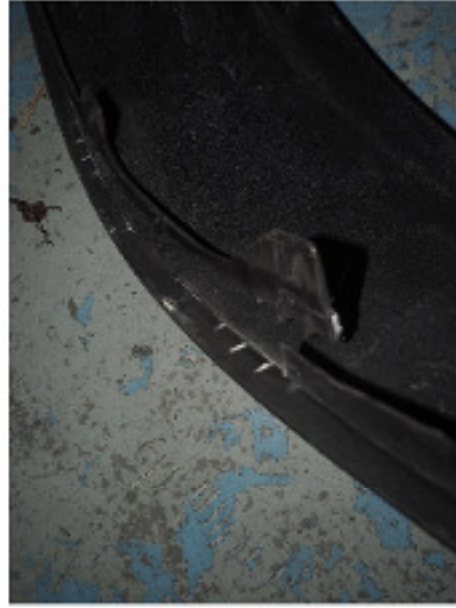
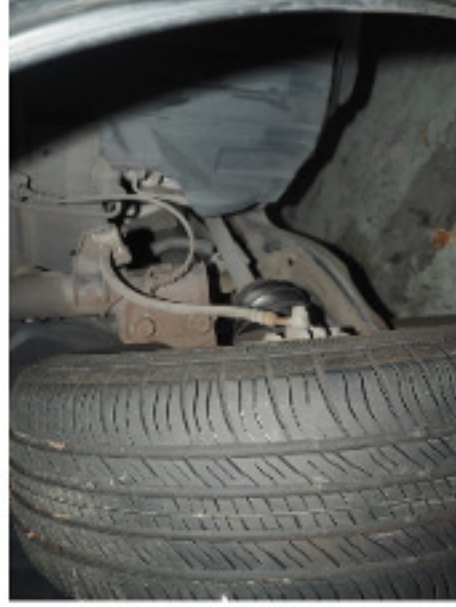
4. Description of Damages				
	THE VEHICLE SUSTAINED DAMAGES AT THE FRONT O/S PORTION AND UNDERCARRIAGE. DAMAGES SEE DETAILS.			
5. General Information				
	Accident Date	13/02/2020	Inspection Date	17/02/2020
	Survey held at	MG SOLUTION PTE LTD 23 KAKI BUKIT AVE 4 (SOUTH WING) #02-03B VICOM INSPECTION CENTRE, SINGAPORE 415933		
5a. Remarks				
	A)THE INSPECTION WAS CONDUCTED ON A"WITHOUT PREJUDICE" BASIS. B)IN ACCORDANCE TO YOUR INSTRUCTIONS, WE HAVE NOT AUTHORISED REPAIRS.			
5b. Estimate Days of Repair				
	ESTIMATED NORMAL PERIOD FOR REPAIR:		6 Working Days
