Your Ref : 6971213085SG
Our Ref : CI/AIG20002946/N

21 February 2020

TECHNICAL INVESTIGATION REPORT OF FIRE INCIDENT INVOLVING THE INSURED VEHICLE SKS 938P ON 7 FEBRUARY 2020

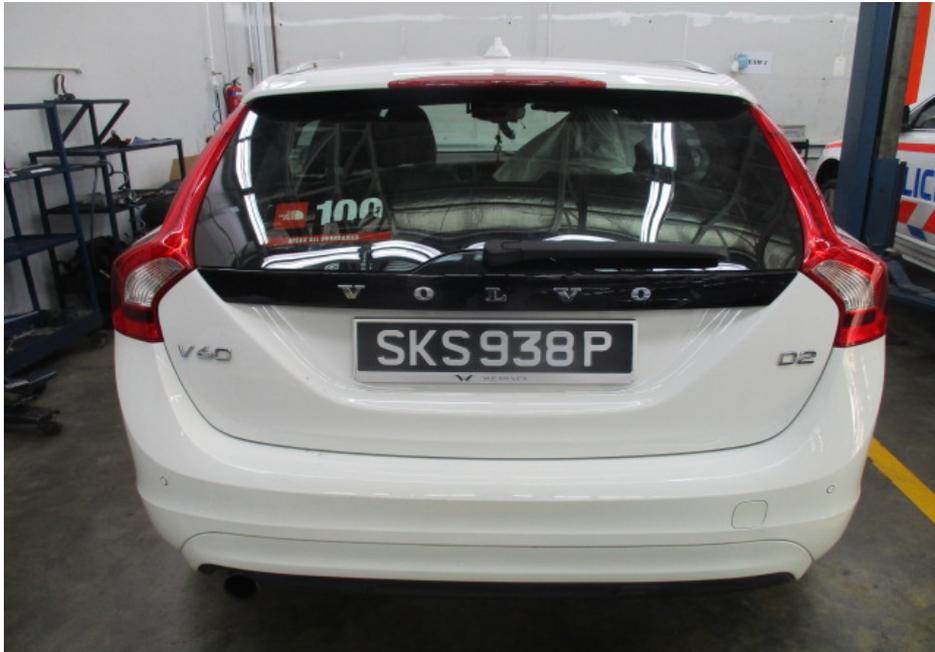
Photo 1 shows the general view of the rear body of the Insured Vehicle at the time of our inspection. The rear portion of the Insured Vehicle was observed to be unaffected by the fire.

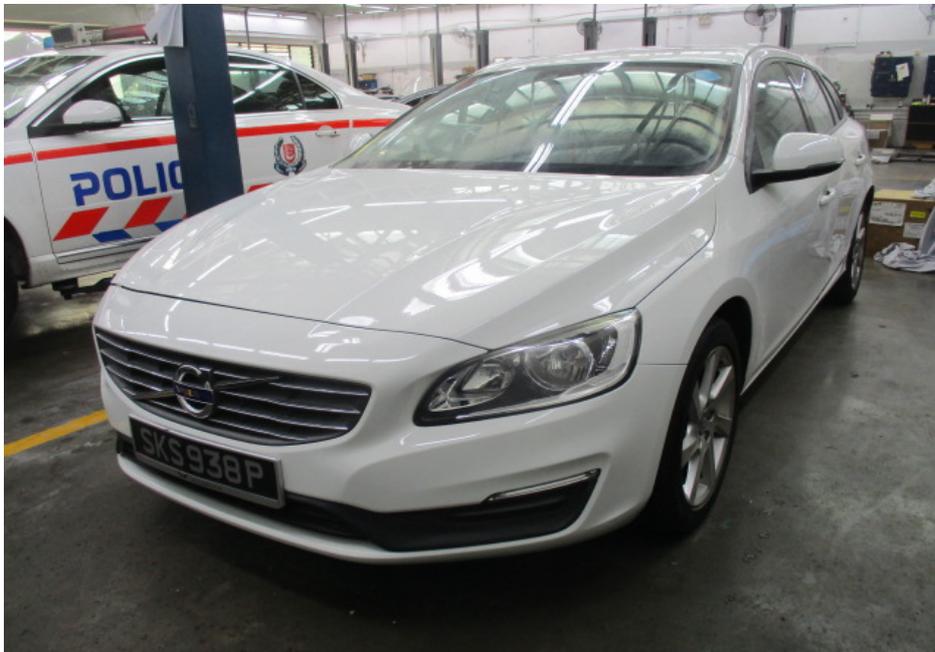
5. The exterior front body and engine compartment of the Insured Vehicle sustained visible fire damage. This included its front windscreen, front bonnet, left 'A' pillar and left side panel.
6. The fire had resulted in minimal damage to the engine compartment of the Insured Vehicle. Some of the components inside the engine compartment were found to be severely burnt and/or melted as a result of the fire. See photos 1 – 6 below.

Photo 2 shows the general view of the left front portion of the Insured Vehicle at the time of our inspection. The exterior body of the Insured Vehicle had sustained visible fire damage. This included its front windscreen, front bonnet, left 'A' pillar and left side panel.

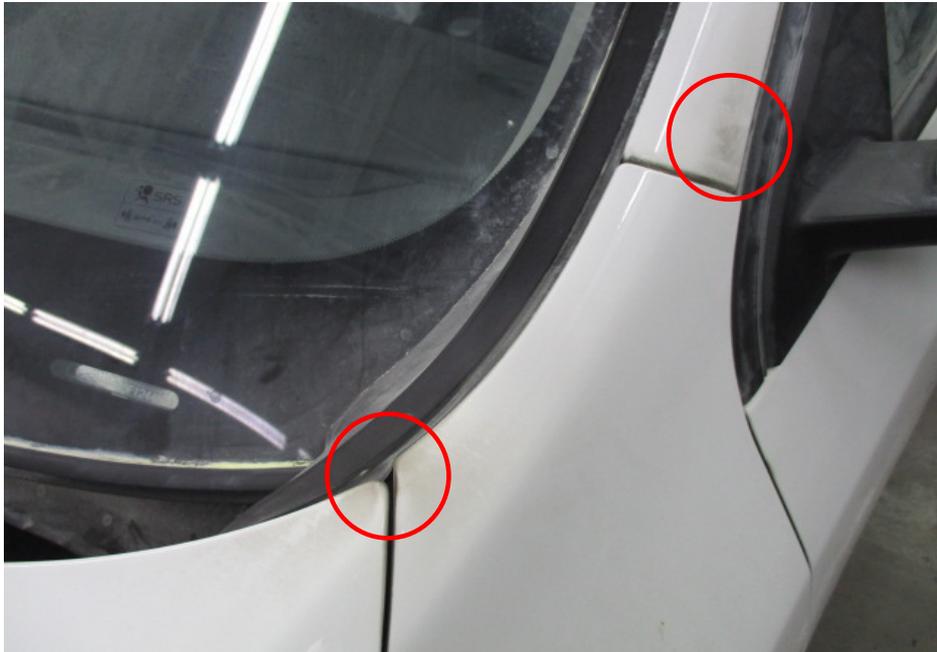
Photo 3 shows a closer view of the left front portion of the Insured Vehicle at the time of our inspection. The exterior body of the Insured Vehicle had sustained visible fire damage. This included its front windscreen, front bonnet, left 'A' pillar and left side panel (circled).

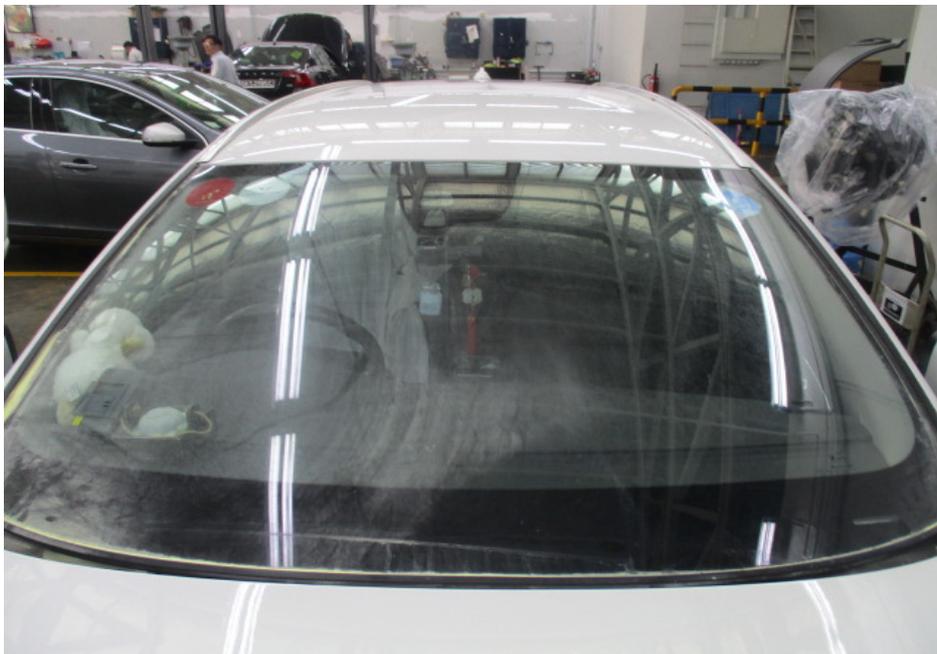
Photo 4 shows a closer view of the front windscreen of the Insured Vehicle at the time of our inspection. The front windscreen had sustained minimal fire damage.

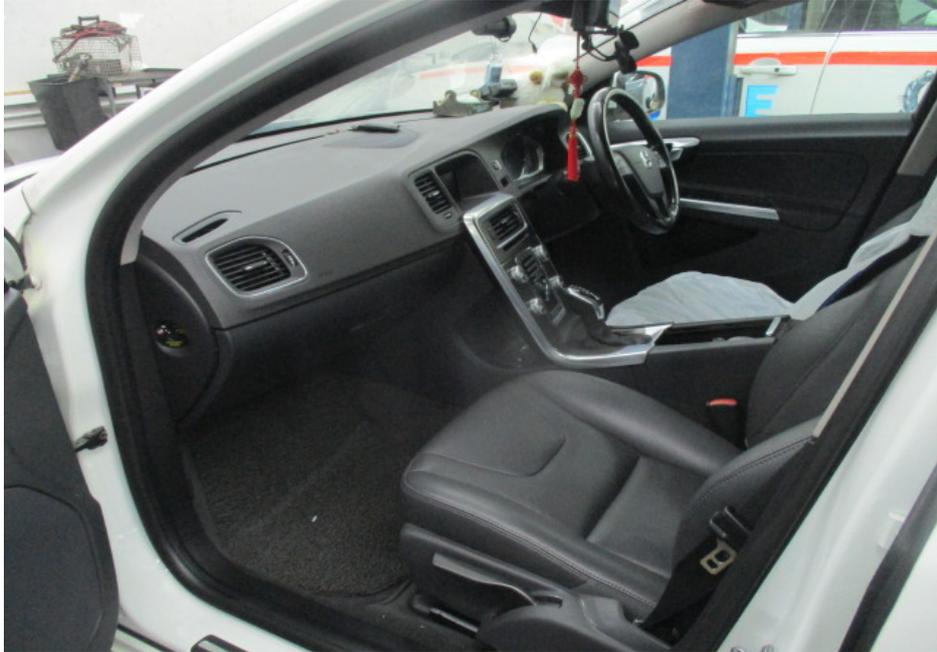
Photo 5 shows the interior compartment of the Insured Vehicle at the time of our inspection. The interior compartment of the Insured Vehicle was relatively unaffected by the fire.

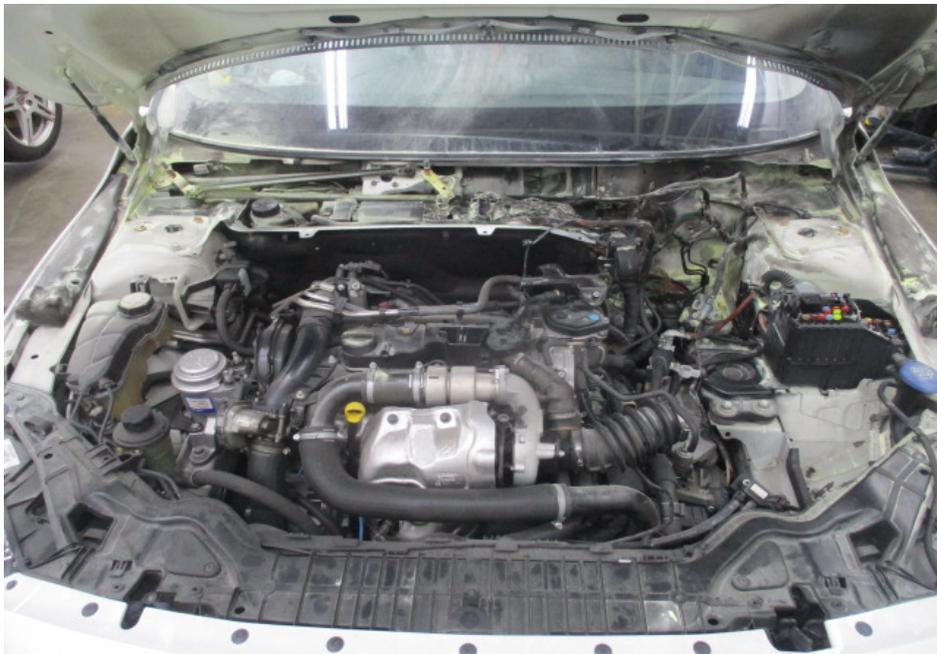
Photo 6 shows a general view of the engine compartment of the Insured Vehicle at the time of our inspection. Some of the components inside the engine compartment were found to be severely burnt and/or melted as a result of the fire.

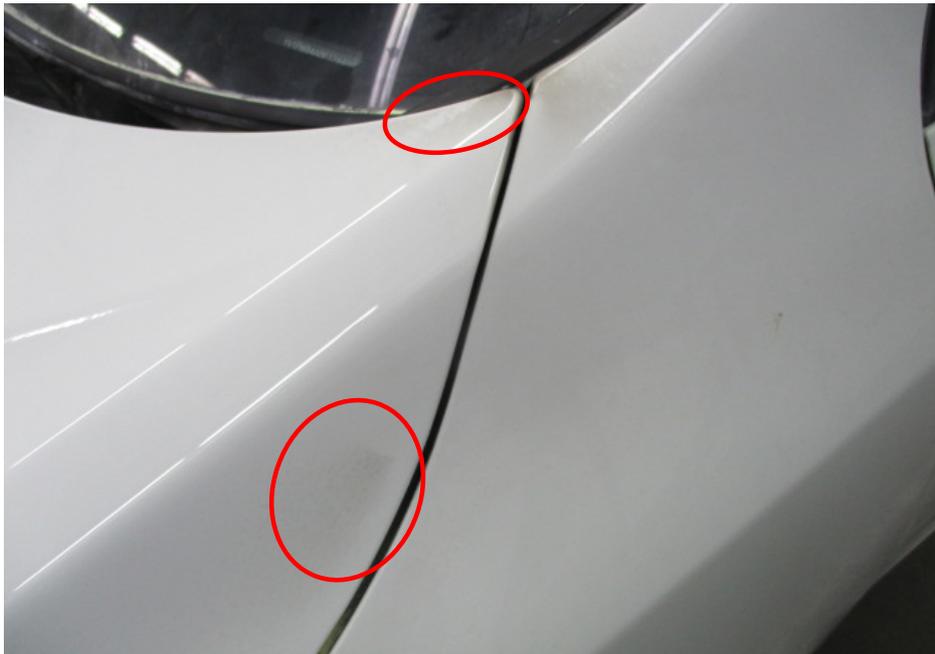
8. For this particular case, the fire appears to have originated within the engine compartment of the Insured Vehicle, somewhere around the left rear portion of the engine compartment. This can be determined from the burn pattern found on the left rear portion of the front bonnet of the Insured Vehicle and also the burn marks that had developed on the underside of the front bonnet, at the left bottom portion. These burn marks are an indication that the left rear portion of the engine compartment had sustained exposure to high heat intensity. See photos 7 - 9 below.

Photo 7 shows the burn pattern that was found on the left rear portion of the front bonnet of the Insured Vehicle (circled).

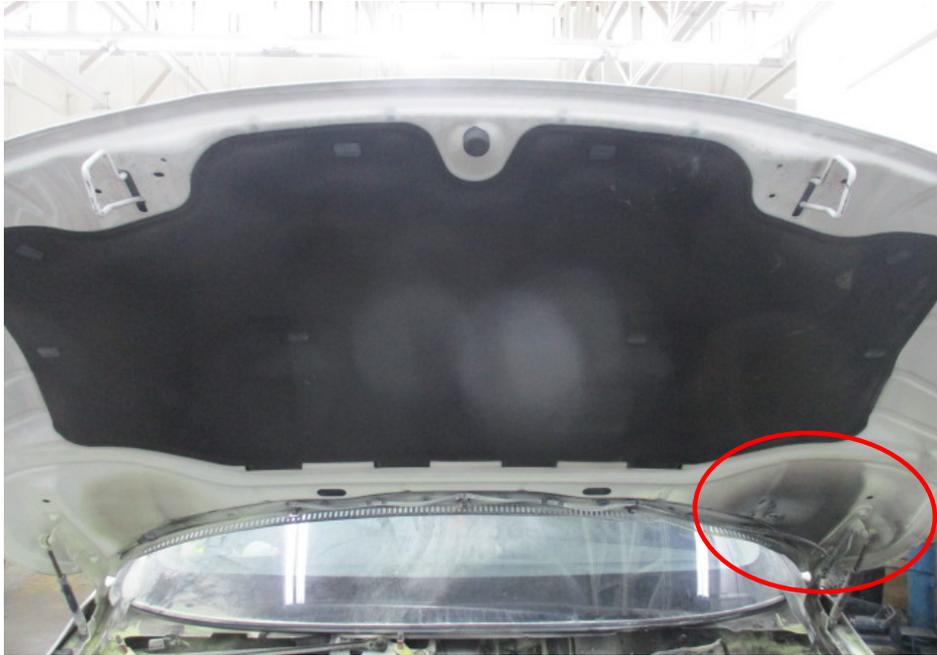
Photo 8 shows the burn marks that were found on the left bottom portion of the underside of the front bonnet of the Insured Vehicle (circled). Such burn marks are a result of exposure to heat intensity, which may indicate where the fire had started. Hence the fire to the Insured Vehicle can be determined to have originated towards the left rear portion of the engine compartment.

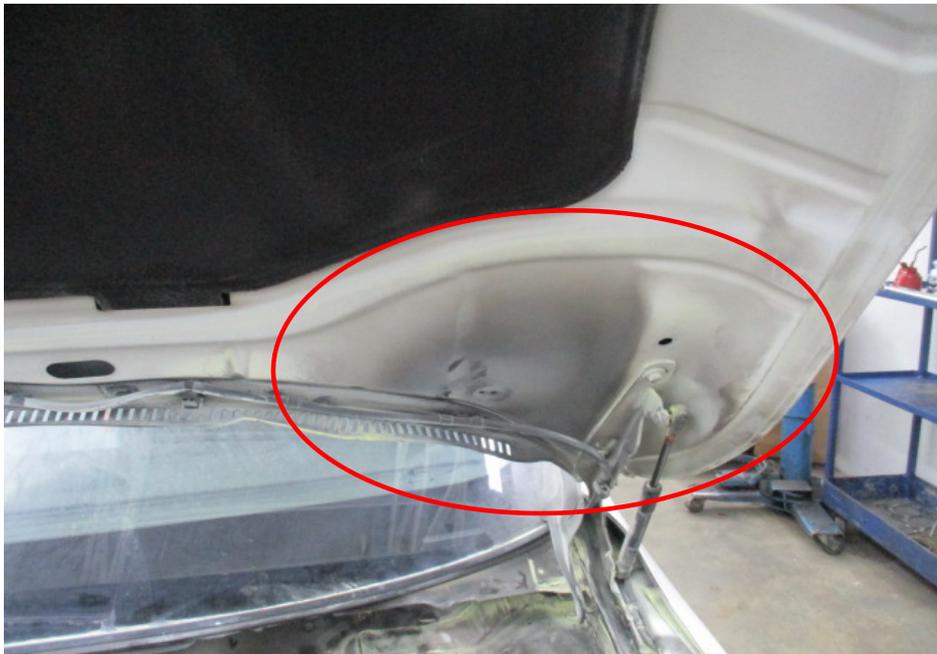
Photo 9 shows a close up view of the burn marks that were found on the left bottom portion of the underside of the front bonnet of the Insured Vehicle (circled).

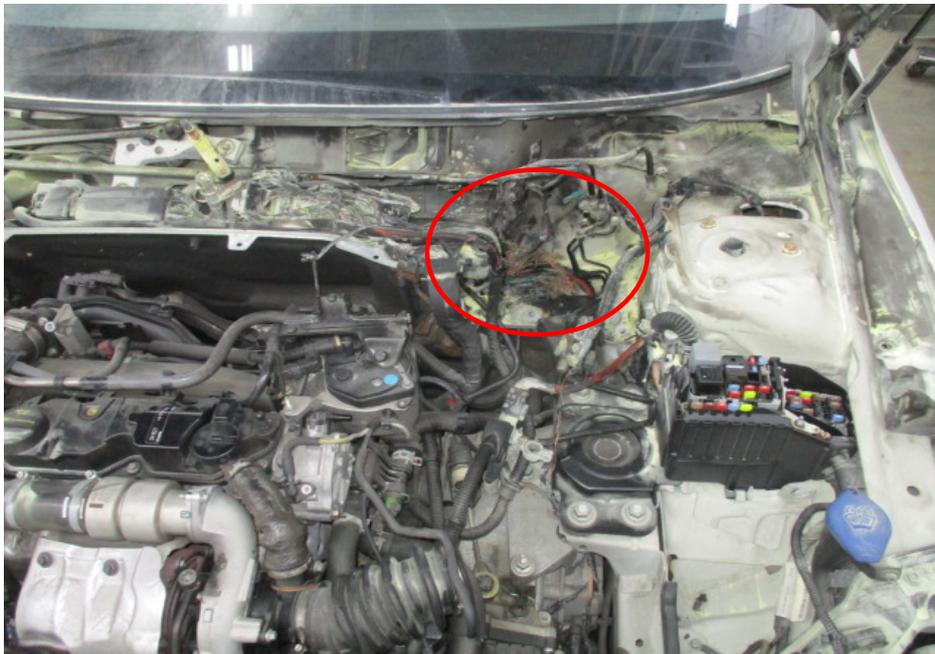
9. Upon closer examination of the left rear portion of the engine compartment which was where the fire to the Insured Vehicle had likely started, we had found several stretches of wirings with greenish residue. These wirings were original factory fitted wirings leading from the wiring harness of the Insured Vehicle. The presence of greenish residue indicates internal heating of copper wires, a sign of an electrical short circuit occurring. The greenish residue is normally left behind from oxidation as a result of chemical reaction involving the copper wires. This physical evidence would appear to suggest that the cause of fire to the Insured Vehicle could have possibly been due to electrical in nature. See photos 10 – 14 below.

Photo 10 shows the wirings around the left rear portion of the engine compartment which is near to the vicinity where the fire to the Insured Vehicle had likely started. We observed greenish residue on the wirings leading from the wiring harness of the Insured Vehicle (circled). The presence of greenish residue indicates internal heating of copper wires, a sign of an electrical short circuit occurring. The greenish residue is normally left behind from oxidation as a result of chemical reaction involving the copper wires.

25. Having investigated and technically analysed the damages of burnt nature to the Insured Vehicle, we are of the view that the cause of fire to the Insured Vehicle was of electrical in nature. For this particular case, the fire had originated along the wirings inside the engine compartment, leading from the wiring harness. The wirings were original factory wirings of the Insured Vehicle.

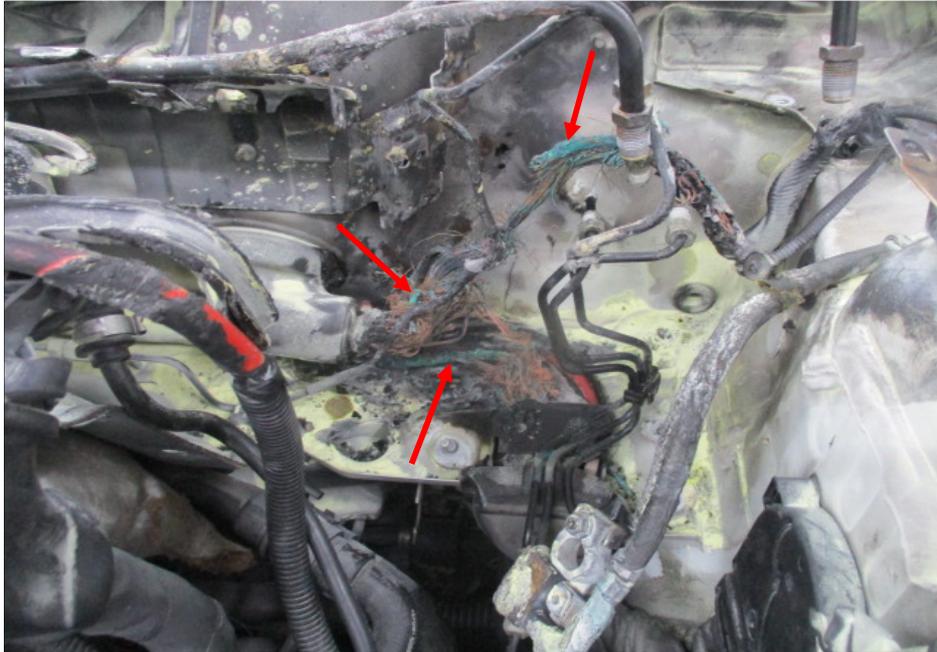
Photo 11 shows a closer view the greenish residue on the wirings at the left rear portion of the engine compartment leading from the wiring harness (red arrows). The presence of such greenish residue suggests occurrence of an electrical short circuit.

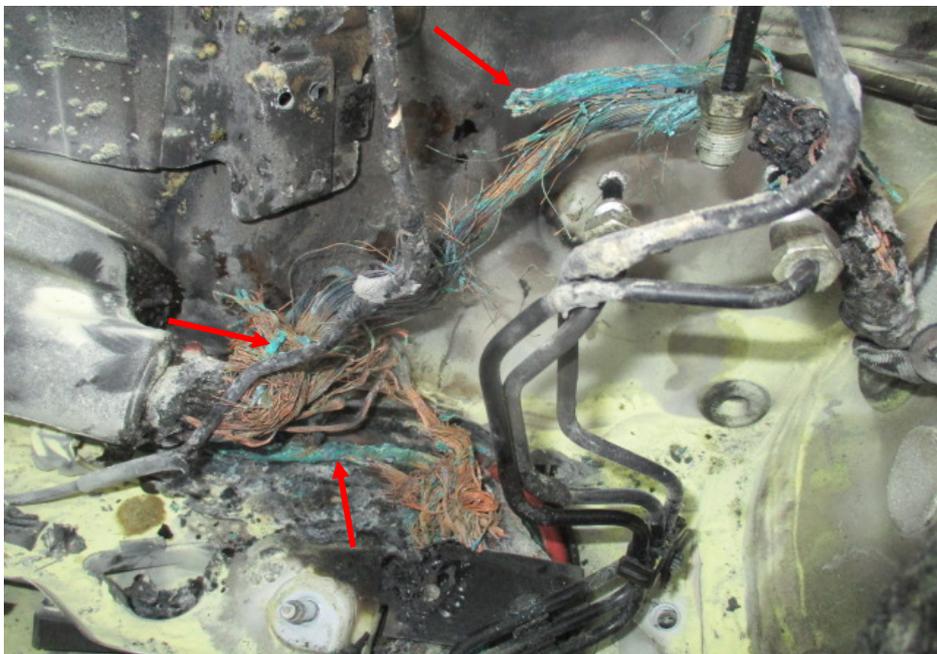
Photo 12 shows a close up view of the greenish residue on the wirings leading from the wiring harness of the Insured Vehicle (red arrows). The presence of such greenish residue suggests occurrence of an electrical short circuit.

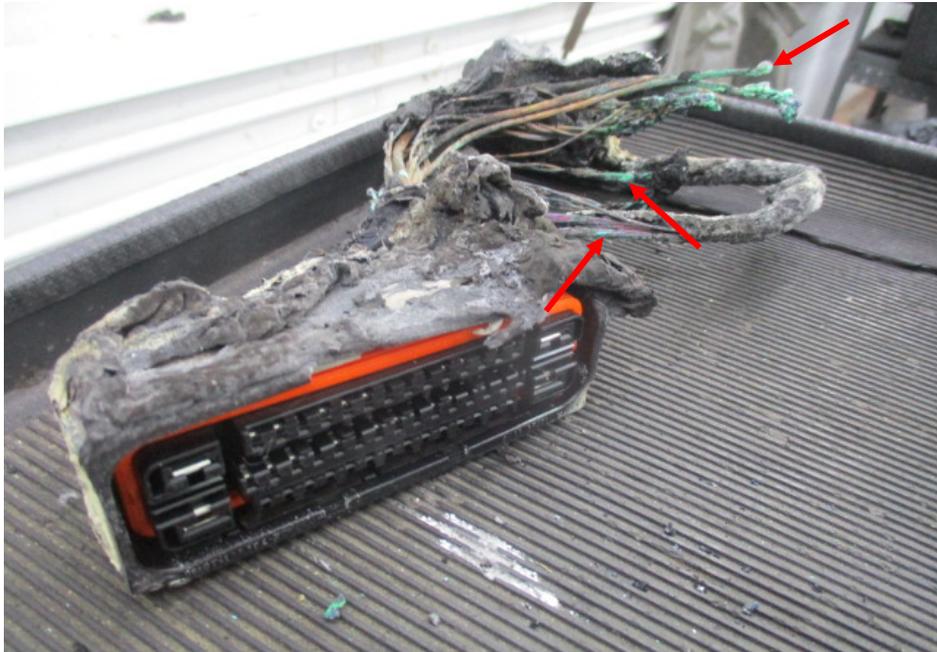
Photo 13 shows a close up view of the greenish residue on the wirings leading from the dismantled wiring harness of the Insured Vehicle (red arrows). The presence of such greenish residue suggests occurrence of an electrical short circuit.

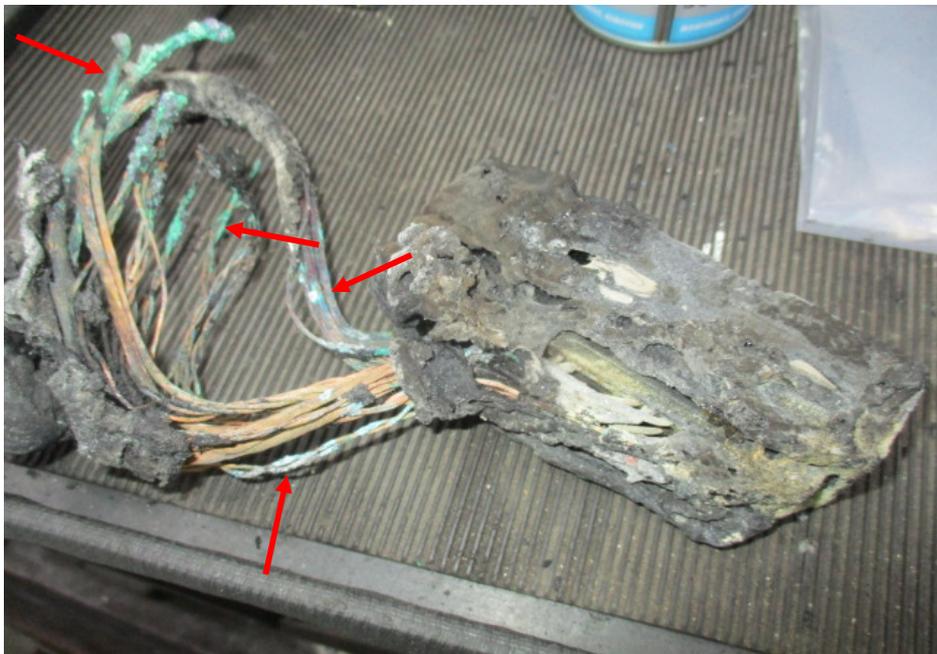
Photo 14 shows a close up back view of the greenish residue on the wirings leading from the dismantled wiring harness of the Insured Vehicle (red arrows). The presence of such greenish residue suggests occurrence of an electrical short circuit.

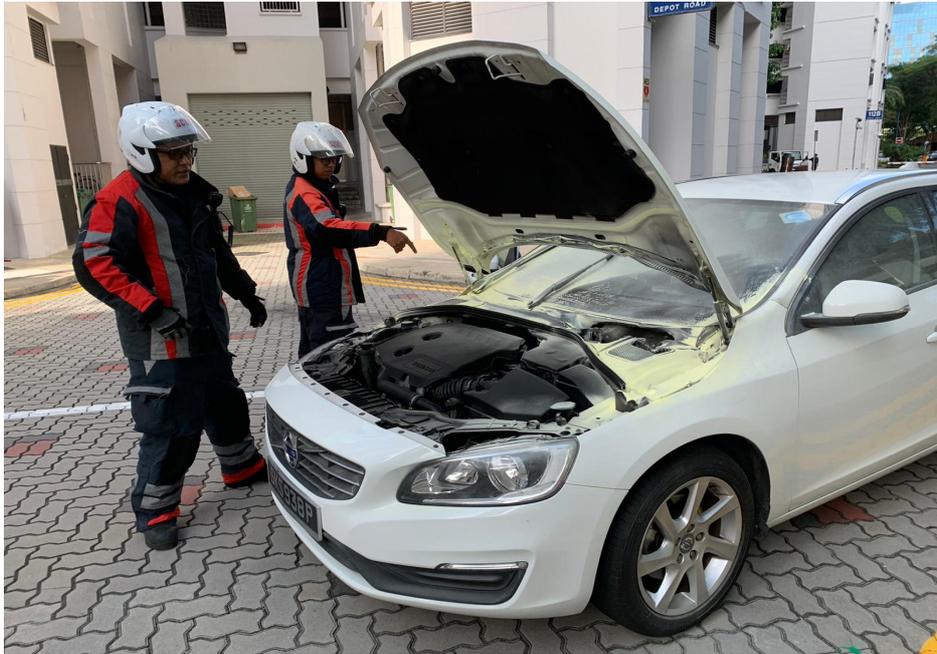
Photo 15 shows the SCDF conducting preliminary investigations post- incident.

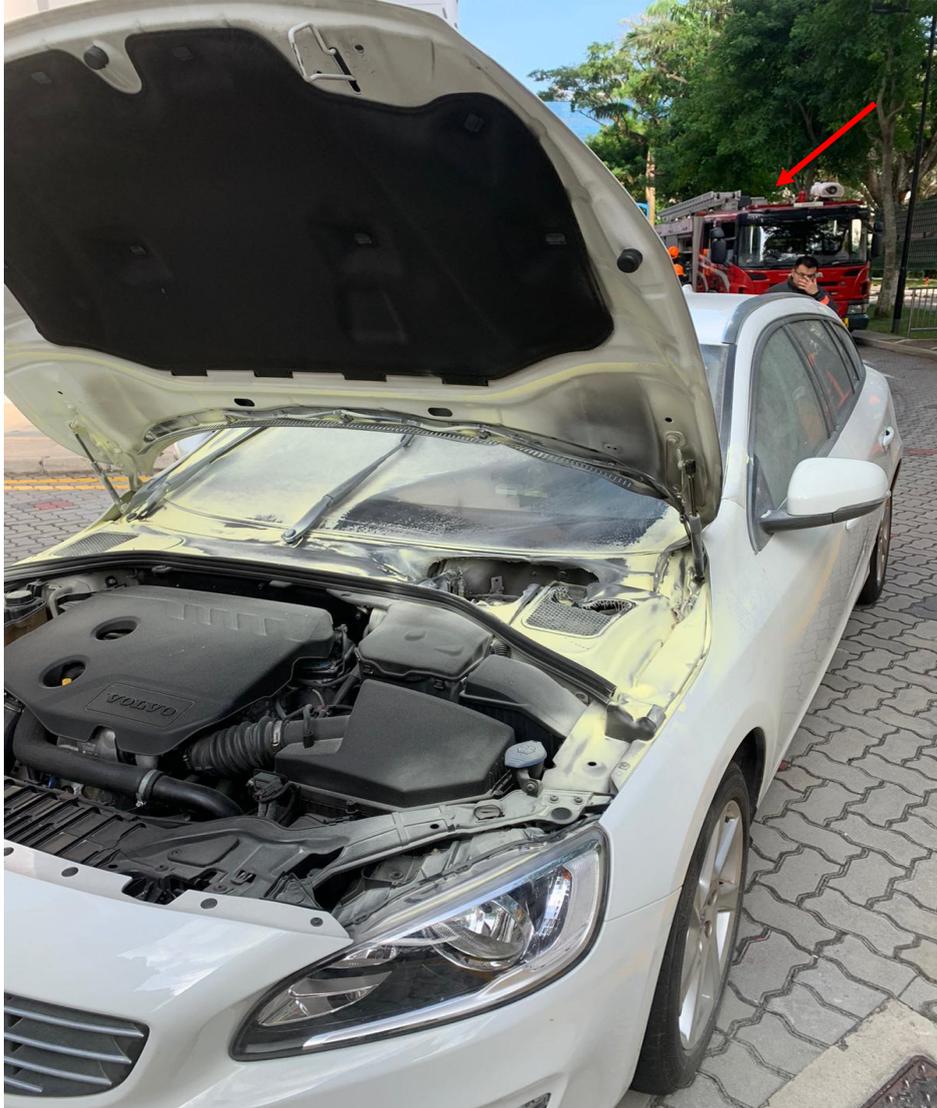
Photo 16 shows the Insured Vehicle at the incident location after the fire was extinguished. In general, the information that could be gathered from this photograph had corresponded to the events that were related to us by Mr Tan, which is the SCDF had responded to the incident (arrowed).

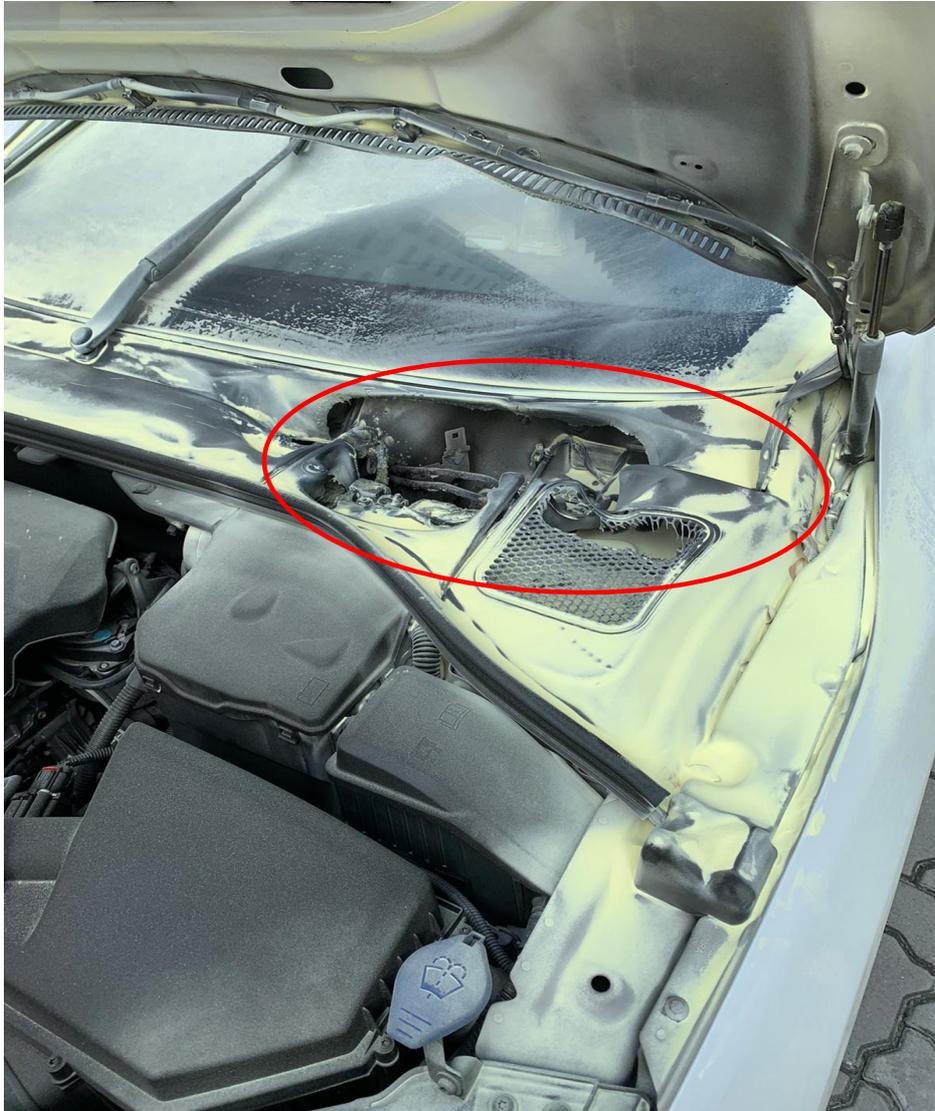
Photo 17 shows the Insured Vehicle at the incident scene after the fire was extinguished. In general, the information that could be gathered from these photographs had corresponded to the events that were related to us by Mr Tan. The burn pattern and concentration of fire extinguisher residue observed at the left rear portion of the engine compartment (circled) is an indication that the fire had started from the left rear portion of the engine compartment.
