LKK Auto Consultants Pte Ltd

ADJUSTMENT ON REPAIR COST FOR VEHICLE NO. SML 9623B

PHOTOGRAPHS FOR VEHICLE NO. SML 9623B

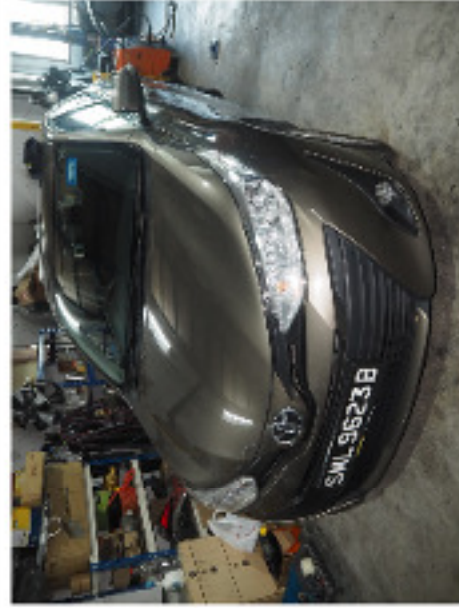
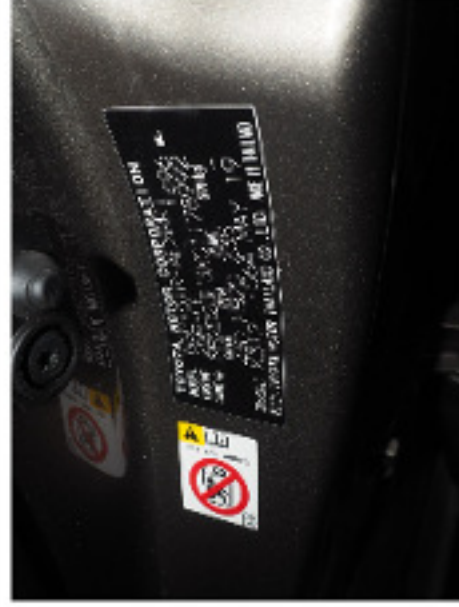
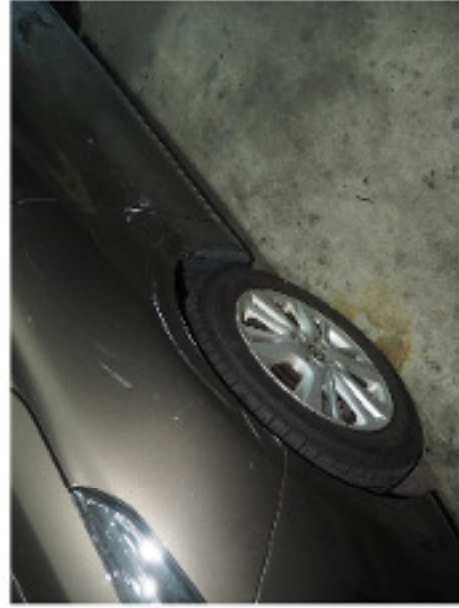
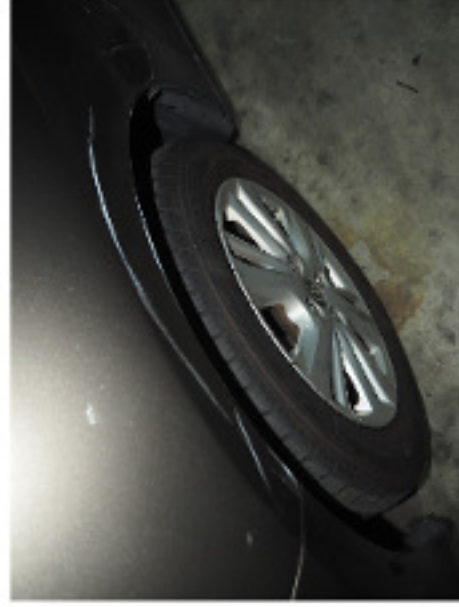
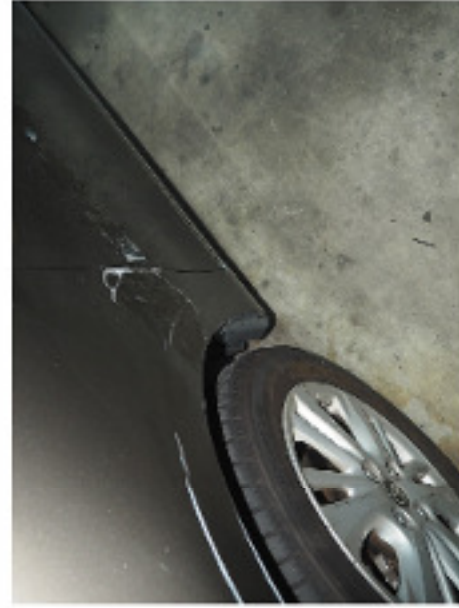
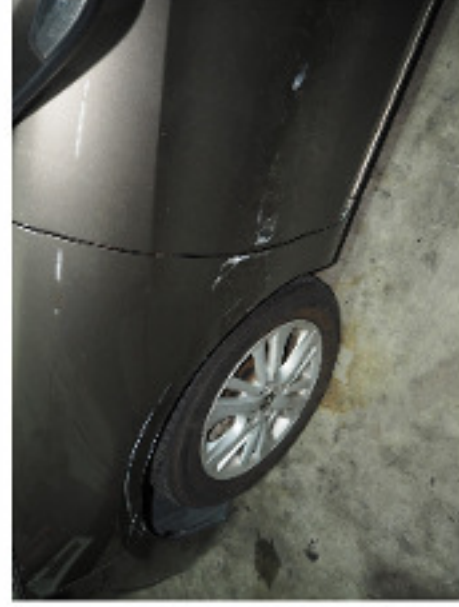
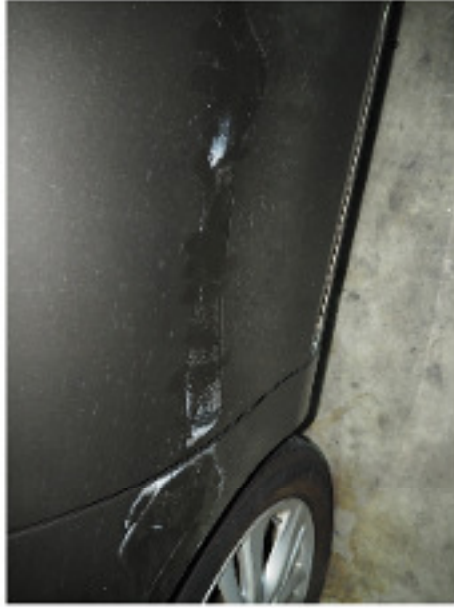
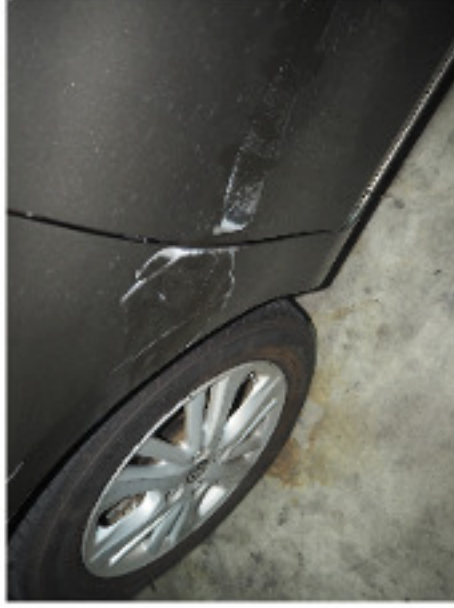
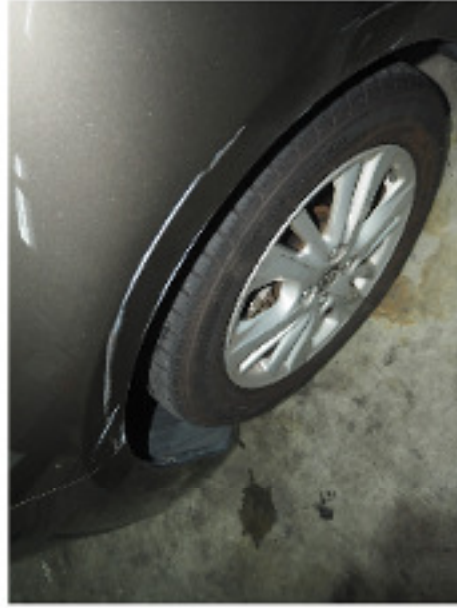
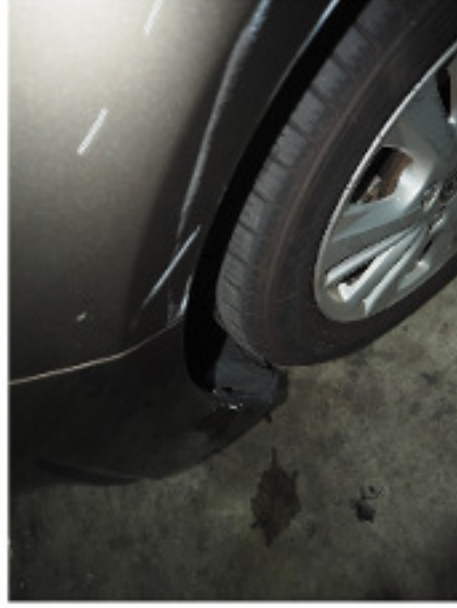
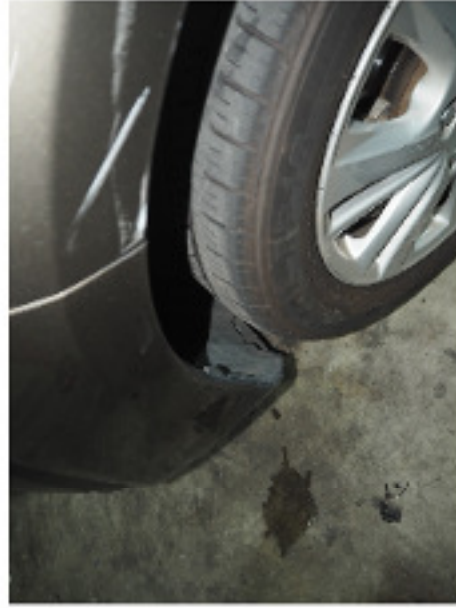
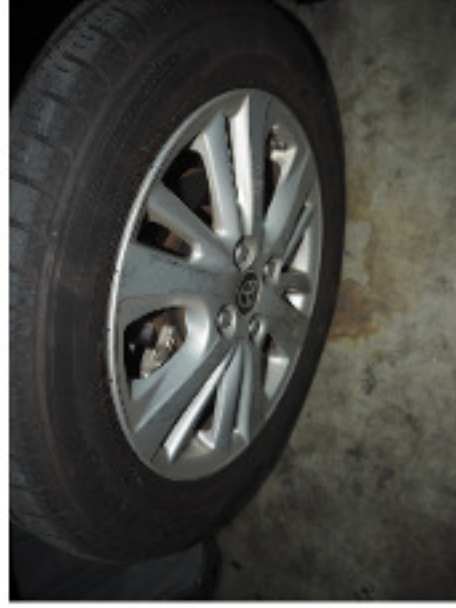
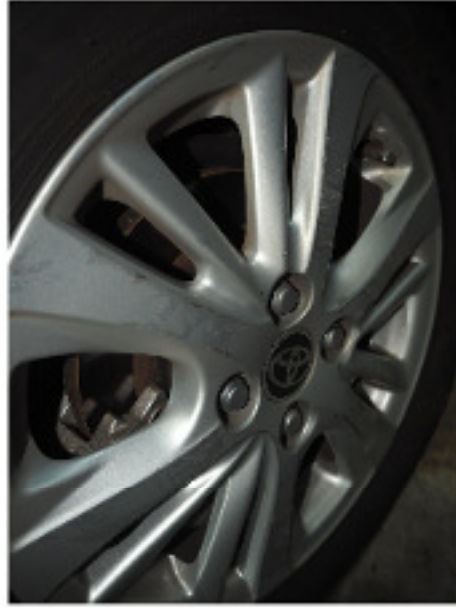
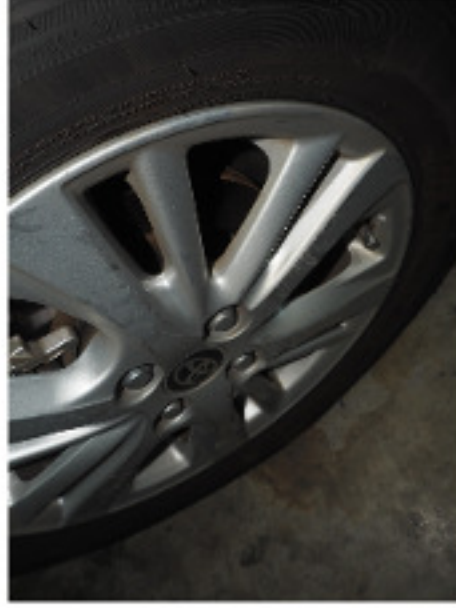
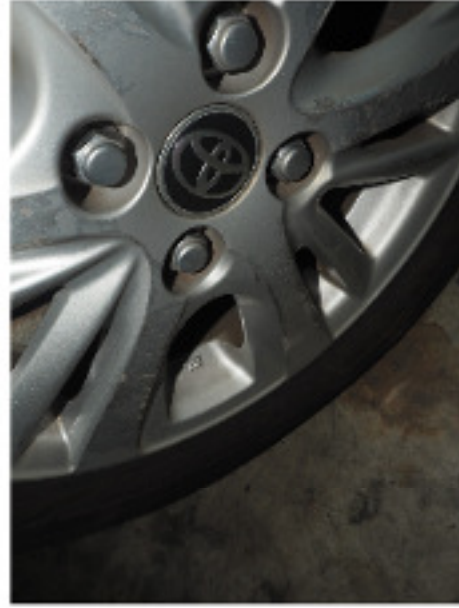
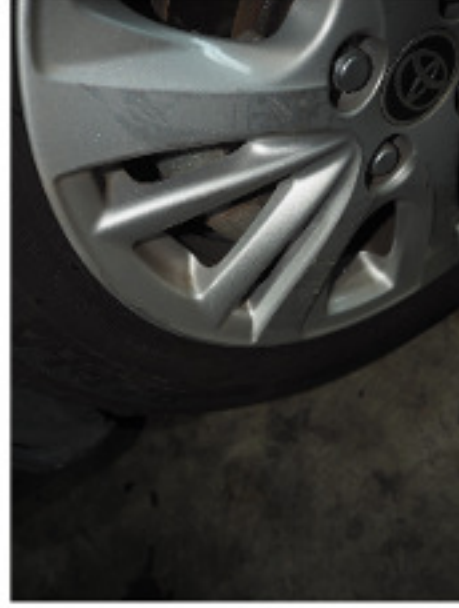
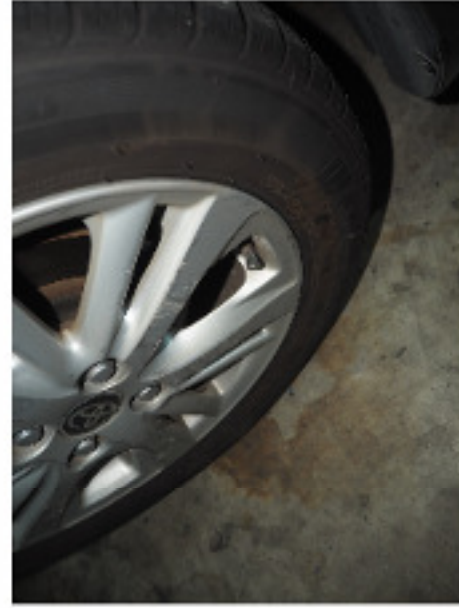
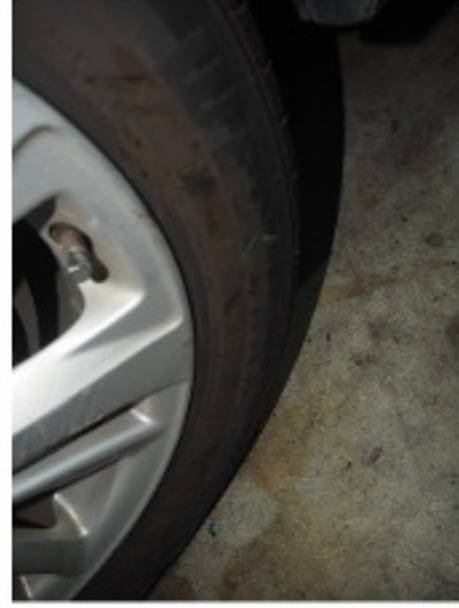
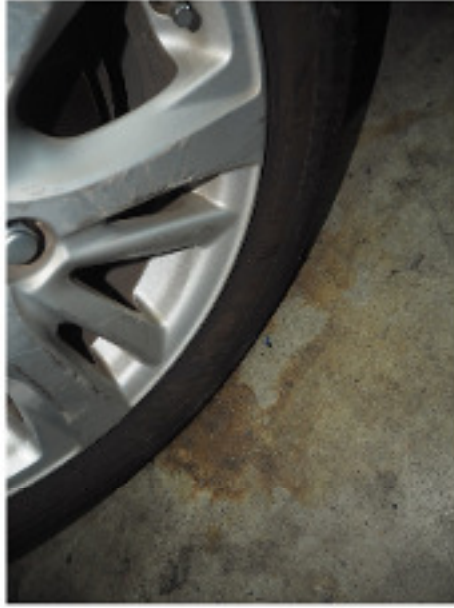
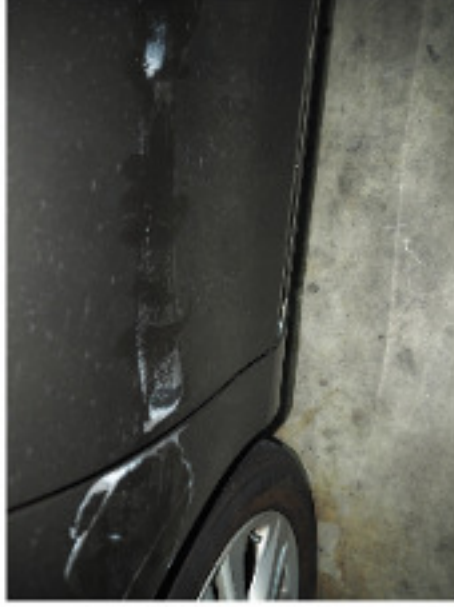
4. Description of Damages				
	THE VEHICLE SUSTAINED DAMAGES AT THE N/S BODY. DAMAGES SEE DETAILS.			
5. General Information				
	Accident Date	18/02/2020	Inspection Date	19/02/2020
	Survey held at	GREEN FOREST AUTOMOBILE PTE LTD 8 KAKI BUKIT AVENUE 4 #05-25 PREMIER @ KAKI BUKIT SINGAPORE 415875		
5a. Remarks				
	A)THE INSPECTION WAS CONDUCTED ON A"WITHOUT PREJUDICE" BASIS. B)IN ACCORDANCE TO YOUR INSTRUCTIONS, WE HAVE NOT AUTHORISED REPAIRS.			
5b. Estimate Days of Repair				
	ESTIMATED NORMAL PERIOD FOR REPAIR:		4 Working Days
