Your Ref: SNM20D200911
Our Ref : CS/CTI20002982/N

28 February 2020

**TECHNICAL INVESTIGATION REPORT OF FIRE INCIDENT INVOLVING THE
INSURED VEHICLE XD 1749L ON 18 FEBRUARY 2020**

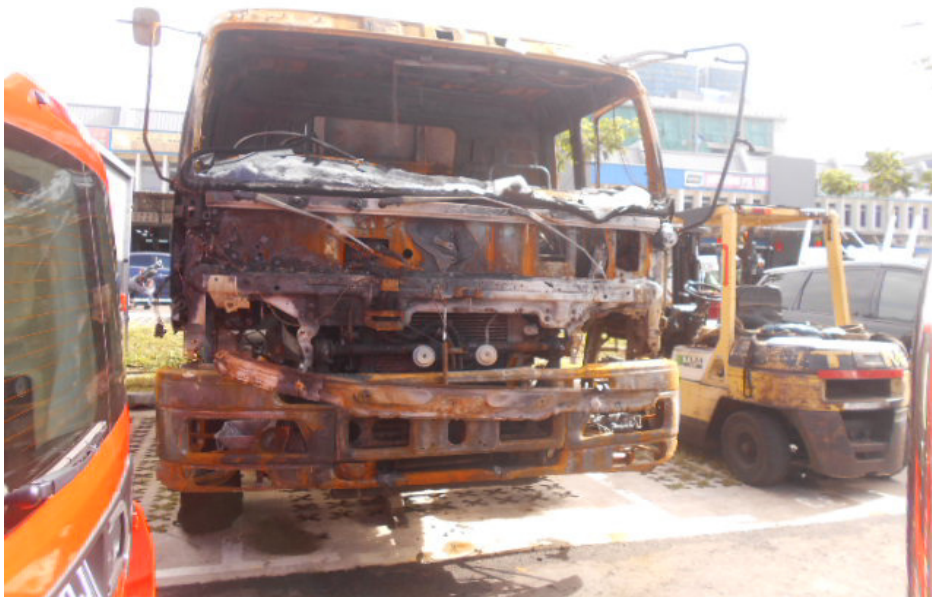
Photo 1 shows a general view of the front body of the Insured Vehicle at the time of inspection. The Insured Vehicle was observed to have sustained extensive fire damage at its frontal portion. The body panels at the frontal portion and the undercarriage components at the front underside were found to have been burnt to char.

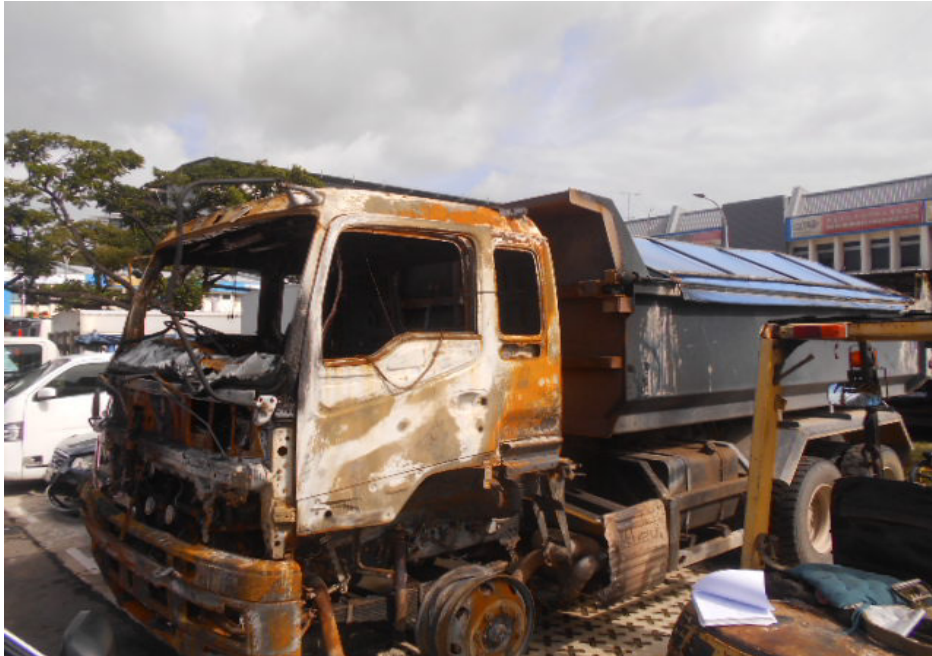
Photo 2 shows a general view of the front left body of the Insured Vehicle at the time of inspection. The Insured Vehicle was observed to have sustained extensive fire damage at its frontal portion. The body panels at the frontal portion were found to have been burnt to char.

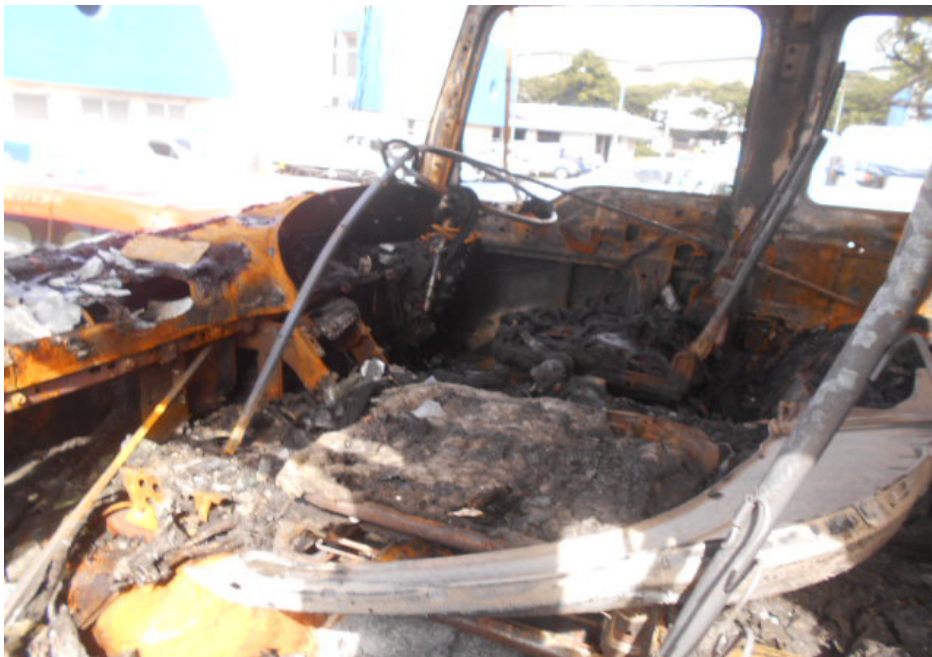
Photo 3 shows the interior compartment of the Insured Vehicle. All the parts inside the interior compartment were found to be burnt and/or melted. Its front seats, rear seats, roof upholstery, carpet and various trims were all burnt and/or melted as a result of the fire.

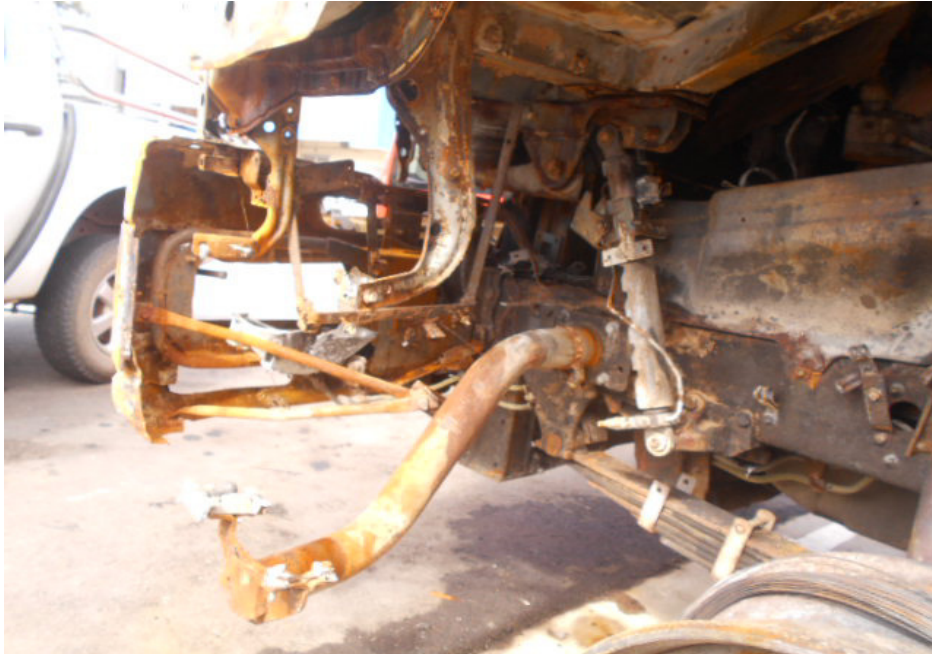
Photo 4 shows the underside of the Insured Vehicle, at its front left area. The various undercarriage components at the front underside of the Insured Vehicle were observed to be affected. This had included components of the braking system and steering system.

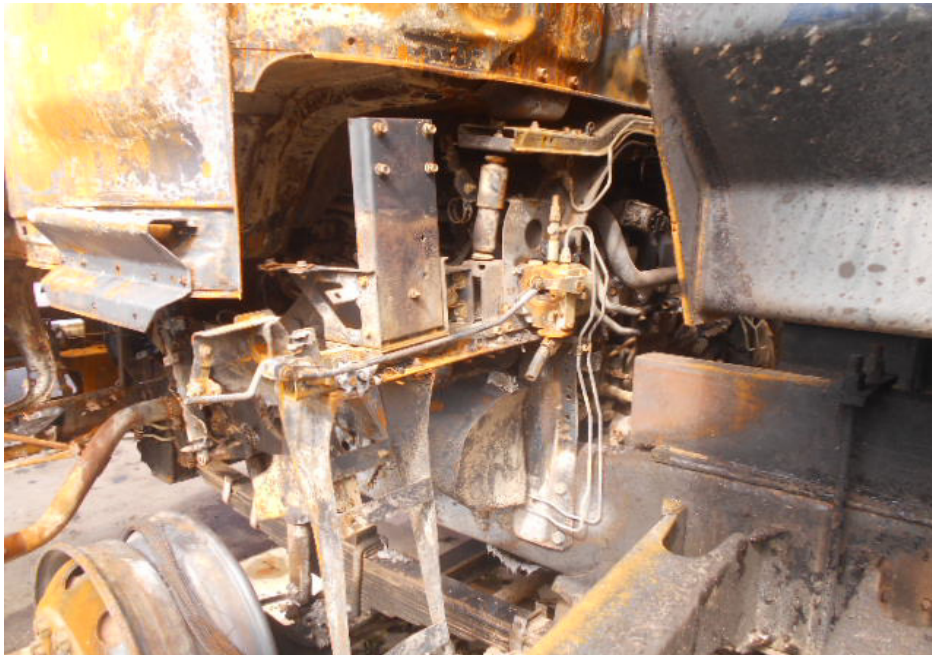
Photo 5 shows the engine compartment, which was located at the back of the Insured Vehicle's front cabin. The various parts and components within the engine compartment of the Insured Vehicle were all affected by the fire. This had included the engine of the Insured Vehicle.

19. Furthermore, the engine was located at the back of the Insured Vehicle's front cabin (refer to photograph 5 below). As seen from the photographs, the area was not a covered area. Heat generated from engine operation would have been easily dissipated out whilst the Insured Vehicle was moving, hence fire resulting from an engine overheat is also unlikely.

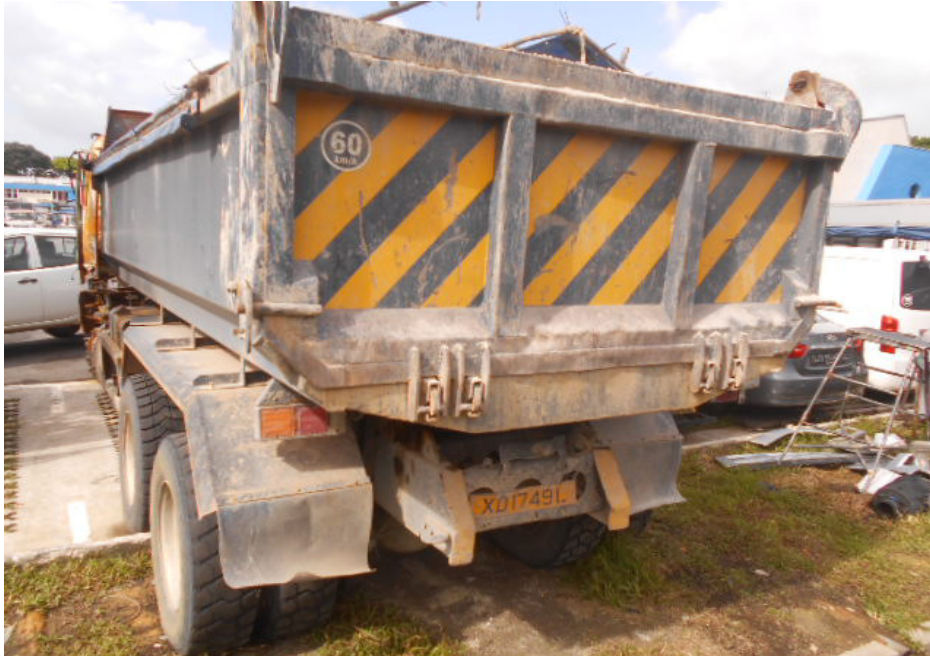
Photo 6 shows a general view of the rear left body of the Insured Vehicle. The rear portion was observed to be relatively unaffected by the fire.

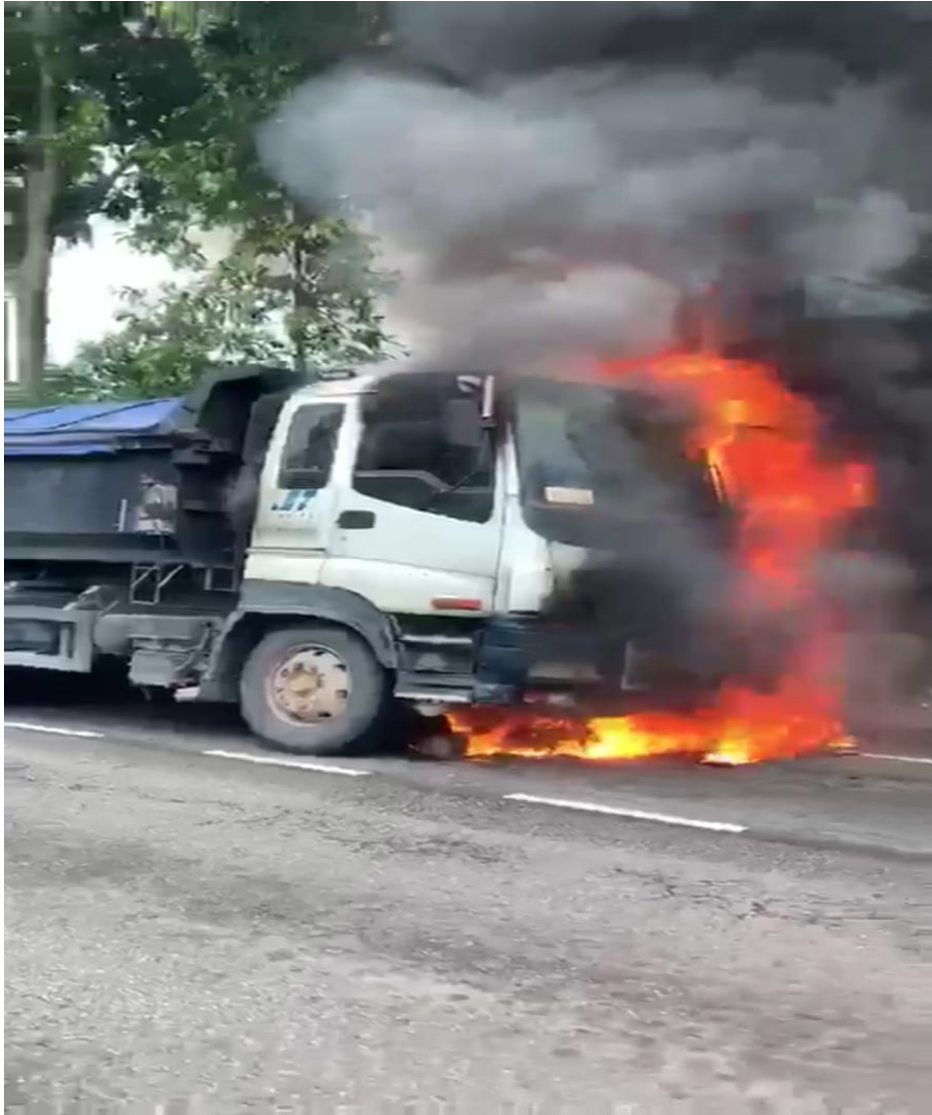
Photo 7 shows a general view of the Insured Vehicle with its frontal portion engulfed in flames. The Insured vehicle could be seen parked along the side of a roadway. Generally, the information that could be gathered from the incident scene photographs provided by Mr Lee had corresponded to the events that he had related to us.

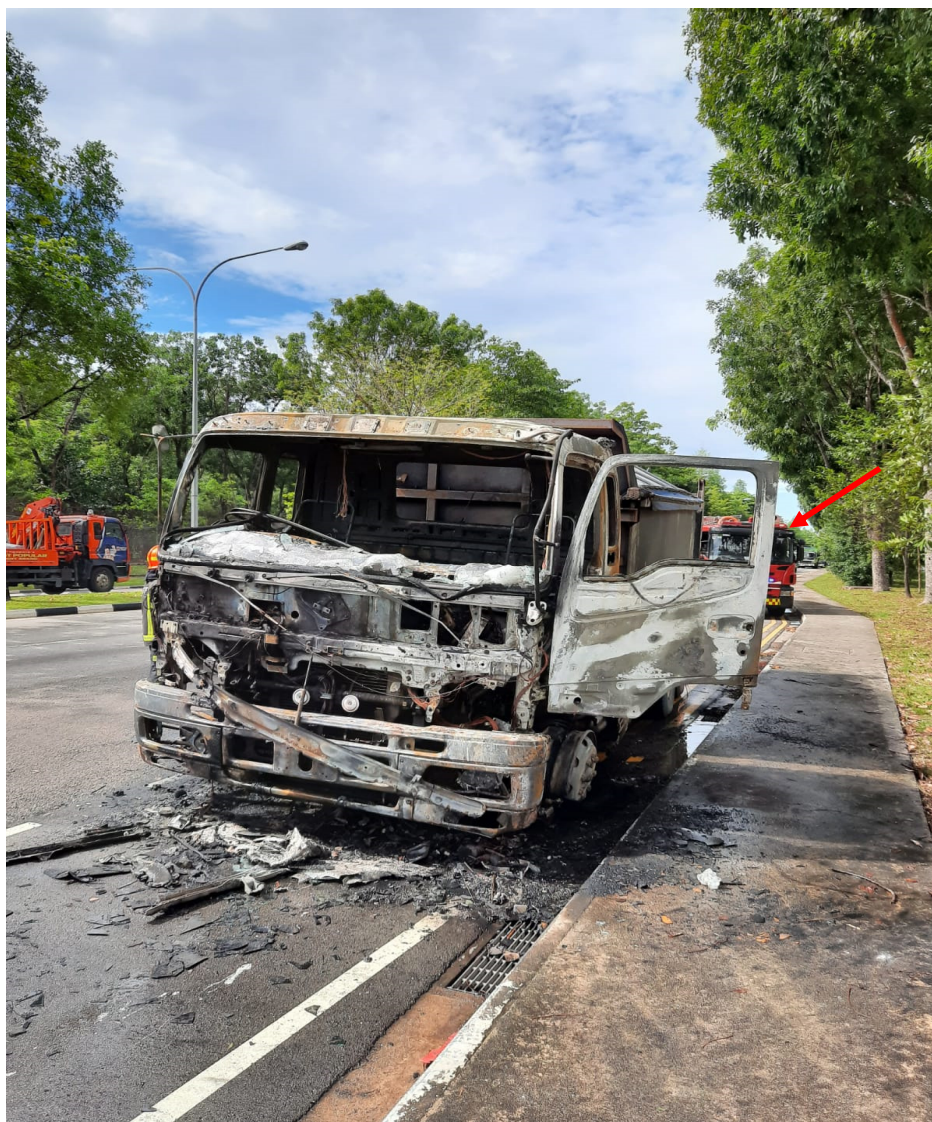
Photo 8 shows a general view of the front body of the Insured Vehicle at the incident scene after the fire was put out. Generally, the information that could be gathered from the incident scene photographs provided by Mr Lee had corresponded to the events that he had related to us, which is SCDF had responded to the incident (arrowed)

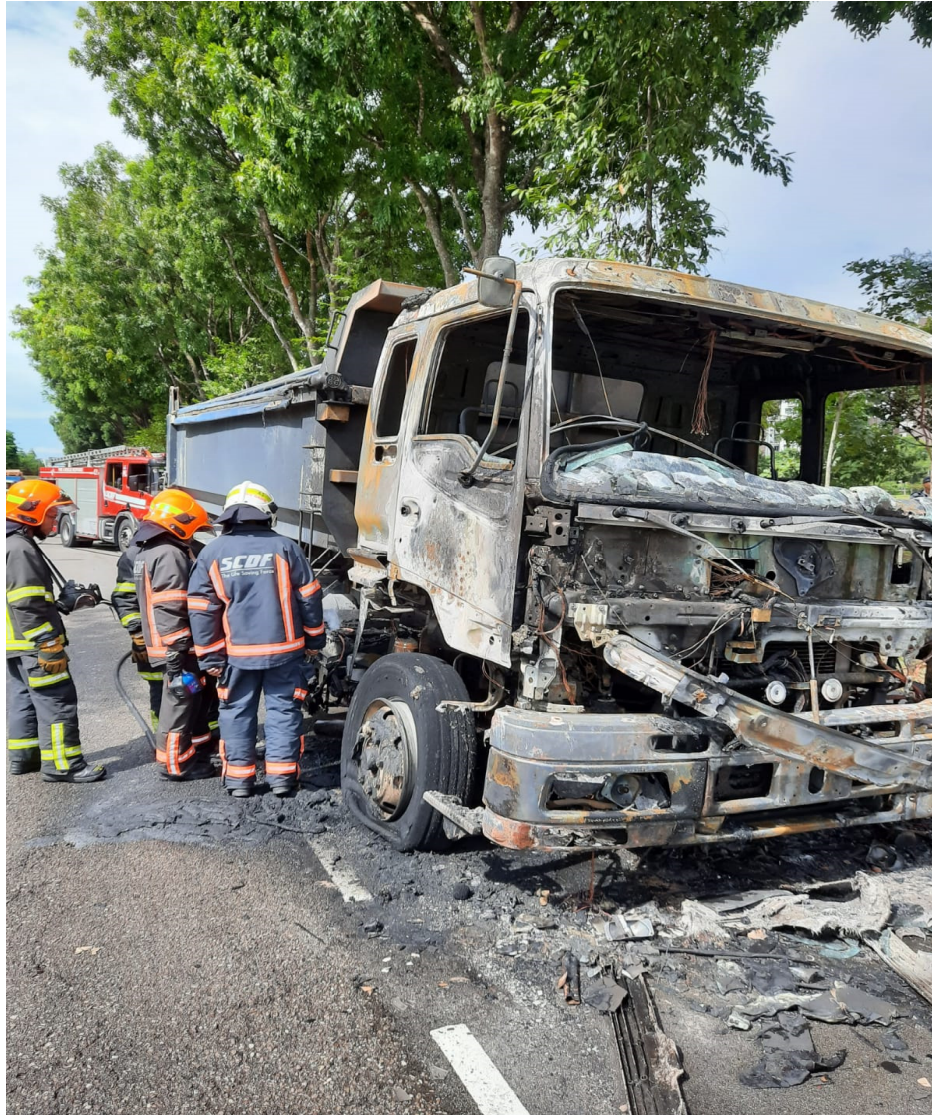
Photo 9 shows a general view of the Insured Vehicle at the incident scene after the fire was extinguished. SCDF officers could be seen conducting a preliminary investigation. Burnt residual remains were observed on the road surface.
