Auto
Consultants
Pte Ltd

INVESTIGATION REPORT:

Our Ref : CS/MSG20003116/P
Policy No : MSD/VPCP/19-000715-00
Insured : SLD 561J
Date of Accident : 22nd February 2020
Location : Along Penang Road (In front of Park Mall)

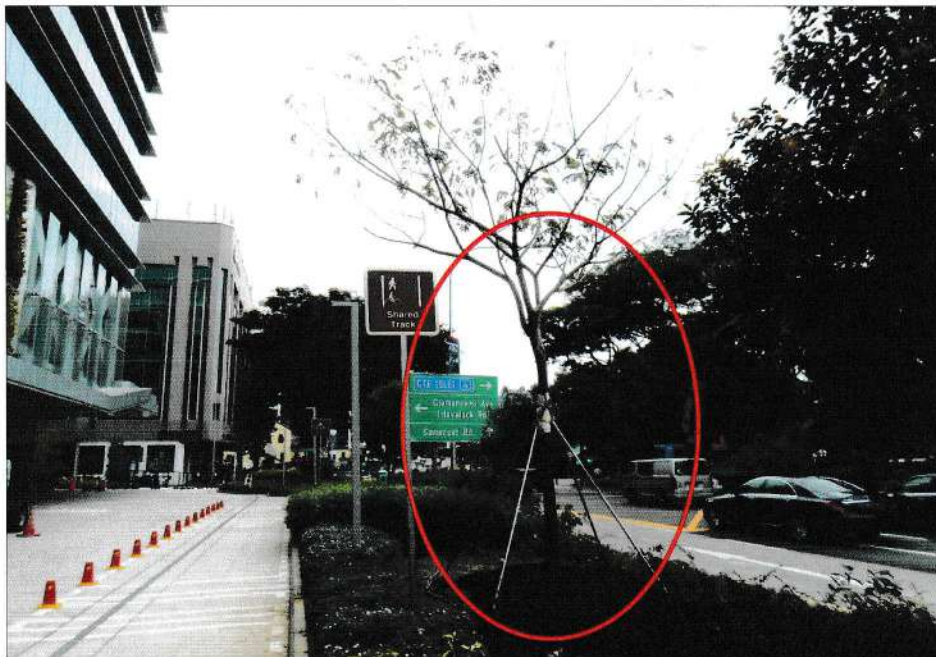
Photo 2 shows general view of the newly planted tree in place of the fallen tree at the time of our site inspection (circled).

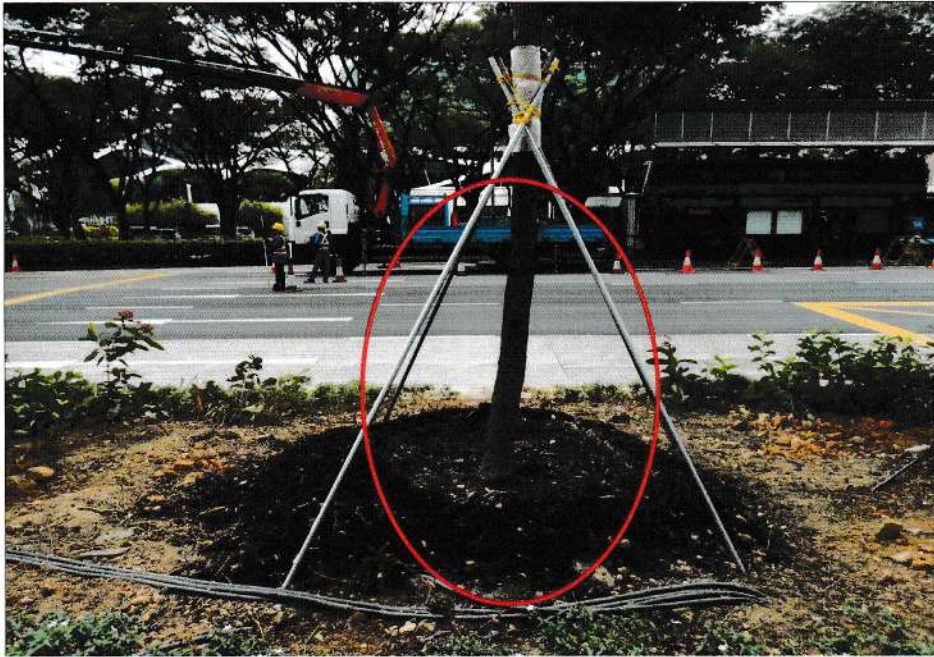
Photo 3 shows the close up view of the newly planted tree in place of the fallen tree at the time of our site inspection (circled).

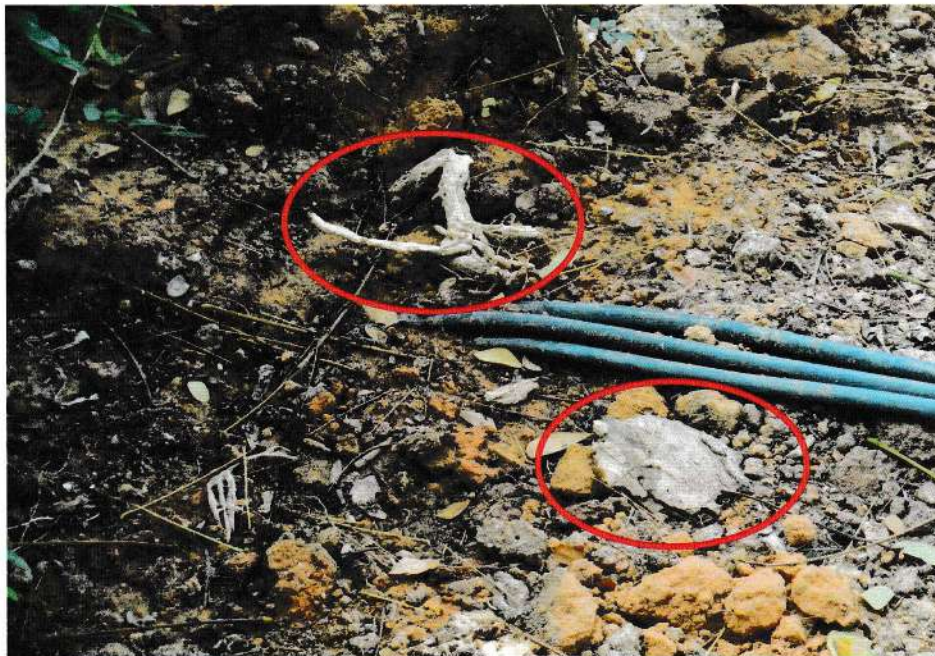
Photo 4 shows a close up view of the surrounding area of the newly planted tree we observed remnants of the fallen tree at the time of our site inspection like the tree bark and roots (circled).

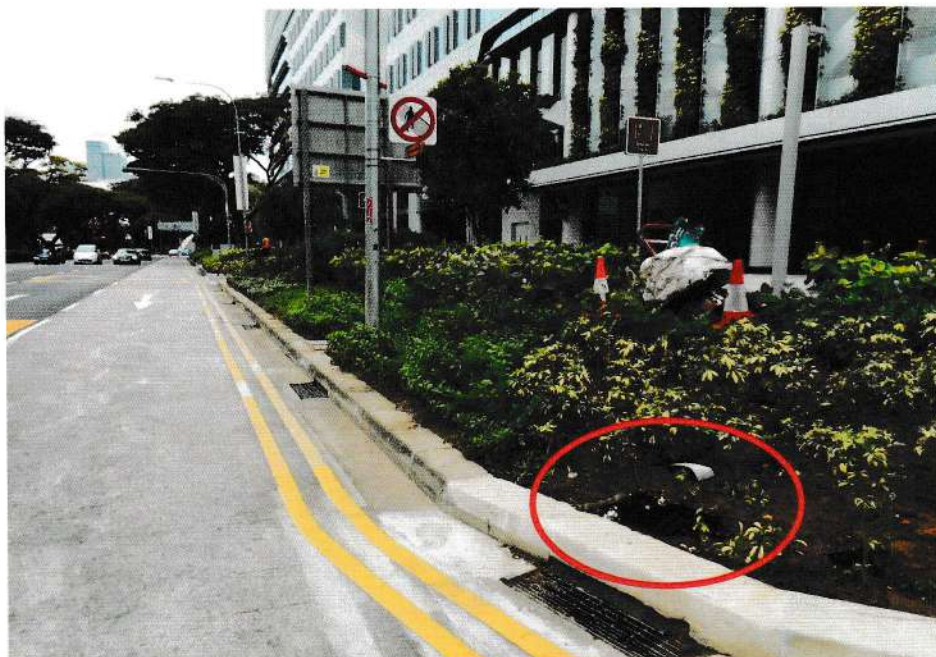
Photo 5 shows a general view of the surrounding area of the newly planted tree we observed remnants of the Insured Vehicle tree at the time of our site inspection like the left rear view mirror and the front grille. (circled).

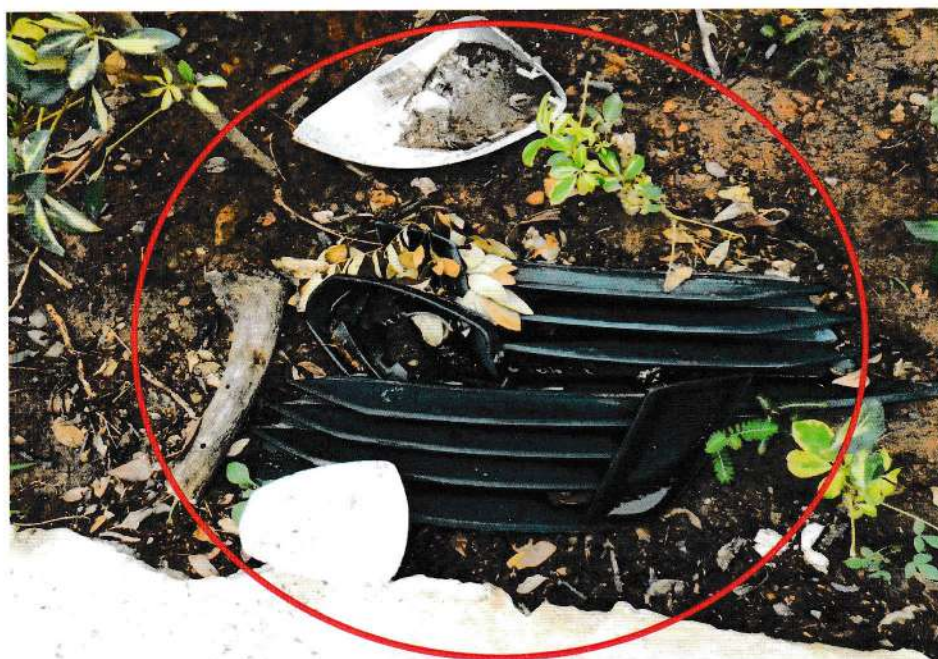
Photo 6 shows a close up view of the surrounding area of the newly planted tree we observed remnants of the Insured Vehicle tree at the time of our site inspection like the left rear view mirror and the front grille. (circled).

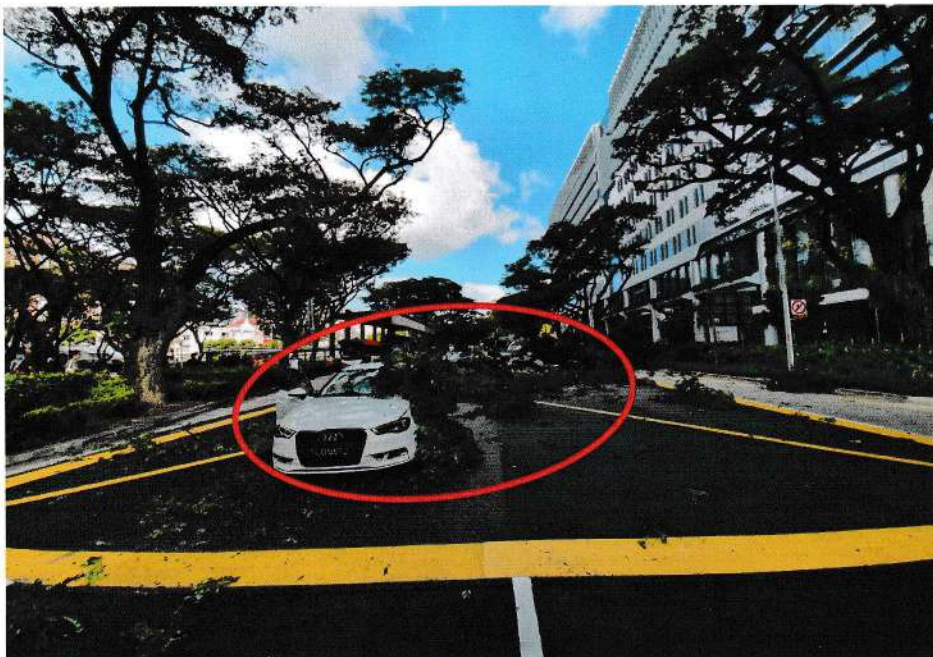
Photo 7 shows a general view of the fallen tree that have landed on the Insured Vehicle and damaged (circled).

16. Having reviewed the video footage recording from the Insured Vehicle, we are in view that the cause of the fallen branch was due to strong winds and lack of maintenance of the tree for a period of time.

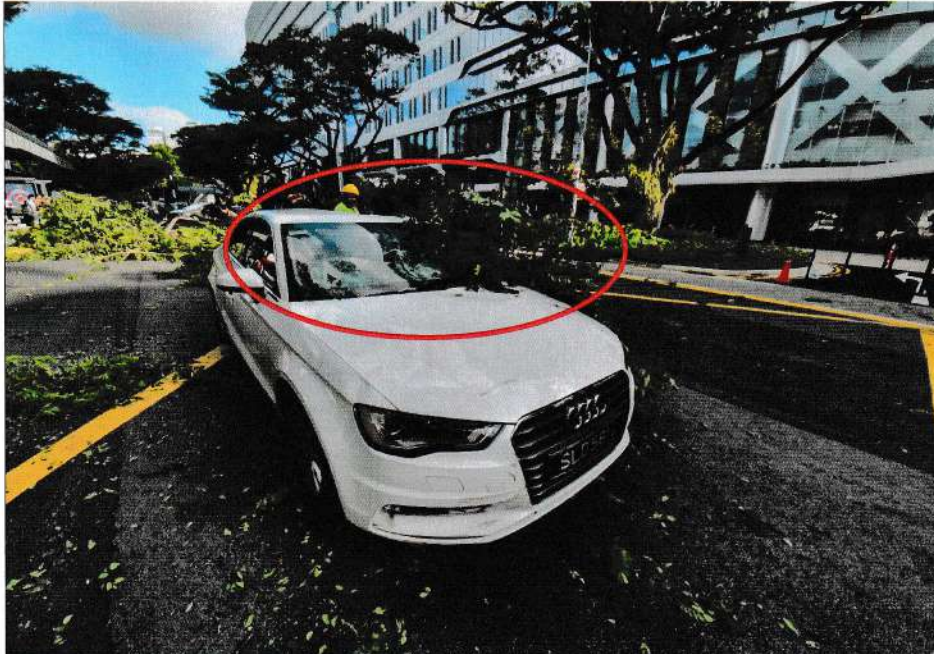
Photo 8 shows the position of the Insured Vehicle after the fallen tree had pinned the Insured Vehicle during the incident. As corroborated in Mr Maung's statement, the front windscreen, roof, left side windcreens and left rear view mirror of the Insured Vehicle were severely damaged by a fallen tree branch (circled).

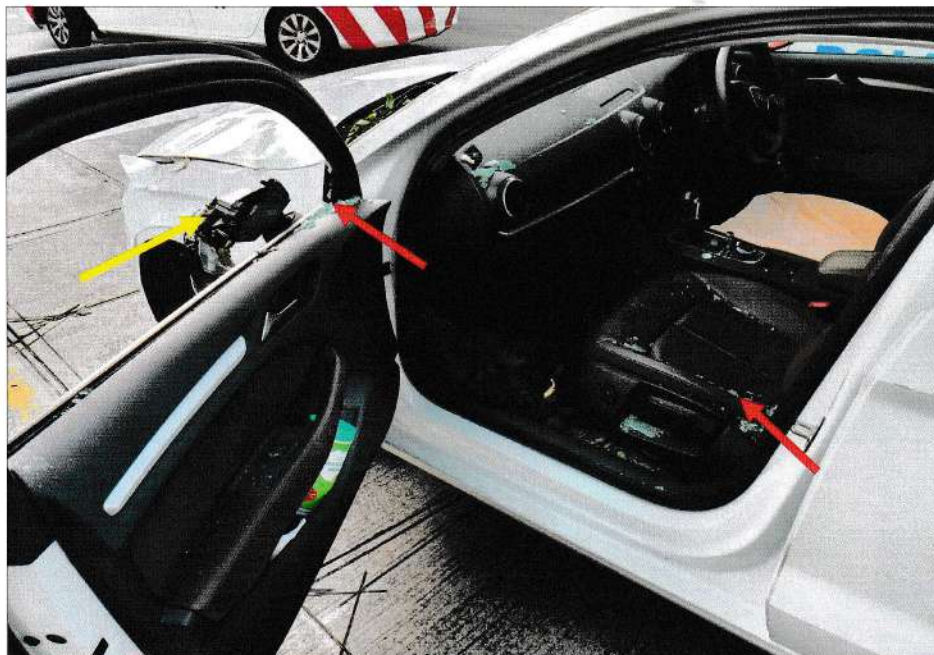
Photo 9 shows the shattered front and left side windscreen (red arrow) and the left rear view mirror (yellow arrow) due to the impact of the fallen tree branch (as seen from the interior of the Insured Vehicle).

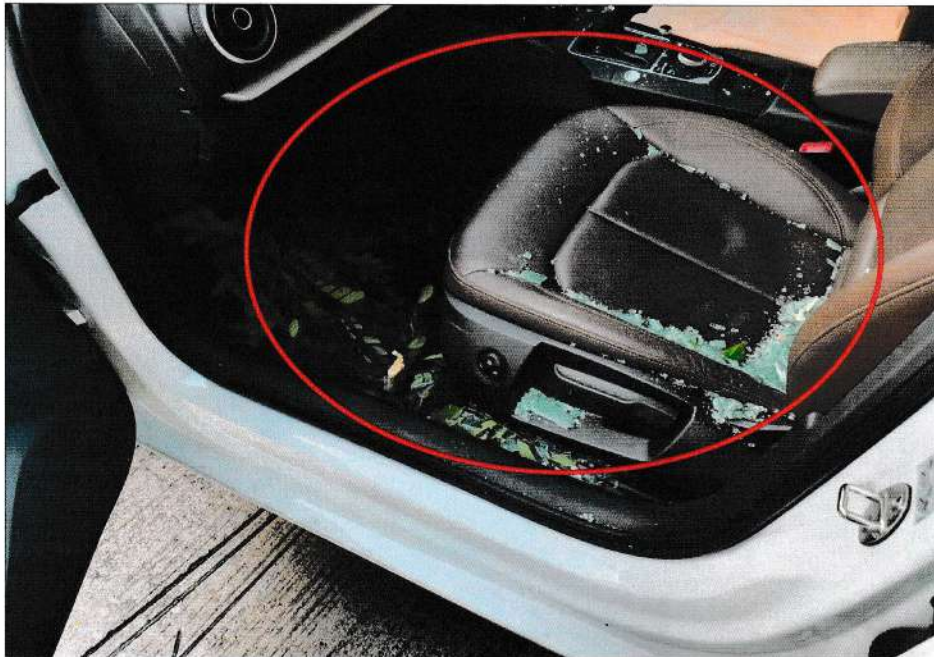
Photo 10 shows close up view of the shattered front and left side windscreen (circled) due to the impact of the fallen tree branch (as seen from the interior of the Insured Vehicle).

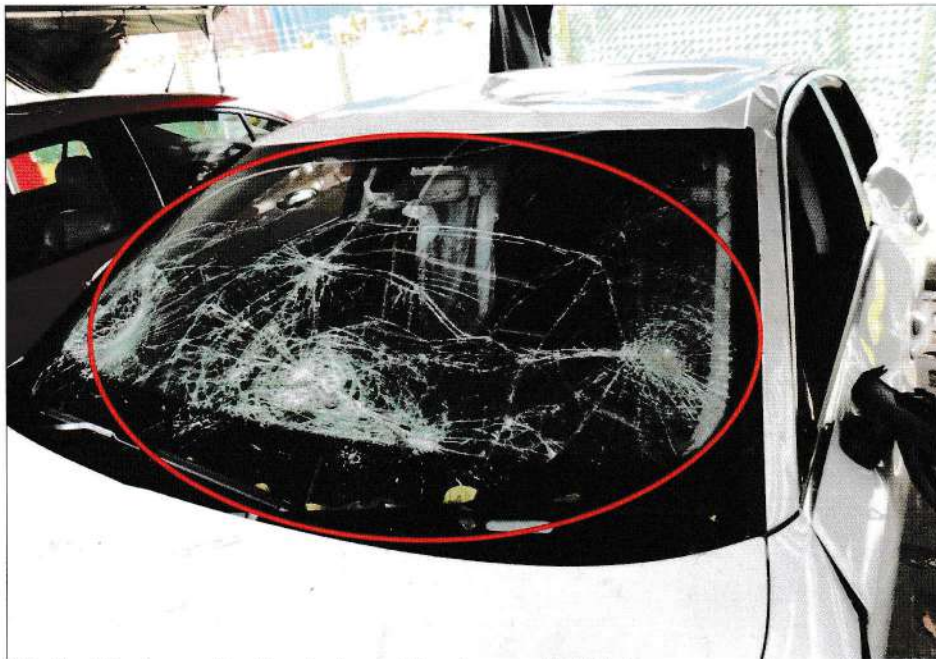
Photo 12 shows the front view of the Insured Vehicle upon our inspection. The severe damages on the front windscreen (circled) correlates with Mr Maung's statement in which the Insured Vehicle was hit by a fallen tree branch.

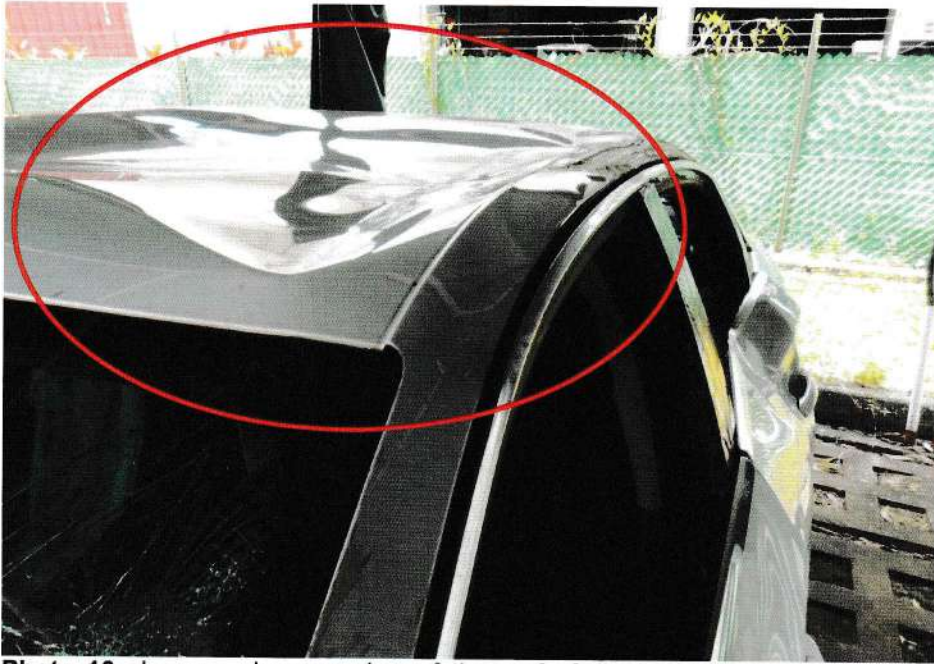
Photo 13 shows a close up view of the roof of the Insured Vehicle upon our inspection. The severe damages on the roof correlate with Mr Maung's statement in which the Insured Vehicle was hit by a fallen tree branch.

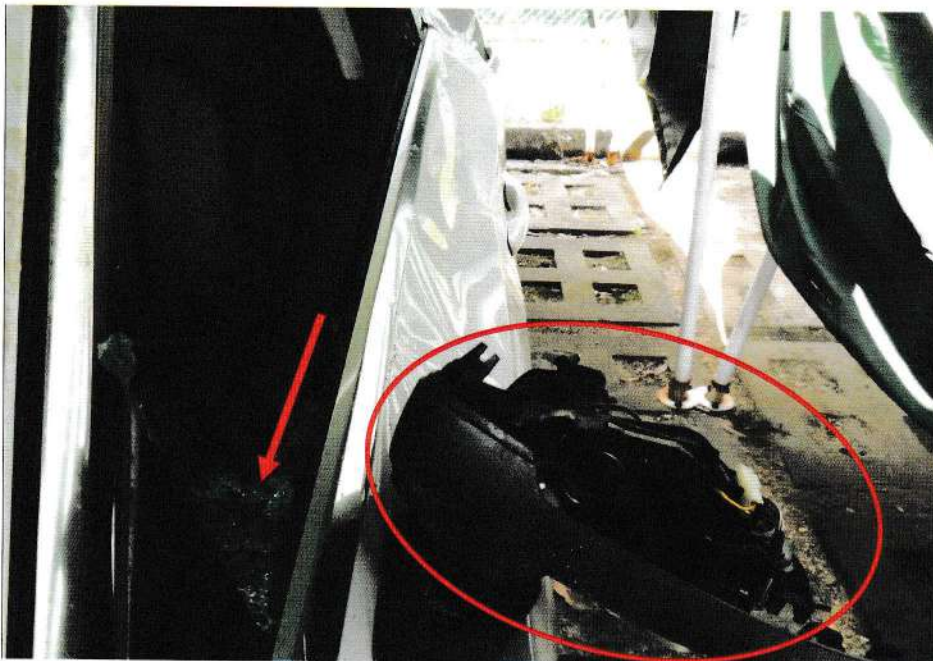
Photo 14 shows a close up view of the left rear view mirror (circled) and the left side windscreen (arrowed) of the Insured Vehicle upon our inspection. The severe damages on the left rear view mirror and windscreen correlate with Mr Maung's statement in which the Insured Vehicle was hit by a fallen tree branch.
