INVESTIGATION REPORT:

Our Ref : CS/MSG20003116/P

Insured : SLD 561J

Date of Accident : 22nd February 2020

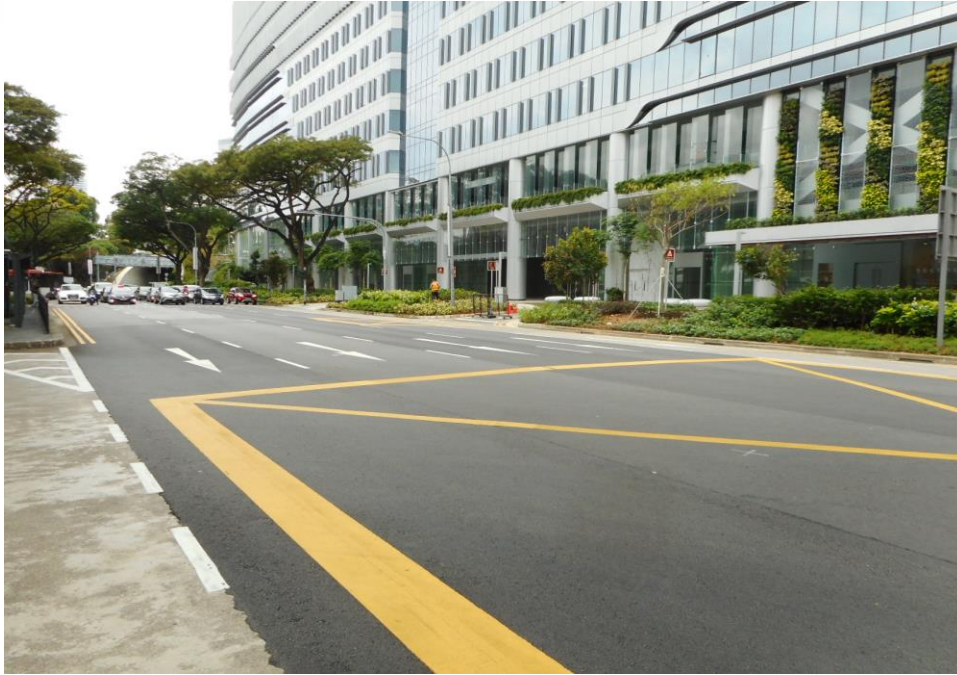
Photo 1 shows the general view of Park Mall which was located along Penang Road.

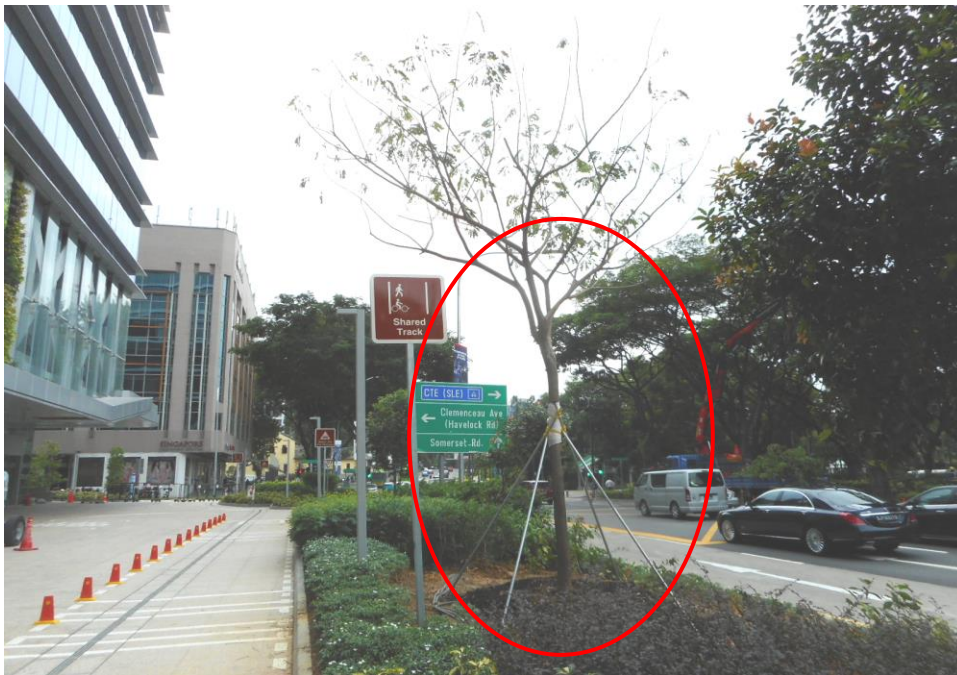
Photo 2 shows general view of the newly planted tree in place of the fallen tree at the time of our site inspection (circled).

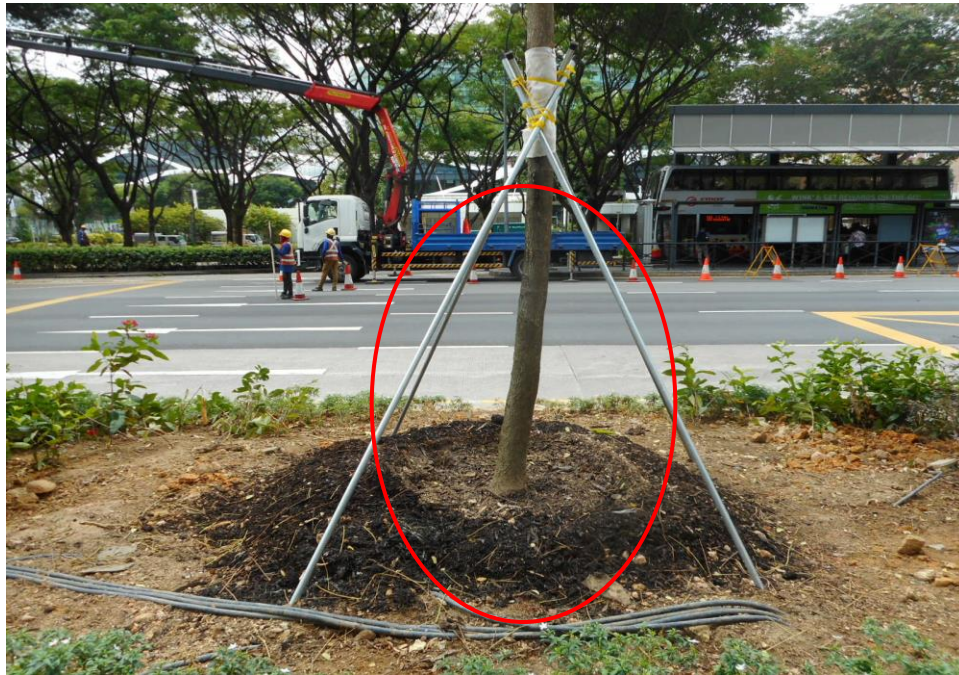
Photo 3 shows the close up view of the newly planted tree in place of the fallen tree at the time of our site inspection (circled).

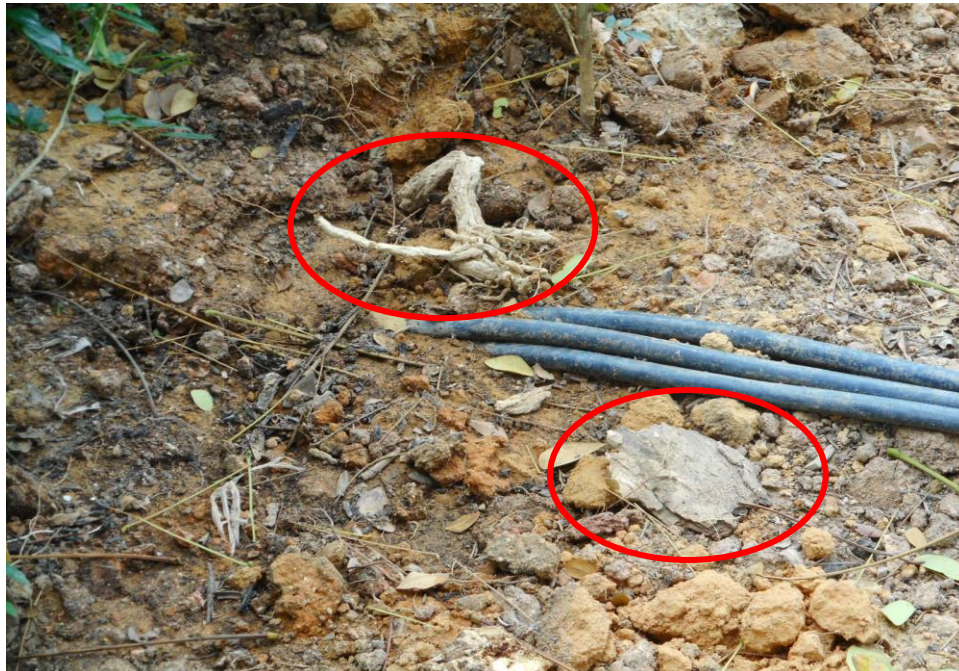
Photo 4 shows a close up view of the surrounding area of the newly planted tree we observed remnants of the fallen tree at the time of our site inspection like the tree bark and roots (circled).

16. Having reviewed the video footage recording from the Insured Vehicle, we are in view that the cause of the fallen branch was due to strong winds and lack of maintenance of the tree for a period of time.

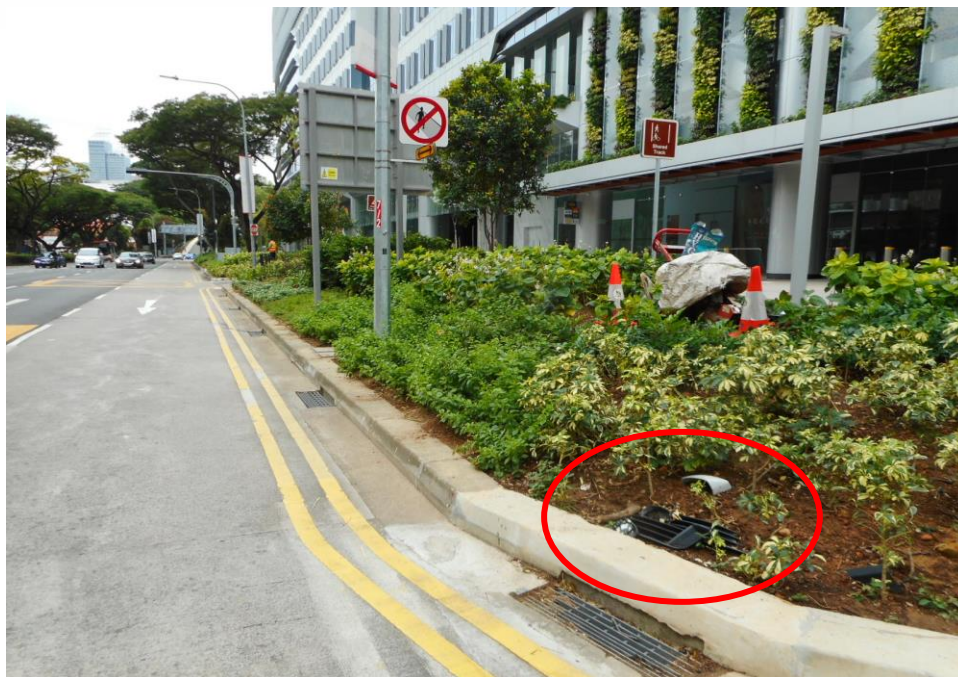
Photo 5 shows a general view of the surrounding area of the newly planted tree we observed remnants of the Insured Vehicle tree at the time of our site inspection like the left rear view mirror and the front grille. (circled).

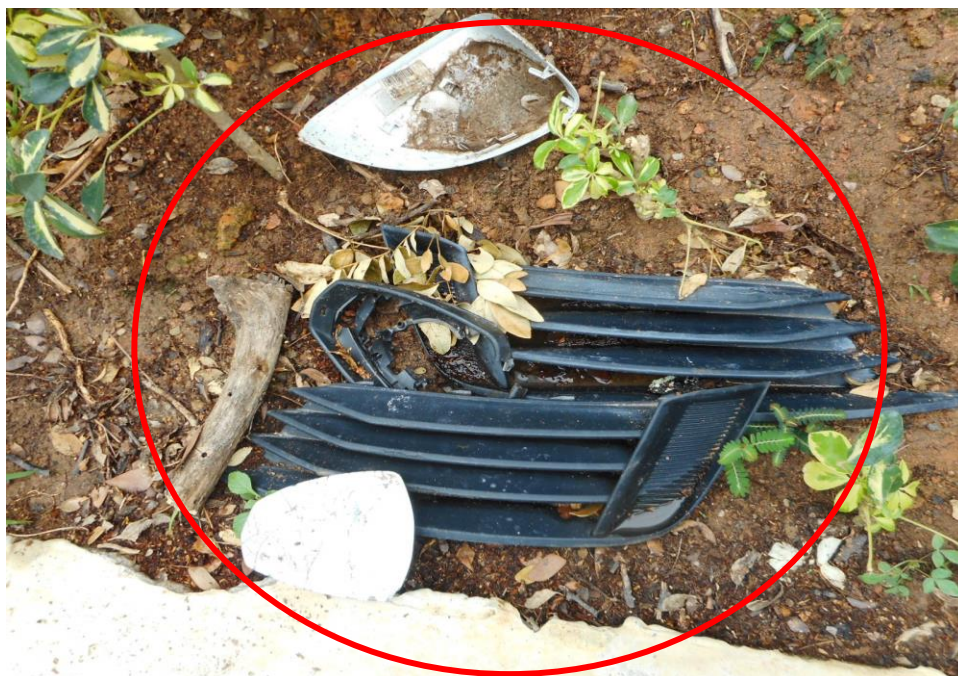
Photo 6 shows a close up view of the surrounding area of the newly planted tree we observed remnants of the Insured Vehicle tree at the time of our site inspection like the left rear view mirror and the front grille. (circled).

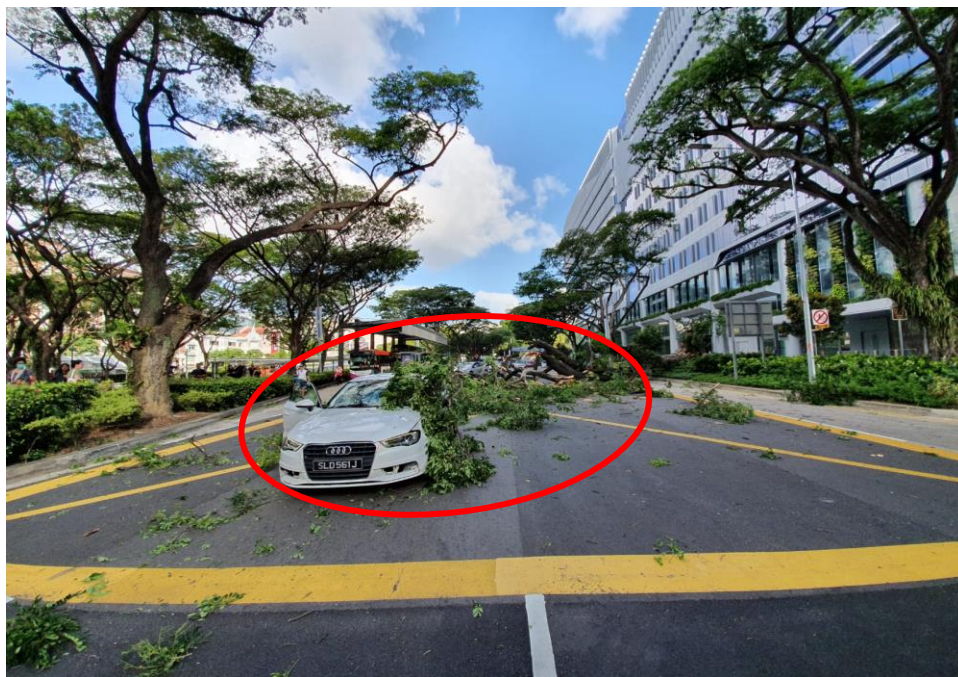
Photo 7 shows a general view of the fallen tree that have landed on the Insured Vehicle and damaged (circled).

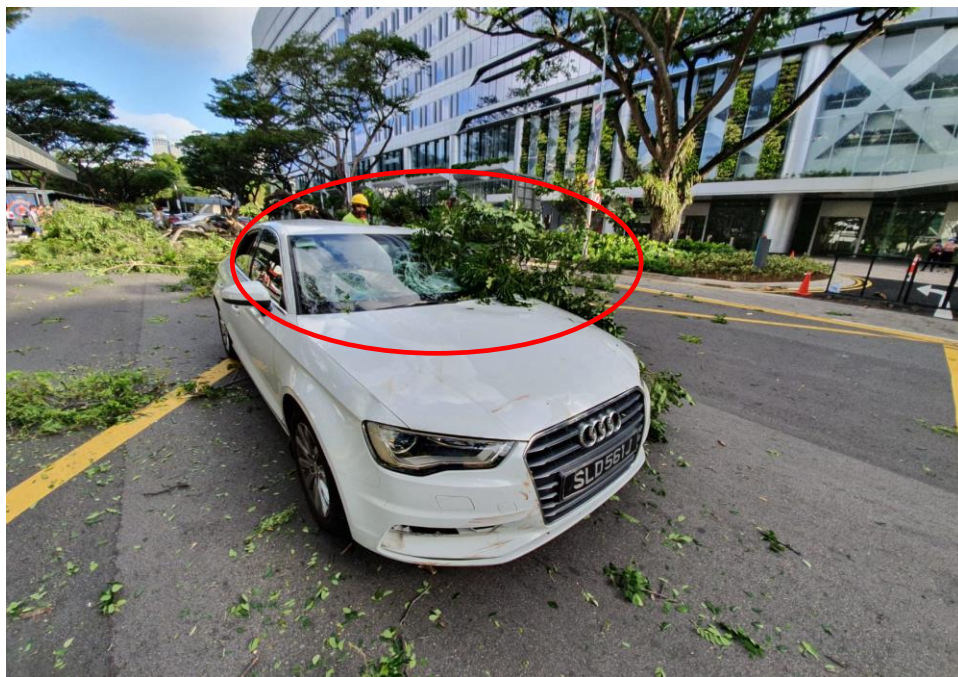
Photo 8 shows the position of the Insured Vehicle after the fallen tree had pinned the Insured Vehicle during the incident. As corroborated in Mr Maung's statement, the front windscreen, roof, left side windscreens and left rear view mirror of the Insured Vehicle were severely damaged by a fallen tree branch (circled).

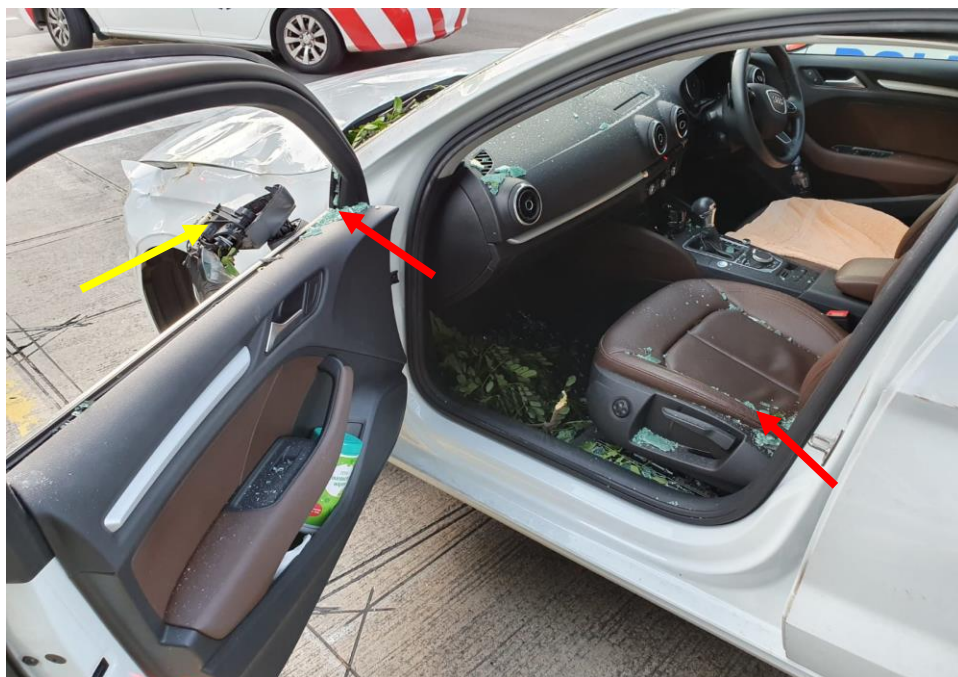
Photo 9 shows the shattered front and left side windscreen (red arrow) and the left rear view mirror (yellow arrow) due to the impact of the fallen tree branch (as seen from the interior of the Insured Vehicle).

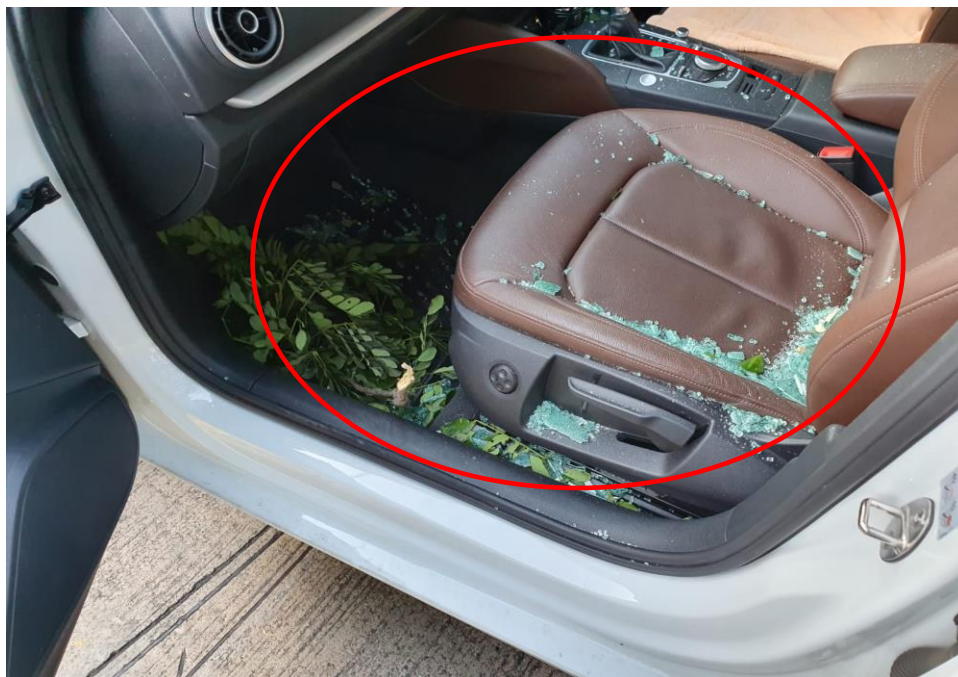
Photo 10 shows close up view of the shattered front and left side windscreen (circled) due to the impact of the fallen tree branch (as seen from the interior of the Insured Vehicle).

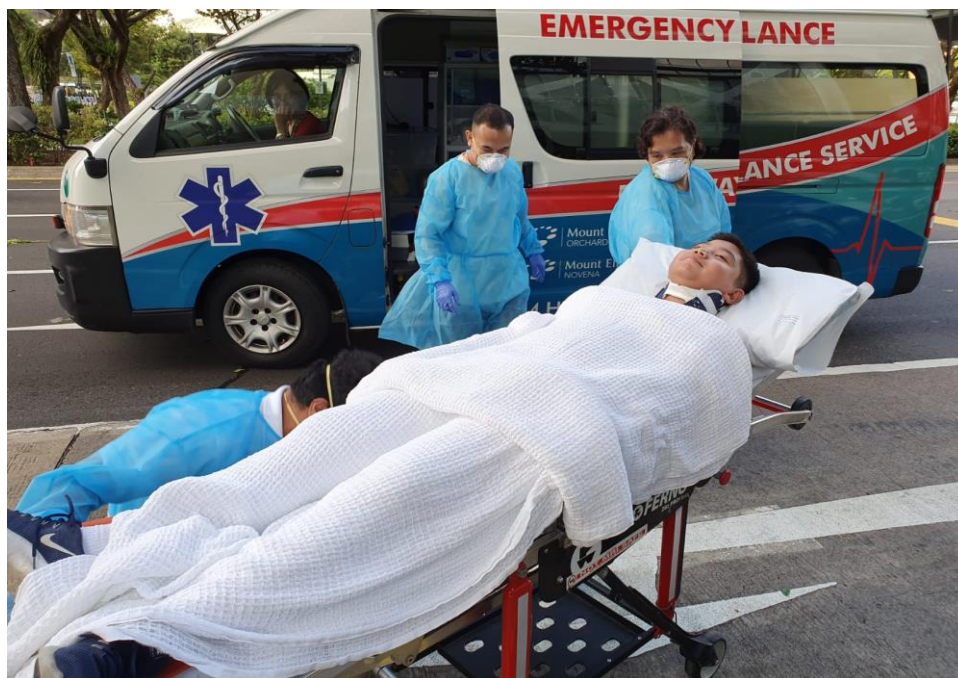
Photo 11 shows the Mr Maung's wife and son being attended by medical staff and conveyed to the hospital

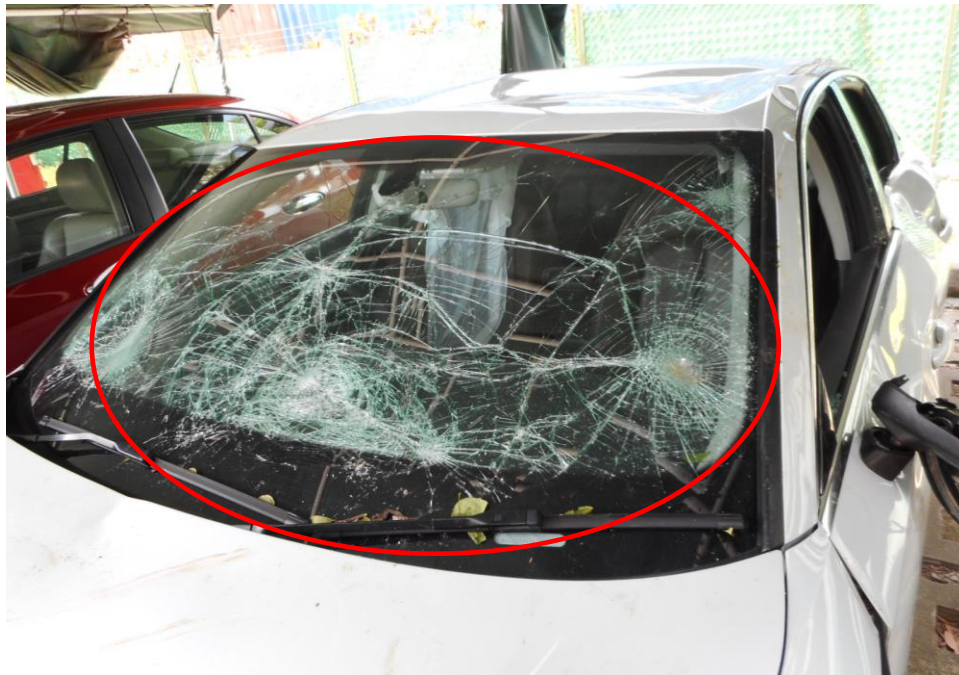
Photo 12 shows the front view of the Insured Vehicle upon our inspection. The severe damages on the front windscreen (circled) correlates with Mr Maung's statement in which the Insured Vehicle was hit by a fallen tree branch.

15. Basing on the available evidence gathered during the course of our investigations, we are of the view that the damages to the Insured Vehicle SLD 561J are consistent to the circumstances of the incident as reported by the driver of the Insured Vehicle SLD 561J, where it was reported that while travelling along Penang Road in front of Park Mall, the front windscreen and roof of the Insured Vehicle were hit by a fallen tree branch.

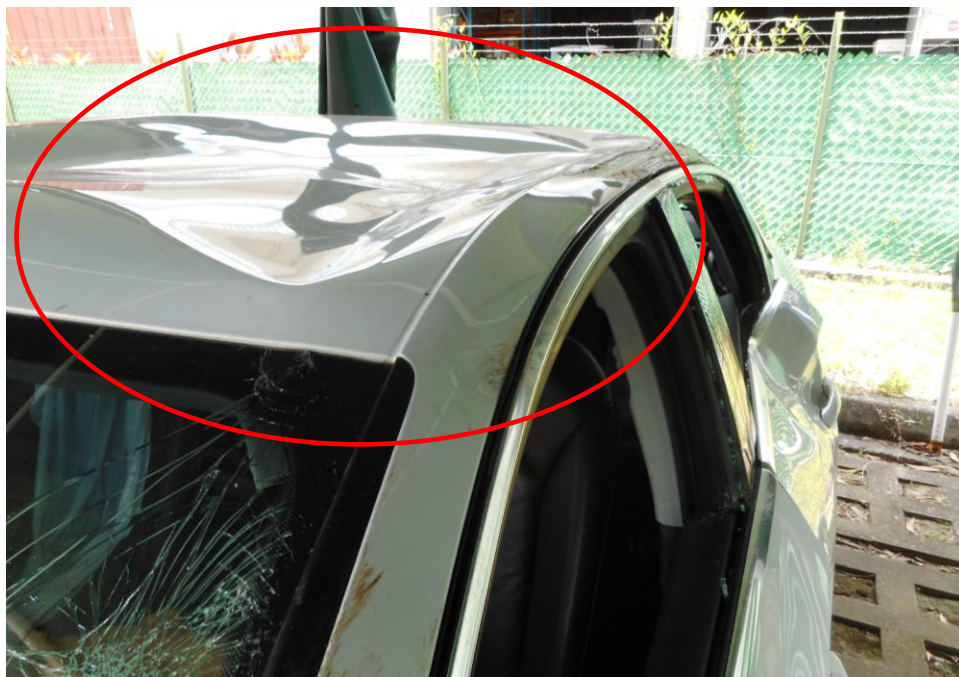
Photo 13 shows a close up view of the roof of the Insured Vehicle upon our inspection. The severe damages on the roof correlate with Mr Maung's statement in which the Insured Vehicle was hit by a fallen tree branch.

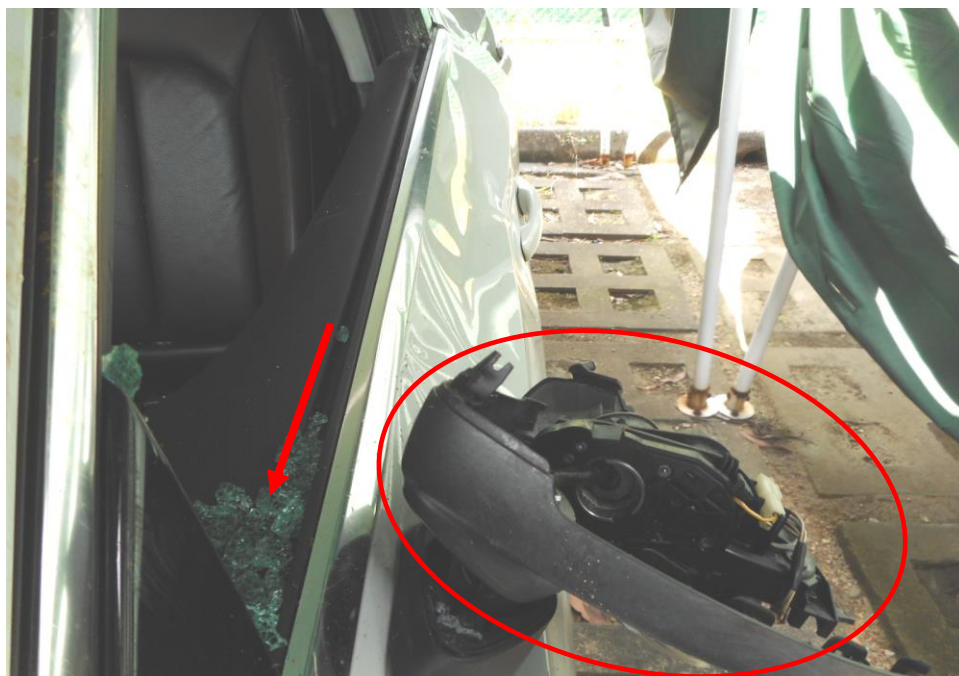
Photo 14 shows a close up view of the left rear view mirror (circled) and the left side windscreen (arrowed) of the Insured Vehicle upon our inspection. The severe damages on the left rear view mirror and windscreen correlate with Mr Maung's statement in which the Insured Vehicle was hit by a fallen tree branch.
