Your Ref: D20001136MFSH  
Our Ref : CS/FCI20003253/N

2 March 2020

**TECHNICAL INVESTIGATION REPORT OF FIRE INCIDENT INVOLVING THE  
INSURED VEHICLE SHC 313L ON 20 FEBRUARY 2020**

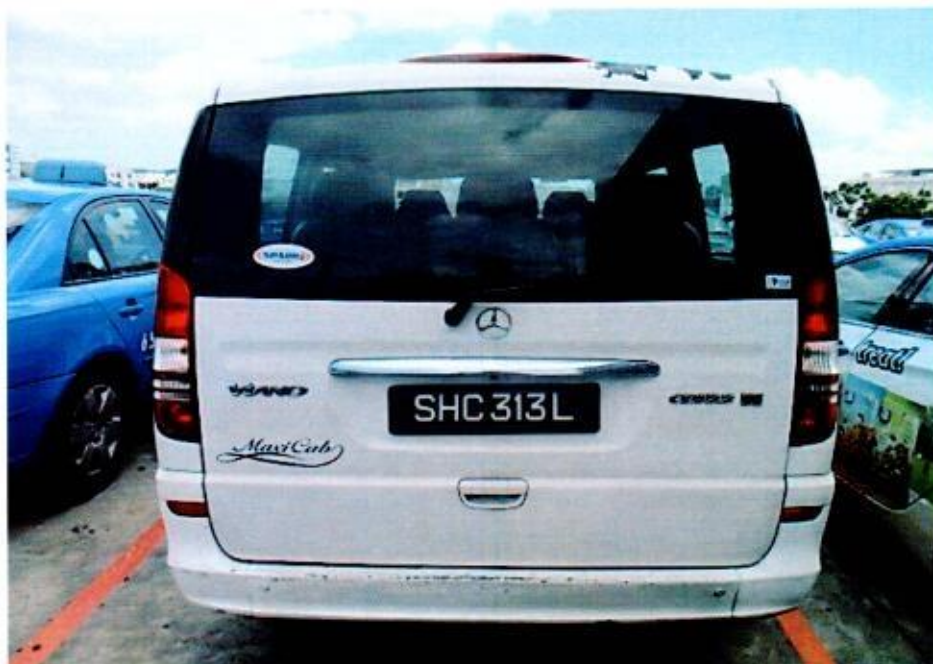
**Photo 1** shows the rear view of the Insured Vehicle. The rear portion of the Insured Vehicle was observed to be relatively unaffected by the fire.

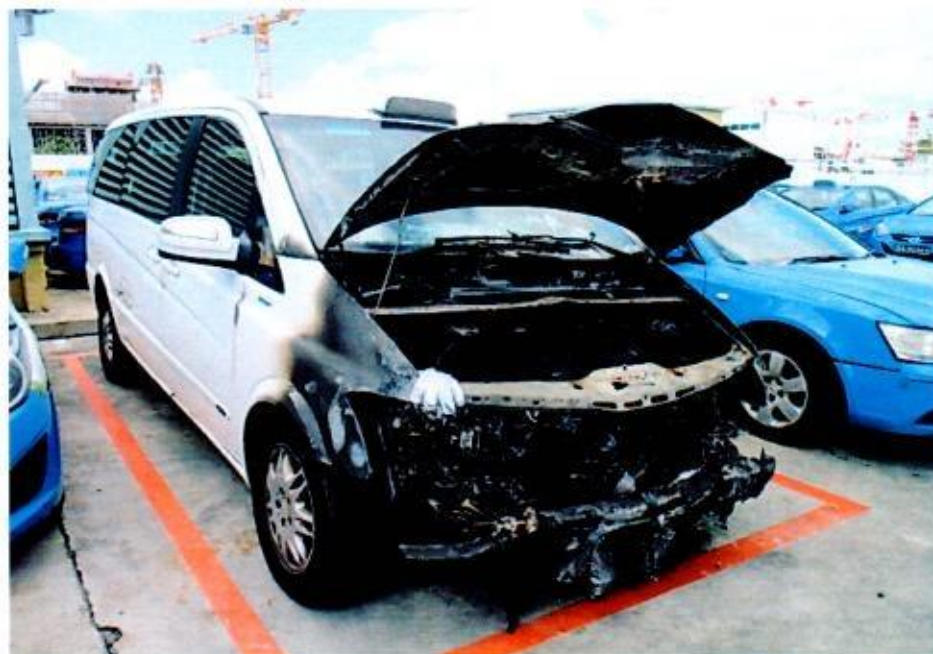
**Photo 2** shows the general view of the right portion of the Insured Vehicle at the time of our inspection. The exterior body of the Insured Vehicle had sustained visible fire damage. This included its front windscreen, front bonnet, front bumper, right front panel and right headlight.

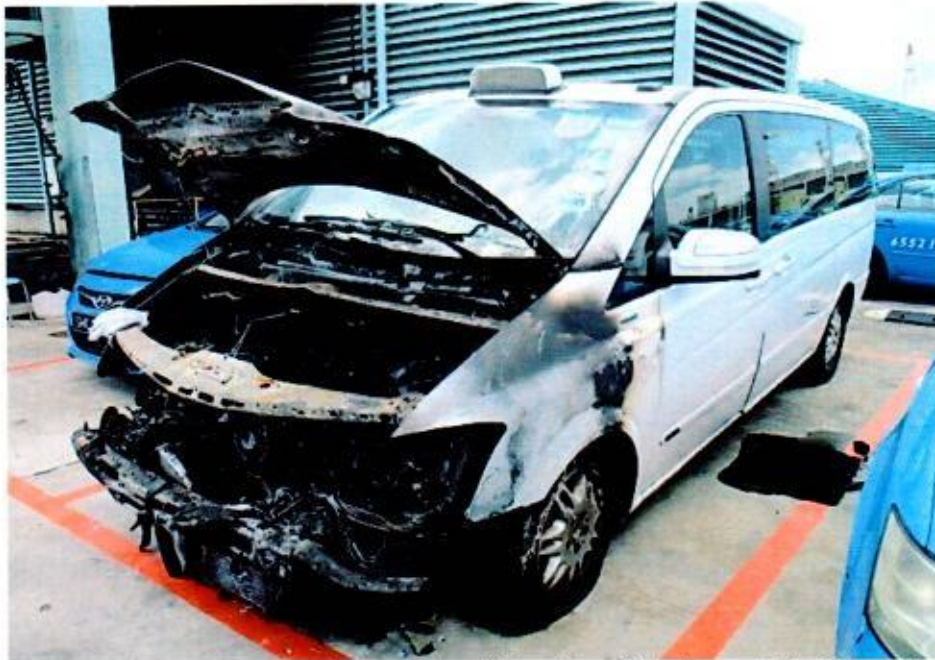
**Photo 3** shows the general view of the left portion of the Insured Vehicle at the time of our inspection. The exterior body of the Insured Vehicle had sustained visible fire damage. This included its front windscreen, front bonnet, left headlight, front bumper, left front panel, left front wheel rim and left front tyre.

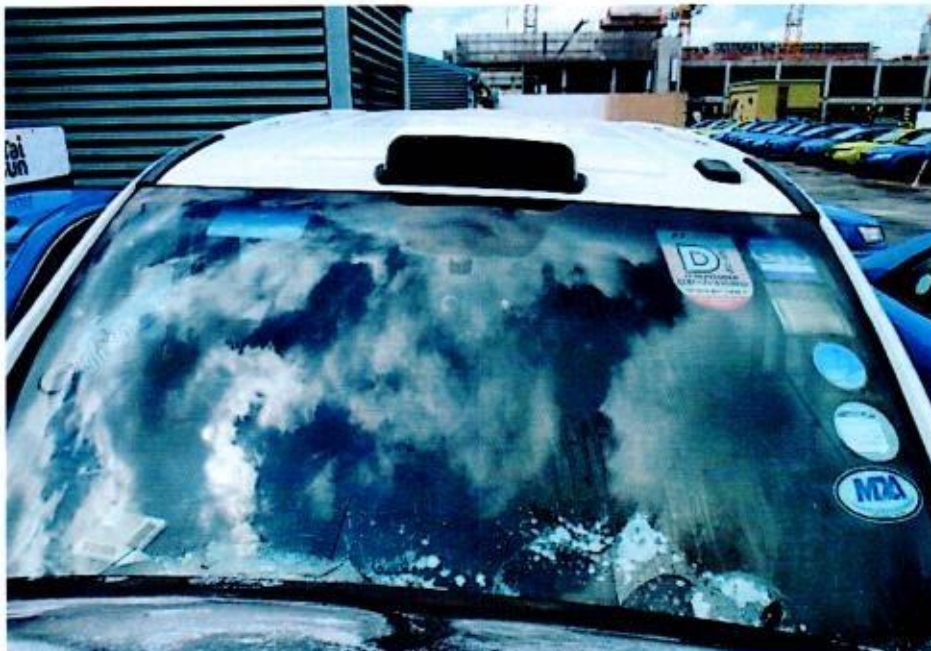
**Photo 4** shows a closer view of the front windscreen of the Insured Vehicle at the time of our inspection. The front windscreen had sustained significant fire damage.

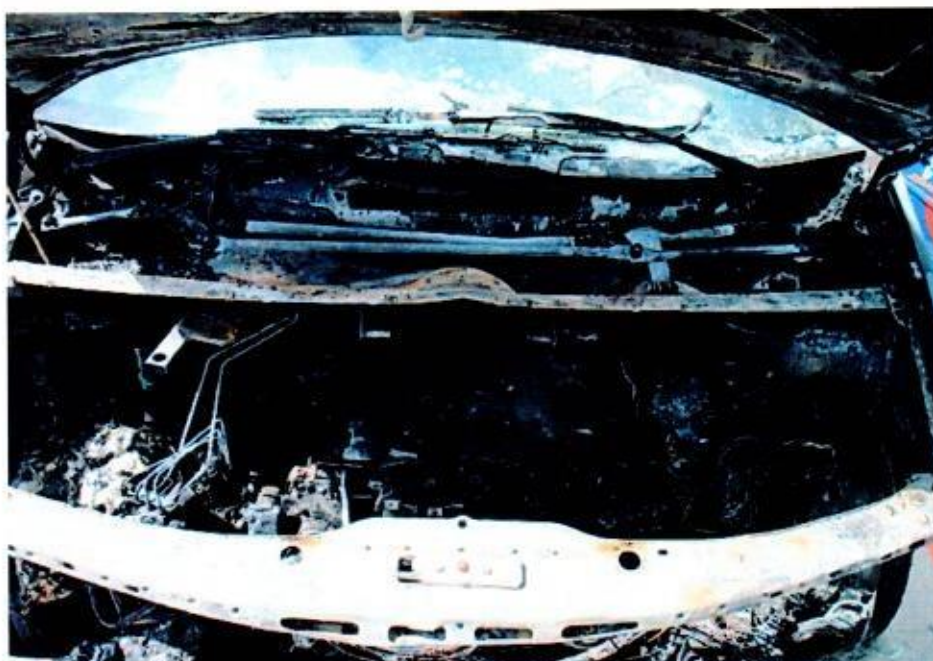
**Photo 5** shows a general view of the engine compartment of the Insured Vehicle at the time of our inspection. Most of the components inside the engine compartment were found to be severely burnt and/or melted as a result of the fire.

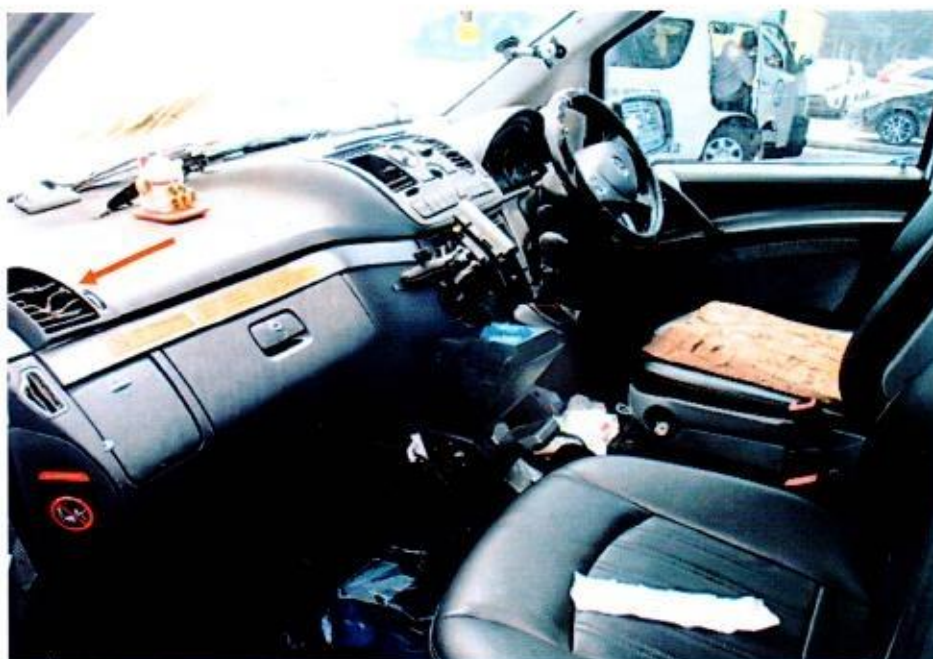
**Photo 6** shows the interior compartment of the Insured Vehicle, which was observed to be slightly affected by the fire (arrowed).

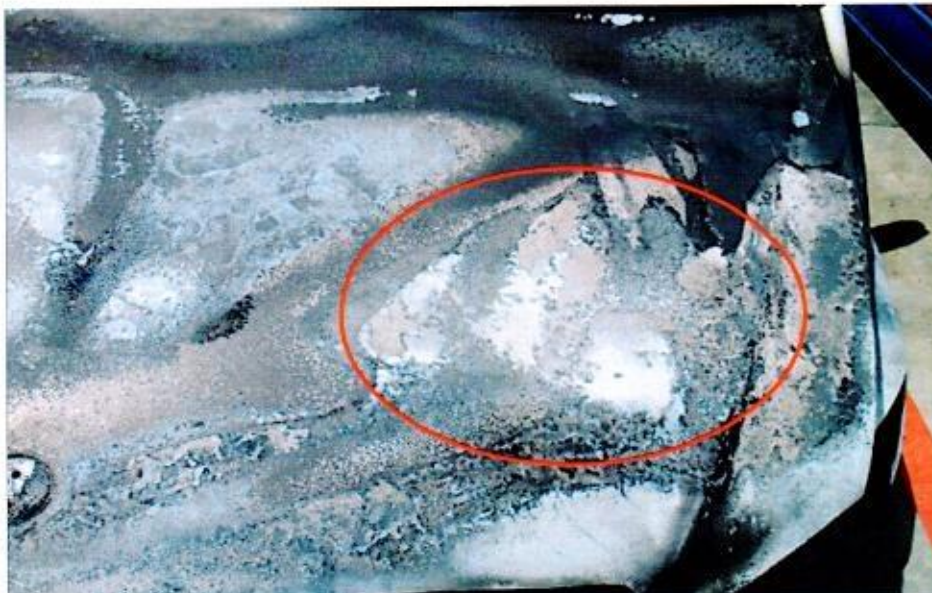
8. For this particular case, the fire appears to have originated within the engine compartment of the Insured Vehicle, somewhere around the left portion of the engine compartment. This can be determined from the burn pattern and the high heat intensity burn marks (whitish burn marks) found on the left portion of the bonnet of the Insured Vehicle and also the rust that had developed on the underside of the front bonnet, at the left portion.

9. The whitish burn marks are a result of exposure to prolonged heat intensity. Rust would normally start to develop around these areas soon after a fire as prolonged exposure to high heat intensity usually causes steel/metal material body parts to be exposed to natural environmental condition. The rust that had developed on the underside of the front bonnet, around the left portion, is an indication that the left portion of the engine compartment had sustained exposure to prolonged high heat intensity. See photos 7 & 8 below.

**Photo 7** shows the burn pattern and whitish burn marks that were found on the left portion of the front bonnet of the Insured Vehicle (circled). Such whitish burn marks are a result of exposure to prolonged heat intensity, which may indicate where the fire had started. Rust would also begin to develop on these areas soon after the fire.

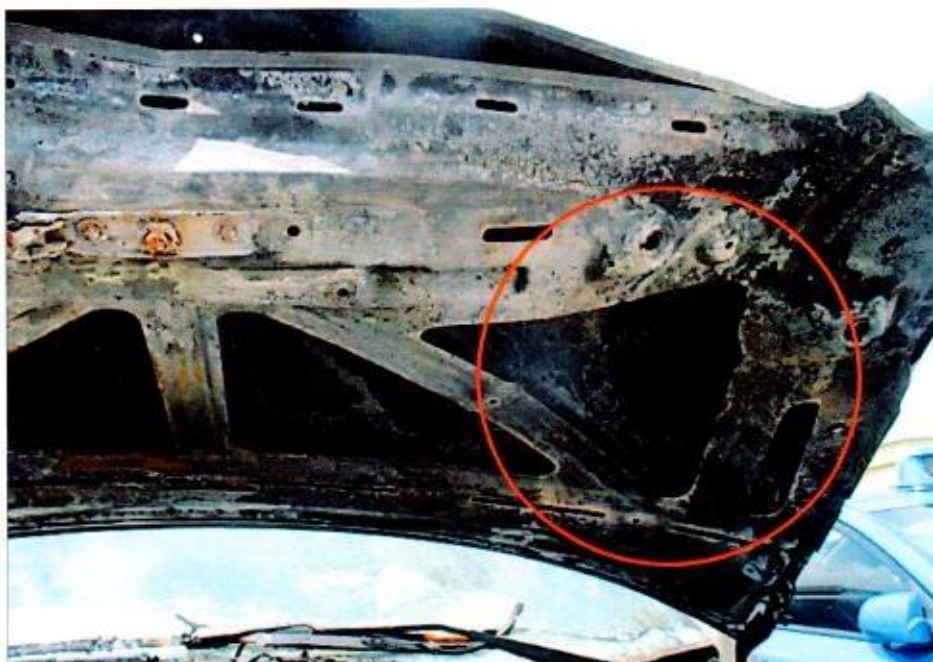
**Photo 8** shows the rust that had developed on the underside of the front bonnet, around the left portion (circled). The development of rust is an indication that this area was subjected to prolonged exposure to high heat intensity, which had caused the steel/metal material of the front bonnet to be exposed to natural environmental condition. Hence the fire to the Insured Vehicle can be determined to have originated towards the left portion of the engine compartment.

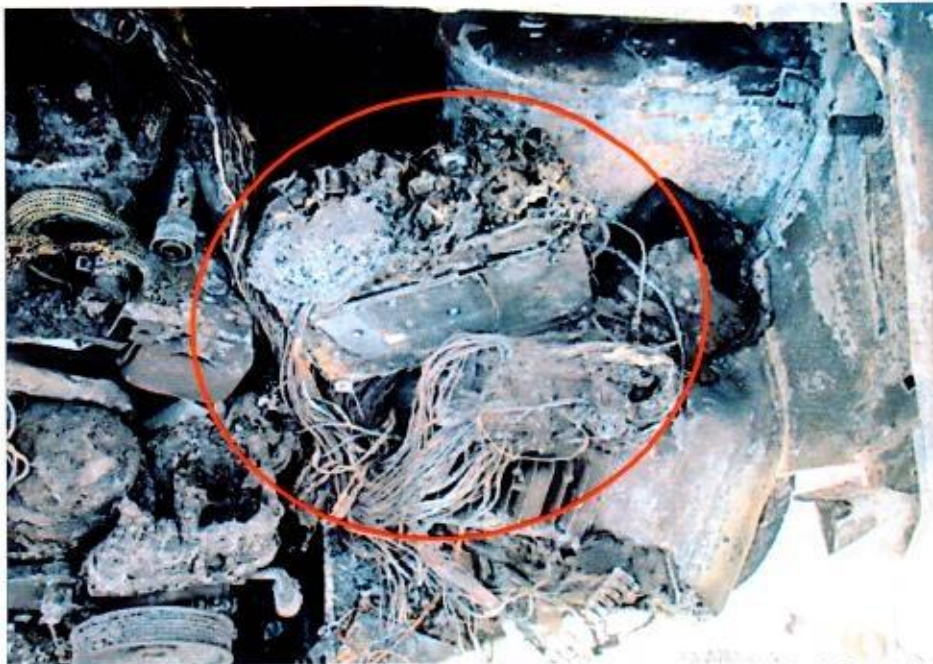
10. Upon closer examination of the left portion of the engine compartment, which was where the fire to the Insured Vehicle had likely started, we had found traces of greenish residue on several stretches of burnt wirings leading from the battery. The presence of greenish residue indicates internal heating of copper wires, a sign of an electrical short circuit occurring. The greenish residue is normally left behind from oxidation as a result of chemical reaction involving the copper wires. This physical evidence would then appear to suggest that the cause of fire to the Insured Vehicle could have possibly been due to electrical in nature. See photos 9 - 12 below.

**Photo 9** shows the burnt wirings leading from the battery around the left portion of the engine compartment (circled), which is in the immediate vicinity where the fire to the Insured Vehicle had likely started.

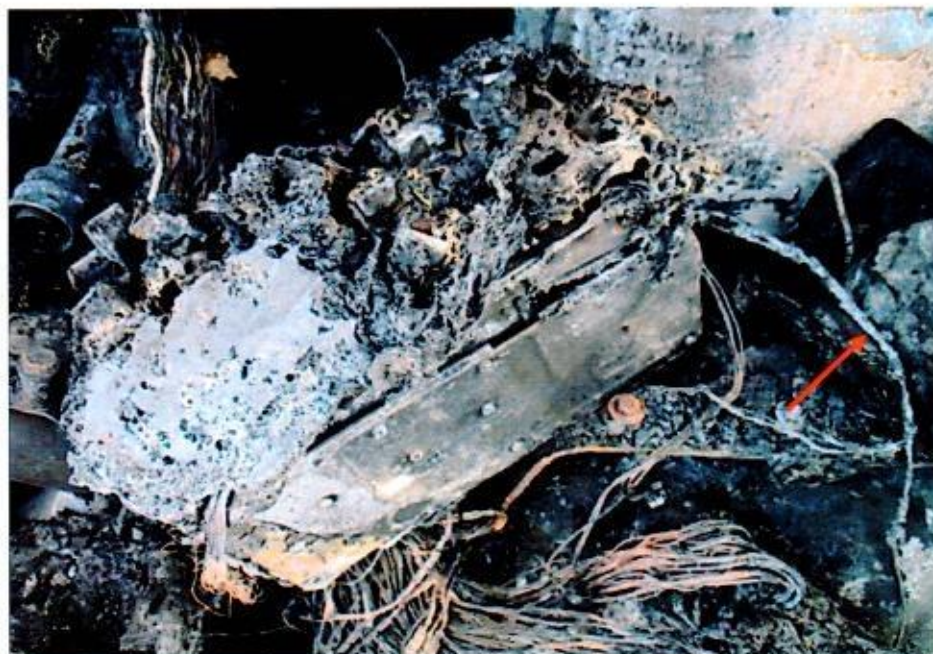
**Photo 10** shows a closer view of the burnt wirings leading from the battery around the left portion of the engine compartment, which is in the immediate vicinity where the fire to the Insured Vehicle had likely started. We noticed greenish residue on several stretches of burnt wirings (arrowed). The presence of greenish residue indicates internal heating of copper wires, a sign of an electrical short circuit occurring. The greenish residue is normally left behind from oxidation as a result of chemical reaction involving the copper wires.

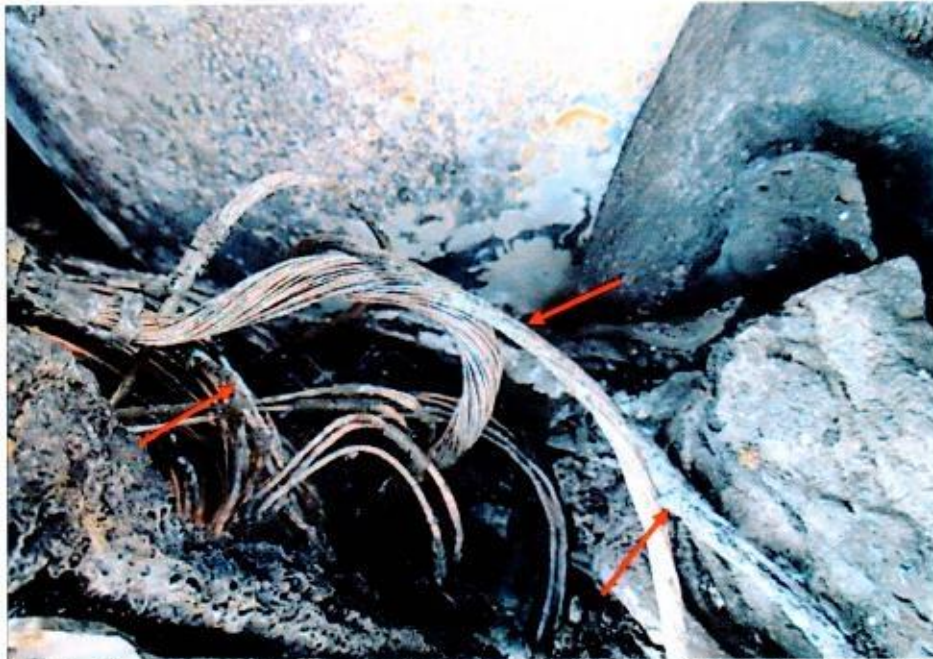
**Photo 11** shows a close up view of the greenish residue found on several stretches of burnt wirings leading from the battery (red arrows). The presence of such greenish residue suggests occurrence of an electrical short circuit.

31. Having investigated and technically analysed the damages to the Insured Vehicle, we are of the view that the cause of fire to the Insured Vehicle was of electrical in nature. For this particular case, the fire had originated along the wirings inside the engine compartment, leading from the battery. The wirings were original factory wirings of the Insured Vehicle.

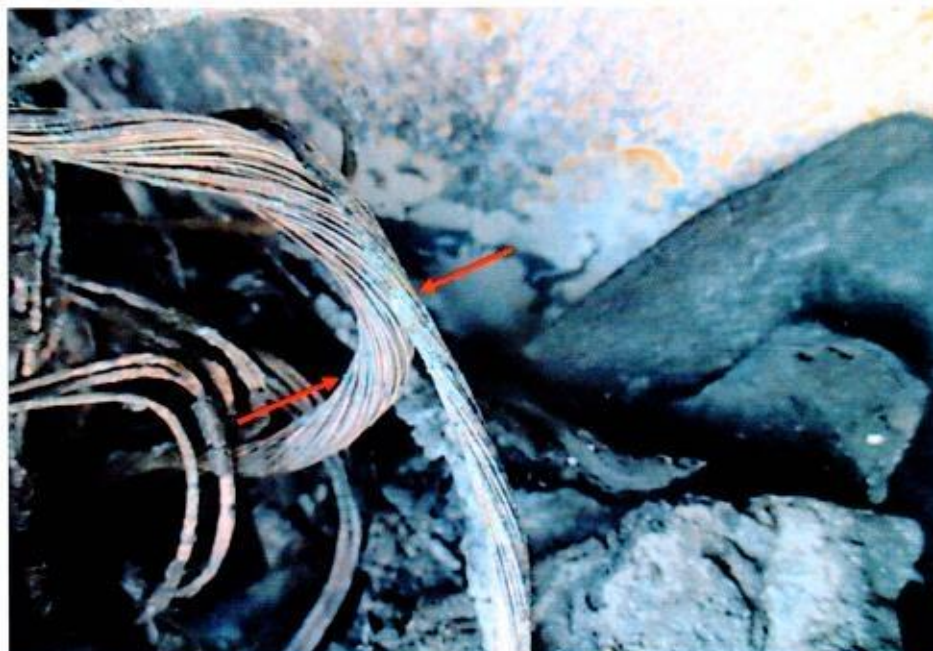
**Photo 12** shows a close up view of the greenish residue found on several stretches of burnt wirings leading from the battery (red arrows). The presence of such greenish residue suggests occurrence of an electrical short circuit.

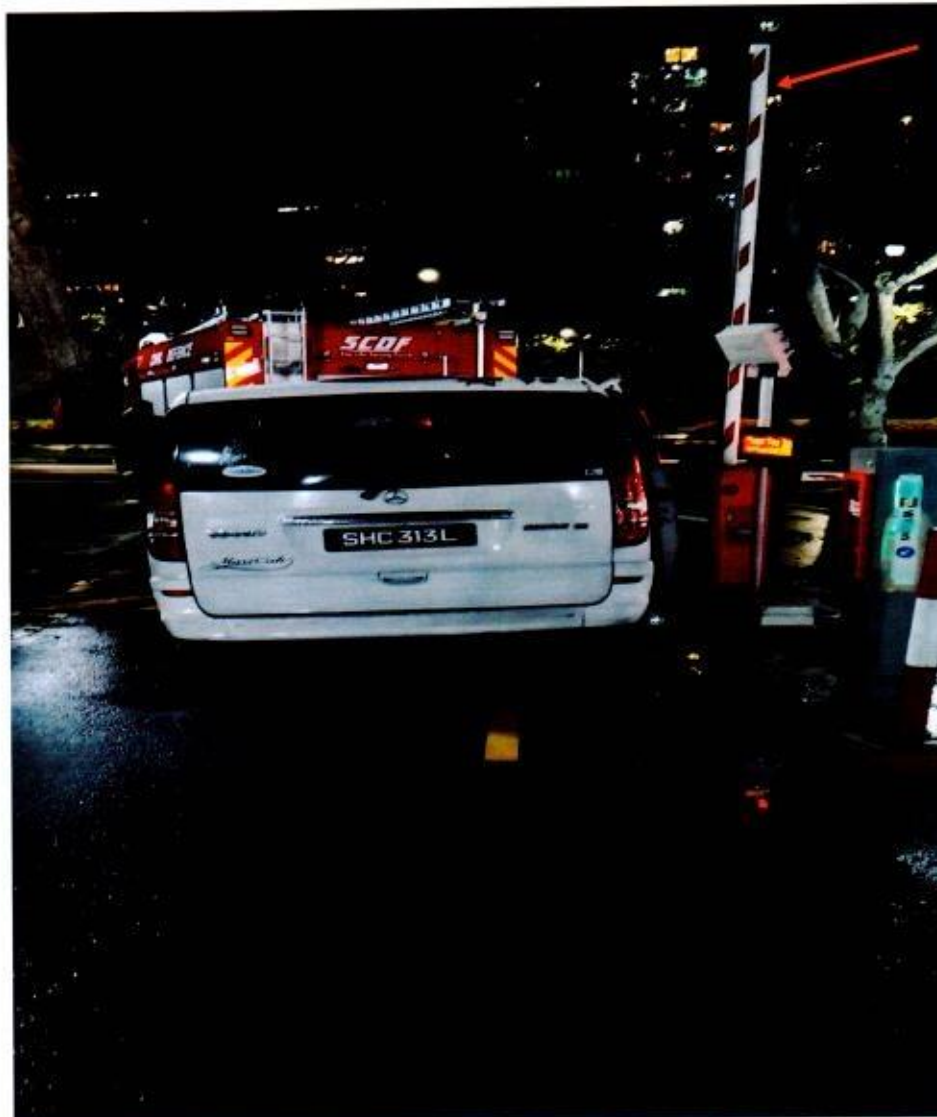
**Photo 13** shows the Insured Vehicle post- incident. In general, the information that could be gathered from this photograph had corresponded to the events that were related to us by Mr Tan which is he had stopped the Insured Vehicle at the carpark exit after the barrier was raised (arrowed).

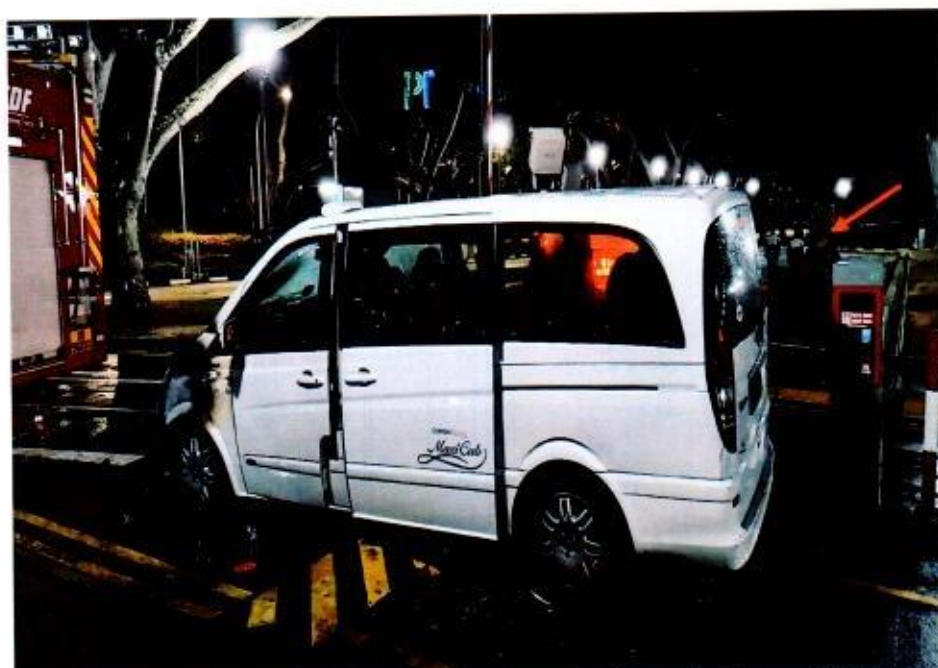
**Photo 14** shows the SCDF having just put out the fire on the Insured Vehicle. In general, the information that could be gathered from this photograph had corresponded to the events that were related to us by Mr Tan which is the police were also present at the incident scene (arrowed).

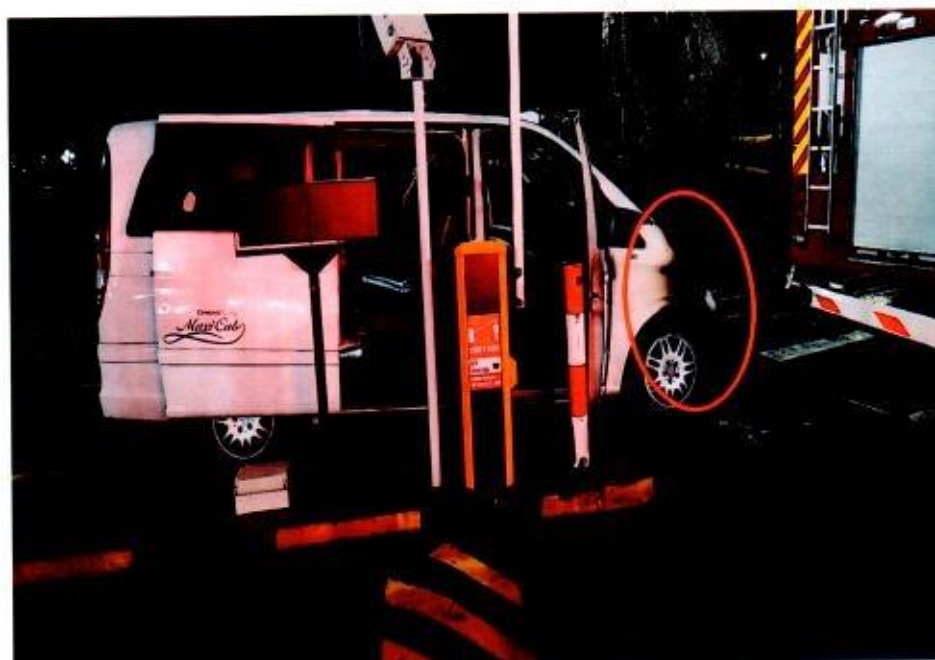
**Photo 15** shows the Insured Vehicle at the incident scene after the fire was extinguished. In general, the information that could be gathered from this photograph had corresponded to the events that were related to us by Mr Tan, which is the fire had started in the engine compartment (circled).
