Your Ref: D20001136MFSH
Our Ref : CS/FCI20003253/N

2 March 2020

**TECHNICAL INVESTIGATION REPORT OF FIRE INCIDENT INVOLVING THE
INSURED VEHICLE SHC 313L ON 20 FEBRUARY 2020**

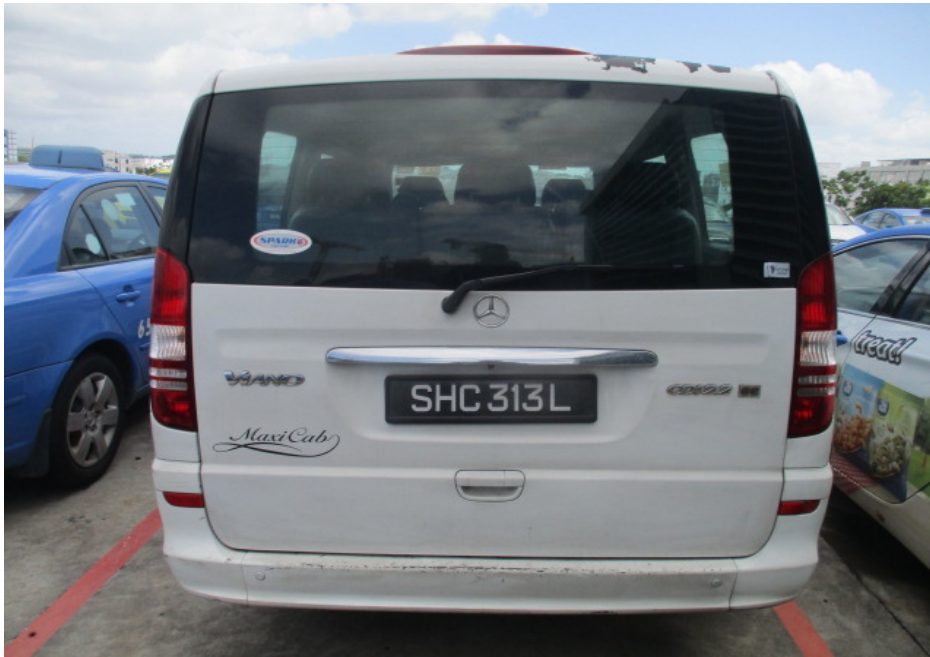
Photo 1 shows the rear view of the Insured Vehicle. The rear portion of the Insured Vehicle was observed to be relatively unaffected by the fire.

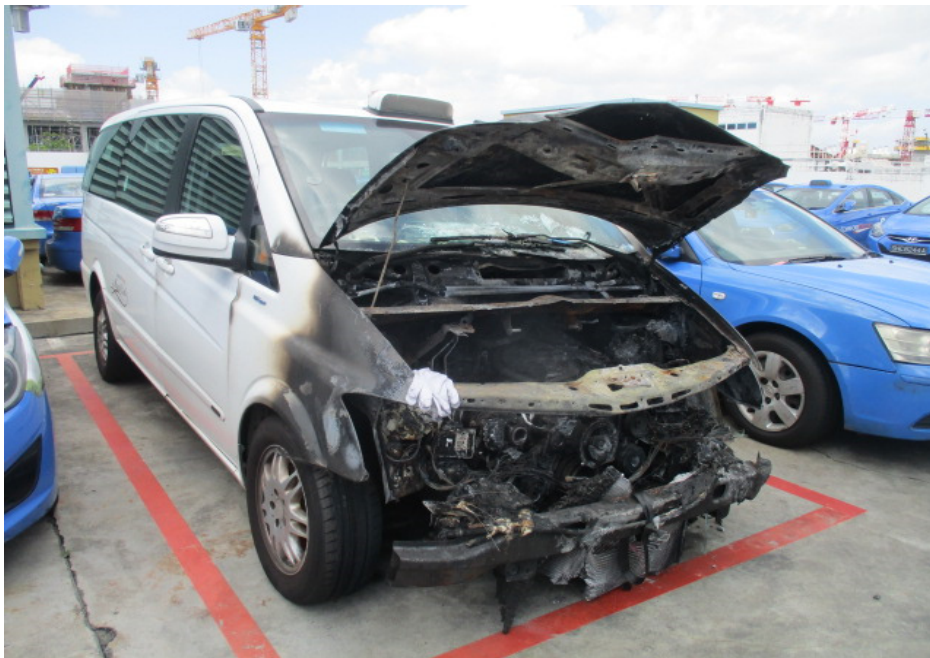
Photo 2 shows the general view of the right portion of the Insured Vehicle at the time of our inspection. The exterior body of the Insured Vehicle had sustained visible fire damage. This included its front windscreen, front bonnet, front bumper, right front panel and right headlight.

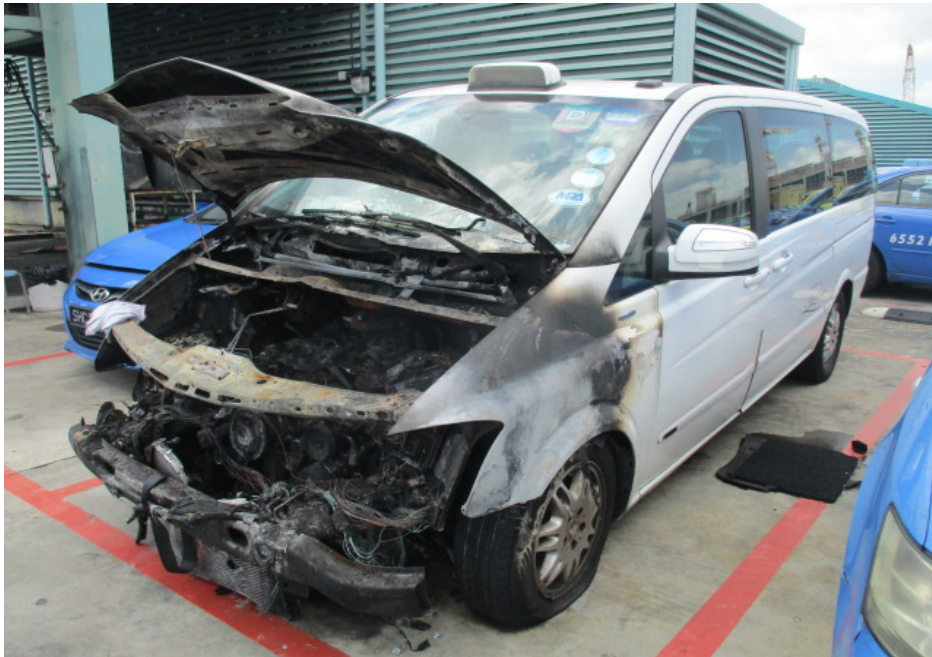
Photo 3 shows the general view of the left portion of the Insured Vehicle at the time of our inspection. The exterior body of the Insured Vehicle had sustained visible fire damage. This included its front windscreen, front bonnet, left headlight, front bumper, left front panel, left front wheel rim and left front tyre.

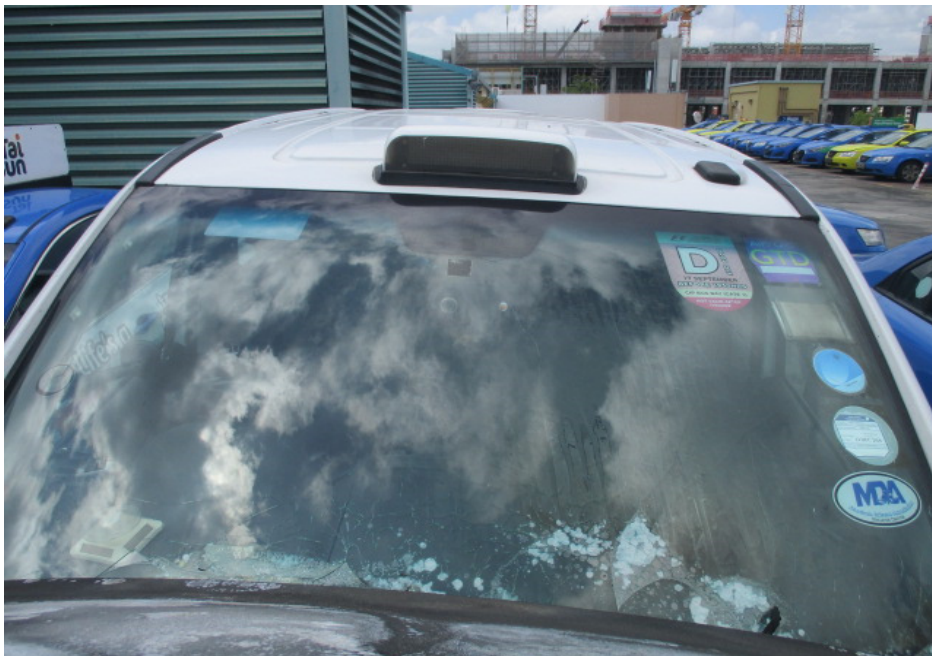
Photo 4 shows a closer view of the front windscreen of the Insured Vehicle at the time of our inspection. The front windscreen had sustained significant fire damage.

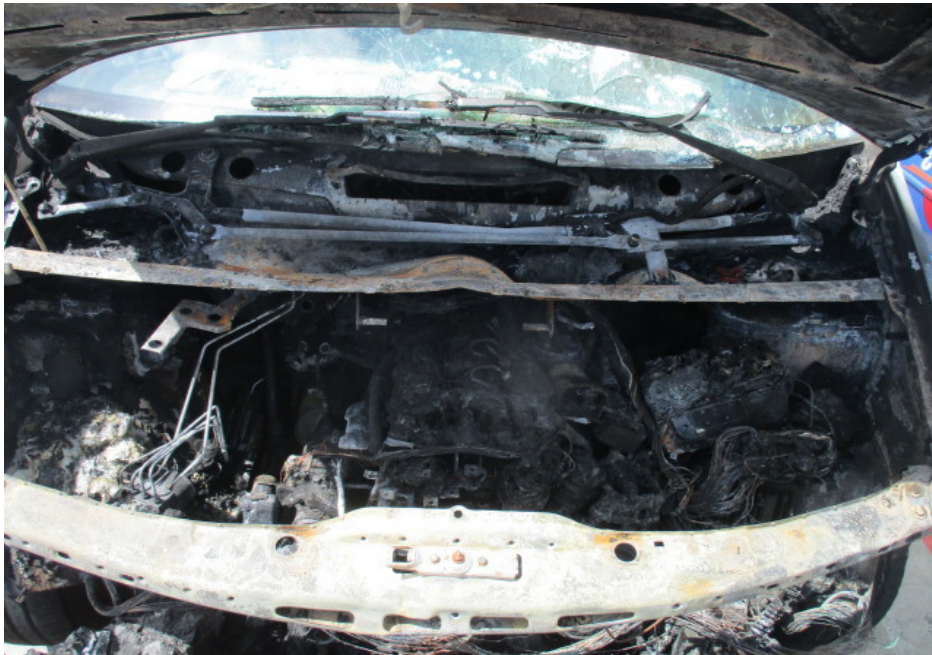
Photo 5 shows a general view of the engine compartment of the Insured Vehicle at the time of our inspection. Most of the components inside the engine compartment were found to be severely burnt and/or melted as a result of the fire.

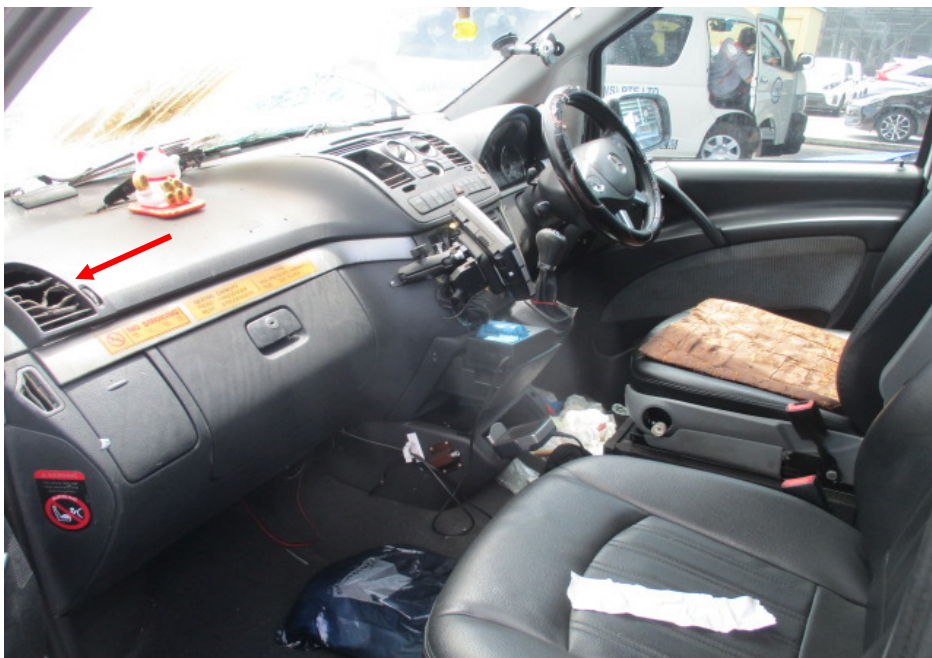
Photo 6 shows the interior compartment of the Insured Vehicle, which was observed to be slightly affected by the fire (arrowed).

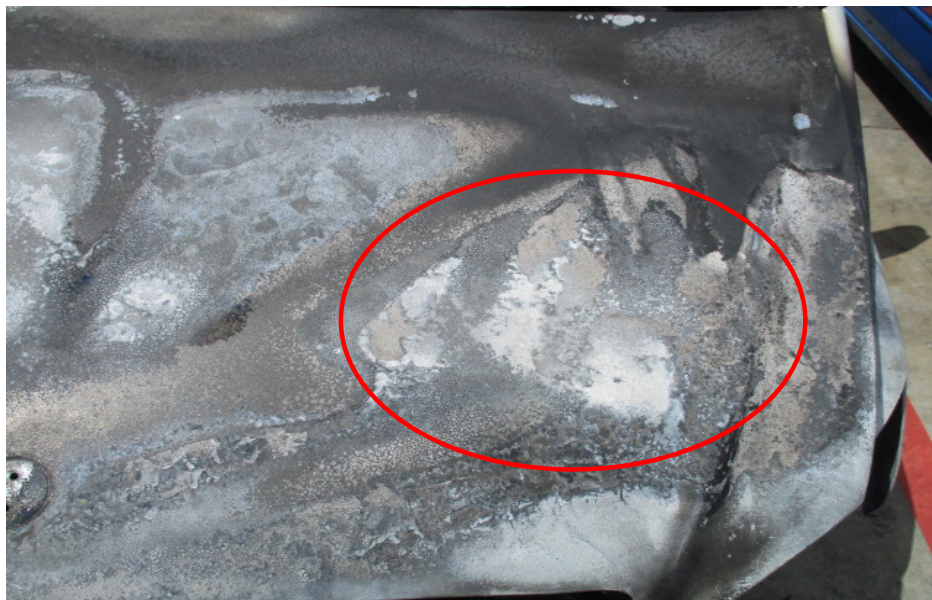
8. For this particular case, the fire appears to have originated within the engine compartment of the Insured Vehicle, somewhere around the left portion of the engine compartment. This can be determined from the burn pattern and the high heat intensity burn marks (whitish burn marks) found on the left portion of the bonnet of the Insured Vehicle and also the rust that had developed on the underside of the front bonnet, at the left portion.

9. The whitish burn marks are a result of exposure to prolonged heat intensity. Rust would normally start to develop around these areas soon after a fire as prolonged exposure to high heat intensity usually causes steel/metal material body parts to be exposed to natural environmental condition. The rust that had developed on the underside of the front bonnet, around the left portion, is an indication that the left portion of the engine compartment had sustained exposure to prolonged high heat intensity. See photos 7 & 8 below.

Photo 7 shows the burn pattern and whitish burn marks that were found on the left portion of the front bonnet of the Insured Vehicle (circled). Such whitish burn marks are a result of exposure to prolonged heat intensity, which may indicate where the fire had started. Rust would also begin to develop on these areas soon after the fire.

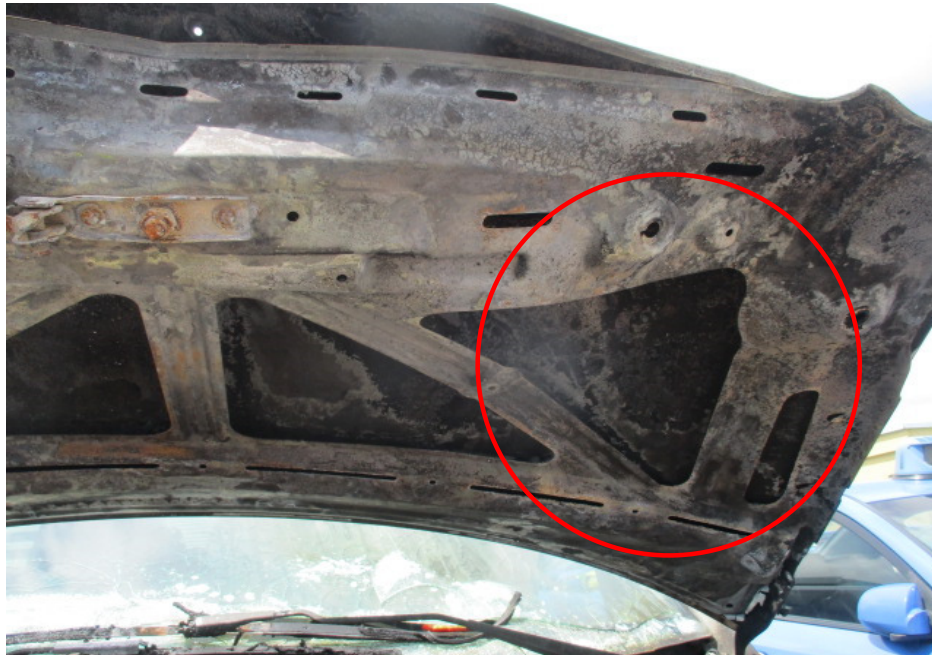
Photo 8 shows the rust that had developed on the underside of the front bonnet, around the left portion (circled). The development of rust is an indication that this area was subjected to prolonged exposure to high heat intensity, which had caused the steel/metal material of the front bonnet to be exposed to natural environmental condition. Hence the fire to the Insured Vehicle can be determined to have originated towards the left portion of the engine compartment.

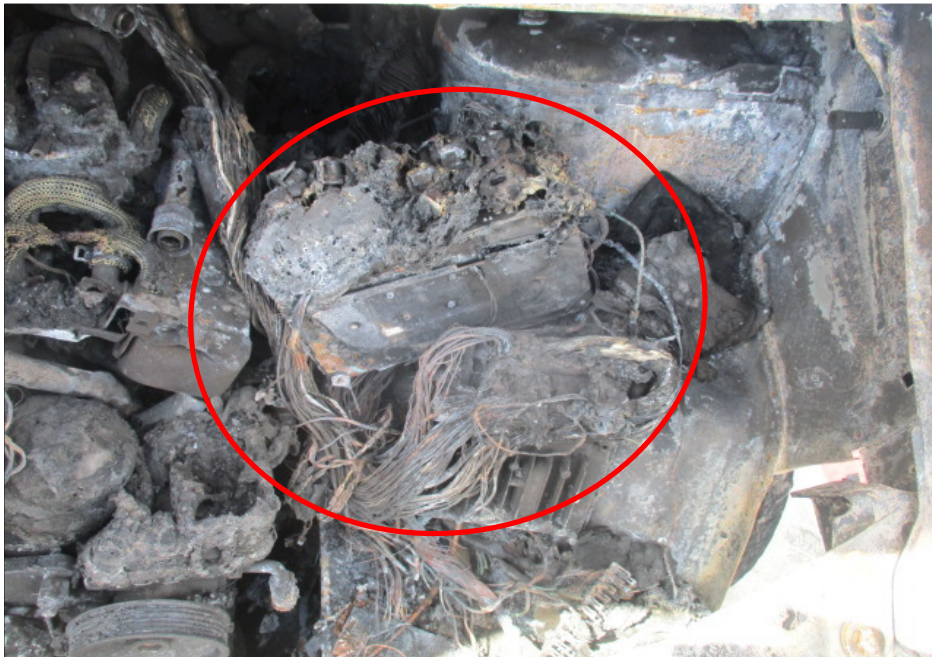
10. Upon closer examination of the left portion of the engine compartment, which was where the fire to the Insured Vehicle had likely started, we had found traces of greenish residue on several stretches of burnt wirings leading from the battery. The presence of greenish residue indicates internal heating of copper wires, a sign of an electrical short circuit occurring. The greenish residue is normally left behind from oxidation as a result of chemical reaction involving the copper wires. This physical evidence would then appear to suggest that the cause of fire to the Insured Vehicle could have possibly been due to electrical in nature. See photos 9 - 12 below.

Photo 9 shows the burnt wirings leading from the battery around the left portion of the engine compartment (circled), which is in the immediate vicinity where the fire to the Insured Vehicle had likely started.

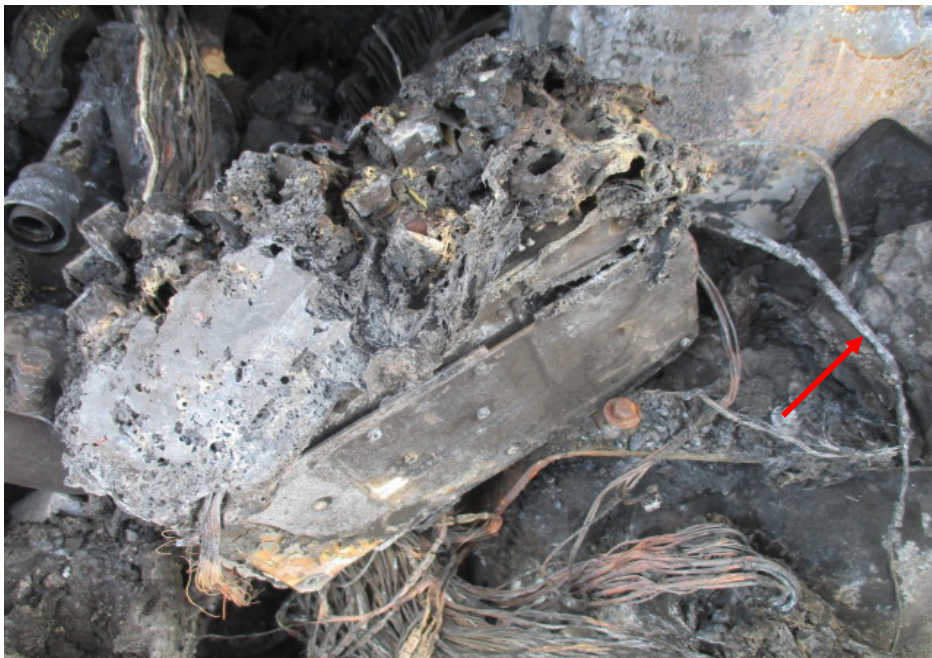
Photo 10 shows a closer view of the burnt wirings leading from the battery around the left portion of the engine compartment, which is in the immediate vicinity where the fire to the Insured Vehicle had likely started. We noticed greenish residue on several stretches of burnt wirings (arrowed). The presence of greenish residue indicates internal heating of copper wires, a sign of an electrical short circuit occurring. The greenish residue is normally left behind from oxidation as a result of chemical reaction involving the copper wires.

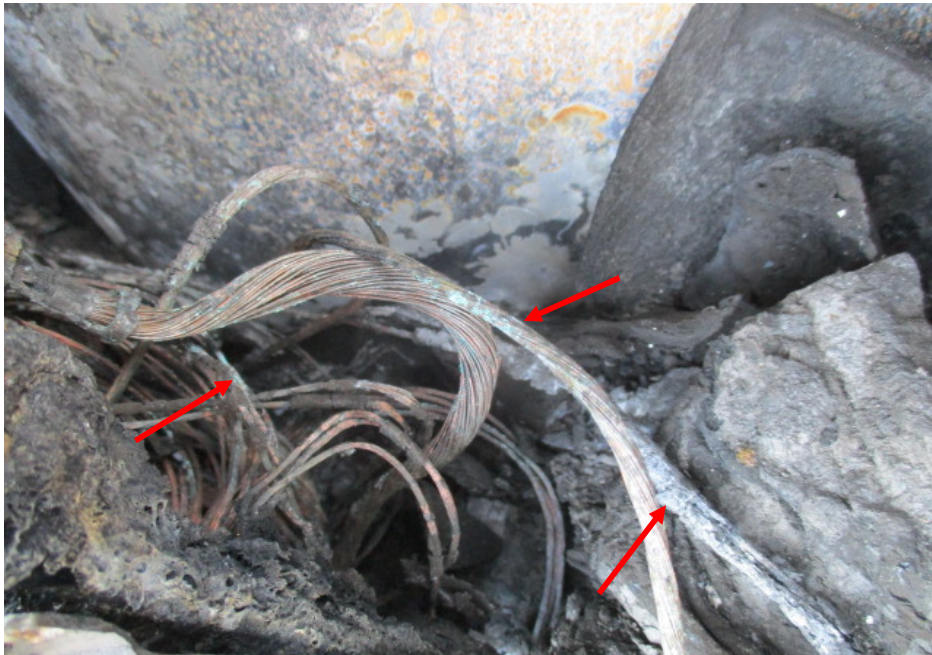
Photo 11 shows a close up view of the greenish residue found on several stretches of burnt wirings leading from the battery (red arrows). The presence of such greenish residue suggests occurrence of an electrical short circuit.

31. Having investigated and technically analysed the damages to the Insured Vehicle, we are of the view that the cause of fire to the Insured Vehicle was of electrical in nature. For this particular case, the fire had originated along the wirings inside the engine compartment, leading from the battery. The wirings were original factory wirings of the Insured Vehicle.

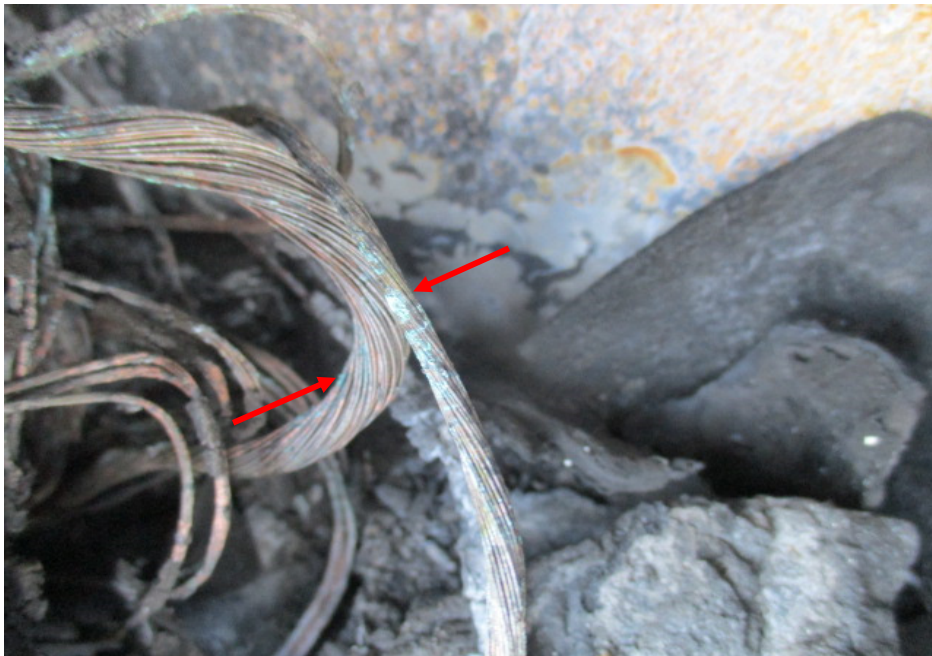
Photo 12 shows a close up view of the greenish residue found on several stretches of burnt wirings leading from the battery (red arrows). The presence of such greenish residue suggests occurrence of an electrical short circuit.

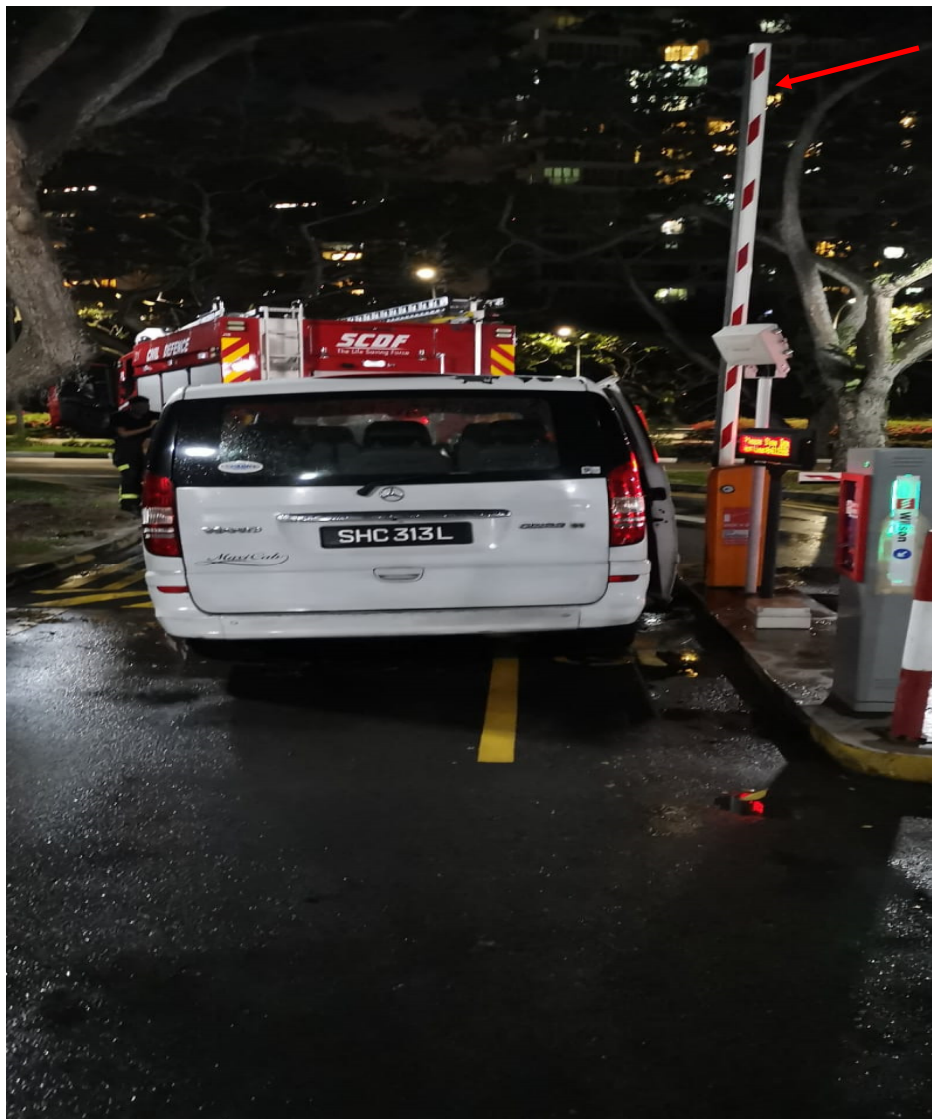
Photo 13 shows the Insured Vehicle post- incident. In general, the information that could be gathered from this photograph had corresponded to the events that were related to us by Mr Tan which is he had stopped the Insured Vehicle at the carpark exit after the barrier was raised (arrowed).

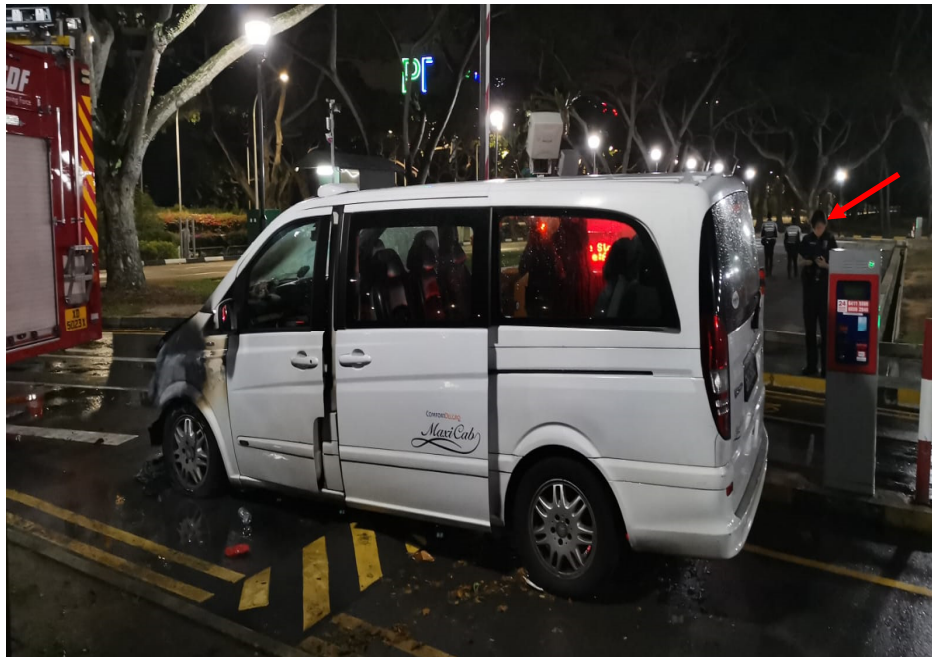
Photo 14 shows the SCDF having just put out the fire on the Insured Vehicle. In general, the information that could be gathered from this photograph had corresponded to the events that were related to us by Mr Tan which is the police were also present at the incident scene (arrowed).

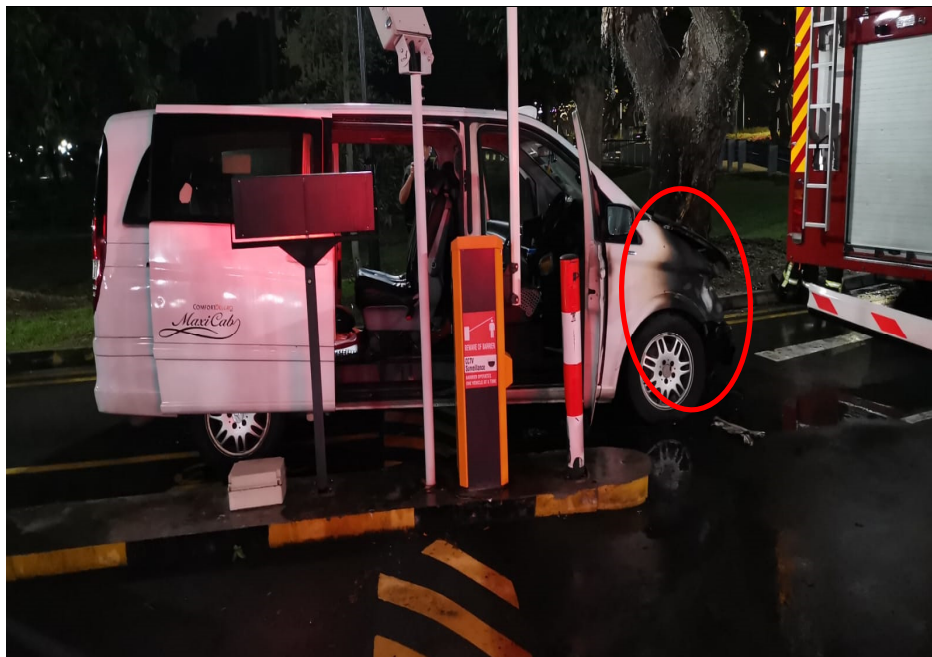
Photo 15 shows the Insured Vehicle at the incident scene after the fire was extinguished. In general, the information that could be gathered from this photograph had corresponded to the events that were related to us by Mr Tan, which is the fire had started in the engine compartment (circled).
