LKK Auto Consultants Pte Ltd

ADJUSTMENT ON REPAIR COST FOR VEHICLE NO. SMM 6791M

PHOTOGRAPHS FOR VEHICLE NO. SMM 6791M

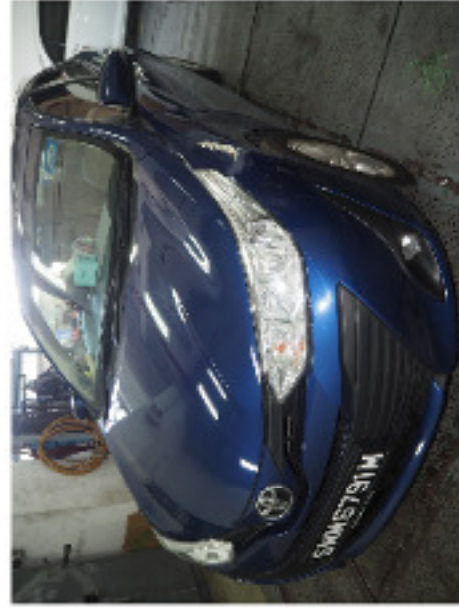
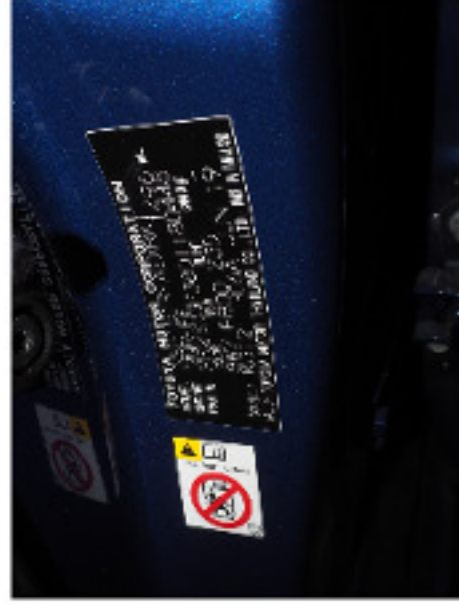
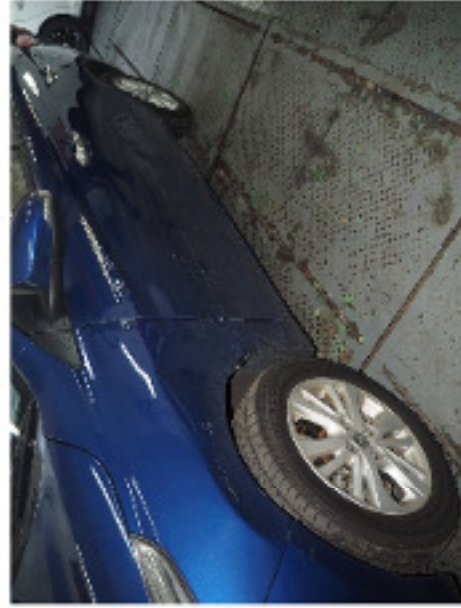
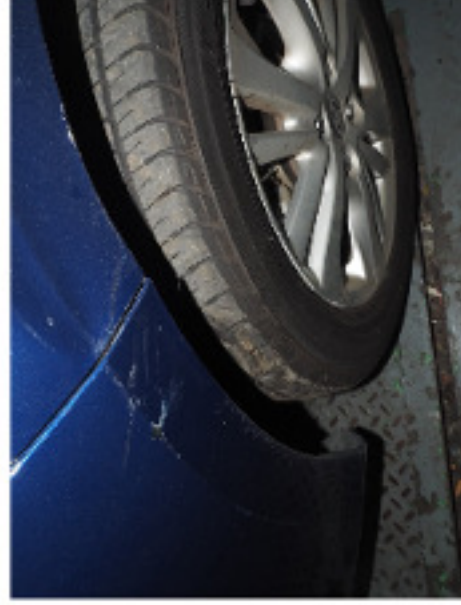
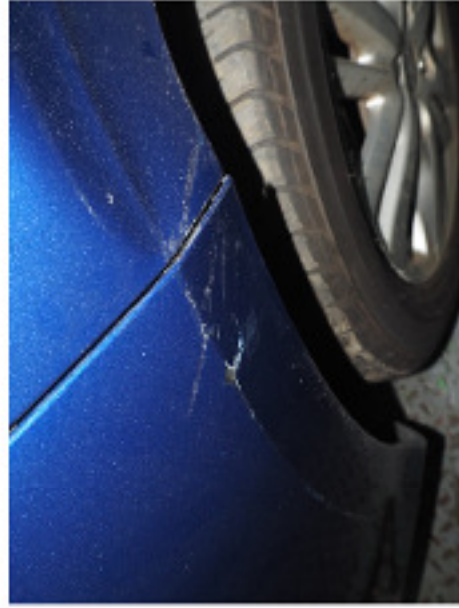
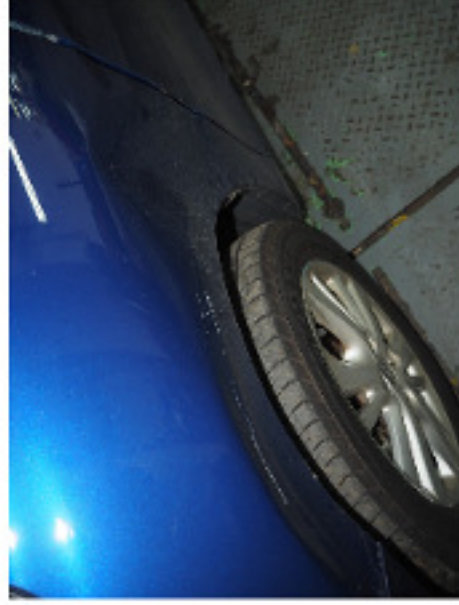
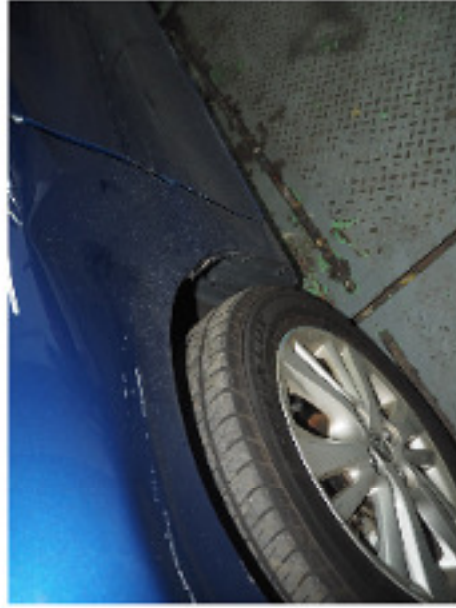
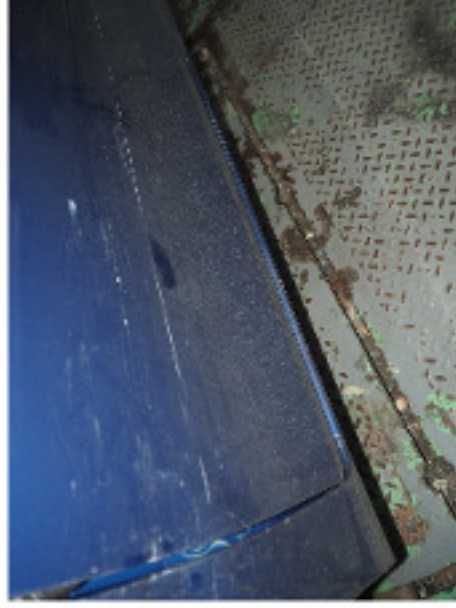
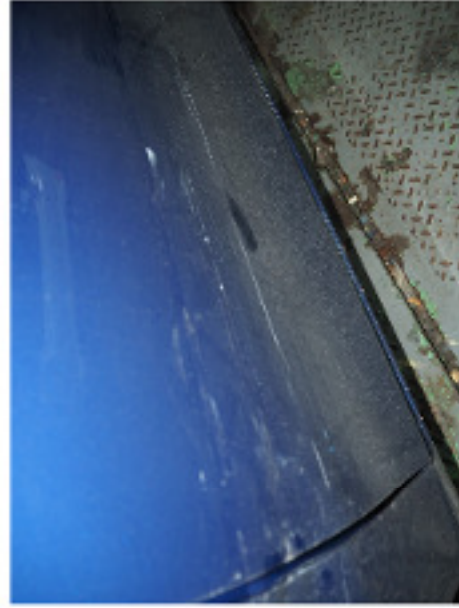
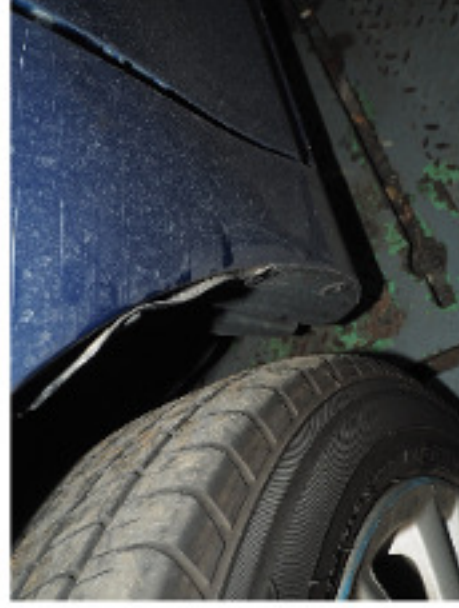
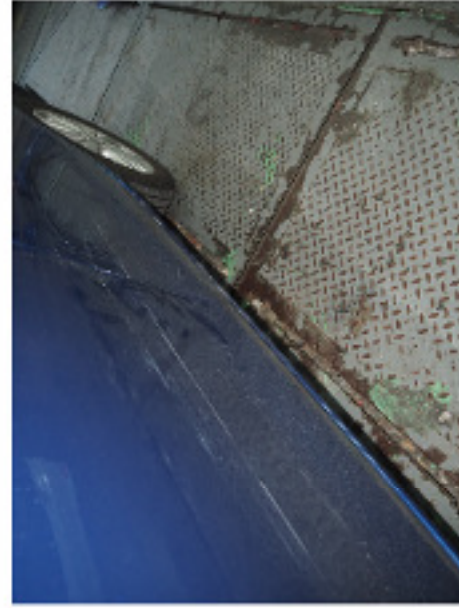
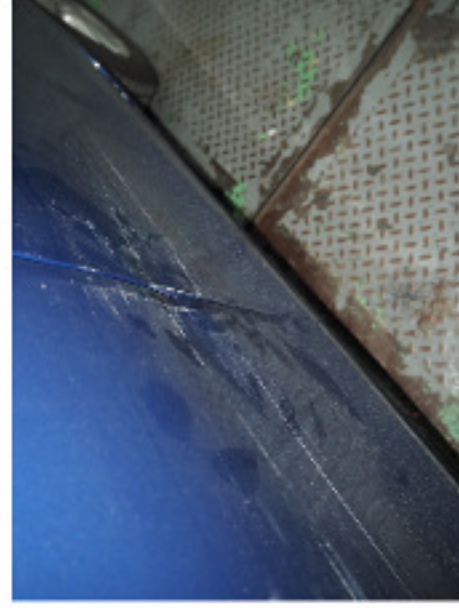
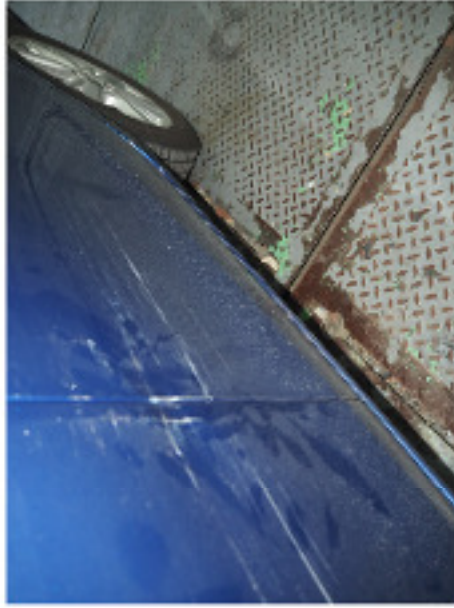
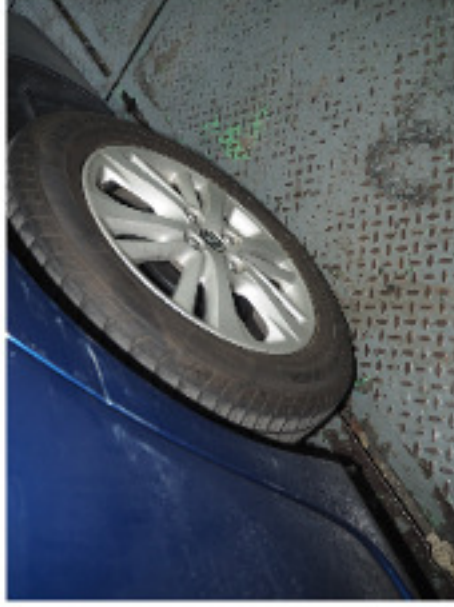
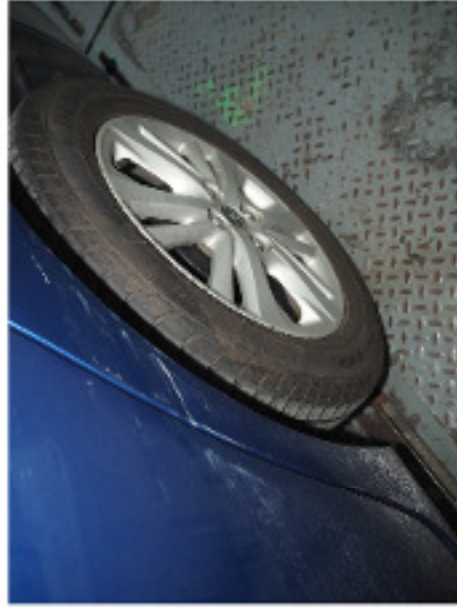
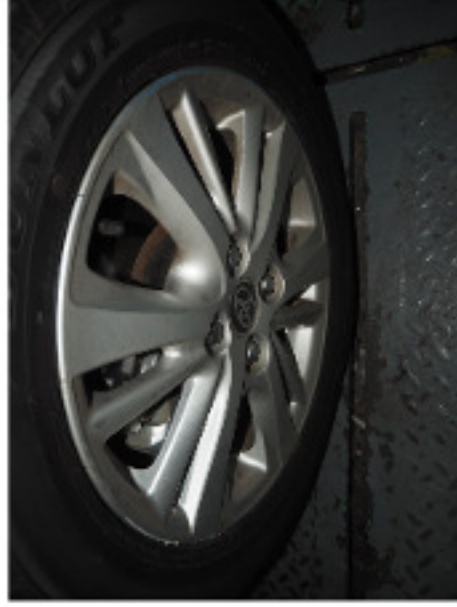
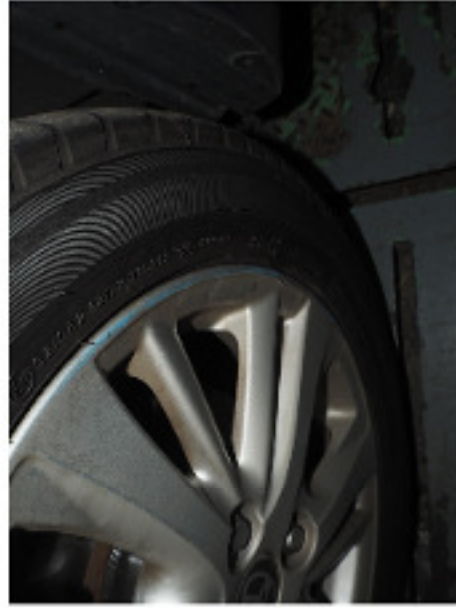
4. Description of Damages				
THE VEHICLE SUSTAINED DAMAGES AT THE N/S BODY. DAMAGES SEE DETAILS.				
5. General Information				
Accident Date	11/02/2020	Inspection Date	25/02/2020	
Survey held at	MG SOLUTION PTE LTD 23 KAKI BUKIT AVE 4 (SOUTH WING) #02-03B VICOM INSPECTION CENTRE, SINGAPORE 415933			
5a. Remarks				
A)THE INSPECTION WAS CONDUCTED ON A"WITHOUT PREJUDICE" BASIS. B)IN ACCORDANCE TO YOUR INSTRUCTIONS, WE HAVE NOT AUTHORISED REPAIRS.				
5b. Estimate Days of Repair				
ESTIMATED NORMAL PERIOD FOR REPAIR:		6 Working Days

Qty	Description of Parts	Condition	Estimate By Workshop (\$))	Our Adjusted (\$)
<u>REPLACEMENT OF PARTS</u>				
1	FRONT BUMPER	TORN	580.00	580.00
1	FRONT BUMPER SIDE RETAINER LH	NOT NECESSARY	52.30	-
1	HEADLAMP LH	NOT NECESSARY	890.50	-
1	FRONT FENDER LH	DENTED	488.90	488.90
1	FRONT FENDER INNER COWLING LH	DEFORMED	155.80	155.80
1	FRONT DOOR LH	DENTED	1,025.30	1,025.30
1	REAR DOOR LH	DENTED	1,025.30	1,025.30
1	REAR FENDER LH	TO REPAIR SEE LABOUR	920.30	-
1	REAR WINDSCREEN MOULDING	NOT NECESSARY	103.00	-
	LESS 25% DISCOUNT		-1,310.35	-818.83
			3,931.05	2,456.47
<u>SPECIAL NETT ITEMS</u>				
1	SET FRONT BUMPER CLIPS (SN)	NECESSARY	20.00	20.00
1	FRONT FENDER COWLING CLIPS (SN)	NECESSARY	22.00	22.00
1	REAR WINDSCREEN SEALANT (SN)	NOT NECESSARY	120.00	-
1	WHEEL TYRE (SN)	NOT NECESSARY	380.00	-
1	WHEEL RIM (SN)	CRUSHED	850.00	580.00
			1,392.00	622.00
<u>LABOUR</u>				
	PANEL BEATING ,REMOVING AND REPLACING PARTS.INCLUSIVE OF THE REPAIR OF REAR FENDER LH .		1,600.00	800.00

SPRAY PAINTING TO AFFECTED AREA.		1,600.00	1,000.00
	TUFF COAT.		250.00	60.00
	WIRING CHECK .		80.00	30.00
	REFOCUS HEADLAMP BEAM.	NOT NECESSARY	80.00	-
	TRANSFER FRONT DOOR MECHANISM LH.		80.00	80.00
	TRANSFER REAR DOOR MECHANISM LH .		80.00	80.00
	TRANSFER REAR WINDSCREEN.	NOT NECESSARY	160.00	-

Qty	Description of Parts	Condition	Estimate By Workshop (\$)	Our Adjusted (\$)
	FOUR WHEEL ALIGNMENT.		100.00	80.00
			4,030.00	2,130.00
GRAND TOTAL			9,353.05	5,208.47
RECOMMENDED COST OF LUMP SUM REPAIRS (TO ITS PRE-ACCIDENT CONDITION)				4,100.00
