Your Ref : 3725638478SG  
Our Ref : CI/AIG20003358/N

5 March 2020

**TECHNICAL INVESTIGATION REPORT OF FIRE INCIDENT INVOLVING THE  
INSURED VEHICLE SKS 2850U ON 23 FEBRUARY 2020**

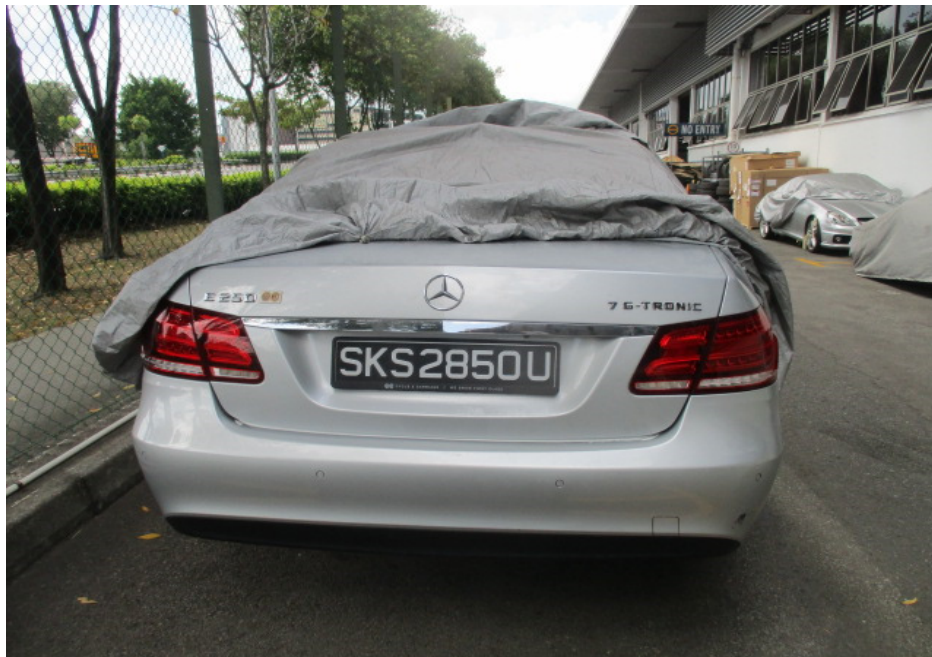
**Photo 1** shows the general view of the rear body of the Insured Vehicle at the time of our inspection. The rear portion of the Insured Vehicle was observed to be unaffected by the fire.

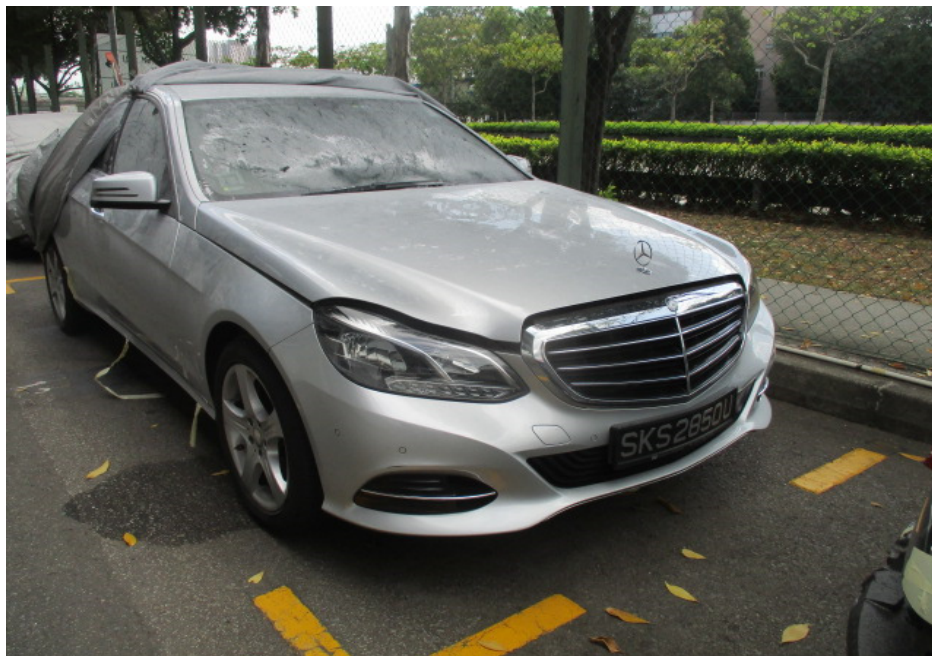
**Photo 2** shows the general view of the right front portion of the Insured Vehicle at the time of our inspection. The exterior body of the Insured Vehicle had sustained visible fire damage. This included its front windscreen and front bonnet.

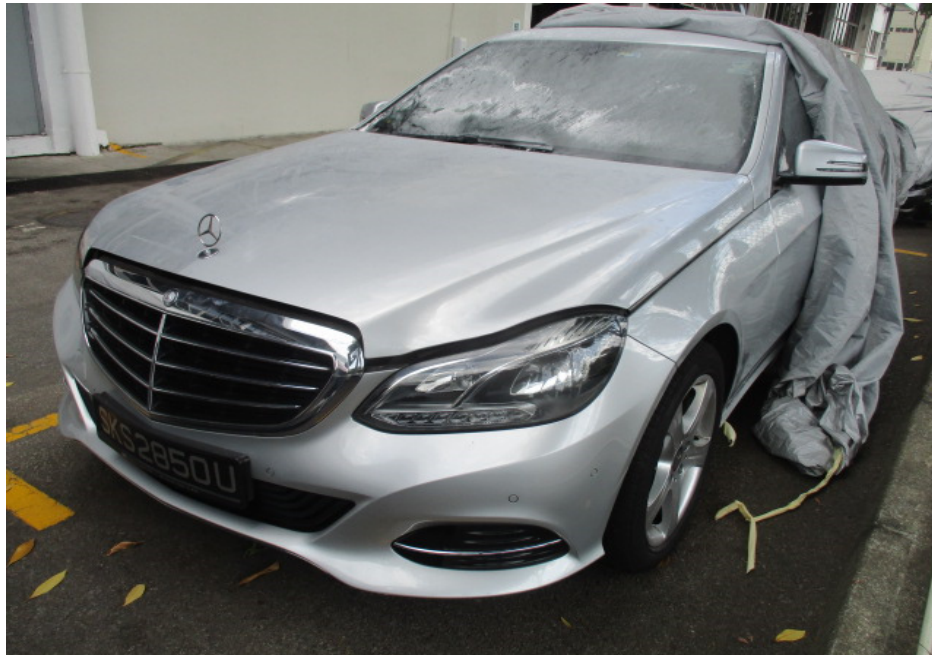
**Photo 3** shows the general view of the left front portion of the Insured Vehicle at the time of our inspection. The exterior body of the Insured Vehicle had sustained visible fire damage. This included its front windscreen and front bonnet.

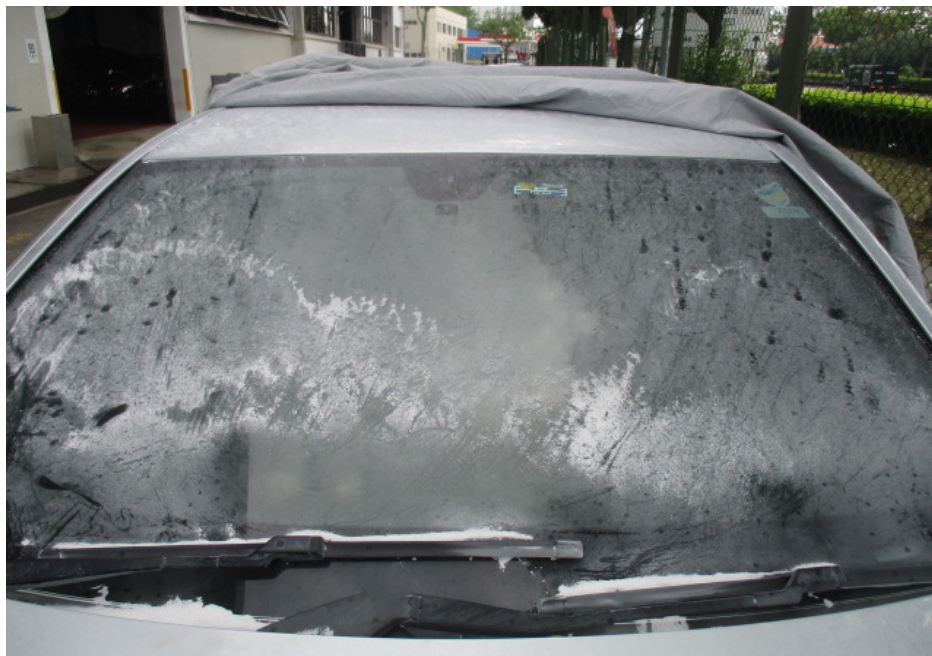
**Photo 4** shows a closer view of the front windscreen of the Insured Vehicle at the time of our inspection. The front windscreen had sustained minimal fire damage.

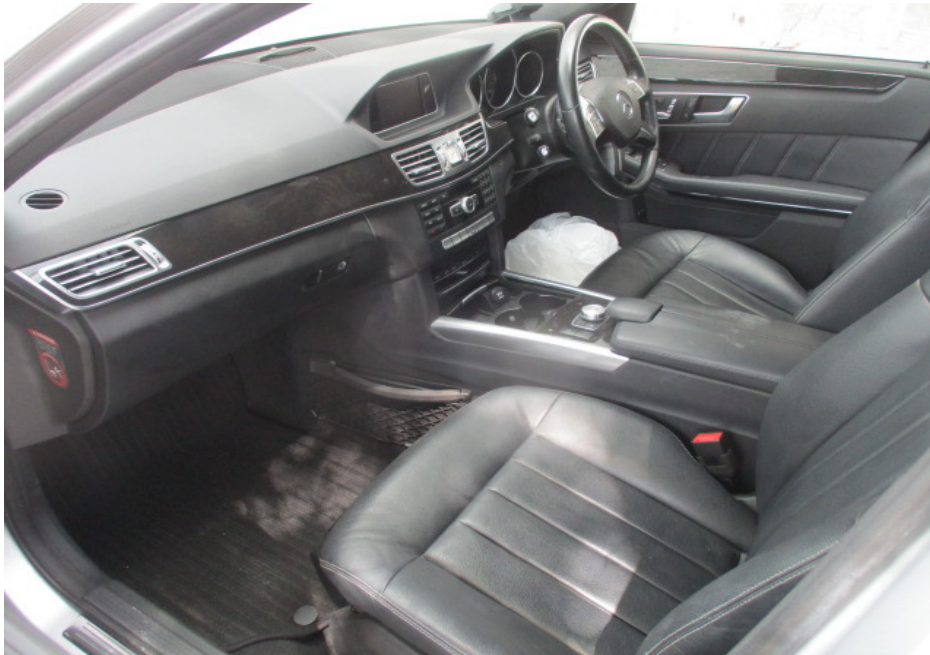
**Photo 5** shows the interior compartment of the Insured Vehicle at the time of our inspection. The interior compartment of the Insured Vehicle was relatively unaffected by the fire.

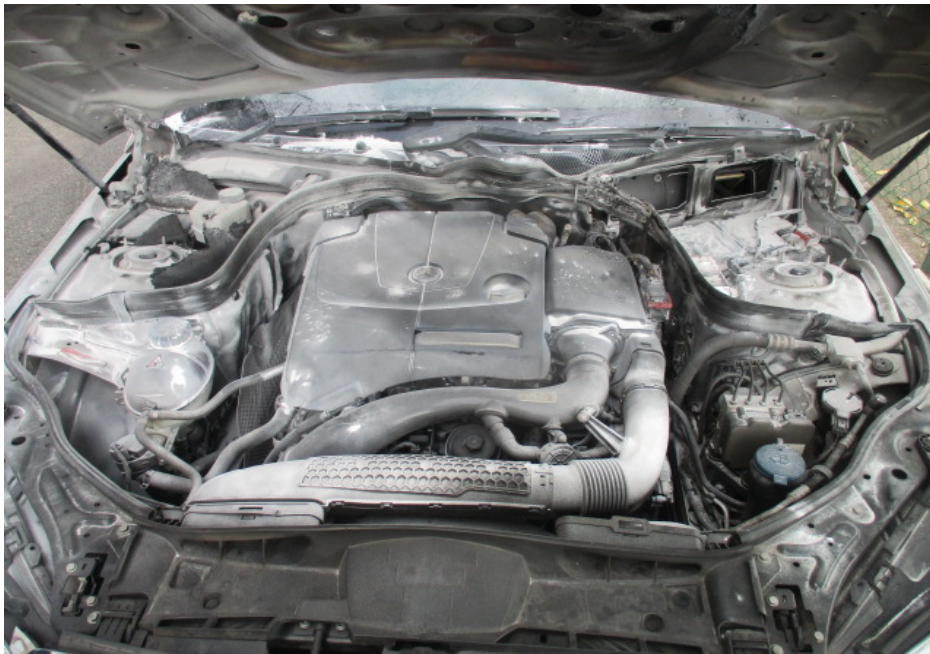
**Photo 6** shows a general view of the engine compartment of the Insured Vehicle at the time of our inspection. Some of the components inside the engine compartment were found to be severely burnt and/or melted as a result of the fire.

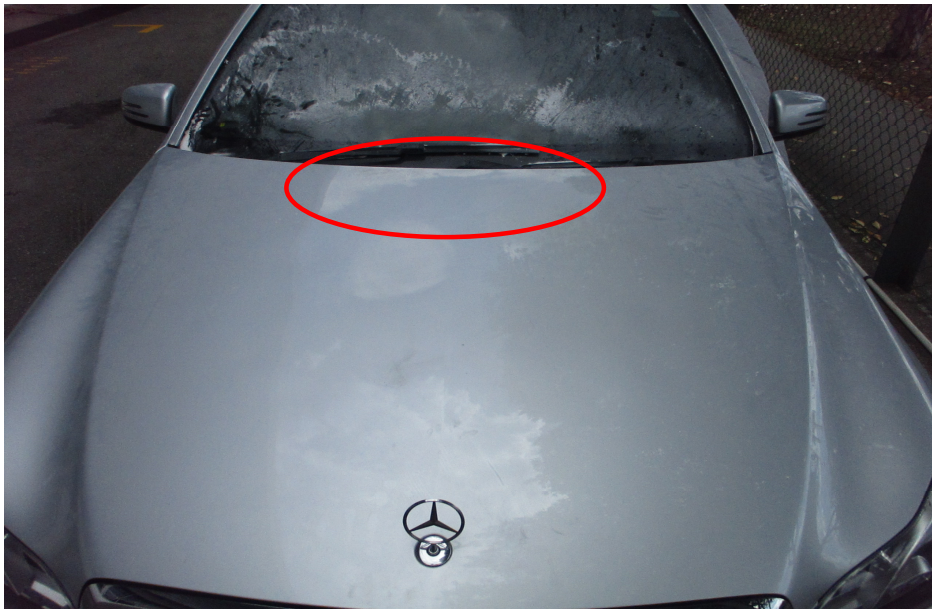
8. For this particular case, the fire appears to have originated within the engine compartment of the Insured Vehicle, somewhere around the rear centre portion of the engine compartment. This can be determined from the whitish burn marks on the rear centre portion of the front bonnet of the Insured Vehicle and also the rust that had developed on the underside of the front bonnet, at the bottom centre portion.

9. The whitish burn marks are a result of exposure to prolonged heat intensity. Rust would normally start to develop around these areas soon after a fire as prolonged exposure to high heat intensity usually causes steel/metal material body parts to be exposed to natural environmental condition. The rust that had developed on the underside of the front bonnet, around the bottom centre portion, is an indication that the rear centre portion of the engine compartment had sustained exposure to prolonged high heat intensity. See photos 7 - 9 below.

**Photo 7** shows the burn pattern and whitish burn marks that were found on the rear centre portion of the front bonnet of the Insured Vehicle (circled). Such whitish burn marks are a result of exposure to prolonged heat intensity, which may indicate where the fire had started. Rust would also begin to develop on these areas soon after the fire.

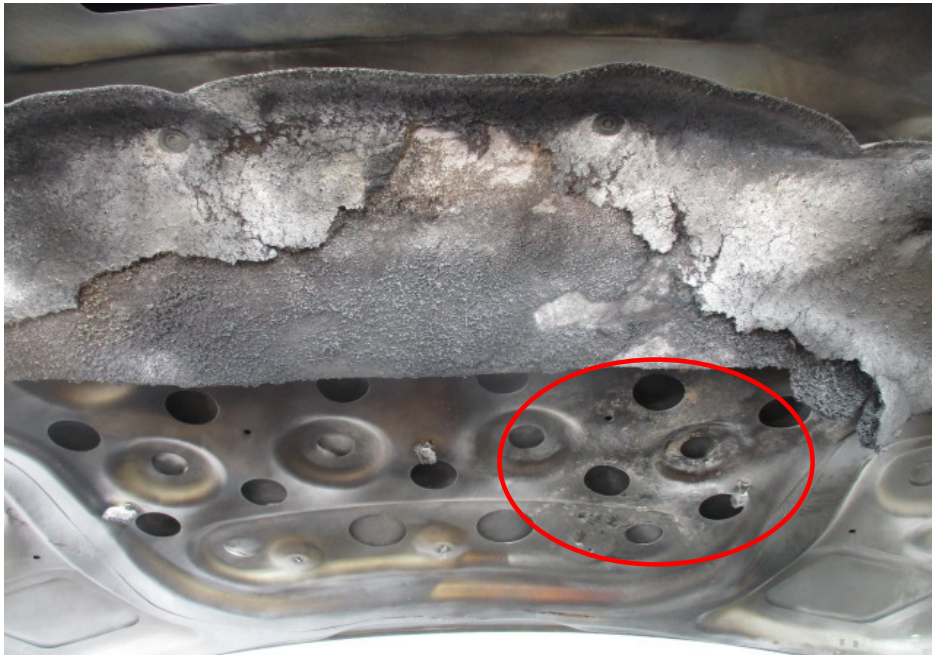
**Photo 8** shows the rust that had developed on the underside of the front bonnet, around the bottom centre portion (circled). The development of rust is an indication that this area was subjected to prolonged exposure to high heat intensity, which had caused the steel/metal material of the front bonnet to be exposed to natural environmental condition. Hence the fire to the Insured Vehicle can be determined to have originated towards the rear centre portion of the engine compartment.

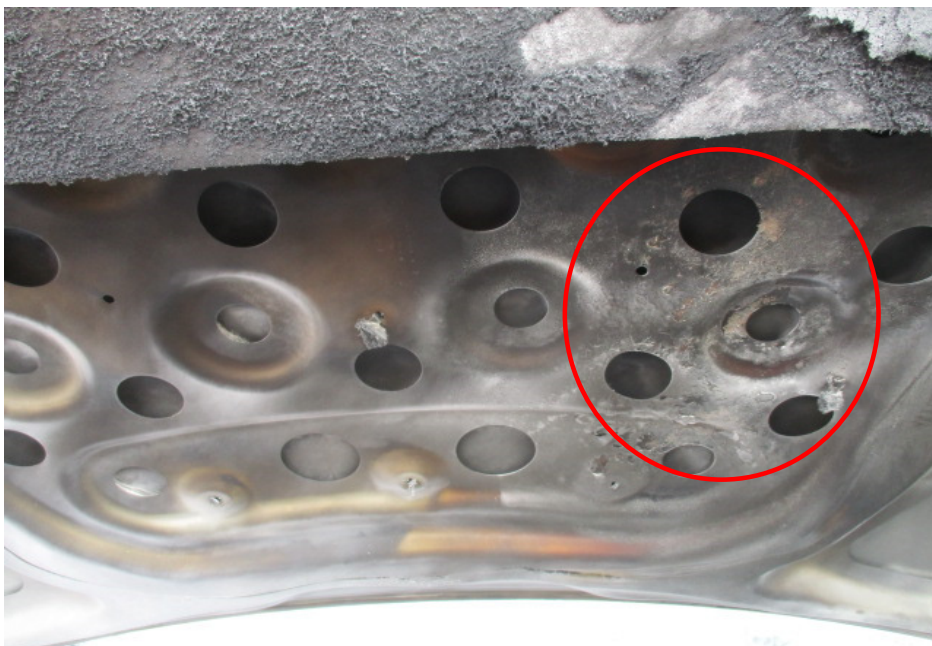
**Photo 9** shows a closer view of the rust that had developed on the underside of the front bonnet, around the bottom centre portion (circled).

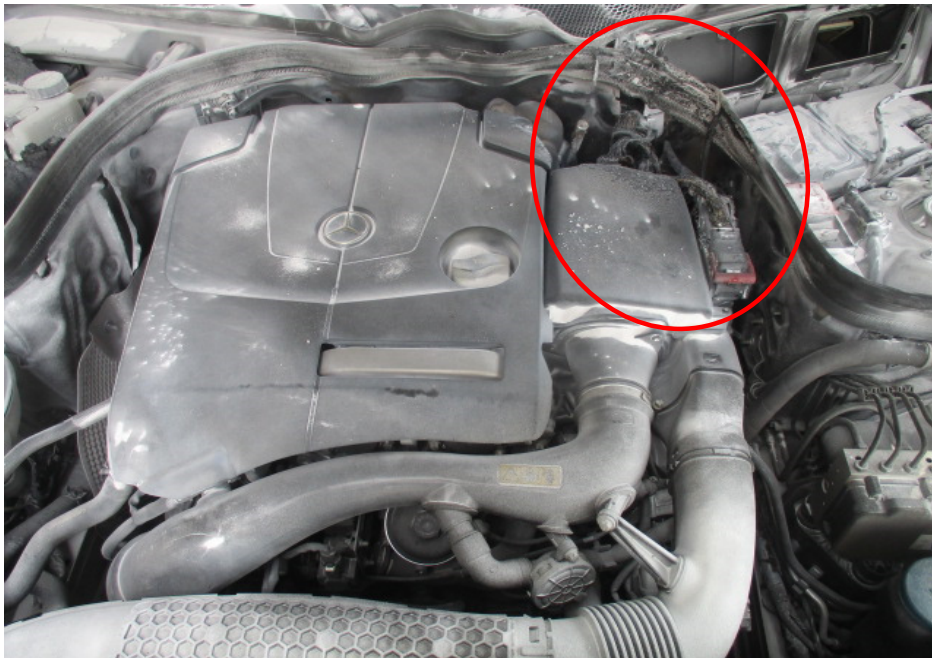
10. Upon closer examination of the rear centre portion of the engine compartment which was where the fire to the Insured Vehicle had likely started, we had found several stretches of wirings with greenish residue. These wirings were original factory fitted wirings leading from the wiring harness of the Insured Vehicle. The presence of greenish residue indicates internal heating of copper wires, a sign of an electrical short circuit occurring. The greenish residue is normally left behind from oxidation as a result of chemical reaction involving the copper wires. This physical evidence would appear to suggest that the cause of fire to the Insured Vehicle could have possibly been due to electrical in nature. See photos 10 – 14 below.

**Photo 10** shows the wirings around the rear centre portion of the engine compartment which is near to the vicinity where the fire to the Insured Vehicle had likely started. We observed greenish residue on the wirings leading from the wiring harness of the Insured Vehicle (circled). The presence of greenish residue indicates internal heating of copper wires, a sign of an electrical short circuit occurring. The greenish residue is normally left behind from oxidation as a result of chemical reaction involving the copper wires.

28. Having investigated and technically analysed the damages of burnt nature to the Insured Vehicle, we are of the view that the cause of fire to the Insured Vehicle was of electrical in nature. For this particular case, the fire had originated along the wirings inside the engine compartment, leading from the wiring harness. The wirings were original factory wirings of the Insured Vehicle.

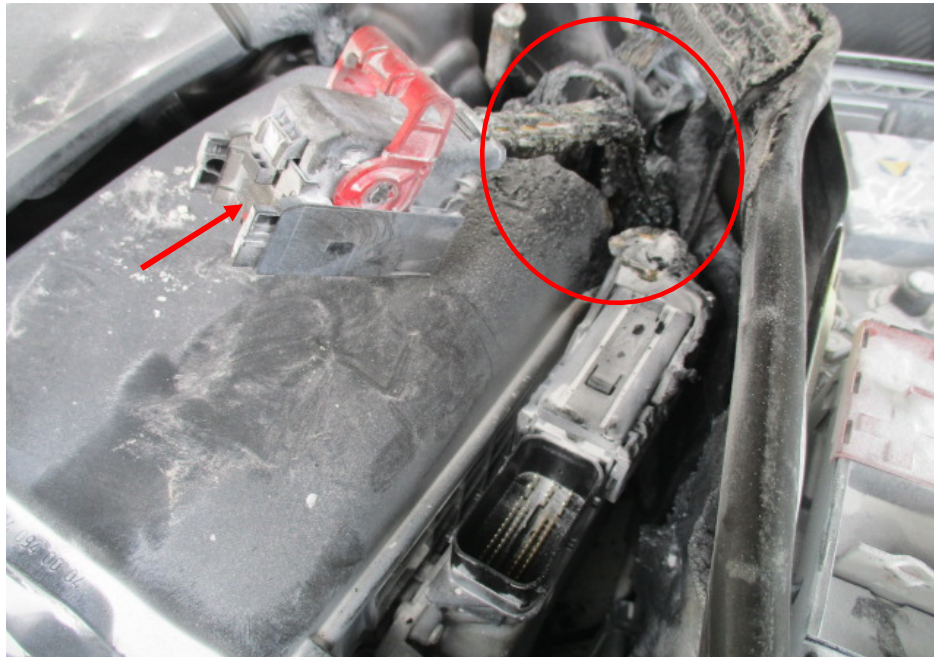
**Photo 11** shows a closer view of the disconnected wiring harness (arrowed). We observed greenish residue on some of the burnt wirings leading from the wiring harness (circled).

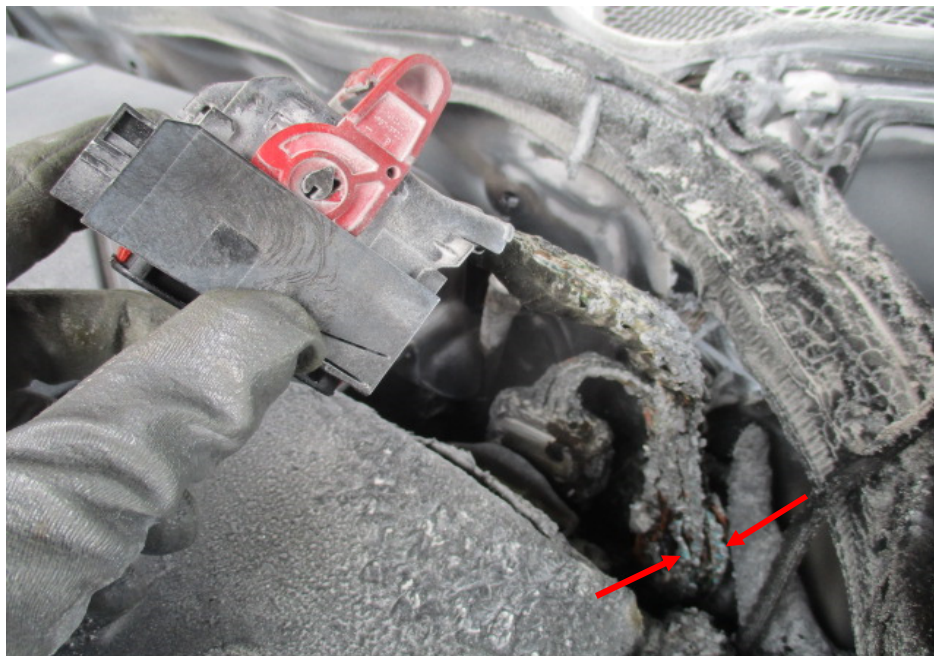
**Photo 12** shows a closer view of the greenish residue on the wirings leading from the wiring harness of the Insured Vehicle (red arrows). The presence of such greenish residue suggests occurrence of an electrical short circuit.

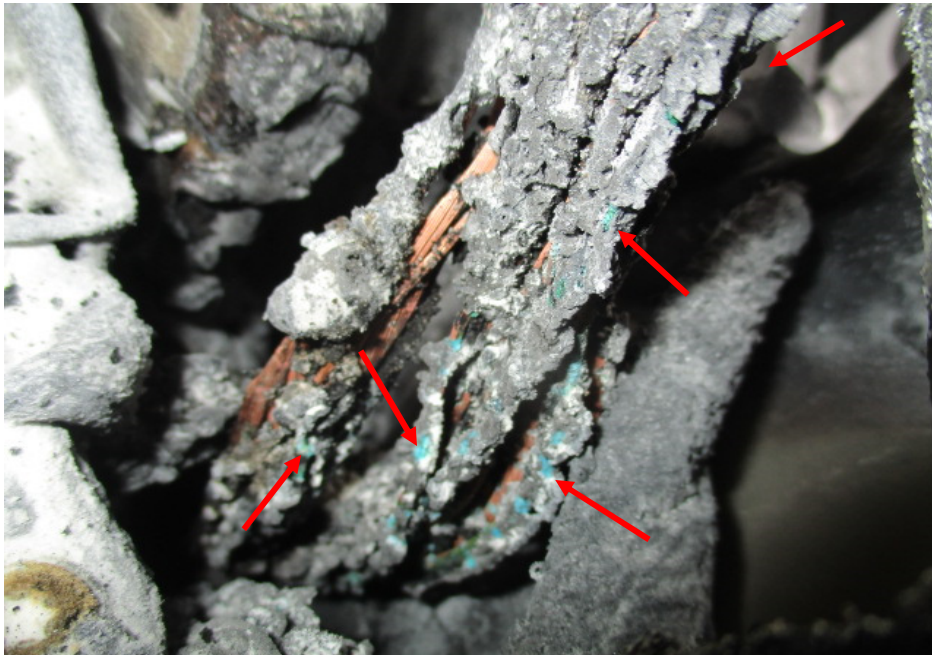
**Photo 13** shows a close up view of the greenish residue on the wirings leading from the disconnected wiring harness of the Insured Vehicle (red arrows). The presence of such greenish residue suggests occurrence of an electrical short circuit.

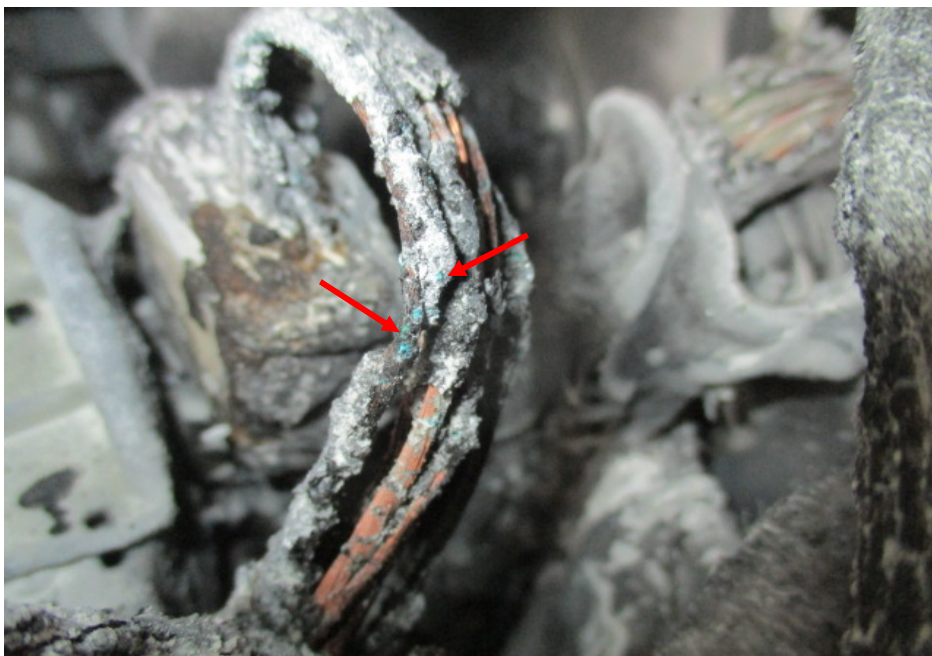
**Photo 14** shows a close up view of the greenish residue on the wirings leading from the disconnected wiring harness of the Insured Vehicle (red arrows). The presence of such greenish residue suggests occurrence of an electrical short circuit.

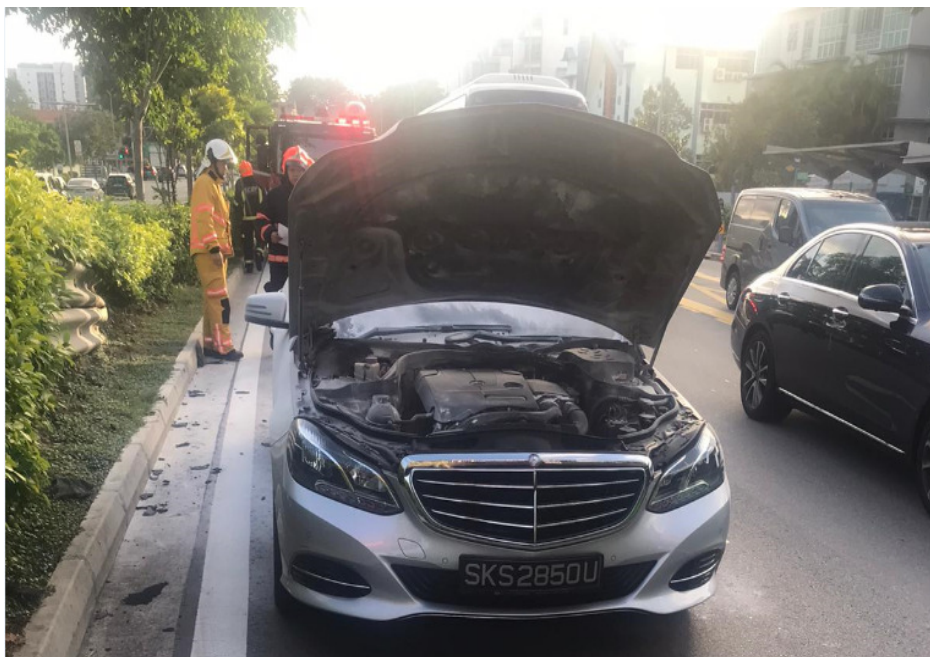
**Photo 15** shows the SCDF conducting preliminary investigations on the Insured Vehicle post- incident.

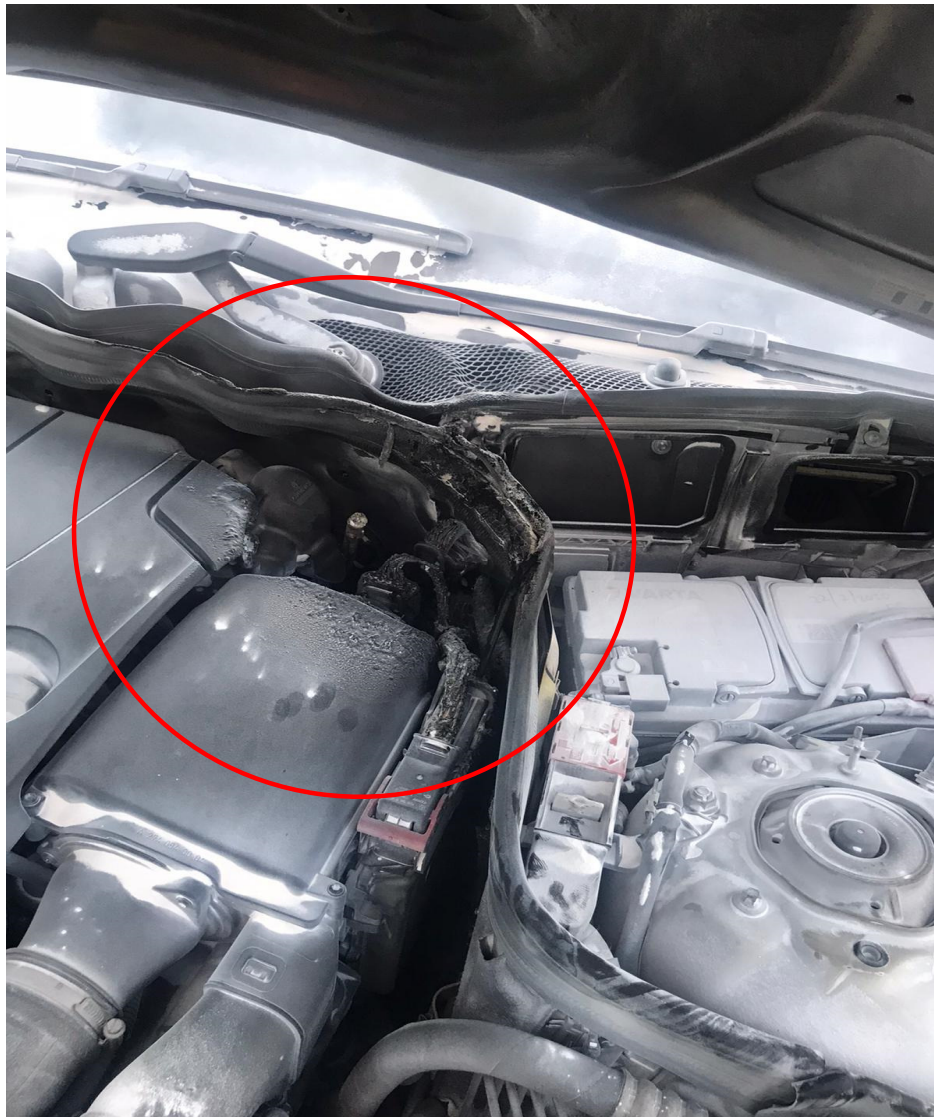
**Photo 16** shows the Insured Vehicle at the incident scene after the fire was extinguished. In general, the information that could be gathered from these photographs had corresponded to the events that were related to us by Mr Lingam. The burn pattern and concentration of fire extinguisher residue observed at the rear centre portion of the engine compartment (circled) is an indication that the fire had started from the rear centre portion of the engine compartment.

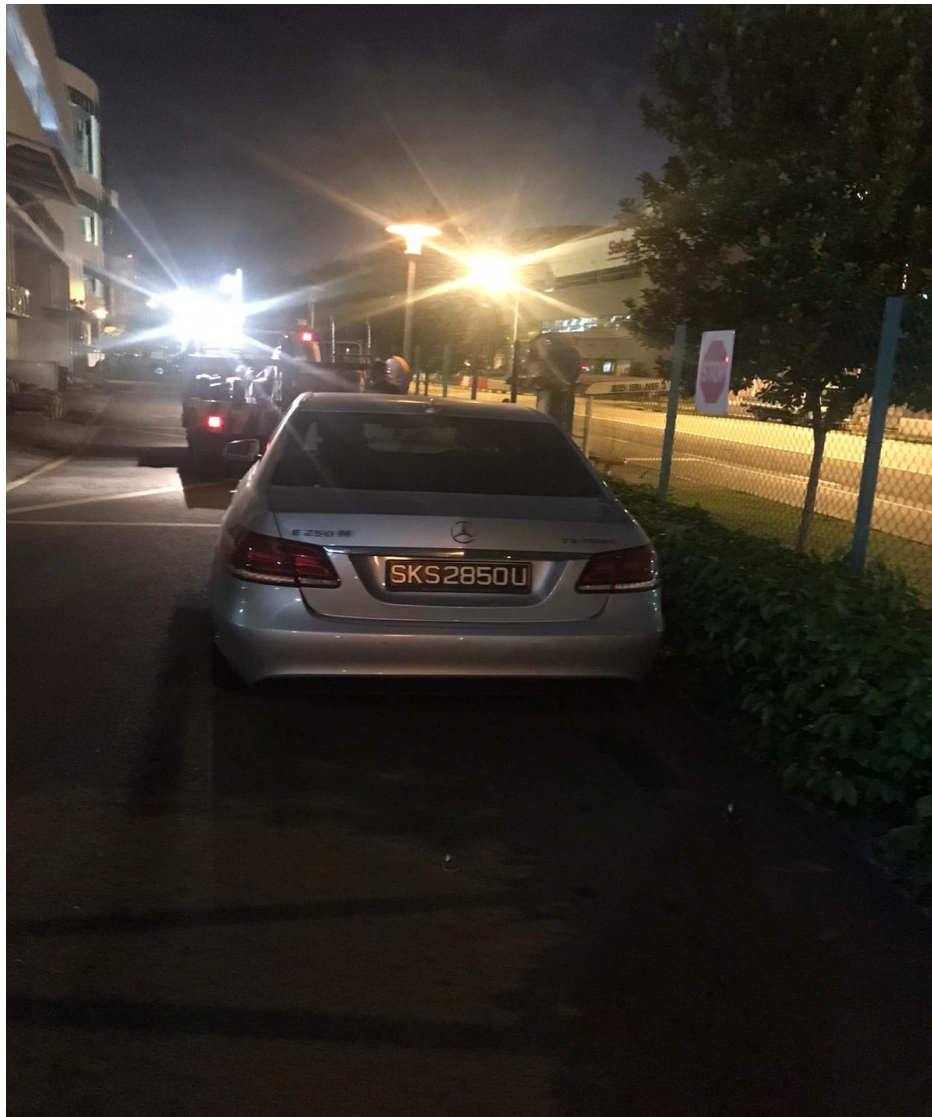
**Photo 17** shows the Insured Vehicle towed to Cycle & Carriage Eunios Service Centre located at 330 Ubi Road 3.
