Your Ref: TP/IP/71957/2019
Our Ref : CI/TPD20003362/N

5 March 2020

INSPECTION REPORT OF MOTORCYCLE FBQ 2458L

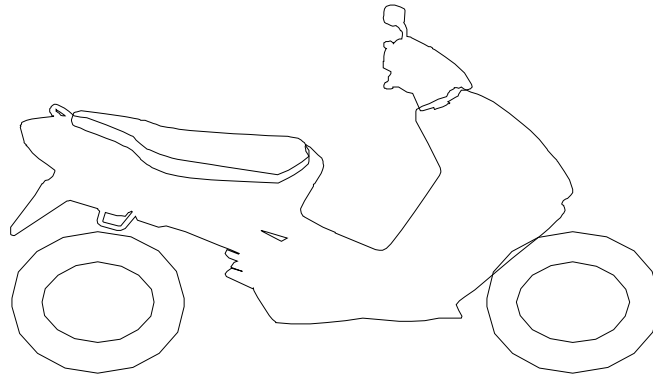
7. The tyre brand, tyre size and remaining tread depth of the 2 tyres were recorded as follows:-

IRC 120/70 - 17 (3mm)

IRC 90/80 - 17 (4mm)

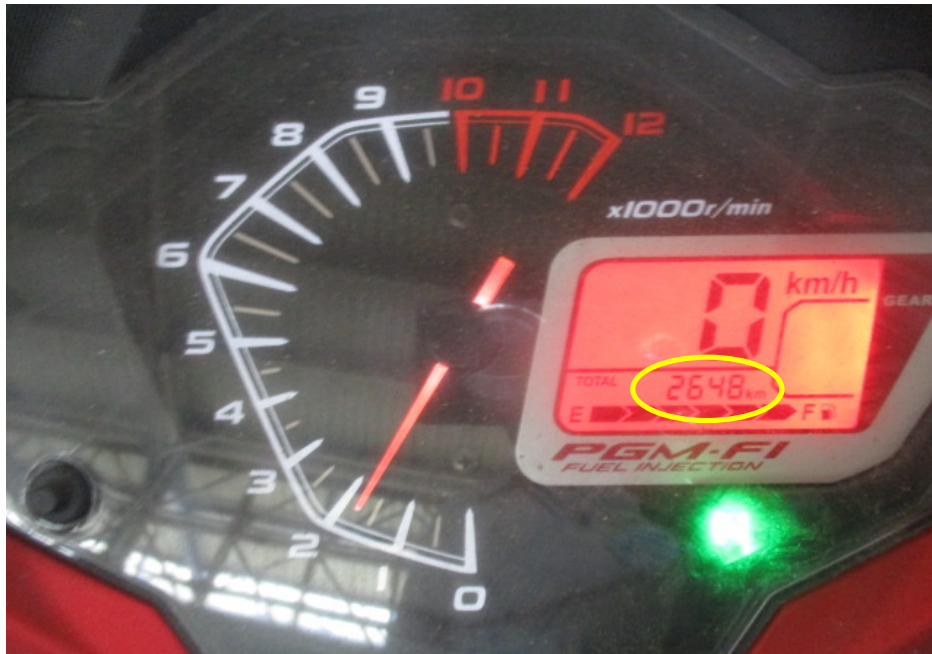
Photo 1 shows the speedometer gauge of the Motorcycle. The mileage of the Motorcycle at the time of our inspection was 2, 648km (circled).

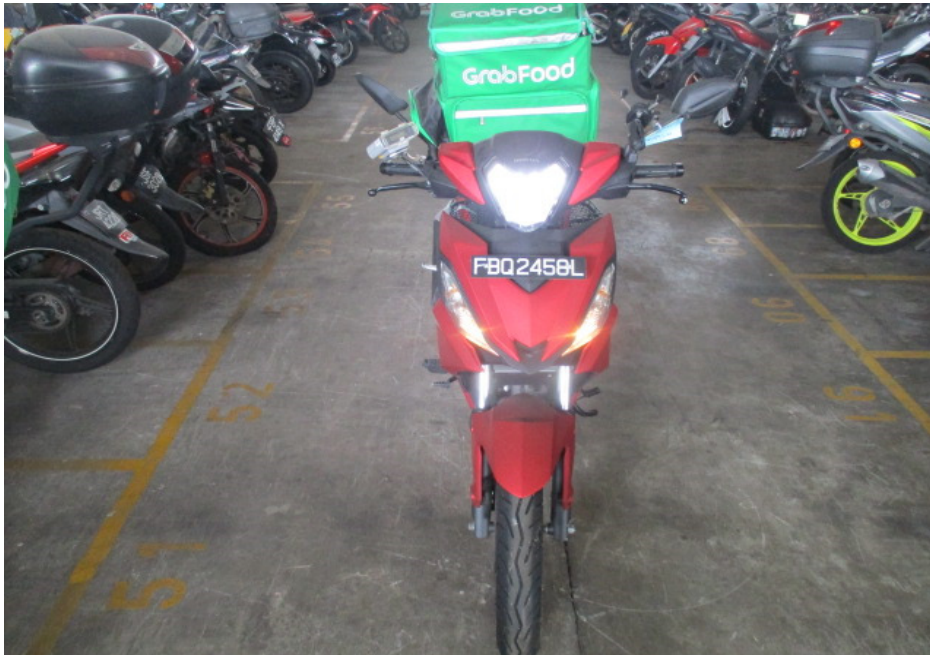
Photo 2 shows a general view of the front body of the Motorcycle at the time of our inspection. The Motorcycle was observed to have sustained damages along its left body.

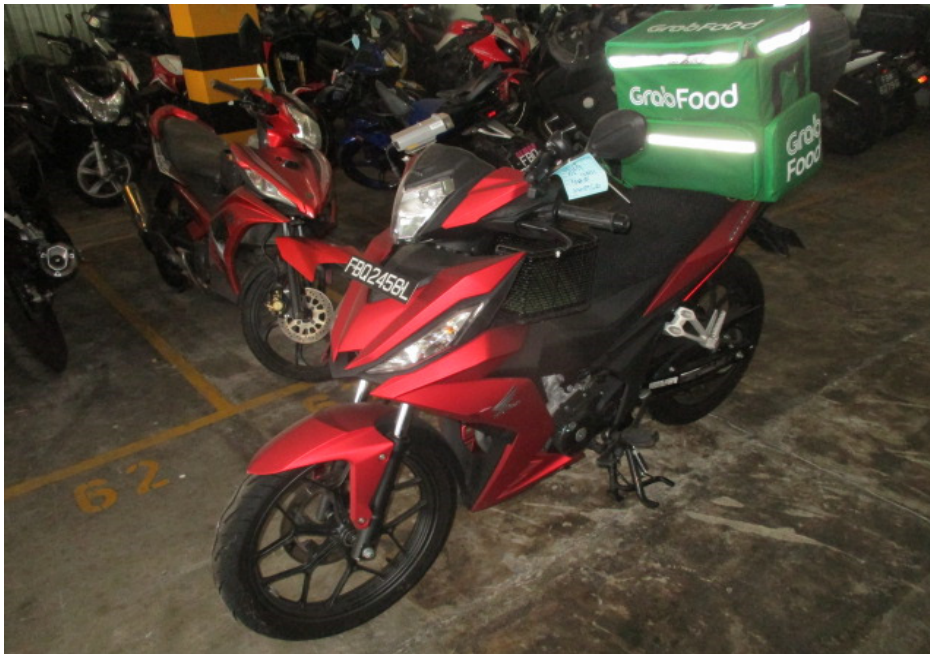
4. The mileage of the Motorcycle at the time of our inspection was 2, 648km.
5. The Motorcycle was observed to have sustained damages along its left body. The body parts that were found to have been damaged include its left front fork outer tube, front wheel axle nut, left cowling, clutch lever, left side mirror, gear shift pedal, left front footrest, left pillion foot peg, top box rack and top box, amongst others.

Photo 3 shows a general view of the left body of the Motorcycle at the time of our inspection. The Motorcycle was observed to have sustained damages along its left body. Amongst the body parts that were found to have been damaged include its left front fork outer tube, front wheel axle nut, left cowling, clutch lever, left side mirror, gear shift pedal, left front footrest, left pillion foot peg, top box rack and top box, amongst others.

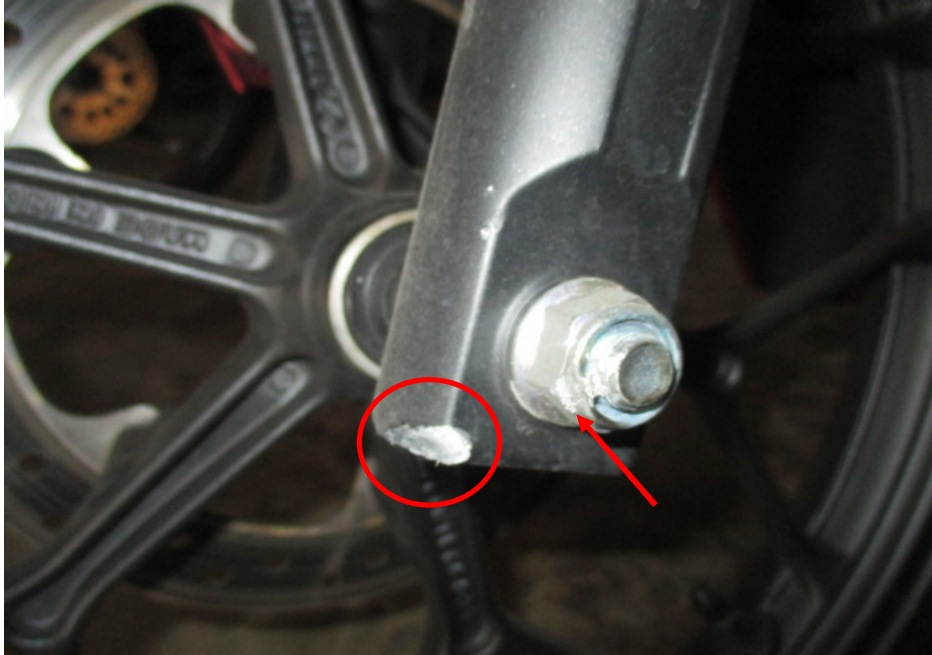
Photo 4 shows a close up view of the left front fork outer tube (circled) and front wheel axle nut (arrowed) which were amongst the body parts at the front of the Motorcycle that had sustained damage as a result of the accident.

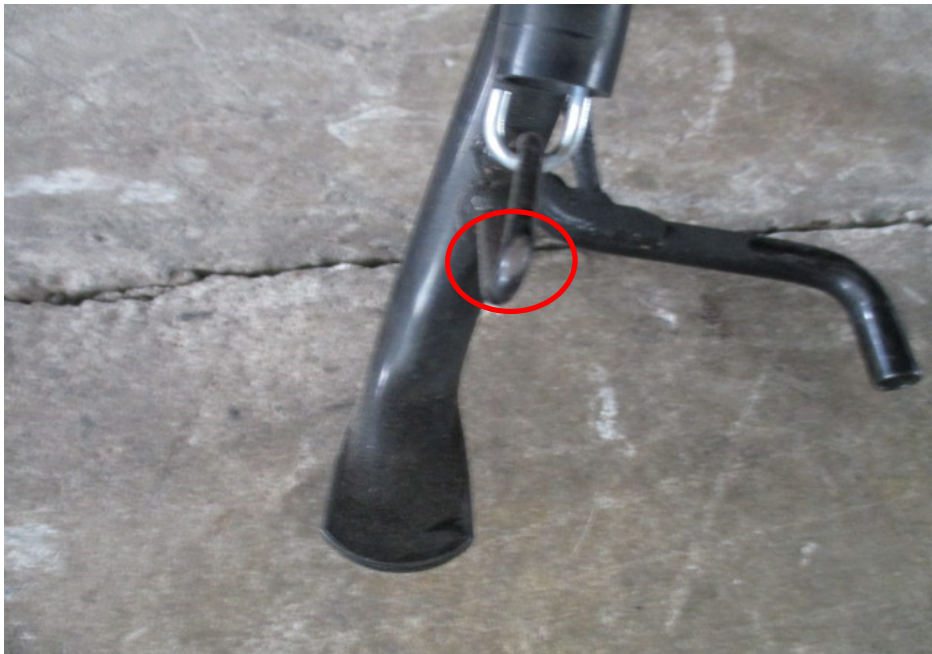
Photo 5 shows a closer view of the side stand (circled) which was amongst the body parts of the Motorcycle that had sustained damage as a result of the accident.

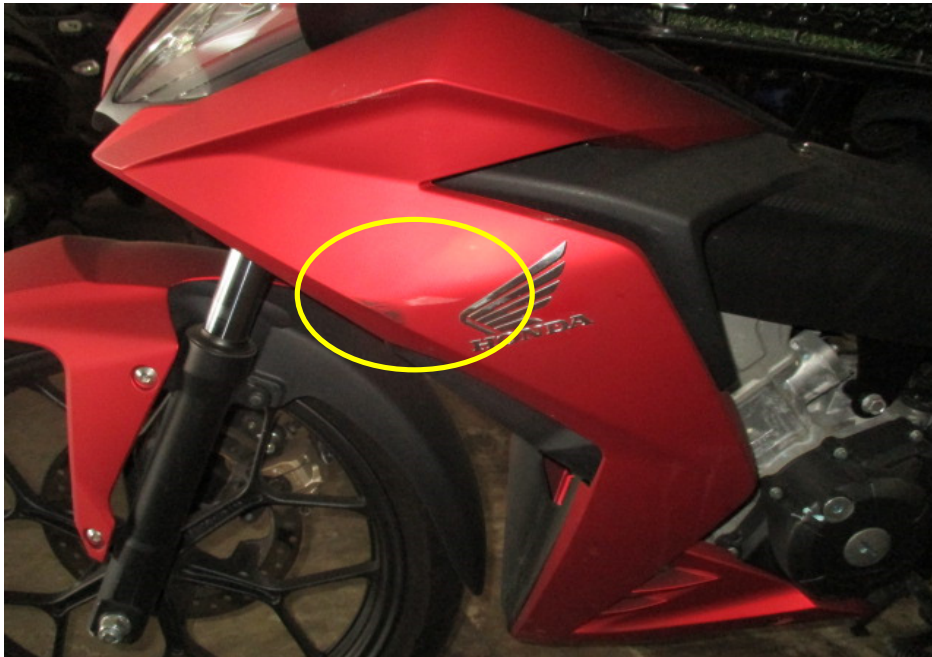
Photo 6 shows a closer view of the left cowling (circled) which was amongst the body parts of the Motorcycle that had sustained damage as a result of the accident.

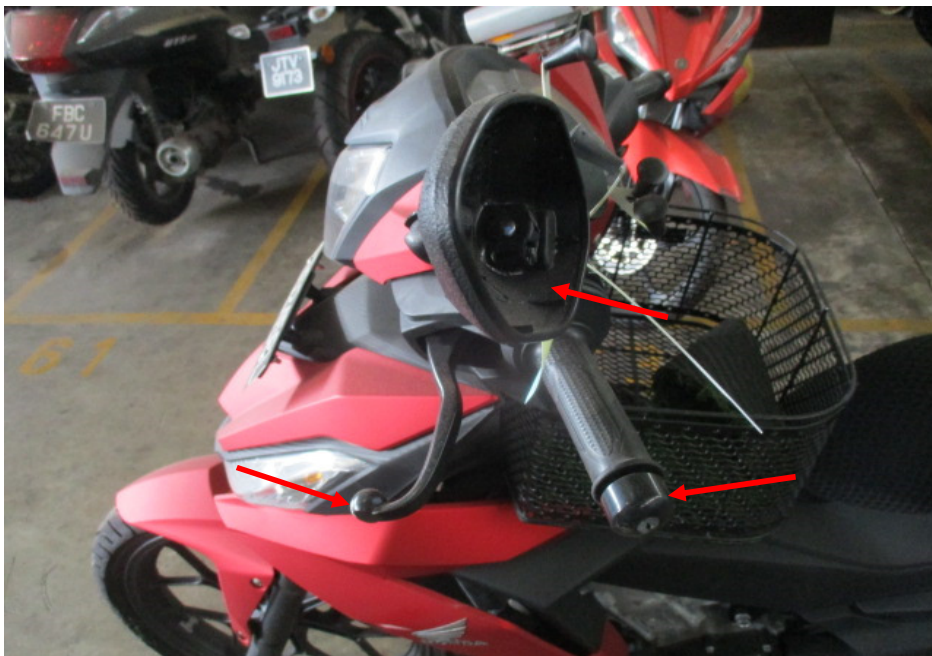
Photo 7 shows the clutch lever, left handlebar end and left side mirror (arrowed), which were amongst the body parts of the Motorcycle that had sustained damage as a result of the accident.

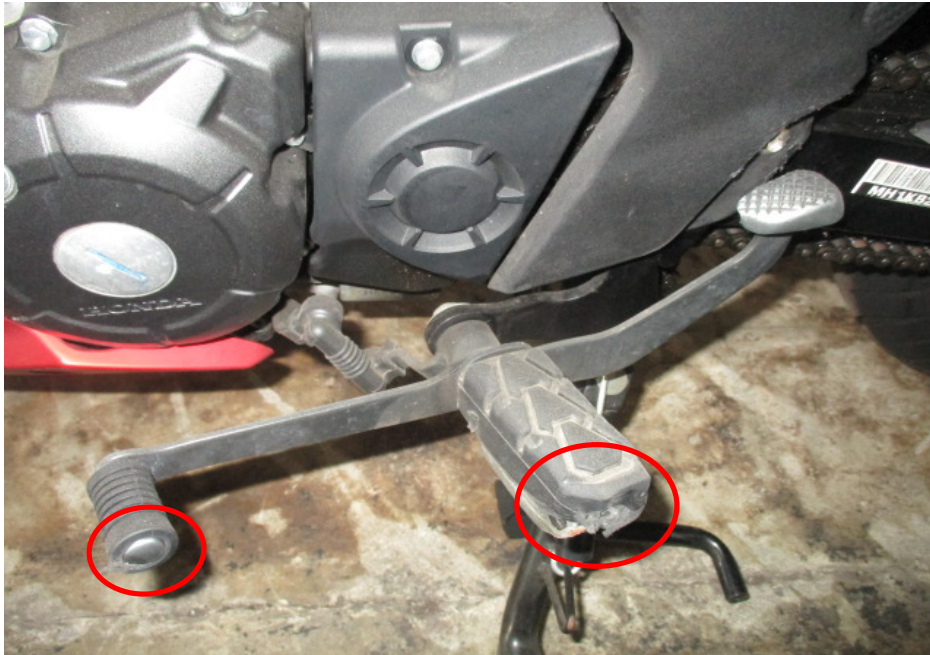
Photo 8 shows a closer view of the gear shift pedal and left front footrest (circled) which were amongst the body parts of the Motorcycle that had sustained damage as a result of the accident.

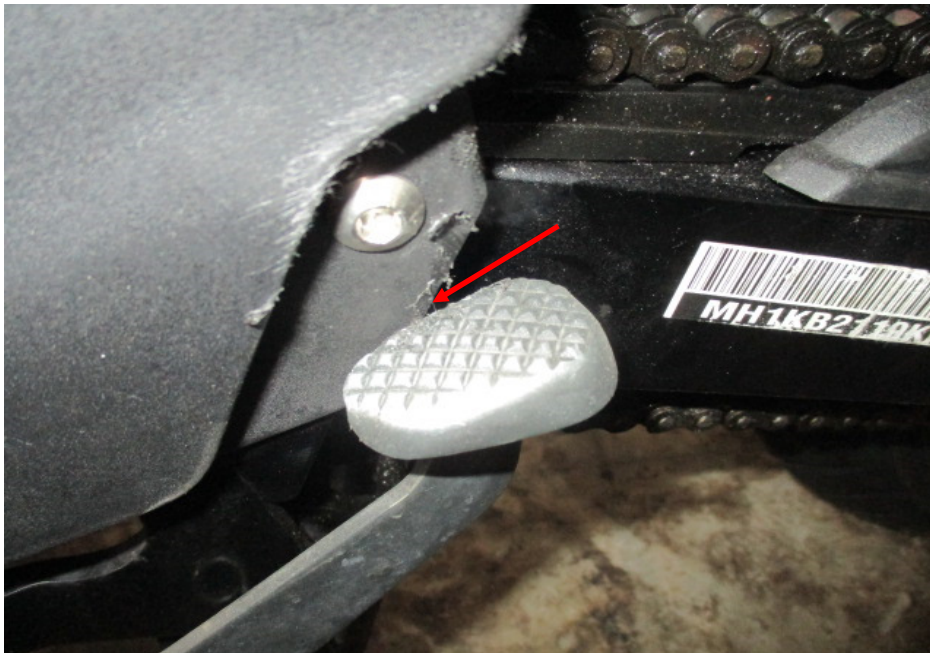
Photo 9 shows as a result of the accident, the rear portion of the gear shift pedal was bent inwards, causing it to be stuck to the lower portion of the left subframe of the Motorcycle (arrowed).

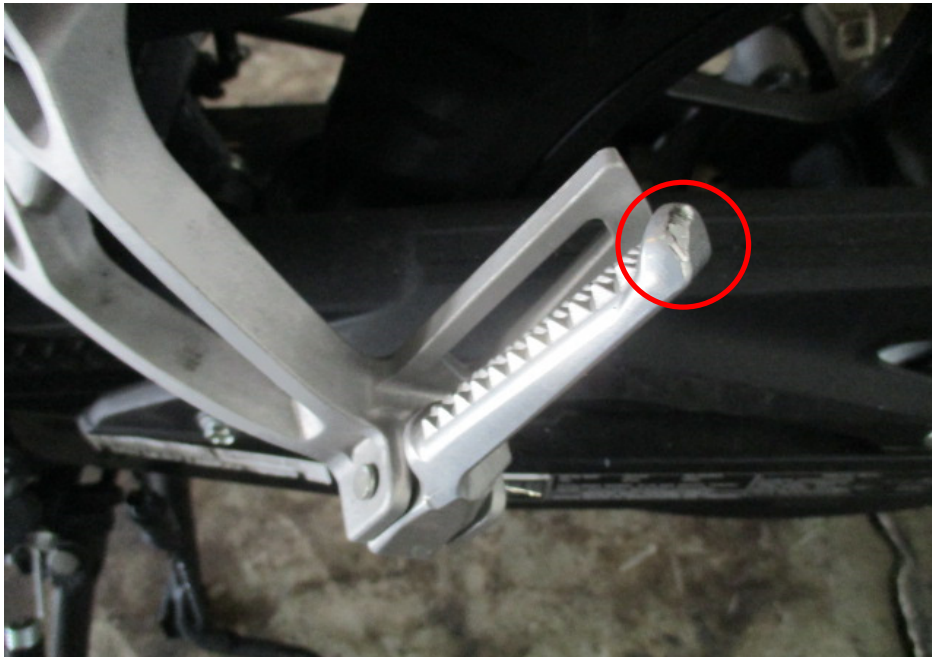
Photo 10 shows a closer view of the left pillion foot peg which was amongst the body parts of the Motorcycle that had sustained damages of grazing nature as a result of the accident (circled).

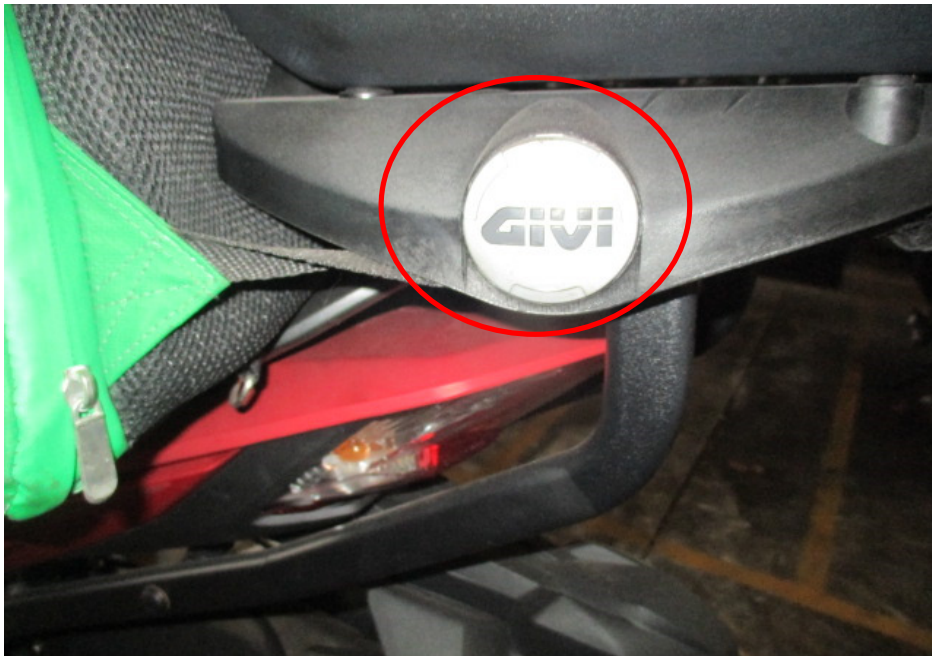
Photo 11 shows the top box rack (circled) of the Motorcycle that had sustained damage as a result of the accident.

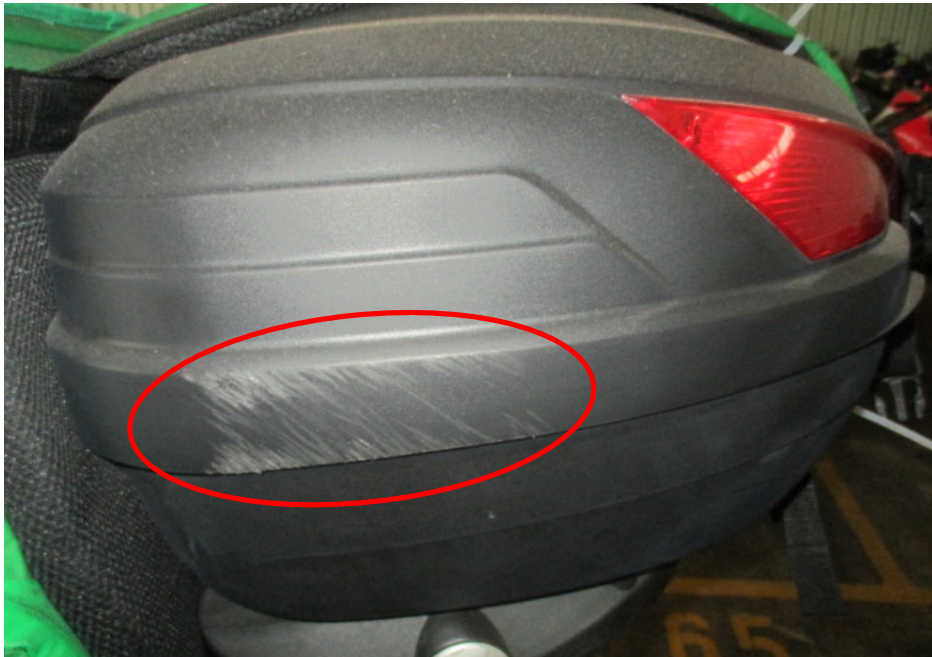
Photo 12 shows the top box of the Motorcycle that had sustained damages of grazing nature as a result of the accident (circled).

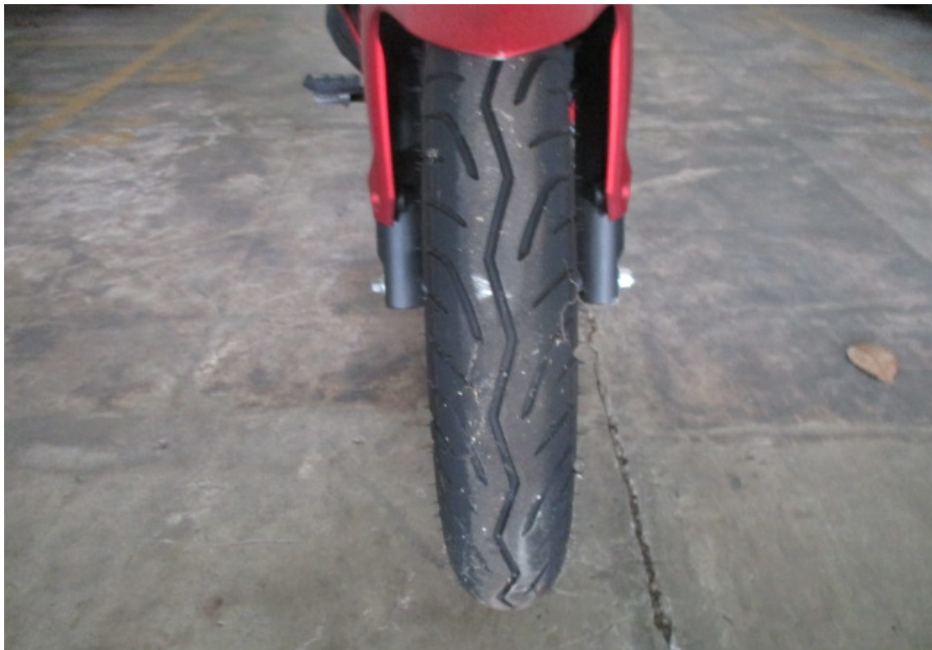
Photo 13 shows the front tyre of the Motorcycle at the time of our inspection. The front tyre was observed to be in serviceable condition with remaining tread depth of approximately 4mm. The pattern of the tread was also clearly visible. There was no tear, burst mark(s) and/or punctured hole(s) on the sidewalls as well as across the tread of the front tyre.

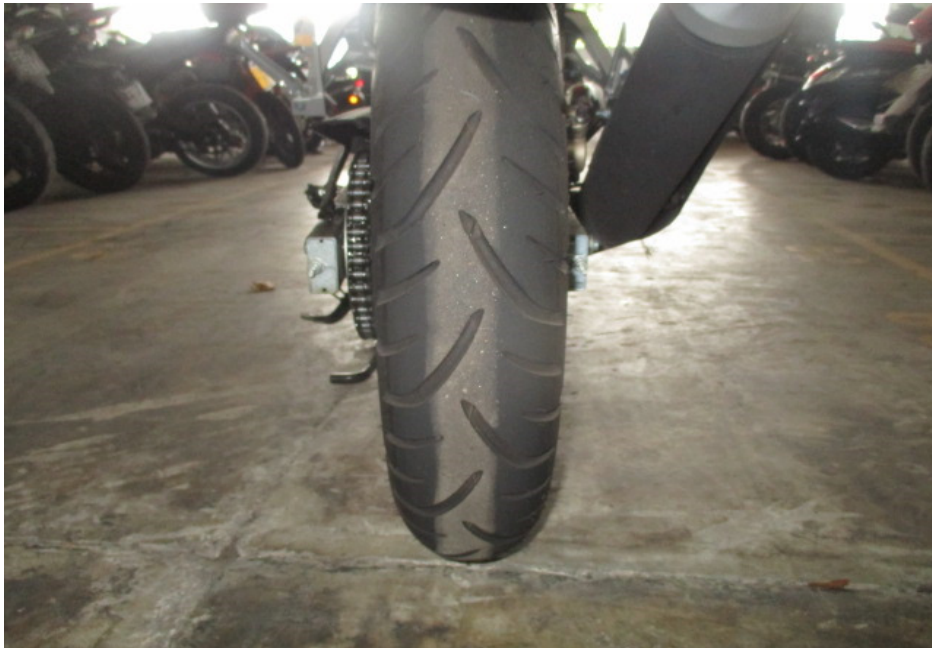
Photo 14 shows the condition of the Motorcycle's rear tyre. The rear tyre was observed to be in serviceable condition with remaining tread depth of approximately 3mm. The tyre was also observed to be sufficiently inflated for vehicular operation. We did not observe any tear, burst mark(s) and/or punctured hole(s) on the sidewalls as well as across the tread of the rear tyre.

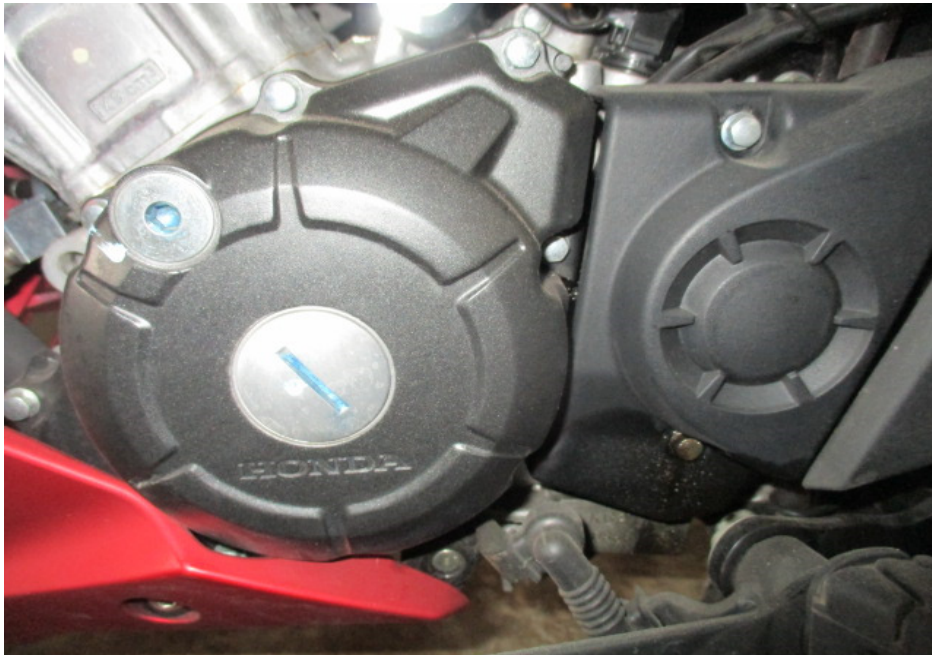
Photo 15 shows the left side of the engine of the Motorcycle at the time of our inspection. The various engine related parts and components were found to be intact with no visible damage. There was also no sign(s) or indication(s) of fluid leak observed around the left engine area of the Motorcycle.

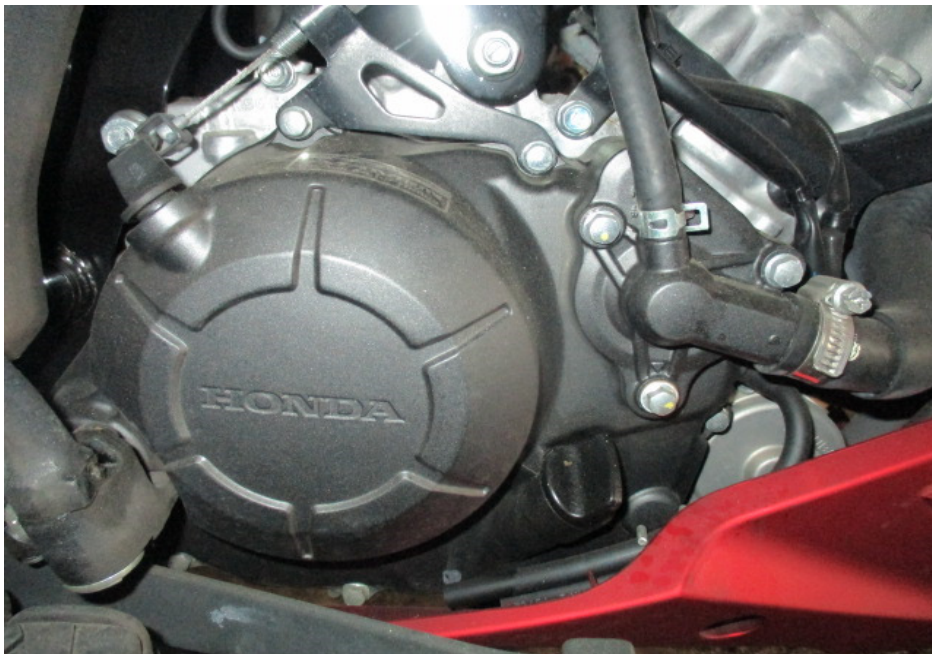
Photo 16 shows the right side of the engine of the Motorcycle at the time of our inspection. The various engine related parts and components were found to be intact with no visible damage. There was also no sign(s) or indication(s) of fluid leak observed around the right engine area of the Motorcycle.

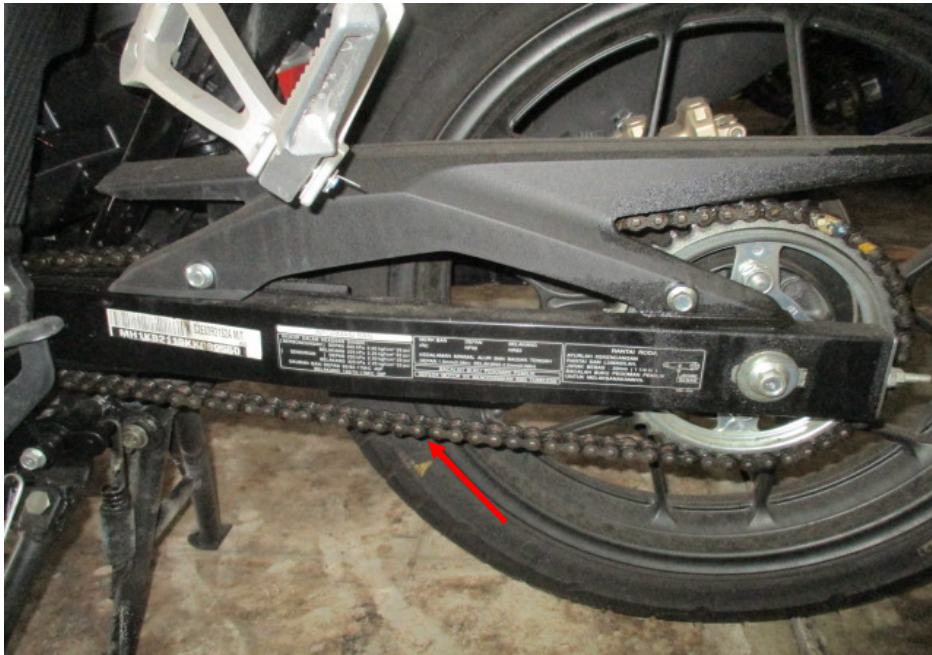
Photo 17 shows the general view of the gear train (arrowed) of the Motorcycle, which was observed to be intact with no misalignment. It was also adequately lubricated for operating purposes.

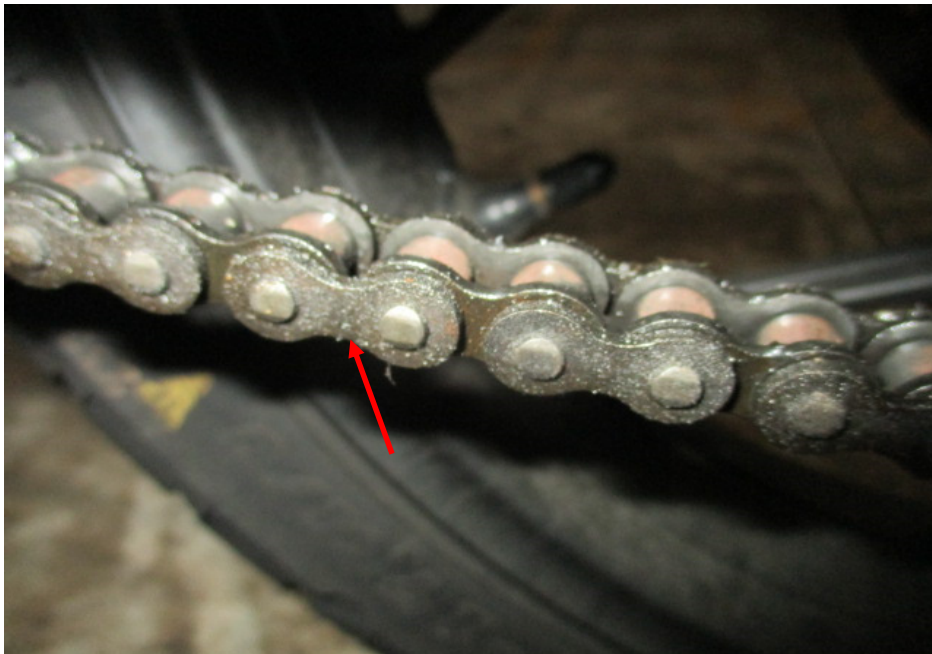
Photo 18 shows a closer view of the gear train (arrowed) of the Motorcycle, which was observed to be intact with no misalignment. It was also adequately lubricated for operating purposes.

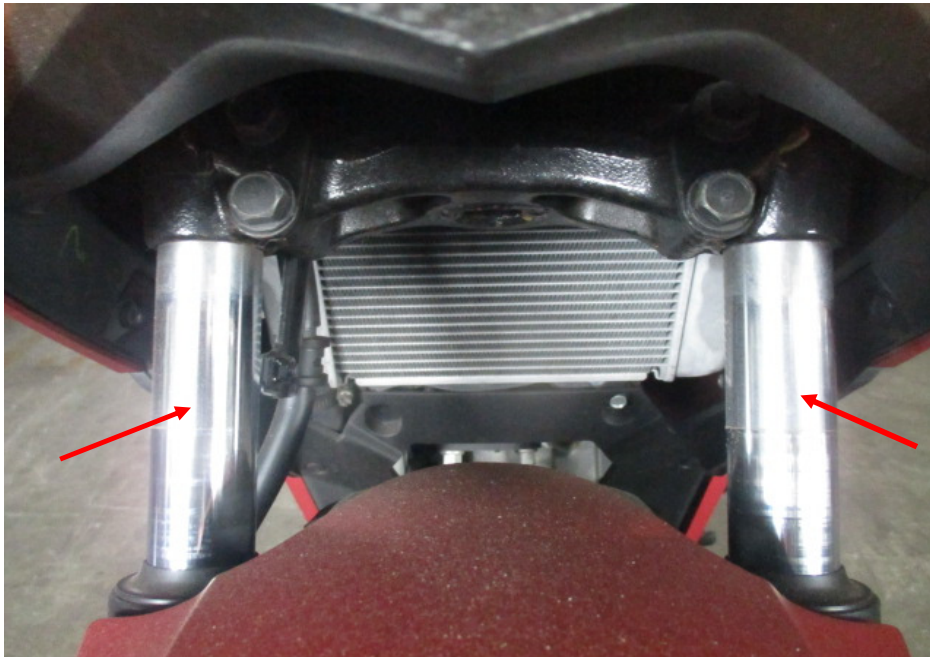
Photo 19 shows the front fork (arrowed) of the Motorcycle. The front fork and fork bracket of the Motorcycle were both found to be intact and undamaged. Turning the Motorcycle's handle bar towards the left and right did not produce any abnormal free play. The steering system of the Motorcycle was in serviceable condition at the time of our inspection.

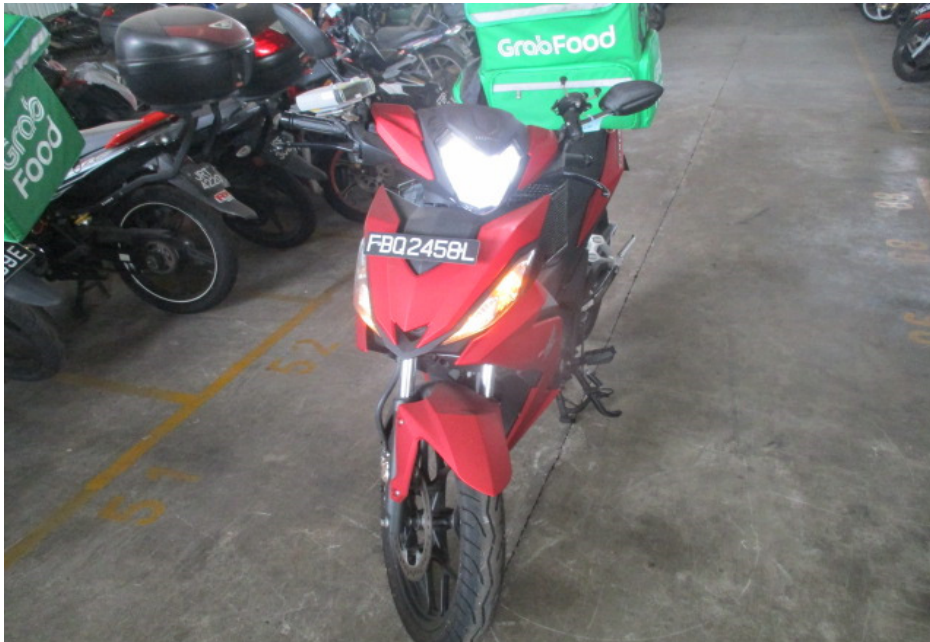
Photo 20 shows the front wheel of the Motorcycle turned towards its full left. Turning the Motorcycle's handle bar towards the left did not produce any abnormal free play and/or resistance. This would indicate that the steering system of the Motorcycle was in serviceable condition at the time of our inspection.

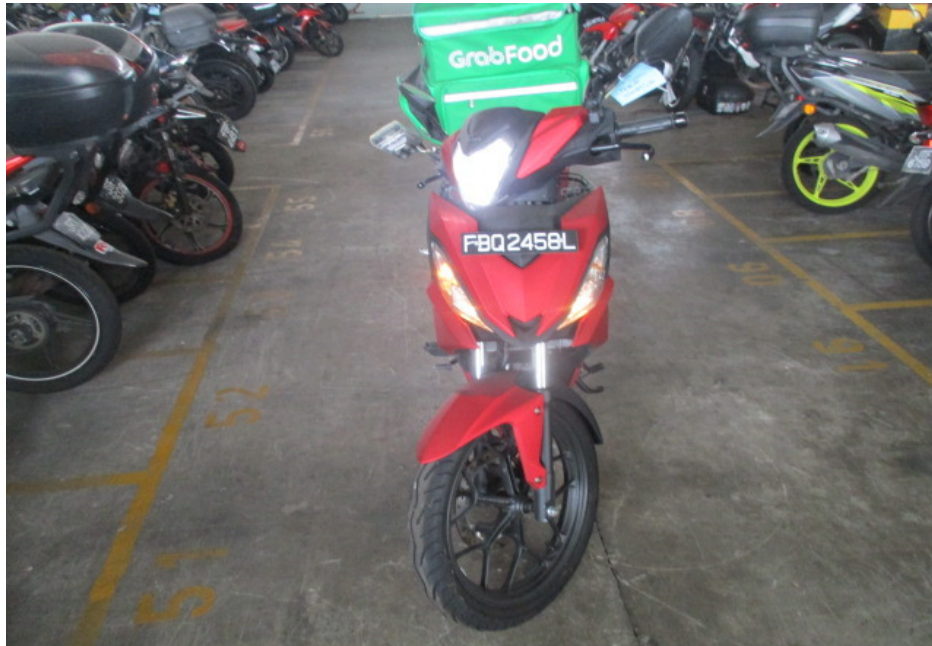
Photo 21 shows the front wheel of the Motorcycle turned towards its full right. Turning the Motorcycle's handle bar towards the right did not produce any abnormal free play and/or resistance. This would indicate that the steering system of the Motorcycle was in serviceable condition at the time of our inspection.

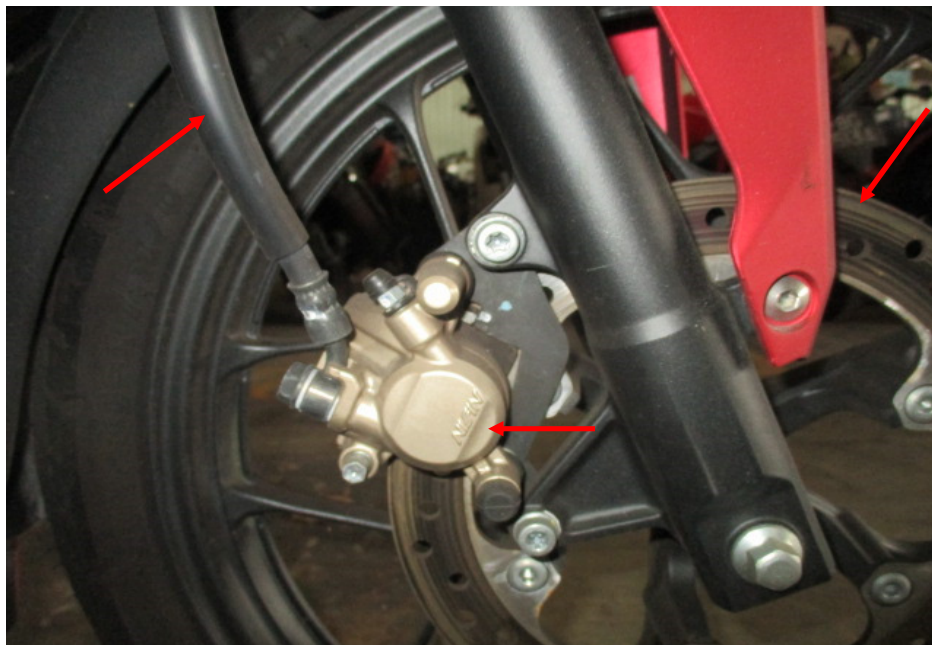
Photo 22 shows a close up view of the front brake caliper, front brake disc and front brake hose (arrowed) of the Motorcycle, which are all part of the components in the hydraulic front brake system of the Motorcycle. Our visual checks of these various components had revealed all to be intact with no visible damage. No leakage of brake fluid was also observed.

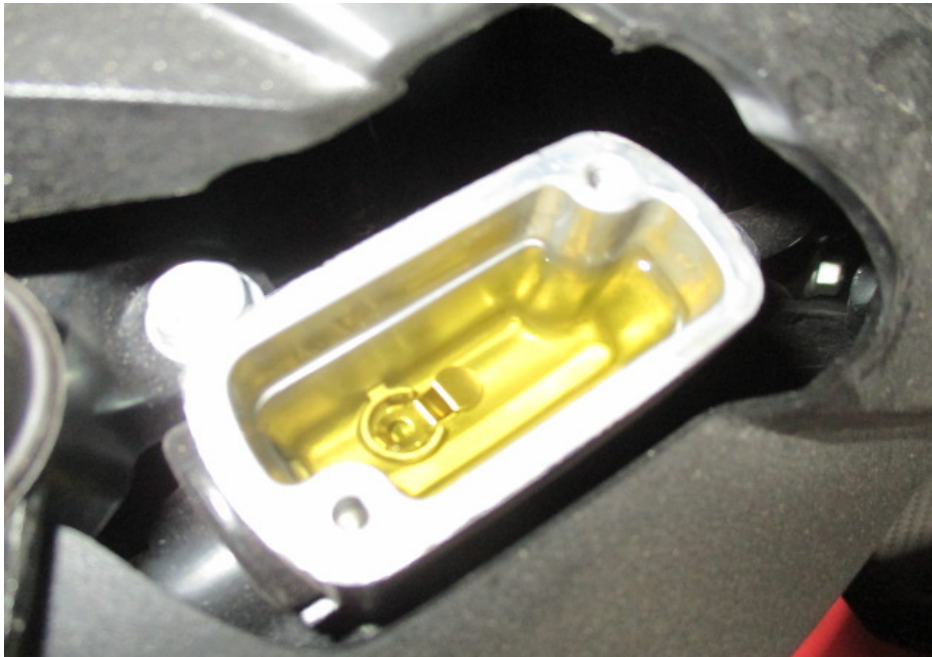
Photo 23 shows the brake fluid reservoir for the front brake of the Motorcycle. The brake fluid was observed to be of sufficient level and without contamination for operational purposes.

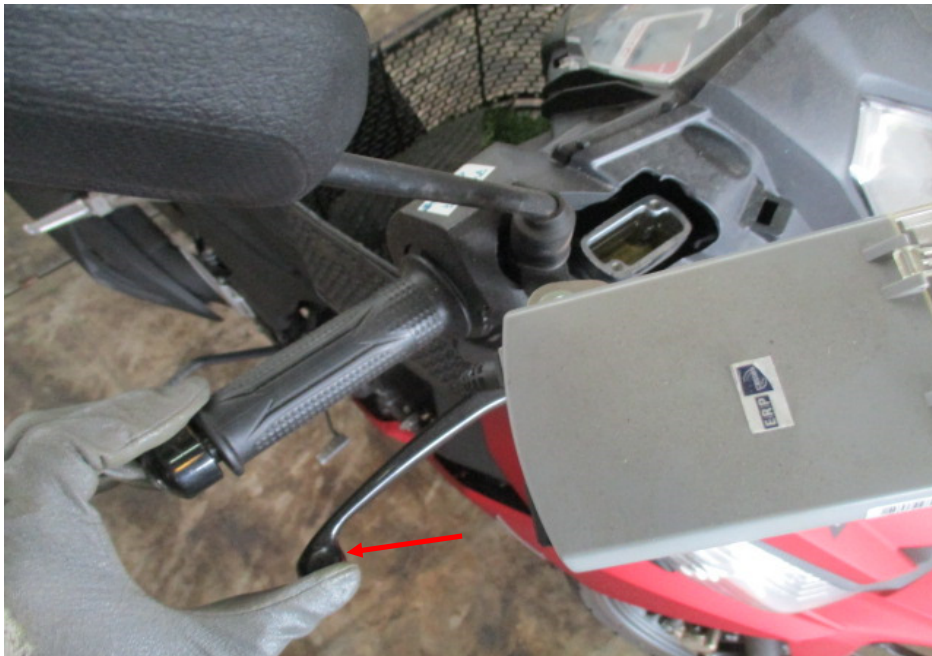
Photo 24 shows the front brake lever being depressed. There was some resistance felt (spongy like feel) upon pressing the front brake lever (arrowed). This would indicate that there is no leakage of pressure/vacuum in the brake system.

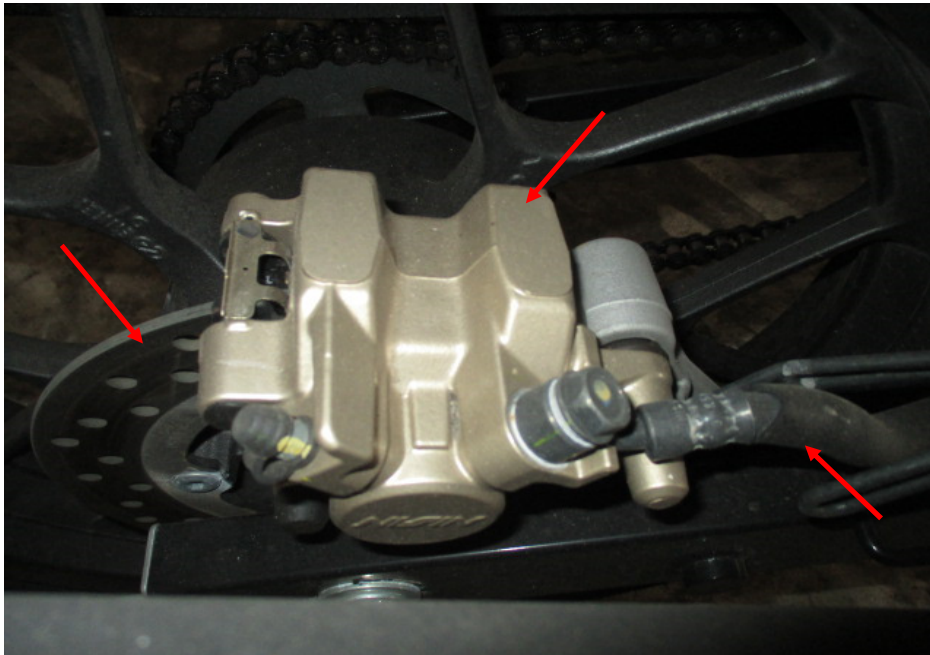
Photo 25 shows a close up view of the rear brake caliper, rear brake disc and rear brake hose (arrowed) of the Motorcycle, which are all part of the components in the hydraulic rear brake system of the Motorcycle. Our visual checks of these various components had revealed all to be intact with no visible damage. No leakage of brake fluid was also observed.

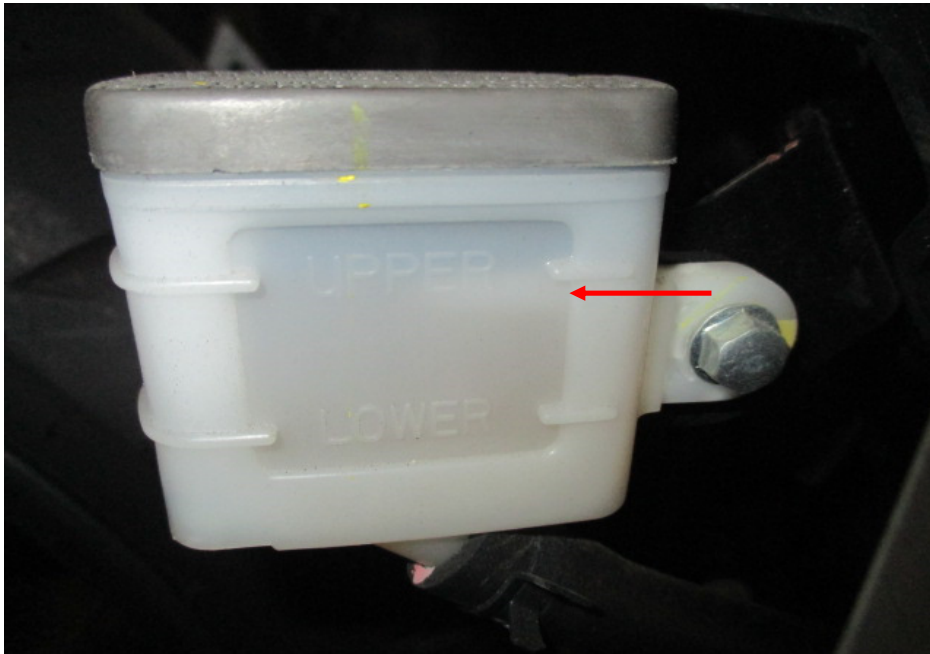
Photo 26 shows the brake fluid reservoir for the rear brake of the Motorcycle. The brake fluid was observed to be of sufficient level (arrowed) and without contamination for operational purposes.
