Your Ref: S0M02HRQ
Our Ref : CS/ASM20003497/P

**TECHNICAL INVESTIGATION REPORT OF FIRE INCIDENT INVOLVING THE
INSURED VEHICLE PA 6846S ON 24th February 2020**

Vehicle Registration No.	: PA 6846S
Make / Model	: ISUZU LT134P-7.8D (M)
Chassis No	: JALLT134P77000101
Year of Registration	: July 2007
Mileage	: N.A. (wiring affected)

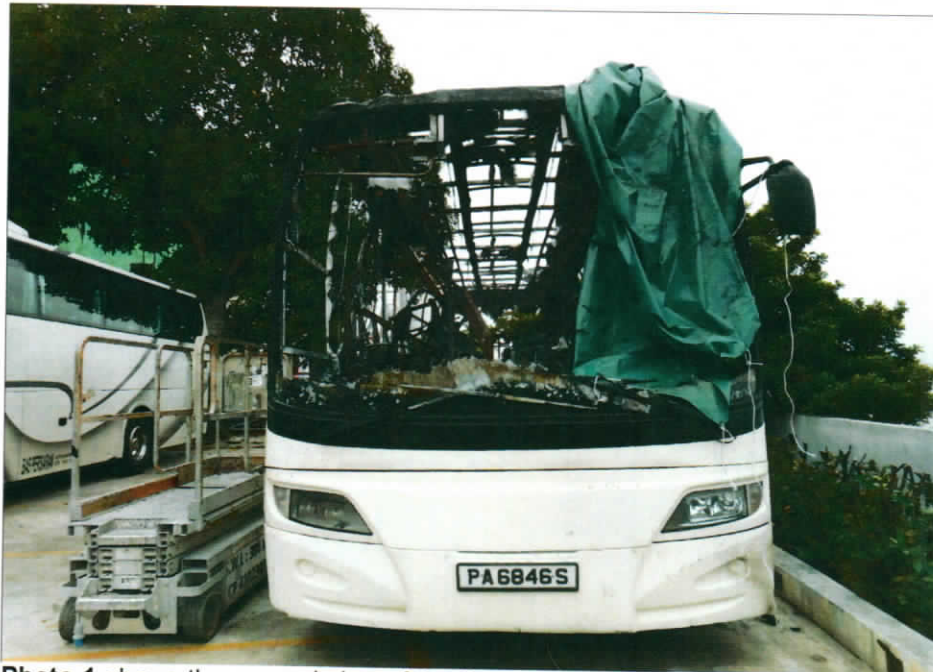
Photo 1 shows the general view of the front portion of the Insured Vehicle at the time of our inspection. The front portion of the Insured Vehicle was significantly affected by the fire.

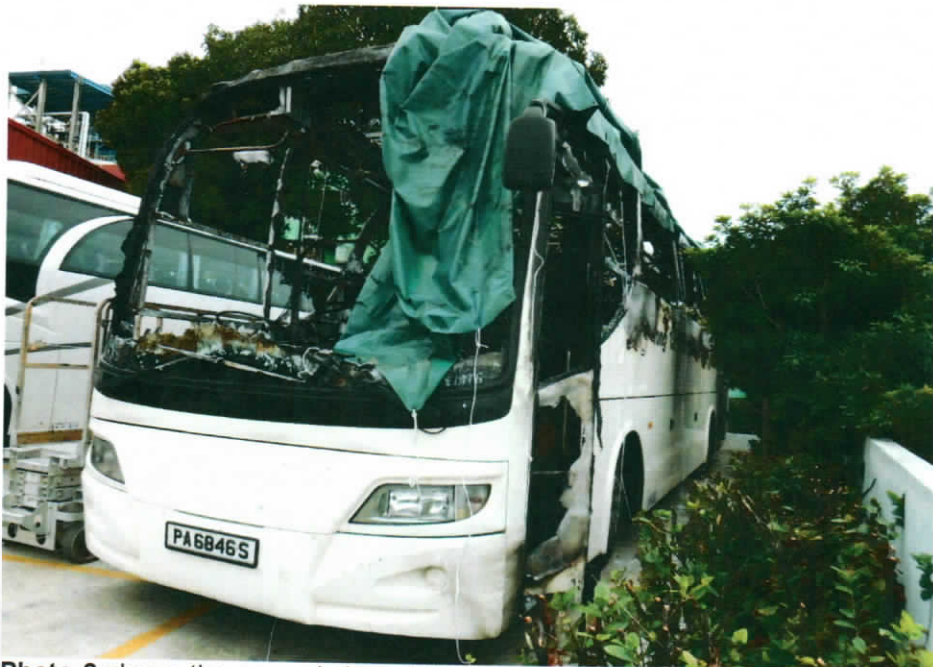
Photo 2 shows the general view of the left portion of the Insured Vehicle at the time of our inspection. The exterior body of the Insured Vehicle had sustained fire damage at the top portion as well as rear portion. Affected parts had included the side mirrors, roof, windows, rear panels, both windscreens and the rear roof air extractor unit.

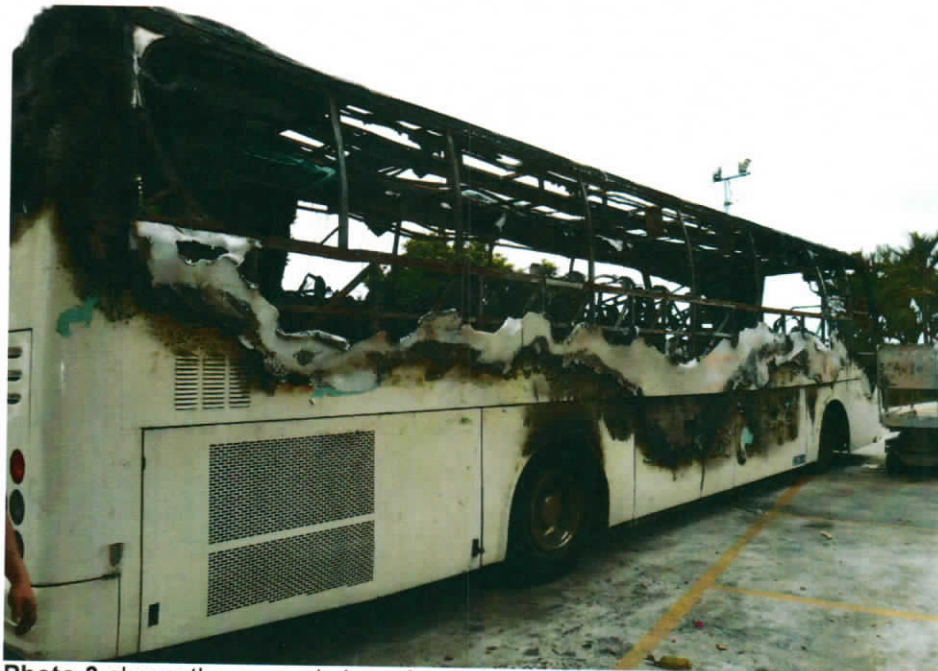
Photo 3 shows the general view of the right portion of the Insured Vehicle at the time of our inspection. The exterior body of the Insured Vehicle had sustained fire damage at the top portion as well as rear portion. Affected parts had included the side mirrors, roof, windows, rear panels, both windscreens and the rear roof air extractor unit

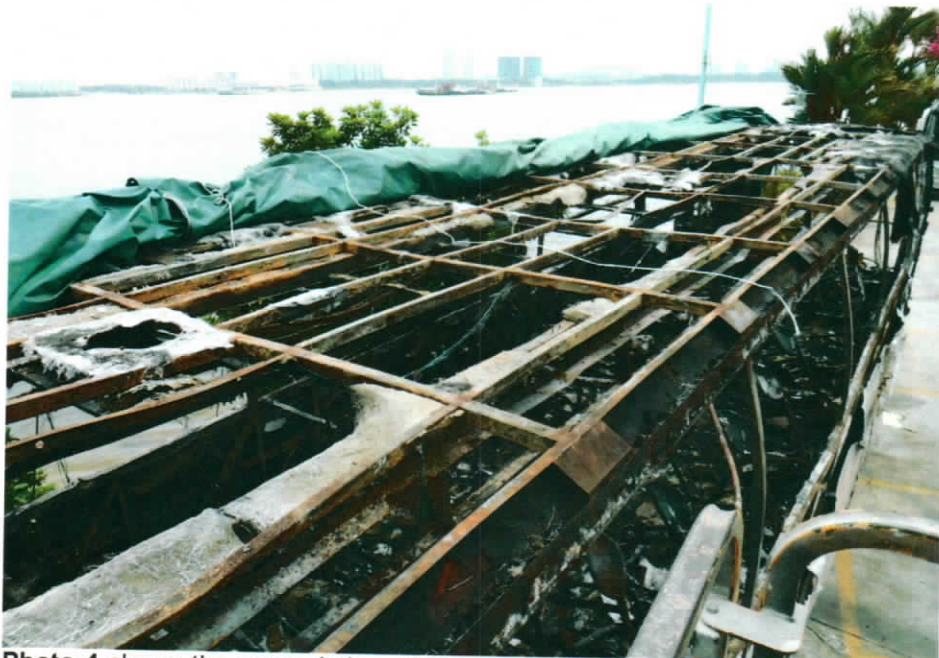
Photo 4 shows the general view of the top portion of the Insured Vehicle at the time of our inspection. The roof of the Insured Vehicle had sustained severe fire damage.

7. For this particular case, the fire appears to have originated from roof portion of the Insured Vehicle, around the rear roof portion of the rear air extractor unit. This can be determined from the nature of the fire damage which was more extensive at the top portion. Basing on the circumstances of the fires' origin at the material time of incident as well as examining the area where the extent of fire damage was most severe, we can determine that the fire had likely started from the rear roof portion of the Insured Vehicle.

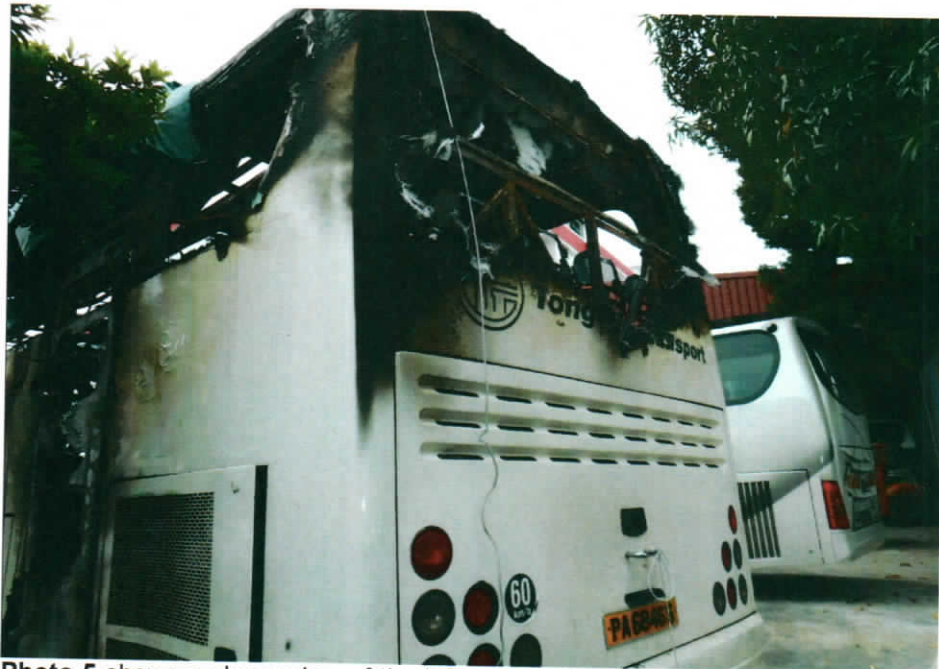
Photo 5 shows a closer view of the left rear portion of the Insured Vehicle at the time of our inspection. The fire damage was observed to be at its rear roof portion. The engine exterior compartment was observed to be unaffected by the fire.

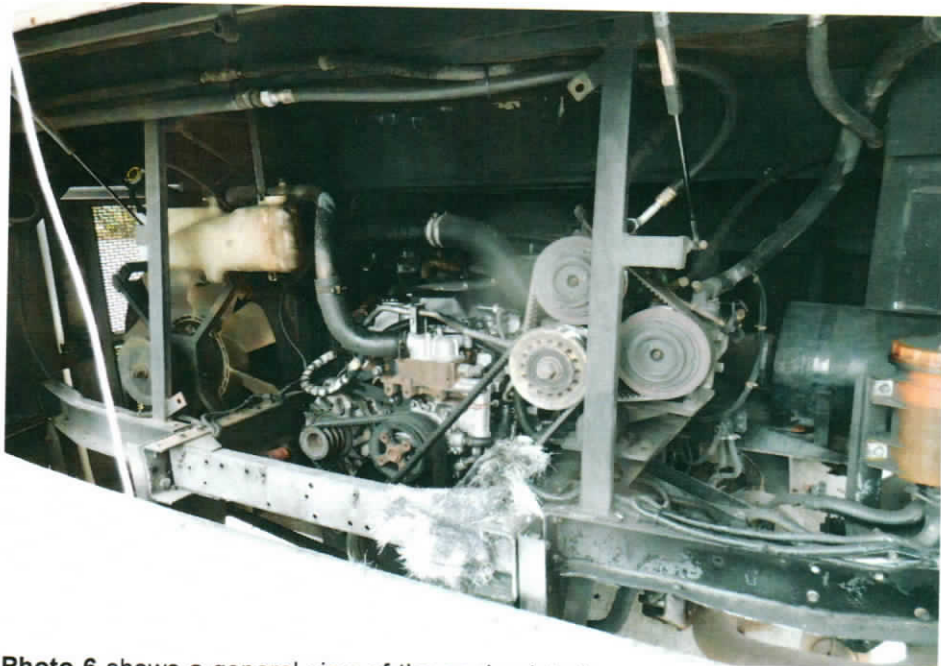
Photo 6 shows a general view of the engine interior compartment of the Insured Vehicle at the time of our inspection. The engine compartment of the Insured Vehicle was observed to be unaffected by the fire.

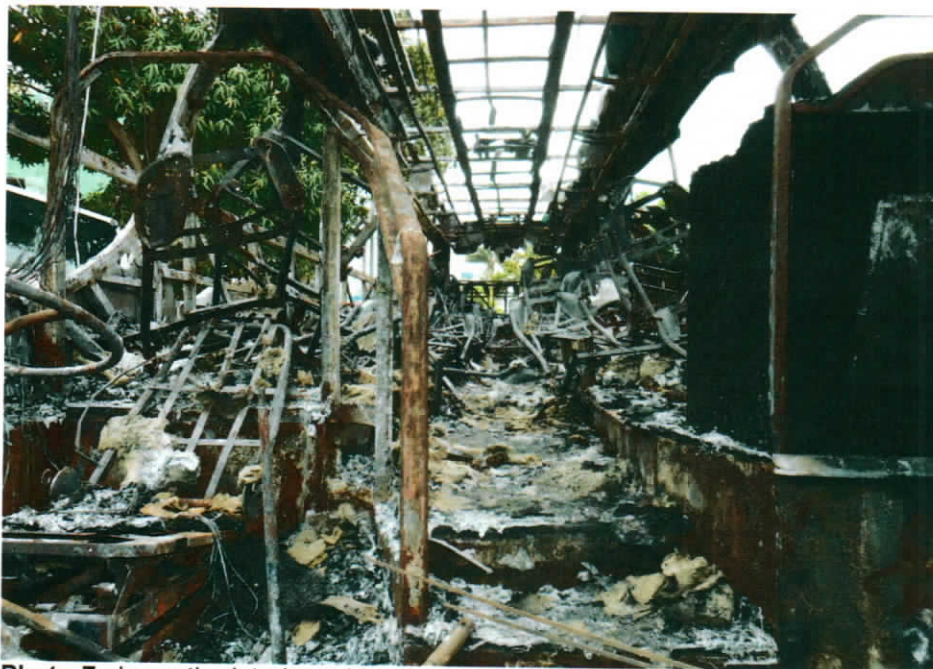
Photo 7 shows the interior cabin of the Insured Vehicle at the time of inspection. The interior rear cabin was completely burnt.

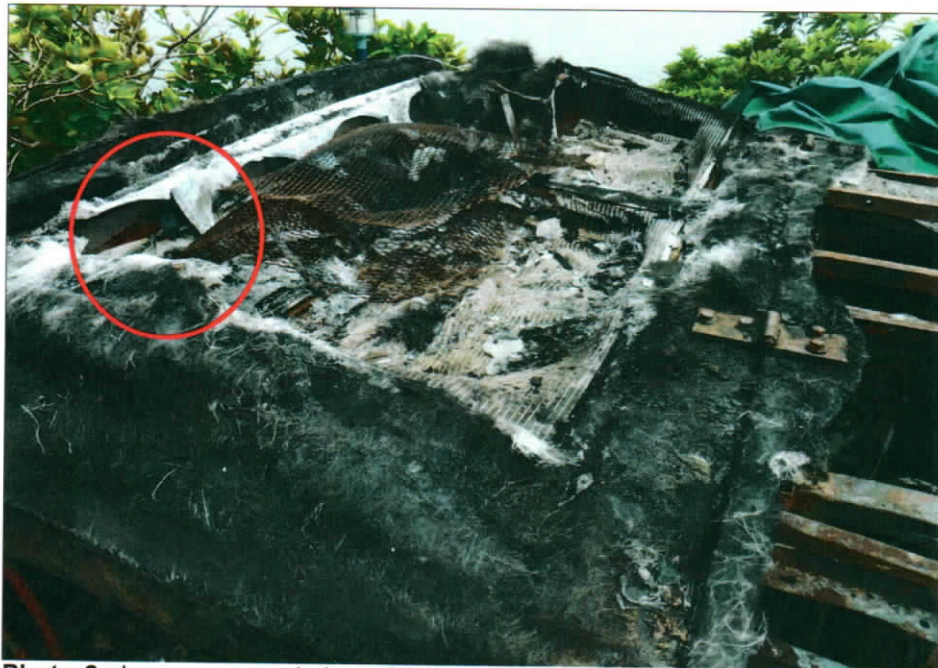
8. Upon closer examination of the rear portion of the roof of the Insured Vehicle as well as around the immediate vicinity to where the fire had likely started, we had found greenish residue on several burnt stretches of original air extractor fans and factory fitted wirings around the rear top portion of the rear air extractor unit. The presence of such greenish residue indicates internal heating of copper wires, a sign of an electrical short circuit occurring. The greenish residue is normally left behind from oxidation as a result of chemical reaction involving the copper wires. This physical evidence would then appear to suggest that the cause of fire to the Insured Vehicle could have possibly been due to electrical in nature. See photos 8 - 11 below.

Photo 8 shows a general view of the rear roof portion of the air extractor unit of the Insured Vehicle. Upon closer examination, we had found greenish residue on several burnt stretches of original extractor fan and factory fitted wirings around the rear roof portion of where the air extractor unit is located with (circled).

29. Having investigated and technically analysed the damages of burnt nature to the Insured Vehicle, we are of the view that the cause of fire to the Insured Vehicle was of electrical in nature. For this particular case, the fire had originated along the factory fitted wirings of original air extractor unit in the rear roof portion of the Insured Vehicle.

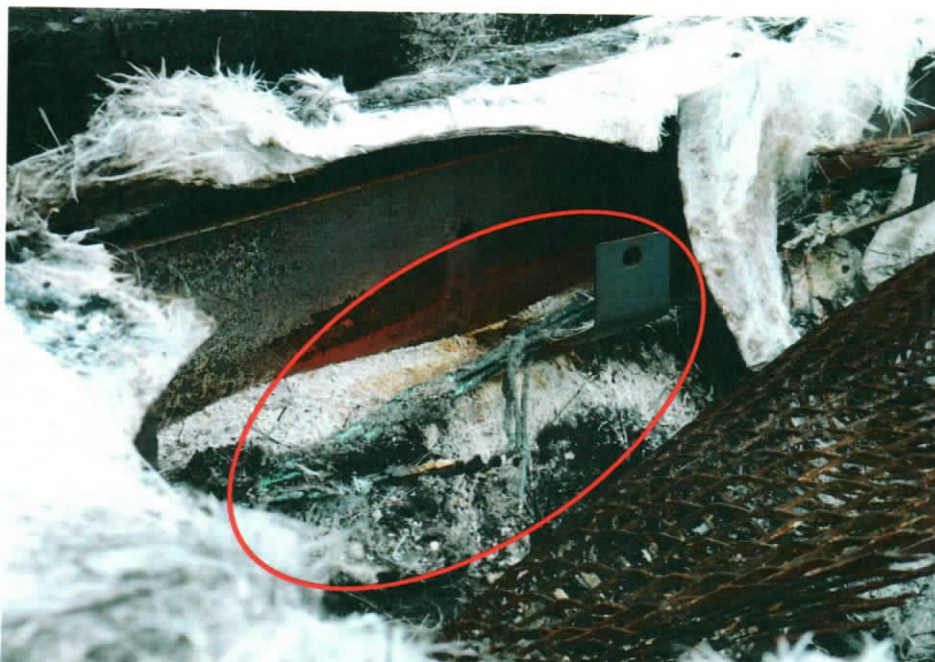
Photo 9 shows a close up view of the greenish residue found on several burnt stretches of original factory fitted wirings, around the rear roof portion of the air extractor unit (circled) of the Insured Vehicle. The presence of such greenish residue indicates internal heating of copper wires, a sign of an electrical short circuit occurring. The greenish residue is normally left behind from oxidation as a result of chemical reaction involving the copper wires.

26. The possibility of the fire being due to electrical in nature would then seem more likely given that engine overheating and external factors would both seem unlikely. The fire being due to electrical nature is also supported by the condition of the wirings that were found leading from the original air extractor unit and the factory fitted wirings to the electrical components on the Insured Vehicle, which was earlier discussed in paragraph 8 above.

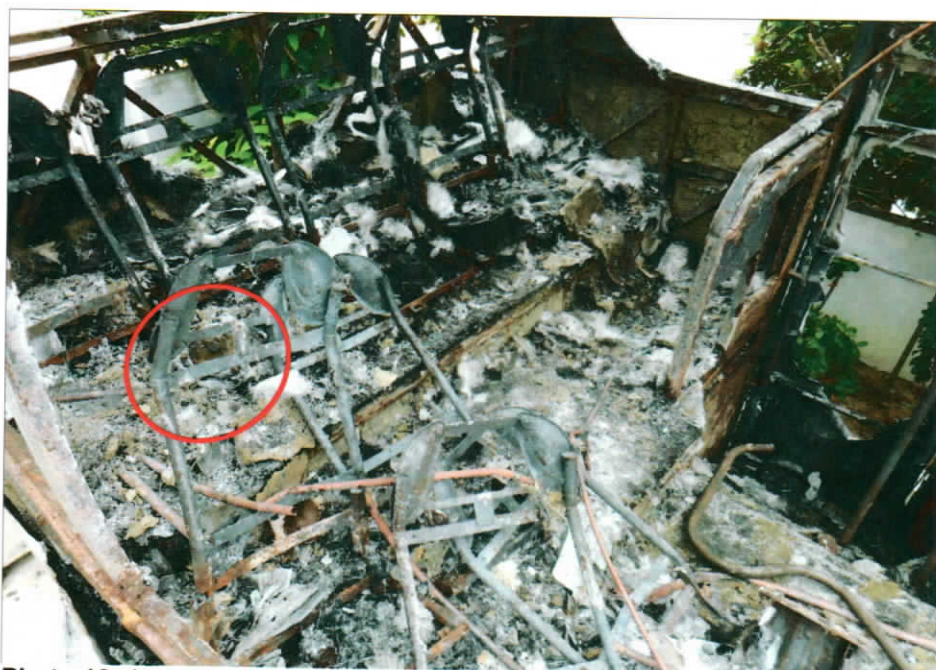
Photo 10 shows a general view of the interior portion. Observed the fan of the air extractor unit from the Insured Vehicle had fallen into the interior portion. Upon closer examination, we had found greenish residue on several burnt stretches of original extractor fan and factory fitted (circled).

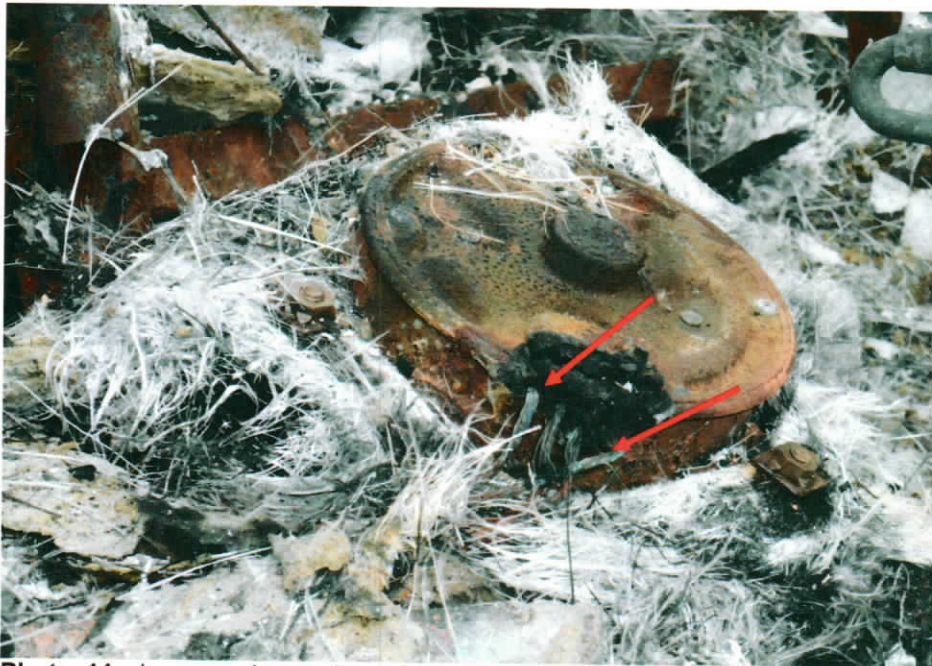
Photo 11 shows a closer view of the fallen original extractor fan from the air extractor unit, greenish residue was found on factory fitted wirings of the air extractor fan (arrowed) of the Insured Vehicle. This seems to suggest the occurrence of an electrical short circuit.

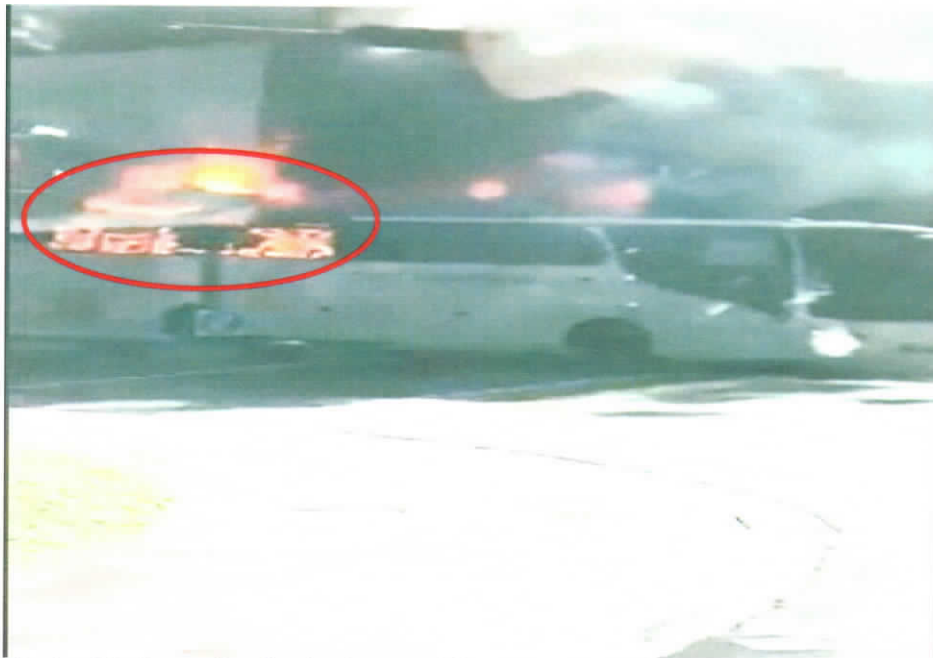
23. We were able to obtain photographs taken of the incident location. The photographs were taken during the fire to the Insured Vehicle.
24. Our examination of the photograph revealed that the fire had started from the rear roof portion and not from the engine compartment of the Insured Vehicle at the material time of incident. The photographs had also showed the Insured Vehicle on fire and similar extent of damage and burn pattern to the Insured Vehicle as per what we had observed during our physical inspection of the Insured Vehicle. Apart from the aforesaid, there was no further notable information that could be gathered from these photographs. See photos 12- 13 below.

Photo 12 shows the fire had started from the rear roof portion (circled) of the Insured Vehicle at the material time of incident. The photographs had also showed the Insured Vehicle on fire and similar extent of damage and burn pattern to the Insured Vehicle as per what we had observed during our physical inspection of the Insured Vehicle.

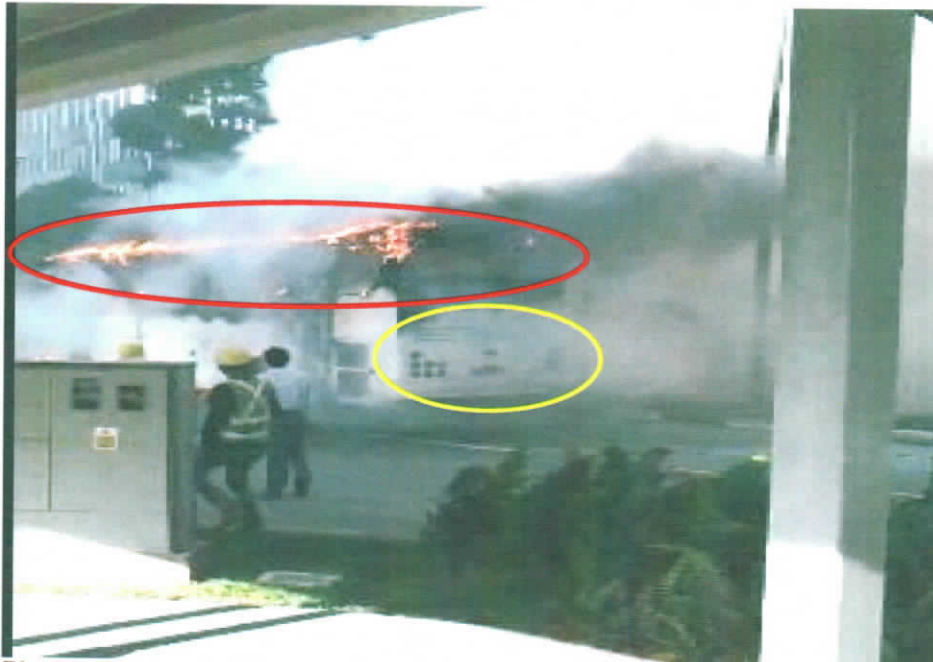
Photo 13 shows the fire had started from the rear roof portion of the Insured Vehicle and spread to the rest of Insured Vehicle (red circle); however the engine portion was not affected (yellow circle) at the material time of incident. The photographs had also showed the Insured Vehicle on fire and similar extent of damage and burn pattern to the Insured Vehicle as per what we had observed during our physical inspection of the Insured Vehicle.
