Your Ref: D20001218MFSH
Our Ref : CS/FCI120003537/P

9th March 2020

M/s First Capital Insurance Pte. Ltd.
36 Robinson Road #16-01
City House
Singapore 068877
(Motor Claims Department)

TECHNICAL INVESTIGATION REPORT OF FIRE INCIDENT INVOLVING THE INSURED VEHICLE SHC 688E ON 25th February 2020

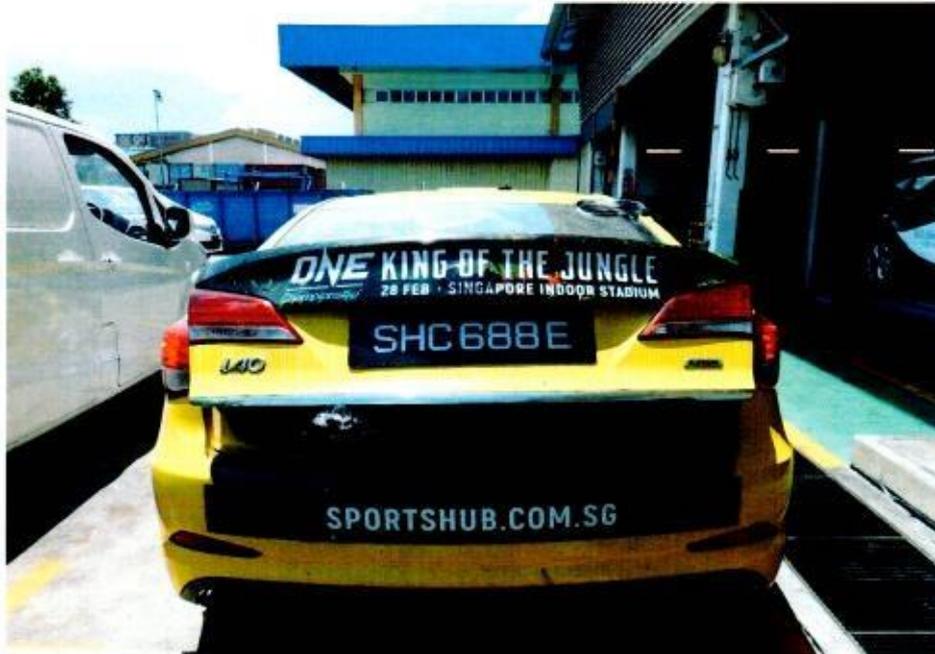
Photo 1 shows the rear portion of the Insured Vehicle, which was observed to be unaffected by the fire.

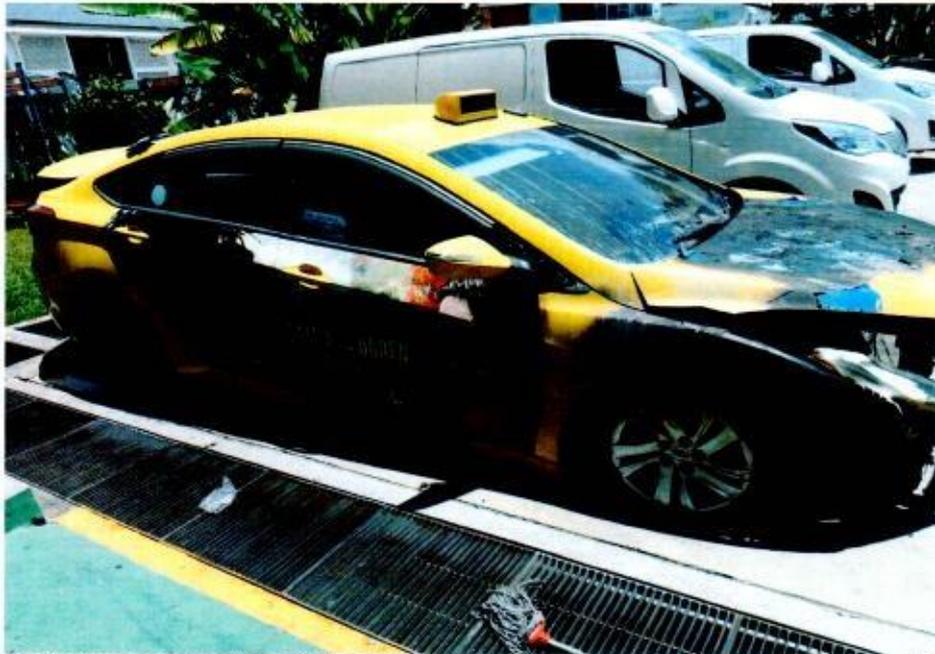
Photo 2 shows the rear right body of the Insured Vehicle, which was observed to be unaffected by the fire.

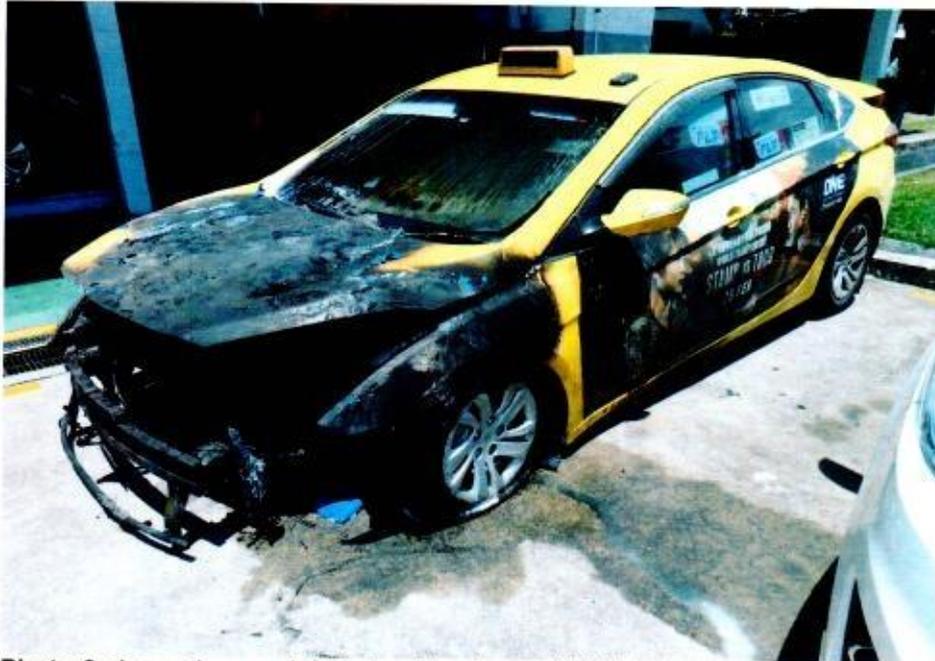
Photo 3 shows the rear left body of the Insured Vehicle, which was observed to be unaffected by the fire.

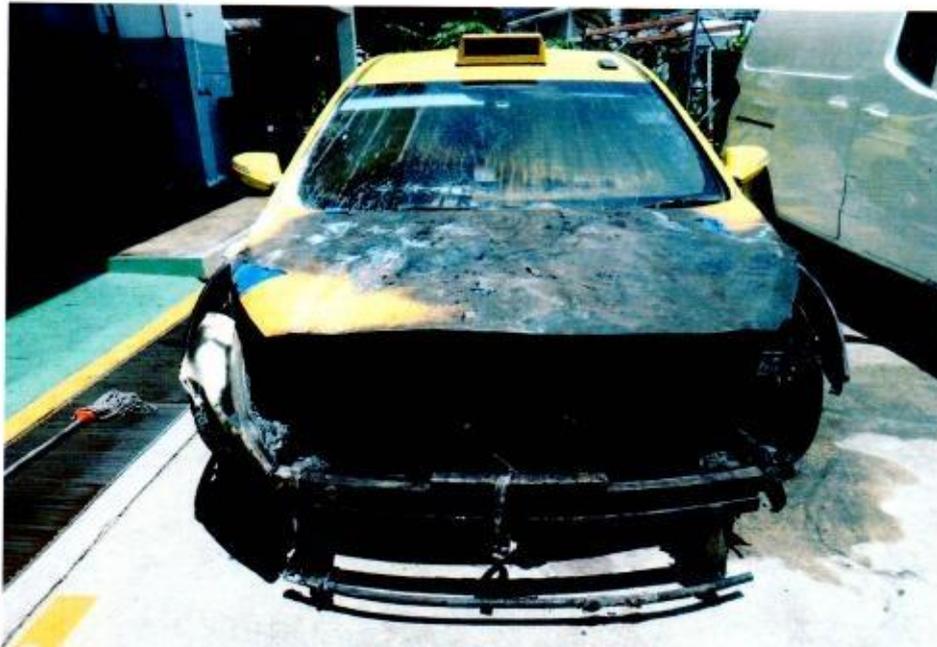
5. The Insured Vehicle was observed to have sustained severe fire damage. Its engine compartment was completely burnt and interior compartment had sustained heat and smoke damage. Rust had accumulated around the engine compartment of the Insured Vehicle as a result of exposure to environmental condition for a period of time. See photos 1 – 6 below.

Photo 4 shows the general view of the front portion of the Insured Vehicle at the time of our inspection. The Insured Vehicle was observed to have sustained severe fire damage. Its engine compartment was completely burnt. Rust had accumulated around the engine compartment of the Insured Vehicle as a result of exposure to environmental condition for a period of time.

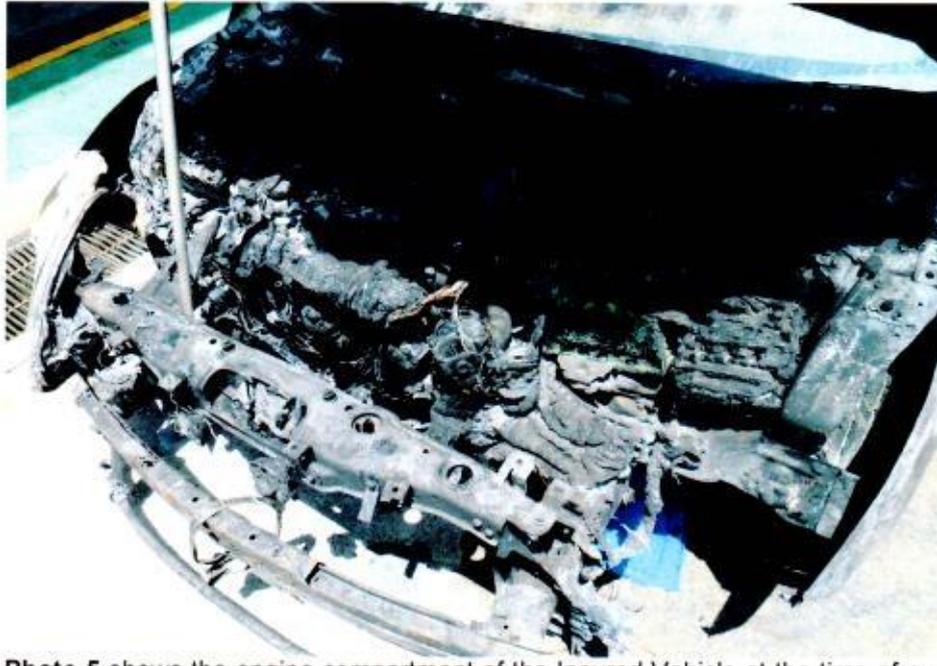
Photo 5 shows the engine compartment of the Insured Vehicle at the time of our inspection. The entire engine compartment of the Insured Vehicle was observed to be severely burnt. Most of the parts inside the engine compartment were found to be burnt and/or melted as a result of the fire.

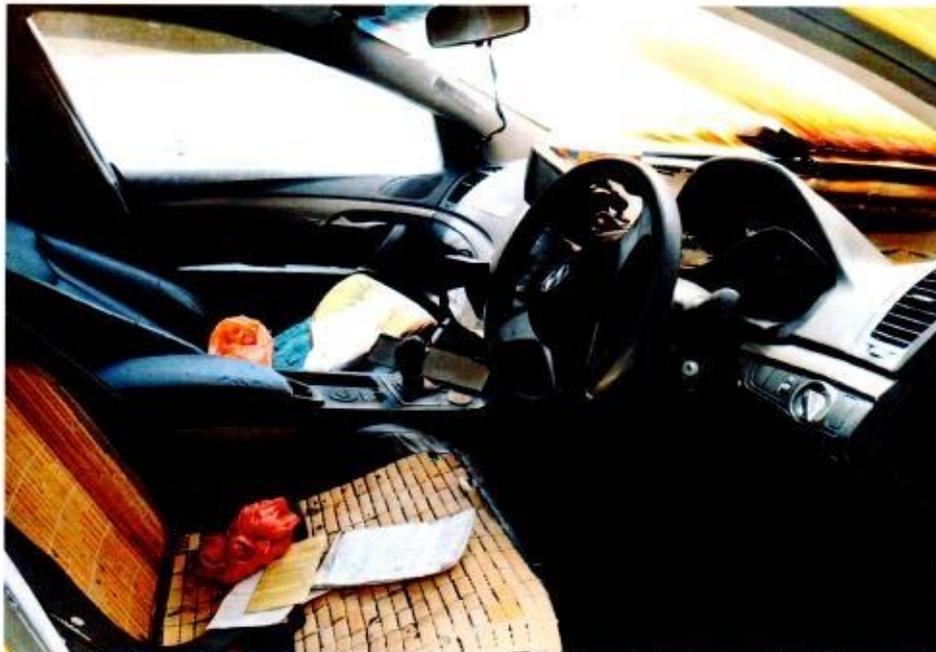
Photo 6 shows the interior view from the right side of the Insured Vehicle at the time of our inspection. The interior of the Insured Vehicle was observed to be affected by heat & smoke damage as the result of the fire.

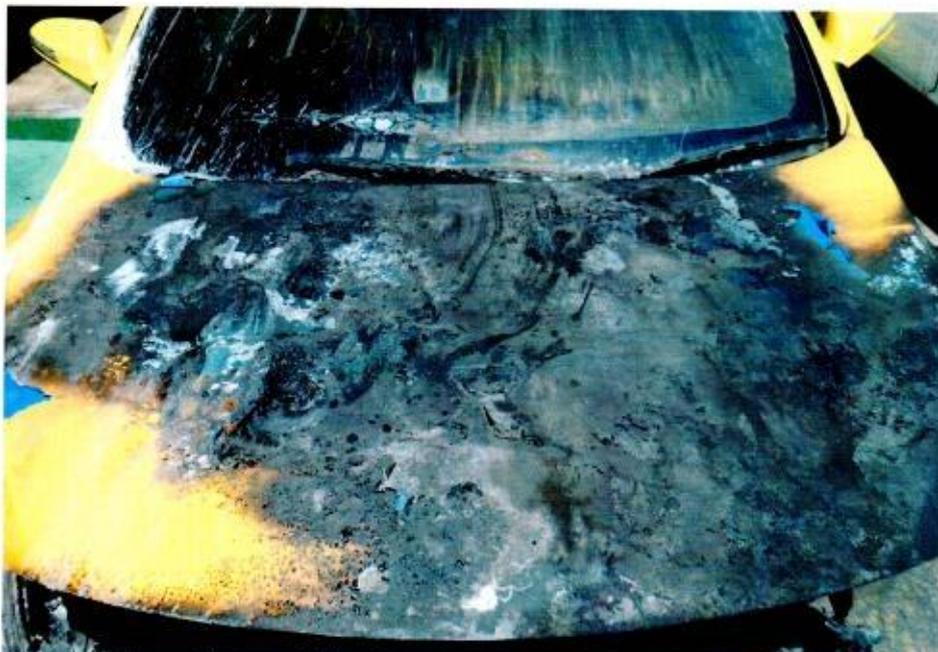
7. For this particular case, the fire appears to have originated from the left portion of the engine compartment of the Insured Vehicle. This can be determined from the burn pattern of the various components in the engine compartment, which were observed to have been partly melted and burn from the high heat intensity and the high heat intensity burn marks (whitish burn marks) found on the metal parts around the Insured Vehicle. Rust had also developed on these metal parts.

8. The whitish burn marks are a result of exposure to prolonged heat intensity. Rust would normally start to develop around these areas soon after a fire as prolonged exposure to high heat intensity usually causes steel/metal material body parts to be exposed to natural environmental condition. The rust that had developed on the metal brackets is an indication that the front right position of the Insured Vehicle had sustained exposure to prolonged high heat intensity. See photos 7 & 8 below.

Photo 7 shows the top of the front bonnet cover of the Insured Vehicle at the time of our inspection. The high heat intensity burn marks (whitish burn marks) and rust that had development found on the exterior surface of the bonnet indicates that the fire had originated from the engine compartment of the Insured Vehicle.

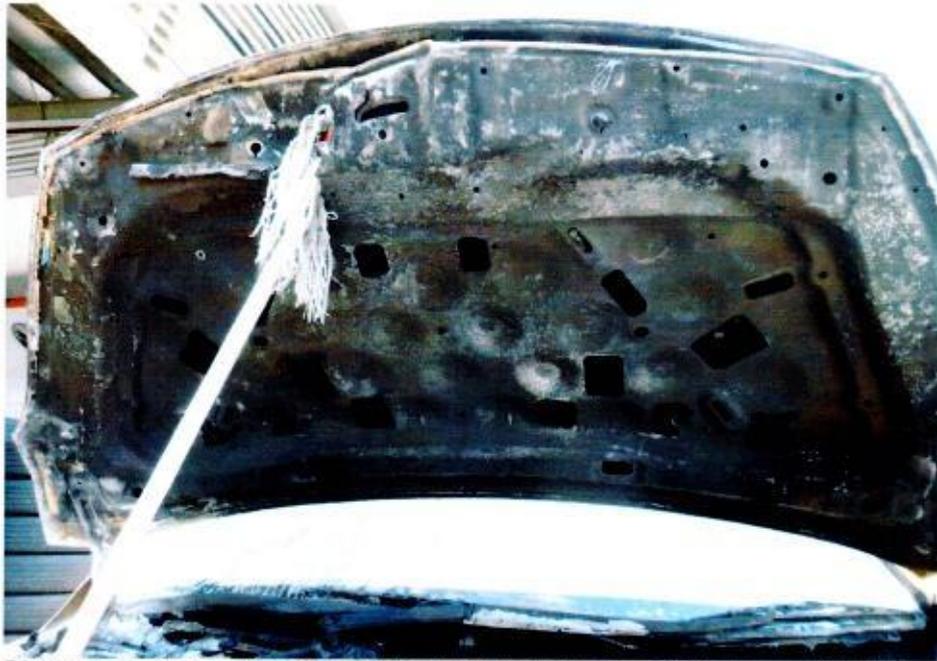
Photo 8 shows the underside of the front bonnet cover of the Insured Vehicle at the time of our inspection. The High heat intensity burn marks (whitish burn marks) and rust that had development found on the exterior surface of the bonnet indicates that the fire had originated from the engine compartment of the Insured Vehicle.

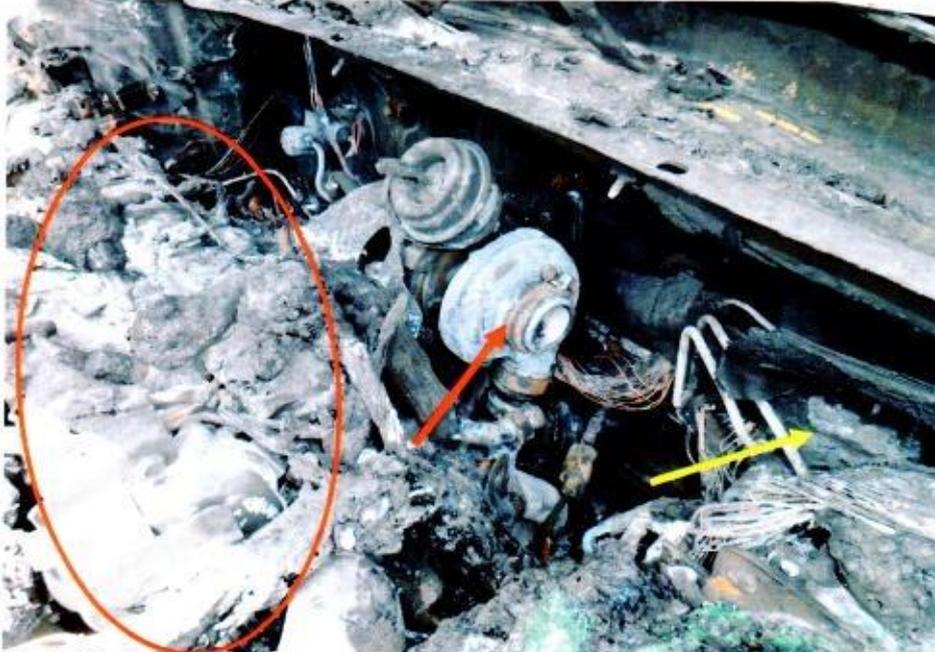
9. Upon closer examination of the engine compartment of the Insured Vehicle which was where the fire had started, we had found traces of greenish residue on the wirings leading from the battery terminal harnesses to the electrical components. The wirings were original wirings fitting from manufacturer. The presence of greenish residue indicates internal heating of copper wires, a sign of an electrical short circuit occurring. The greenish residue is normally left behind from the oxidation as a result of chemical reaction involving the copper wires. This physical evidence would then appear to suggest that the cause of fire to the Insured Vehicle could have possibly been due to electrical in nature. See photos 9 - 11 below.

Photo 9 shows the close up view of the front engine compartment portion of the Insured Vehicle at the time of our inspection. The fire damage to the Insured Vehicle was confined to its engine compartment portion and. Its engine valve cover (circled), turbocharger (red arrow) abs pump (yellow arrow) and original wiring harnesses was amongst the parts in the compartment that were found to have been affected as a result of the fire.

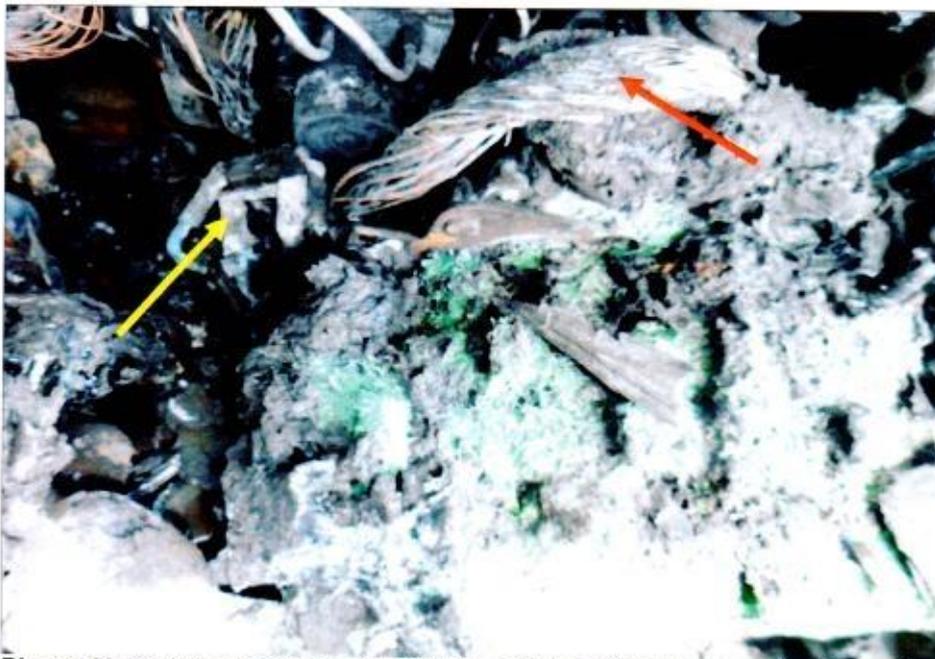
Photo 10 shows a general view of the original wiring harness in the engine compartment. The battery terminal harness (yellow arrow) and the original wiring harness (red arrow) were observed with greenish residue on the surface. The presence of greenish residue indicates internal heating of copper wires, a sign of an electrical short circuit occurring. The greenish residue is normally left behind from oxidation as a result of chemical reaction involving the copper wires.

23. The possibility of the fire being due to electrical in nature would then seem more likely given that engine overheating and external factors would both seem unlikely. The fire being due to electrical nature is also supported by the condition of the wirings that were found leading from the battery terminal harness to the electrical components on the Insured Vehicle, which was earlier discussed in paragraph 9 above.

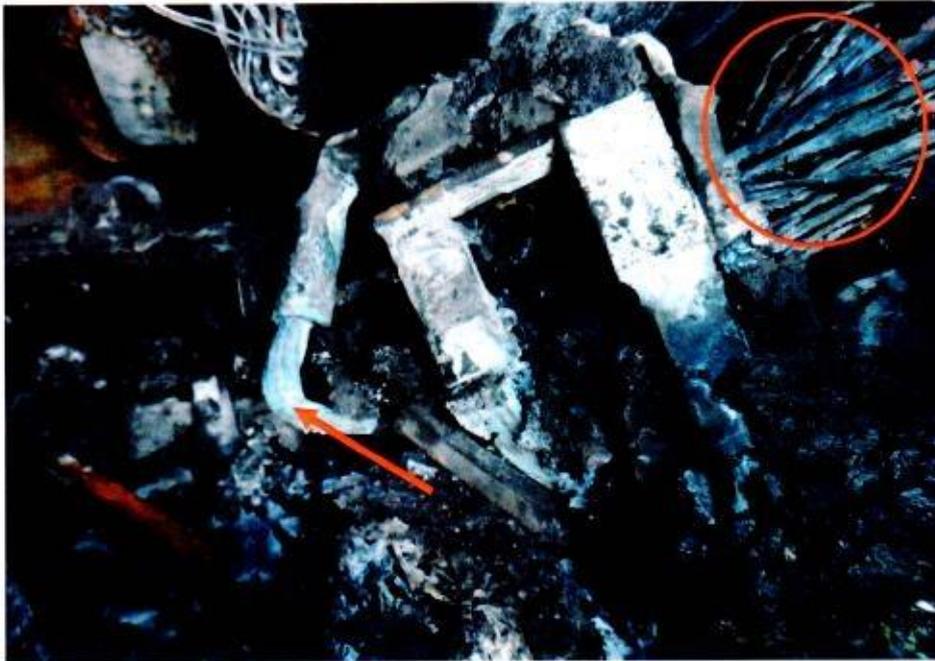
Photo 11 shows a close up view of the original wiring harness in the engine compartment. The battery terminal harness (arrowed) and original wiring harness (circled) was observed with greenish residue on the surface. The presence of greenish residue indicates internal heating of copper wires, a sign of an electrical short circuit occurring. The greenish residue is normally left behind from oxidation as a result of chemical reaction involving the copper wires.

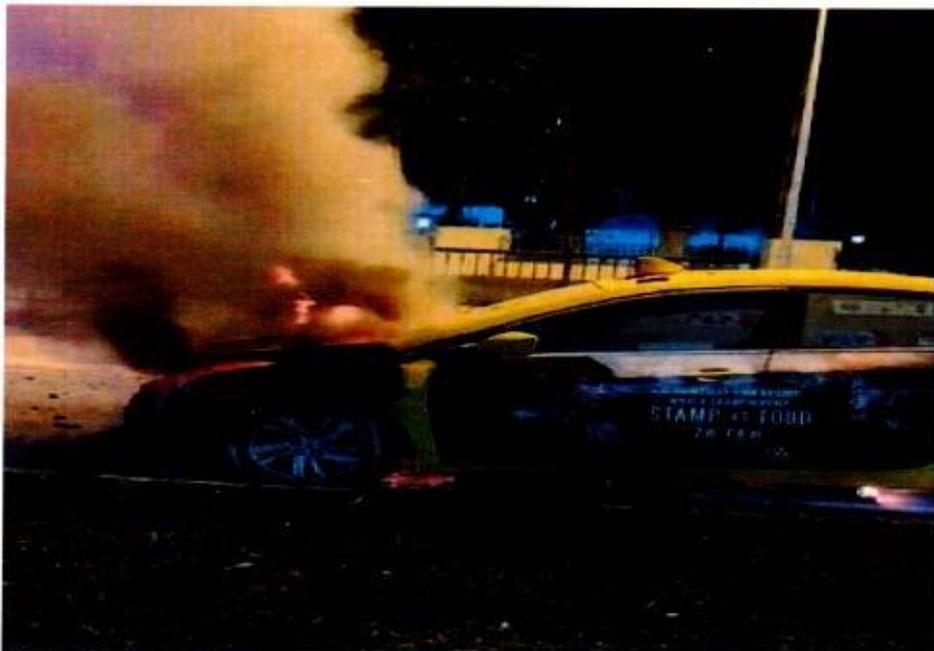
Photo 12 shows the smoke and flames emitting from the front and undercarriage of the Insured Vehicle before the arrival of the SCDF. In general, the information that could be gathered from this photograph had corresponded to the events that were related to us by Mr Wong, location when the fire broke out.

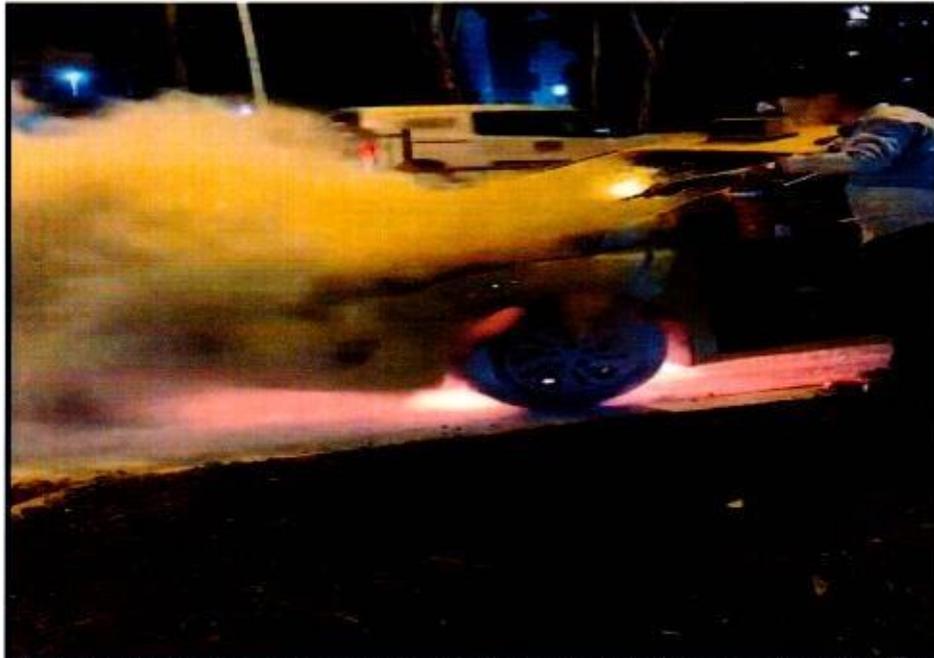
Photo 13 shows members of public in attempt to put of the fire at the front and undercarriage of the Insured Vehicle before the arrival of the SCDF. In general, the information that could be gathered from this photograph had corresponded to the events that were related to us by Mr Wong, location when the fire broke out.

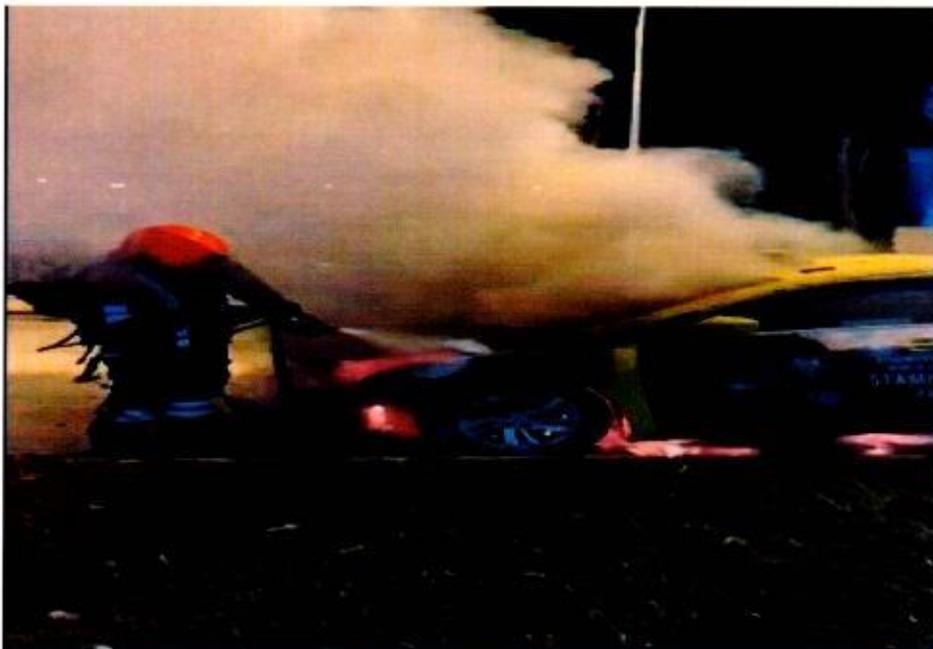
Photo 14 shows the Insured Vehicle at the incident location as the fire was extinguished by SCDF personnel. In general, the information that could be gathered from this photograph had corresponded to the events that were related to us by Mr Wong, location when the fire broke out.
