LKK Auto Consultants Pte Ltd

Insured Veh.	GBH 5693B	Veh. Inspected	SLA 2691U
Policy No.		Coverage (\$)	0.00
Claim No.	SNM20D201163	Excess (\$)	0.00
Assign From		Assign Date	03/03/2020

Make & Model	HYUNDAI ELANTRA	c.c	1591
Engine No.	HIDDEN	Year of Reg.	2016
Chassis No.	KMHDH41CMGU656783	Colour	BLUE
Odometer	67514	Steering	IN ORDER
Brakes	IN ORDER	Modification	SPORTS RIM
General	GOOD

ADJUSTMENT ON REPAIR COST FOR VEHICLE NO. SLA 2691U

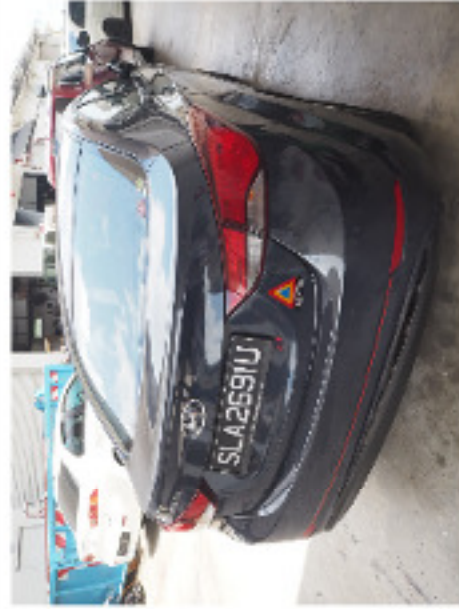
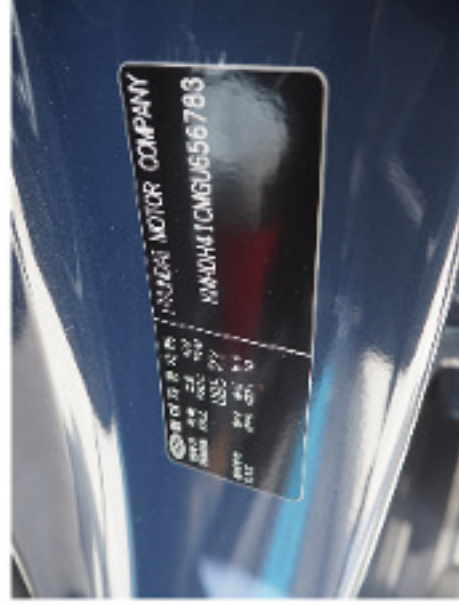
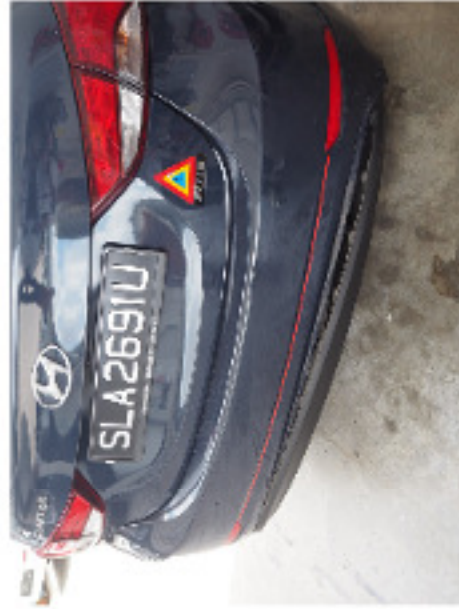
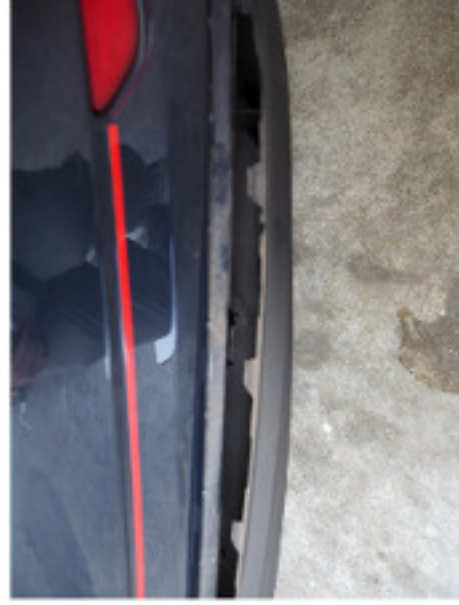
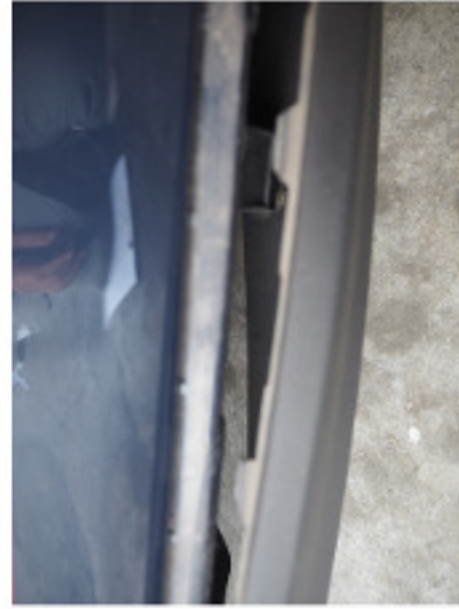
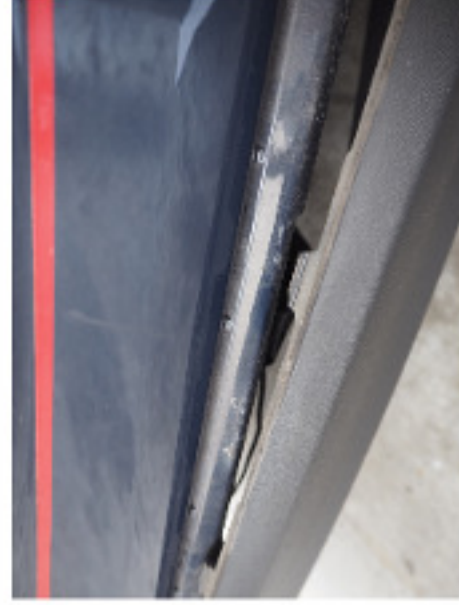
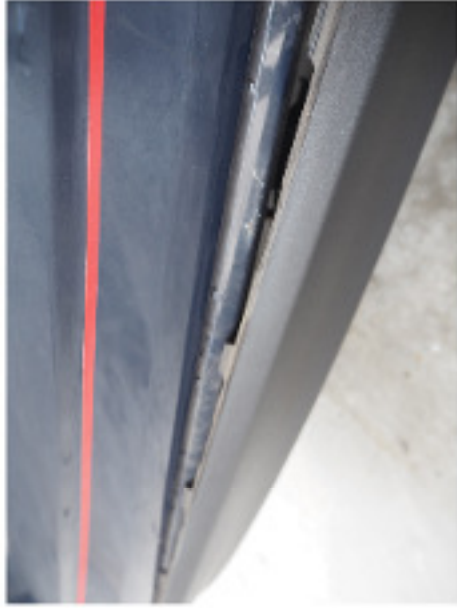
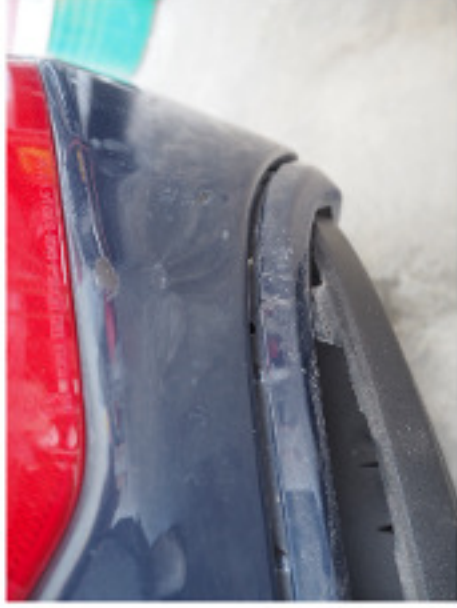
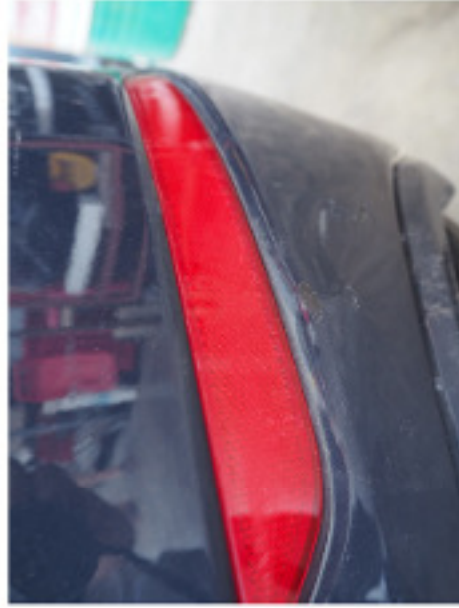
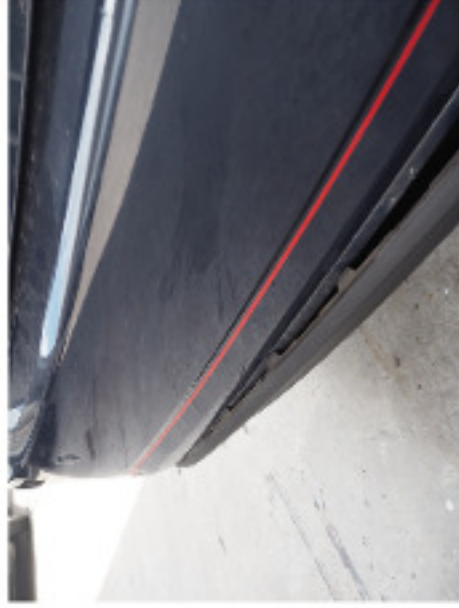
INSPECTION

THE VEHICLE SUSTAINED DAMAGES AT THE REAR PORTION. DAMAGES SEE DETAILS.
