Your Ref: TP/IP/9655/2019
Our Ref : CI/TPD20003589/P

Fatal Accident Investigation Team

MECHANICAL INSPECTION REPORT OF MINI BUS PA 5844D

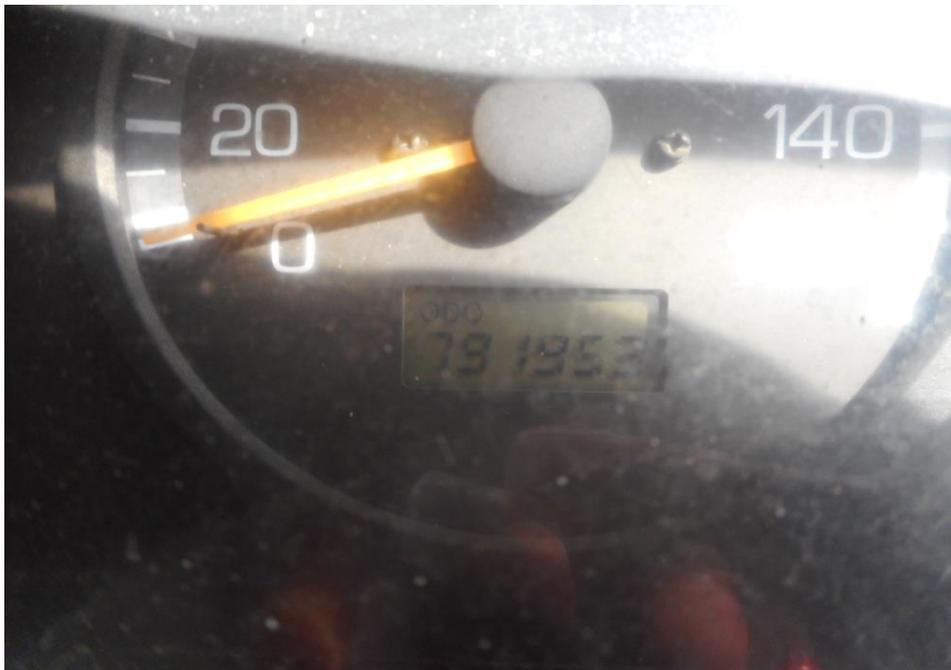
4. The mileage of the Mini Bus at the time of my inspection was 791,952km.
5. The Mini Bus was observed to have sustained damage at its front portion. Its front windscreen and front body panel were amongst the body parts that were damaged as a result of the accident.

Photo 1 shows a general view of the instrument cluster of the Mini Bus at the time of my inspection. The mileage of the Mini Bus was 791,952km

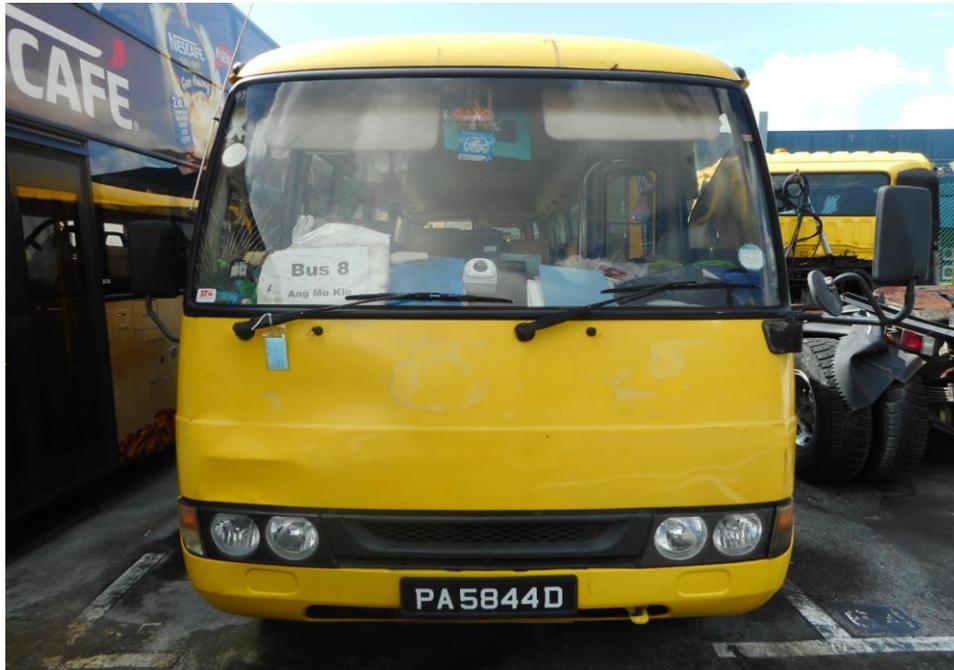
Photo 2 shows a general view of the Mini Bus front body at the time of my inspection. The Mini Bus was observed to have sustained damage at its frontal portion. Its front windscreen and front body panel were amongst the body parts that were damaged as a result of the accident.

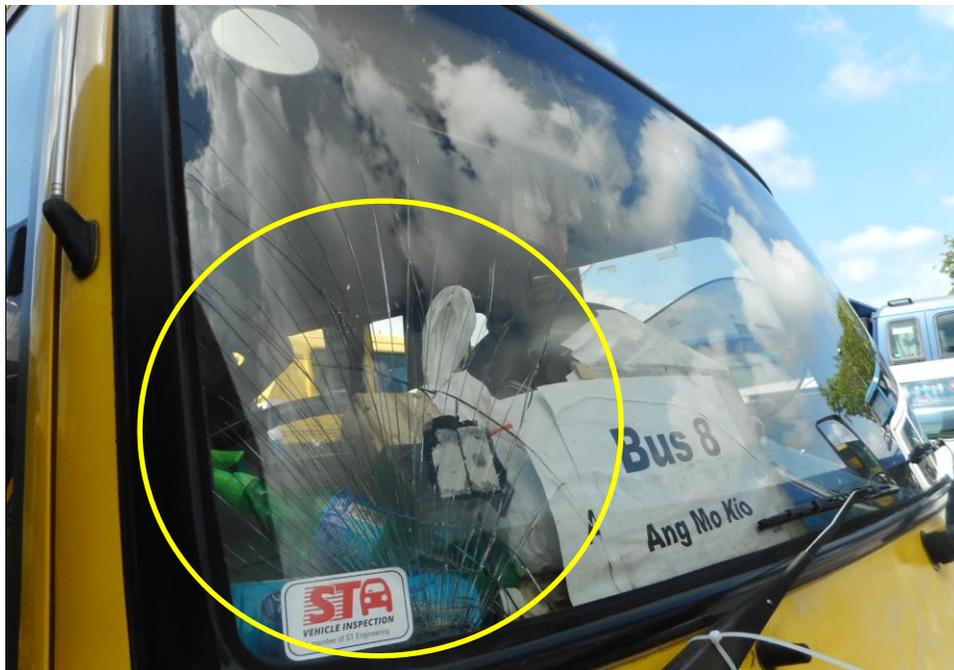
Photo 3 shows the close up view of the Mini Bus front body at the time of my inspection. The Mini Bus was observed to have sustained damage at its front windscreen (circled), as a result of the accident.

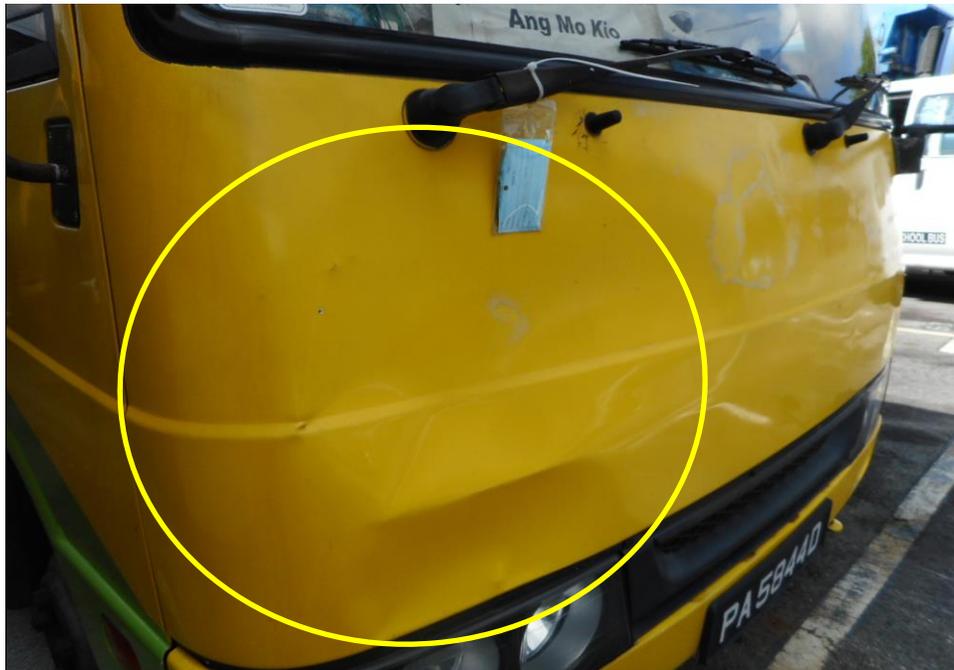
Photo 4 shows the close up view of the Mini Bus front body at the time of my inspection. The Mini Bus was observed to have sustained damage at its front body panel (circled), as a result of the accident.

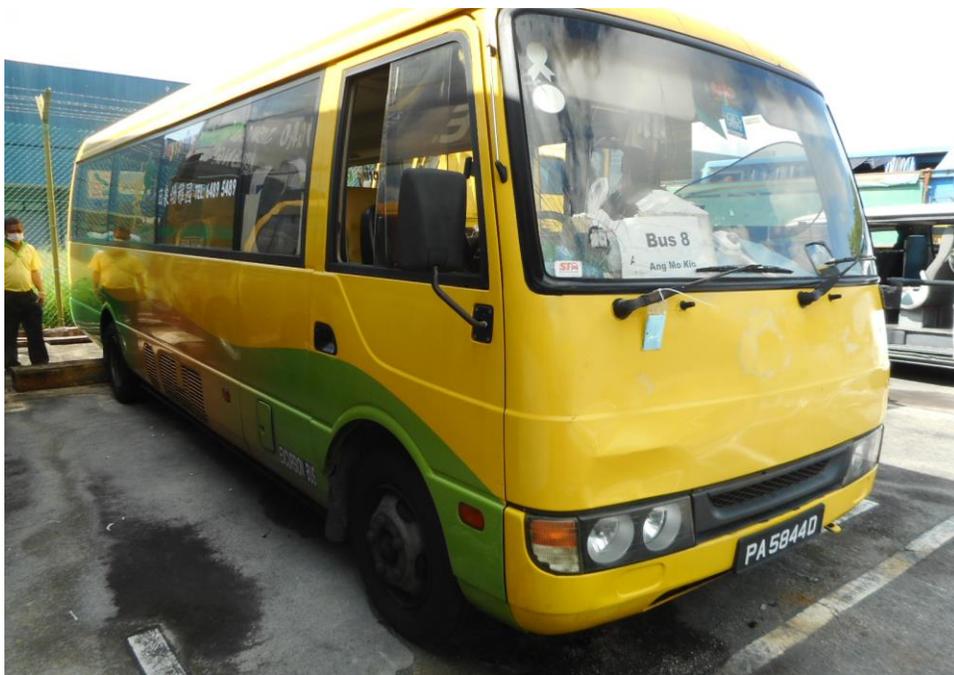
Photo 5 shows a general view of the front right body of the Mini Bus at the time of my inspection, observed to have been unaffected by the accident.

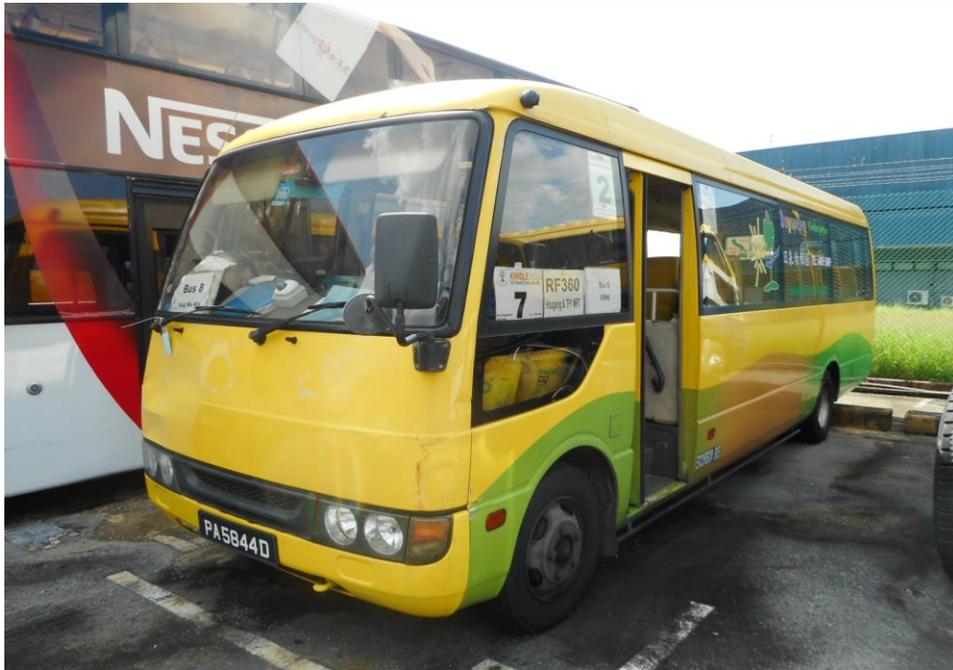
Photo 6 shows a general view of the front right body of the Mini Bus at the time of my inspection, observed to have been unaffected by the accident.

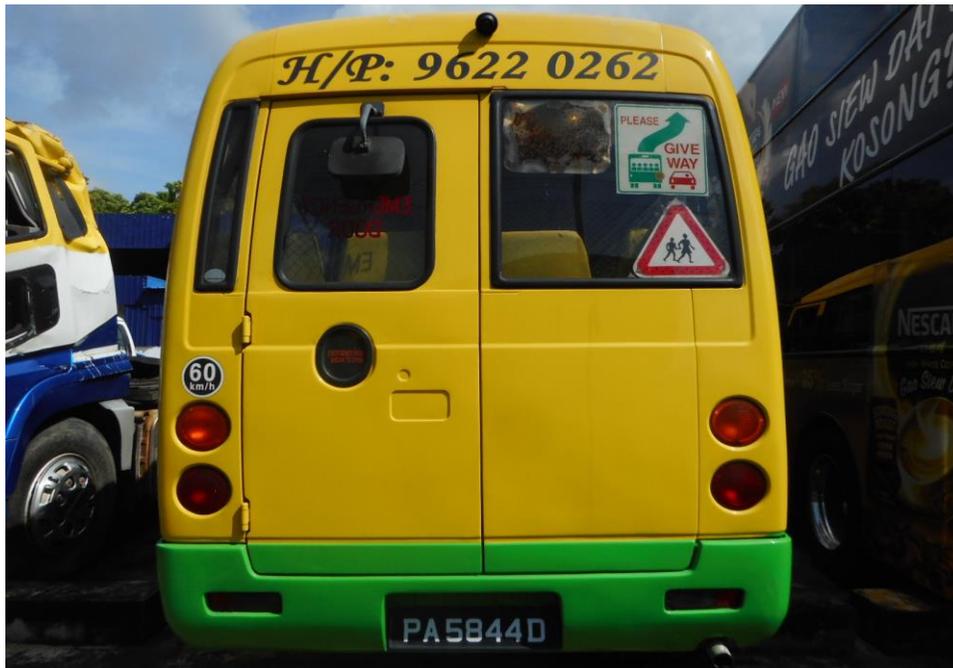
Photo 7 shows a general view of the Mini Bus's rear body at the time of my inspection. There was no damage found to the rear portion of the Mini Bus.

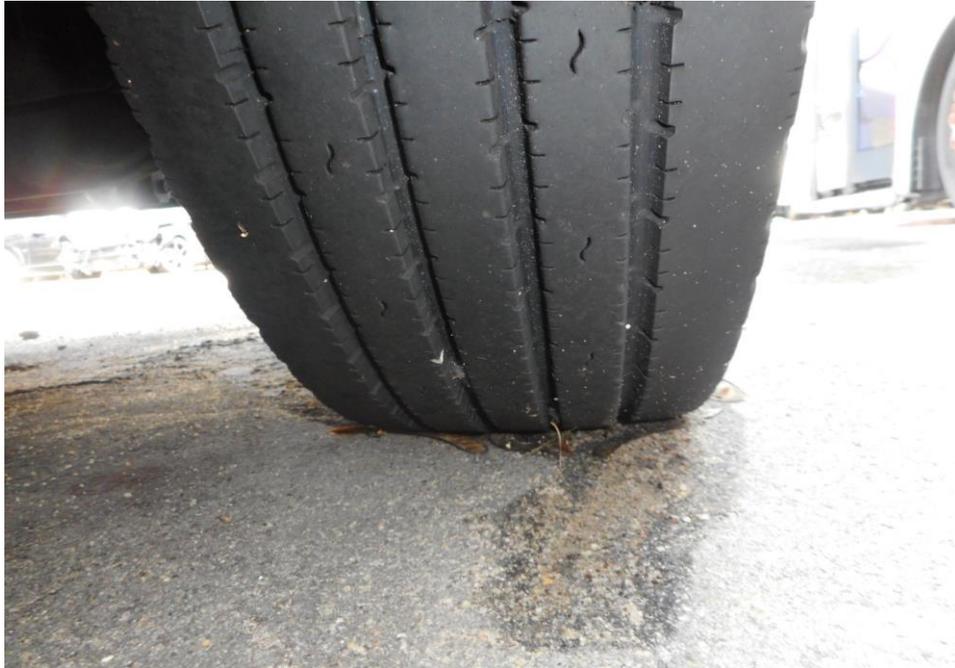
Photo 8 shows the condition of the front right tyre of the Mini Bus, which was observed to be in serviceable condition with remaining tread depth of approximately 8.1 mm. The tyre, which was wrapped around standard steel wheel rim, was also observed to be sufficiently inflated for vehicular operation. There was no tear, cut or burst mark(s) on the outer and the inner sidewalls as well as across the tread of the 6 tyres that were fitted on the Mini Bus.

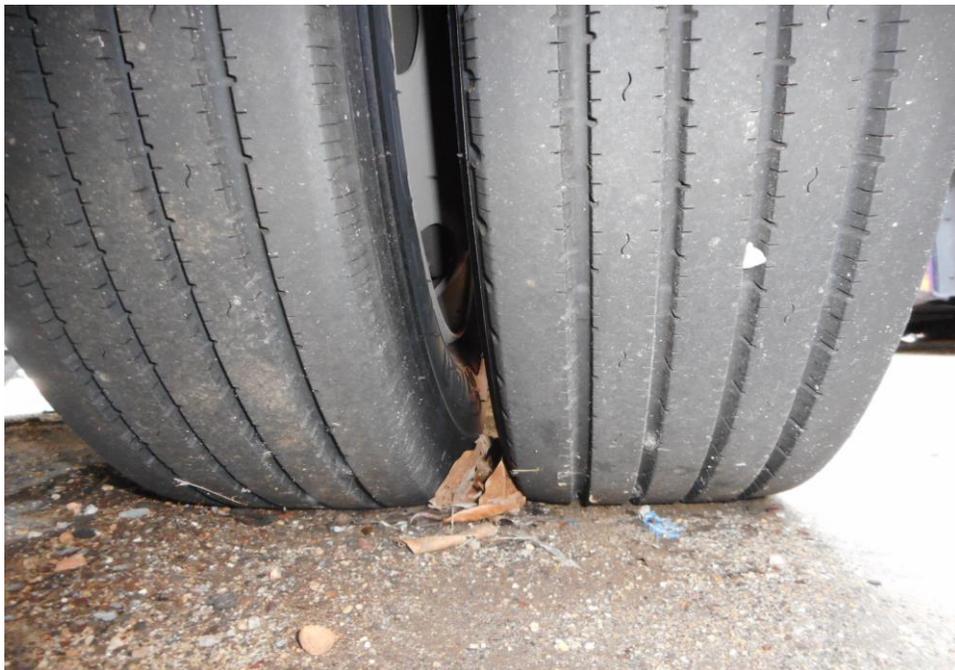
Photo 9 shows the condition of the rear right tyre of the Mini Bus, which was observed to be in serviceable condition with remaining tread depth of approximately 7.8mm. The tyre, which was wrapped around standard steel wheel rim, was also observed to be sufficiently inflated for vehicular operation.

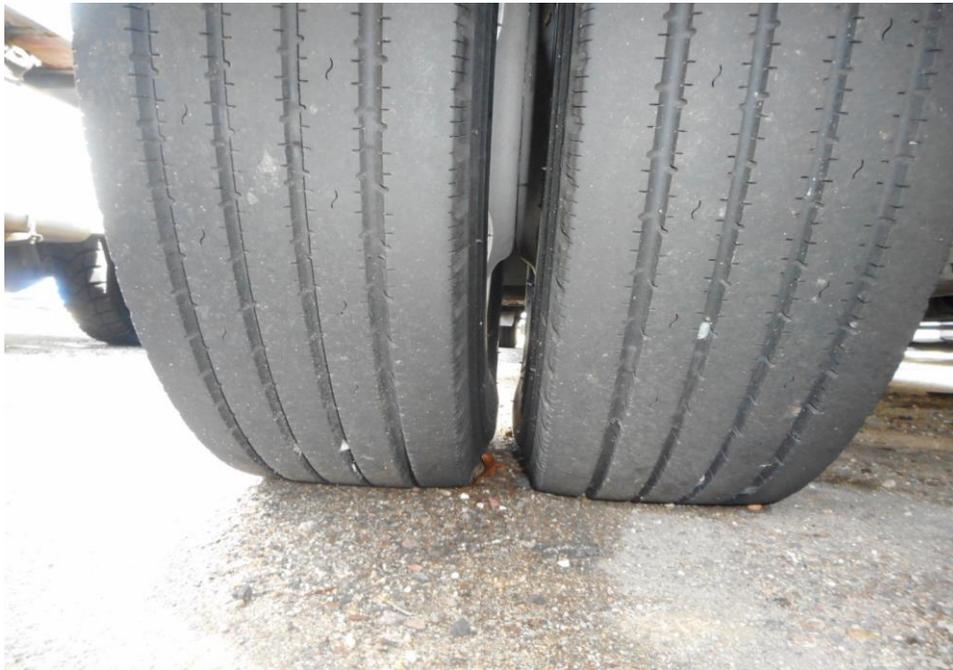
Photo 10 shows the condition of the rear left tyres of the Mini Bus, which was observed to be in serviceable condition with remaining tread depth of approximately 6.7mm. The tyres, which were wrapped around standard steel wheel rim, were also observed to be sufficiently inflated for vehicular operation. There was also no damage found on all 6 steel wheel rims of the Mini Bus.

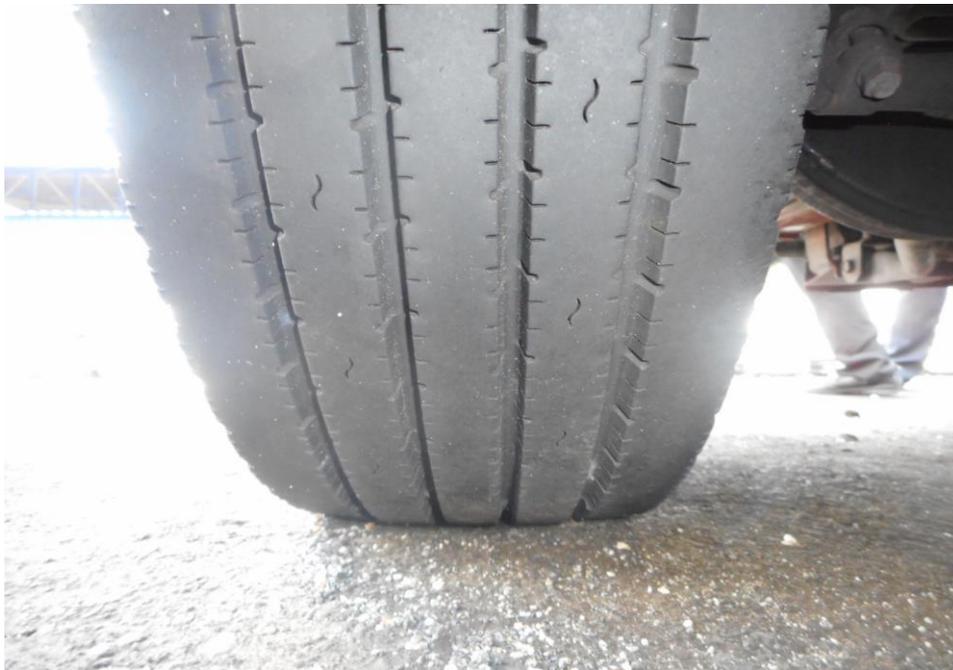
Photo 11 shows the condition of the front left tyres of the Mini Bus, which were observed to be in serviceable condition with remaining tread depth of approximately 8.5mm. There was also no tear, cut or burst mark(s) on the outer and the inner sidewalls as well as across the tread of the 6 tyres that were fitted on the Mini Bus.

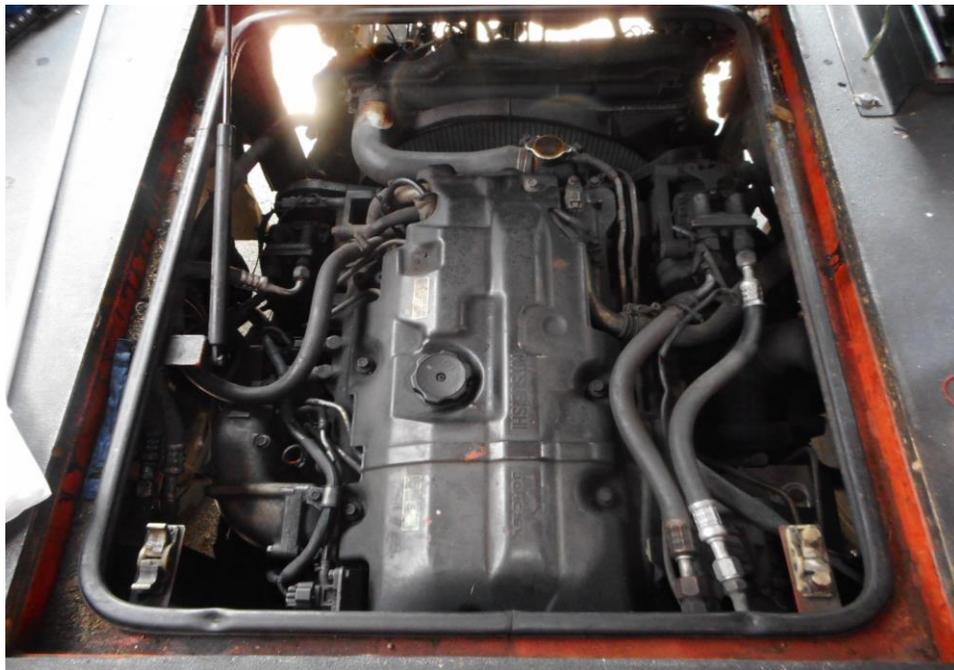
Photo 12 shows a general view of the Mini Bus's engine compartment, which was accessed by lifting the front cabin of the Mini Bus. The various parts and components inside the engine compartment were unaffected by the accident. There was also no sign(s) or indication(s) of fresh fluid leakage and/or fluid stain within the engine compartment

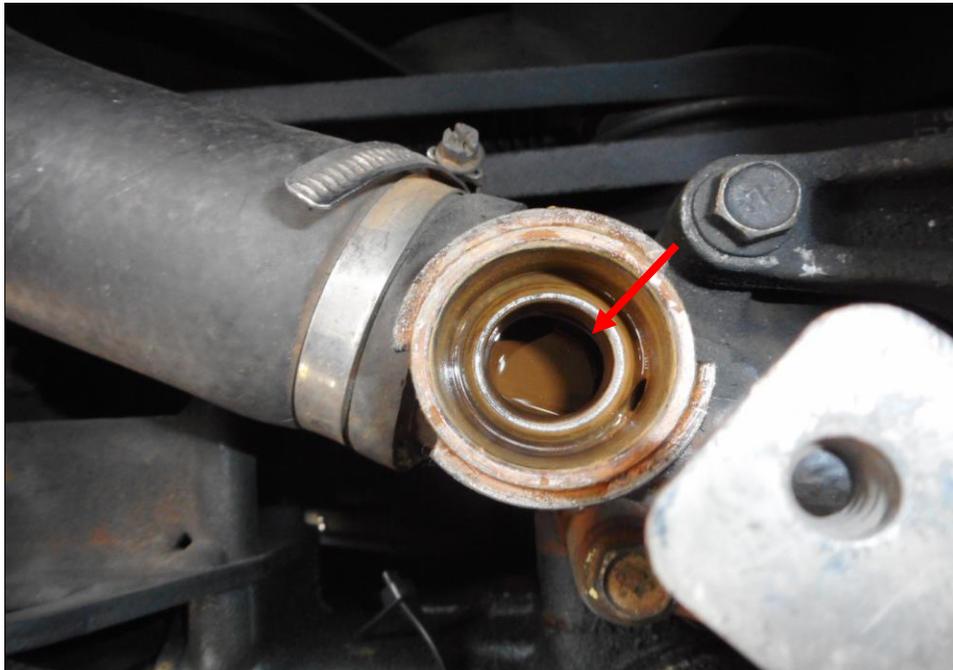
Photo 13 shows the engine coolant reservoir of the Mini Bus at the time of my inspection. The engine coolant was observed to be of sufficient level (arrowed) and without any visible contamination.

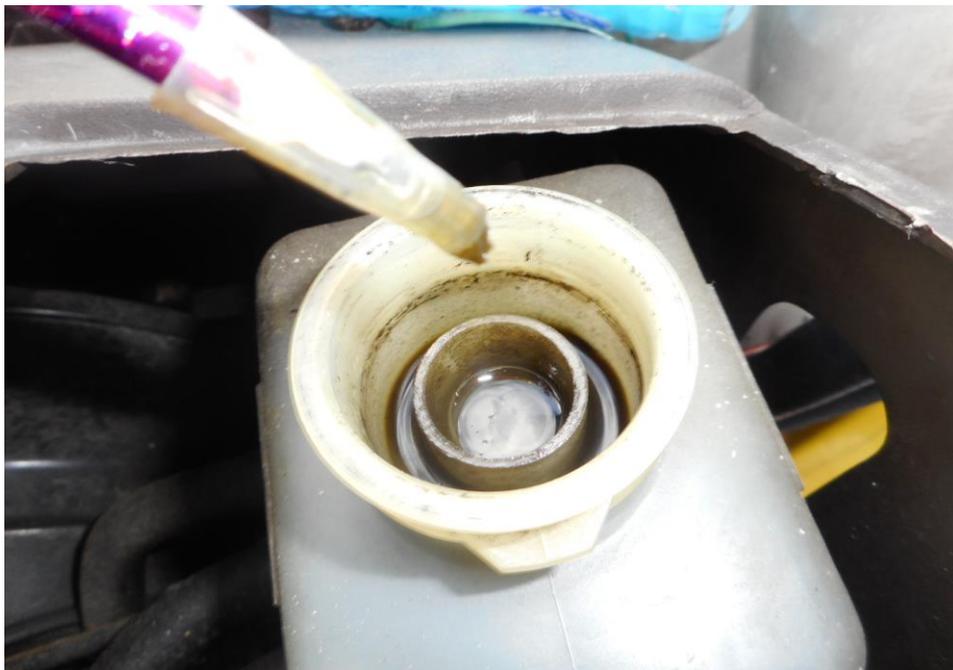
Photo 14 shows the brake fluid reservoir of the Mini Bus at the time of my inspection. The brake fluid was observed to be of sufficient level and without any visible contamination.

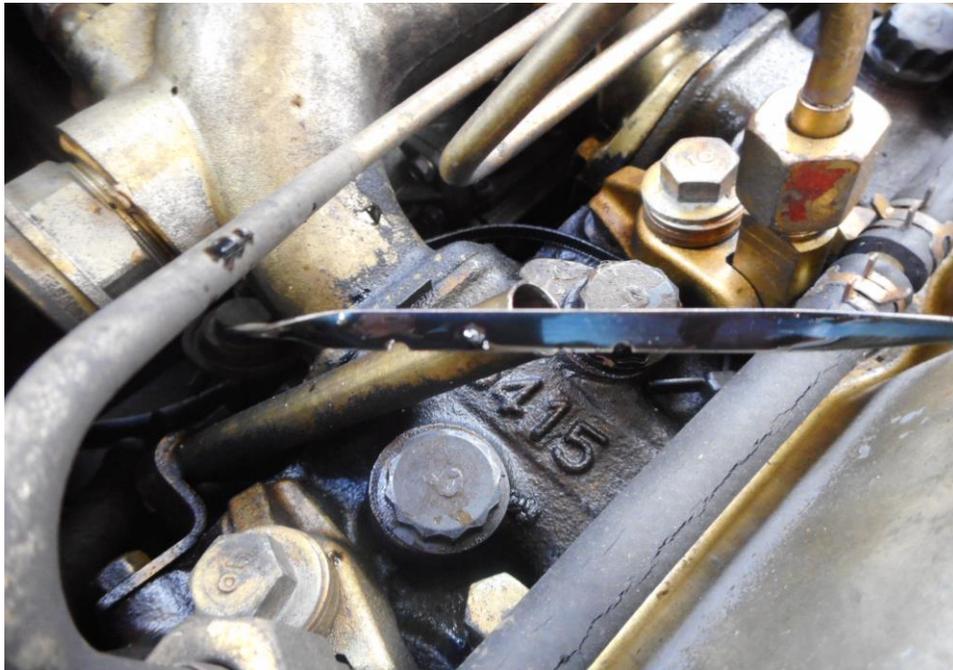
Photo 15 shows the engine oil level display of the Mini Bus at the time of my inspection. The engine oil was observed to be of sufficient level.

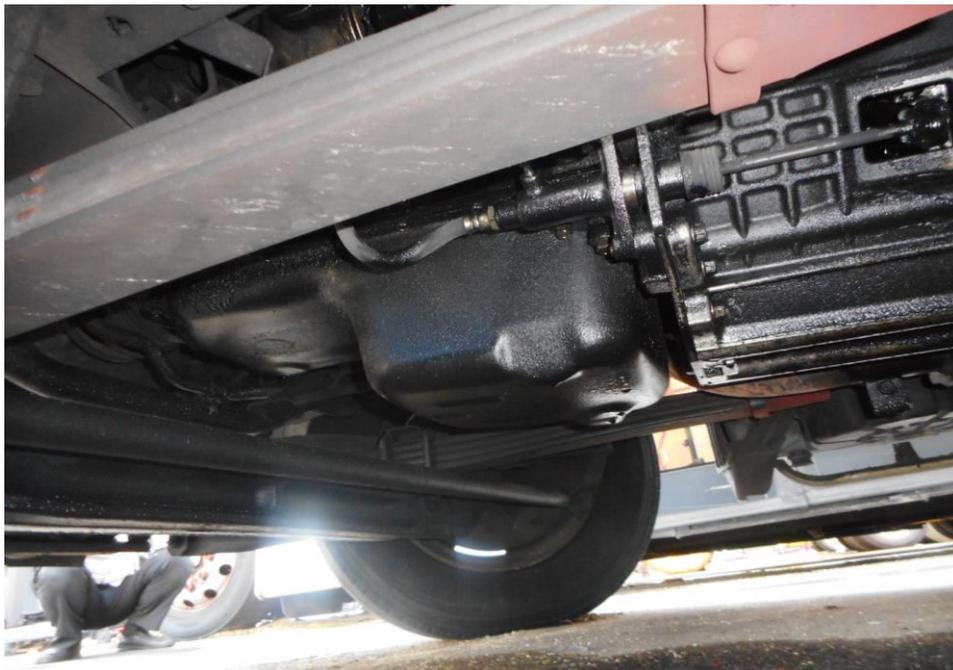
Photo 16 shows the undercarriage of the Mini Bus, at the area where the engine housing located. I did not find any sign(s) or indication(s) of fluid leak and/or fluid stain(s) on the underside of the Mini Bus.

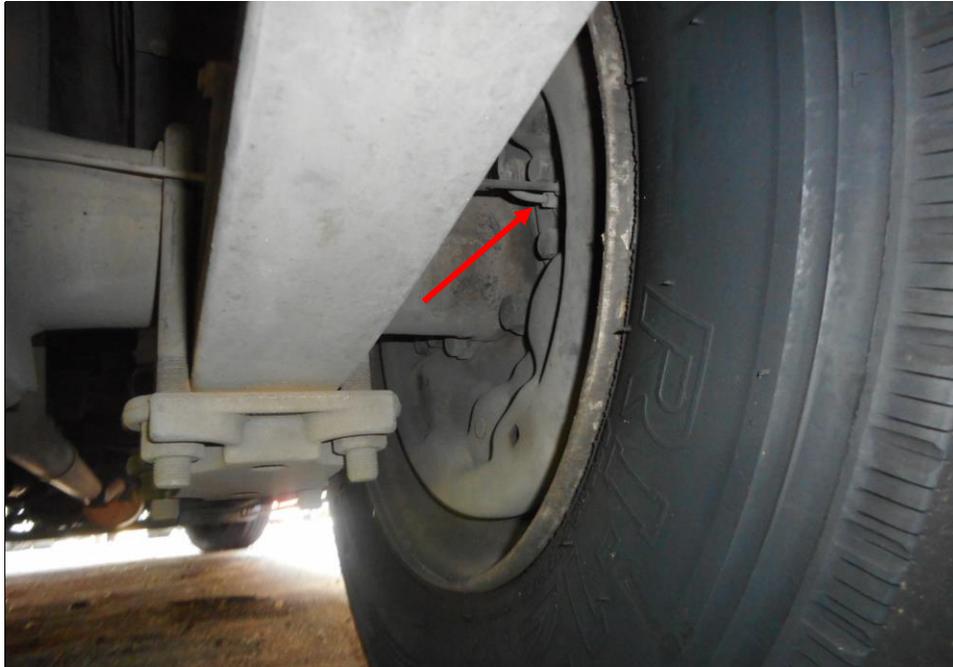
Photo 17 shows the brake pipe (arrowed) at the rear right wheel of the Mini Bus. I did not observe any leakage of brake fluid at the time of my inspection of the Mini Bus. My static tests of the Mini Bus's braking system, along with my visual examination of the various mechanical components in the braking system, had indicated that there was no internal leakage of pressure/vacuum. Hence the braking system of the Mini Bus was likely to be in serviceable condition at the material time of accident.

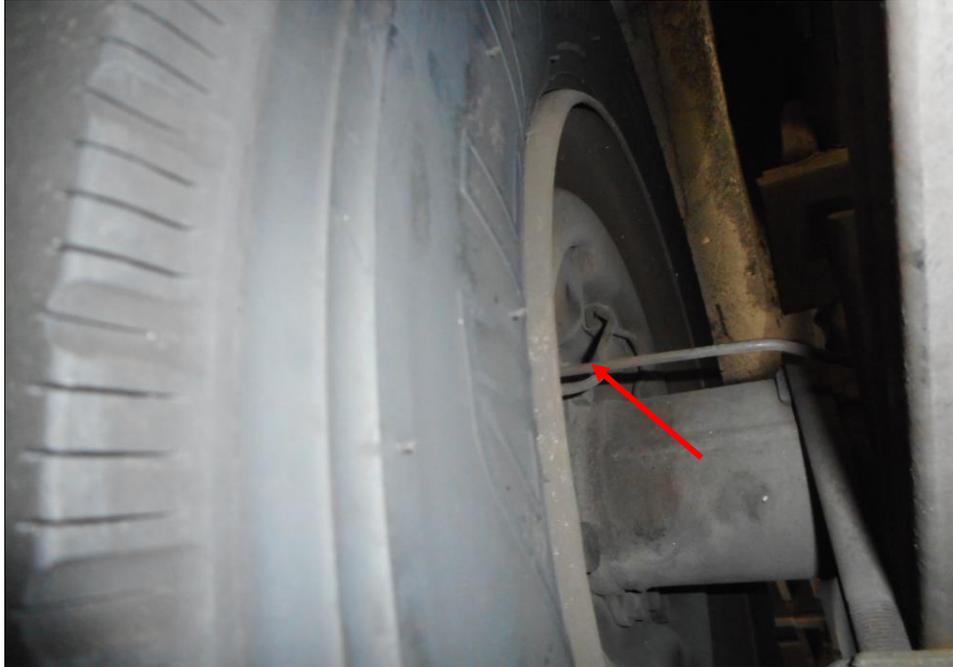
Photo 18 shows the brake pipe (arrowed) at the rear left wheel of the Mini Bus. I did not observe any leakage of brake fluid at the time of my inspection of the Mini Bus. My static tests of the Mini Bus's braking system, along with my visual examination of the various mechanical components in the braking system, had indicated that there was no internal leakage of pressure/vacuum. Hence the braking system of the Mini Bus was likely to be in serviceable condition at the material time of accident.

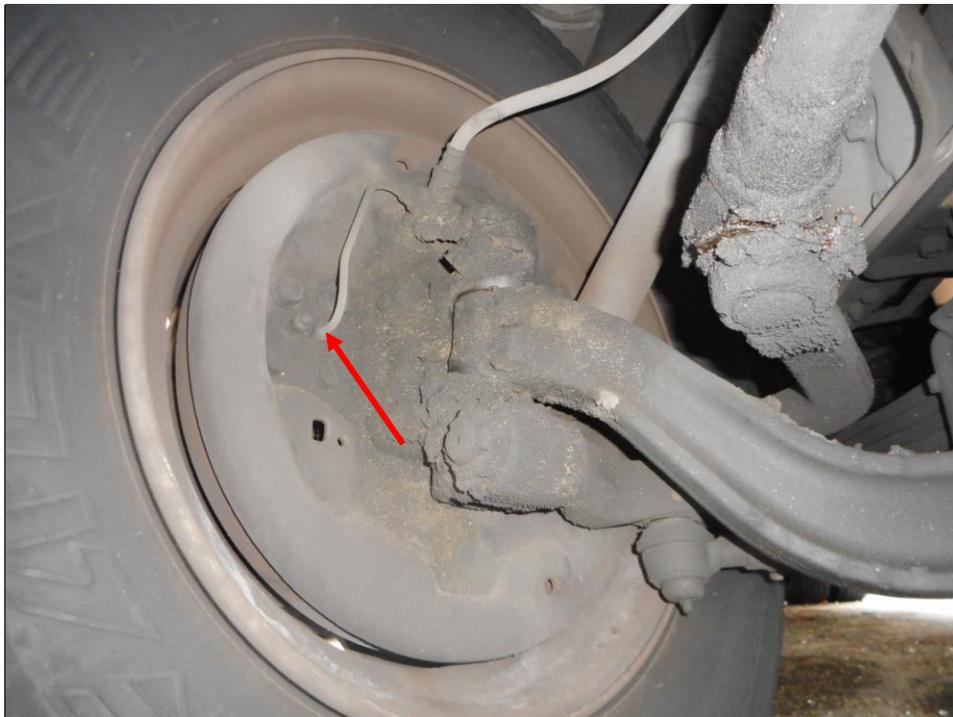
Photo 19 shows the brake pipe (arrowed) at the front left wheel of the Mini Bus. I did not observe any leakage of brake fluid at the time of my inspection of the Mini Bus. My static tests of the Mini Bus's braking system, along with my visual examination of the various mechanical components in the braking system, had indicated that there was no internal leakage of pressure/vacuum.

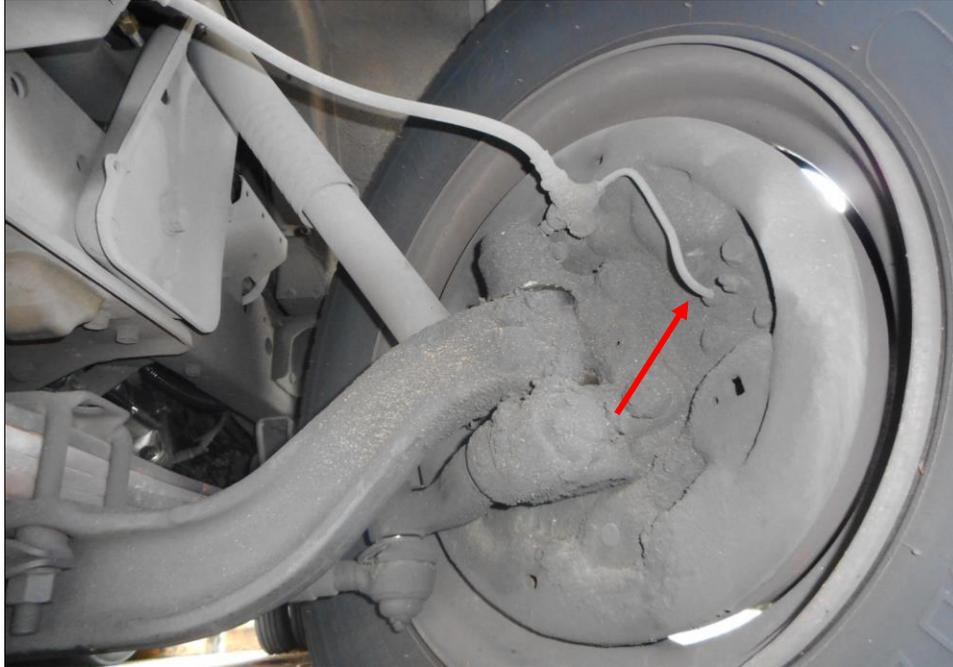
Photo 20 shows the brake pipe (arrowed) at the front right wheel of the Mini Bus. I did not observe any leakage of brake fluid at the time of my inspection of the Mini Bus. My static tests of the Mini Bus's braking system, along with my visual examination of the various mechanical components in the braking system had indicated that there was no internal leakage of pressure/vacuum. Hence the braking system of the Mini Bus was likely to be in serviceable condition at the material time of accident.

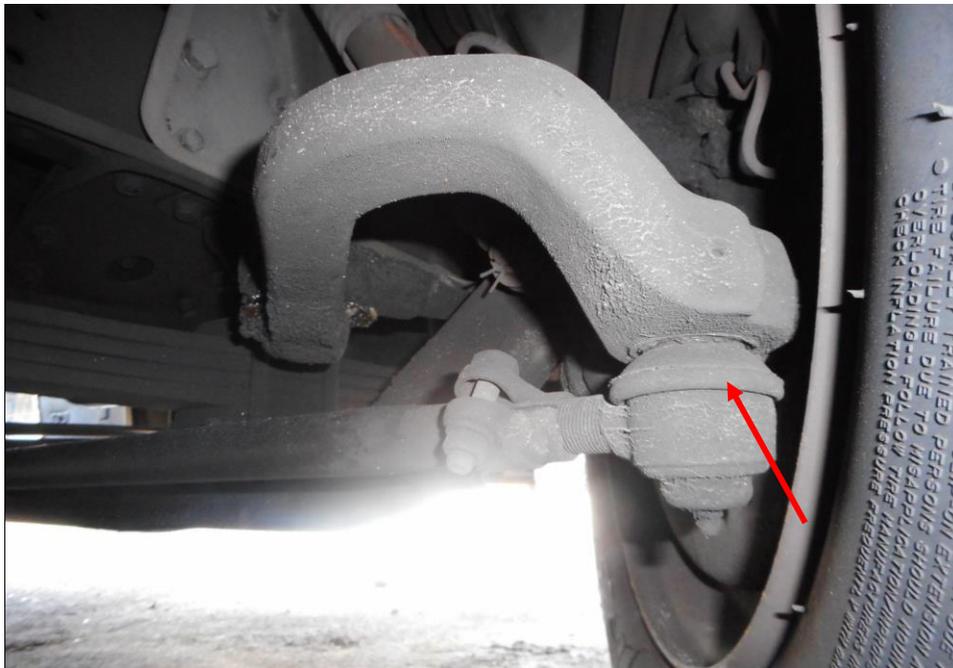
Photo 21 shows the various undercarriage components at the front right wheel of the Mini Bus, in particular the steering tie rod end (arrowed). The various steering components were all found to be intact, suggesting that the steering system of the Mini Bus was likely to be in serviceable condition at the material time of accident. There was also no sign of fluid stain(s) observed on the various undercarriage components.

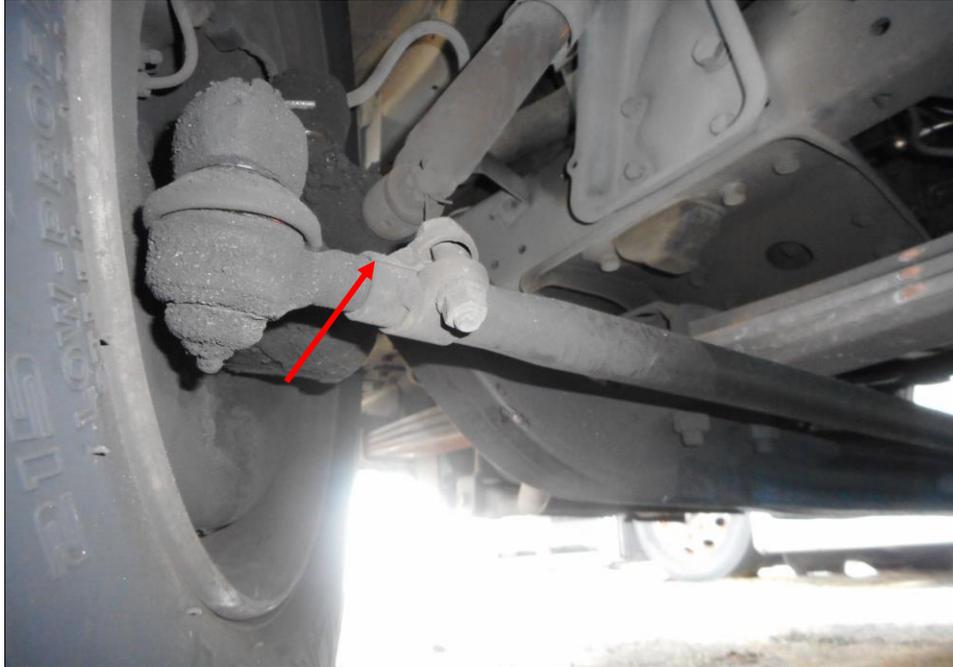
Photo 22 shows the various undercarriage components at the front left wheel of the Mini Bus, in particular the steering tie rod end (arrowed). The various undercarriage components of the Mini Bus were all found to be intact without any visible damage. There was also no sign of fluid stain(s) observed on the various undercarriage components.

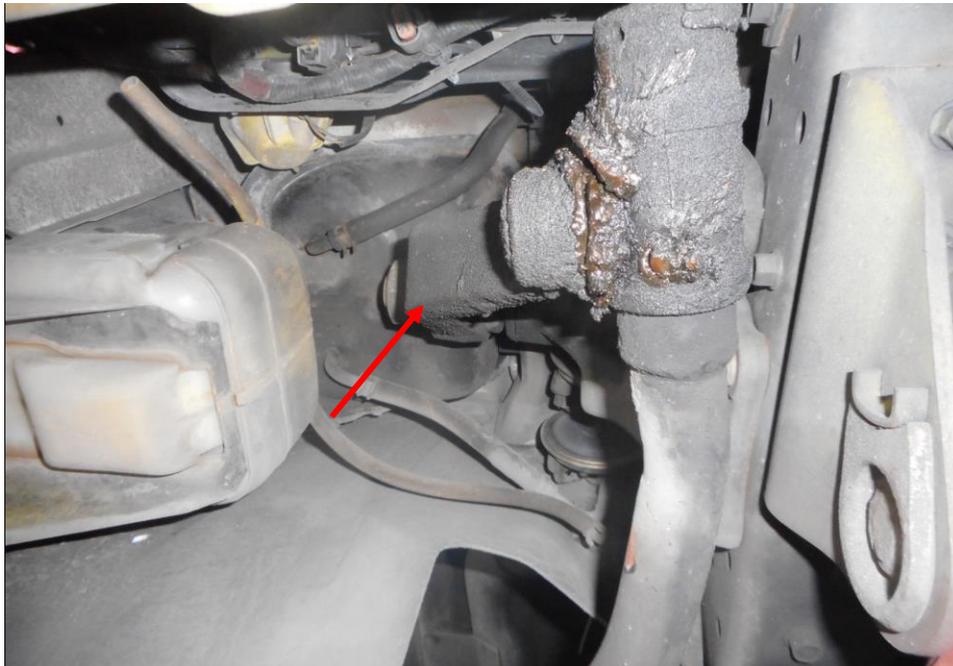
Photo 23 shows the steering box component (arrowed) at the undercarriage of the Mini Bus was found to be intact without any visible damage. There was also no sign of fluid stain(s) observed on the various undercarriage components.

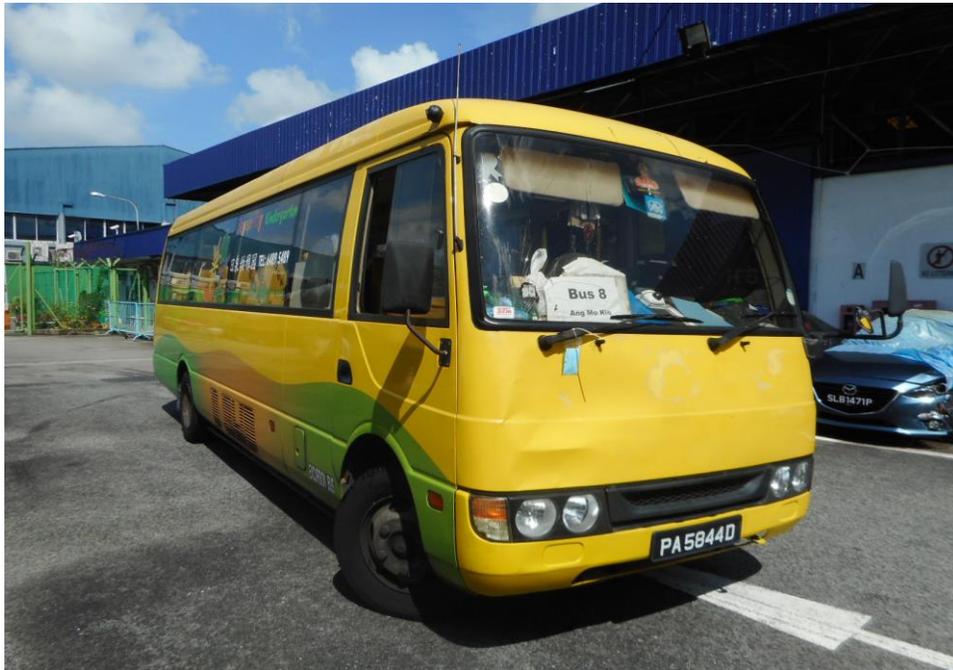
Photo 24 shows the front left of the steering wheel of the Mini Bus turned to its full right. During my steering system test, I did not experience any abnormal free play and/or resistance when I had turned the steering wheel towards full left and full right. This would suggest that the steering system of the Mini Bus was likely to be in serviceable condition at the material time of accident.
