Your Ref: TP/IP/80209/2019
Our Ref : CI/TPD20003591/P

17th June 2020

MECHANICAL INSPECTION REPORT OF MOTOR TRAILER XD 2600A

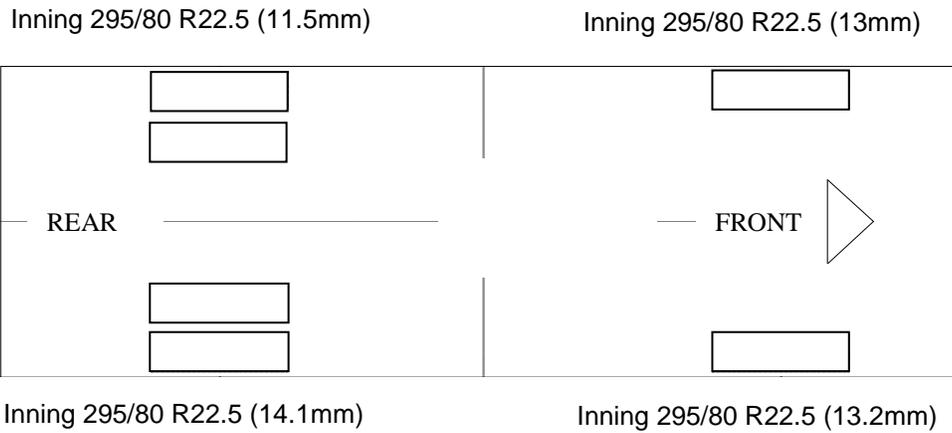
6. The 2 front tyres and 4 rear tyres of the Motor Trailer and 12 tyres of the trailer were observed to be in serviceable condition and sufficiently inflated for vehicular operation. I did not find any tear, cut or burst mark(s) on the outer and the inner sidewalls as well as across the tread of the 6 tyres of the Motor Trailer and the 12 tyres of the trailer. The tyre brand, tyre size and remaining tread depth of the 6 tyres of the Motor Trailer and 12 tyres of the trailer were recorded as follows:-

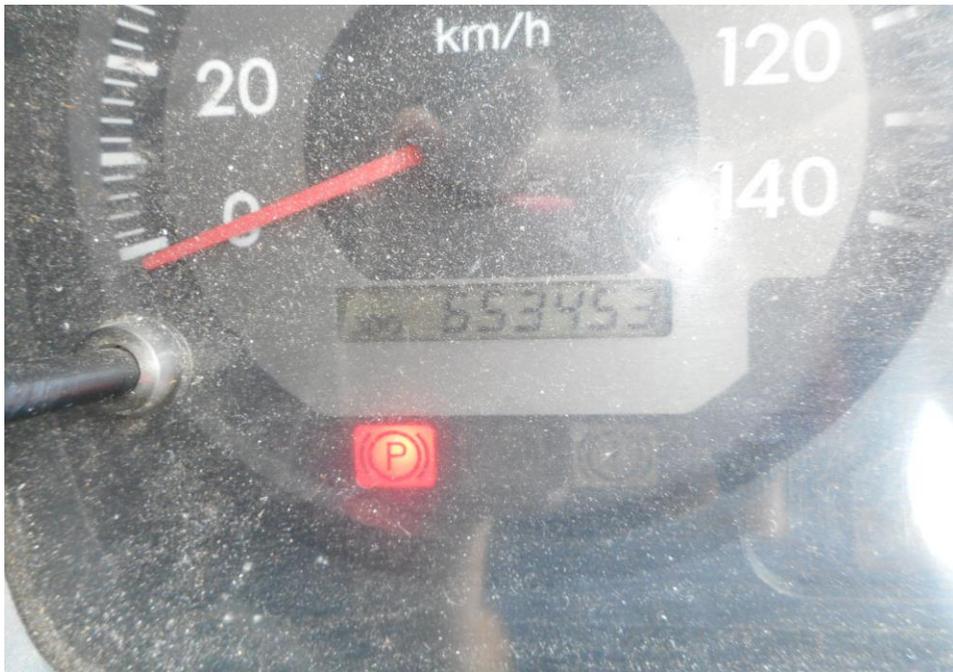
Photo 1 shows a general view of the instrument cluster of the Motor Trailer at the time of my inspection. The mileage of the Motor Trailer was 653,453km

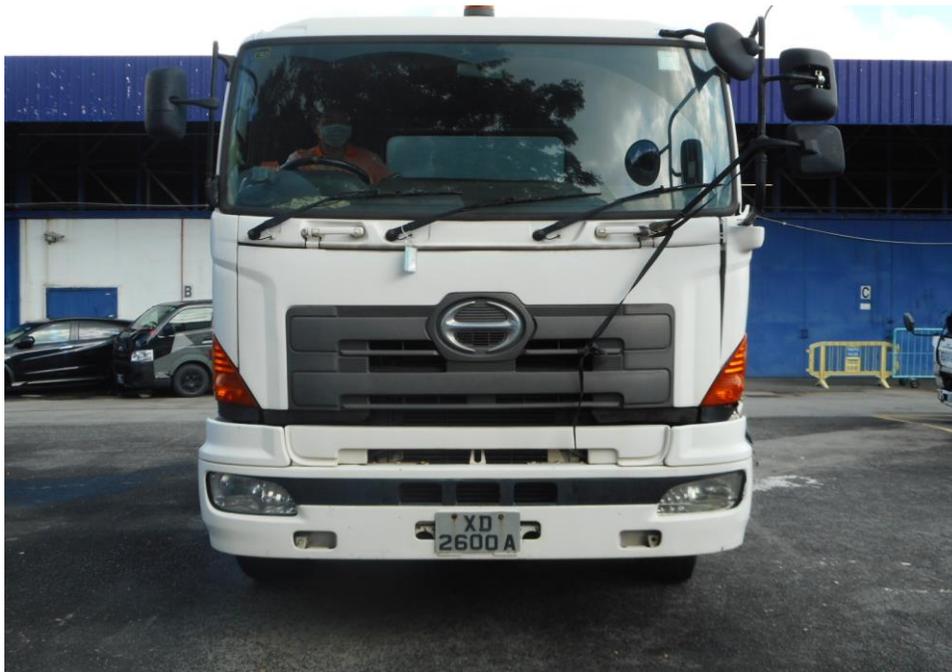
Photo 2 shows a general view of the front body of the Motor Trailer at the time of my inspection. The Motor Trailer was observed to be intact and unaffected by the accident.

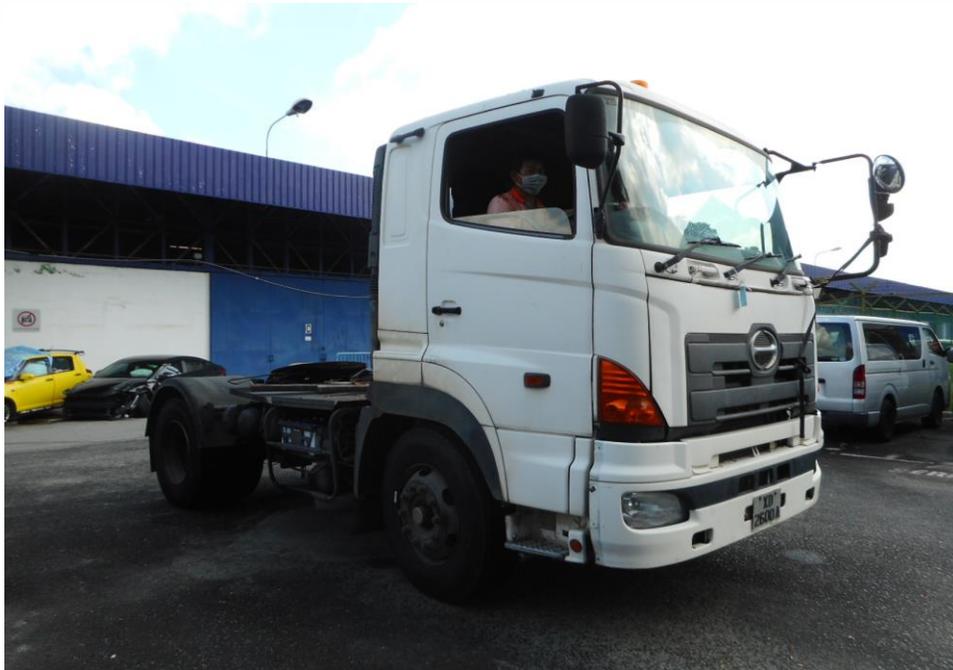
Photo 3 shows a general view of the front right body of the Motor Trailer at the time of my inspection. The Motor Trailer was observed to be intact and unaffected by the accident.

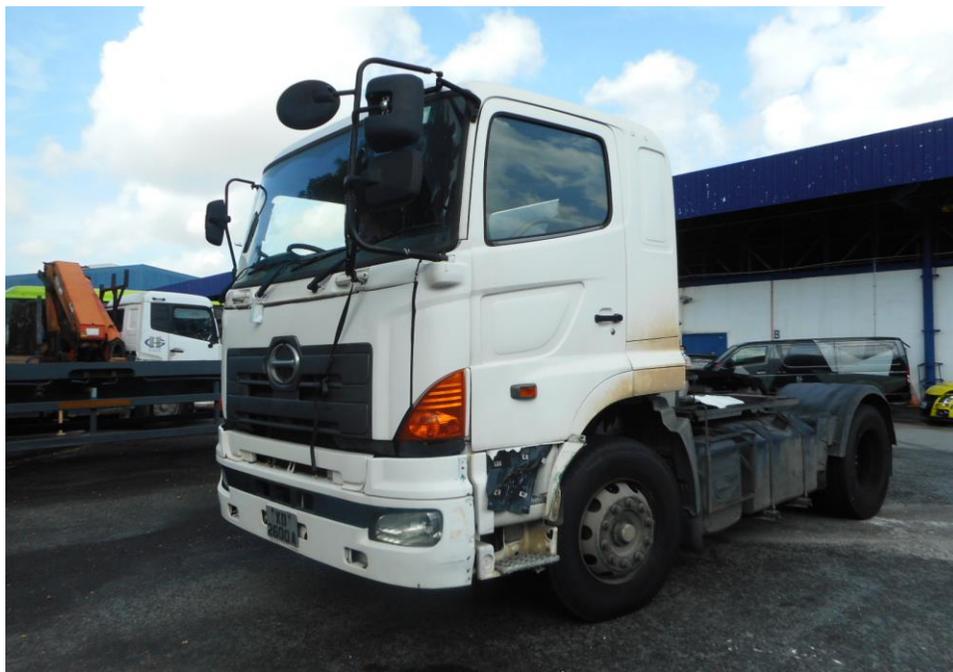
Photo 4 shows a general view of the front left body of the Motor Trailer at the time of my inspection. The Motor Trailer was observed to be intact and unaffected by the accident.

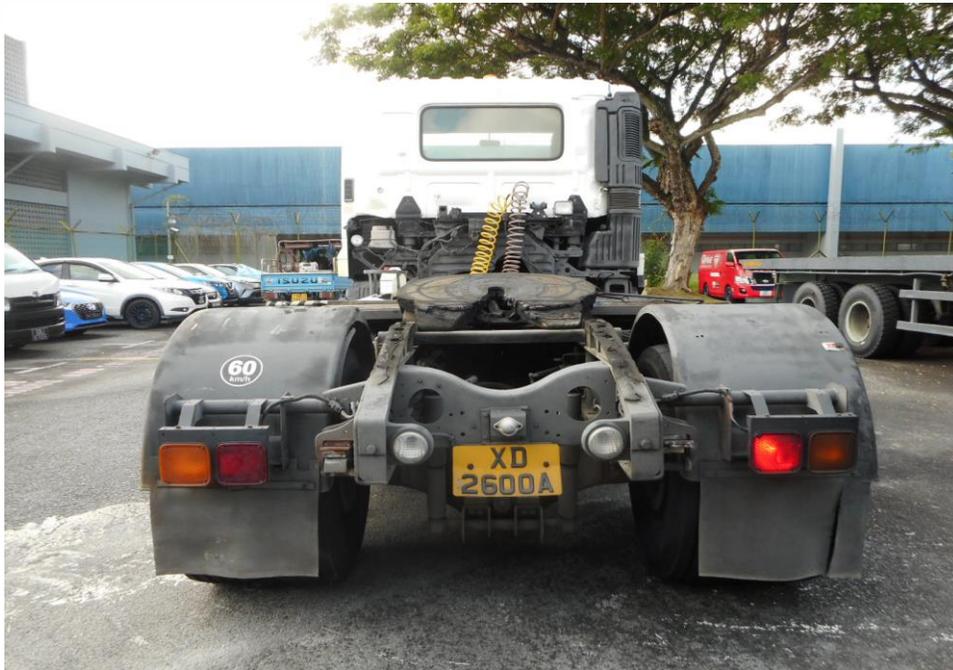
Photo 5 shows a general view of the Motor Trailer's rear body at the time of my inspection. The Motor Trailer was observed to be intact and unaffected by the accident.

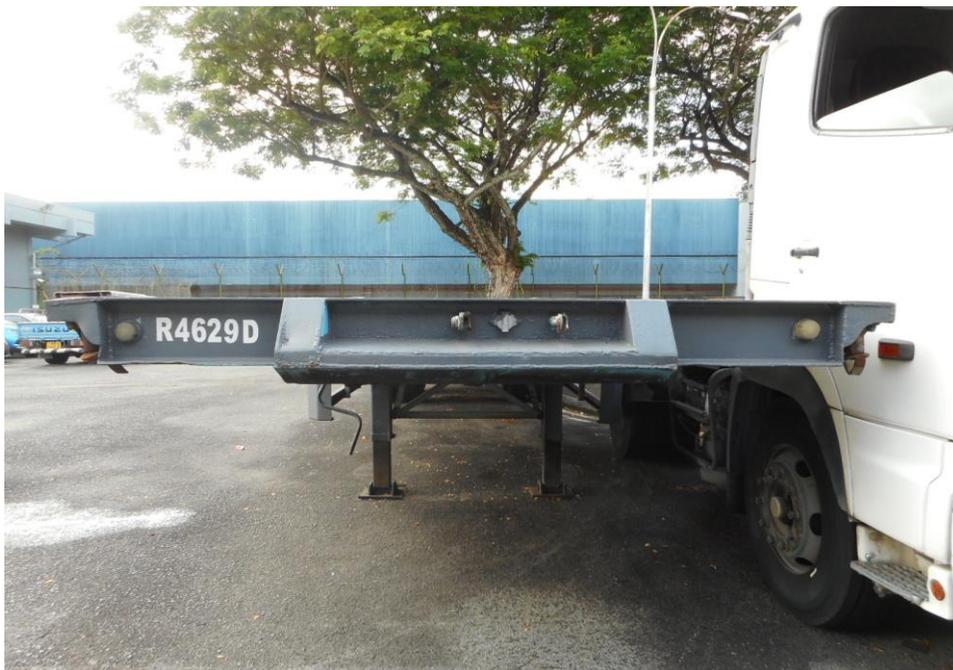
Photo 6 shows a general view of the front body of the trailer at the time of my inspection. The Motor Trailer was observed to be intact and unaffected by the accident.

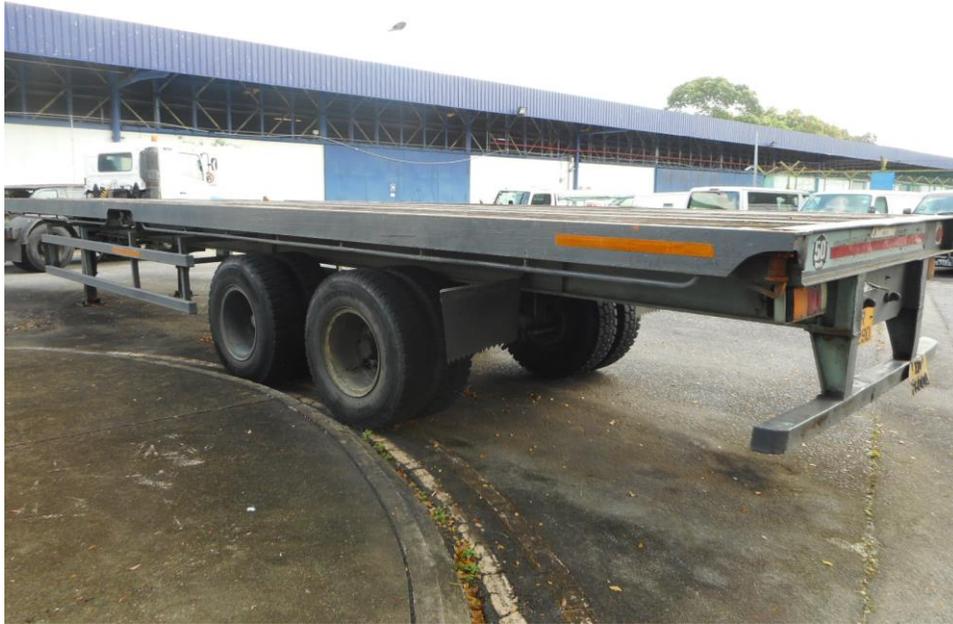
Photo 7 shows a general view of the trailer's left body at the time of my inspection. The Motor Trailer was observed to be intact and unaffected by the accident.

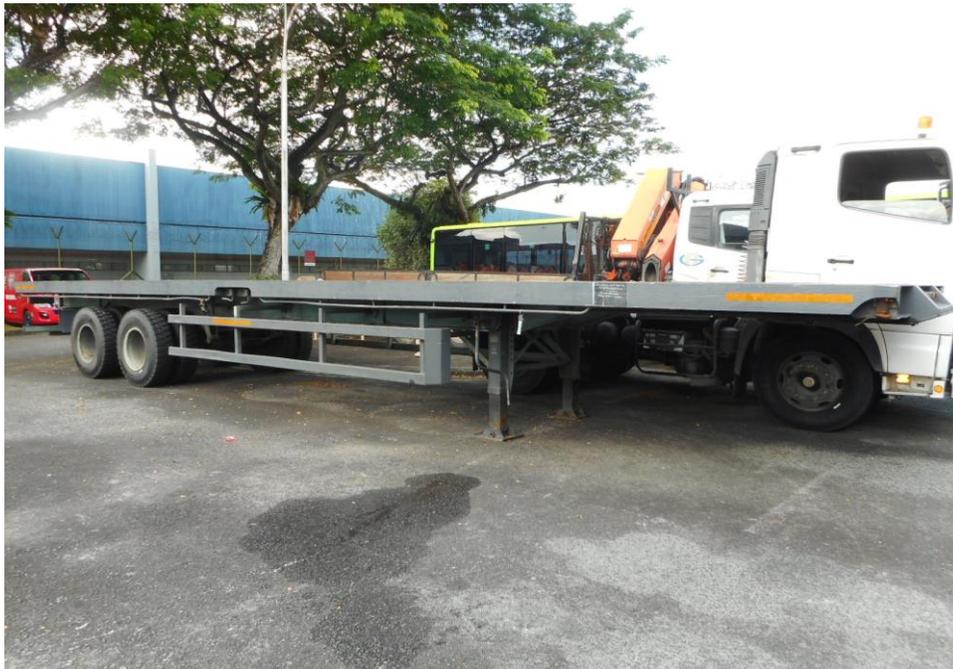
Photo 8 shows a general view of the trailer's right body at the time of my inspection. The Motor Trailer was observed to be intact and unaffected by the accident.

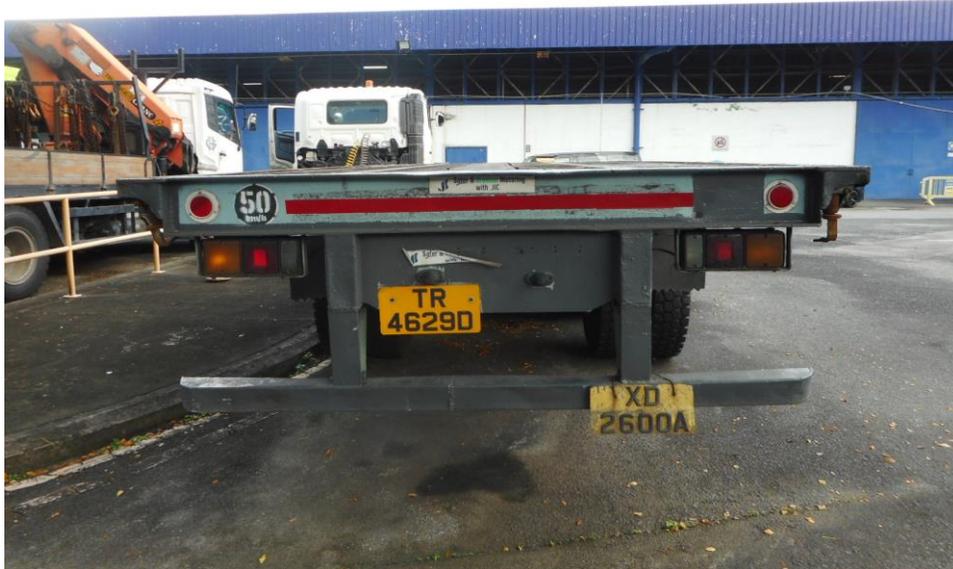
Photo 9 shows a general view of the trailer's rear body at the time of my inspection. The Motor Trailer was observed to be intact.

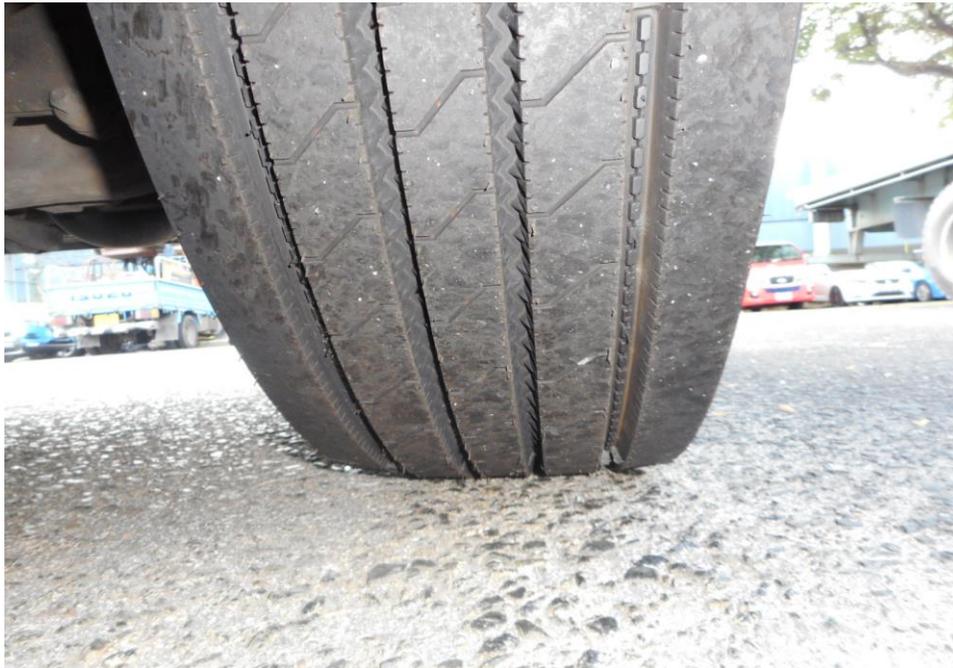
Photo 10 shows the condition of the front right tyre of the Motor Trailer, which was observed to be in serviceable condition with remaining tread depth of approximately 13.2 mm. The tyre, which was wrapped around standard steel wheel rim, was also observed to be sufficiently inflated for vehicular operation. There was no tear, cut or burst mark(s) on the outer and the inner sidewalls as well as across the tread of the 6 tyres that were fitted on the Motor Trailer.

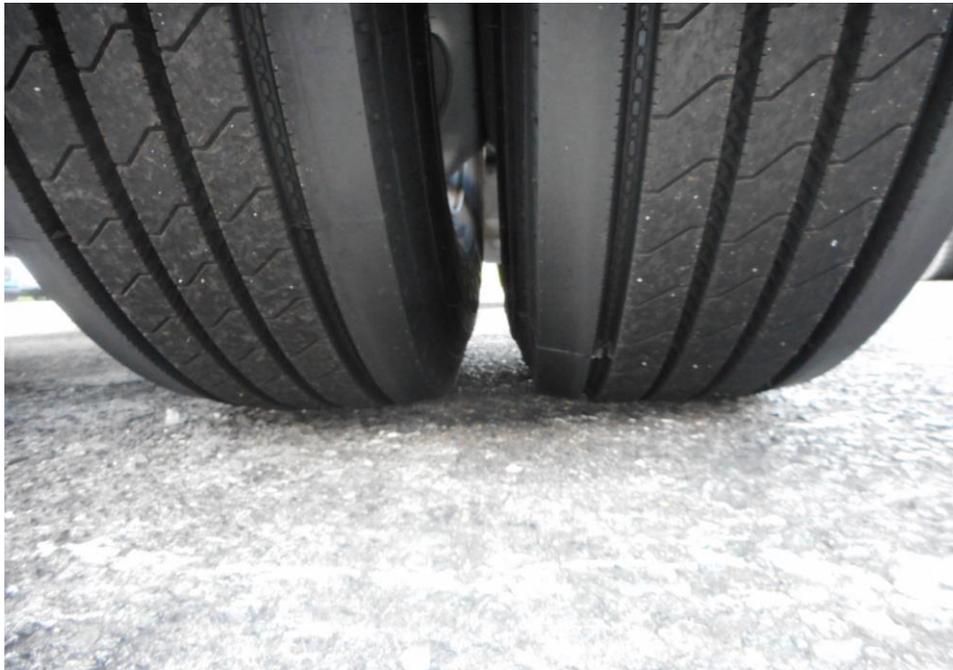
Photo 11 shows the condition of the rear right tyre of the Motor Trailer, which was observed to be in serviceable condition with remaining tread depth of approximately 14.1mm. The tyre, which was wrapped around standard steel wheel rim, was also observed to be sufficiently inflated for vehicular operation.

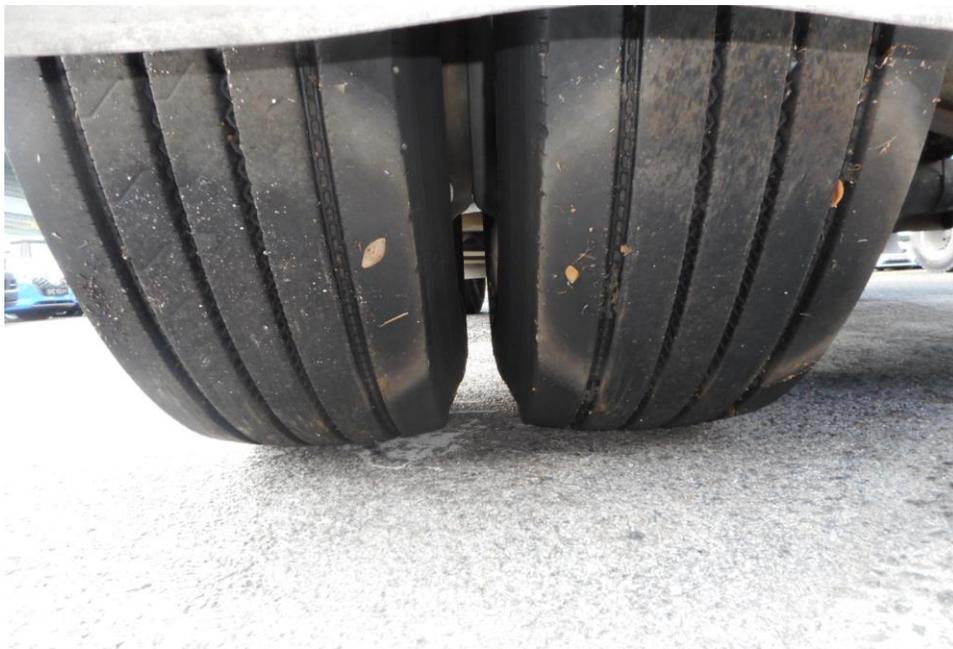
Photo 12 shows the condition of the rear left tyres of the Motor Trailer, which was observed to be in serviceable condition with remaining tread depth of approximately 11.5mm. The tyres, which were wrapped around standard steel wheel rim, were also observed to be sufficiently inflated for vehicular operation. There was also no damage found on all 6 steel wheel rims of the Motor Trailer.

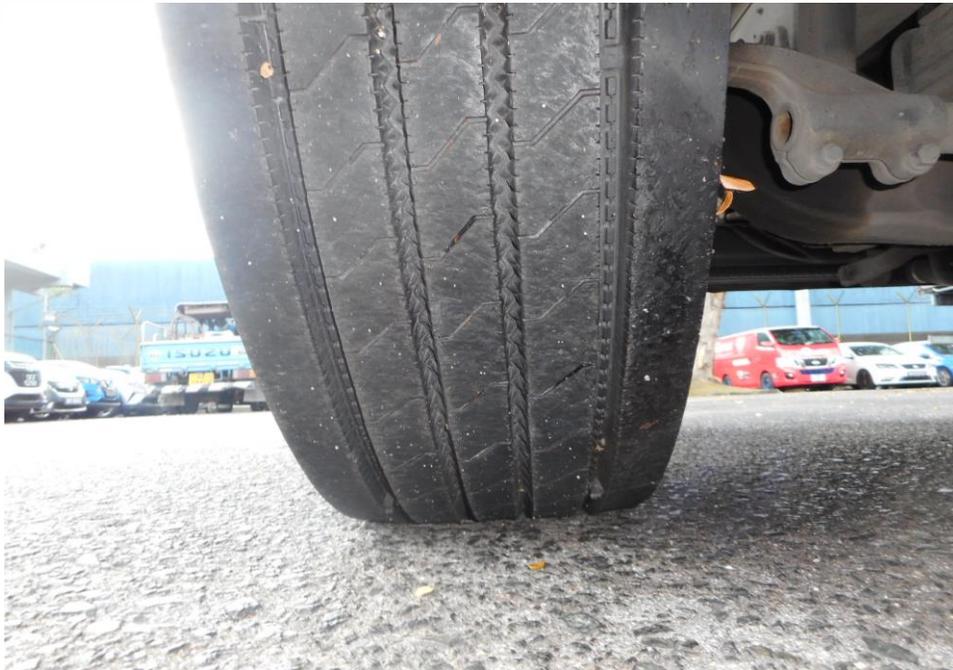
Photo 13 shows the condition of the front left tyres of the Motor Trailer, which were observed to be in serviceable condition with remaining tread depth of approximately 13mm. There was also no tear, cut or burst mark(s) on the outer and the inner sidewalls as well as across the tread of the 6 tyres that were fitted on the Motor Trailer.

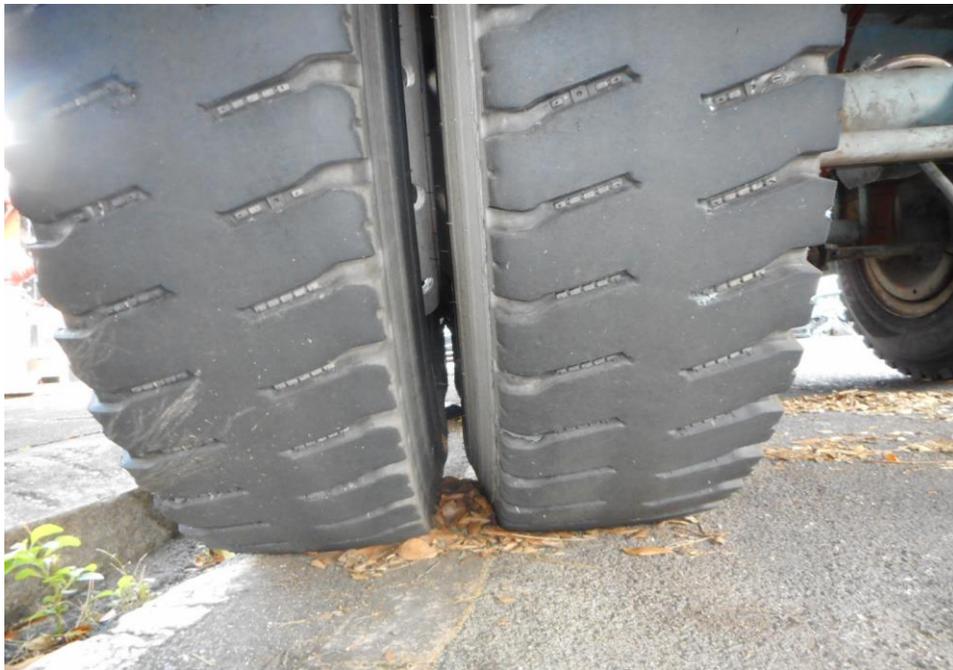
Photo 14 shows the condition of the right tyres of the trailer, which was observed to be in serviceable condition with remaining, tread depth of approximately 6.9mm. The tyre, which was wrapped around standard steel wheel rim, was also observed to be sufficiently inflated for vehicular operation.

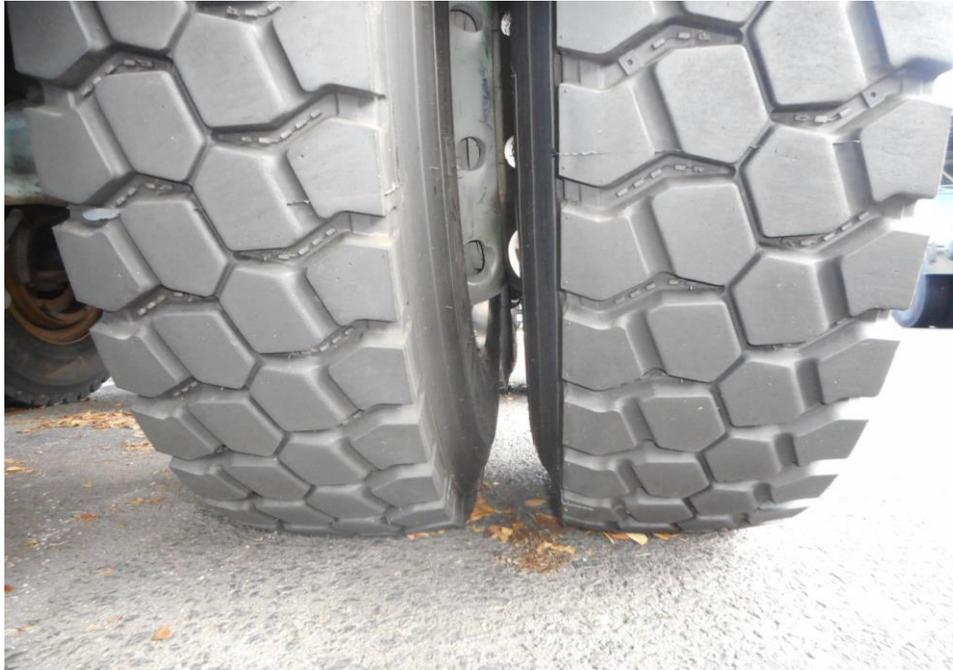
Photo 15 shows the condition of the left tyres of the trailer, which was observed to be in serviceable condition with remaining tread depth of approximately 7.5mm. The tyres, which were wrapped around standard steel wheel rim, were also observed to be sufficiently inflated for vehicular operation. There was also no damage found on all 6 steel wheel rims of the Motor Trailer.

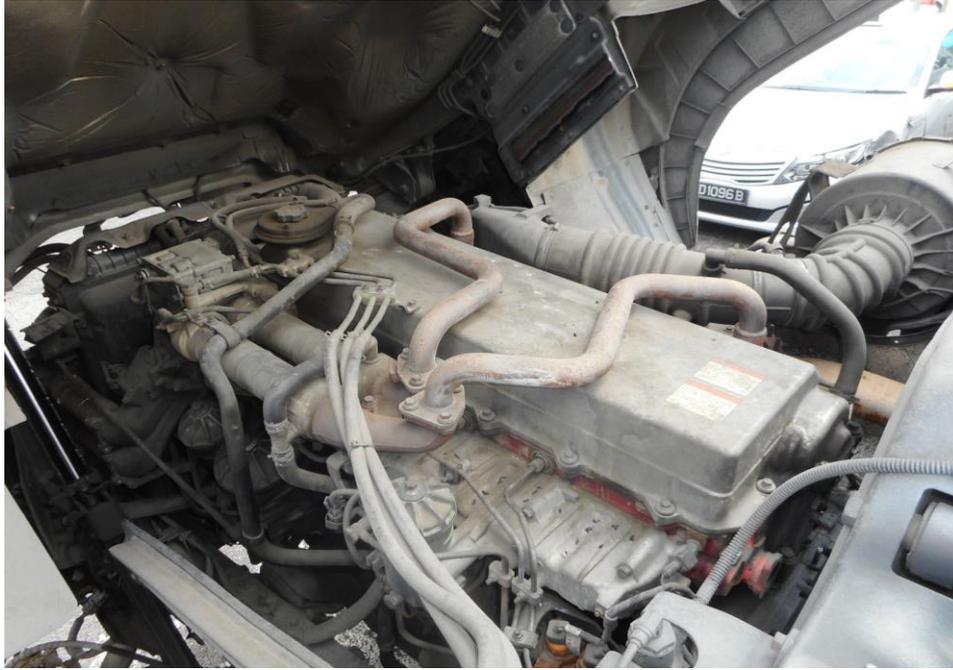
Photo 16 shows a general view of the Motor Trailer's engine compartment, which was accessed by lifting the front cabin of the Motor Trailer. The various parts and components inside the engine compartment were unaffected by the accident. There was also no sign(s) or indication(s) of fresh fluid leakage and/or fluid stain within the engine compartment

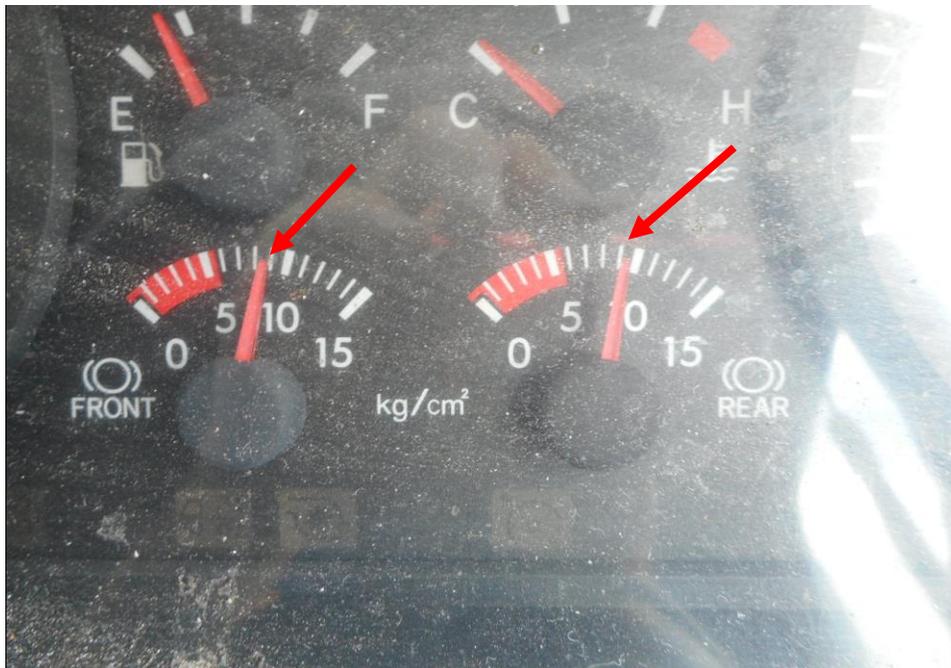
Photo 17 shows the air in the air brake cylinders of the Motor Trailer at the time of my inspection. The air in the cylinder was observed to be of sufficient level & serviceable at the time of the accident.

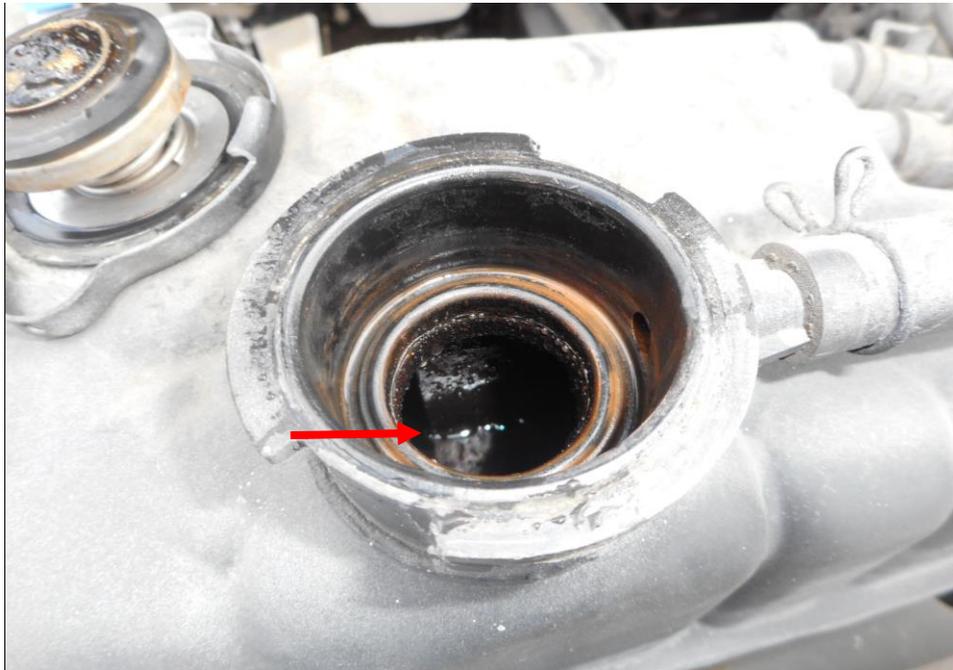
Photo 18 shows the engine coolant reservoir of the Motor Trailer at the time of my inspection. The engine coolant was observed to be of sufficient level (arrowed) and without any visible contamination.

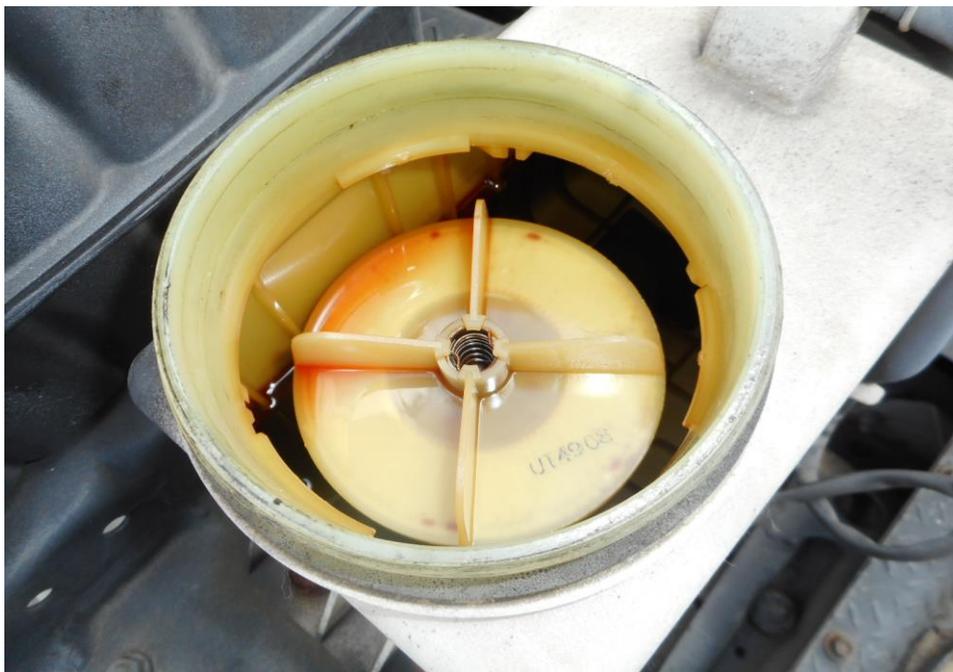
Photo 19 shows the power steering fluid reservoir of the Motor Trailer at the time of my inspection. The power steering fluid was observed to be of sufficient level and without any visible contamination.

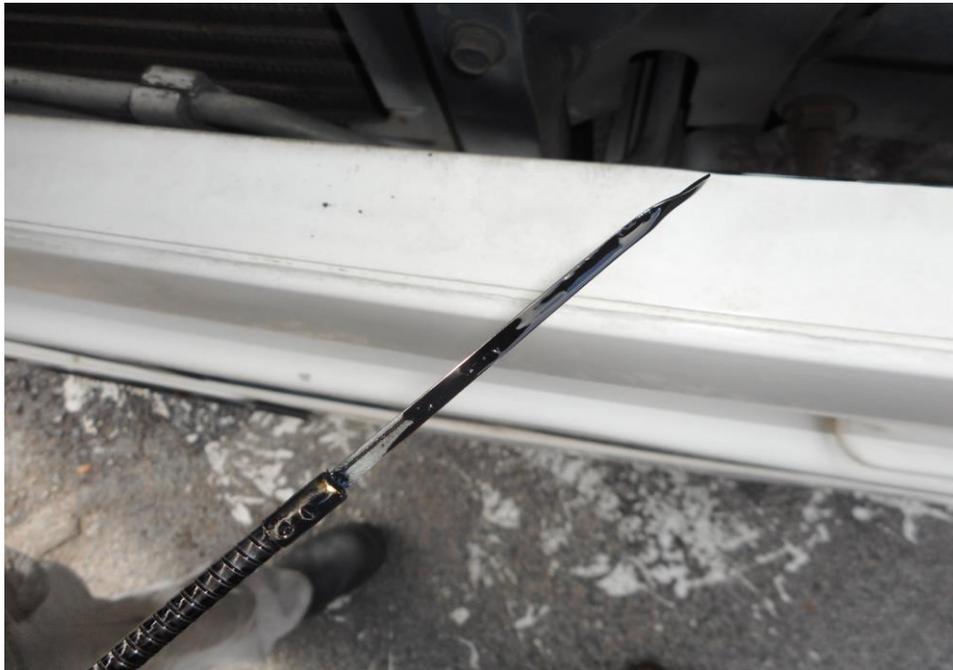
Photo 20 shows the engine oil dip stick of the Motor Trailer at the time of my inspection. The engine oil was observed to be of sufficient level and without any visible contamination.

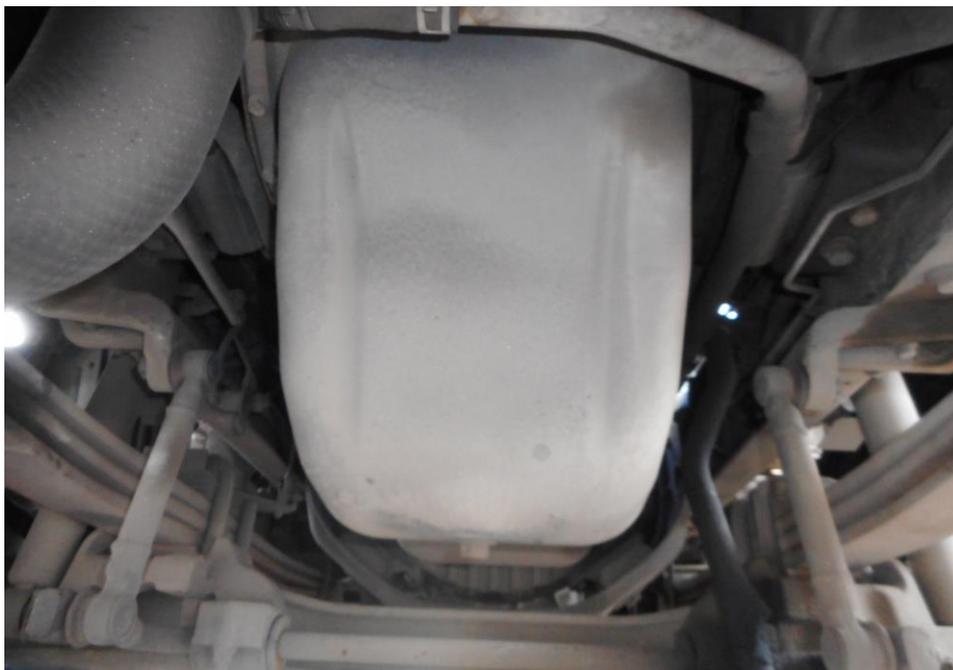
Photo 21 shows the undercarriage of the Motor Trailer, at the area where the engine housing located. I did not find any sign(s) or indication(s) of fluid leak, however old fluid stain(s) was observed on the underside of the Motor Trailer.

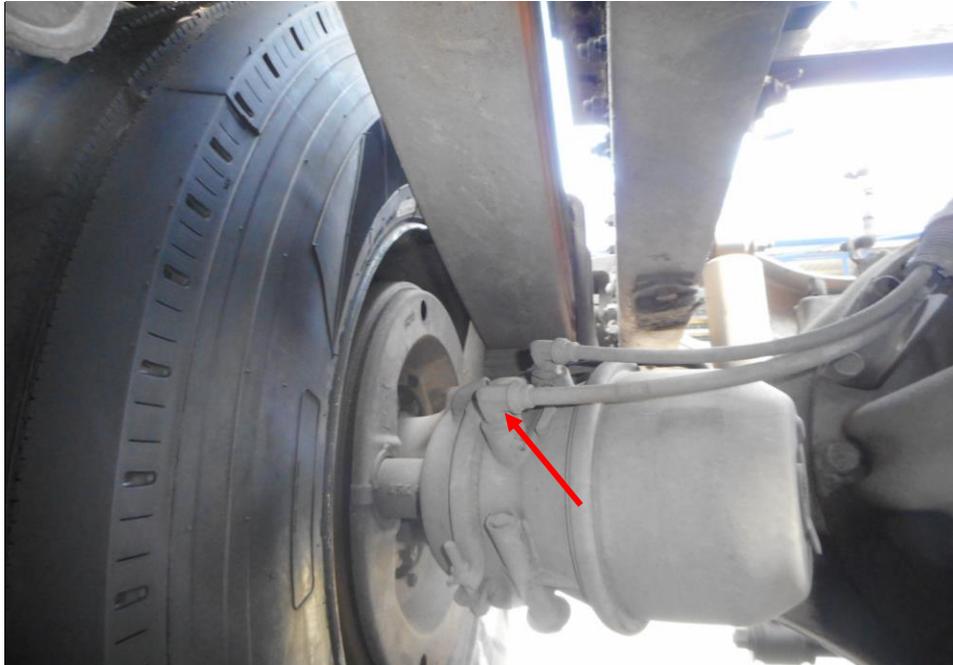
Photo 22 shows the brake pipe (arrowed) at the rear right wheel of the Motor Trailer. I did not observe any leakage of brake fluid at the time of my inspection of the Motor Trailer. My static tests of the Motor Trailer's braking system, along with my visual examination of the various mechanical components in the braking system, had indicated that there was no internal leakage of pressure/vacuum. Hence the braking system of the Motor Trailer was likely to be in serviceable condition at the material time of accident.

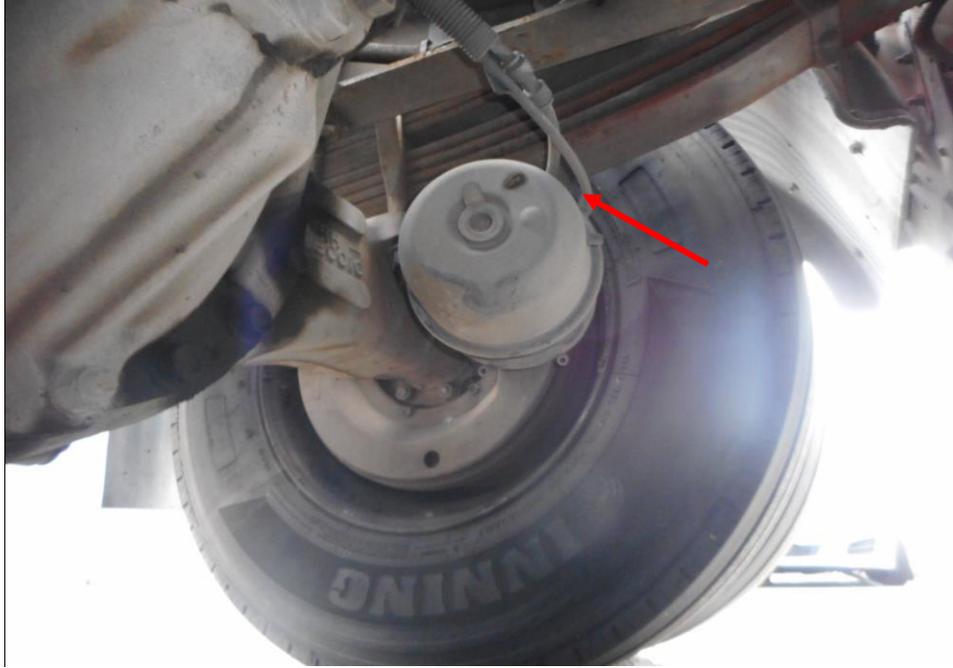
Photo 23 shows the brake pipe (arrowed) at the rear left wheel of the Motor Trailer. I did not observe any leakage of brake fluid at the time of my inspection of the Motor Trailer. My static tests of the Motor Trailer's braking system, along with my visual examination of the various mechanical components in the braking system, had indicated that there was no internal leakage of pressure/vacuum. Hence the braking system of the Motor Trailer was likely to be in serviceable condition at the material time of accident.

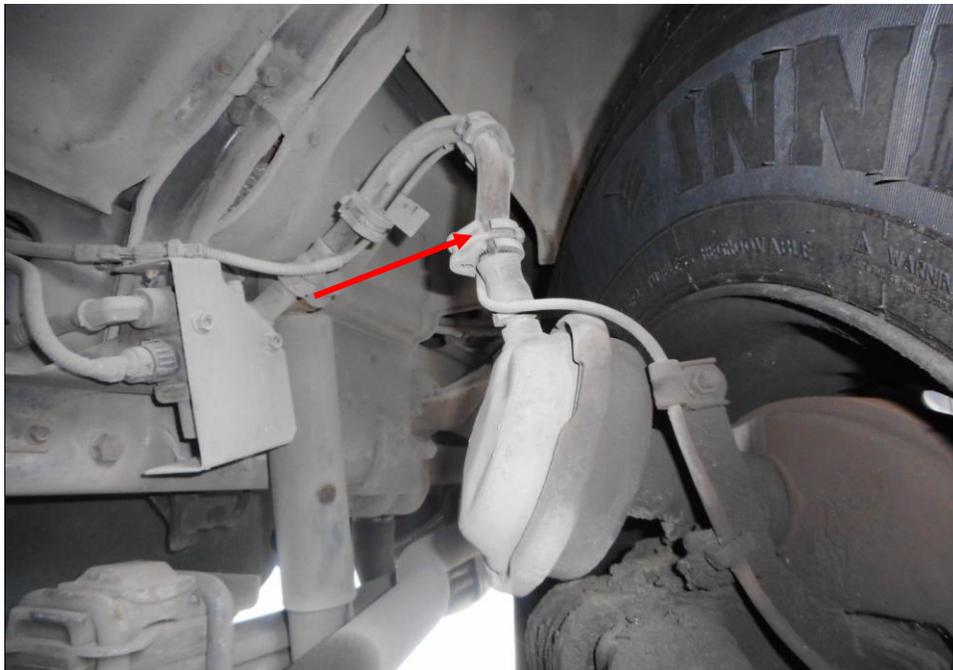
Photo 24 shows the brake pipe (arrowed) at the front right wheel of the Motor Trailer. I did not observe any leakage of brake fluid at the time of my inspection of the Motor Trailer. My static tests of the Motor Trailer's braking system, along with my visual examination of the various mechanical components in the braking system, had indicated that there was no internal leakage of pressure/vacuum. Hence the braking system of the Motor Trailer was likely to be in serviceable condition at the material time of accident.

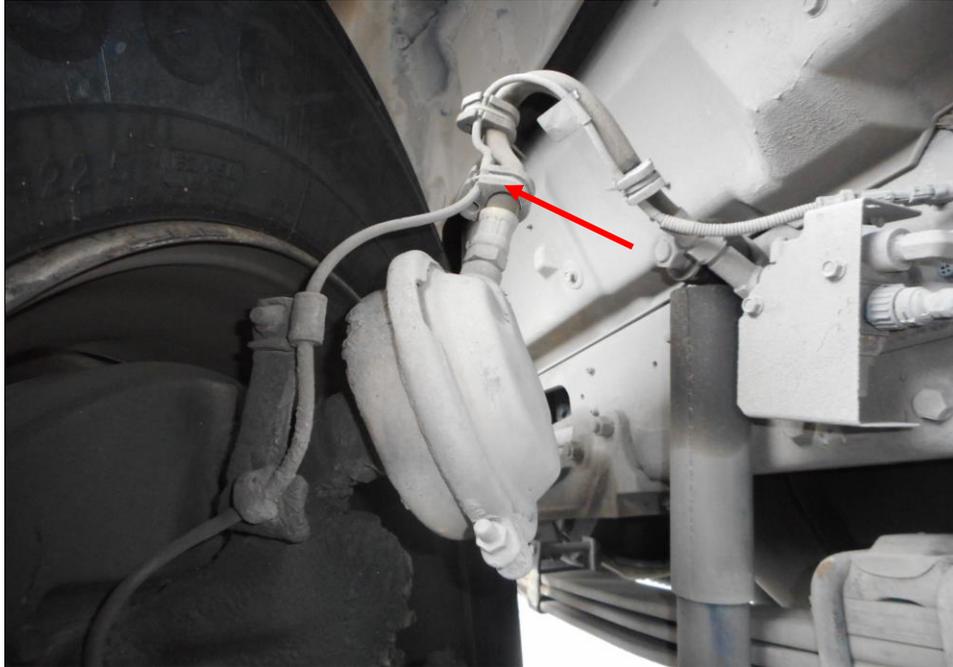
Photo 25 shows the brake pipe (arrowed) at the front left wheel of the Motor Trailer. I did not observe any leakage of brake fluid at the time of my inspection of the Motor Trailer. My static tests of the Motor Trailer's braking system, along with my visual examination of the various mechanical components in the braking system had indicated that there was no internal leakage of pressure/vacuum. Hence the braking system of the Motor Trailer was likely to be in serviceable condition at the material time of accident.

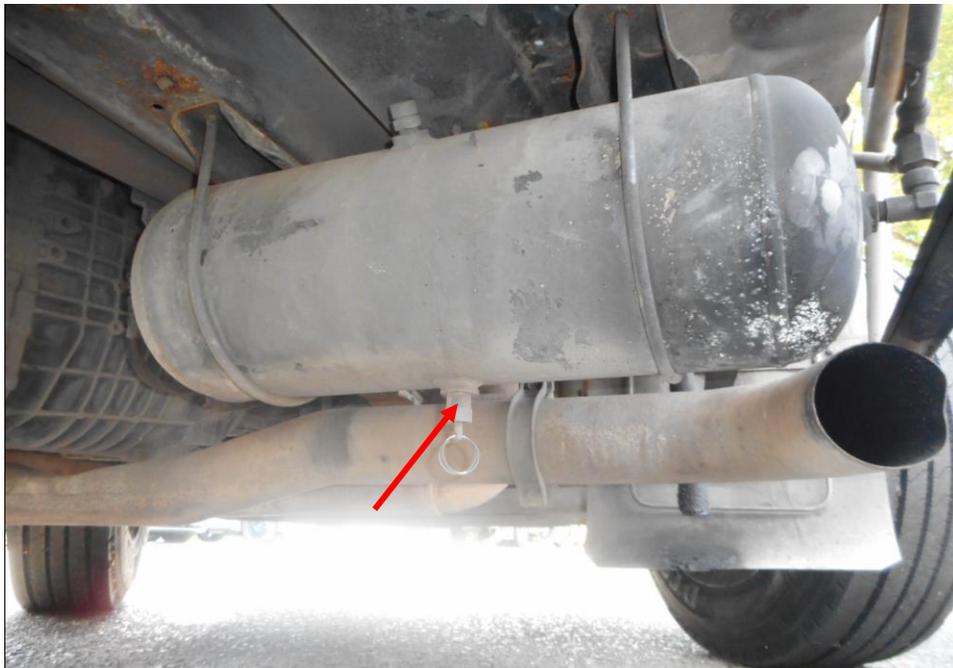
Photo 26 shows the air brake cylinders (arrowed) at the undercarriage of the Motor Trailer. I did not observe any leakage of air brake fluid at the time of my inspection of the Motor Trailer. My static tests of the Motor Trailer's braking system, along with my visual examination of the various mechanical components in the braking system had indicated that there was no internal leakage of pressure/vacuum. Hence the braking system of the Motor Trailer was likely to be in serviceable condition at the material time of accident.

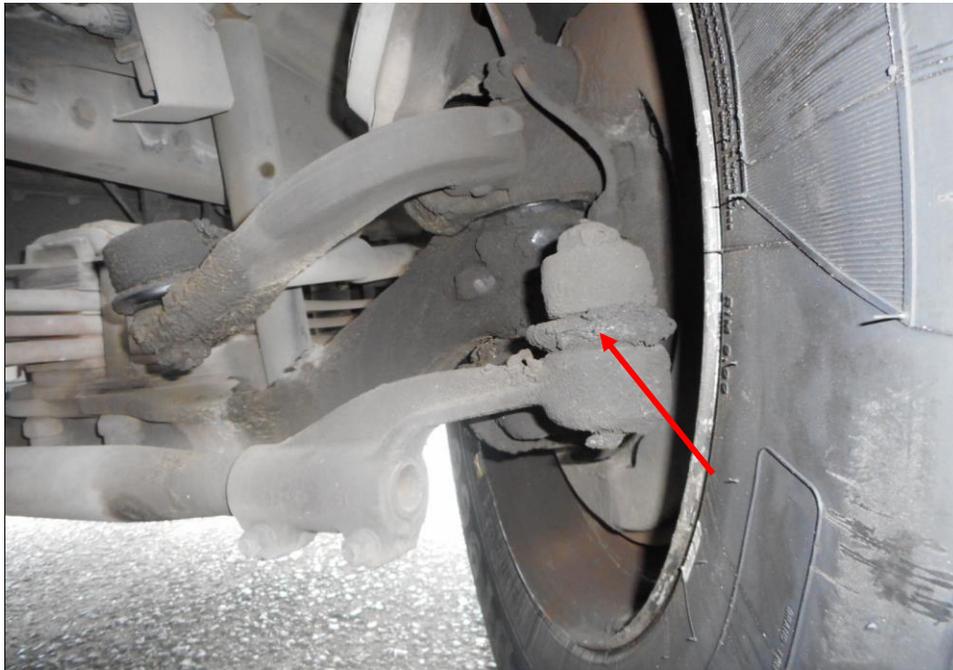
Photo 27 shows the various undercarriage components at the front right wheel of the Motor Trailer, in particular the steering tie rod end (arrowed). The various steering components were all found to be intact, suggesting that the steering system of the Motor Trailer was likely to be in serviceable condition at the material time of accident. There was also no sign of fluid stain(s) observed on the various undercarriage components.

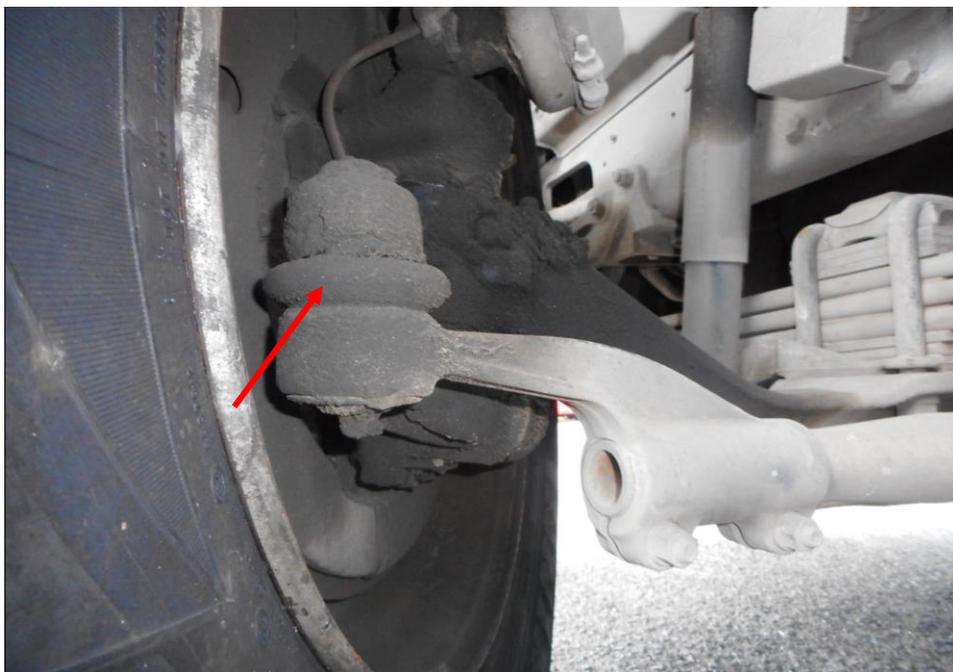
Photo 28 shows the various undercarriage components at the front left wheel of the Motor Trailer, in particular the steering tie rod end (arrowed). The various undercarriage components of the Motor Trailer were all found to be intact without any visible damage. There was also no sign of fluid stain(s) observed on the various undercarriage components.

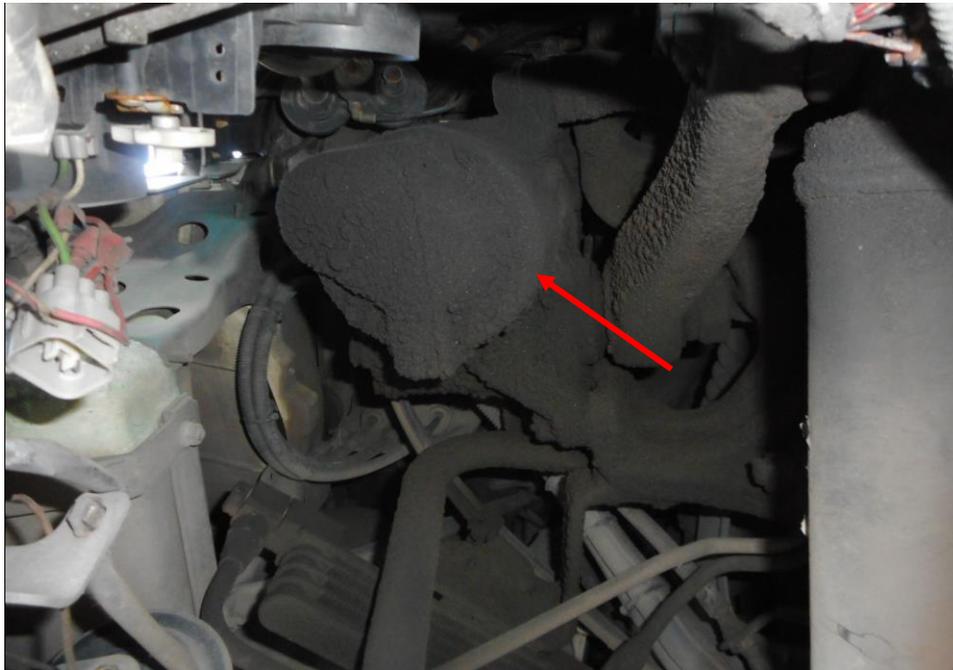
Photo 29 shows the steering box component (arrowed) at the undercarriage of the Motor Trailer was found to be intact without any visible damage. There was also no sign of fluid stain(s) observed on the various undercarriage components.

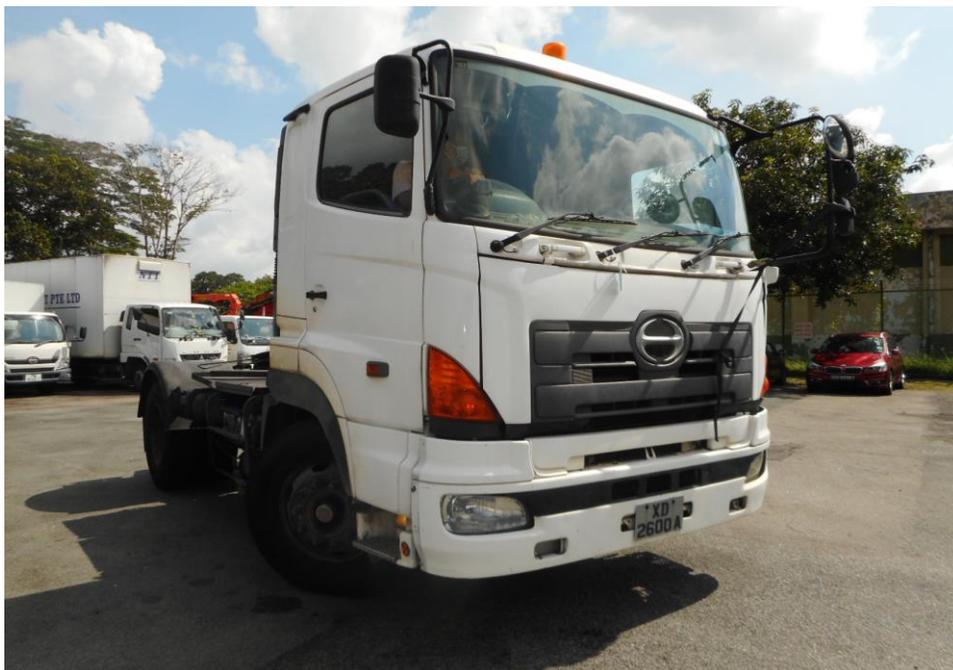
Photo 30 shows the front right wheel of the Motor Trailer turned to its full left. During my steering system test, I did not experience any abnormal free play and/or resistance when I had turned the steering wheel towards full left and full right. This would suggest that the steering system of the Motor Trailer was likely to be in serviceable condition at the material time of accident.
