Your Ref: TP/IP/69677/2019
Our Ref : CI/TPD20003592/P

30th March 2020

MECHANICAL INSPECTION REPORT OF MOTOR LORRY YP 264A

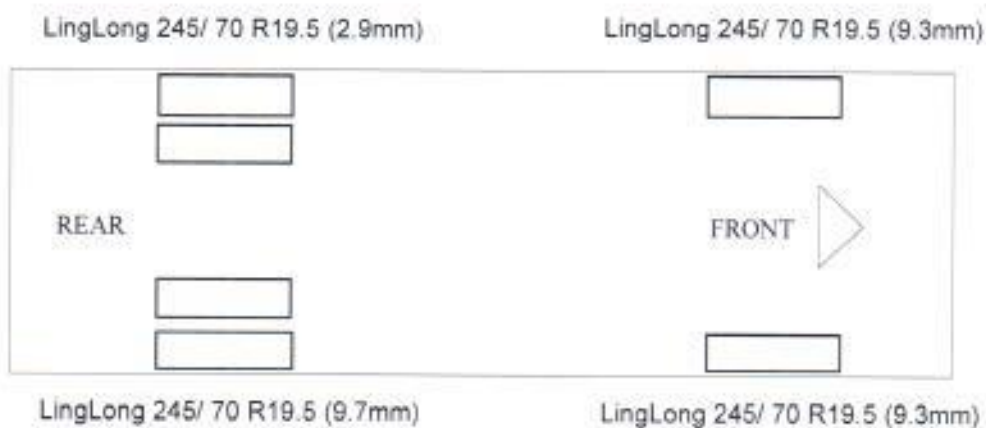
6. The 6 tyres of the Motor Lorry was observed to be in serviceable condition; sufficiently inflated for vehicular operation. I did not find any tear, cut or burst mark(s) on the outer and the inner sidewalls as well as across the tread of the 6 tyres. The tyre brand, tyre size and remaining tread depth of the 6 tyres of the Motor Lorry were recorded as follows:-

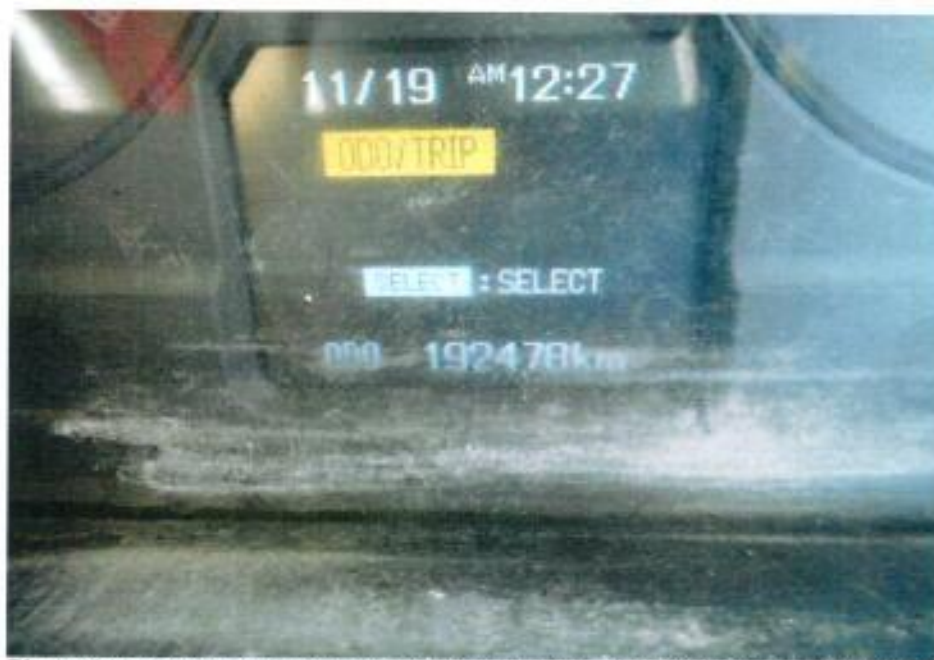
Photo 1 shows a general view of the instrument cluster of the Motor Lorry at the time of my inspection. The mileage of the Motor Lorry was 192,478m

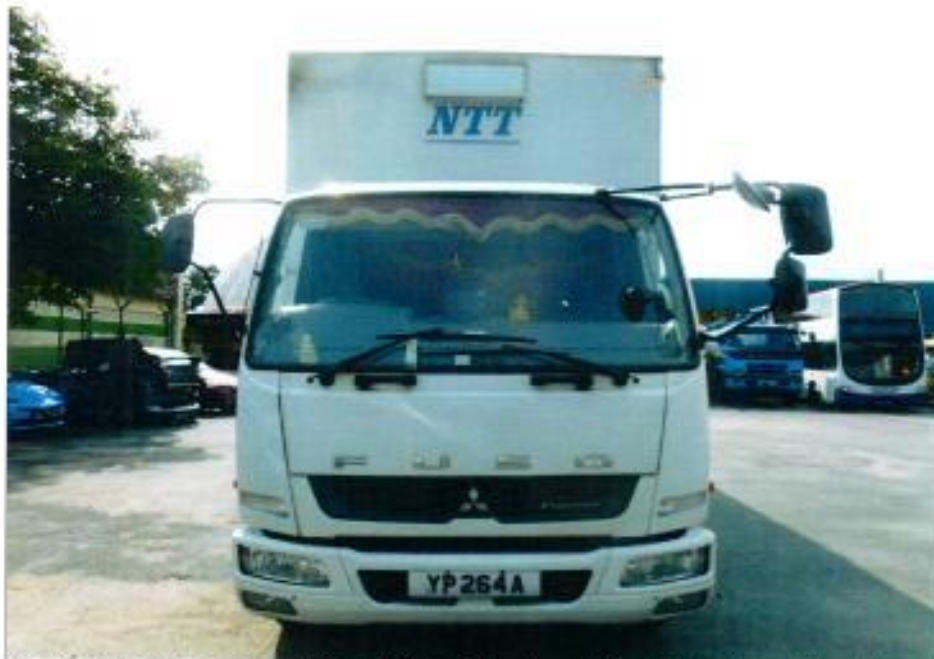
Photo 2 shows a general view of the Motor Lorry's frontal portion at the time of my inspection. The Motor Lorry was observed to be intact and unaffected by the accident.

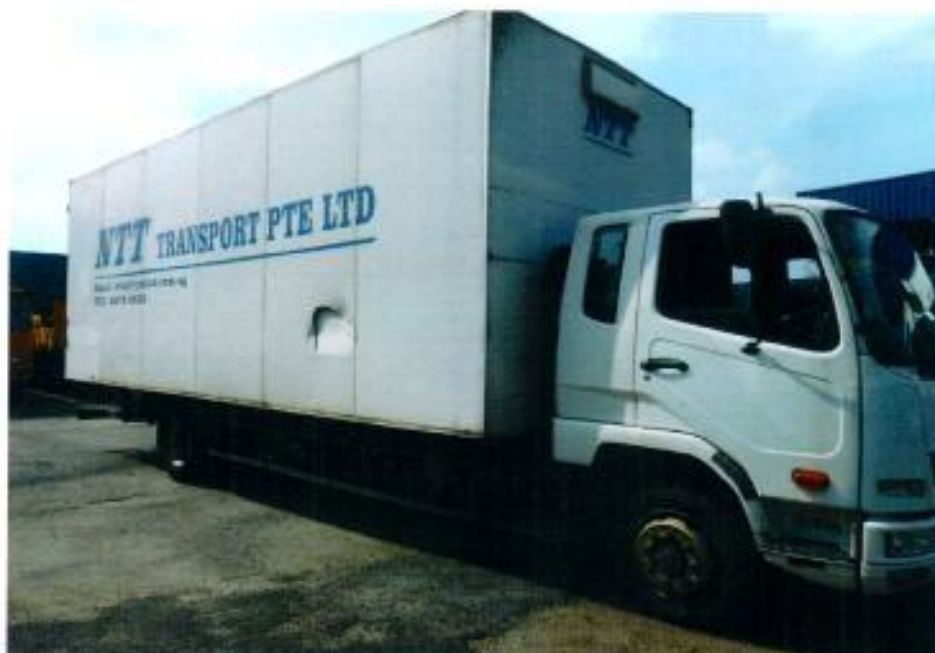
4. The mileage of the Motor Lorry at the time of my inspection was 192,478km.
5. The Motor Lorry was observed to have sustained damage at its right portion. Its right side body panel was damaged as a result of the accident.

Photo 3 shows a general view of the right body of the Motor Lorry at the time of my inspection. The Motor Lorry was observed to have sustained damage at its right portion. Its right side body panel was damaged as a result of the accident.

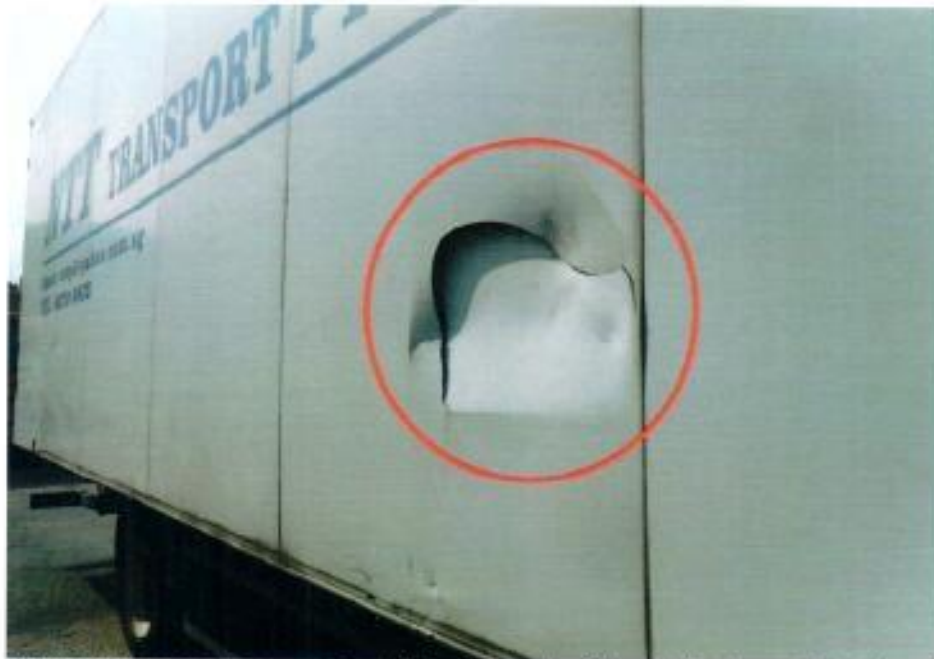
Photo 4 shows a close up view of the right body of the Motor Lorry at the time of my inspection. The Motor Lorry was observed to have sustained damage at its right portion. Its right side body panel (circled) was damaged as a result of the accident.

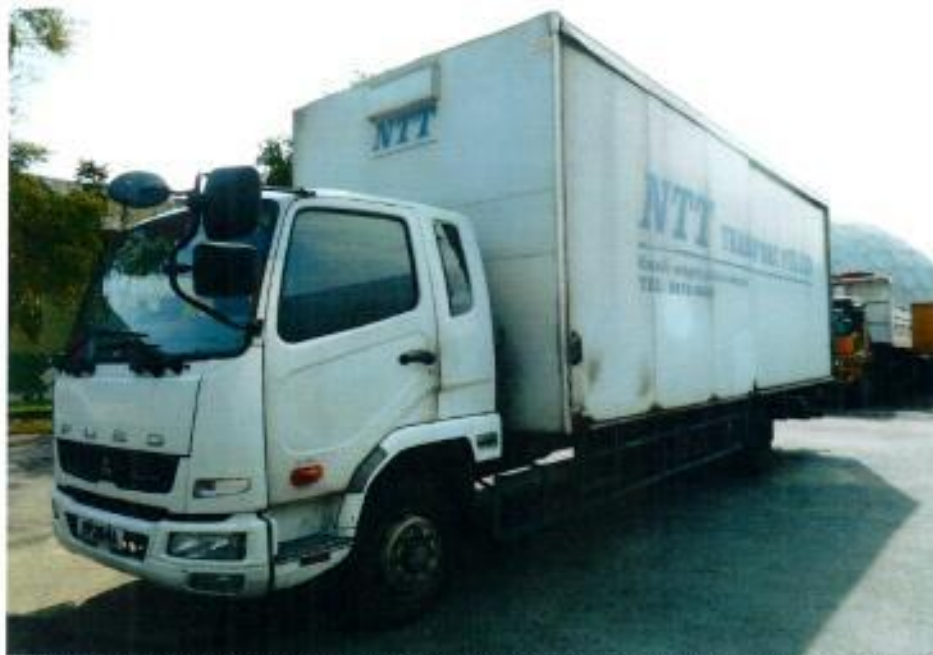
Photo 5 shows a general view of the left body of the Motor Lorry at the time of my inspection. The Motor Lorry was observed to be intact and unaffected by the accident.

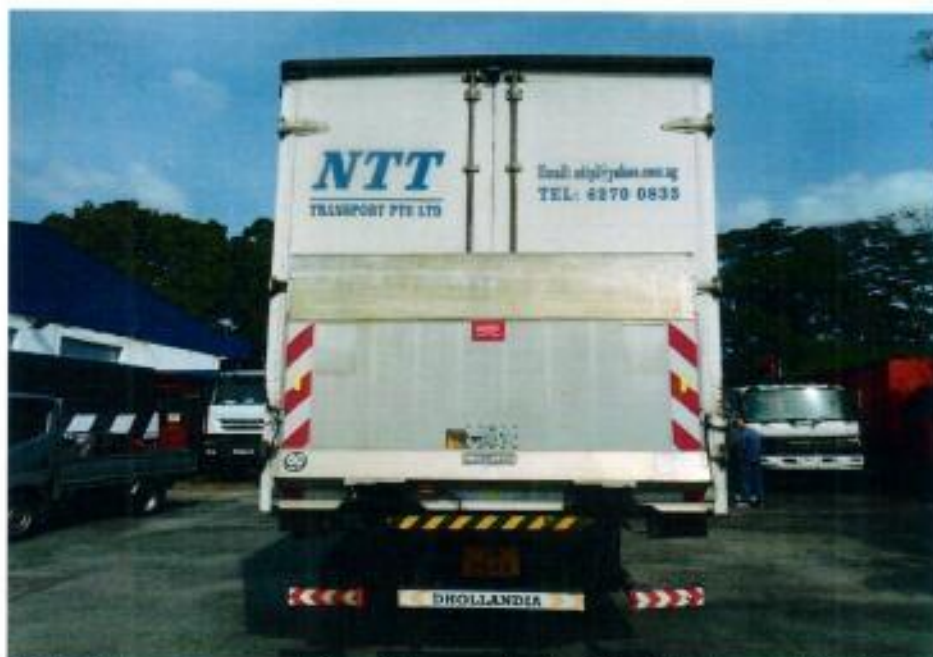
Photo 6 shows a general view of the rear body of the Motor Lorry at the time of my inspection. The Motor Lorry was observed to be intact and unaffected by the accident.

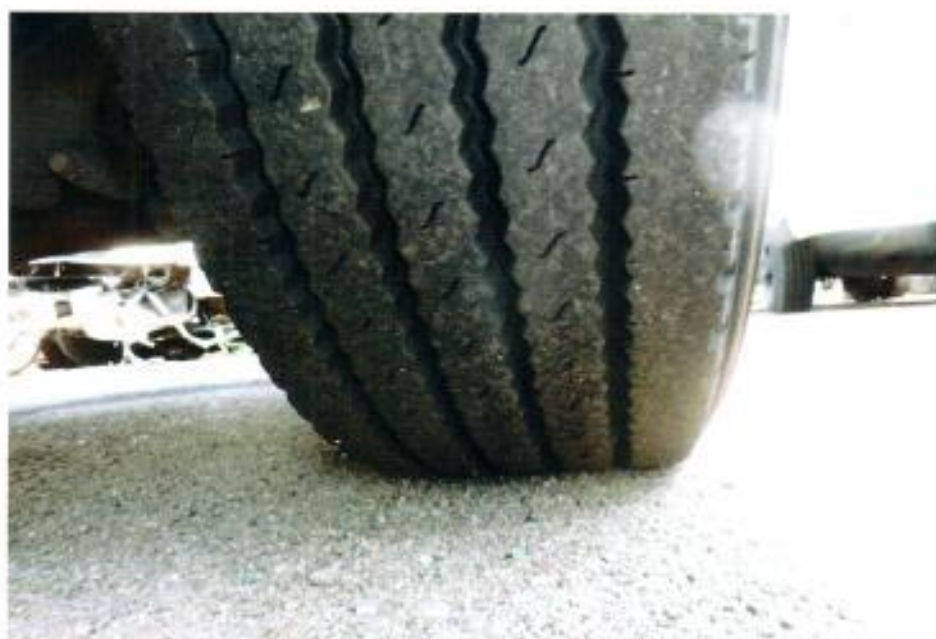
Photo 7 shows the condition of the front right tyre of the Motor Lorry, which was observed to be in serviceable condition with remaining tread depth of approximately 9.3mm. The tyre, which was wrapped around standard steel wheel rim, was also observed to be sufficiently inflated for vehicular operation. There was no tear, cut or burst mark(s) on the outer and the inner sidewalls as well as across the tread of the 6 tyres that were fitted on the Motor Lorry.

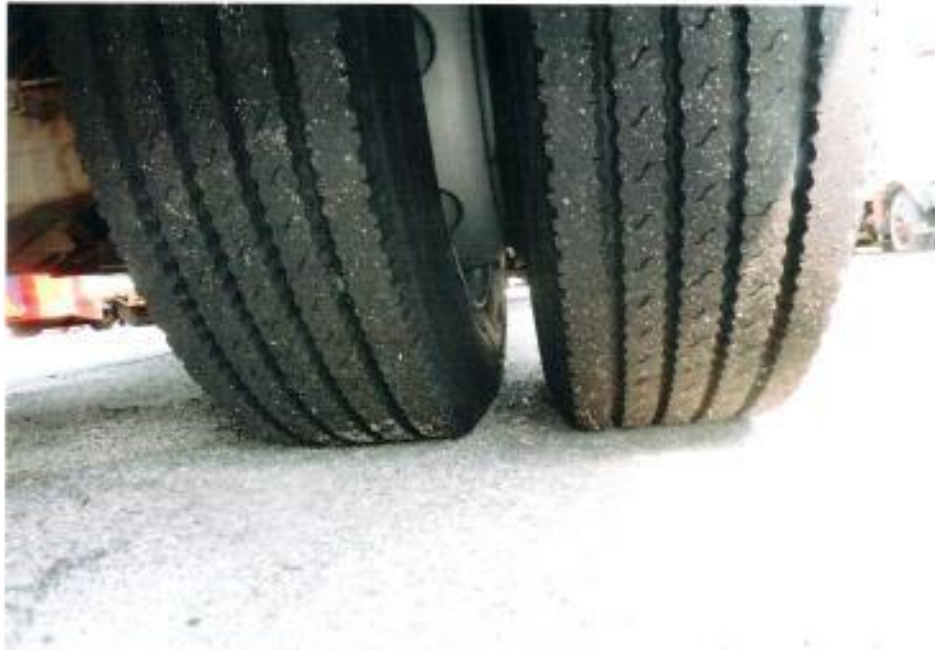
Photo 8 shows the condition of the rear right tyres of the Motor Lorry, which was observed to be in serviceable condition with remaining, tread depth of approximately 9.7mm. The tyres, which were wrapped around standard steel wheel rim, were also observed to be sufficiently inflated for vehicular operation. There was also no damage found on all 6 steel wheel rims of the Motor Lorry.

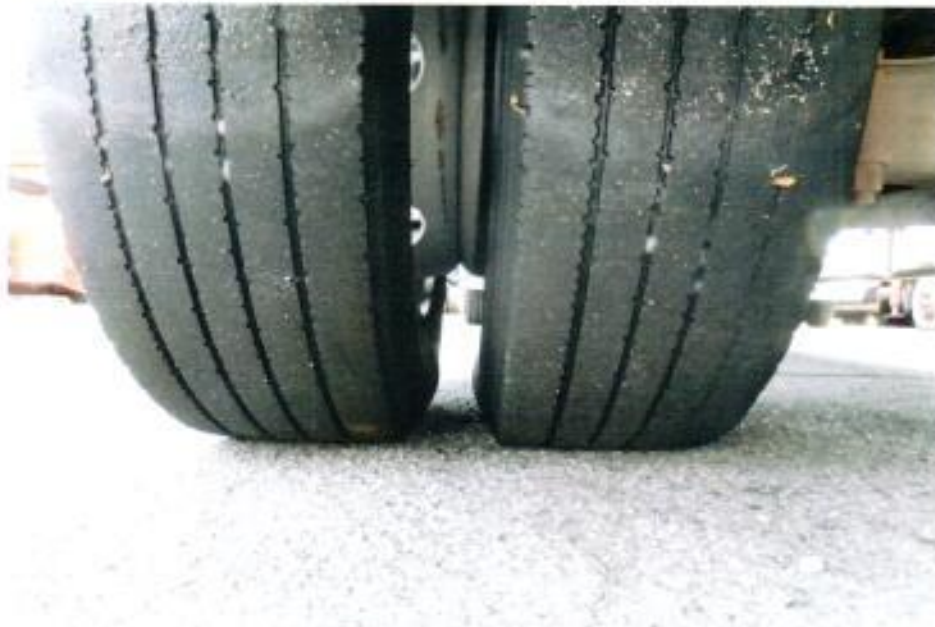
Photo 9 the condition of the rear left tyres of the Motor Lorry, which was observed to be in serviceable condition with remaining, tread depth of approximately 2.9mm. The tyres, which were wrapped around standard steel wheel rim, were also observed to be sufficiently inflated for vehicular operation. There was also no damage found on all 6 steel wheel rims of the Motor Lorry.

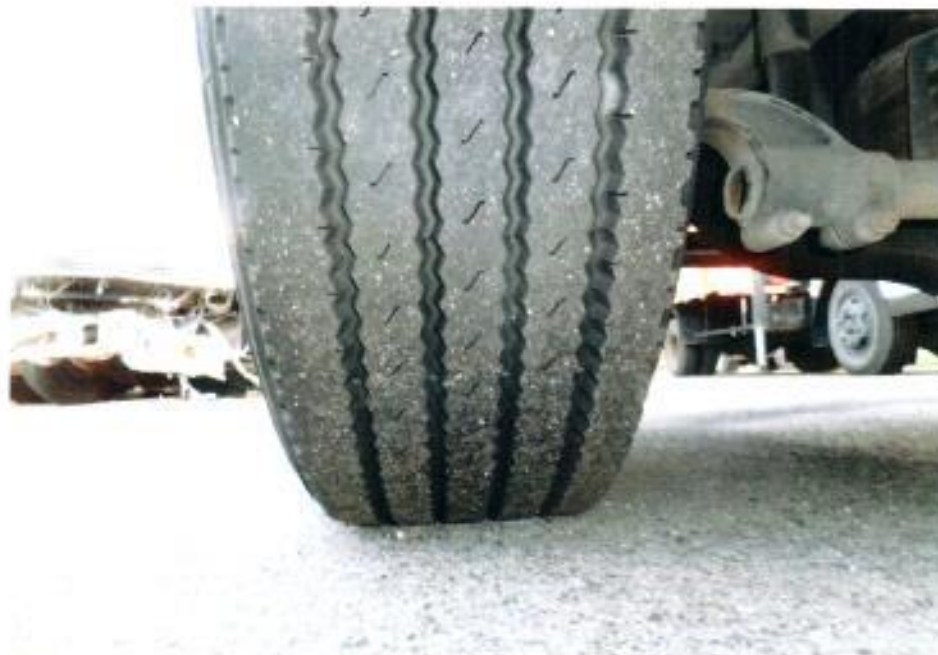
Photo 10 shows the condition of the front left tyre of the Motor Lorry, which were observed to be in serviceable condition with remaining tread depth of approximately 9.3mm. There was also no tear, cut or burst mark(s) on the outer and the inner sidewalls as well as across the tread of the 6 tyres that were fitted on the Motor Lorry.

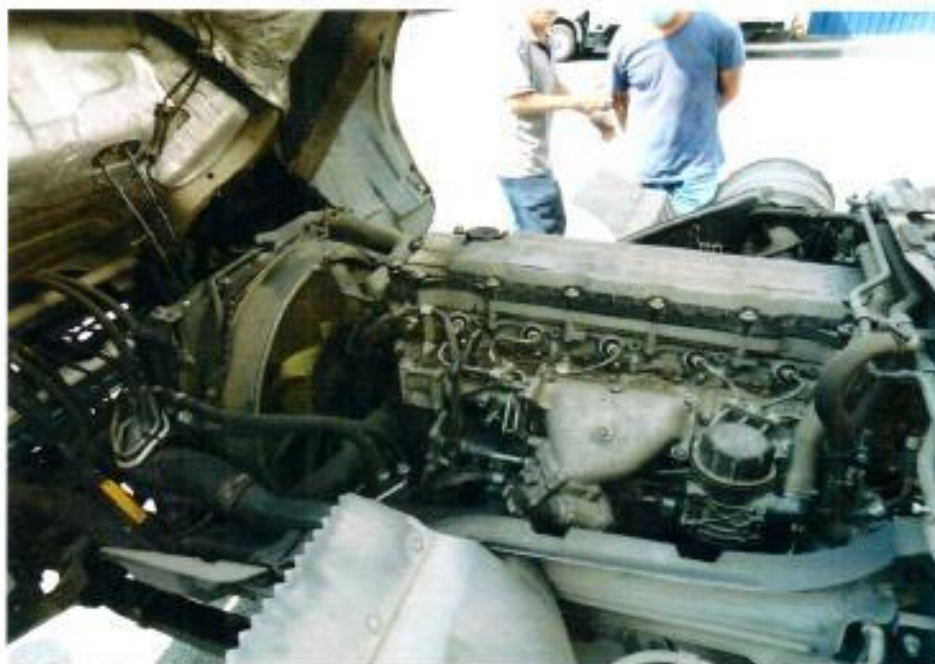
Photo 11 shows a general view of the Motor Lorry's engine compartment, which was accessed by lifting the front cabin of the Motor Lorry. The various parts and components inside the engine compartment were unaffected by the accident. There was also no sign(s) or indication(s) of fresh fluid leakage and/or fluid stain within the engine compartment.

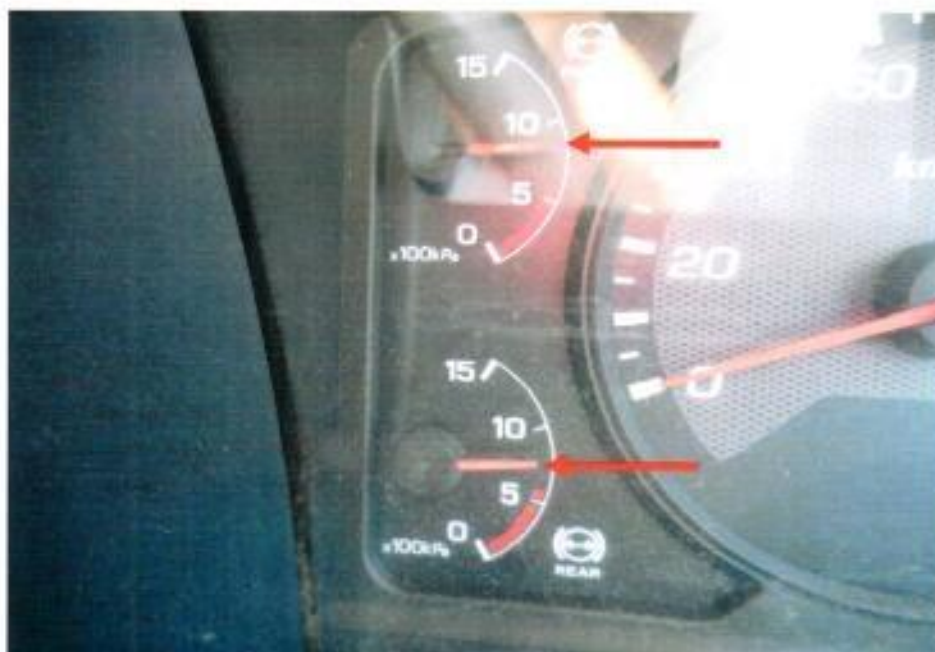
Photo 13 shows the air in the air brake cylinders of the Motor Lorry at the time of my inspection. The air in the cylinder (arrowed) was observed to be of sufficient level & serviceable at the time of the accident.

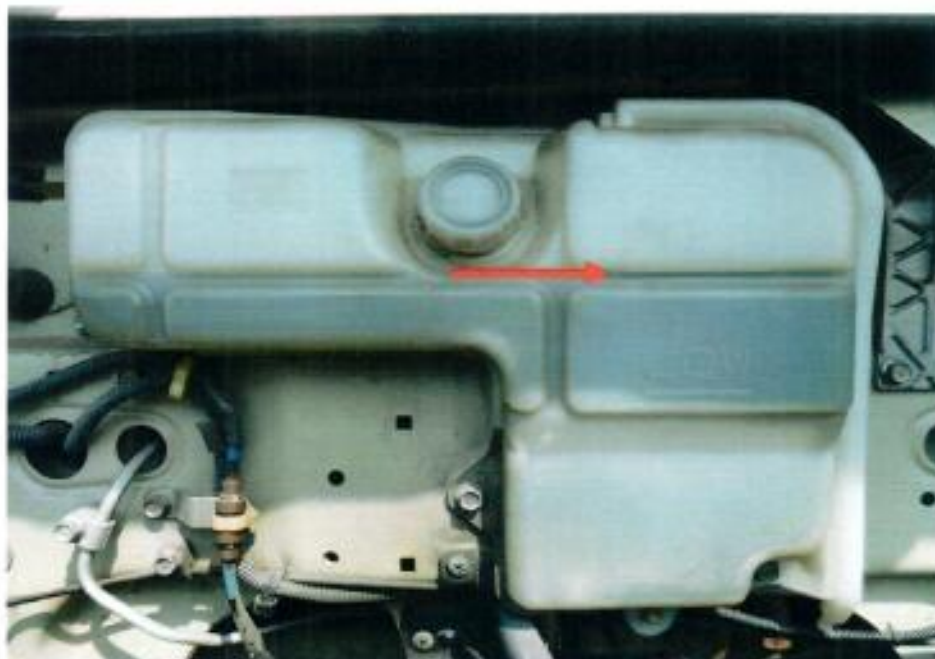
Photo 13 shows the engine coolant reservoir of the Motor Lorry at the time of my inspection. The engine coolant was observed to be of sufficient level (arrowed) and without any visible contamination.

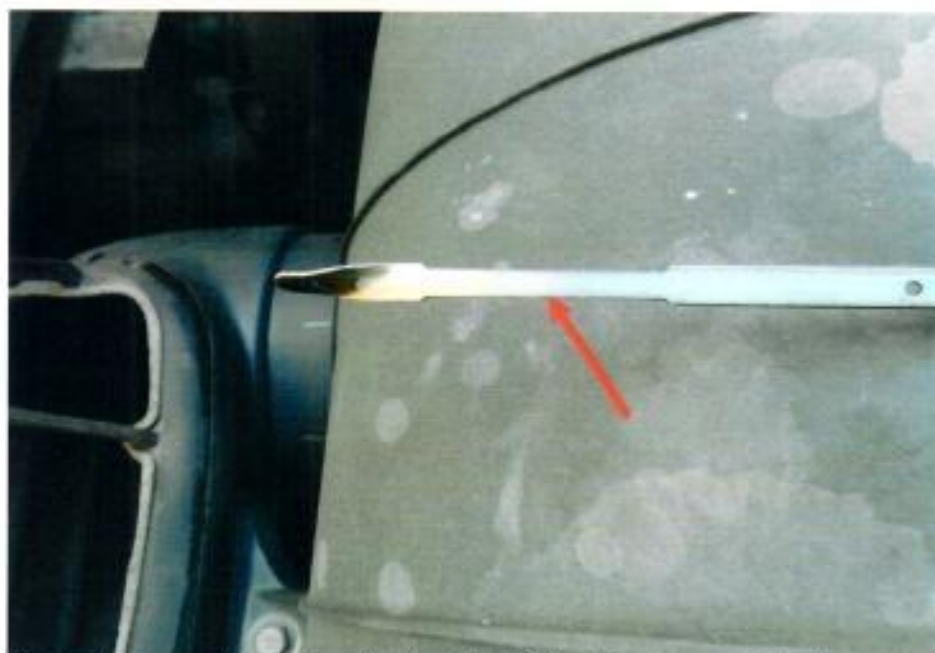
Photo 14 shows the engine oil dip stick of the Motor Lorry at the time of my inspection. The engine oil was observed to be of sufficient level (arrowed) and without any visible contamination.

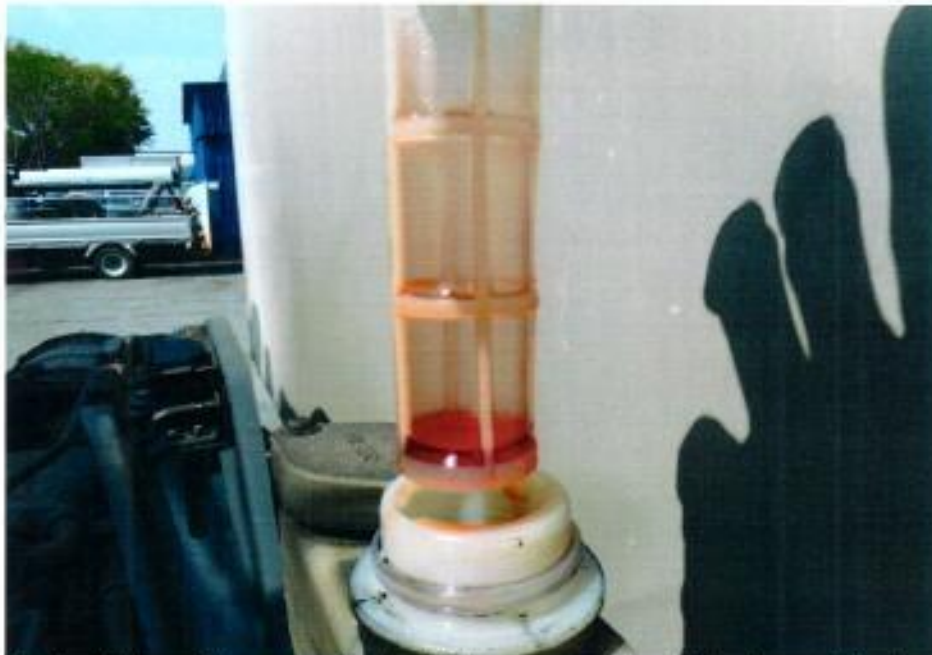
Photo 15 shows the power steering fluid reservoir of the Motor Lorry at the time of my inspection. The power steering fluid was observed to be of sufficient level and without any visible contamination.

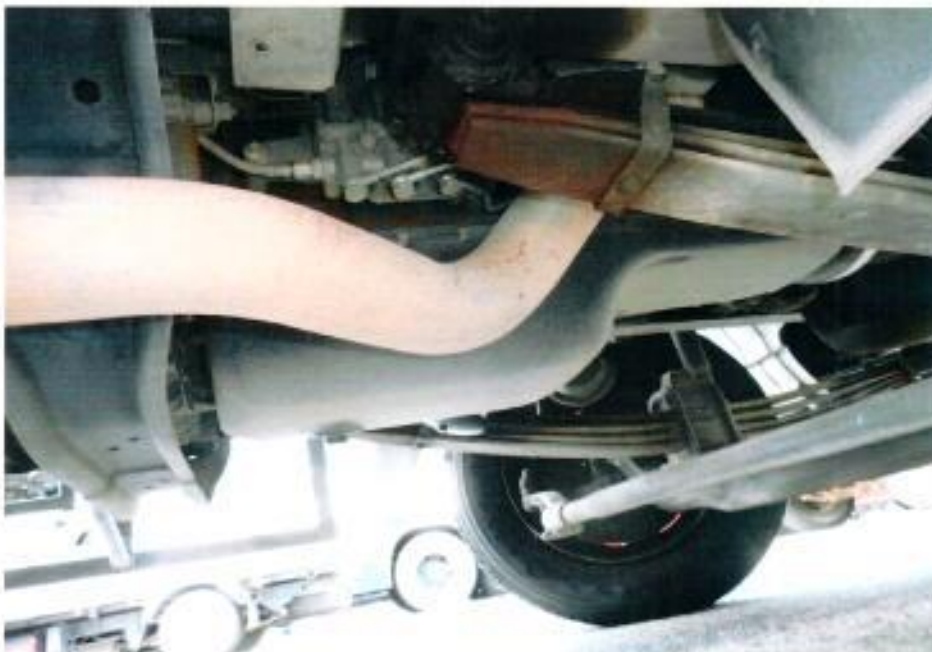
Photo 16 shows the undercarriage of the Motor Lorry, at the area where the engine housing and transmission housing are located. I did not observe any leakage or fluid stain on the underside of the Motor Lorry.

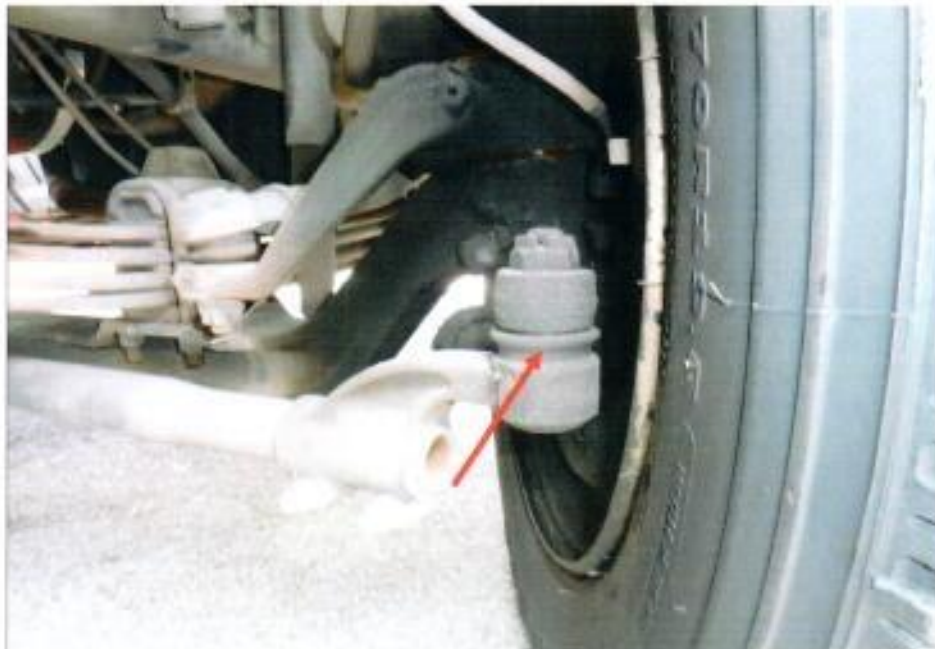
Photo 17 shows the various undercarriage components at the front right wheel of the Motor Lorry, in particular the steering tie rod end (arrowed). The various steering components were all found to be intact, suggesting that the steering system of the Motor Lorry was likely to be in serviceable condition at the material time of accident. There was also no sign of fluid stain(s) observed on the various undercarriage components.

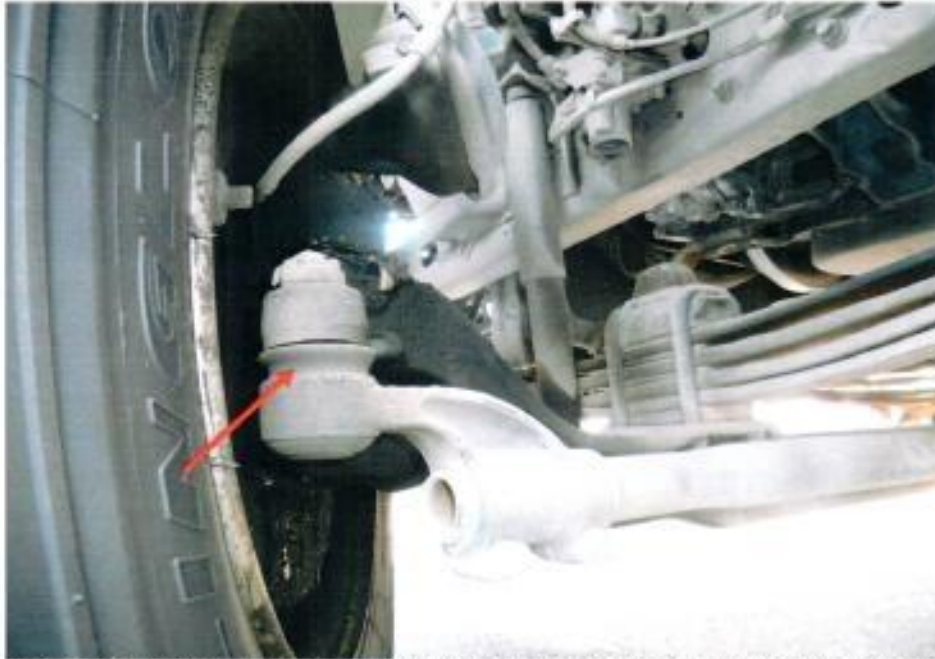
Photo 18 shows the various undercarriage components at the front left wheel of the Motor Lorry, in particular the steering tie rod end (arrowed). The various Undercarriage components of the Motor Lorry were all found to be intact without any visible damage. There was also no sign of fluid stain(s) observed on the various undercarriage components.

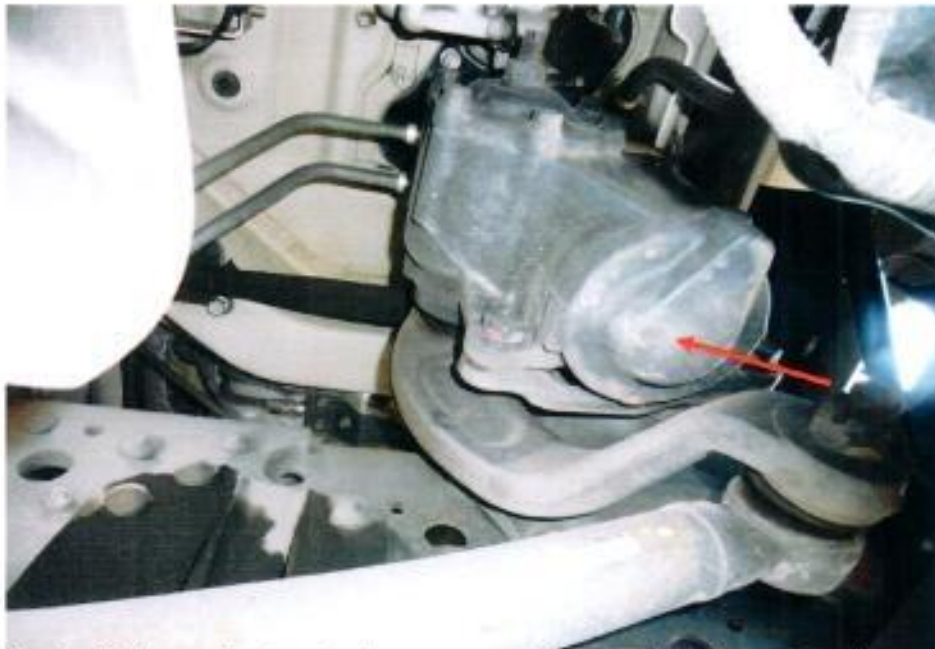
Photo 19 shows the steering box component (arrowed) at the undercarriage of the Motor Lorry was found to be intact without any visible damage. There was also no sign of fluid stain(s) observed on the various undercarriage components.

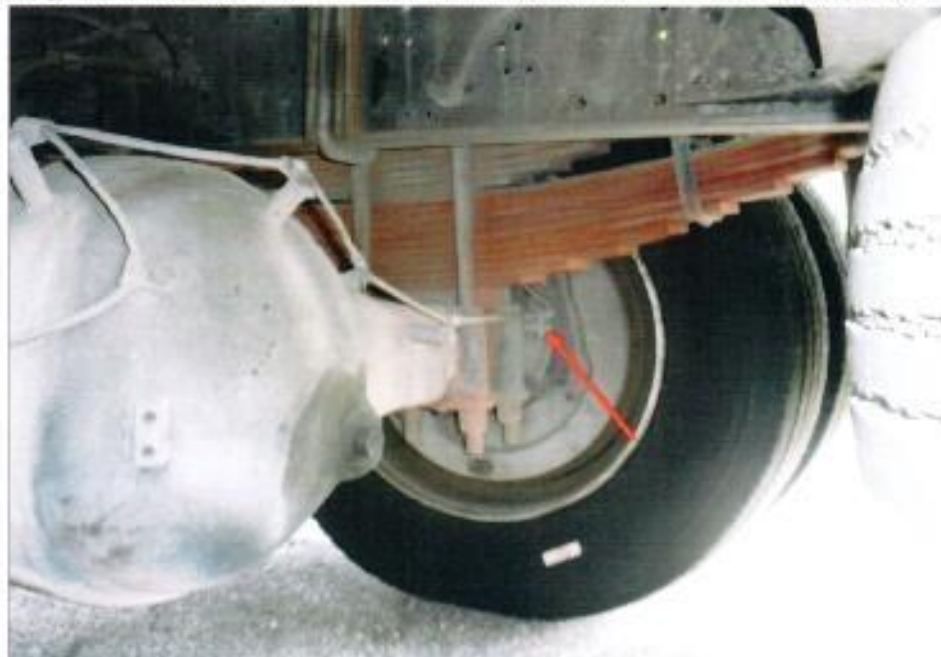
Photo 20 shows the brake pipe (arrowed) at the rear right wheel of the Motor Lorry. I did not observe any leakage of brake fluid at the time of my inspection of the Motor Lorry. My static tests of the Motor Lorry's braking system, along with my visual examination of the various mechanical components in the braking system, had indicated that there was no internal leakage of pressure/vacuum. Hence the braking system of the Motor Lorry was likely to be in serviceable condition at the material time of accident.

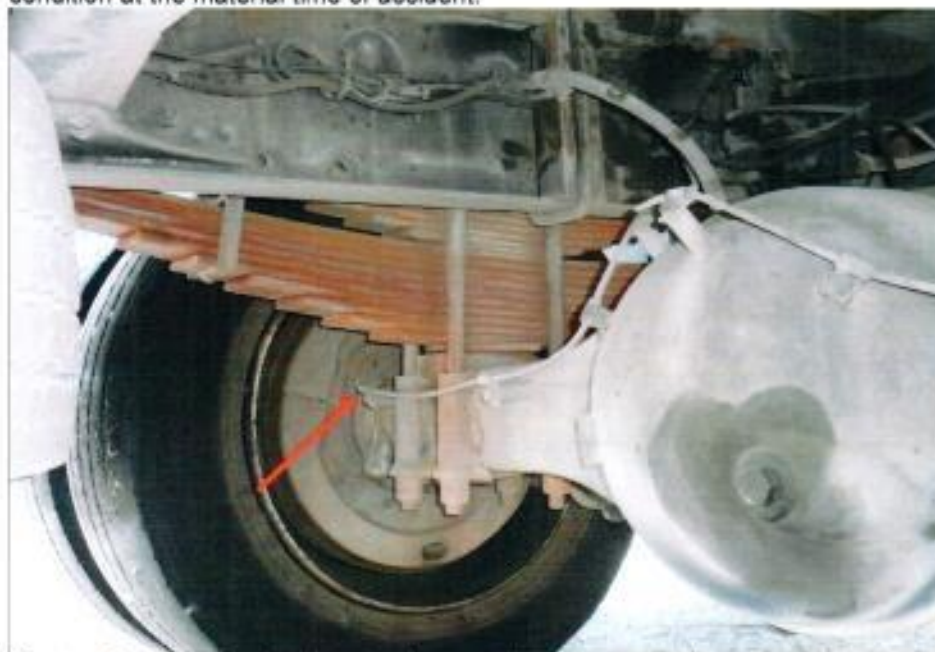
Photo 21 shows the brake pipe (arrowed) at the rear left wheel of the Motor Lorry. I did not observe any leakage of brake fluid at the time of my inspection of the Motor Lorry. My static tests of the Motor Lorry's braking system, along with my visual examination of the various mechanical components in the braking system had indicated that there was no internal leakage of pressure/vacuum. Hence the braking system of the Motor Lorry was likely to be in serviceable condition at the material time of accident.

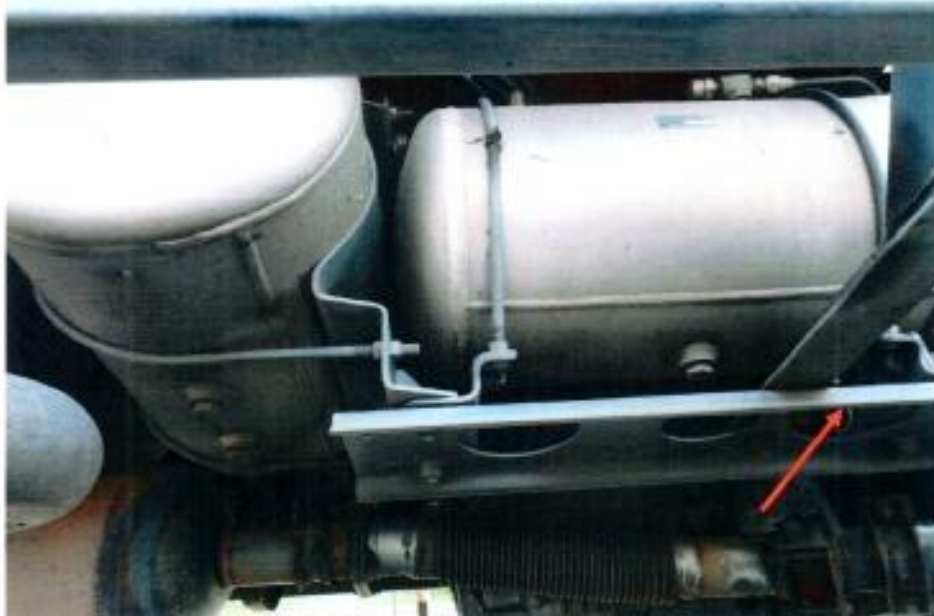
Photo 22 shows the air brake cylinders (arrowed) at the undercarriage of the Motor Lorry. I did not observe any leakage of air brake fluid at the time of my inspection of the Motor Lorry. My static tests of the Motor Lorry's braking system, along with my visual examination of the various mechanical components in the braking system had indicated that there was no internal leakage of pressure/vacuum. Hence the braking system of the Motor Lorry was likely to be in serviceable condition at the material time of accident.

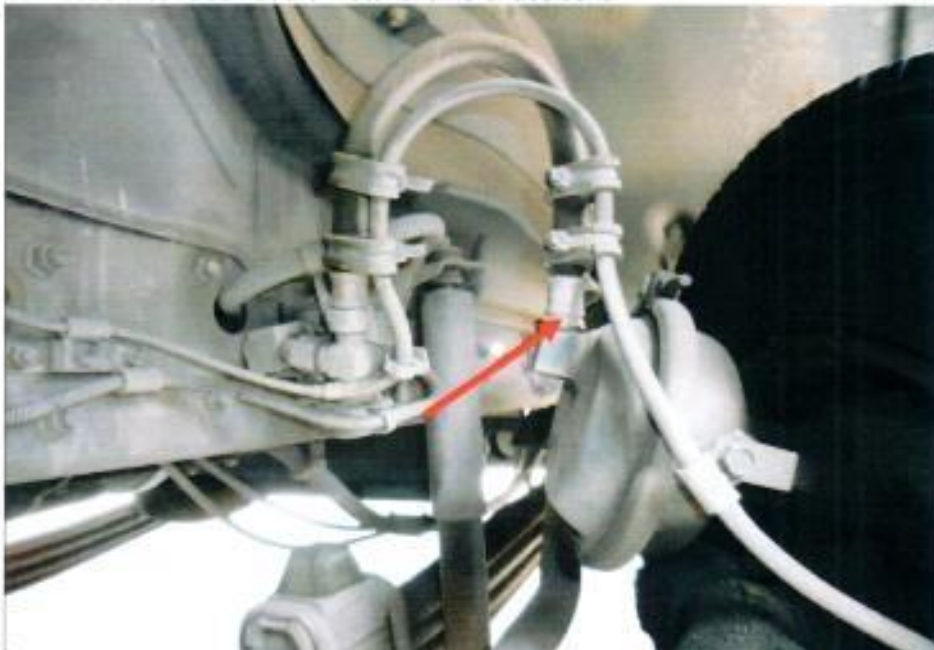
Photo 23 shows the brake hose/pipe (arrowed) at the front right wheel of the Motor Lorry. I did not observe any leakage of brake fluid at the time of my inspection of the Motor Lorry. My static tests of the Motor Lorry's braking system, along with my visual examination of the various mechanical components in the braking system had indicated that there was no internal leakage of pressure/vacuum. Hence the braking system of the Motor Lorry was likely to be in serviceable condition at the material time of accident.

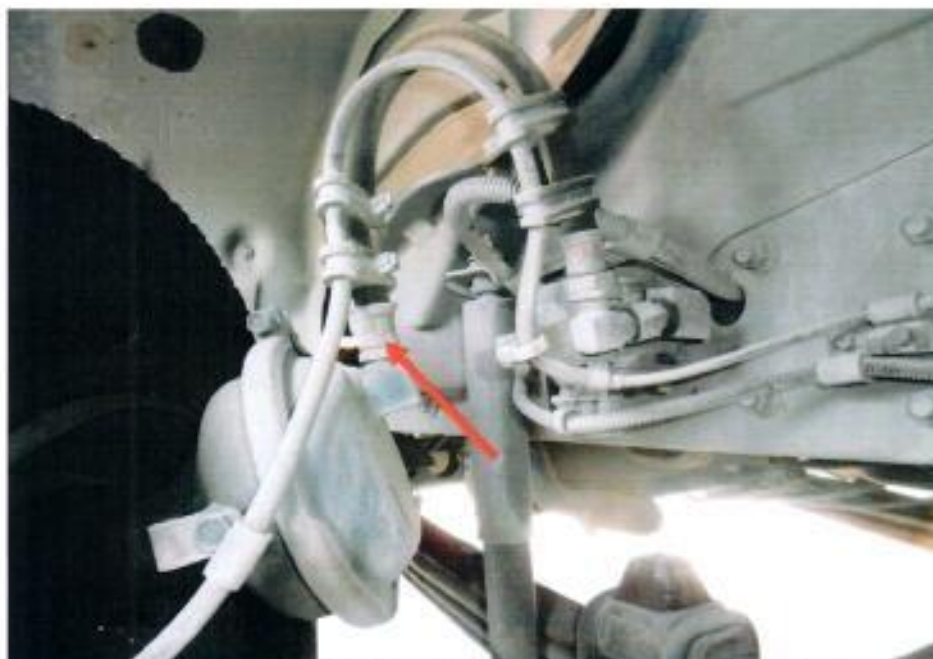
Photo 24 shows the brake hose/pipe (arrowed) at the front left wheel of the Motor Lorry. I did not observe any leakage of brake fluid at the time of my inspection of the Motor Lorry. My static tests of the Motor Lorry's braking system, along with my visual examination of the various mechanical components in the braking system had indicated that there was no internal leakage of pressure/vacuum. Hence the braking system of the Motor Lorry was likely to be in serviceable condition at the material time of accident.

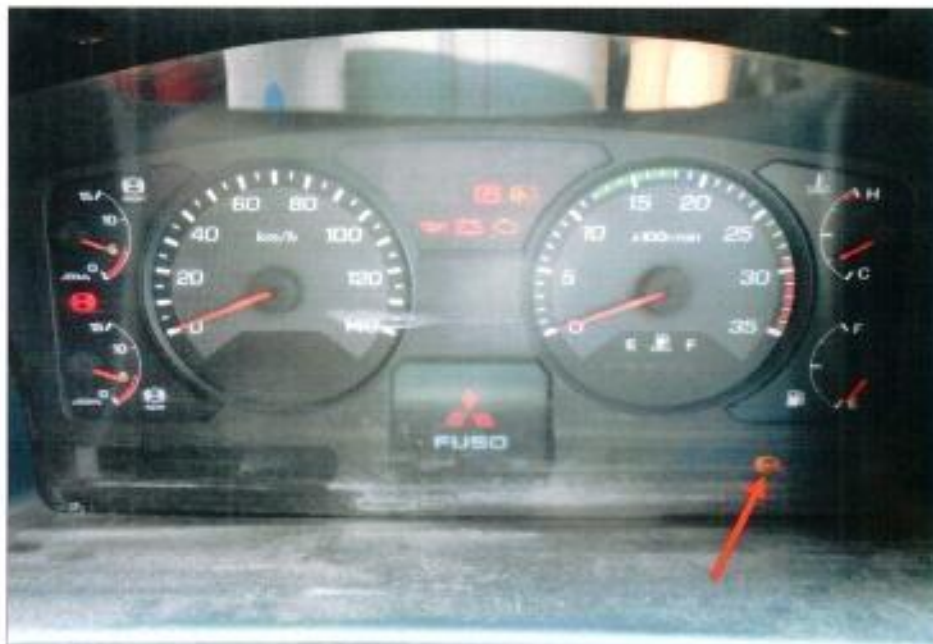
Photo 26 shows the warning light for Anti-Lock Brake System (ABS) (arrowed) appearing on the instrument panel of the Motor Lorry during the self-test of its various electronic operating systems when its engine was cranked.

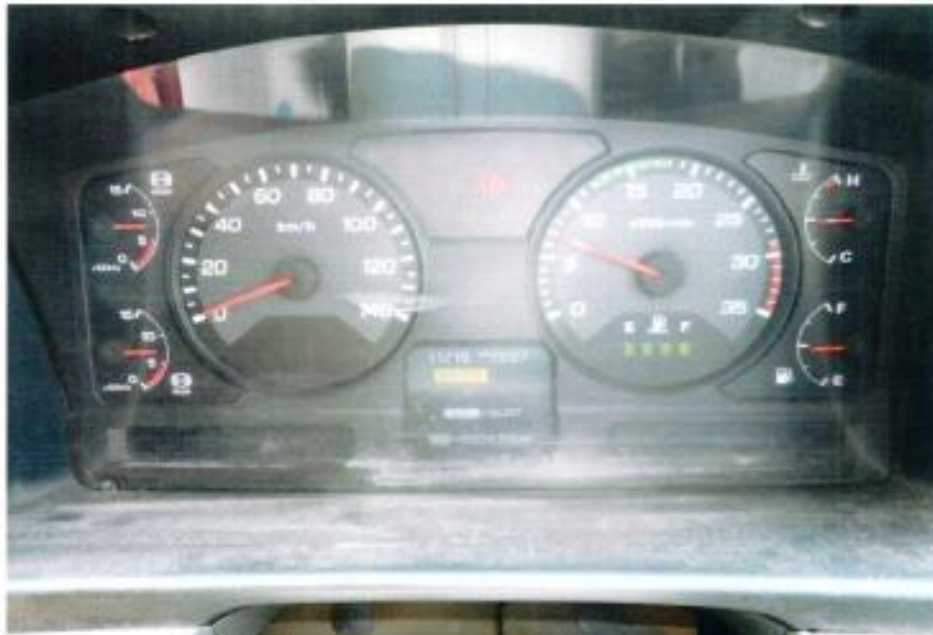
Photo 27 shows no warning lights illuminated on the instrument panel of the Motor Lorry after the engine was cranked. This would suggest that there was no abnormality to the electronic operating system of the Motor Lorry, like the ABS and etc.
