Your Ref: TP/IP/61167/2019  
Our Ref : CI/TPD20003593/P

**Fatal Accident Investigation Team**

**MECHANICAL INSPECTION REPORT OF MOTOR TAXI SHC 4668L**

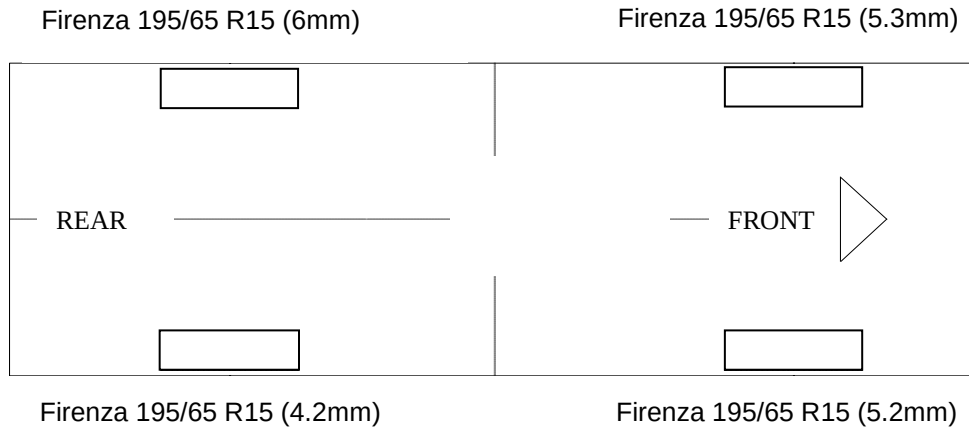
6. The 4 tyres of the Motor Taxi were observed to be in serviceable condition and sufficiently inflated for vehicular operation. I did not find any tear, cut or burst mark(s) on the outer and the inner sidewalls as well as across the tread of the 4 tyres. The tyre brand, tyre size and remaining tread depth of the 4 tyres of the Motor Taxi were recorded as follows:-

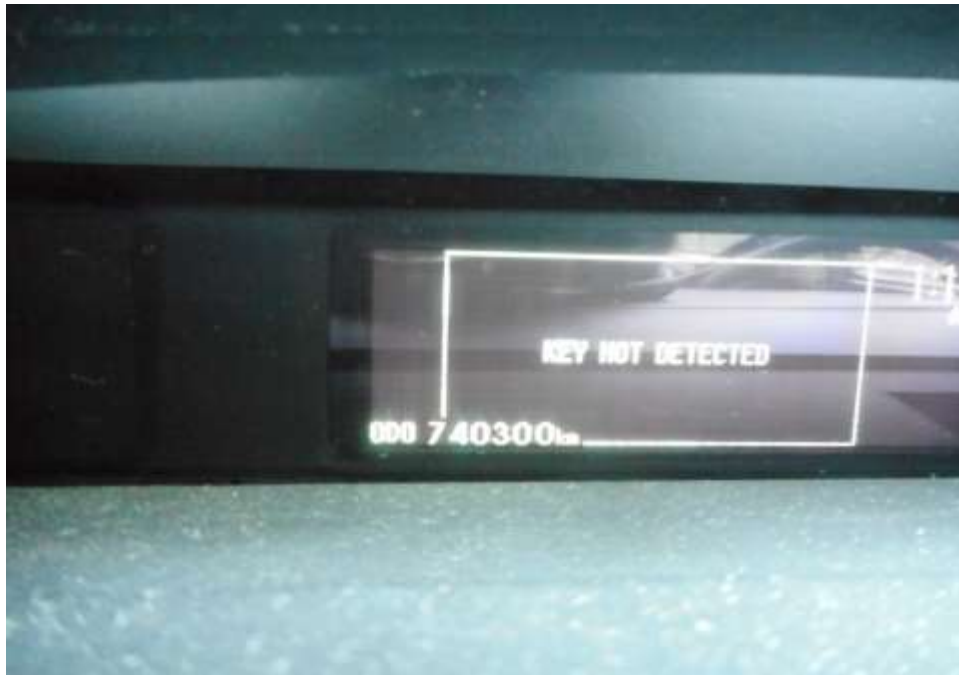
**Photo 1** shows a general view of the instrument cluster of the Motor Taxi at the time of my inspection. The mileage of the Motor Taxi was 740,300km

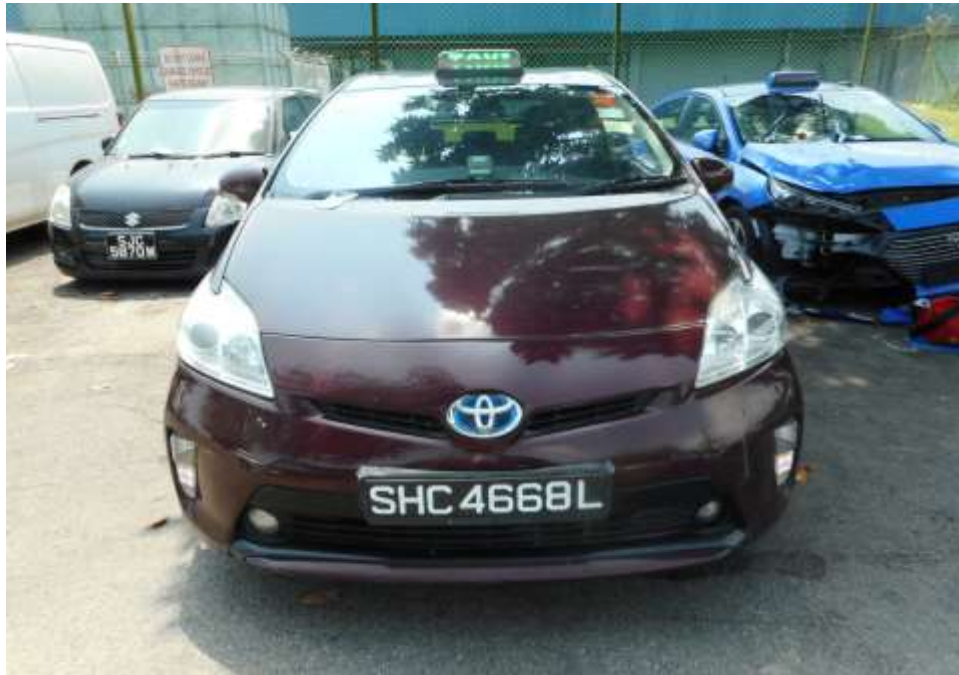
**Photo 2** shows a general view of the Motor Taxi front portion at the time of my inspection. The Motor Taxi was observed to be intact and unaffected by the accident

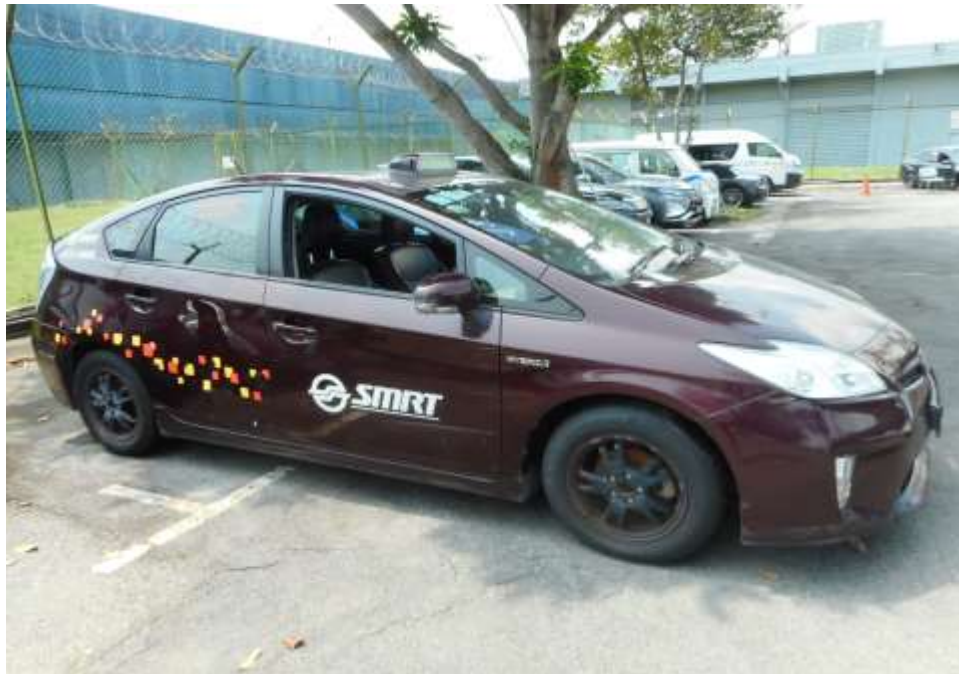
4. The mileage of the Motor Taxi at the time of my inspection was 740,300km.
5. There was visible damage observed on Motor Taxi's right side door panel portion at the time of my inspection.

**Photo 3** shows a general view of the right body of the Motor Taxi at the time of my inspection. The Motor Taxi was observed to visually sustain damage at its right side door panel portion.

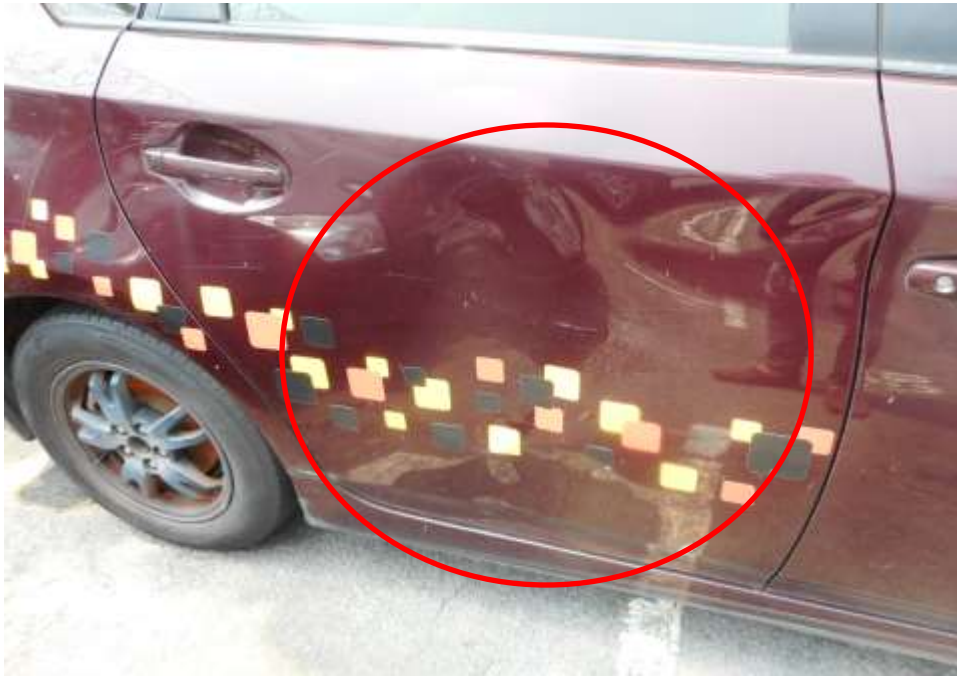
**Photo 4** shows a close up view of the right body of the Motor Taxi at the time of my inspection. The Motor Taxi was observed to visually sustain damage at its right side door panel portion (circled).

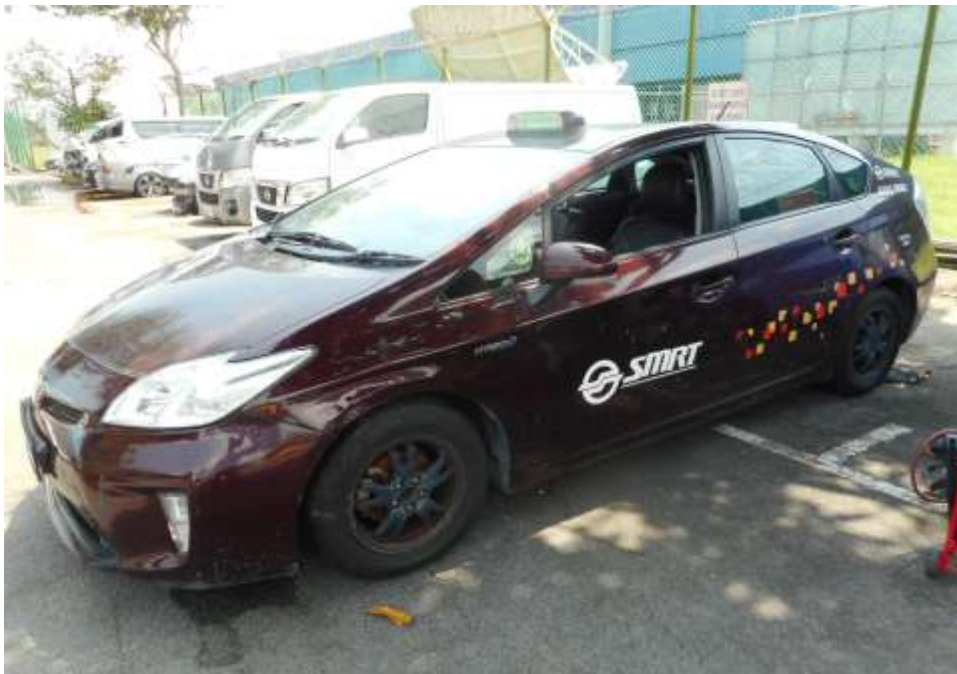
**Photo 5** shows a general view of the left body of the Motor Taxi at the time of my inspection. The Motor Taxi was observed to be intact and unaffected by the accident.

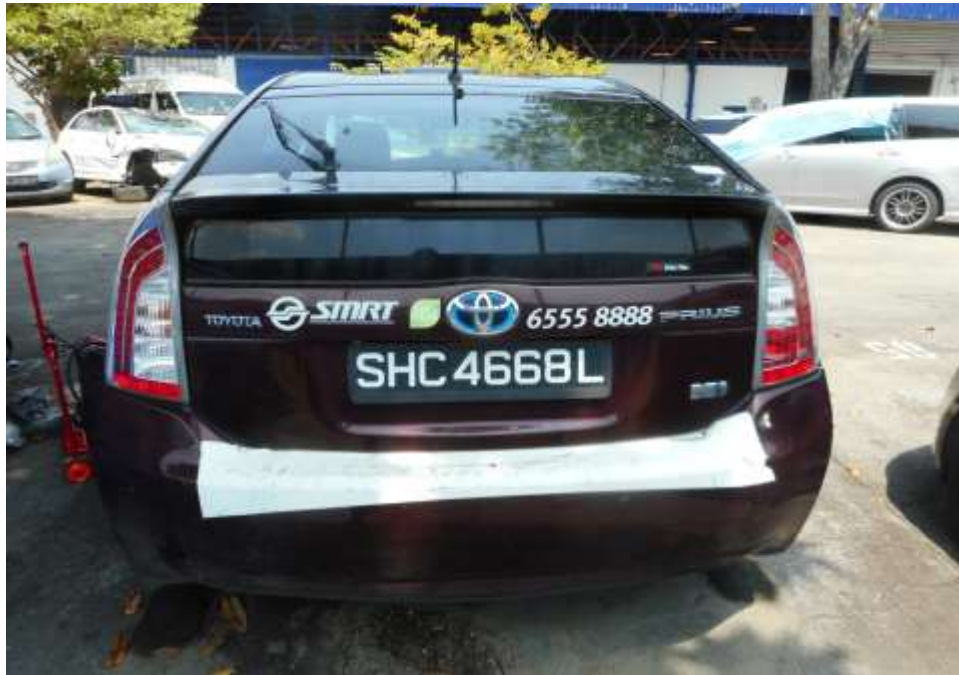
**Photo 6** shows a general view of the rear body of the Motor Taxi at the time of my inspection. The Motor Taxi was observed to be intact and unaffected by the accident.

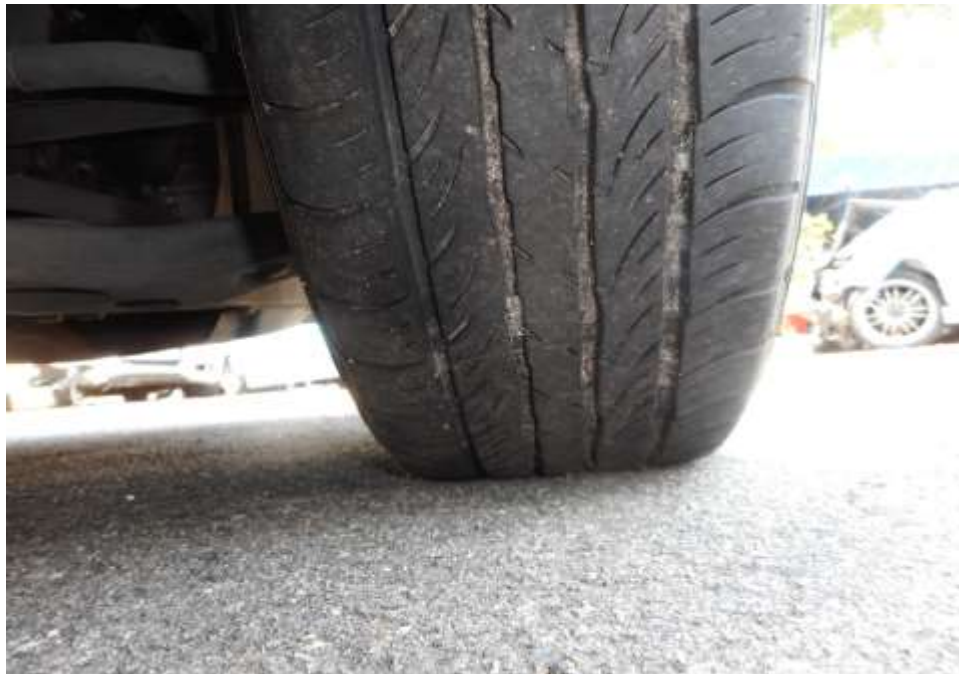
**Photo 7** shows the condition of the front right tyre of the Motor Taxi, which was observed to be in serviceable condition with remaining tread depth of approximately 5.2mm. The tyre, which was wrapped around standard alloy wheel rim, was also observed to be sufficiently inflated for vehicular operation. There was no tear, cut or burst mark(s) on the outer and the inner sidewalls as well as across the tread of the 4 tyres that were fitted on the Motor Taxi.

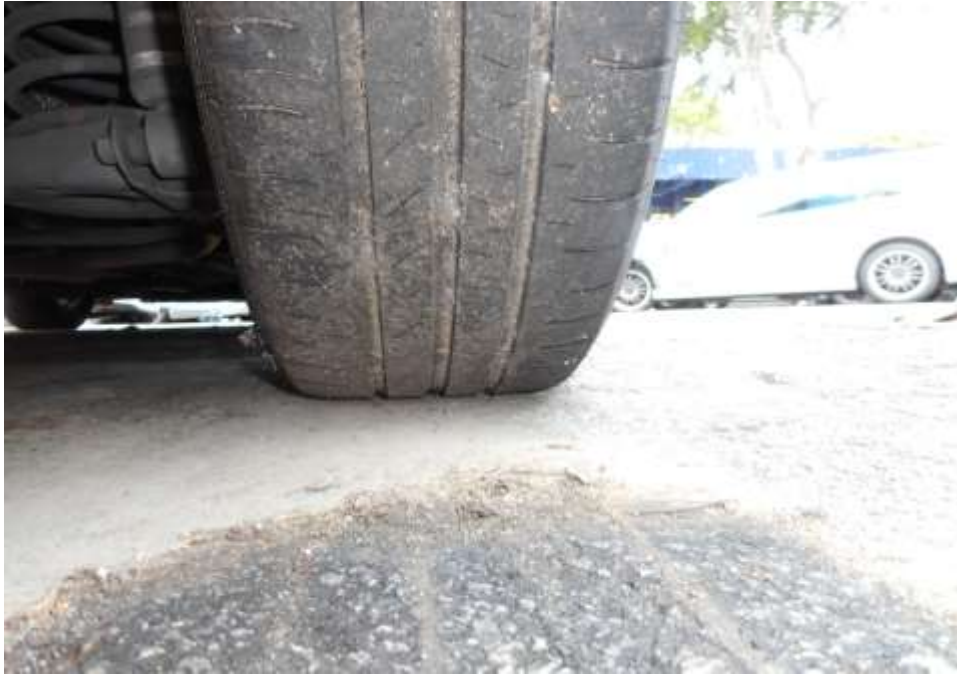
**Photo 8** shows the condition of the rear right tyre of the Motor Taxi, which was observed to be in serviceable condition with remaining tread depth of approximately 4.2mm. The tyre, which was wrapped around standard alloy wheel rim, was also observed to be sufficiently inflated for vehicular operation.

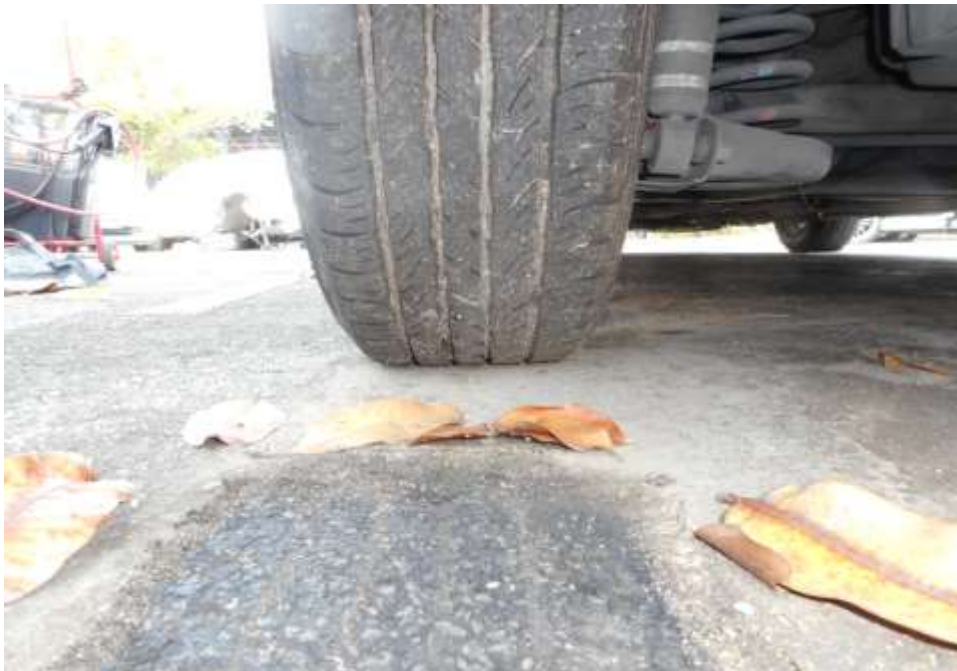
**Photo 9** shows the condition of the rear left tyres of the Motor Taxi, which was observed to be in serviceable condition with remaining tread depth of approximately 6mm. The tyres, which were wrapped around standard alloy wheel rim, were also observed to be sufficiently inflated for vehicular operation. There was also no damage found on all 4 alloy wheel rims of the Motor Taxi.

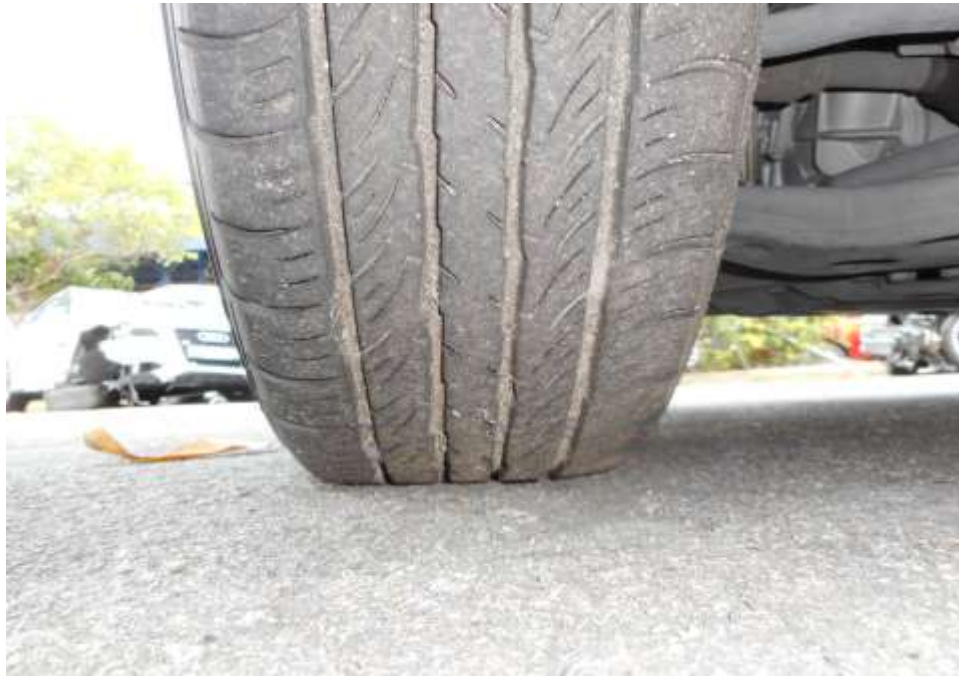
**Photo 10** shows the condition of the rear right tyres of the Motor Taxi, which were observed to be in serviceable condition with remaining, tread depth of approximately 5.3mm. There was also no tear, cut or burst mark(s) on the outer and the inner sidewalls as well as across the tread of the 4 tyres that were fitted on the Motor Taxi.

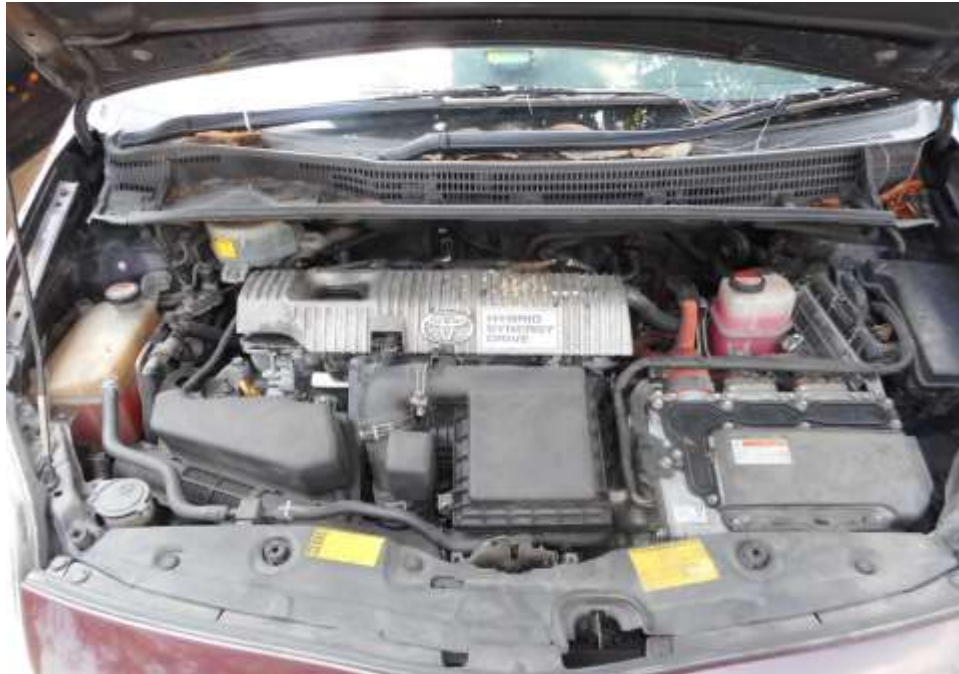
**Photo 11** shows a general view of the Motor Taxi's engine compartment, which was accessed by lifting the front cabin of the Motor Taxi. The various parts and components inside the engine compartment were unaffected by the accident. There was also no sign(s) or indication(s) of fresh fluid leakage and/or fluid stain within the engine compartment

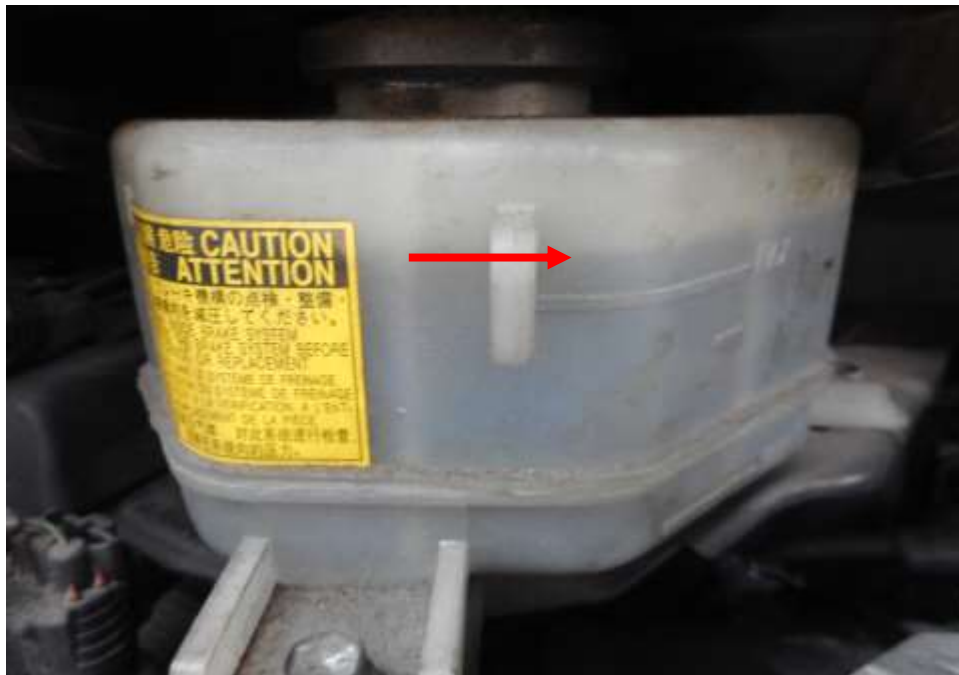
**Photo 12** shows the brake fluid reservoir of the Motor Taxi at the time of my inspection. The brake fluid was observed to be of sufficient level (arrowed) and without any visible contamination.

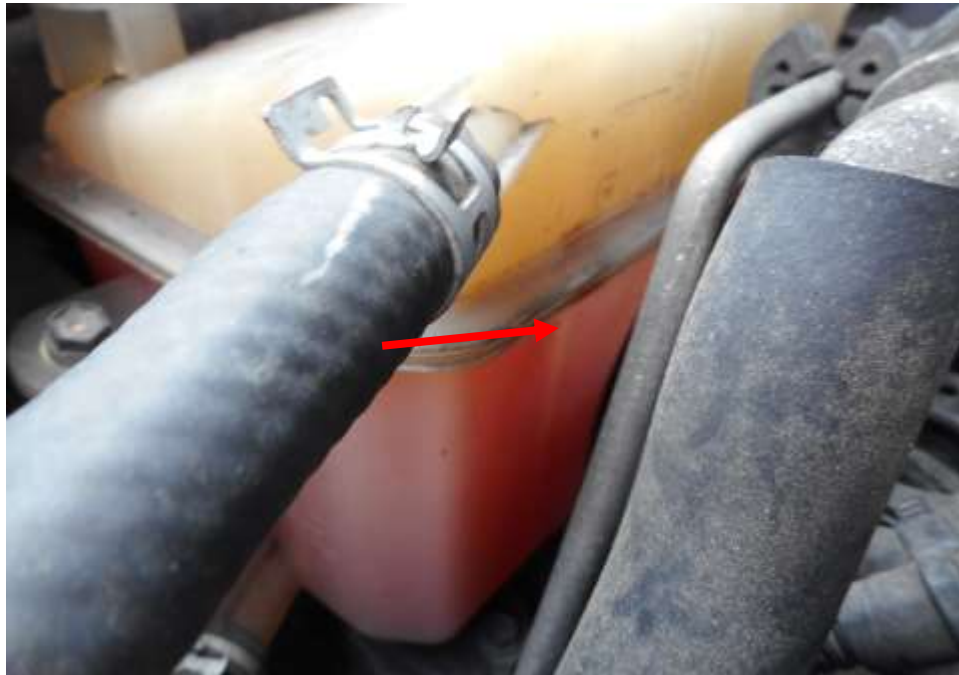
**Photo 13** shows the engine coolant reservoir of the Motor Taxi at the time of my inspection. The engine coolant was observed to be of sufficient level (arrowed) and without any visible contamination.

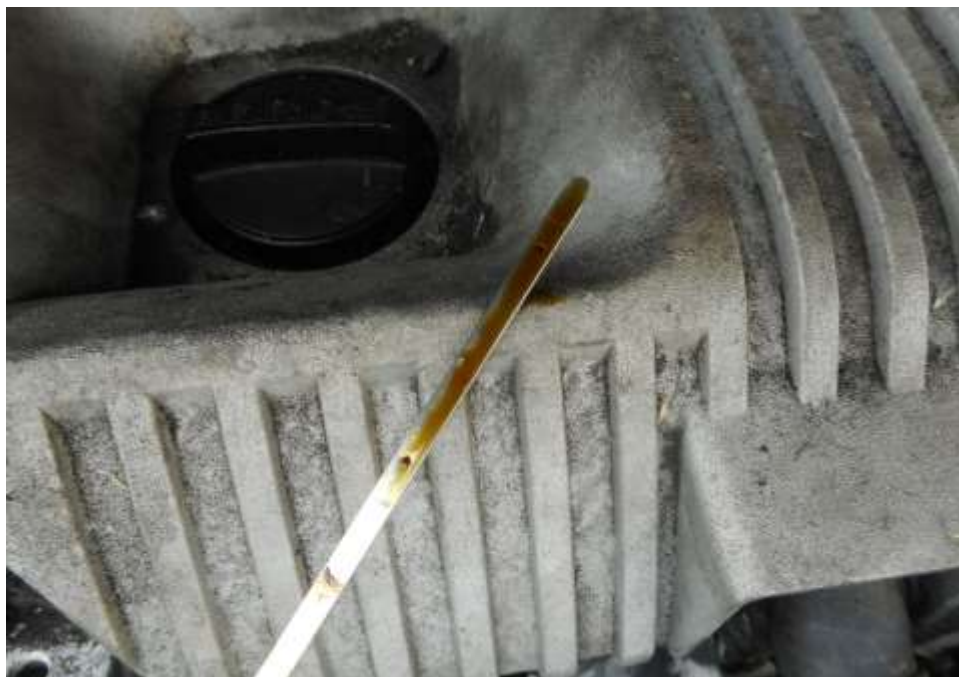
**Photo 14** shows the engine oil dip stick of the Motor Taxi at the time of my inspection. The engine oil was observed to be of sufficient level and without any visible contamination.

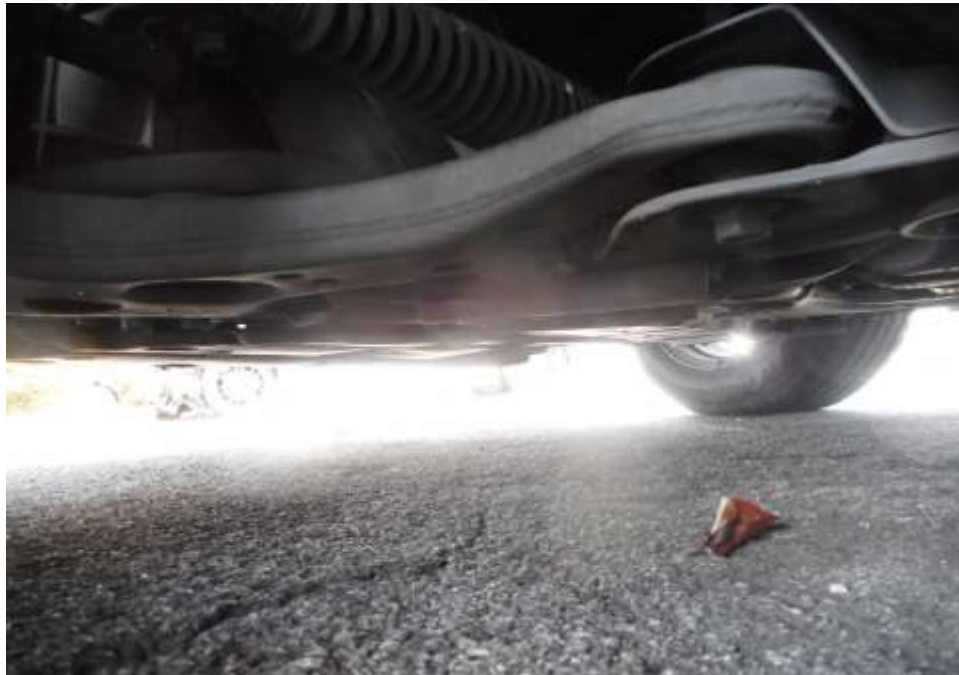
**Photo 15** shows the undercarriage of the Motor Taxi, at the area where the engine housing and transmission housing are located. . I did not find any sign(s) or indication(s) of fluid leak and/or fluid stain(s) on the underside of the Motor Taxi.

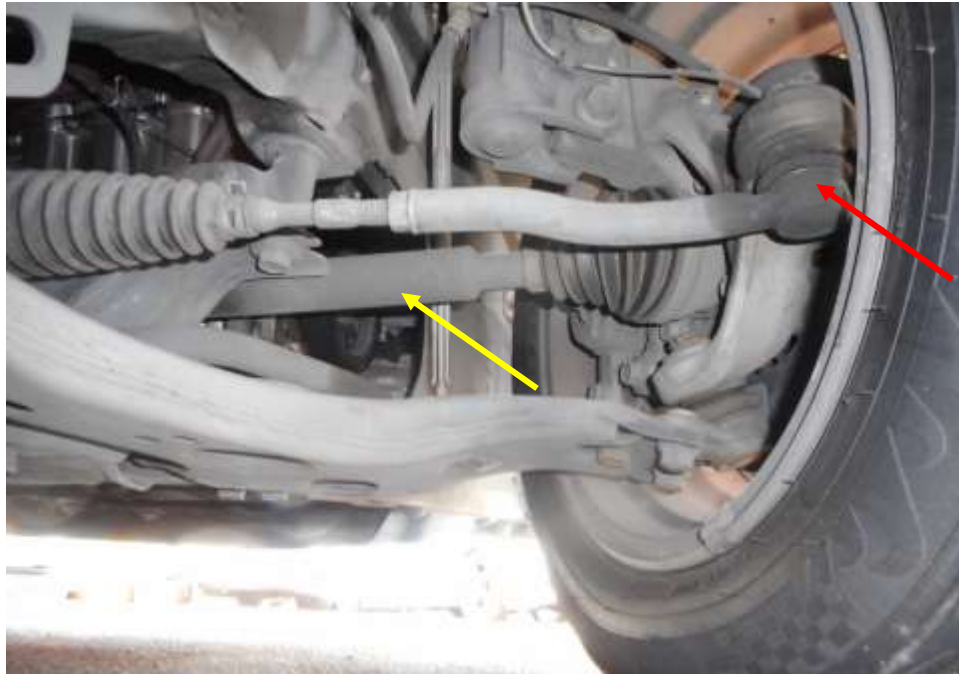
**Photo 16** shows the various undercarriage components at the front right wheel of the Motor Taxi, in particular the steering tie rod end (arrowed) and drive shaft (yellow arrow). The various steering components were all found to be intact, suggesting that the steering system of the Motor Taxi was likely to be in serviceable condition at the material time of accident. There was also no sign of fluid stain(s) observed on the various undercarriage components.

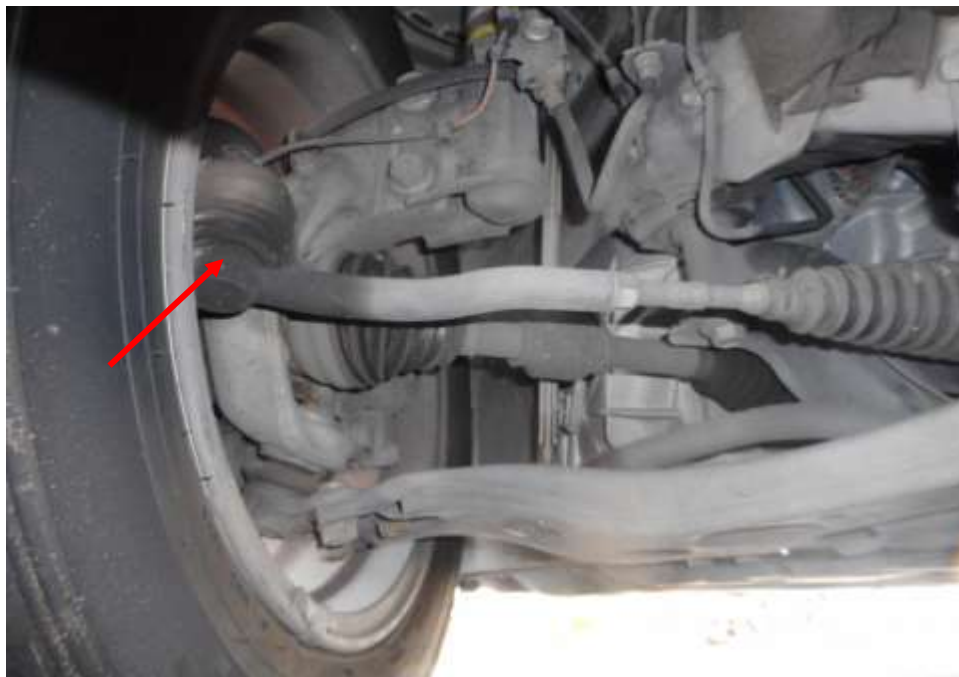
**Photo 17** shows the various undercarriage components at the front left wheel of the Motor Taxi, in particular the steering tie rod end (arrowed). The various Undercarriage components of the Motor Taxi were all found to be intact without any visible damage. There was also no sign of fluid stain(s) observed on the various undercarriage components.

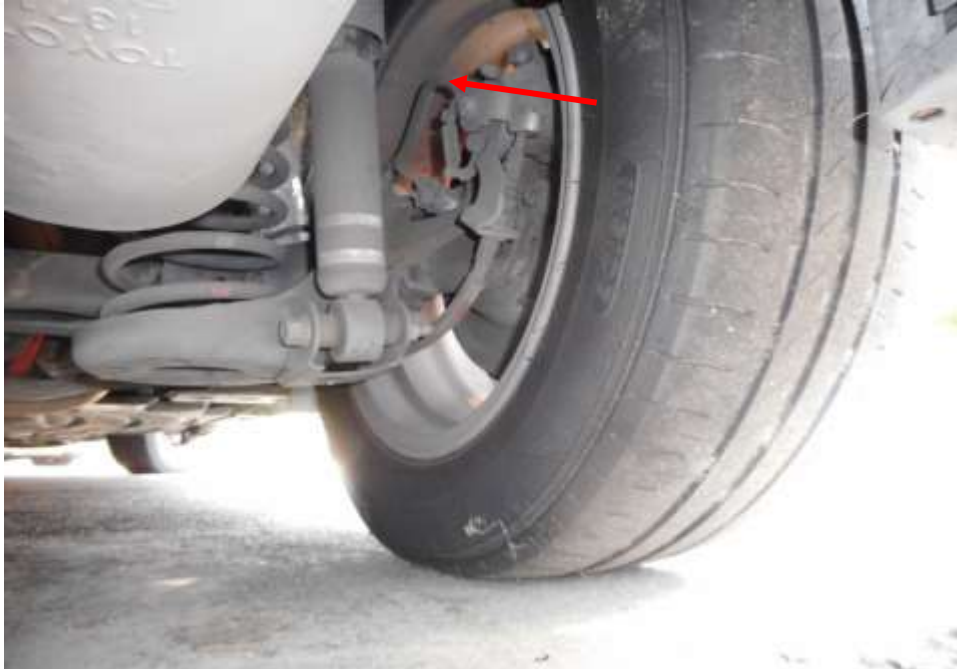
**Photo 18** shows the brake pipe (arrowed) at the rear right wheel of the Motor Taxi. I did not observe any leakage of brake fluid at the time of my inspection of the Motor Taxi. My static tests of the Motor Taxi's braking system, along with my visual examination of the various mechanical components in the braking system, had indicated that there was no internal leakage of pressure/vacuum. Hence the braking system of the Motor Taxi was likely to be in serviceable condition at the material time of accident.

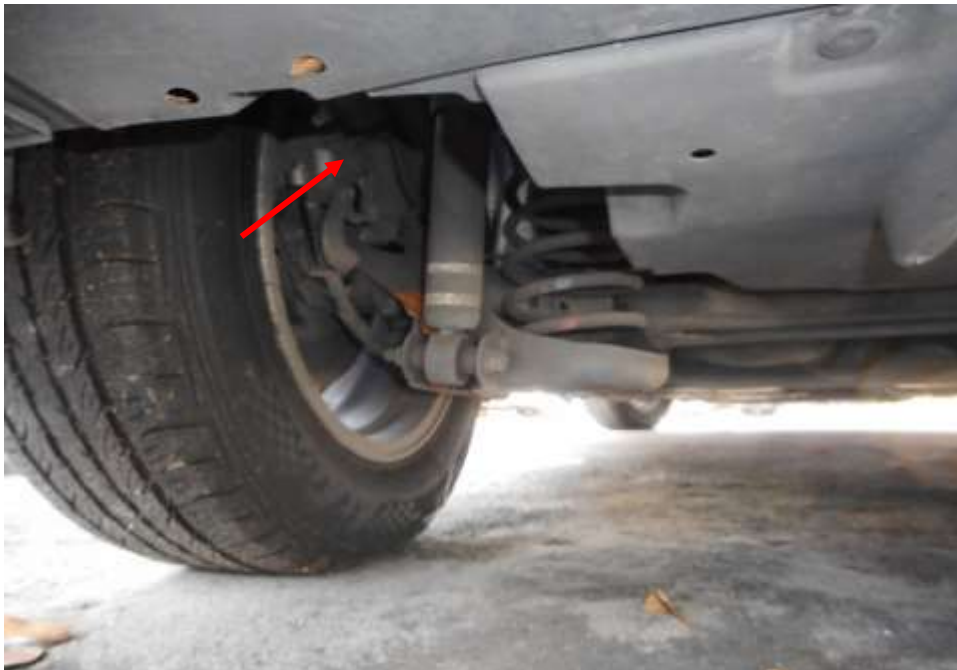
**Photo 19** shows the brake pipe (arrowed) at the rear left wheel of the Motor Taxi. I did not observe any leakage of brake fluid at the time of my inspection of the Motor Taxi. My static tests of the Motor Taxi's braking system, along with my visual examination of the various mechanical components in the braking system had indicated that there was no internal leakage of pressure/vacuum. Hence the braking system of the Motor Taxi was likely to be in serviceable condition at the material time of accident.

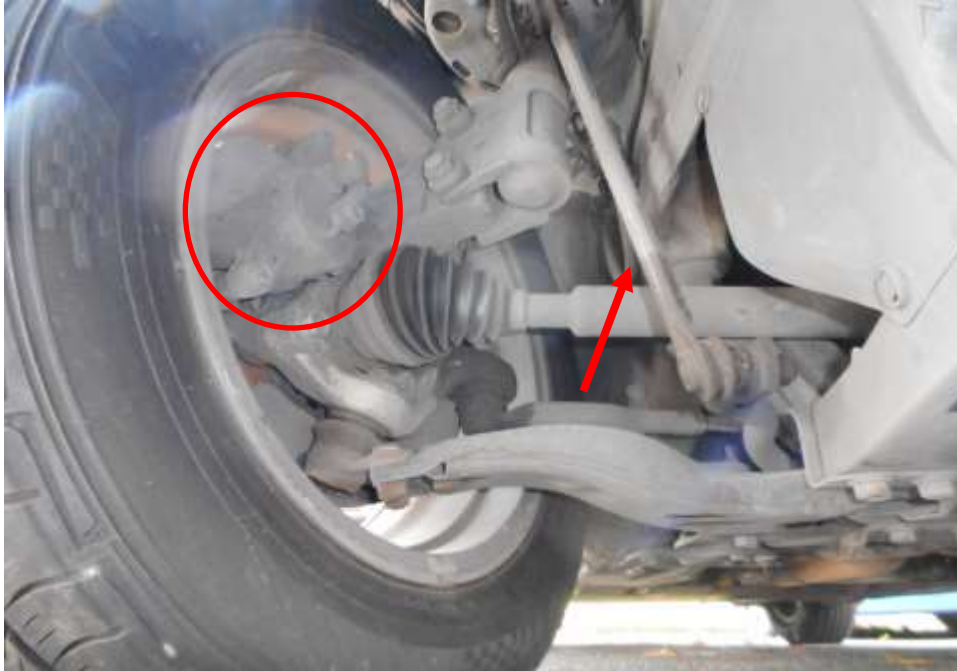
**Photo 20** shows the brake hose/pipe (arrowed) at the front right wheel of the Motor Taxi. No leakage of brake fluid was observed. Visual examination of the various components of the braking system like the brake caliper (circled), brake booster, brake pedal etc had revealed all to be intact and without visible damage at the time of accident. There was also no sign of fluid stain(s) observed on the various undercarriage components.

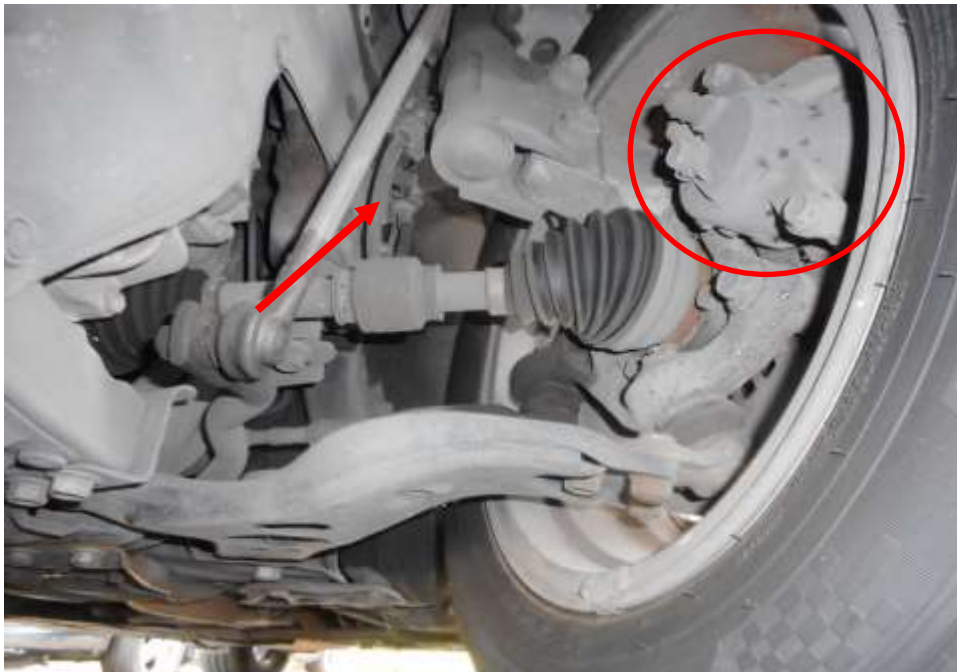
**Photo 21** shows the brake hose/pipe (arrowed) at the front left wheel of the Motor Taxi. No leakage of brake fluid was observed. Visual examination of the various components of the braking system like the brake caliper (circled), brake booster, brake pedal etc had revealed all to be intact and without visible damage at the time of accident. There was also no sign of fluid stain(s) observed on the various undercarriage components.

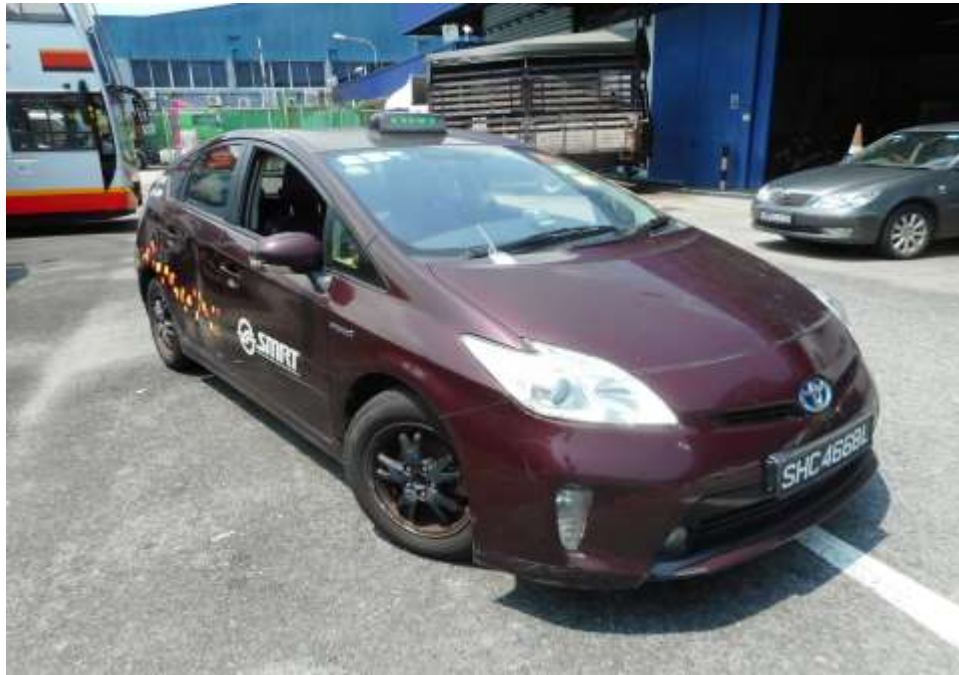
**Photo 22** shows the front right wheel of the Motor Taxi turned to its full left. During my steering system test, I did not experience any abnormal free play and/or resistance when I had turned the steering wheel towards full left and full right. This would suggest that the steering system of the Motor Taxi was likely to be in serviceable condition at the material time of accident.

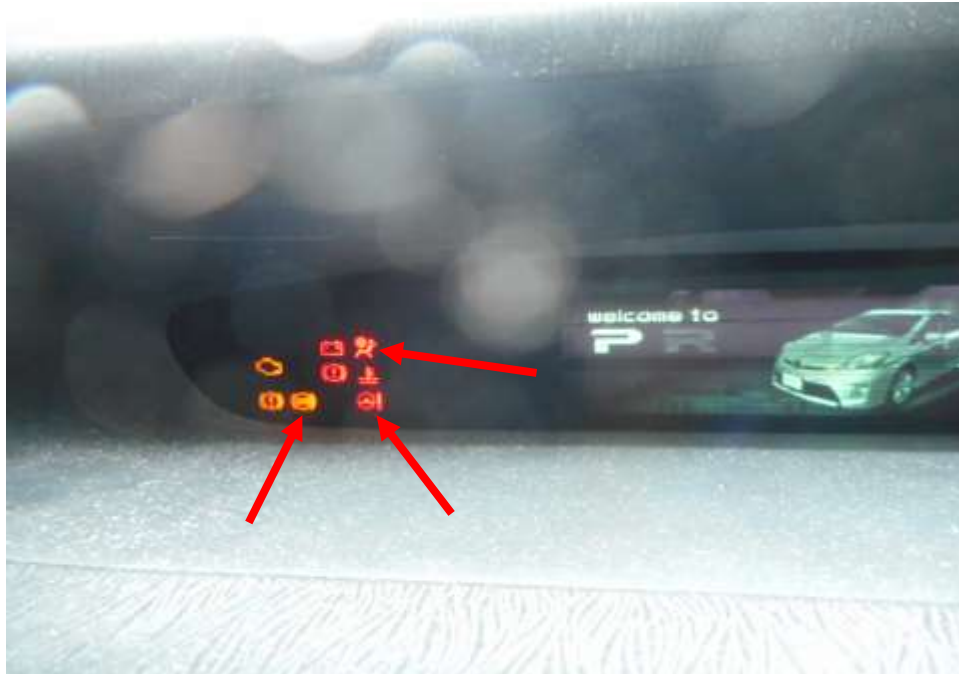
**Photo 23** shows the warning light for Anti-Lock Brake System (ABS), Supplemental Restraint System (SRS) and Electric Power Steering System (EPS) appearing on the instrument panel of the Motor Taxi during the self-test of its various electronic operating systems when its engine was cranked.

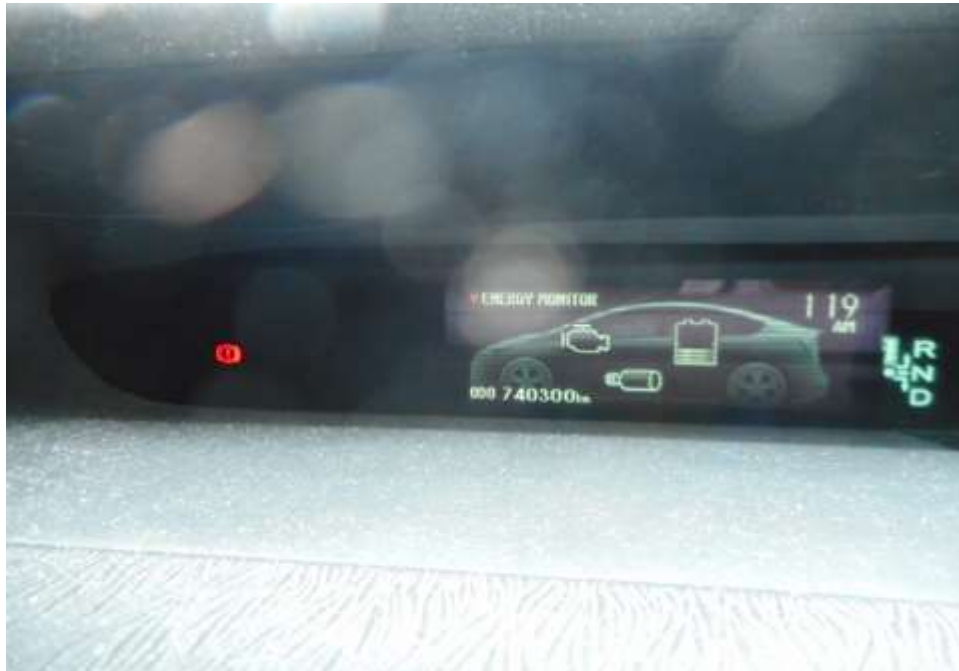
**Photo 24** shows no warning lights illuminated on the instrument panel of the Motor Taxi after the engine was cranked. This would suggest that there was no abnormality to the various electronic operating systems of the Motor Taxi, like the ABS, SRS and EPS.
