LKK Auto Consultants Pte Ltd

Vehicle No. SJD 4836P

ADJUSTMENT ON REPAIR COST FOR VEHICLE NO. SJD 4836P

PHOTOGRAPHS FOR VEHICLE NO. SJD 4836P

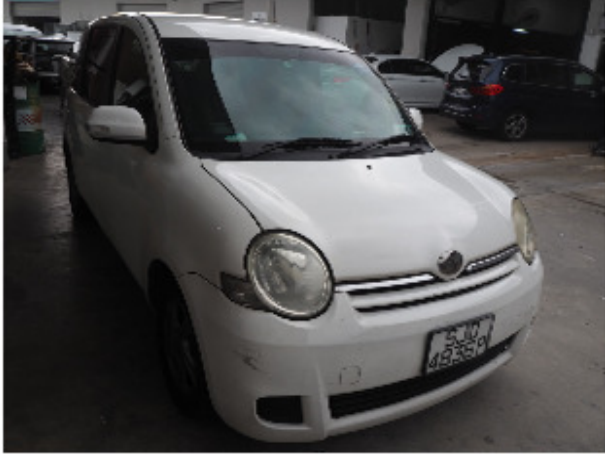
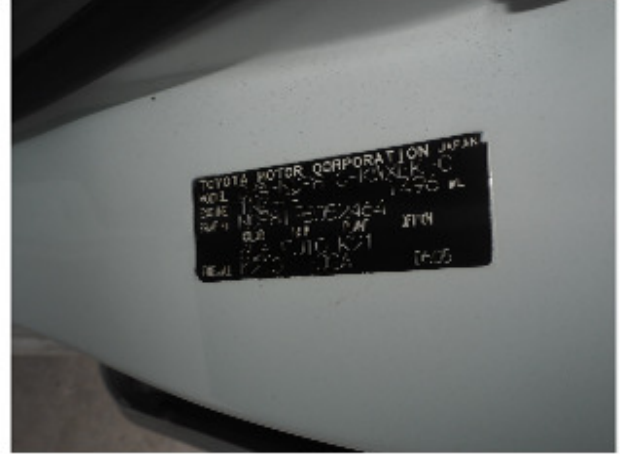
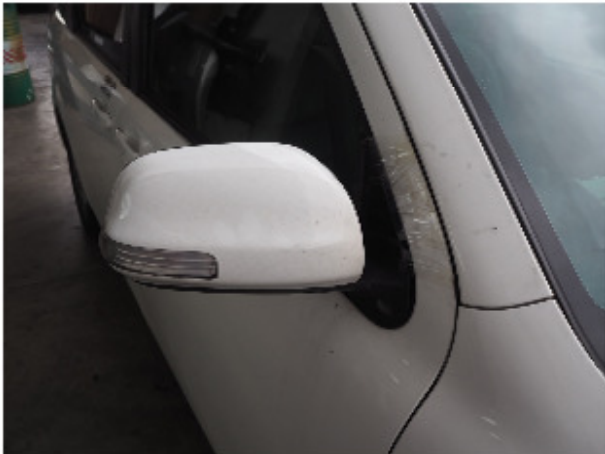
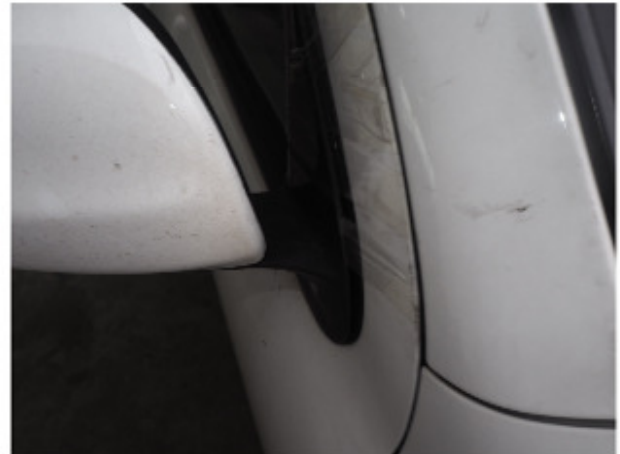
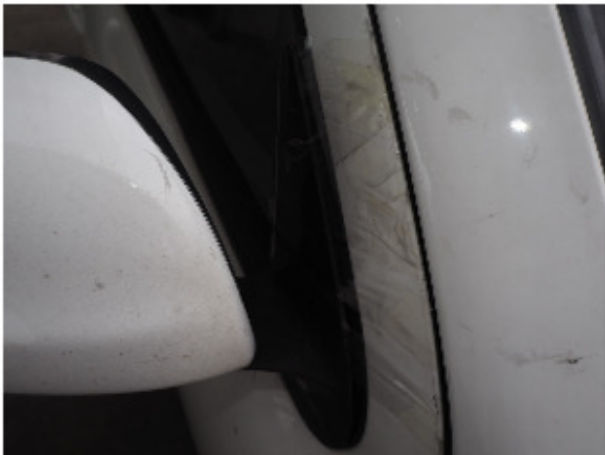
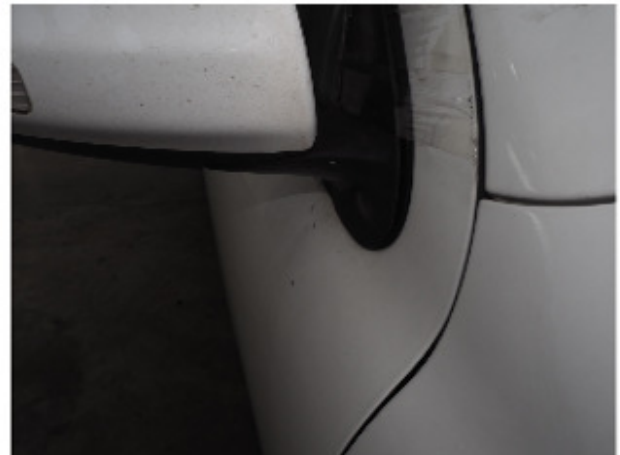
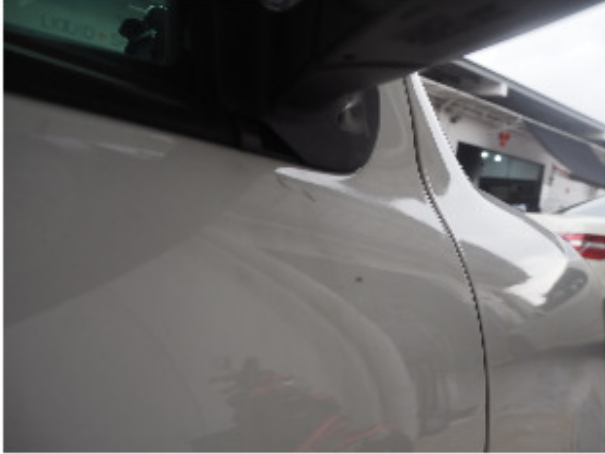
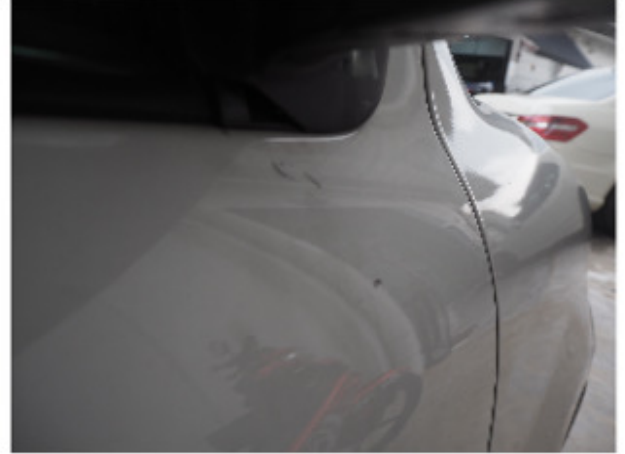
INSPECTION

THE VEHICLE SUSTAINED DAMAGES AT THE O/S BODY. DAMAGES SEE DETAILS.
--

Qty	Description of Parts	Condition	Estimate By Workshop (\$)	Our Adjusted (\$)
	<u>REPLACEMENT OF PARTS</u>			
1	RH SIDE MIRROR HOUSING	DAMAGED	630.00	630.00
1	RH SIDE SIGNAL LAMP	CRACKED	180.00	180.00
1	RH SIDE SIGNAL COVER	CRACKED	120.00	120.00
1	RH SIDE SIGNAL LIGHTS	NOT NECESSARY	135.00	-
1	RH DRIVER DOOR	TO REPAIR SEE LABOUR	1,150.00	-
	LESS 25% DISCOUNT		-	-232.50
			2,215.00	697.50
	<u>LABOUR</u>			
	LABOUR PANEL BEAT.INCLUSIVE OF THE REPAIR OF RH DRIVER DOOR.		400.00	100.00
	SPRAY PAINTING.		400.00	300.00
	REMOVE & REFIT DOOR ATTACHMENTS.	NOT NECESSARY	150.00	-
			950.00	400.00
	GRAND TOTAL		3,165.00	1,097.50
	RECOMMENDED COST OF LUMP SUM REPAIRS (TO ITS PRE-ACCIDENT CONDITION)			850.00
