Your Ref : 592258/IT  
Our Ref : CI/MSG20003636/D

**M/s MSIG Insurance (Singapore) Pte Ltd**

**AUTOMOBILE TECHNICAL INVESTIGATION REPORT OF INCIDENT  
INVOLVING SKN 1352Z AND SMC 6250K ON 29 APRIL 2019**

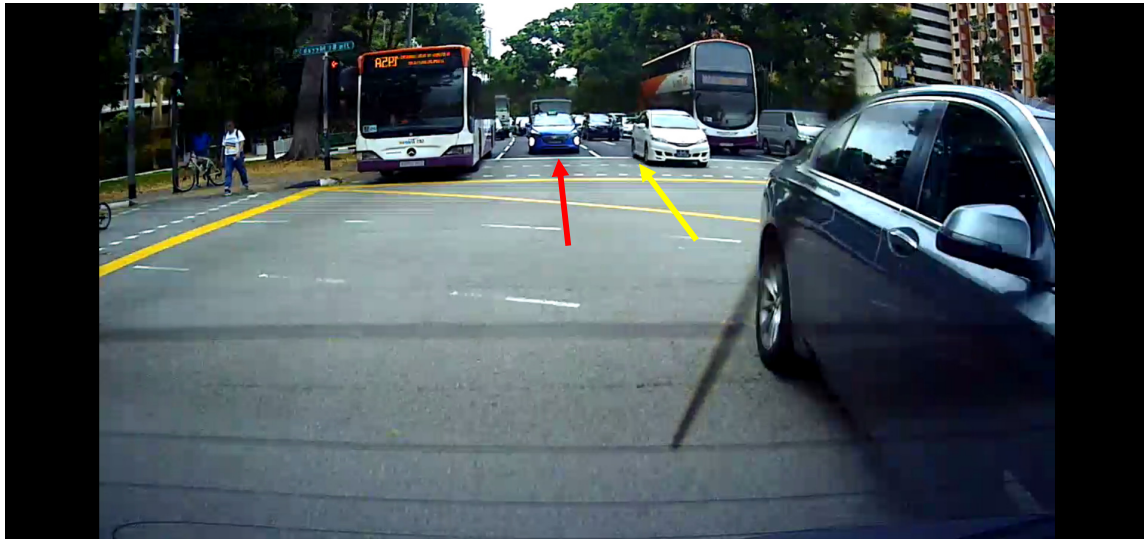
**Photo 1** shows the left front of Insured Vehicle in close proximity with the rear right of the Third Party Vehicle (photo extracted from the video recording showing the incident that was taken from the recording device mounted onto the rear windscreen of the Third Party Vehicle). The Third Party Vehicle had moved off from the lane indicated by the red arrow while the Insured Vehicle had moved off from the lane indicated by the yellow arrow. The contact, if any, had occurred at or around this area inside the traffic junction, with the contact being at the left front body of the Insured Vehicle and the right rear body of the Third Party Vehicle.

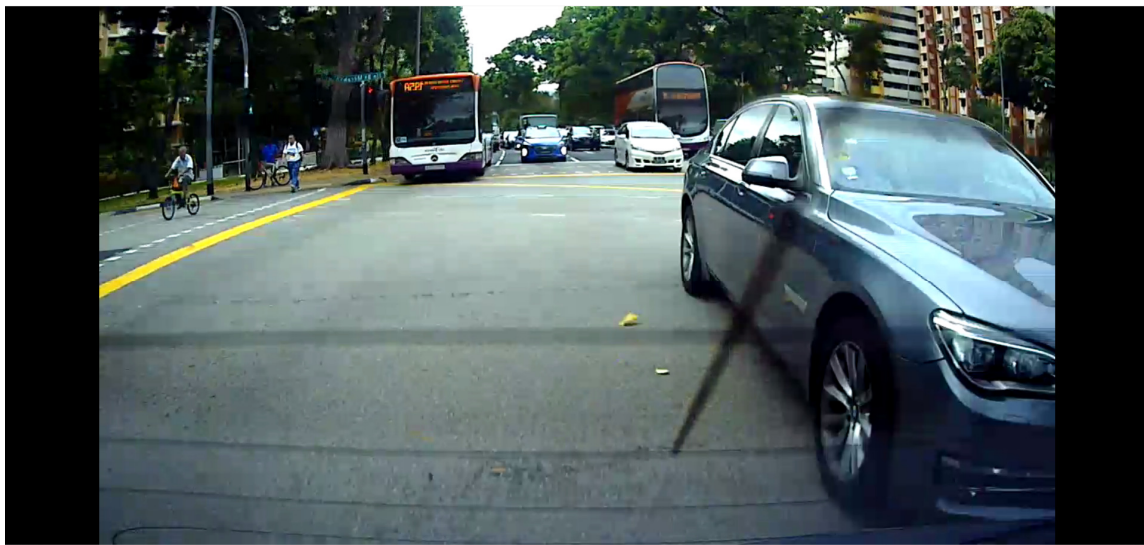
**Photo 2** shows the Insured Vehicle moving into the travelling lane of the Third Party Vehicle inside the traffic junction. This was after both vehicles were in close proximity with each other (photo extracted from the video recording showing the incident that was taken from the recording device mounted onto the rear windscreen of the Third Party Vehicle).

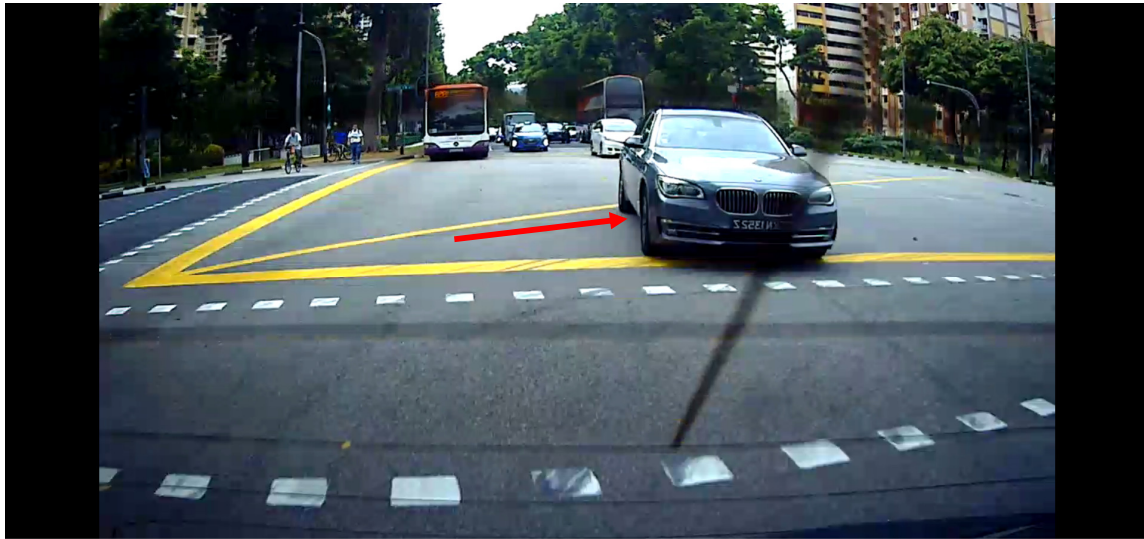
**Photo 3** shows the Insured Vehicle (arrowed) moving into the travelling lane of the Third Party Vehicle inside the traffic junction. This was after both vehicles were in close proximity with each other (photo extracted from the video recording showing the incident that was taken from the recording device mounted onto the rear windscreen of the Third Party Vehicle).

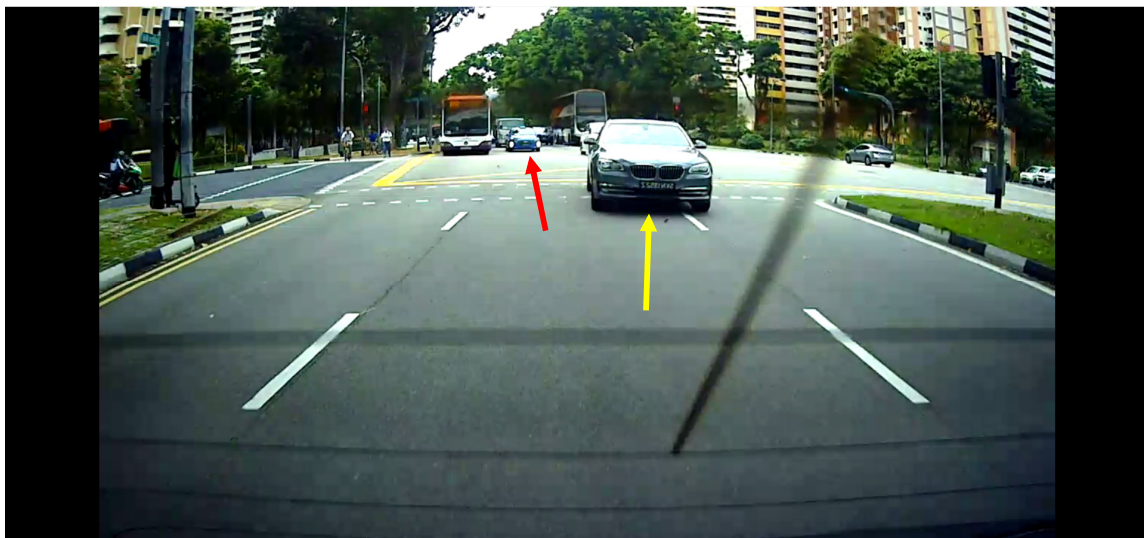
**Photo 4** shows the Insured Vehicle (yellow arrow) straddling the demarcation lines of the extreme right lane and the second lane from the right before moving into the same lane as the Third Party Vehicle, travelling behind the Third Party Vehicle thereafter. The lane that the Third Party Vehicle had moved off at the start of the traffic junction is indicated by the red arrow (photo extracted from the video recording showing the incident that was taken from the recording device mounted onto the rear windscreen of the Third Party Vehicle).

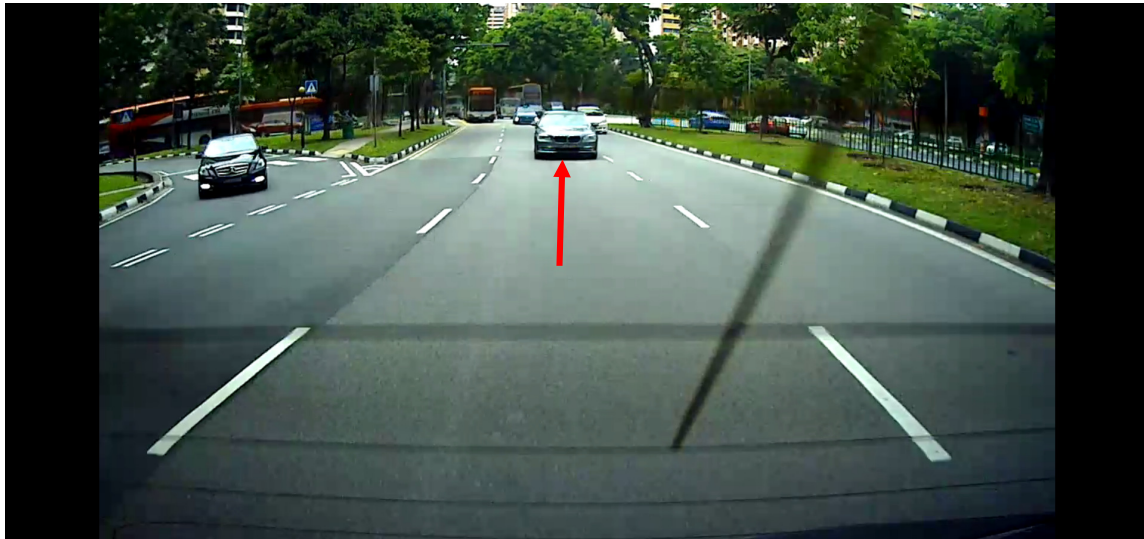
**Photo 5** shows the Insured Vehicle (arrowed) after having moved into the same lane as the Third Party Vehicle (photo extracted from the video recording showing the incident that was taken from the recording device mounted onto the rear windscreen of the Third Party Vehicle).

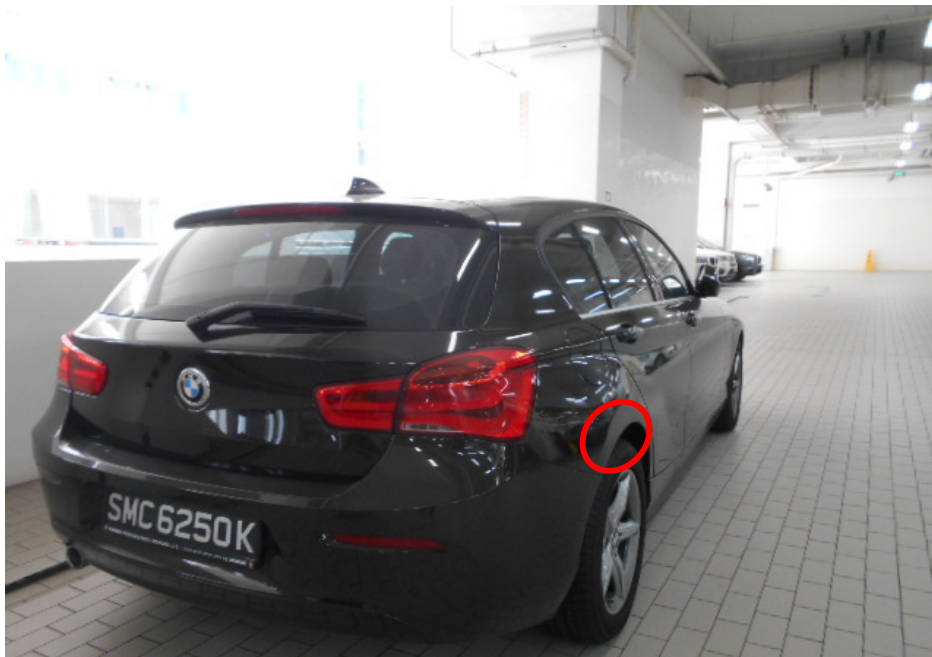
13. The Third Party Vehicle was physically inspected by me on 20 August 2019. At the time of my inspection, I had observed some relatively slight scratches and a minor dent at the right rear fender of the Third Party Vehicle. This was above the rear right wheel. The damage observed at this body area of the Third Party Vehicle had corresponded to the contact area on the Third Party Vehicle (if indeed there was contact) that I had identified from my review of the video recording. Refer to paragraph 11 c) above. See photo 6 - 8 below.

**Photo 6** shows a general view of the right rear body of the Third Party Vehicle. At the time of my inspection, I had observed some relatively light scratches and a minor dent at the right rear fender of the Third Party Vehicle, above the rear right wheel. The damage observed at this body area (circled) of the Third Party Vehicle had corresponded to the contact area on the Third Party Vehicle (if indeed there was contact) that I had identified from my review of the video recording.

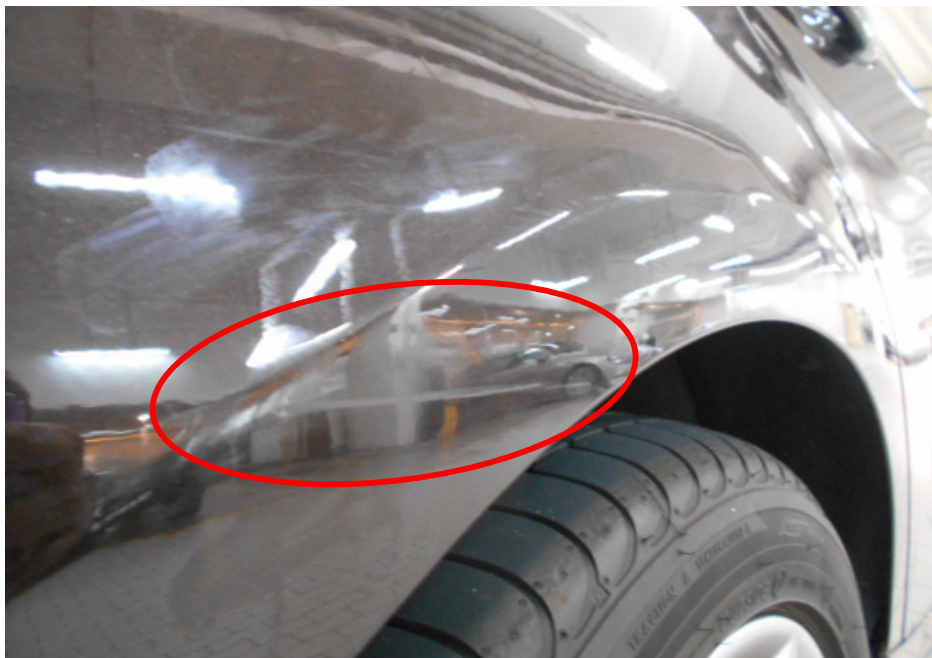
**Photo 7** shows a close-up view of the light scratches (circled) that I had observed on the right rear fender of the Third Party Vehicle.

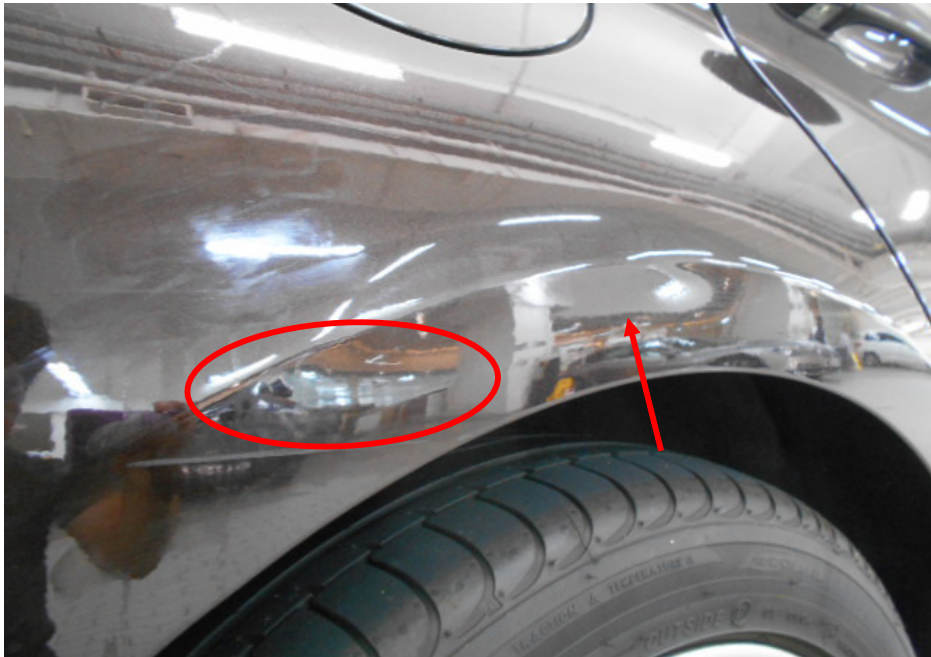
**Photo 8** shows a closer view of the relatively light scratches (circled) and a minor dent (arrowed) at the right rear fender of the Third Party Vehicle, above the rear right wheel.

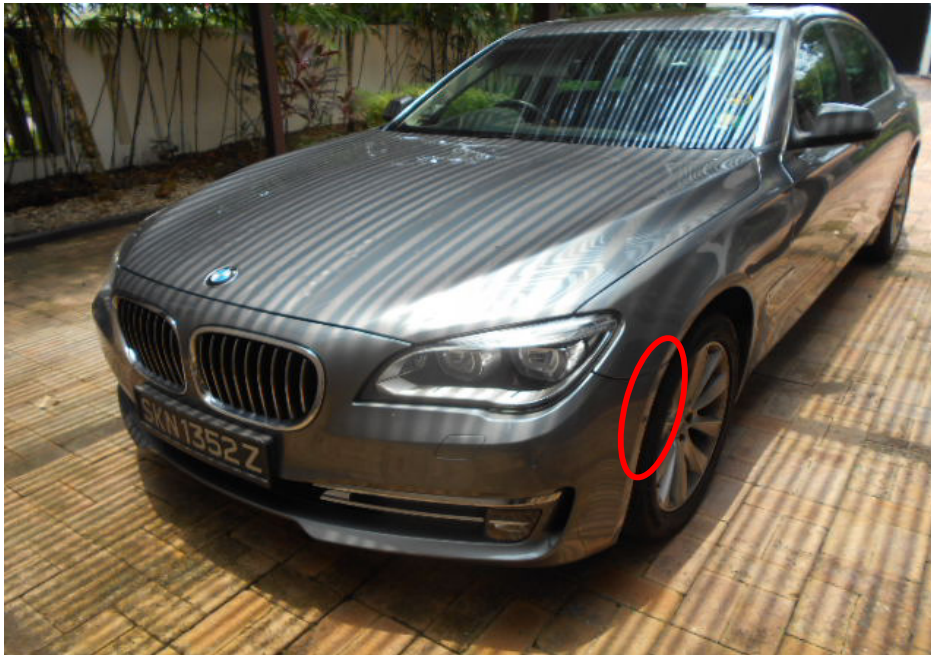
14. With regard to the Insured Vehicle, I had physically inspected it on 27 September 2019. The inspection carried out had primarily focused on the left front body of the Insured Vehicle given the observations gathered from my review of the video recording pertaining to the possible area of contact on the Insured Vehicle (if indeed there was contact). Refer to paragraph 11 c) above.
15. Upon my close examination, I had observed some relatively light scratches at the left side of the front bumper and at the left front fender, above the front left wheel of the Insured Vehicle. See photo 9 – 12 below.

**Photo 9** shows a general view of the left front body of the Insured Vehicle. At the time of my inspection, I had observed some relatively light scratches at the left side of the front bumper and at the left front fender, above the front left wheel of the Insured Vehicle. The damage observed at this body area (circled) of the Insured Vehicle had corresponded to the contact area on the Insured Vehicle (if indeed there was contact) that I had identified from my review of the video recording.

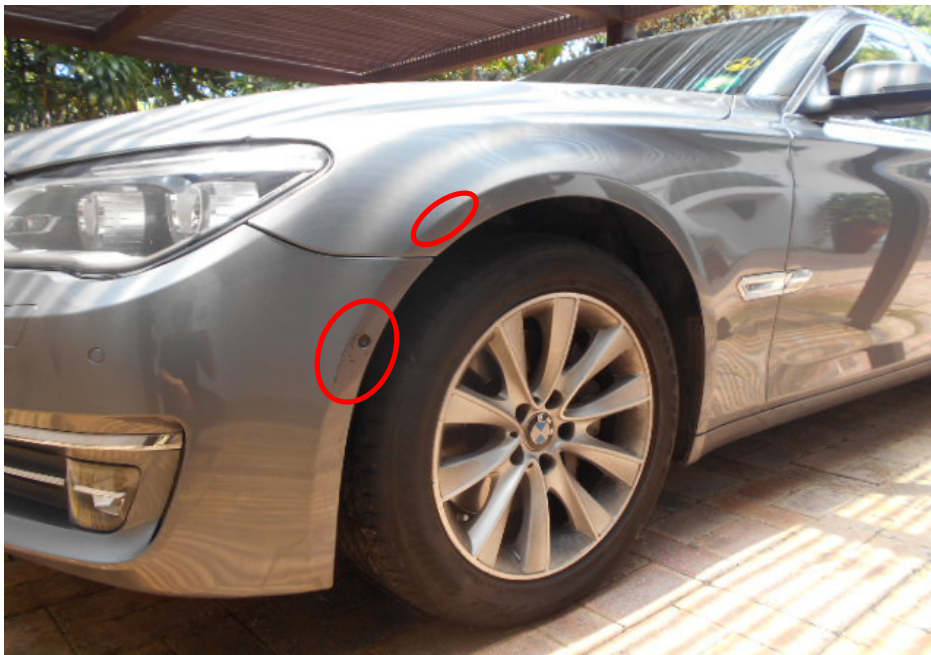
**Photo 10** shows a general view of where the relatively light scratches (circled) were observed on the left front body of the Insured Vehicle. This was at the left side of the front bumper and at the left front fender, above the front left wheel.

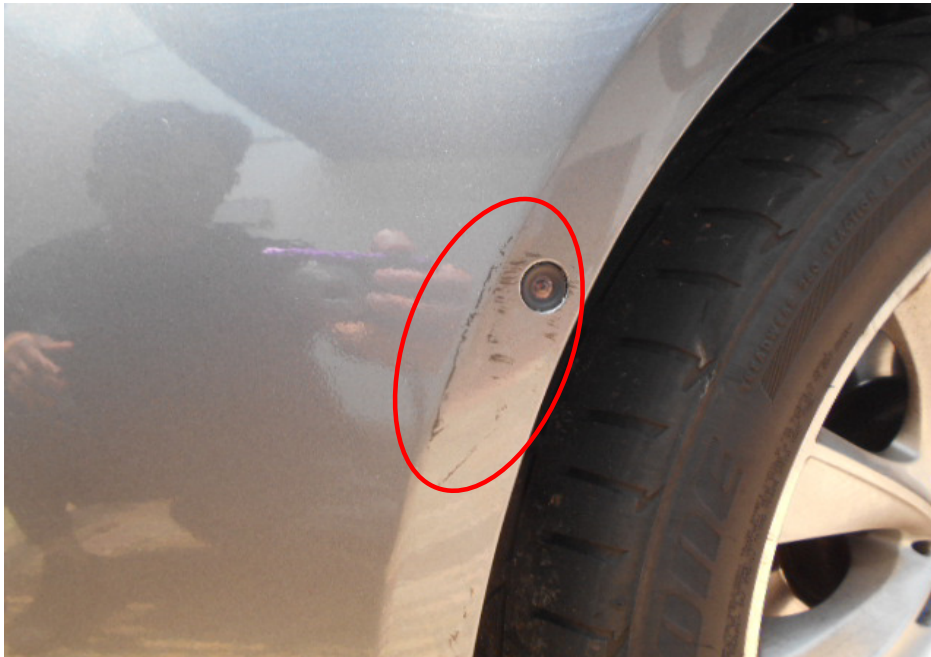
**Photo 11** shows a close-up view of the relatively light scratches (circled) that I had observed on the left side of the Insured Vehicle's front bumper.

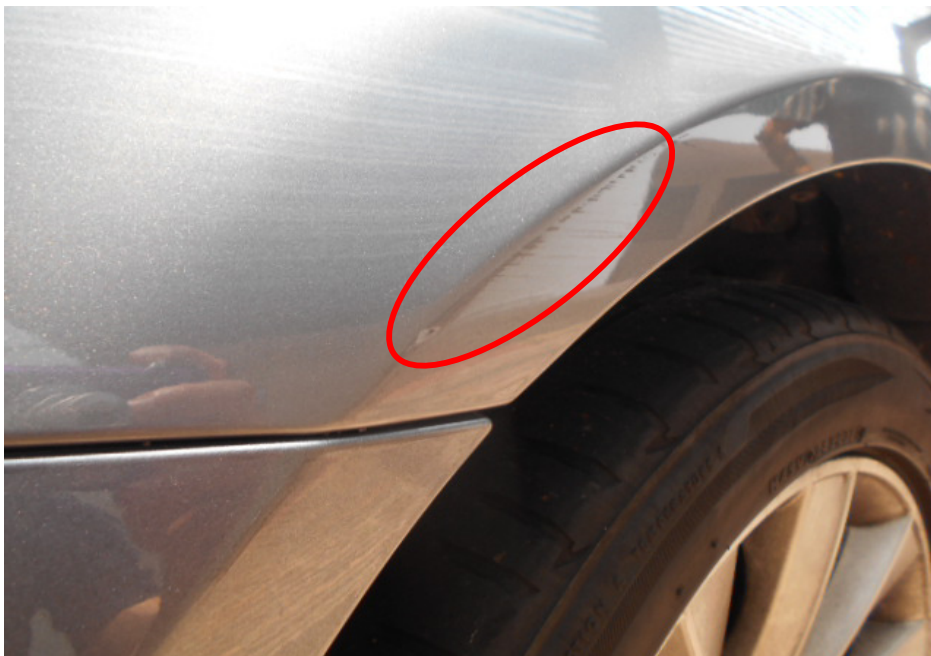
**Photo 12** shows a close-up view of the relatively light scratches (circled) that I had observed on the left front fender of the Insured Vehicle's.

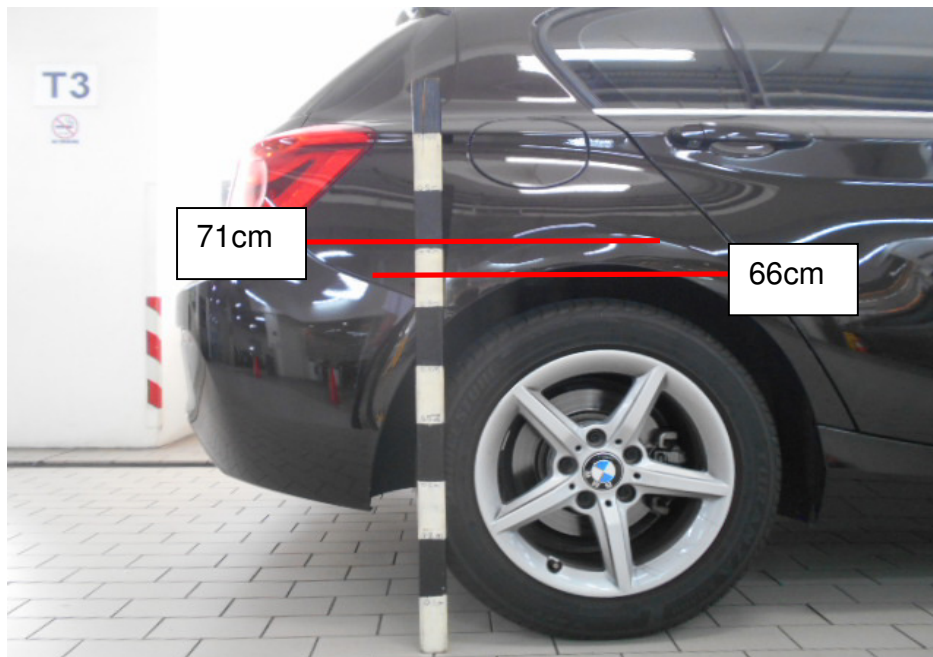
18. Basing on the measurements, the height above ground level of the scratches and dent at the right rear fender of the Third Party Vehicle was approximately 66cm to 71cm above ground level. Upon comparison with the damage area of the Insured Vehicle, I note that the scratches at its left front fender was also at the approximate height of 66cm to 71cm above ground level. The scratches at the left side of the Insured Vehicle's front bumper was approximately 46cm to 53cm above ground level and not within the height of the damage area of the Third Party Vehicle; hence, this damage is not related to this particular incident.

**Photo 13** shows the height measurement that was conducted on the damage area of the Third Party Vehicle. The damage area on the right rear fender of the Third Party Vehicle, where the relatively light scratches and minor dent were located, was approximately 66cm to 71cm above ground level.

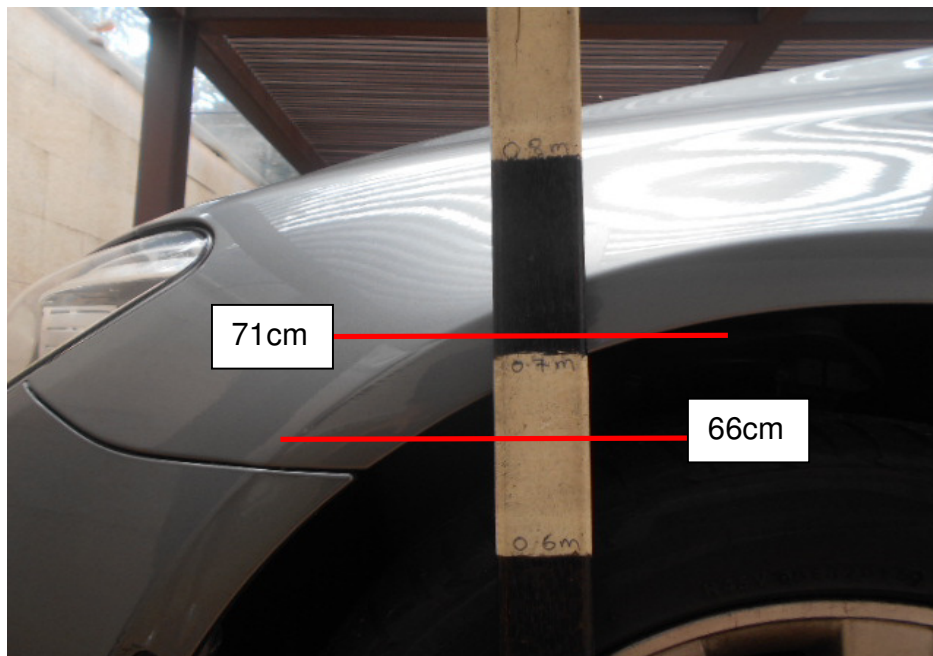
19. The findings of the height measurements had indicated that there was contact between the left front body of the Insured Vehicle and the right rear body of the Third Party Vehicle. See photo 13 & 14 below.

**Photo 14** shows a close-up of the height measurement that was conducted on the damage area of the Insured Vehicle. The damage area on the left front fender of the Insured Vehicle, where the relatively light scratches were located, was approximately 66cm to 71cm above ground level. This had corresponded to the height above ground level of the damage area at the right rear fender of the Third Party Vehicle. Refer to photo 13 above.
