Your Ref: TP/IP/66691/2019  
Our Ref : CI/TPD20003672/P

18<sup>th</sup> March 2020

### **Fatal Accident Investigation Team**

### **MECHANICAL INSPECTION REPORT OF MOTOR CAR SLP 1145H**

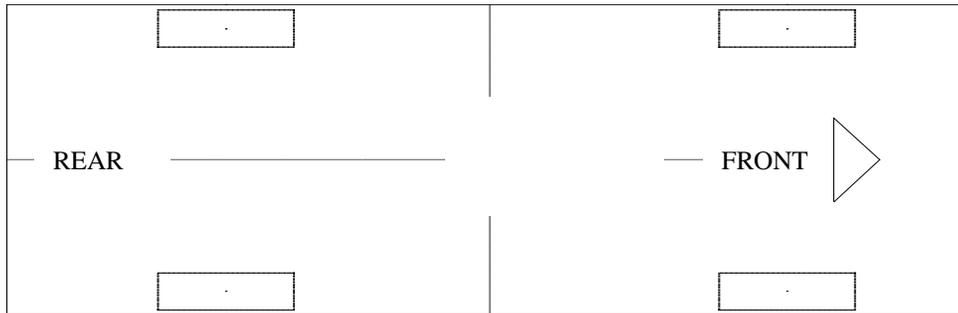
6. The condition of the Motor Car's 4 tyres was observed to be in serviceable condition. I did not find any tear, cut or burst mark(s) on the outer and the inner sidewalls as well as across the tread of the 4 tyres. The 4 tyres were also observed to be sufficiently inflated for vehicular operation. The tyre brand, tyre size and remaining tread depth of the 4 tyres were recorded as follows:-

Goodyear 195/65R15 (6.3mm)

Goodyear 195/65R15 (4.8mm)

Goodyear 195/65R15 (5.6mm)

Goodyear 195/65R15 (4.6mm)

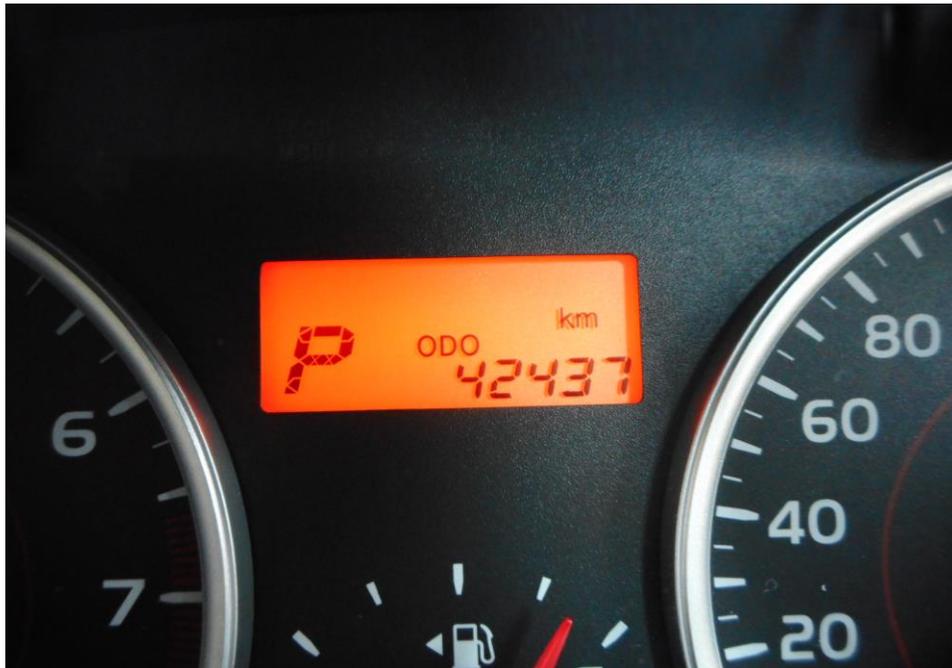
**Photo 1** shows the mileage of the Motor Car at the time of my inspection. The mileage observed was 42,437km.

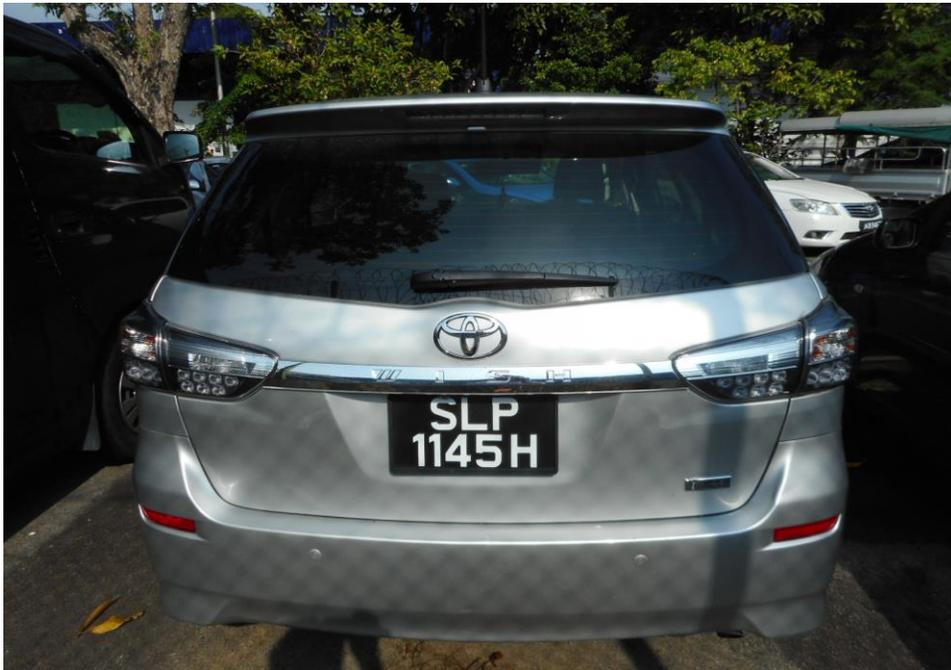
**Photo 2** shows the general view of the Motor Car's rear body at the time of my inspection. The Motor Car rear was observed to be unaffected by the accident.

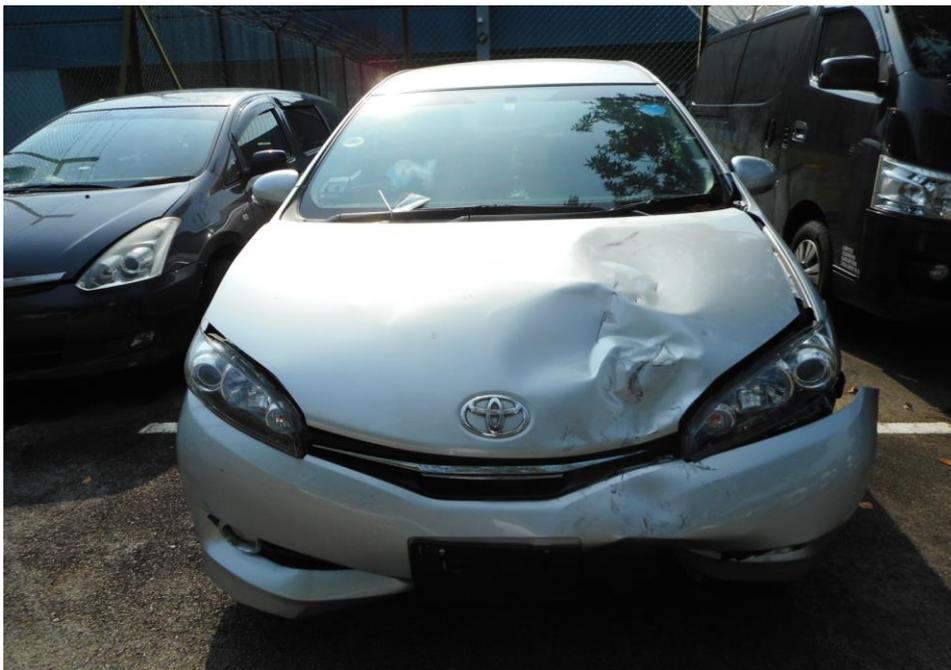
4. The mileage of the Motor Car at the time of my inspection was 42,437km.
5. The Motor Car was observed to have sustained damage at its front portion. Its front bonnet and front bumper were amongst the body parts that were damaged as a result of the accident.

**Photo 3** shows a general view of the Motor Car's front body at the time of my inspection. The Motor Car was observed to have sustained damage at its frontal portion. Its front bonnet and front bumper were amongst the body parts that were damaged as a result of the accident.

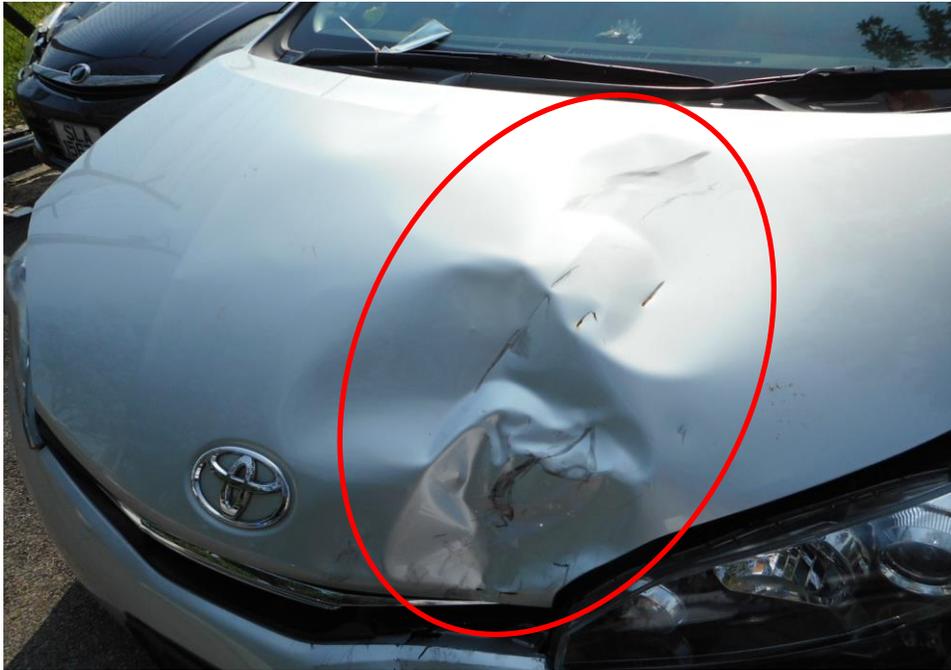
**Photo 4** shows the close up view of the Motor Car's front body at the time of my inspection. The Motor Car was observed to have sustained damage at its front bonnet (circled), as a result of the accident.

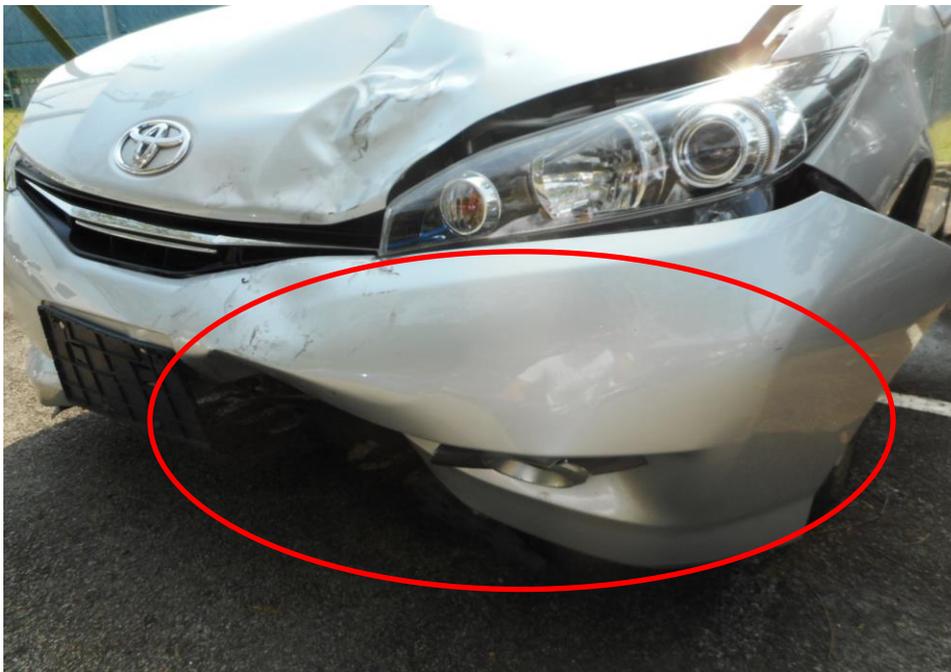
**Photo 5** shows the close up view of the Motor Car's front body at the time of my inspection. The Motor Car was observed to have sustained damage at its front bumper (circled) as a result of the accident.

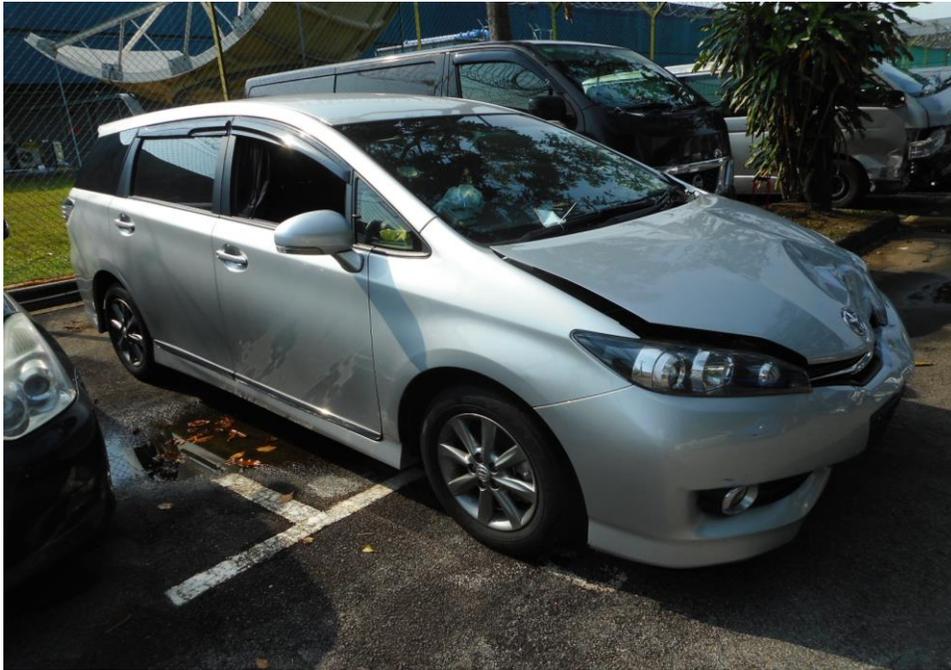
**Photo 6** shows a general view of the Motor Car's right body at the time of my inspection. The right portion of the Motor Car was observed to have been unaffected by the accident.

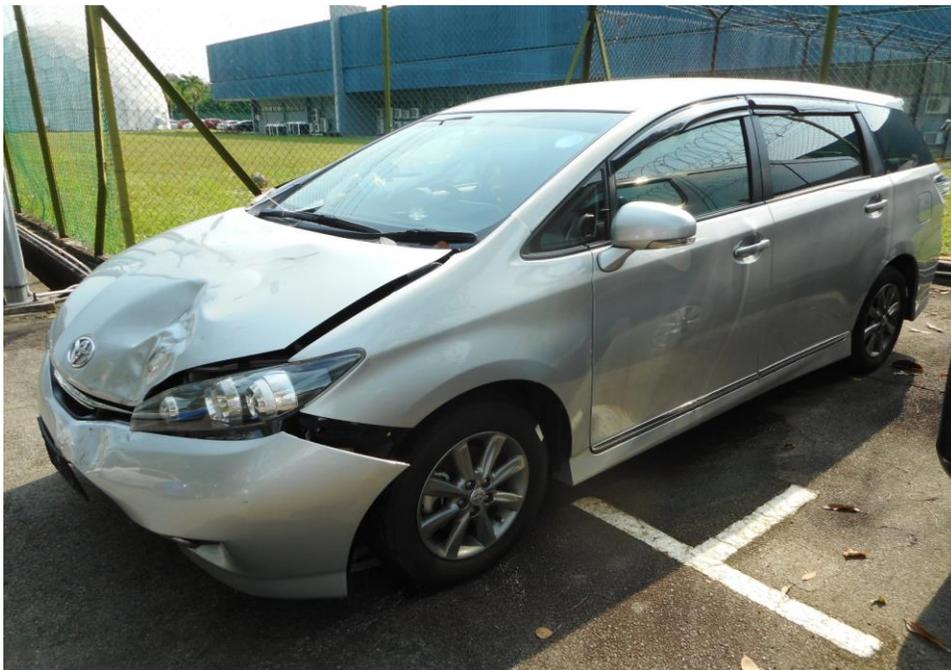
**Photo 7** shows a general view of the Motor Car's left body at the time of my inspection. The left portion of the Motor Car was observed to have been unaffected by the accident.

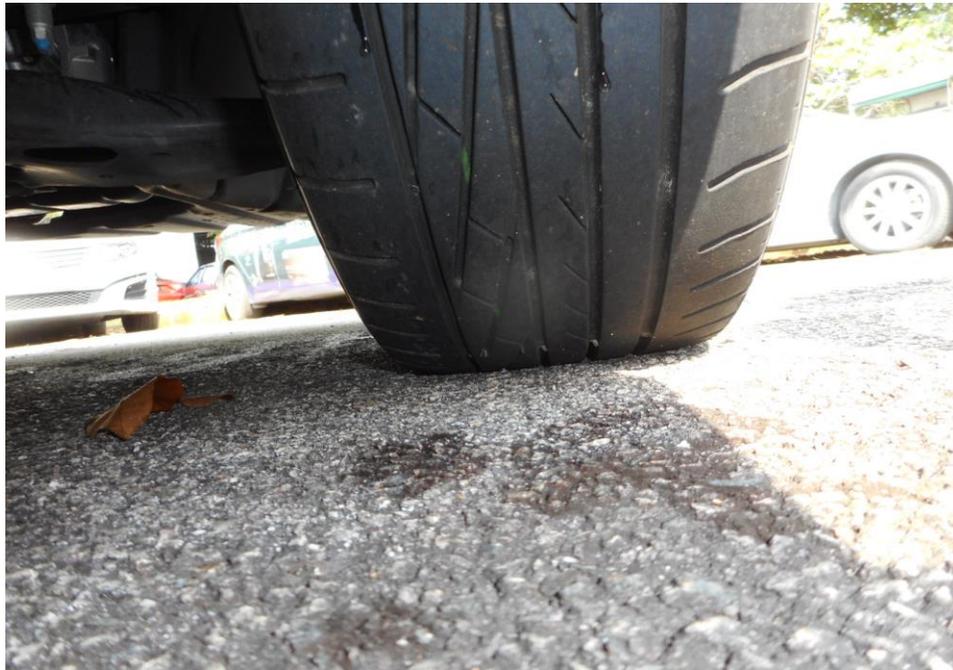
**Photo 8** shows the condition of the front right tyre of the Motor Car, which was observed to be in serviceable condition with remaining tread depth of approximately 4.6mm. The tyre was sufficiently inflated for vehicular operation with no tear, cut or burst mark(s) on the outer and the inner sidewalls as well as across the tread. The 4 tyres of the Motor Car were wrapped around standard steel wheel rims without any damage.

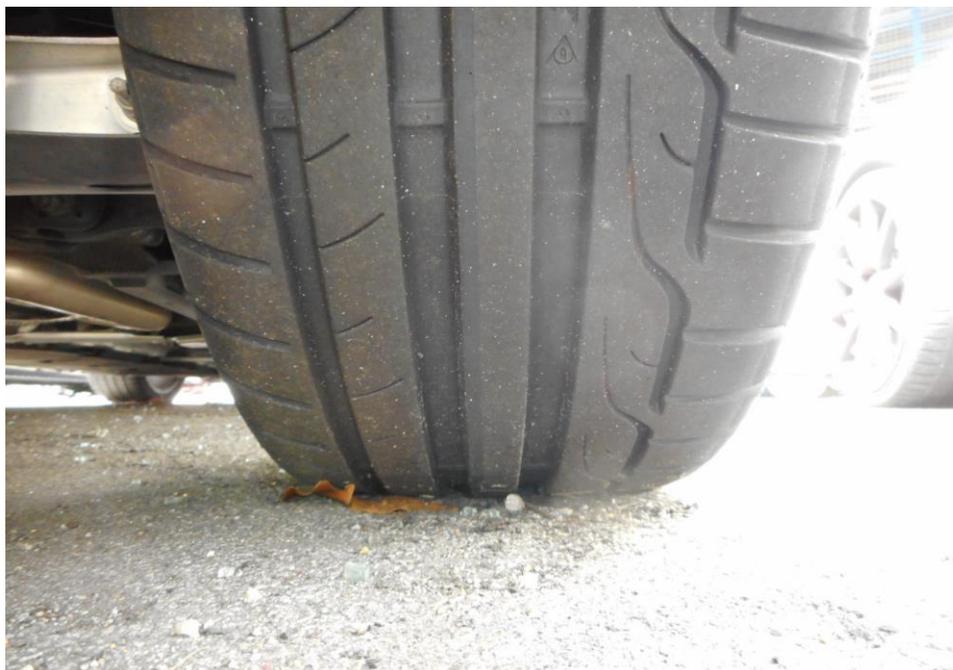
**Photo 9** shows the condition of the rear right tyre of the Motor Car, which was observed to be in serviceable condition with remaining tread depth of approximately 5.6mm. The tyre was also observed to be sufficiently inflated for vehicular operation with no tear, cut or burst mark(s).

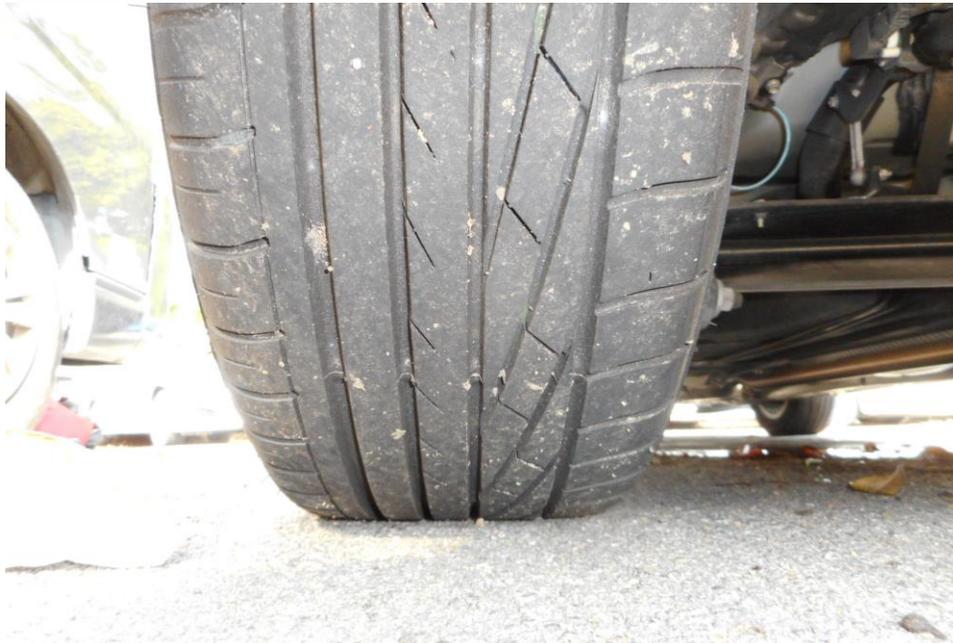
**Photo 10** shows the condition of the rear left tyre of the Motor Car, which was observed to be in serviceable condition with remaining tread depth of approximately 6.3mm. The tyre, which was wrapped around steel wheel rim, was also observed to be sufficiently inflated for vehicular operation. The 4 tyres of the Motor Car were wrapped around standard steel wheel rims.

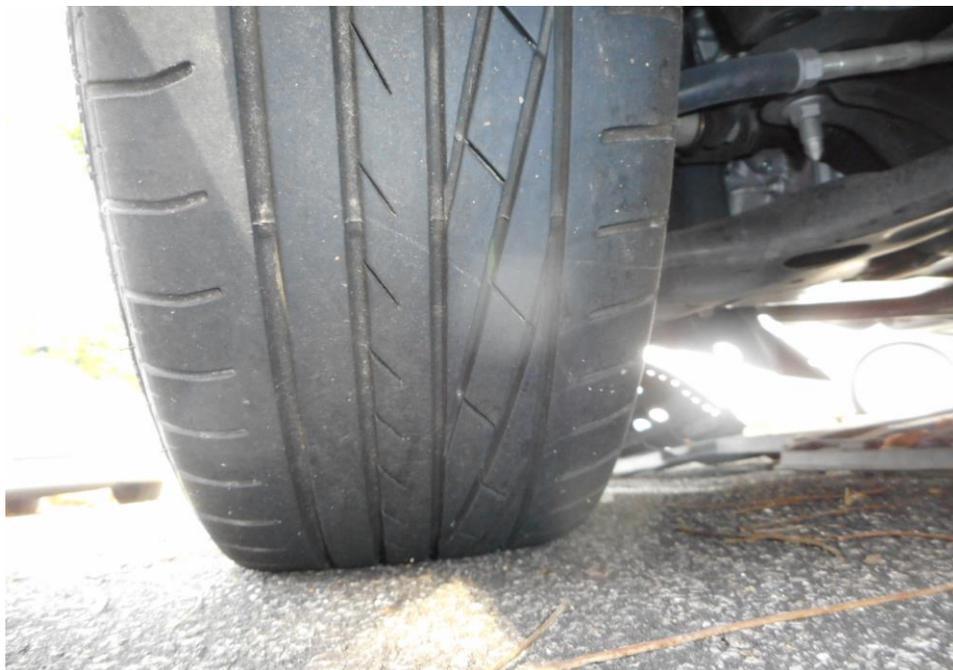
**Photo 11** shows the condition of the front left tyre of the Motor Car, which was observed to be in serviceable condition with remaining tread depth of approximately 4.8mm. There was also no tear, cut or burst mark(s) on the outer and the inner sidewalls as well as across the tread of the Motor Car's 4 tyres.

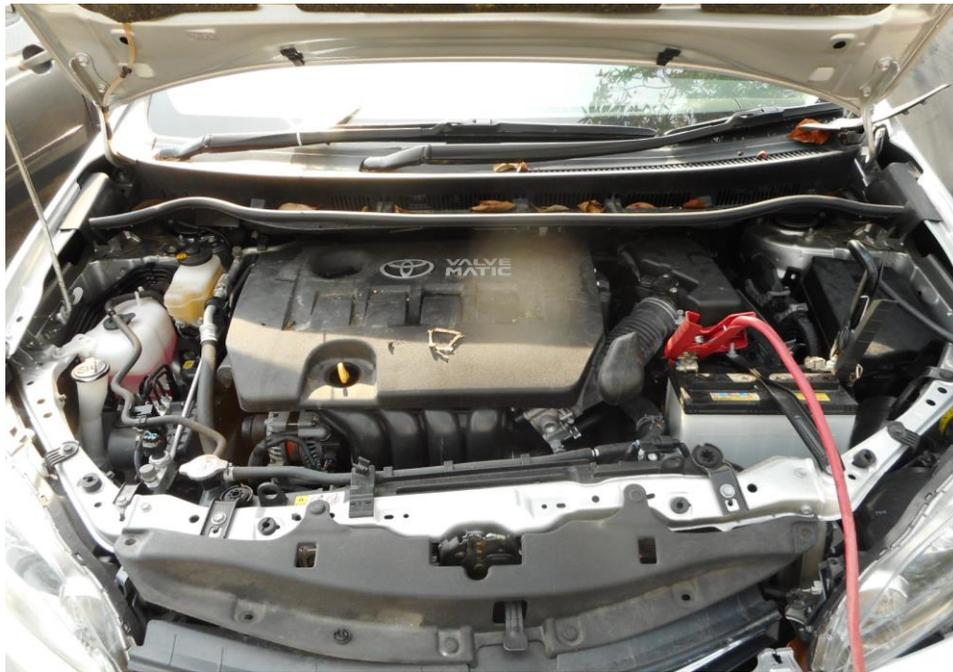
**Photo 12** shows a general view of the Motor Car's engine compartment. The various parts and components inside the engine compartment were unaffected by the accident. There was also no sign(s) or indication(s) of fluid leakage and/or fluid stain within the engine compartment.

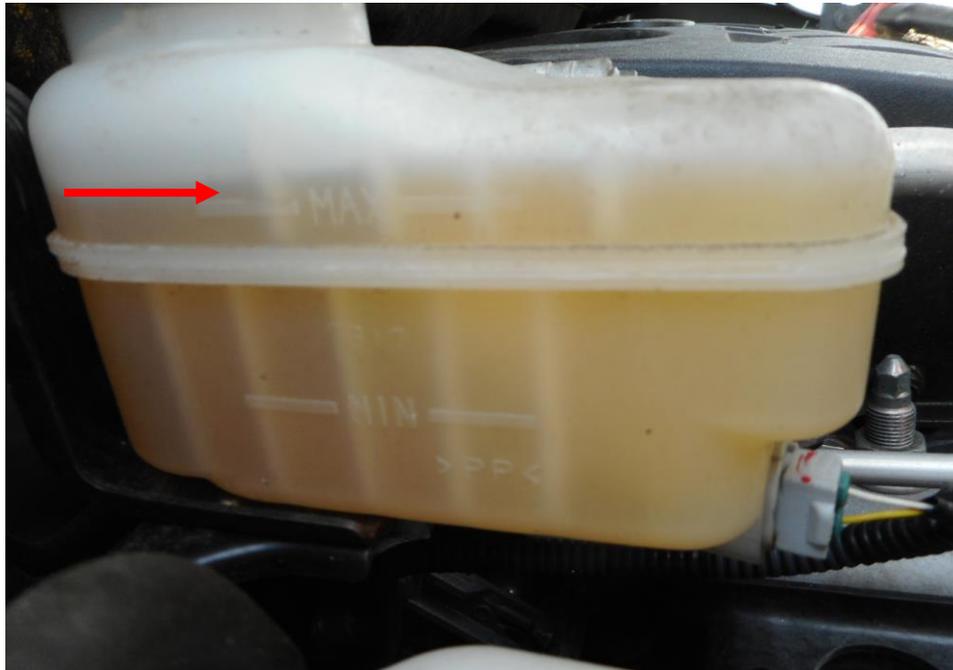
**Photo 13** shows the brake fluid reservoir of the Motor Car at the time of my inspection. The brake fluid was observed to be of sufficient level (arrowed) and without any visible contamination.

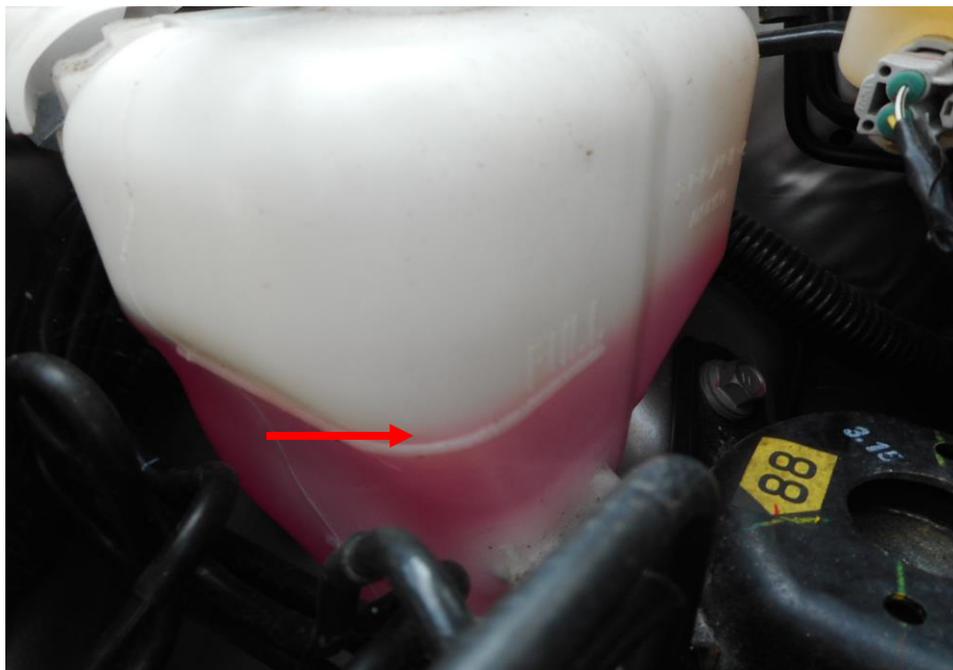
**Photo 14** shows checks being carried out to the engine coolant of the Motor Car at the time of my inspection. The engine coolant was observed to be of sufficient level (arrowed) and without any visible contamination.

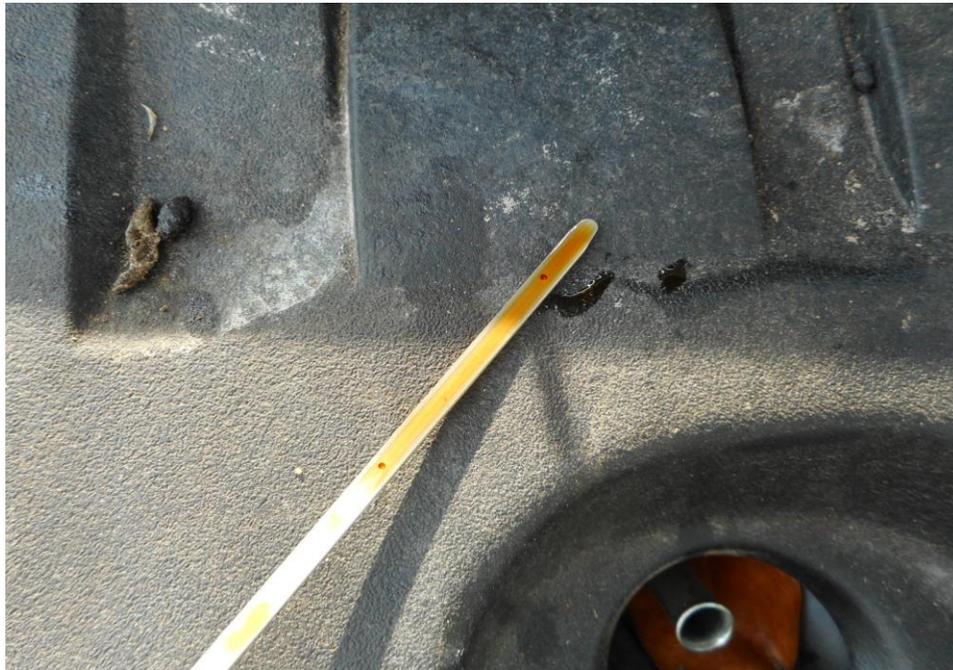
**Photo 15** shows the engine oil dip stick of the Motor Car at the time of my inspection. The engine oil was observed to be of sufficient level and without any visible contamination.

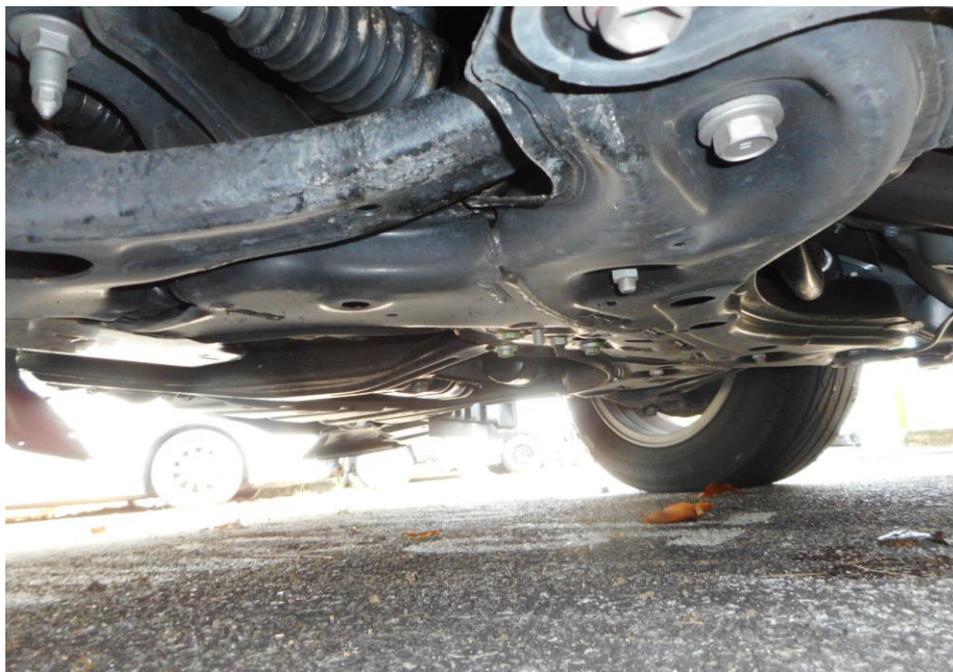
**Photo 16** shows the undercarriage of the Motor Car, at the area where the engine housing and transmission housing are located. I did not find any sign(s) or indication(s) of fluid leak and/or fluid stain(s) on the underside of the Motor Car.

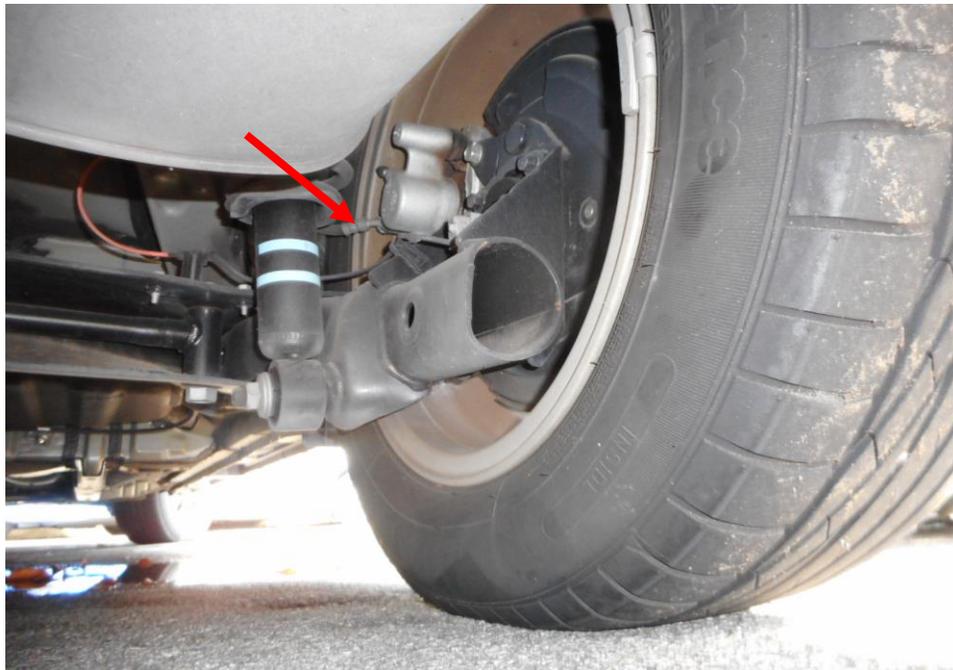
**Photo 17** shows the brake hose/pipe (arrowed) at the rear right wheel of the Motor Car. No leakage of brake fluid was observed. Visual examination of the various components of the braking system like the drum brake, brake booster, brake pedal etc. had revealed all to be intact and without visible damage.

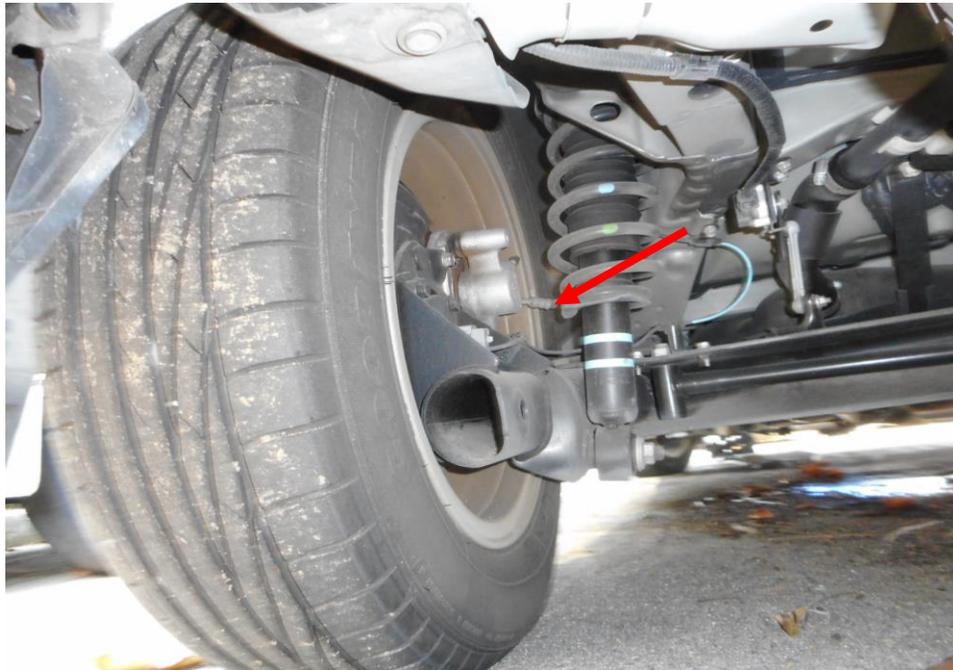
**Photo 18** shows the brake hose/pipe (arrowed) at the rear left wheel of the Motor Car. I did not observe any leakage of brake fluid at the time of my inspection of the Motor Car. Static tests of the Motor Car's braking system had indicated that there was no internal leakage of pressure/vacuum. The undercarriage components of the Motor Car were also all found to be intact and without any visible damage.

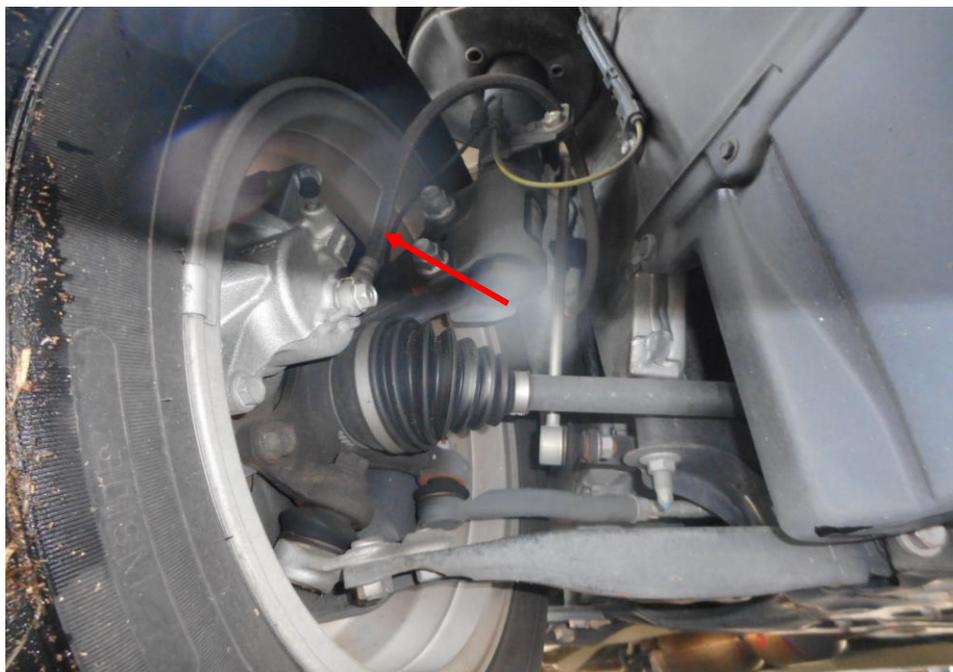
**Photo 19** shows the brake hose/pipe (arrowed) at the front right wheel of the Motor Car. I did not observe any leakage of brake fluid at the time of my inspection of the Motor Car. Static tests of the Motor Car's braking system had indicated that there was no internal leakage of pressure/vacuum. The undercarriage components of the Motor Car were also all found to be intact and without any visible damage.

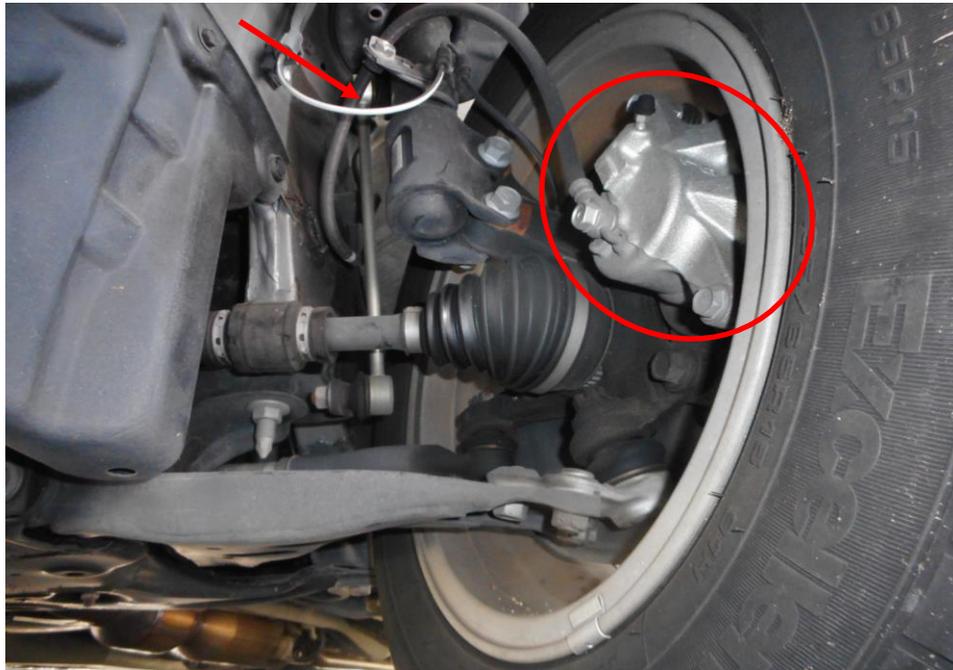
**Photo 20** shows the brake hose/pipe (arrowed) at the front left wheel of the Motor Car. No leakage of brake fluid was observed. Visual examination of the various components of the braking system like the brake caliper (circled), brake booster, brake pedal etc had revealed all to be intact and without visible damage.

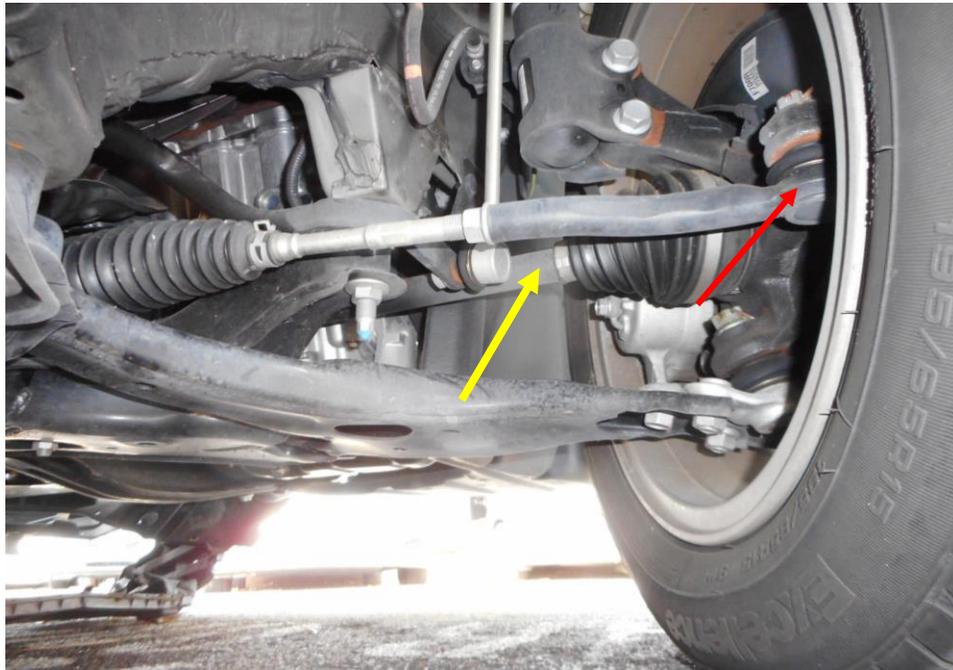
**Photo 22** shows the various undercarriage components at the front right wheel of the Motor Car, in particular the steering tie rod (red arrow) and drive shaft (yellow arrow). The various steering components were all found to be intact, suggesting that the steering system of the Motor Car was likely to be in serviceable condition at the material time of accident. There was also no sign of fluid stain observed on the various undercarriage components at the front right wheel of the Motor Car.

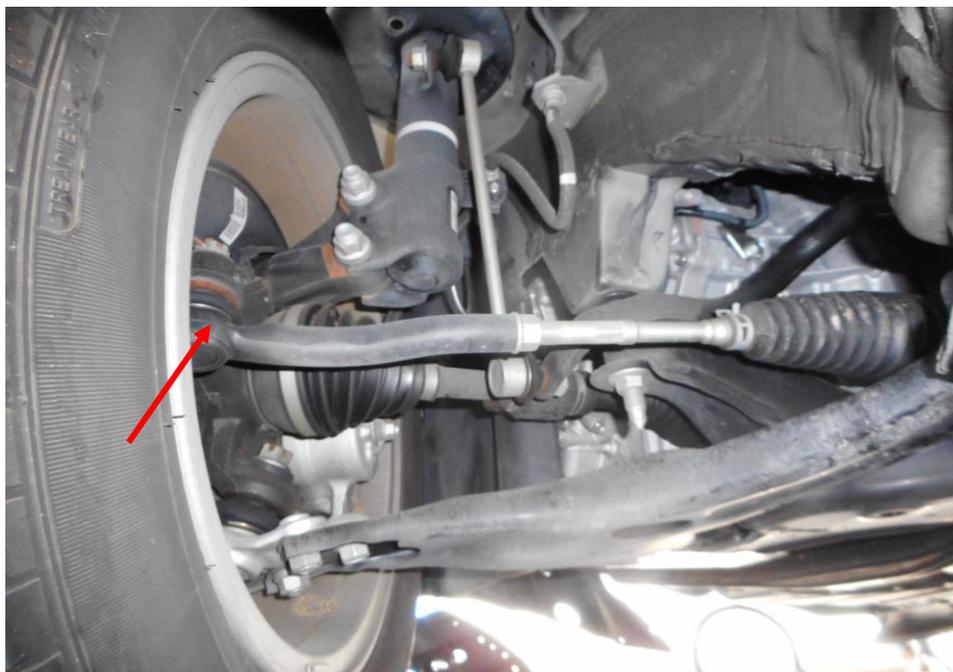
**Photo 23** shows the various undercarriage components at the front left wheel of the Motor Car, which had included the steering tie rod (red arrow). The various undercarriage components of the Motor Car were all found to be intact without any visible damage.

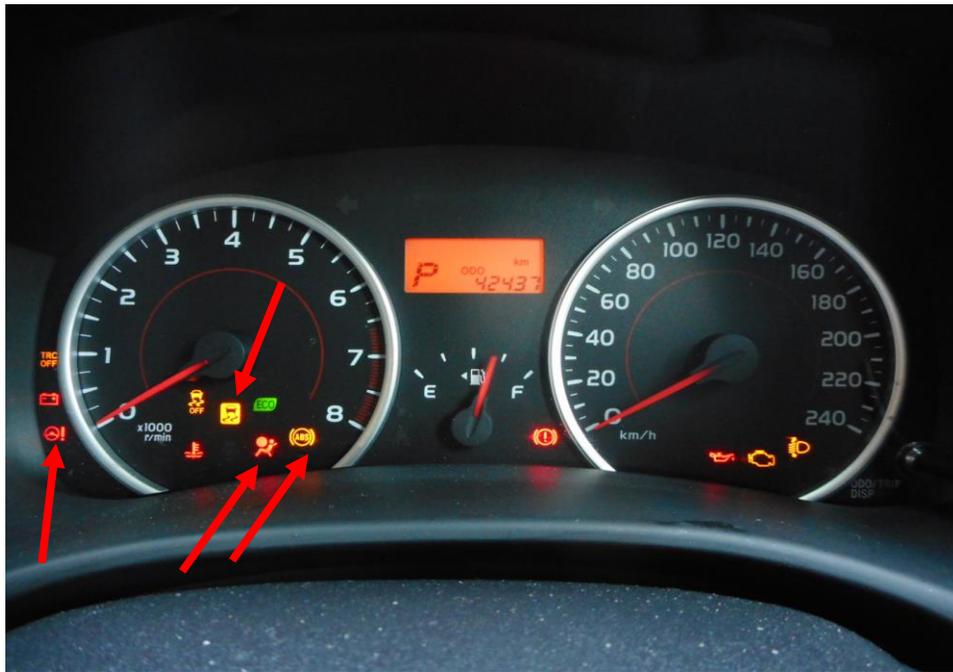
**Photo 24** shows the warning light for Anti-Lock Brake System (ABS), Power Steering System (EPS), Traction Control System (TC) and Supplemental Restraint System (SRS) (arrowed) appearing on the instrument panel of the Motor Car during the self-test of its various electronic operating systems when its engine was cranked.

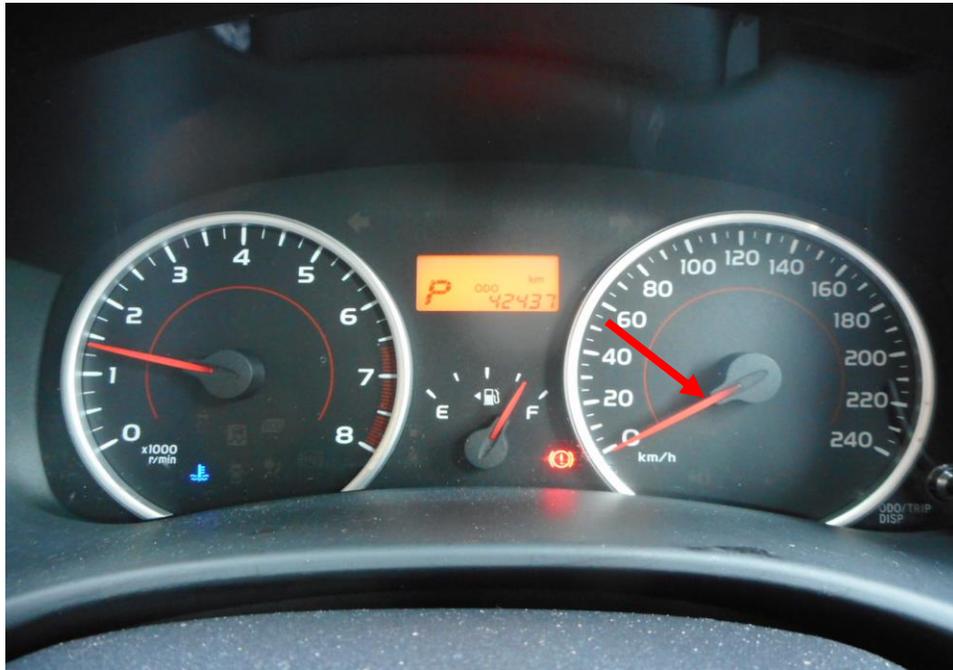
**Photo 25** shows no warning lights illuminated on the instrument panel of the Motor Car after the engine was cranked. This would suggest that there was no abnormality to the electronic operating system of the Motor Car, like the ABS, EPS, TC and SRS etc.
