LKK Auto Consultants Pte Ltd

Vehicle No. SLK 4473S
Insured Veh. SJP 9747S
Claim No. C10005804
Policy No.
Accident Date 04/03/2020
Inspection Date 10/03/2020

ADJUSTMENT ON REPAIR COST FOR VEHICLE NO. SLK 4473S

PHOTOGRAPHS FOR VEHICLE NO. SLK 4473S

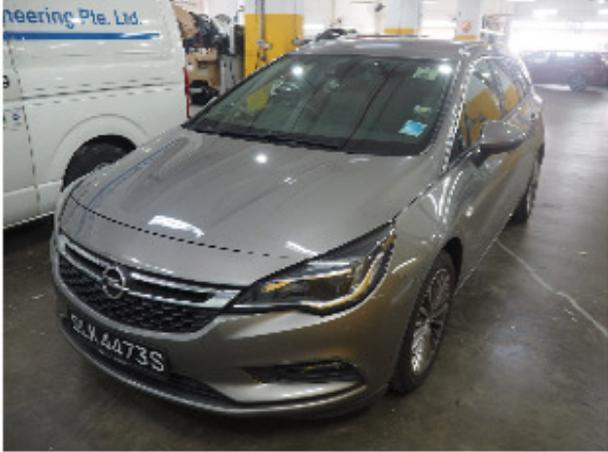
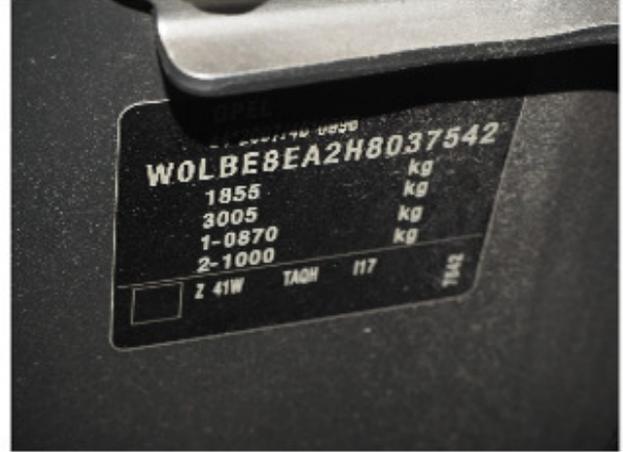
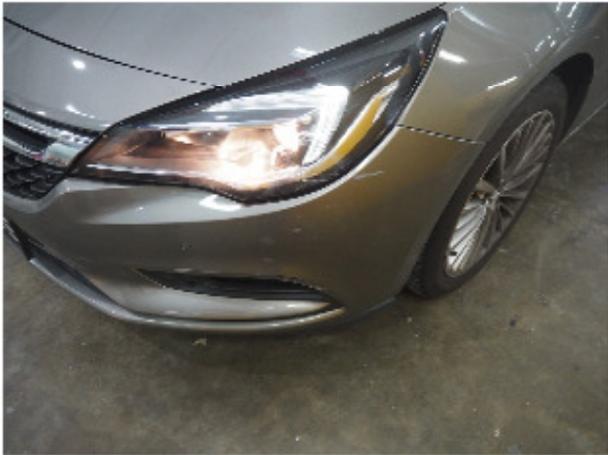
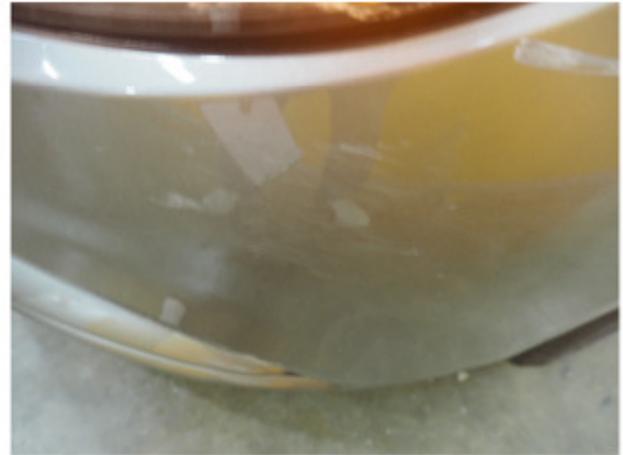
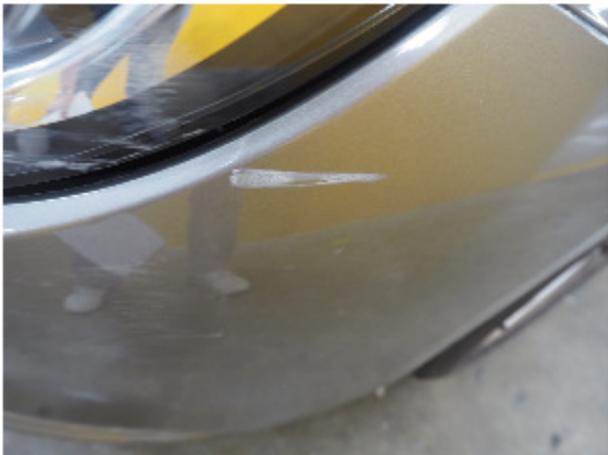
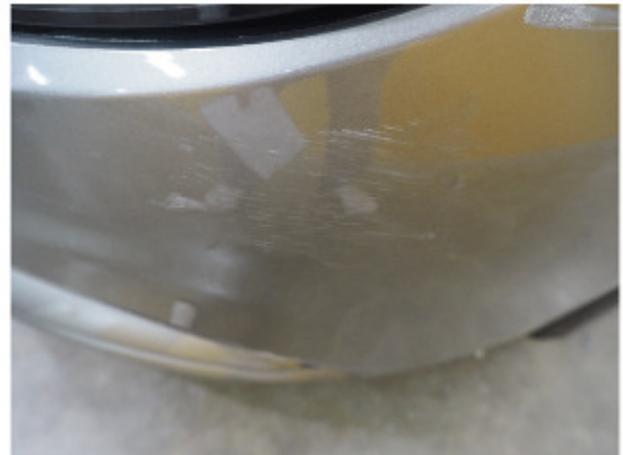
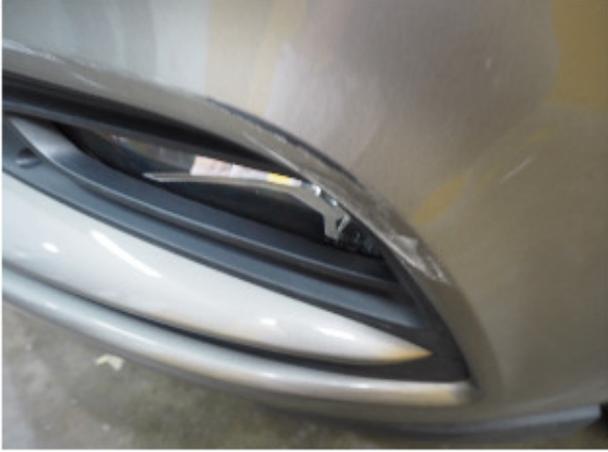
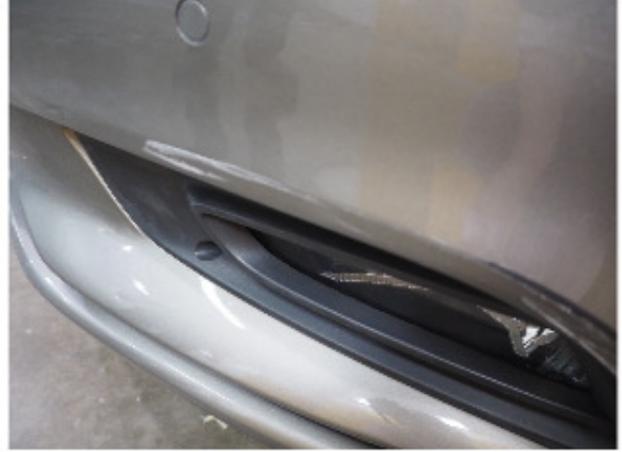
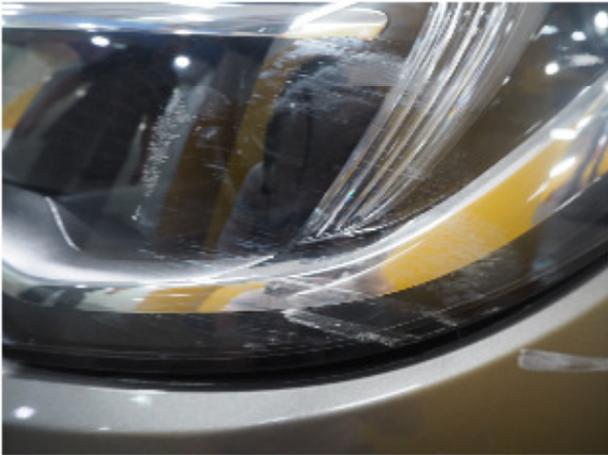
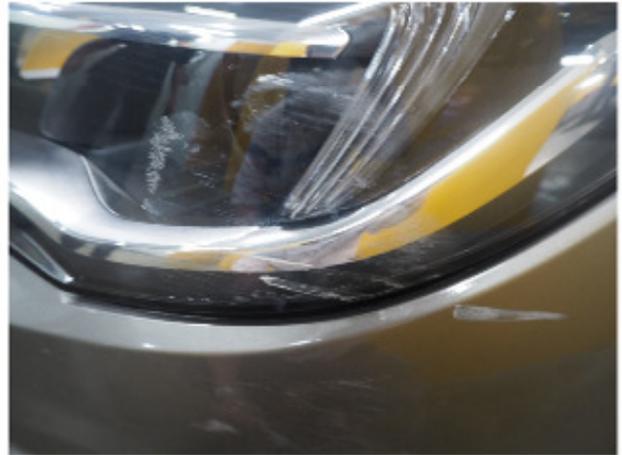
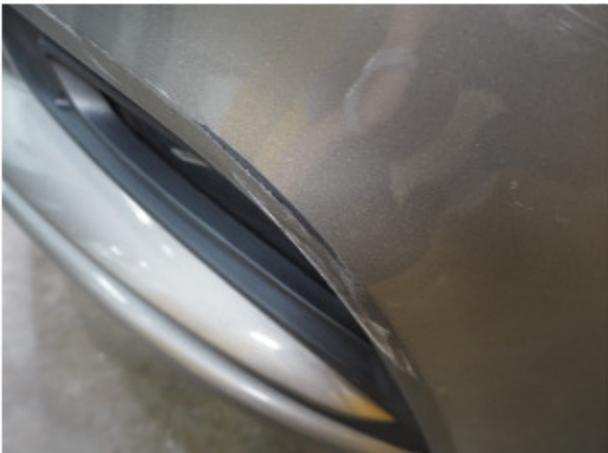
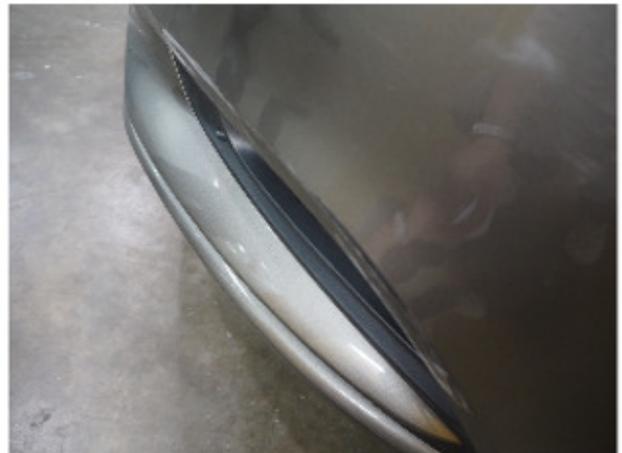
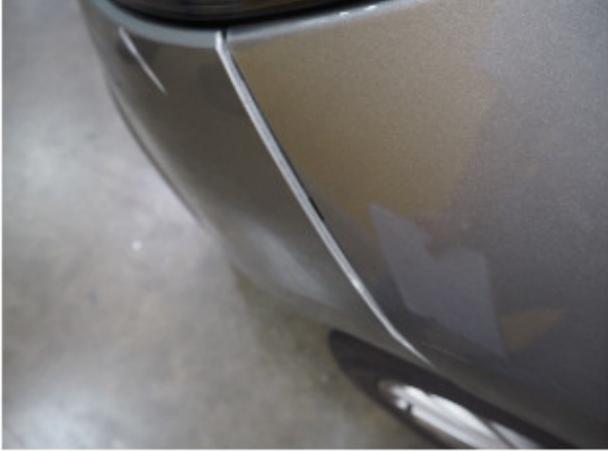
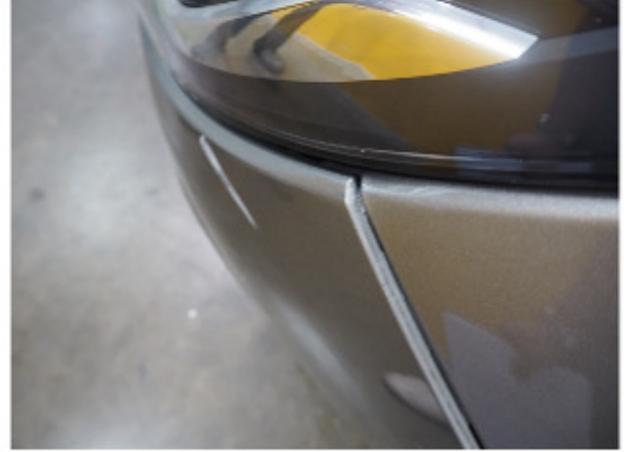
INSPECTION

THE VEHICLE SUSTAINED DAMAGES AT THE FRONT N/S PORTION.
DAMAGES SEE DETAILS.
