LKK Auto Consultants Pte Ltd

ADJUSTMENT ON REPAIR COST FOR VEHICLE NO. SHD 552H

PHOTOGRAPHS FOR VEHICLE NO. SHD 552H

INSPECTION

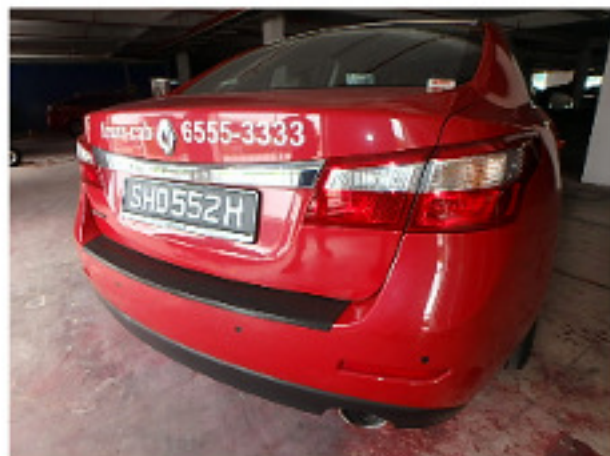
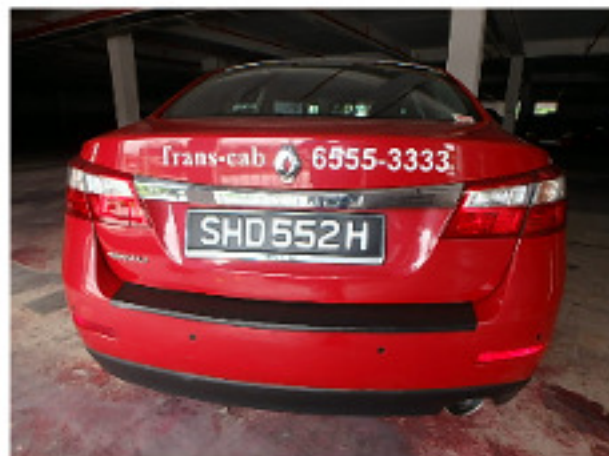
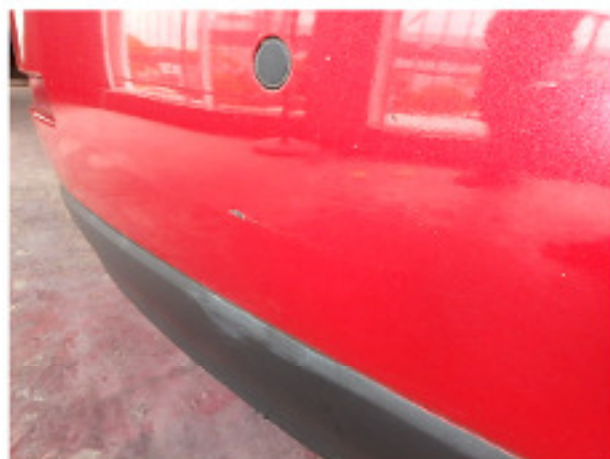
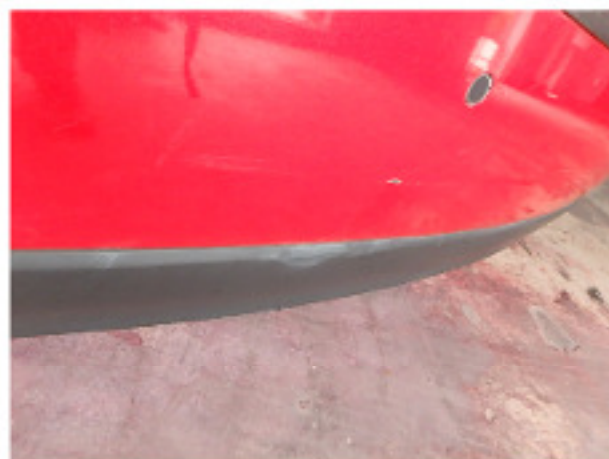
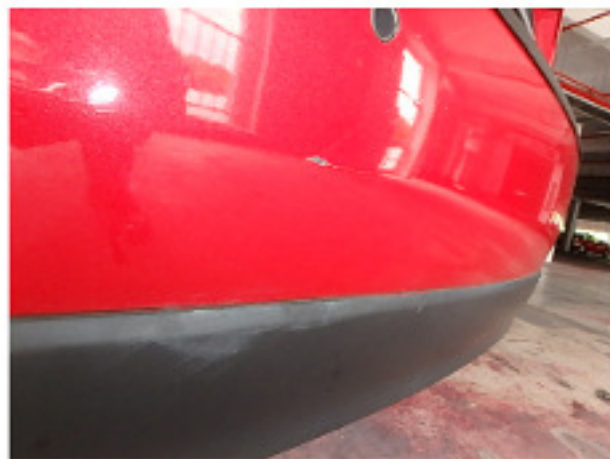
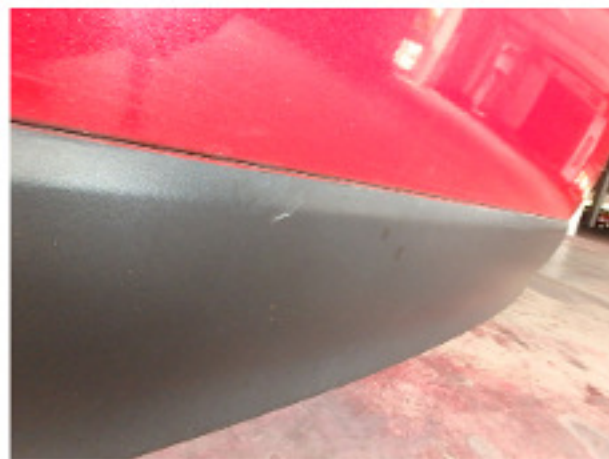
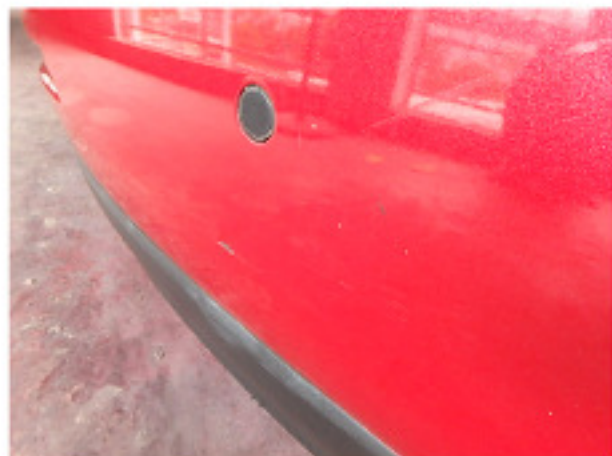
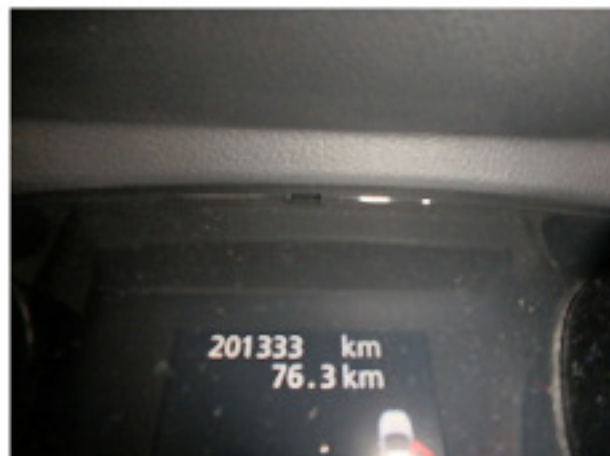
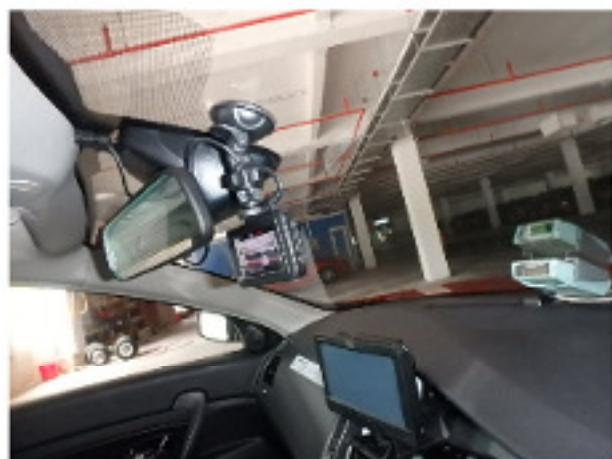
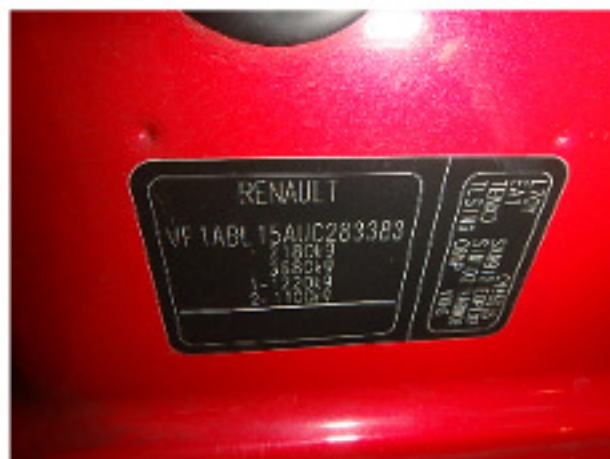
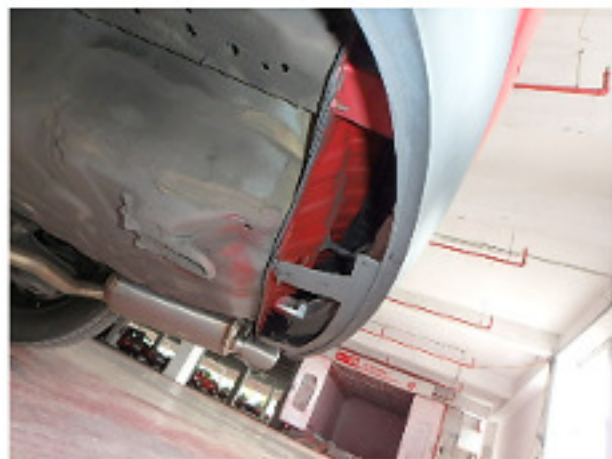
4. Description of Damages				
THE VEHICLE SUSTAINED DAMAGES AT THE REAR PORTION. DAMAGES SEE DETAILS.				
5. General Information				
Accident Date	02/03/2020	Inspection Date	05/03/2020	
Survey held at	TRANS-CAB AUTO SERVICES PTE LTD NO.2 ANG MO KIO ST 63 SINGAPORE 569111			
5a. Remarks				
A)THE INSPECTION WAS CONDUCTED ON A"WITHOUT PREJUDICE" BASIS. B)IN ACCORDANCE TO YOUR INSTRUCTIONS, WE HAVE NOT AUTHORISED REPAIRS.				
5b. Estimate Days of Repair				
ESTIMATED NORMAL PERIOD FOR REPAIR:		2 Working Days
