Your Ref: TP/IP/66691/2019
Our Ref : CI/TPD20003783/N

9 March 2020

INSPECTION REPORT OF MOTORCYCLE FBH 1556R

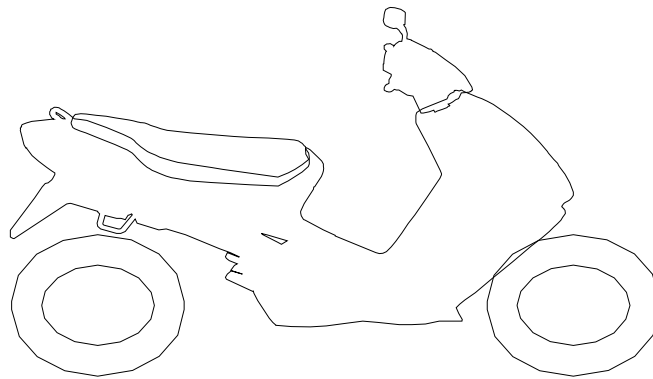
7. The tyre brand, tyre size and remaining tread depth of the 2 tyres were recorded as follows:-

Pirelli 140/70 - 17 (4mm)

Pirelli 110/70 - 17 (3mm)

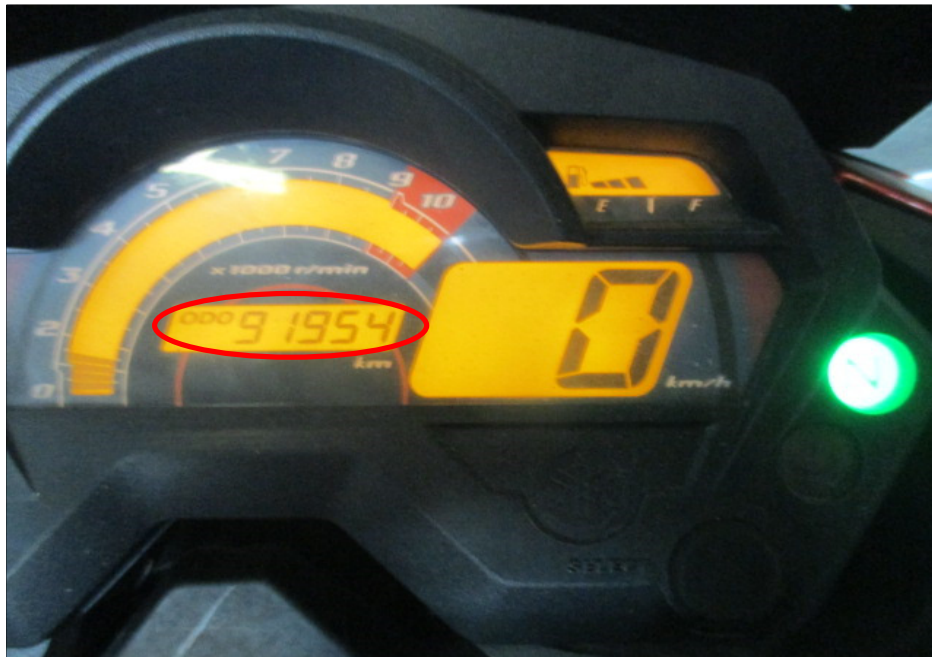
Photo 1 shows the speedometer gauge of the Motorcycle. The mileage of the Motorcycle at the time of our inspection was 91,954km (circled).

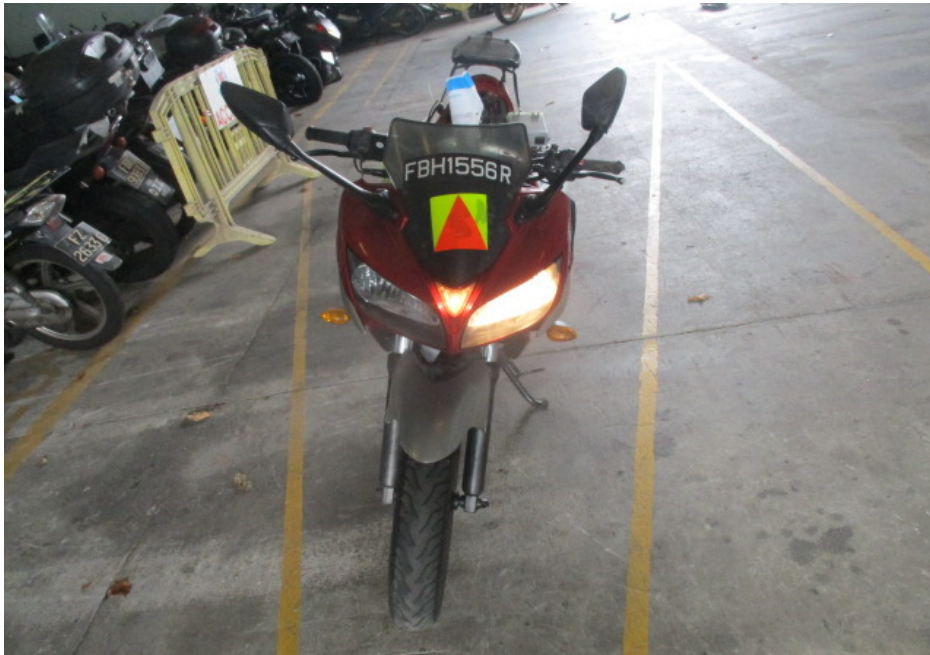
Photo 2 shows a general view of the front body of the Motorcycle at the time of our inspection. The Motorcycle was observed to have sustained damages along its left body.

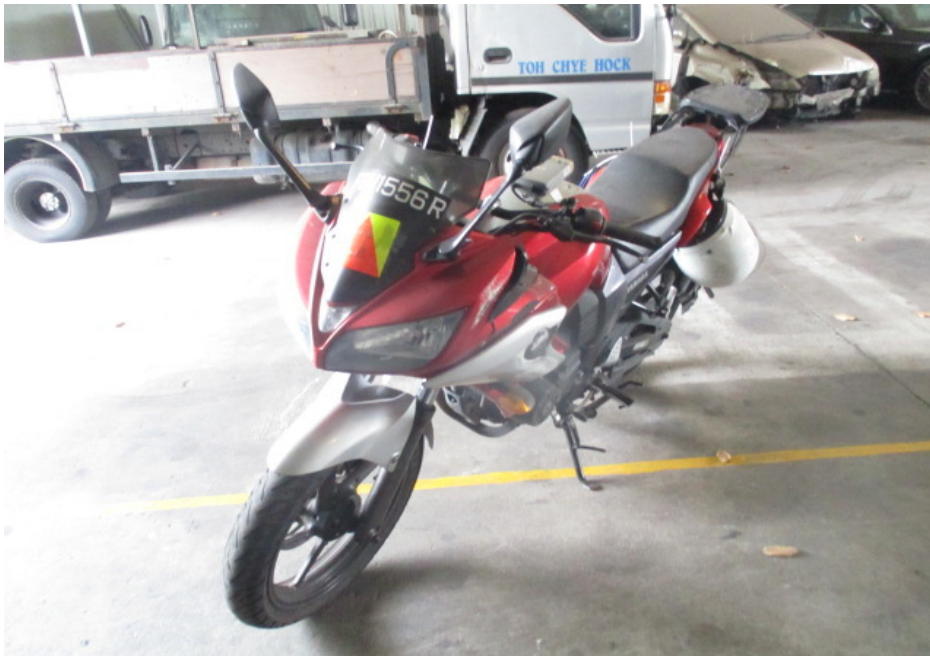
4. The mileage of the Motorcycle at the time of our inspection was 91, 954km.
5. The Motorcycle was observed to have sustained damages along its left body. The body parts that were found to have been damaged include its head cowl, left cowl, clutch lever, left side mirror, fuel tank, left pillion foot peg, left rear side cover, top box rack and rear mudguard, amongst others.

Photo 3 shows a general view of the left body of the Motorcycle at the time of our inspection. The Motorcycle was observed to have sustained damages along its left body. Amongst the body parts that were found to have been damaged include its head cowling, left cowling, clutch lever, left side mirror, fuel tank, left pillion foot peg, left rear side cover, top box rack and rear mudguard, amongst others.

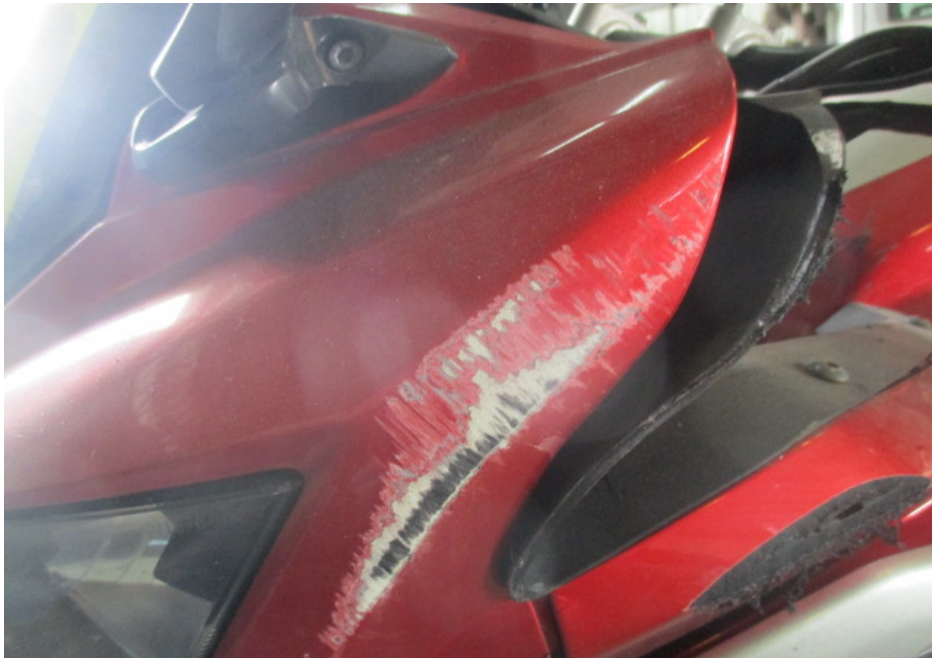
Photo 4 shows a close up view of the head cowl which was amongst the body parts at the front of the Motorcycle that had sustained damage as a result of the accident.

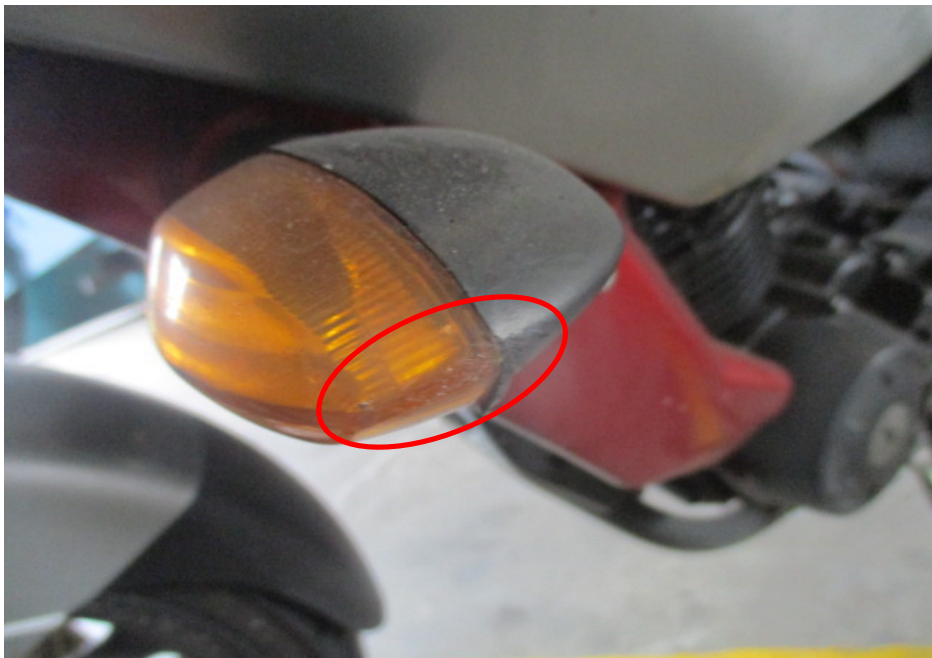
Photo 5 shows a closer view of the left front signal lamp (circled) which was amongst the body parts of the Motorcycle that had sustained damage as a result of the accident.

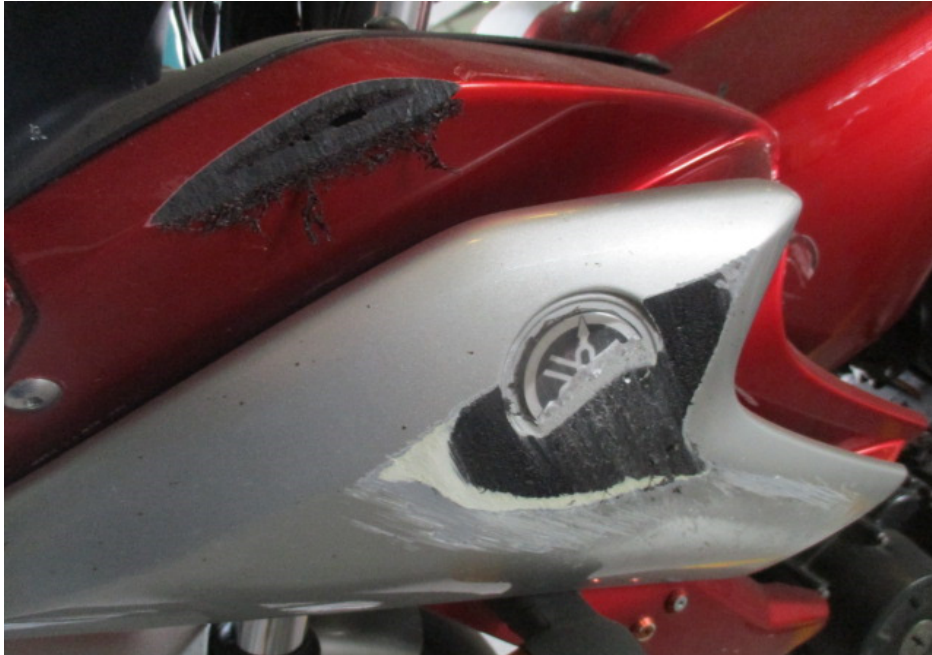
Photo 6 shows a closer view of the left cowling which was amongst the body parts of the Motorcycle that had sustained damage as a result of the accident.

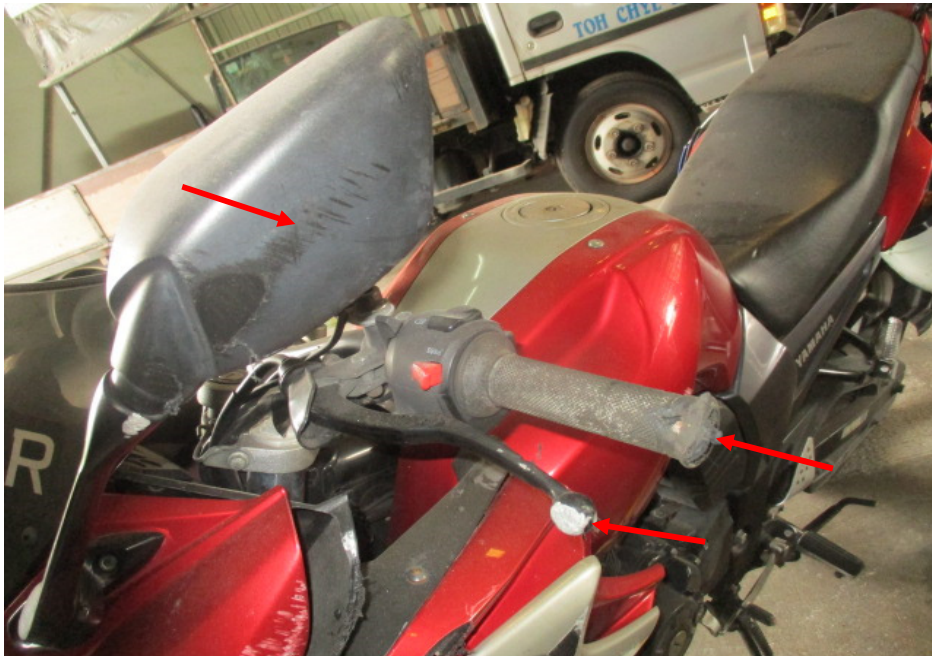
Photo 7 shows the clutch lever, left handlebar end and left side mirror (arrowed), which were amongst the body parts of the Motorcycle that had sustained damage as a result of the accident.

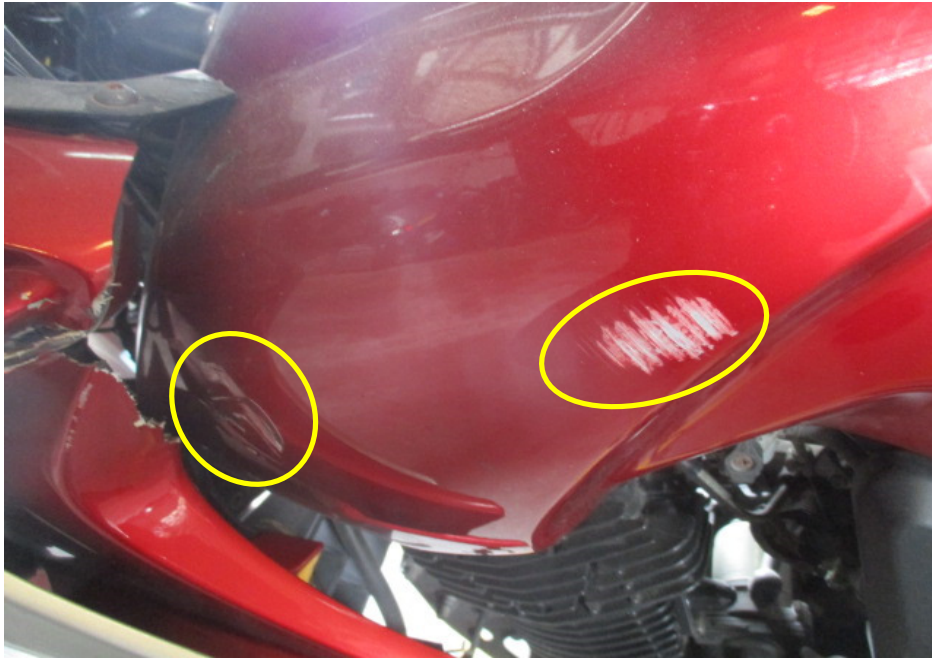
Photo 8 shows a closer view of the fuel tank (circled) which was amongst the body parts of the Motorcycle that had sustained damage as a result of the accident.

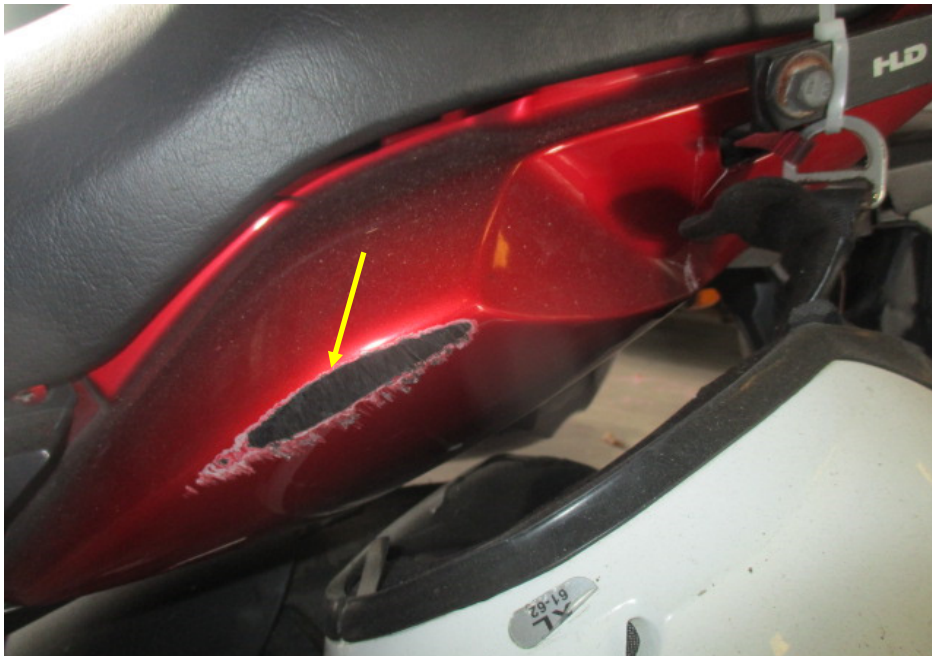
Photo 9 shows a closer view of the left rear side cover which was amongst the body parts of the Motorcycle that had sustained damages of grazing nature as a result of the accident (arrowed).

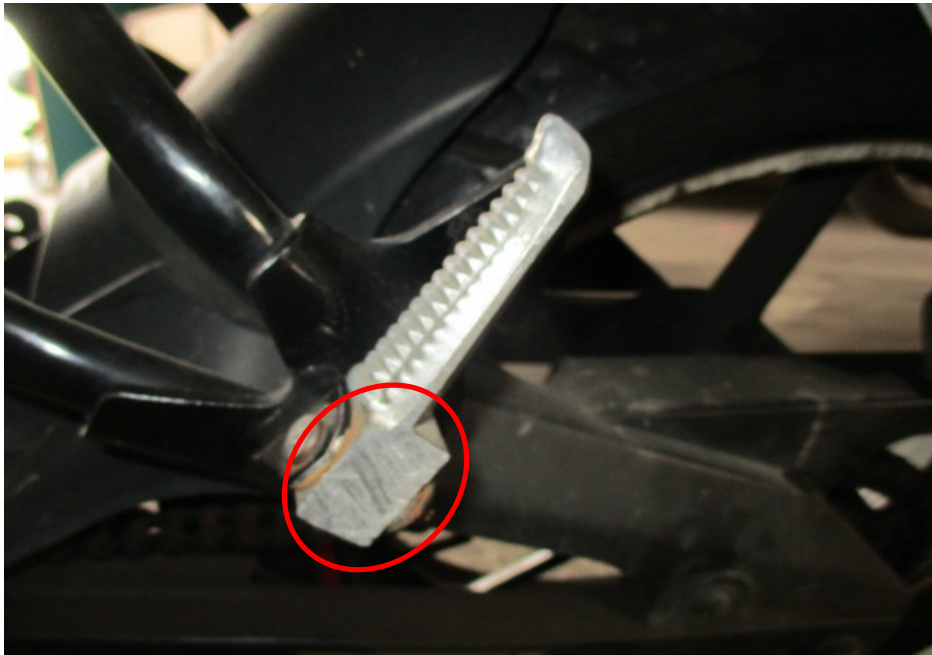
Photo 10 shows a closer view of the left pillion foot peg which was amongst the body parts of the Motorcycle that had sustained damages of grazing nature as a result of the accident (circled).

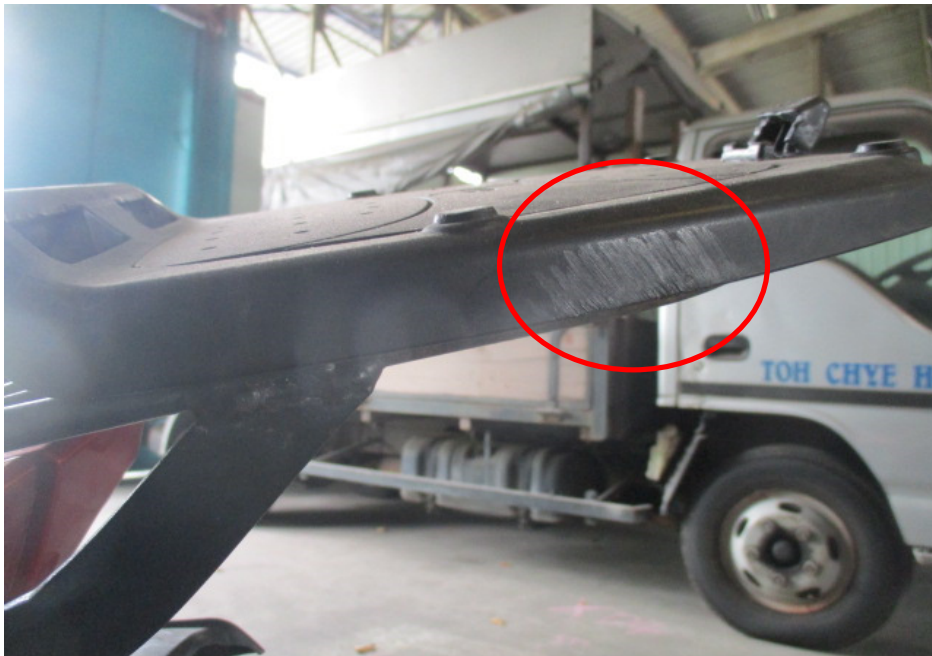
Photo 11 shows the top box rack (circled) of the Motorcycle that had sustained damage as a result of the accident.

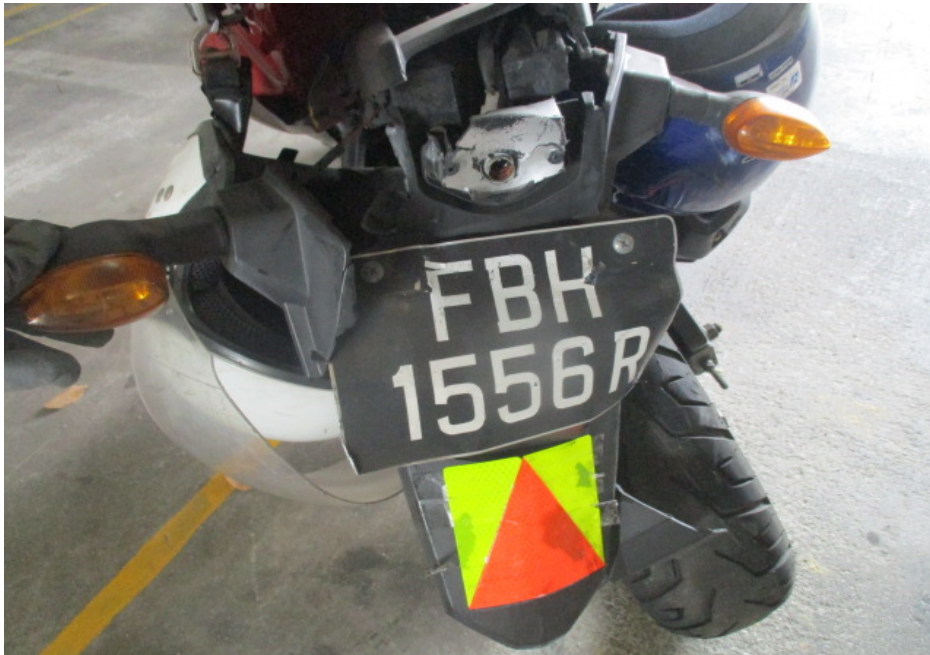
Photo 12 shows the rear mudguard, tail lamp and rear number plate of the Motorcycle that had sustained extensive damage as a result of the accident.

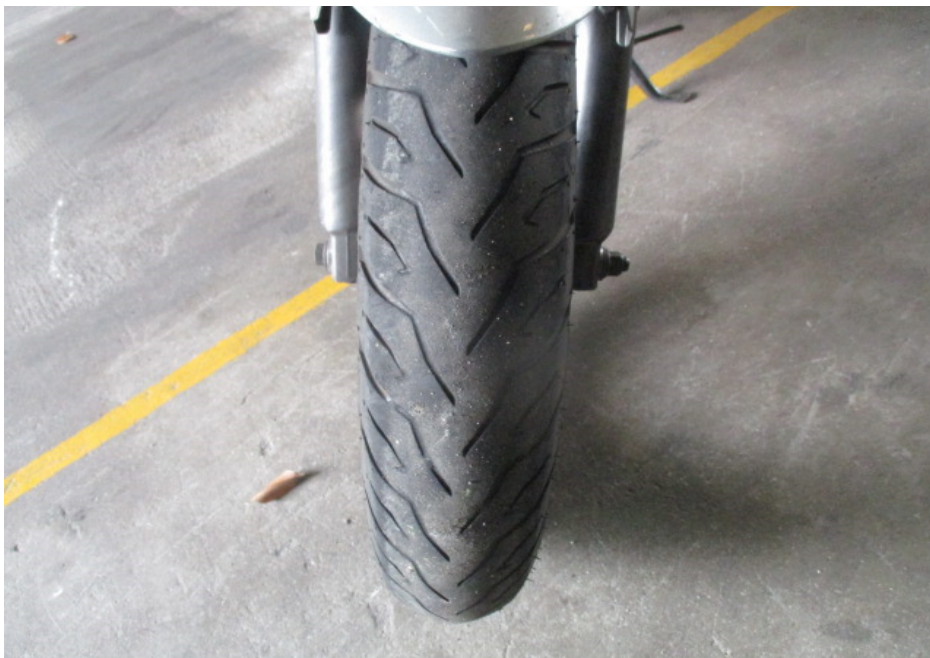
Photo 13 shows the front tyre of the Motorcycle at the time of our inspection. The front tyre was observed to be in serviceable condition with remaining tread depth of approximately 3mm. The pattern of the tread was also clearly visible. There was no tear, burst mark(s) and/or punctured hole(s) on the sidewalls as well as across the tread of the front tyre.

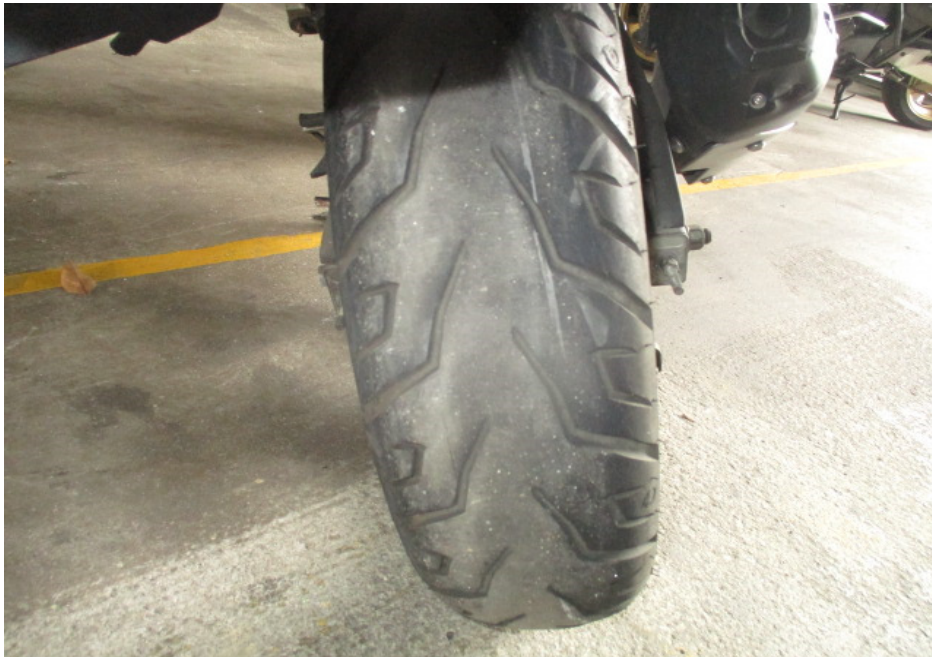
Photo 14 shows the condition of the Motorcycle's rear tyre. The rear tyre was observed to be in serviceable condition with remaining tread depth of approximately 4mm. The tyre was also observed to be sufficiently inflated for vehicular operation. We did not observe any tear, burst mark(s) and/or punctured hole(s) on the sidewalls as well as across the tread of the rear tyre.

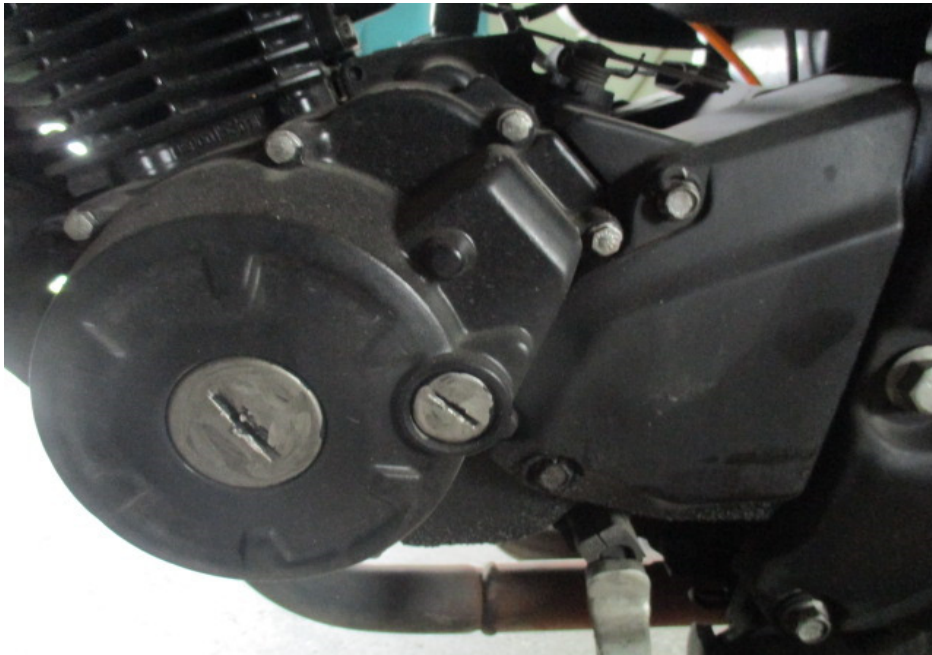
Photo 15 shows the left side of the engine of the Motorcycle at the time of our inspection. The various engine related parts and components were found to be intact with no visible damage. There was also no sign(s) or indication(s) of fluid leak observed around the left engine area of the Motorcycle.

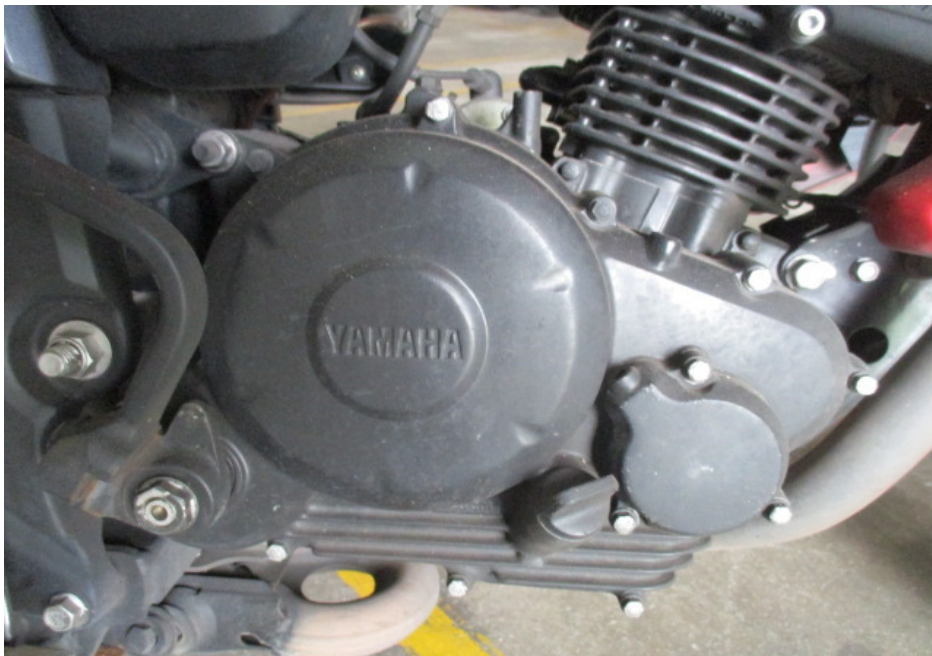
Photo 16 shows the right side of the engine of the Motorcycle at the time of our inspection. The various engine related parts and components were found to be intact with no visible damage. There was also no sign(s) or indication(s) of fluid leak observed around the right engine area of the Motorcycle.

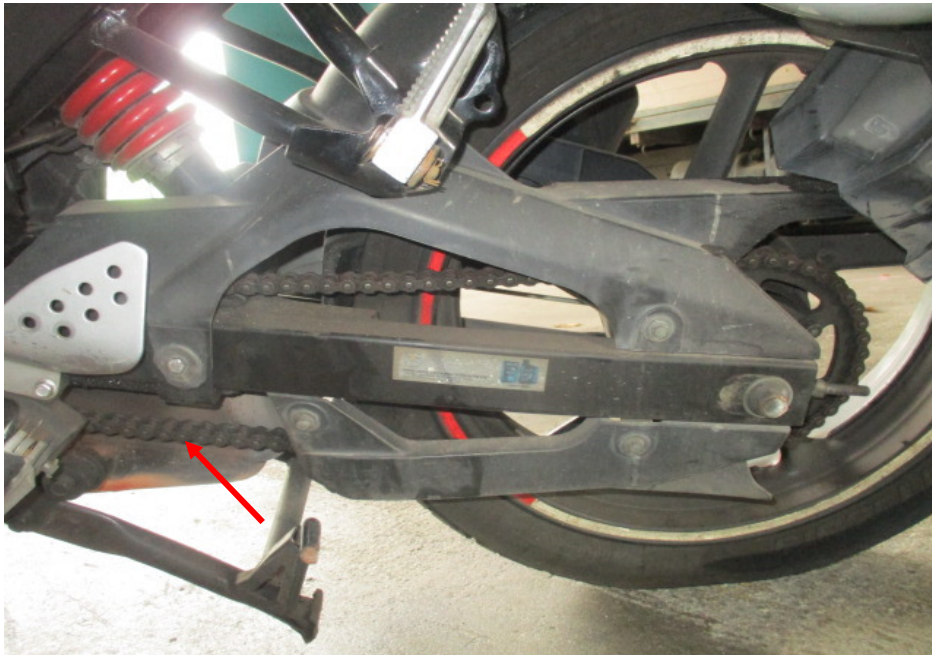
Photo 17 shows the general view of the gear train (arrowed) of the Motorcycle, which was observed to be intact with no misalignment. It was also adequately lubricated for operating purposes.

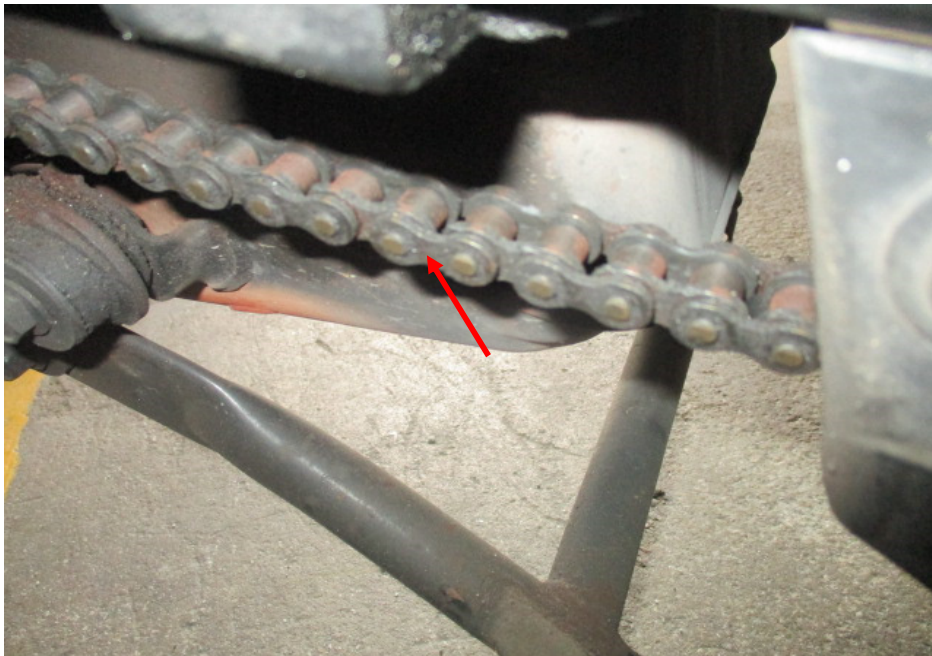
Photo 18 shows a closer view of the gear train (arrowed) of the Motorcycle, which was observed to be intact with no misalignment. It was also adequately lubricated for operating purposes.

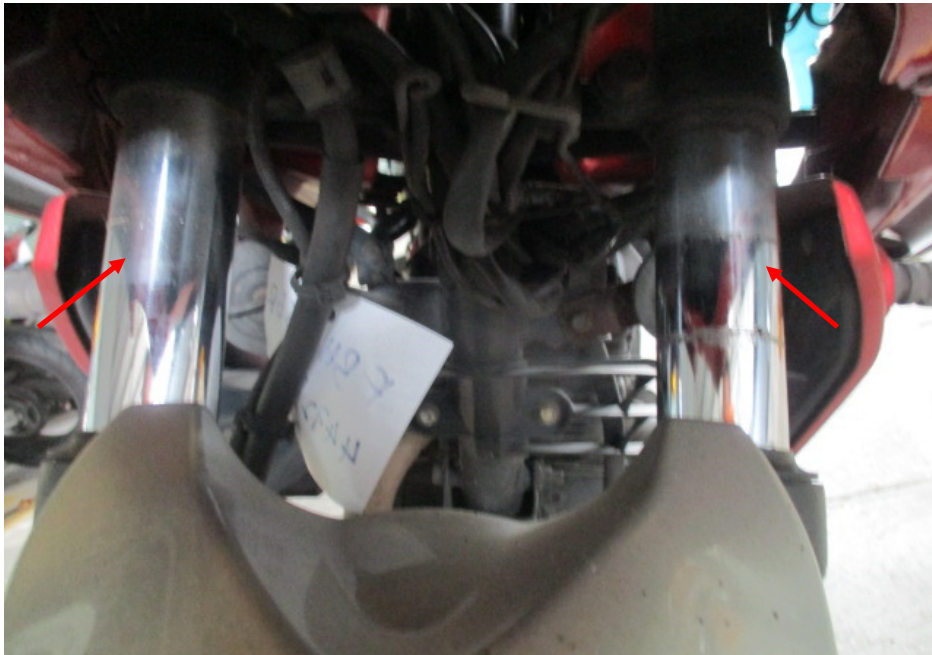
11. Our checks on the various steering components of the Motorcycle revealed that its steering system was in serviceable condition. Its front fork was found to be intact and undamaged. Turning the handle bar towards the left and right also did not produce any abnormal free play and/or resistance.

Photo 19 shows the front fork (arrowed) of the Motorcycle. The front fork and fork bracket of the Motorcycle were both found to be intact and undamaged. Turning the Motorcycle's handle bar towards the left and right did not produce any abnormal free play. The steering system of the Motorcycle was in serviceable condition at the time of our inspection.

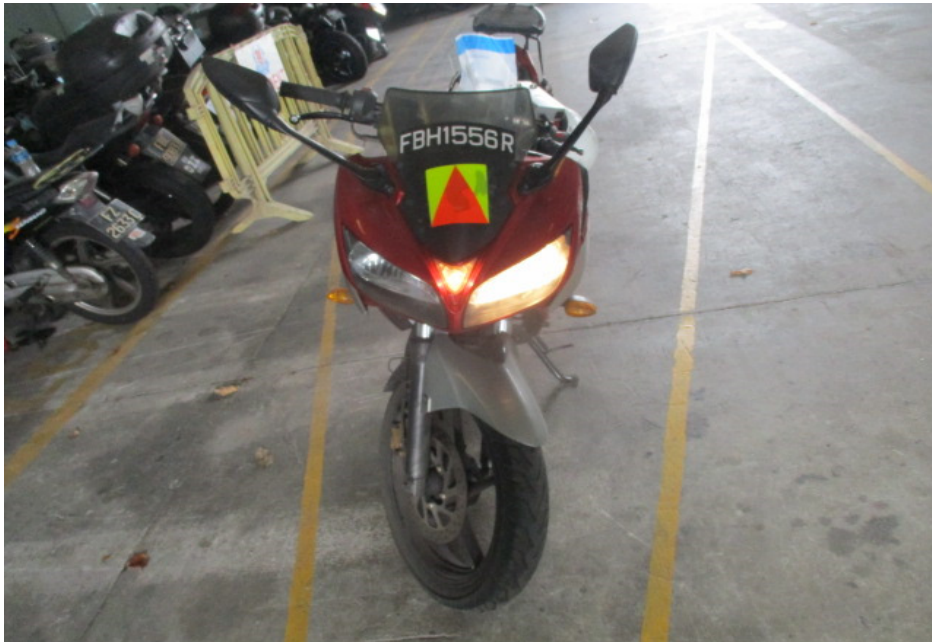
Photo 20 shows the front wheel of the Motorcycle turned towards its full left. Turning the Motorcycle's handle bar towards the left did not produce any abnormal free play and/or resistance. This would indicate that the steering system of the Motorcycle was in serviceable condition at the time of our inspection.

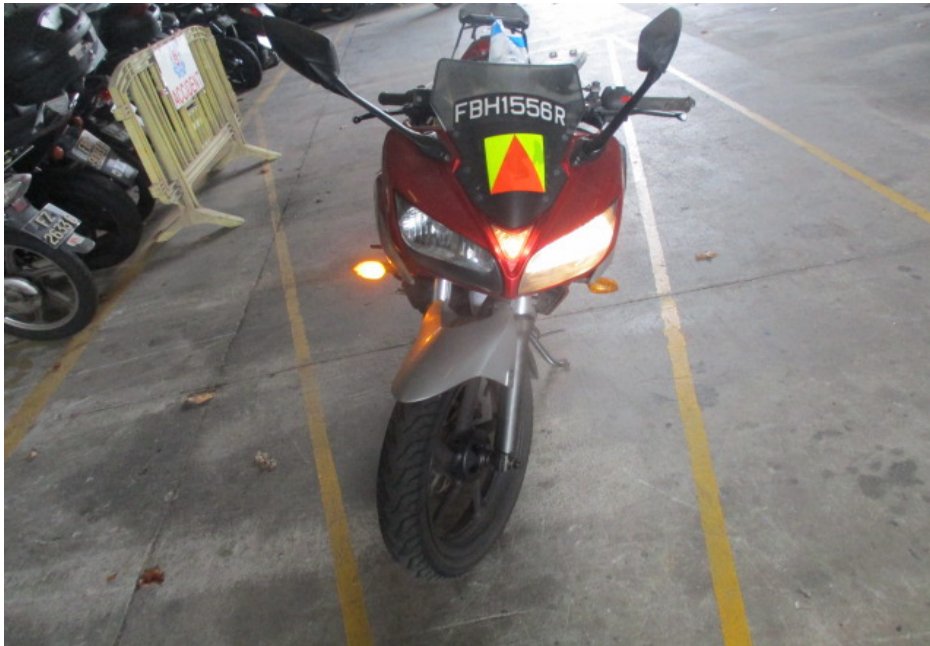
Photo 21 shows the front wheel of the Motorcycle turned towards its full right. Turning the Motorcycle's handle bar towards the right did not produce any abnormal free play and/or resistance. This would indicate that the steering system of the Motorcycle was in serviceable condition at the time of our inspection.

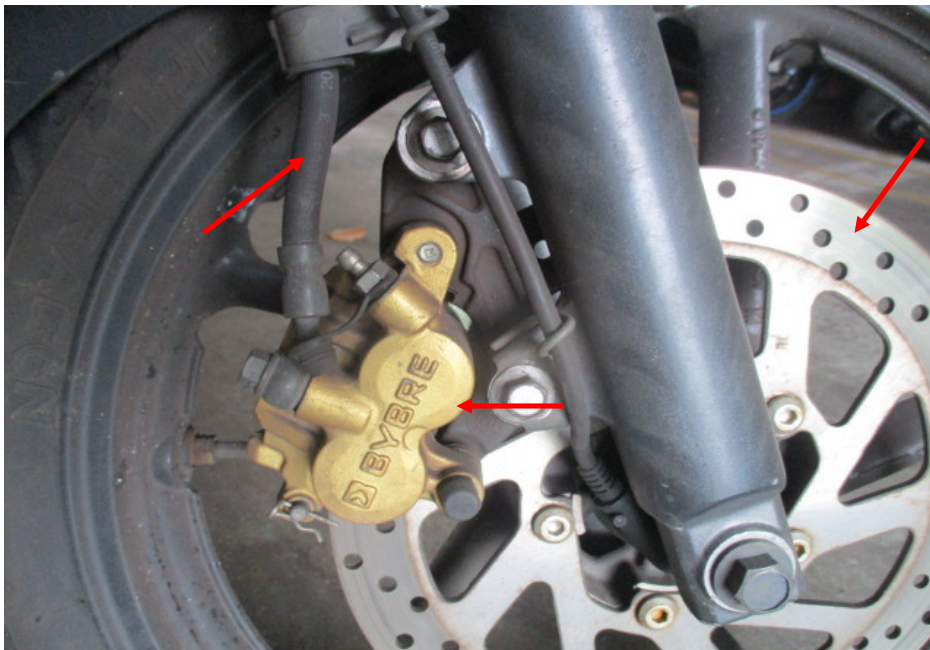
Photo 22 shows a close up view of the front brake caliper, front brake disc and front brake hose (arrowed) of the Motorcycle, which are all part of the components in the hydraulic front brake system of the Motorcycle. Our visual checks of these various components had revealed all to be intact with no visible damage. No leakage of brake fluid was also observed.

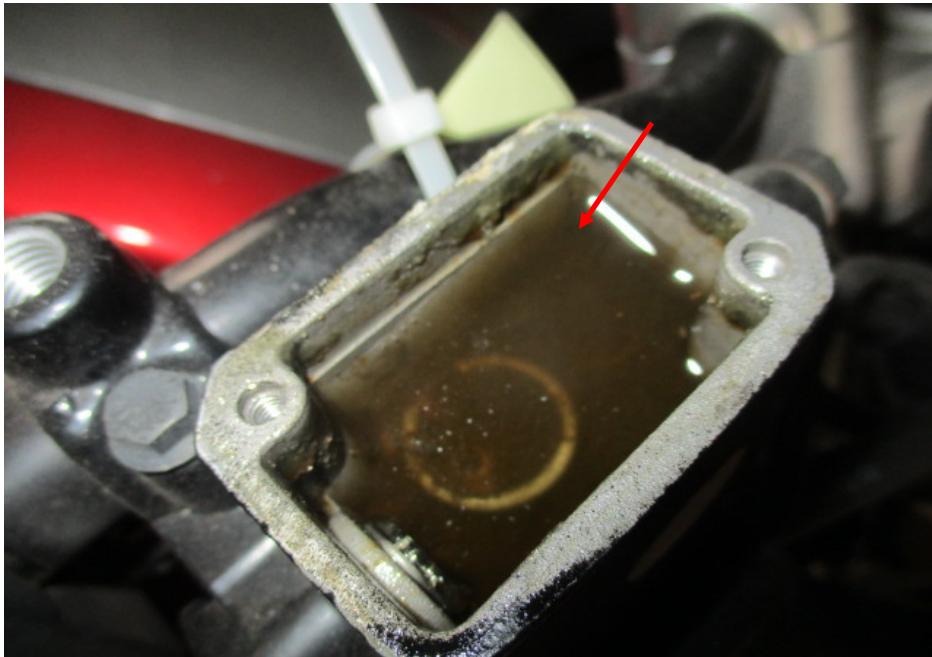
Photo 23 shows the brake fluid reservoir for the front brake of the Motorcycle. The brake fluid was found to be of sufficient level for operating purposes. However the brake fluid was found to be slightly contaminated (arrowed).

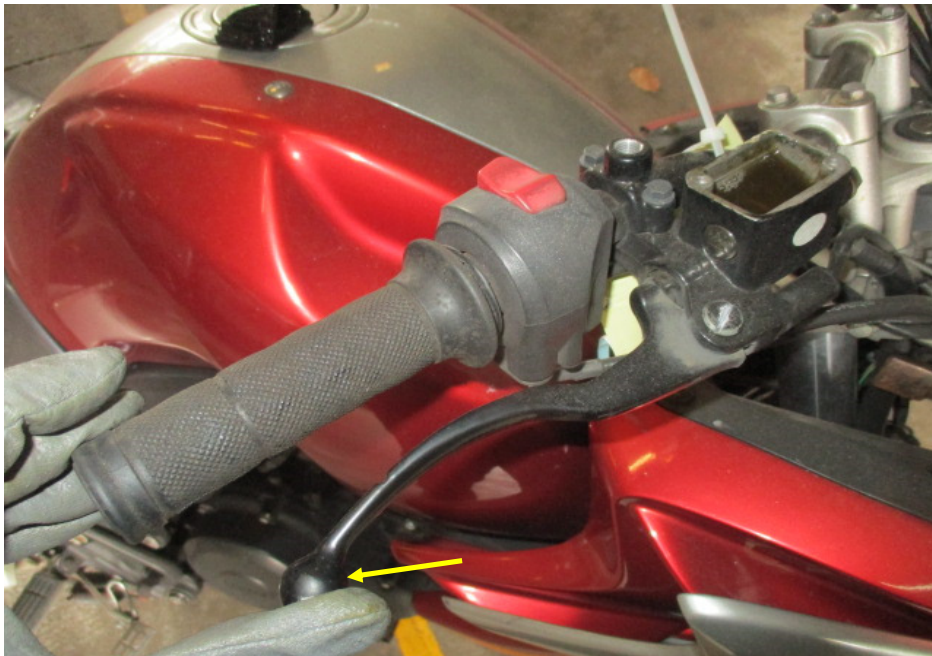
13. Static brake tests conducted on the Motorcycle had appeared to indicate that the brake system of the Motorcycle was in serviceable condition. There was some resistance felt (spongy like feel) upon pressing the front brake lever. This would indicate that there's no leakage of pressure/vacuum in the front brake system.

Photo 24 shows the front brake lever being depressed. There was some resistance felt (spongy like feel) upon pressing the front brake lever (arrowed). This would indicate that there is no leakage of pressure/vacuum in the brake system.

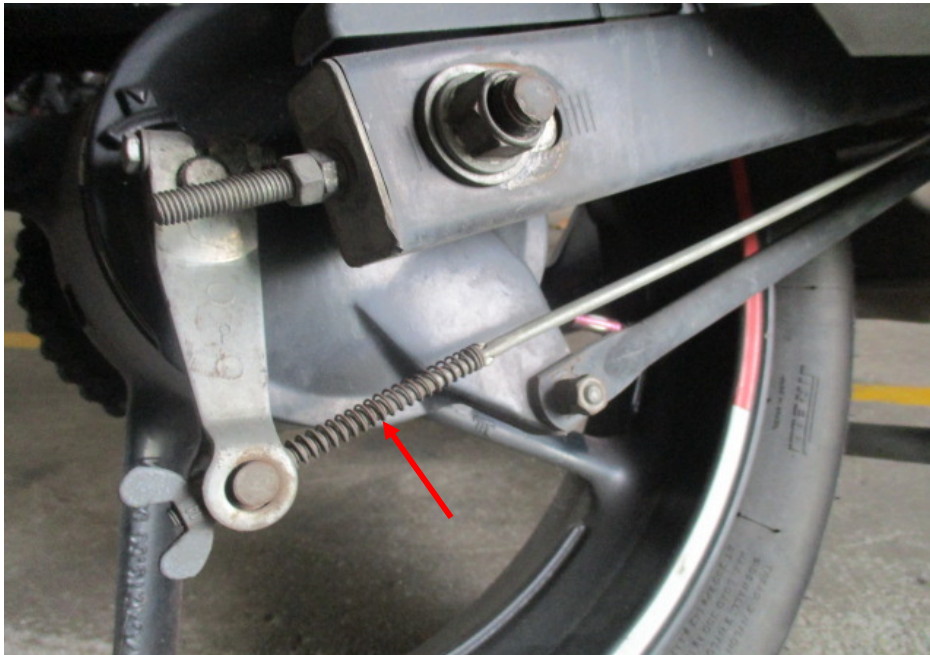
Photo 27 shows the rear wheel of the Motorcycle. The type of brake system for the rear wheel was of a mechanical type, controlled by the brake foot pedal of the Motorcycle. Our checks of the cable (arrowed), spring and drum which are all part of the components in the rear brake system of the Motorcycle reveal all to be intact and without damage.
