LKK Auto Consultants Pte Ltd

4. Description of Damages

ADJUSTMENT ON REPAIR COST FOR VEHICLE NO. SLD 1454D

PHOTOGRAPHS FOR VEHICLE NO. SLD 1454D

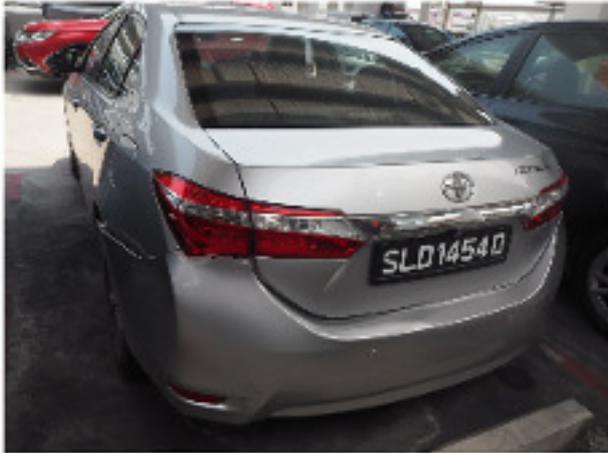
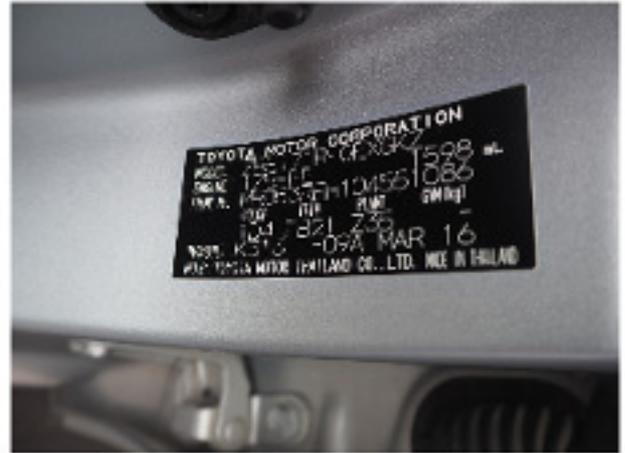
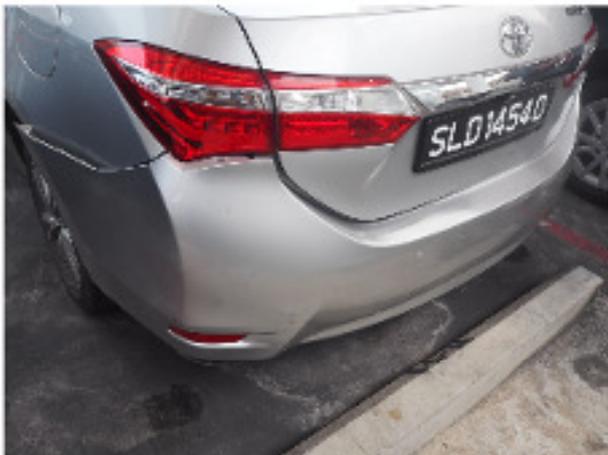
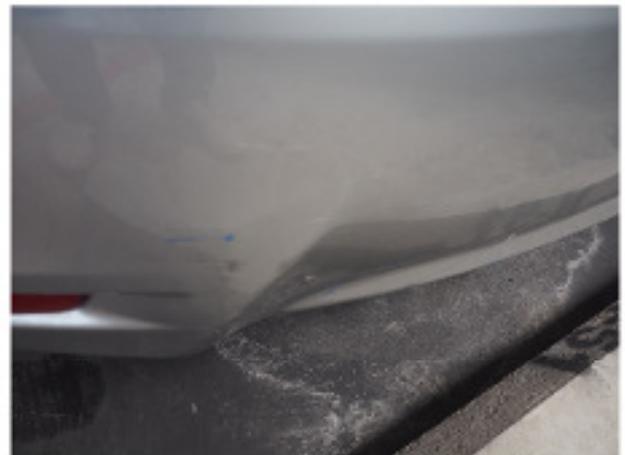
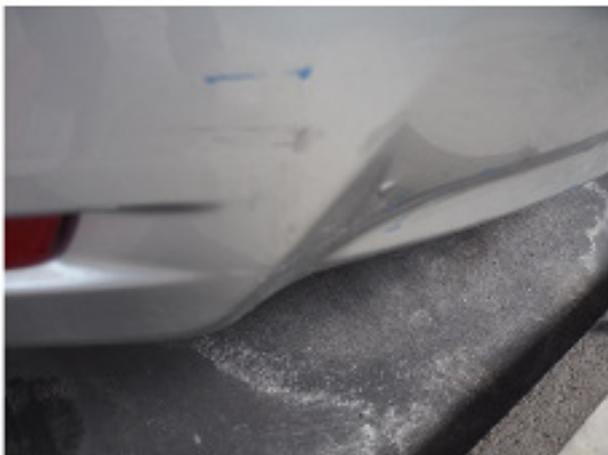
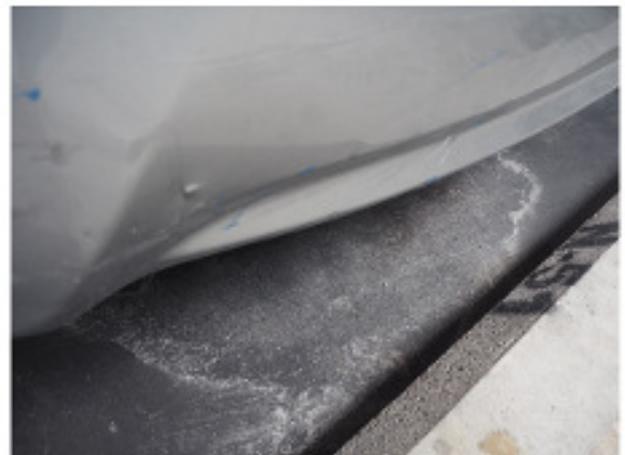
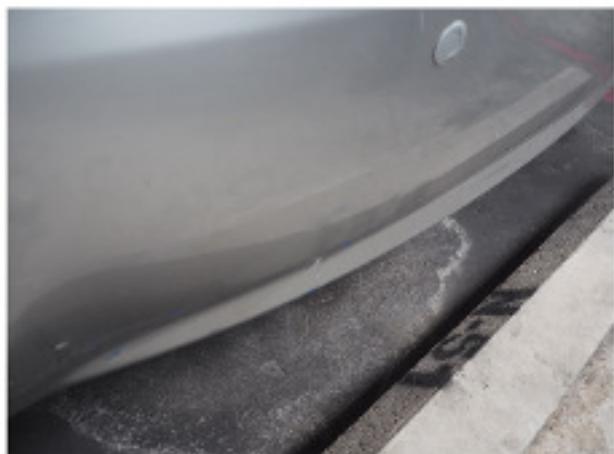
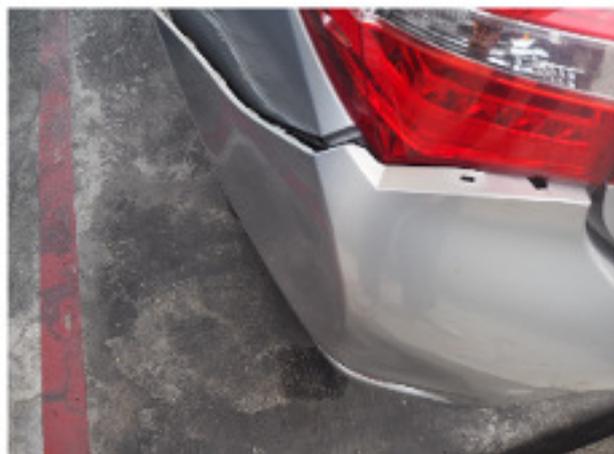
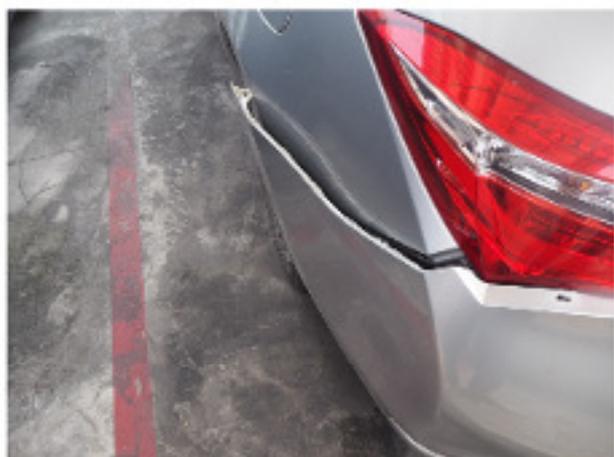
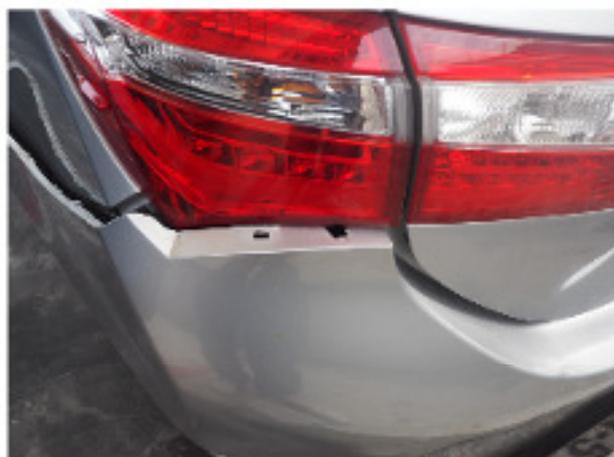
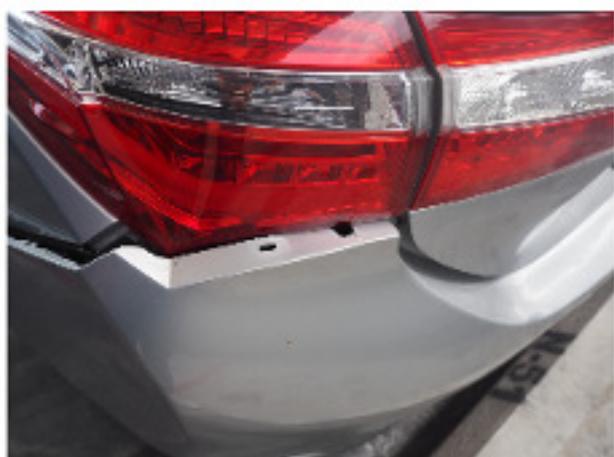
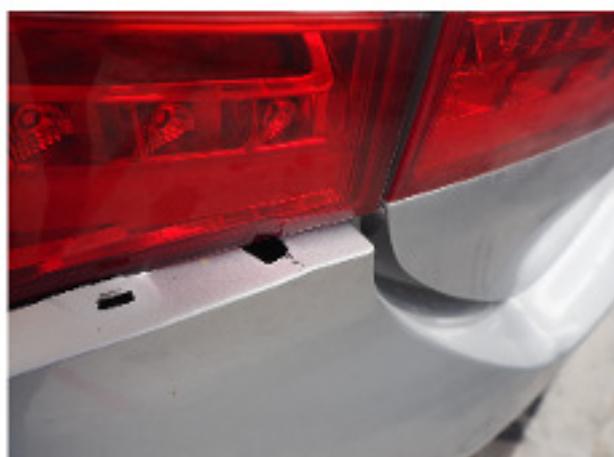
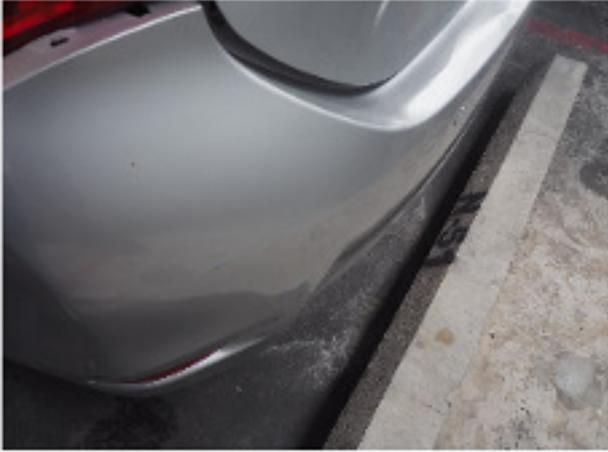
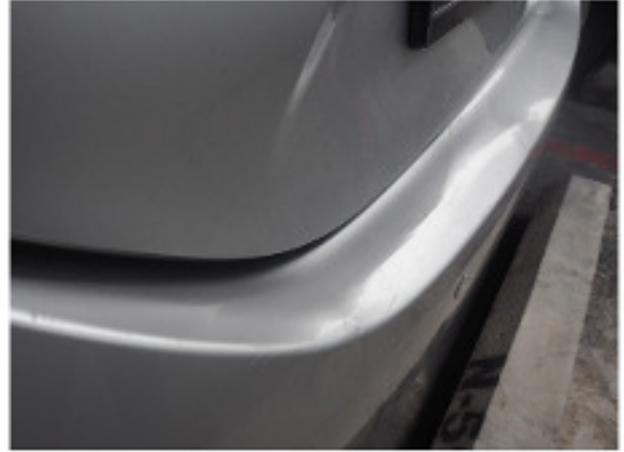
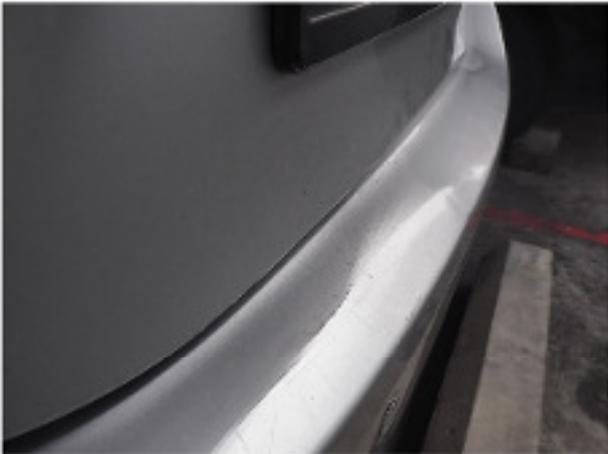
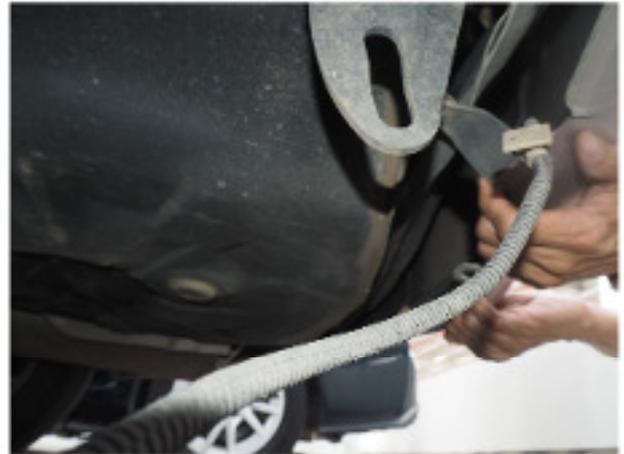
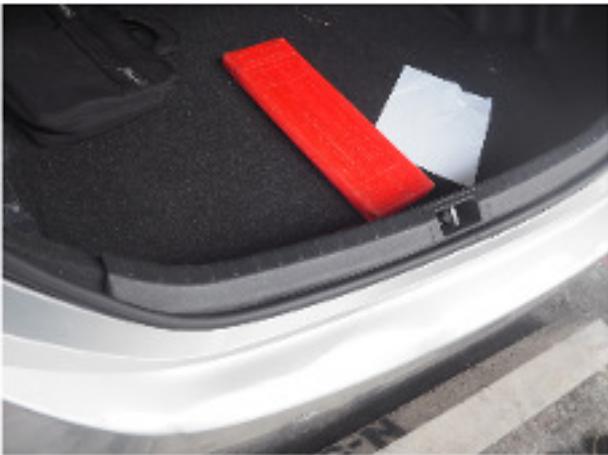
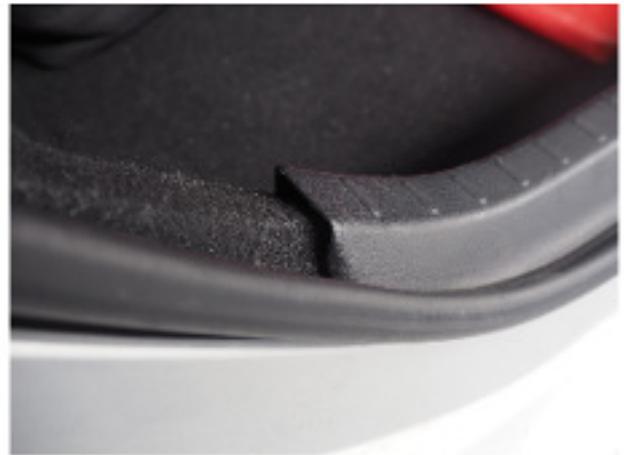
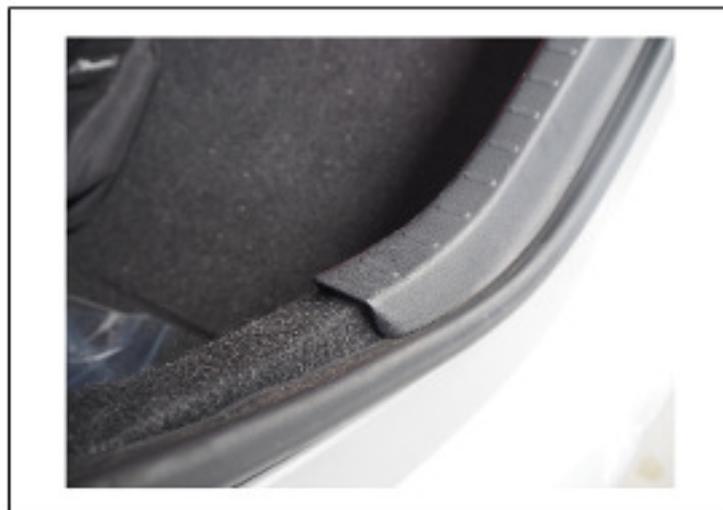
INSPECTION

THE VEHICLE SUSTAINED DAMAGES AT THE REAR N/S PORTION.
DAMAGES SEE DETAILS.
