LKK Auto Consultants Pte Ltd

1.		Policy Particulars	- THIRD PARTY CLAIM		
	Insured Veh.	SHA 2897R	Veh. Inspected	SLP 1482J	
	Policy No.	D-20094922MFSH	Coverage (\$)	0.00	
	Claim No.	D20001384MFSH	Excess (\$)	0.00	
	Assign From	HENG DING CHAO	Assign Date	10/03/2020

ADJUSTMENT ON REPAIR COST FOR VEHICLE NO. SLP 1482J

PHOTOGRAPHS FOR VEHICLE NO. SLP 1482J

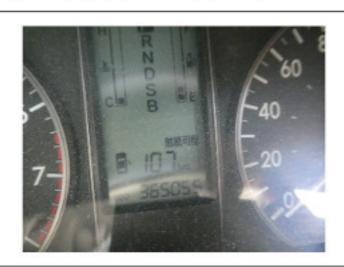
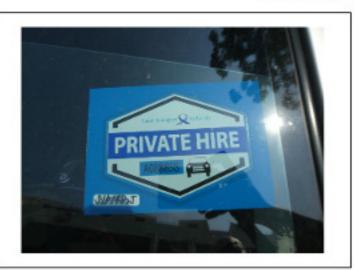
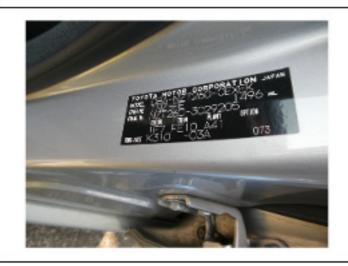
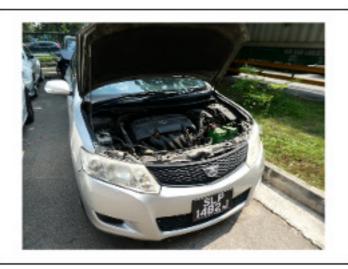
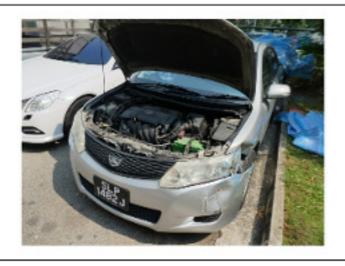
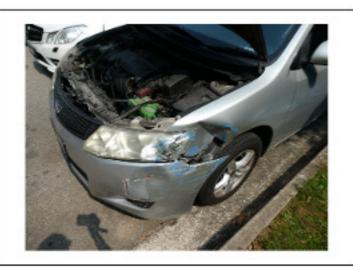
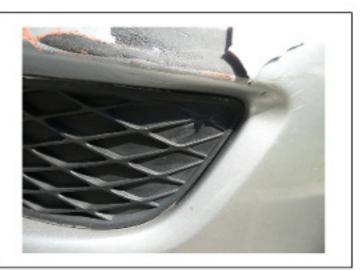
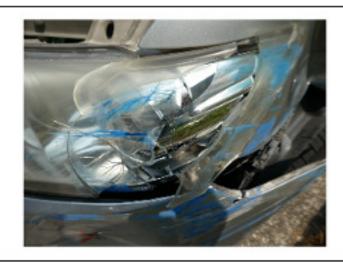
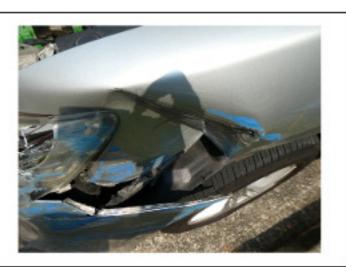
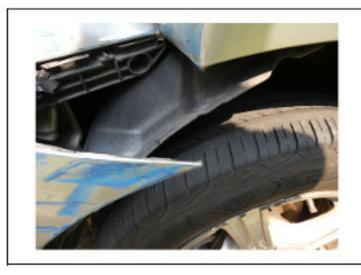
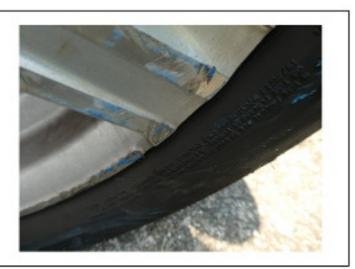
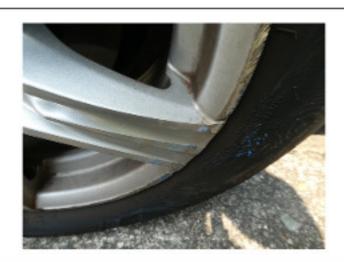
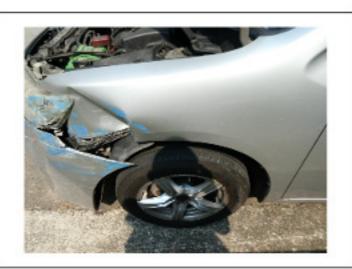
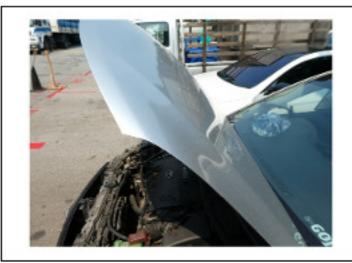
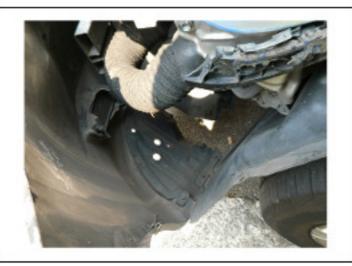
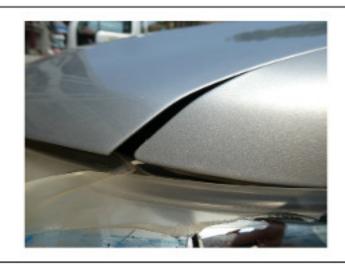
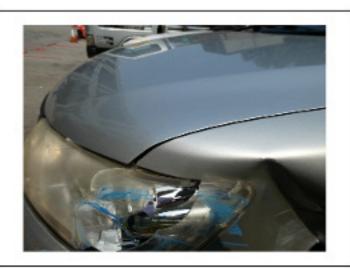
4.		<u> </u>	on of Damages		
	THE VEHICLE SU	STAINED DAMAGES AT THE FRO	ONT O/S PORTION AND UN	DERCARRIAGE.	
	DAMAGES SEE D	ETAILS.			
5.		General	Information		
	Accident Date	08/03/2020	Inspection Date	10/03/2020	
	Survey held at	MY CAR CONSULTANT PTE LT	D		
	53 UBI AVENUE 1 #01-33 PAYA UBI INDUSTRIAL PARK SINGAPORE 408934				
5a.			emarks		
	A)THE INSPECTION WAS CONDUCTED ON A"WITHOUT PREJUDICE" BASIS. B)IN ACCORDANCE TO YOUR INSTRUCTIONS, WE HAVE NOT AUTHORISED REPAIRS.				
5b.					
	ESTIMATED NORMAL PERIOD FOR REPAIR: 5 Working Days
