Your Ref: TP/IP/10029/2020  
Our Ref : CI/TPD20004218/P

23<sup>rd</sup> March 2020

### **MECHANICAL INSPECTION REPORT OF MOTOR CAR SJM 5980B**

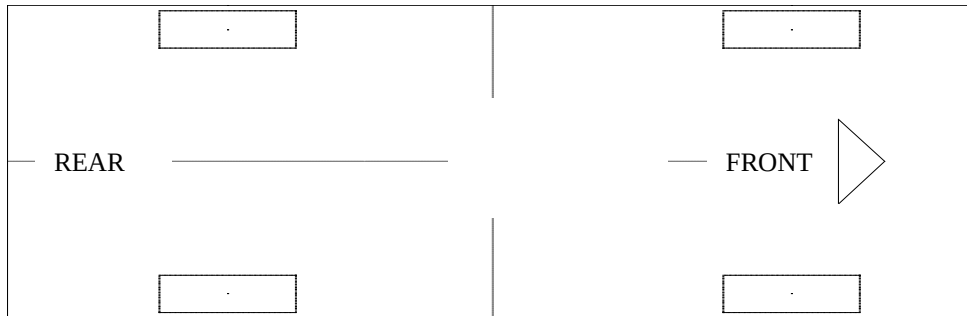
6. The condition of the Motor Car's 4 tyres was observed to be in serviceable condition. I did not find any tear, cut or burst mark(s) on the outer and the inner sidewalls as well as across the tread of the 4 tyres. The 4 tyres were also observed to be sufficiently inflated for vehicular operation. The tyre brand, tyre size and remaining tread depth of the 4 tyres were recorded as follows:-

Bridgestone 195/60R15 (4.1mm)

Bridgestone 195/60R15 (3mm)

Bridgestone 195/60R15 (4.8mm)

Bridgestone 195/60R15 (3.5mm)

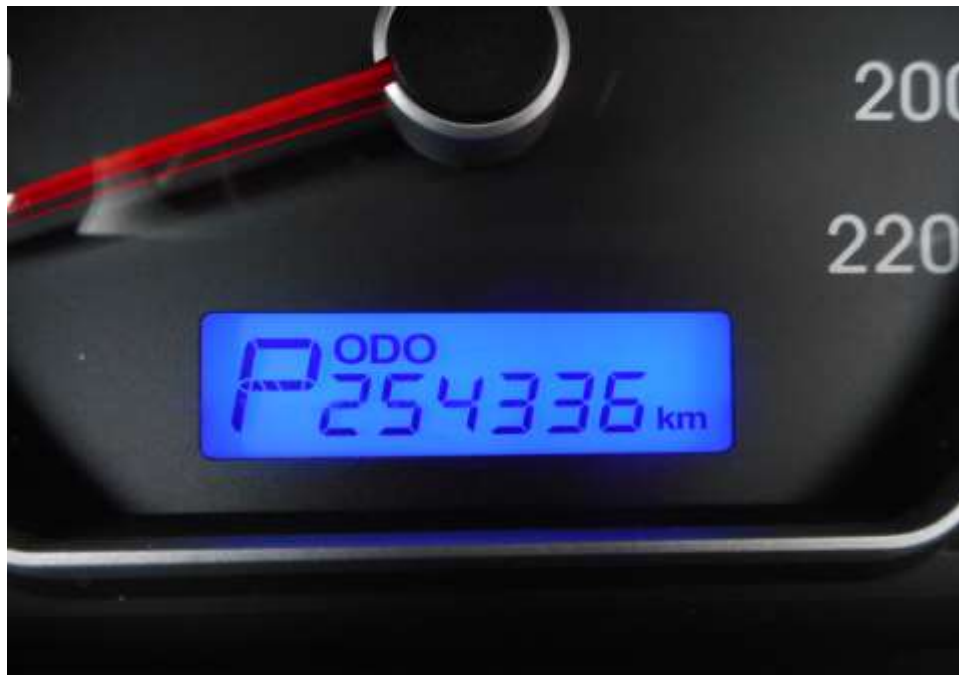
**Photo 1** shows the mileage of the Motor Car at the time of my inspection. The mileage observed was 254,336km.

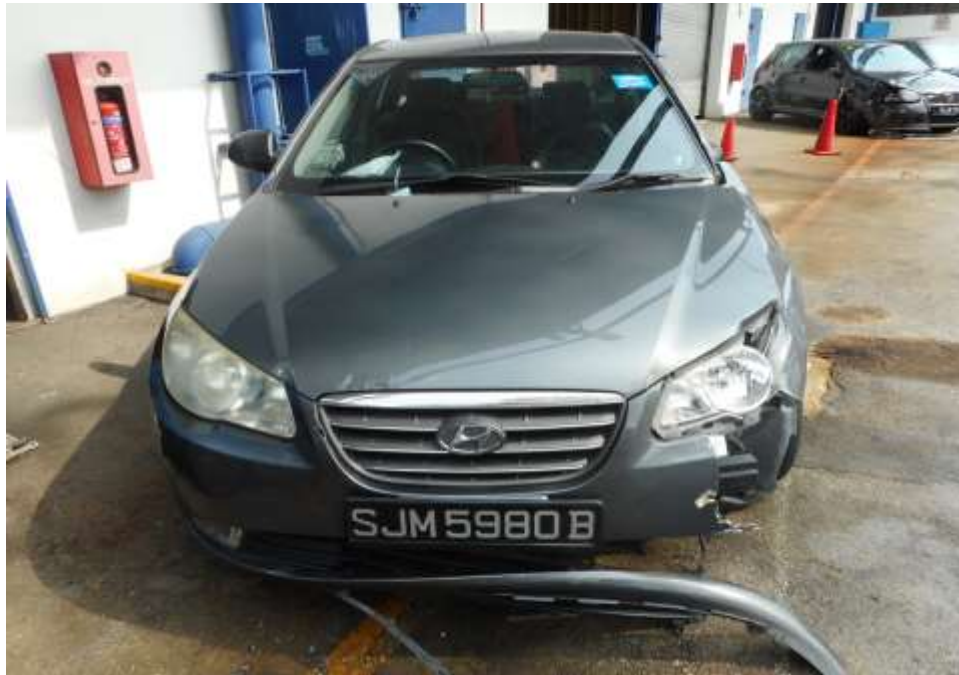
4. The mileage of the Motor Car at the time of my inspection was 254,336km.
5. The Motor Car was observed to have sustained damage at its front portion. Its front windscreen, front bonnet, front bumper, front left headlamp, front left fender and the front left rear view mirror were amongst the body parts that were damaged as a result of the accident.

**Photo 2** shows a general view of the Motor Car's front body at the time of my inspection. The Motor Car was observed to have sustained damage at its frontal portion. Its front bonnet, front bumper, front left headlamp, front left fender and the front left rear view mirror were amongst the body parts that were damaged as a result of the accident.

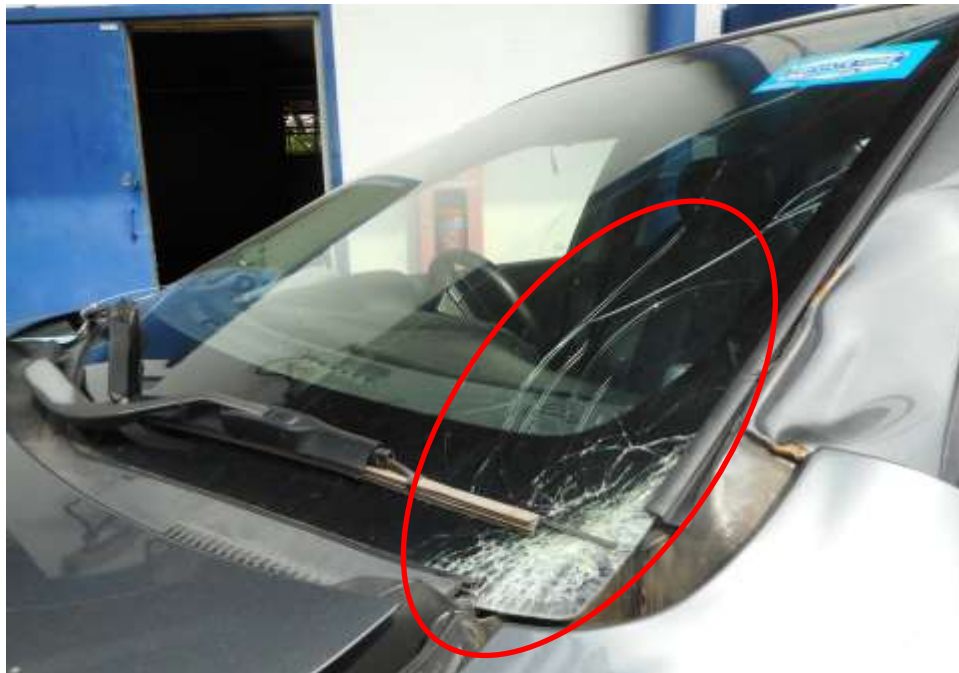
**Photo 3** shows the close up view of the Motor Car's front body at the time of my inspection. The Motor Car was observed to have sustained damage at its front windscreen (circled) as a result of the accident.

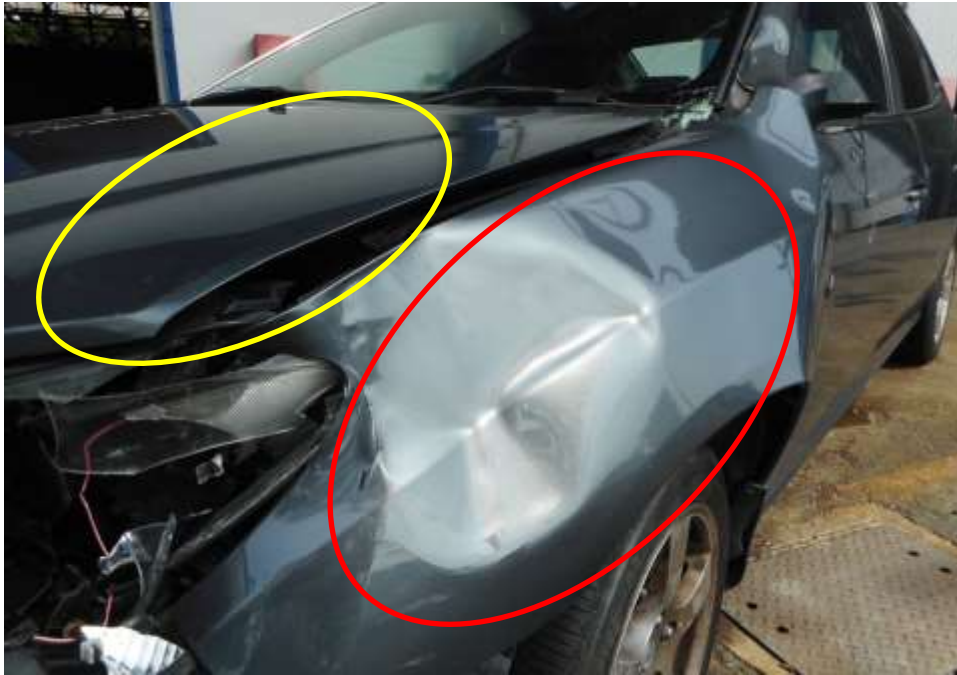
**Photo 4** shows the close up view of the Motor Car's front body at the time of my inspection. The Motor Car was observed to have sustained damage at its front bonnet (yellow circle) and front left fender (red circle), as a result of the accident.

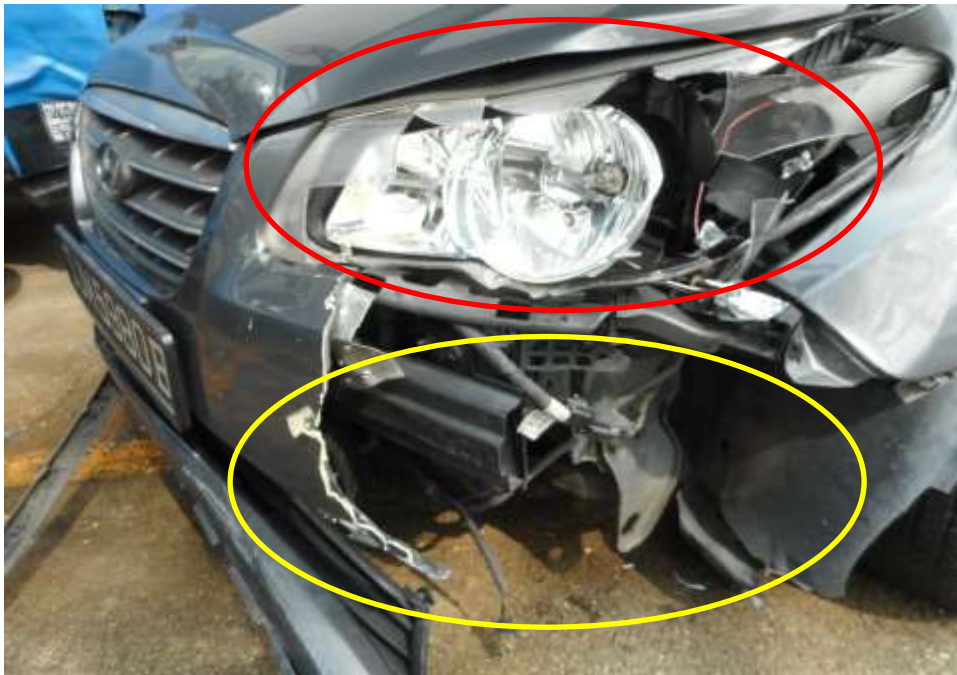
**Photo 5** shows the close up view of the Motor Car's front body at the time of my inspection. The Motor Car was observed to have sustained damage at its front left headlamp (red circle) and front bumper (yellow circle) as a result of the accident.

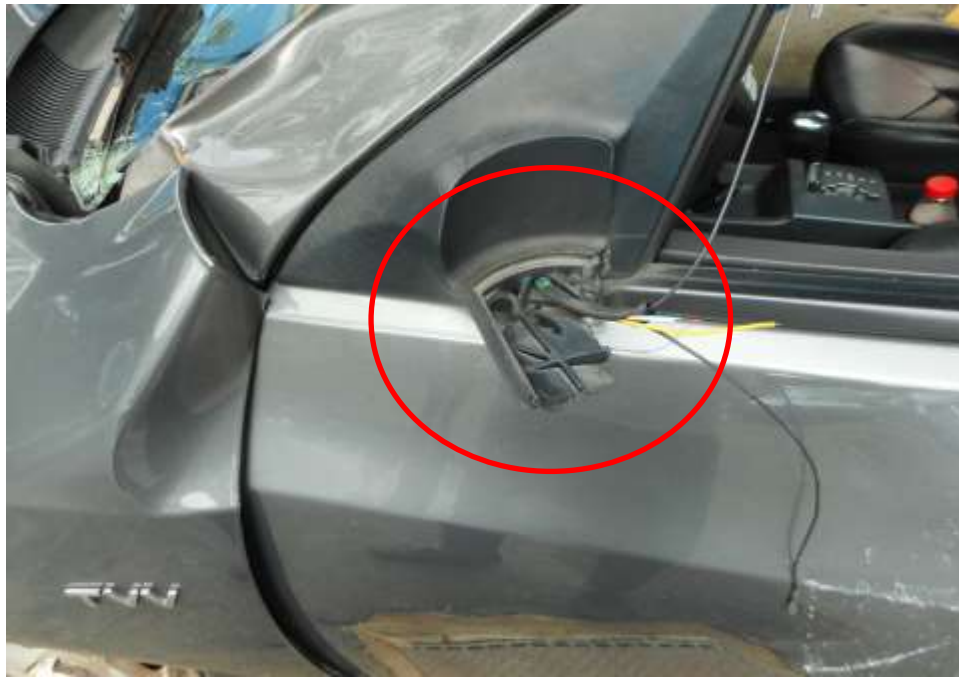
**Photo 6** shows the close up view of the Motor Car's front body at the time of my inspection. The Motor Car was observed to have sustained damage at its front left rear view mirror (circled) as a result of the accident.

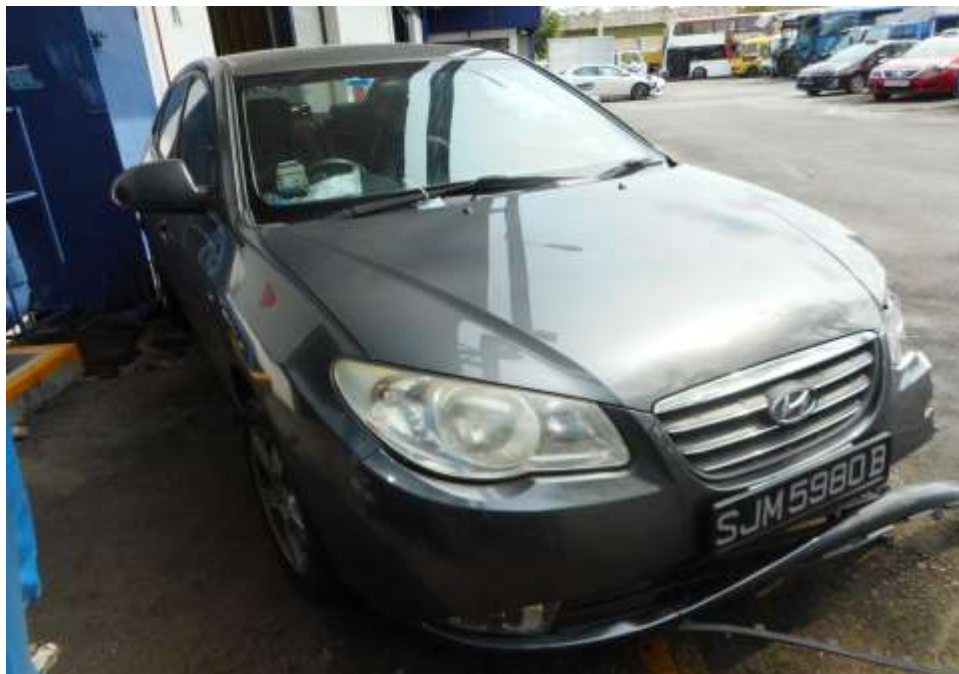
**Photo 7** shows a general view of the Motor Car's right body at the time of my inspection. The right portion of the Motor Car was observed to have been unaffected by the accident.

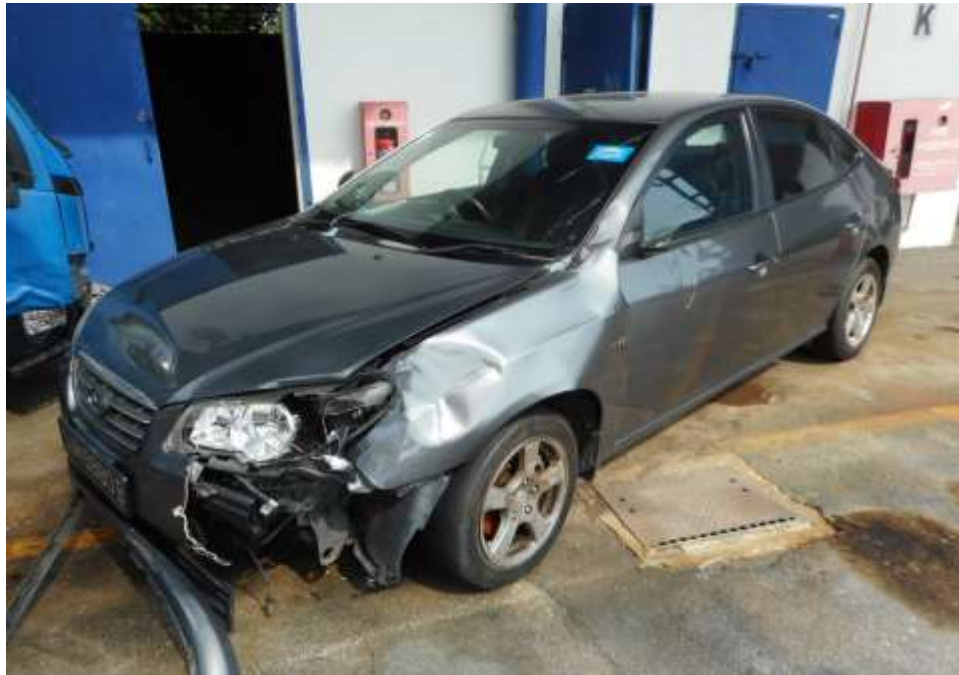
**Photo 8** shows a general view of the Motor Car's left body at the time of my inspection. The left portion of the Motor Car was observed to have been unaffected by the accident.

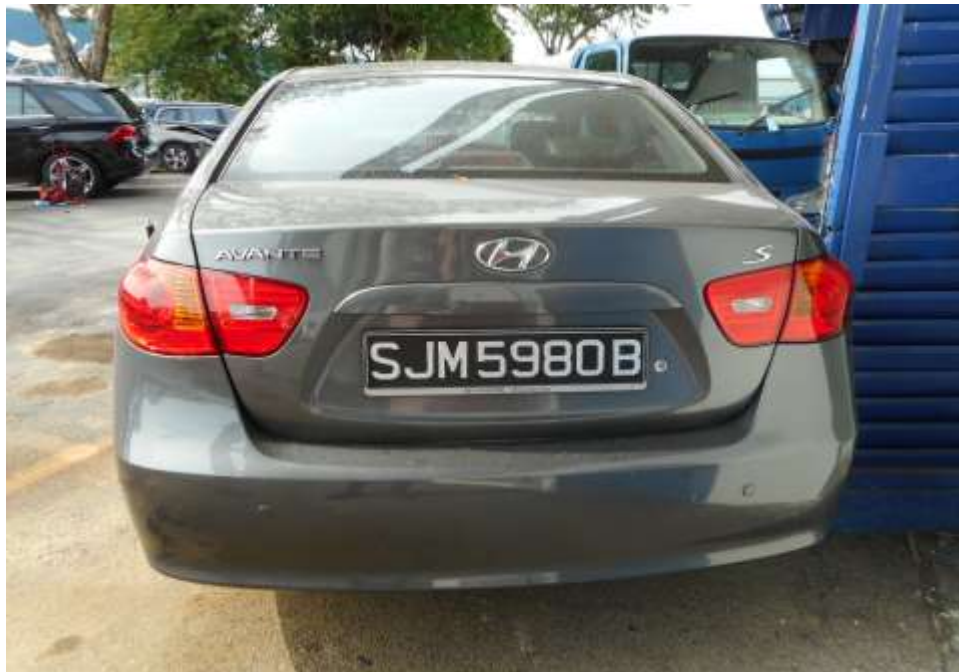
**Photo 9** shows the general view of the Motor Car's rear body at the time of my inspection. The Motor Car rear was observed to be unaffected by the accident.

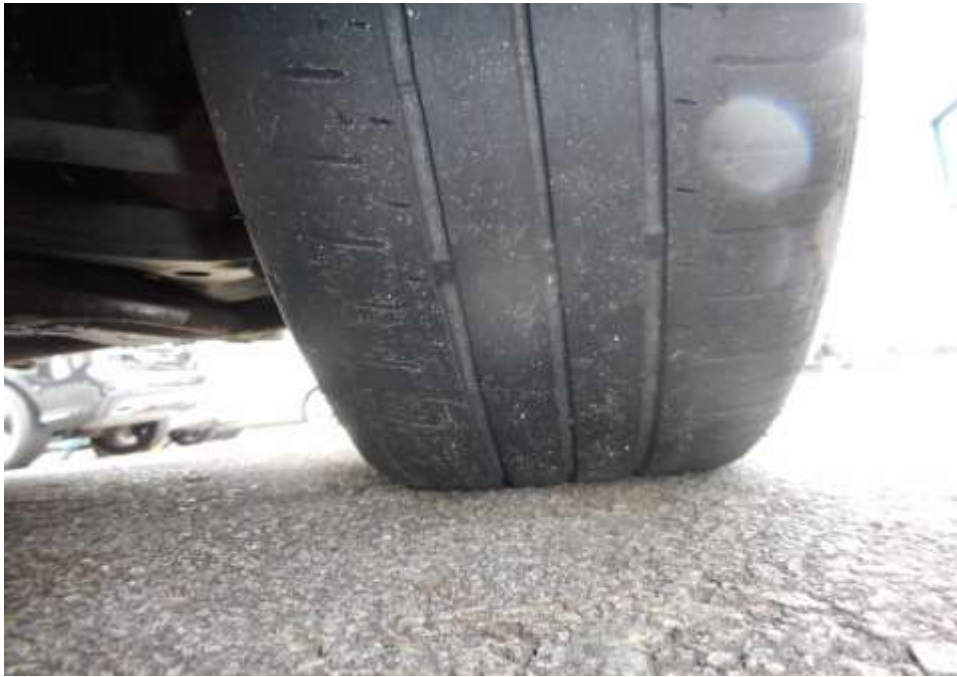
**Photo 10** shows the condition of the front right tyre of the Motor Car, which was observed to be in serviceable condition with remaining tread depth of approximately 3.5mm. The tyre was sufficiently inflated for vehicular operation with no tear, cut or burst mark(s) on the outer and the inner sidewalls as well as across the tread. The 4 tyres of the Motor Car were wrapped around standard steel wheel rims without any damage.

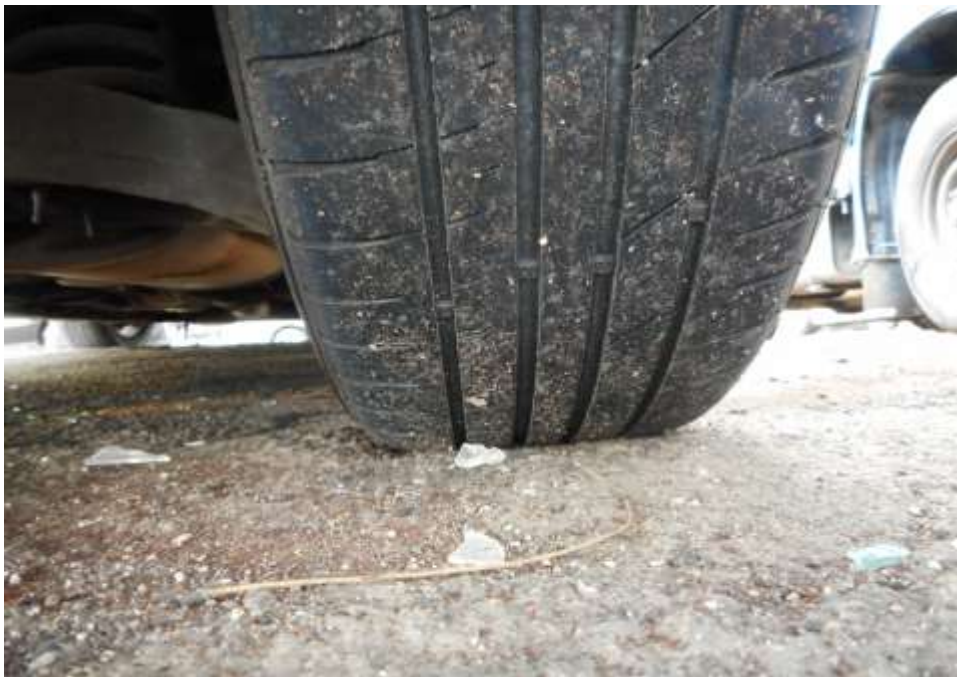
**Photo 11** shows the condition of the rear right tyre of the Motor Car, which was observed to be in serviceable condition with remaining tread depth of approximately 4.8mm. The tyre was also observed to be sufficiently inflated for vehicular operation with no tear, cut or burst mark(s).

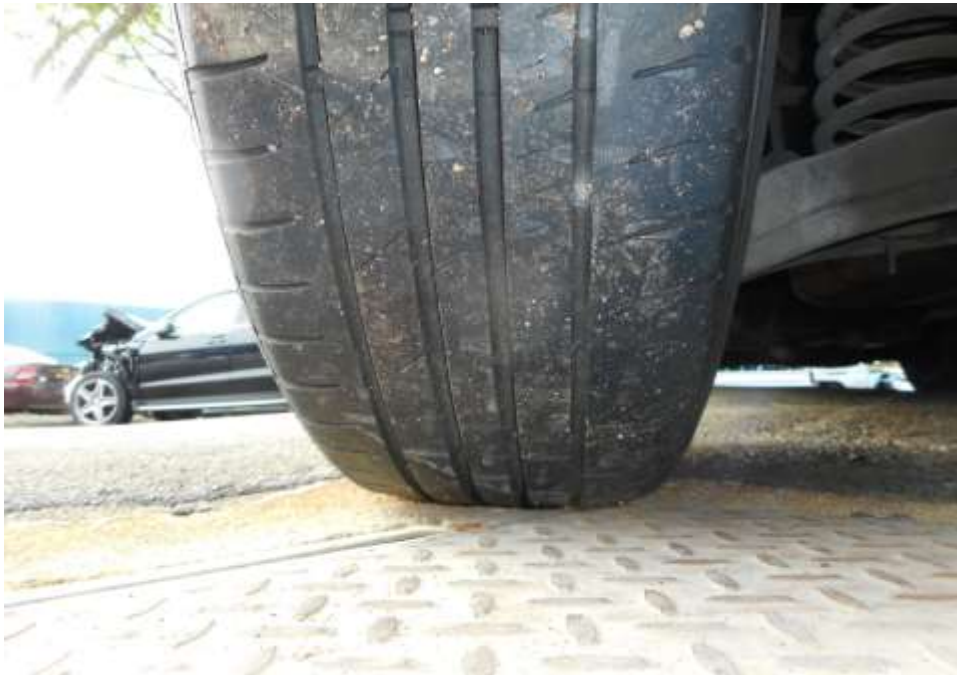
**Photo 12** shows the condition of the rear left tyre of the Motor Car, which was observed to be in serviceable condition with remaining tread depth of approximately 4.1mm. The tyre, which was wrapped around steel wheel rim, was also observed to be sufficiently inflated for vehicular operation. The 4 tyres of the Motor Car were wrapped around standard steel wheel rims.

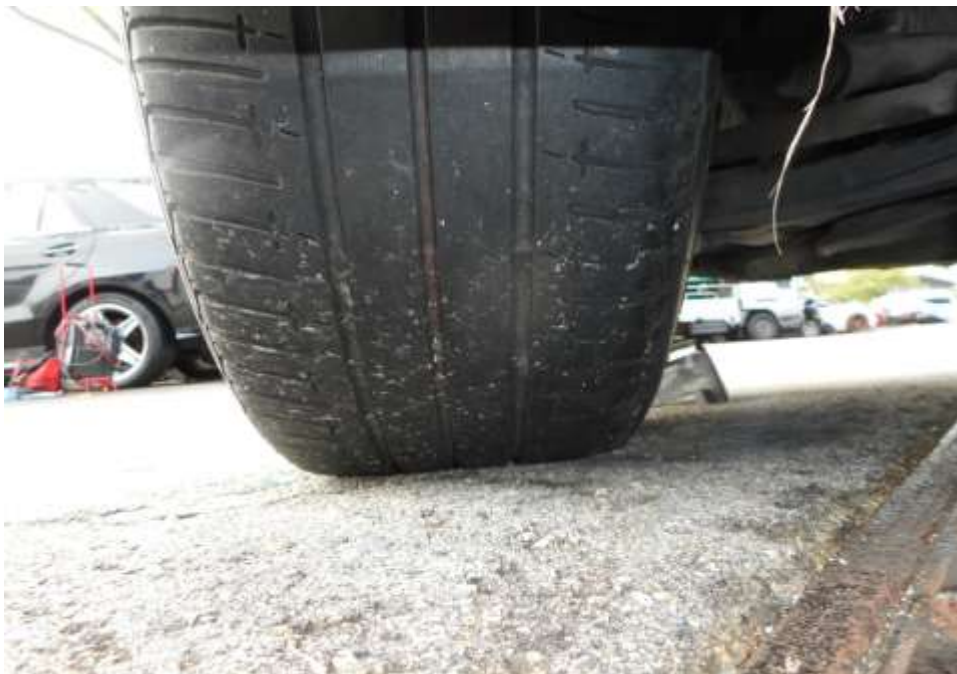
**Photo 13** shows the condition of the front left tyre of the Motor Car, which was observed to be in serviceable condition with remaining tread depth of approximately 3mm. There was also no tear, cut or burst mark(s) on the outer and the inner sidewalls as well as across the tread of the Motor Car's 4 tyres.

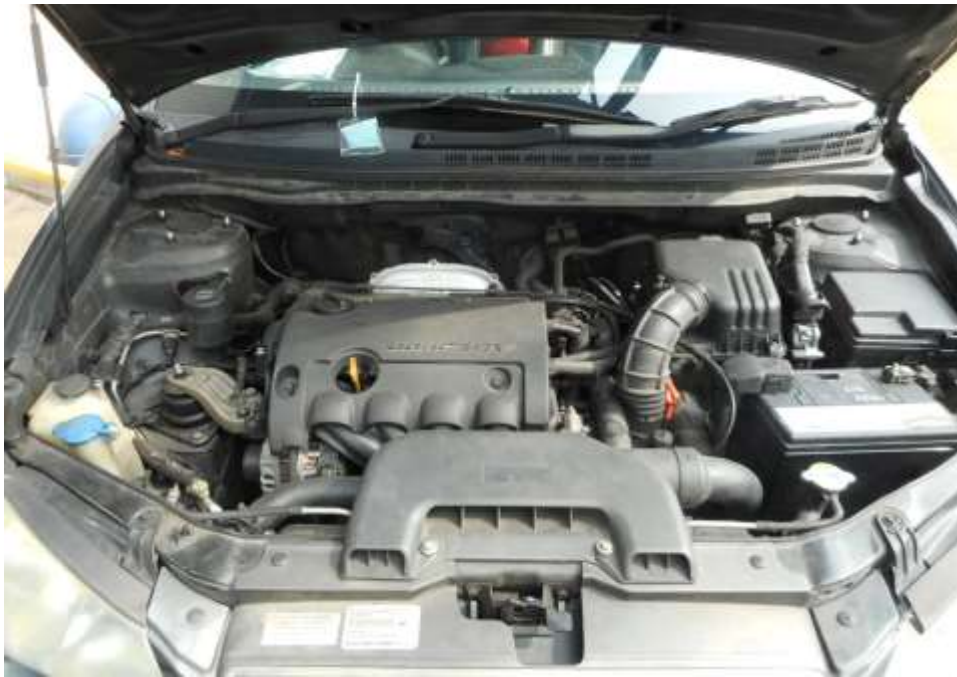
**Photo 14** shows a general view of the Motor Car's engine compartment. The various parts and components inside the engine compartment were unaffected by the accident. There was also no sign(s) or indication(s) of fluid leakage and/or fluid stain within the engine compartment.

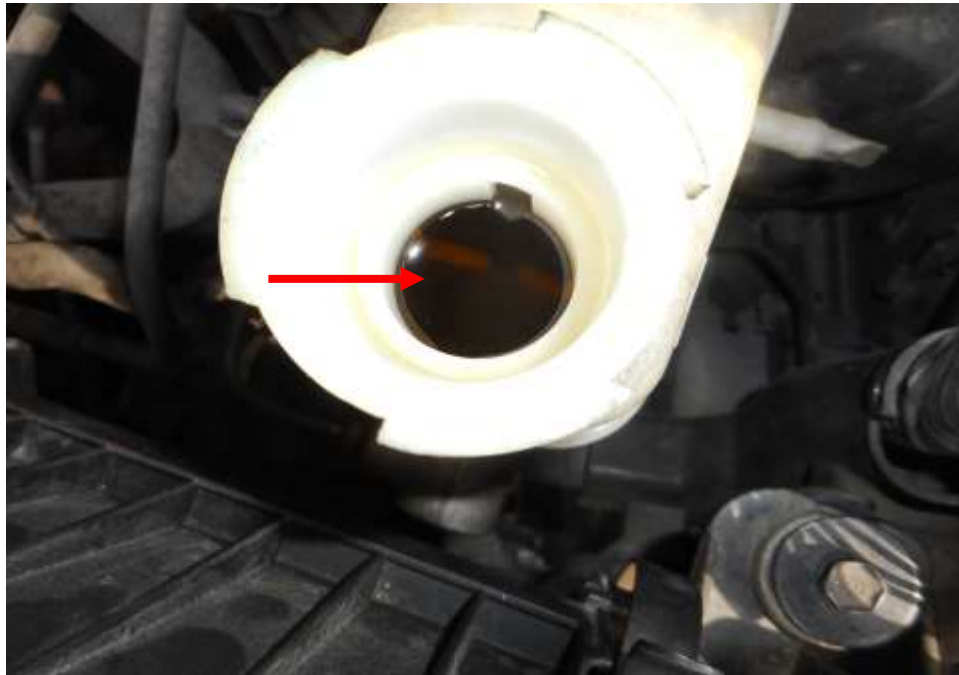
**Photo 15** shows the brake fluid reservoir of the Motor Car at the time of my inspection. The brake fluid was observed to be of sufficient level (arrowed) and without any visible contamination.

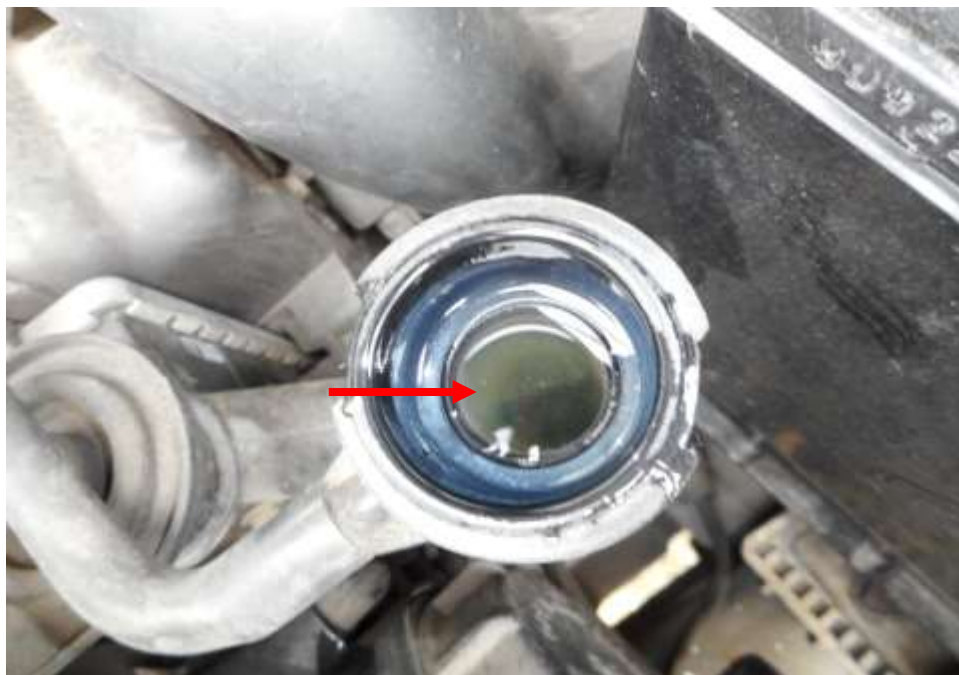
**Photo 16** shows checks being carried out to the engine coolant of the Motor Car at the time of my inspection. The engine coolant was observed to be of sufficient level (arrowed) and without any visible contamination.

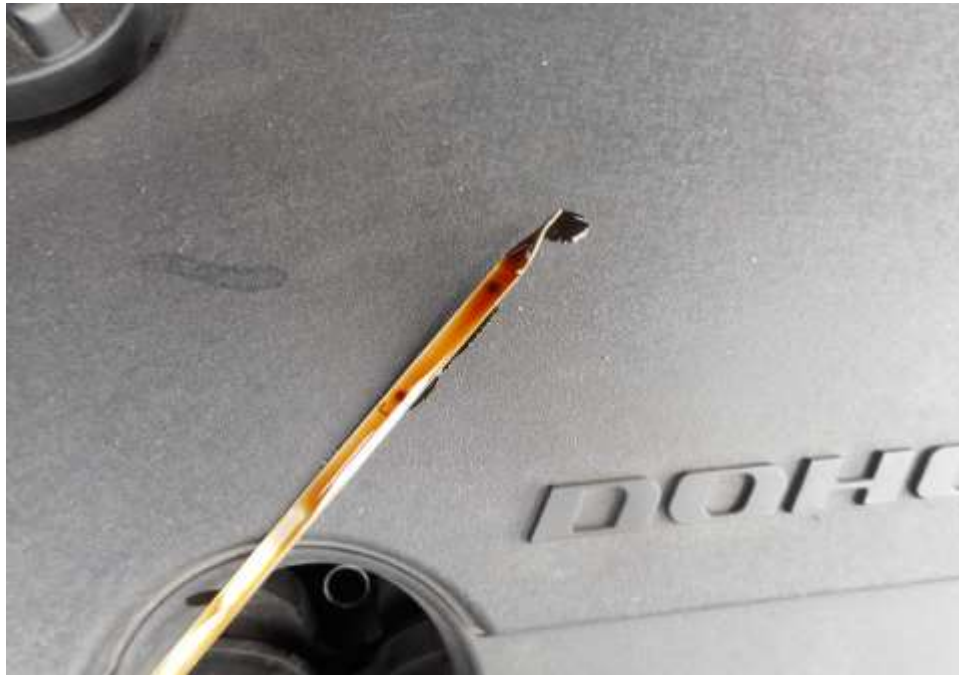
**Photo 17** shows the engine oil dip stick of the Motor Car at the time of my inspection. The engine oil was observed to be of sufficient level and without any visible contamination.

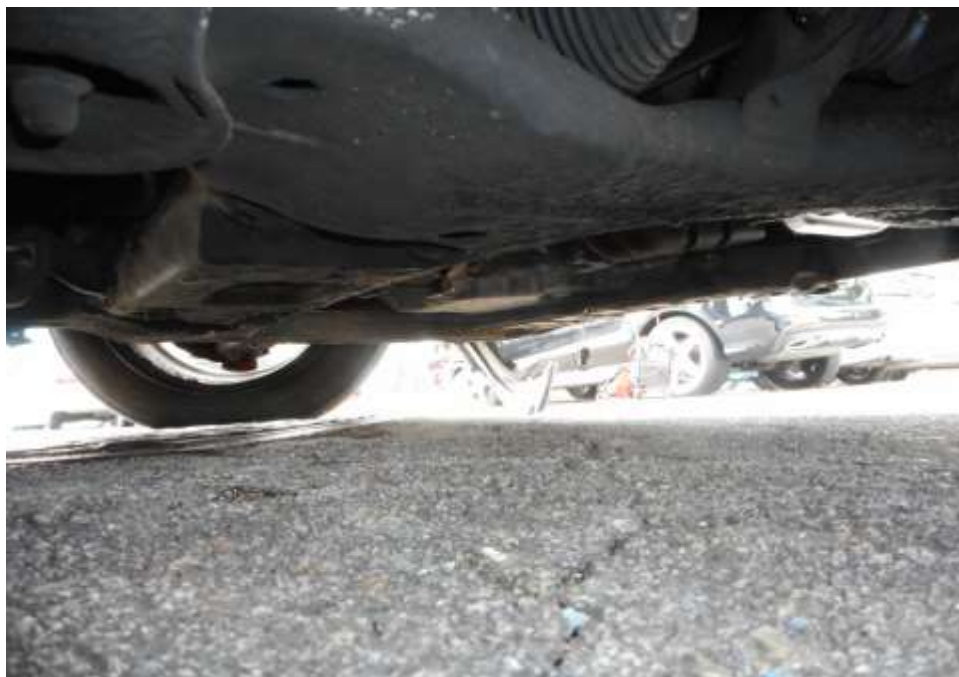
**Photo 18** shows the undercarriage of the Motor Car, at the area where the engine housing and transmission housing are located. I did not find any sign(s) or indication(s) of fluid leak and/or fluid stain(s) on the underside of the Motor Car.

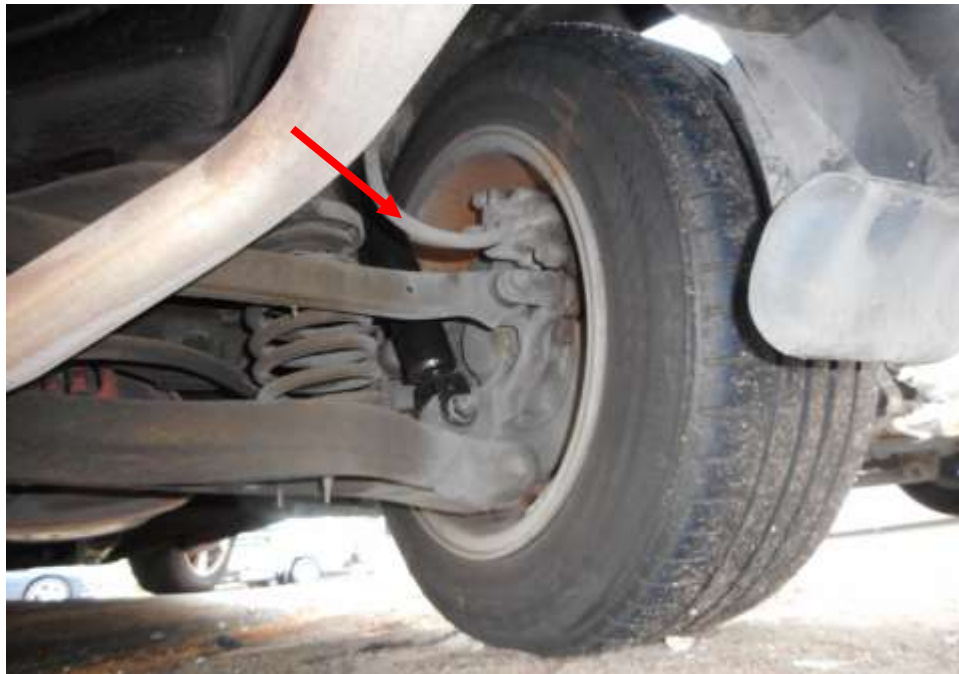
**Photo 19** shows the brake hose/pipe (arrowed) at the rear right wheel of the Motor Car. No leakage of brake fluid was observed. Visual examination of the various components of the braking system like the drum brake, brake booster, brake pedal etc. had revealed all to be intact and without visible damage.

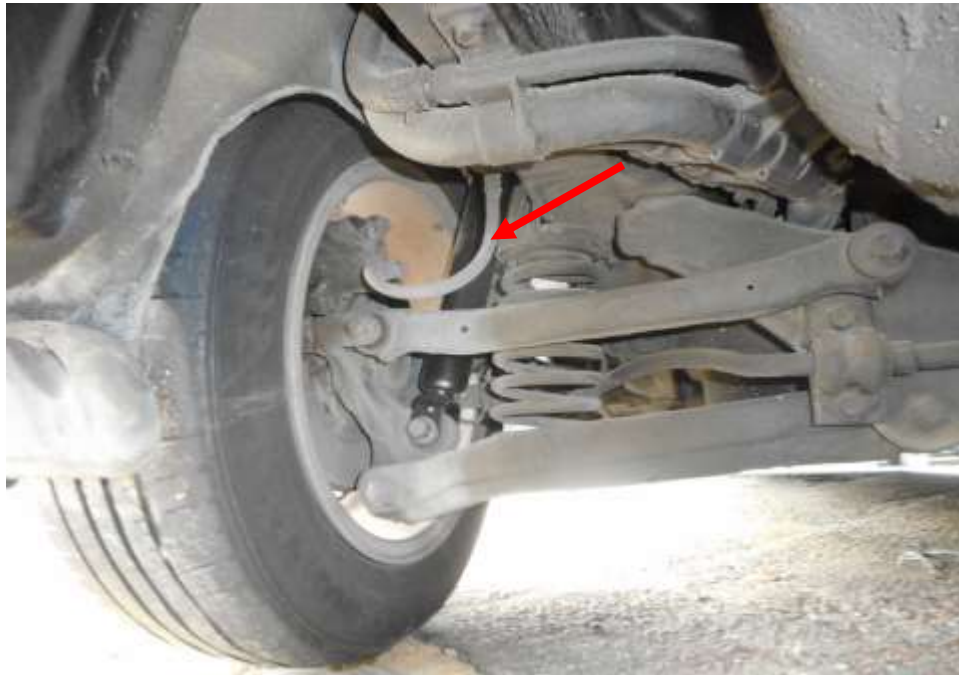
**Photo 20** shows the brake hose/pipe (arrowed) at the rear left wheel of the Motor Car. I did not observe any leakage of brake fluid at the time of my inspection of the Motor Car. Static tests of the Motor Car's braking system had indicated that there was no internal leakage of pressure/vacuum. The undercarriage components of the Motor Car were also all found to be intact and without any visible damage.

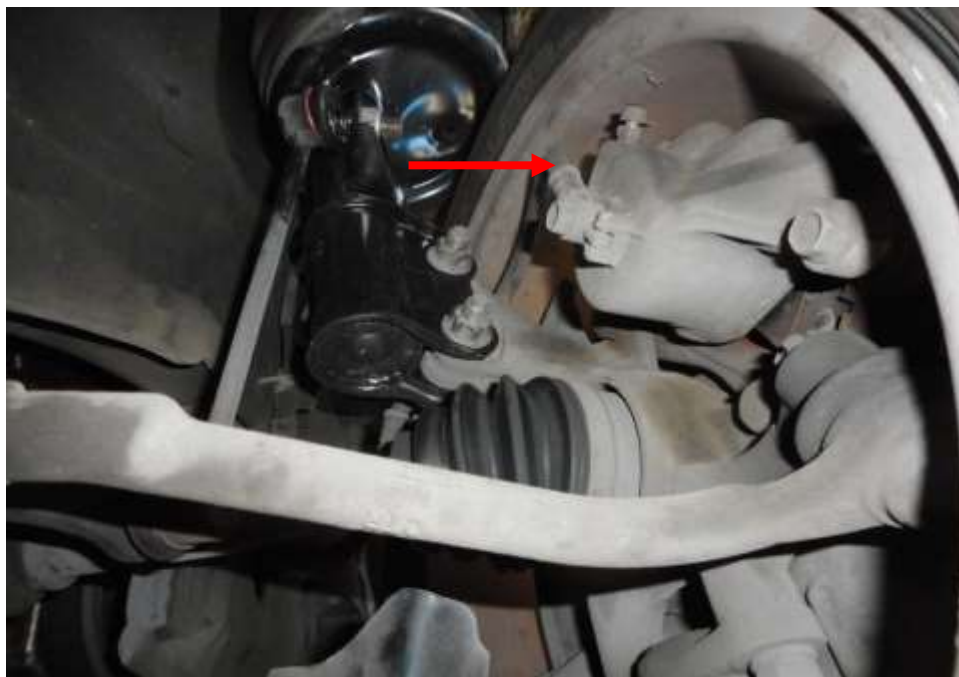
**Photo 21** shows the brake hose/pipe (arrowed) at the front right wheel of the Motor Car. I did not observe any leakage of brake fluid at the time of my inspection of the Motor Car. Static tests of the Motor Car's braking system had indicated that there was no internal leakage of pressure/vacuum. The undercarriage components of the Motor Car were also all found to be intact and without any visible damage.

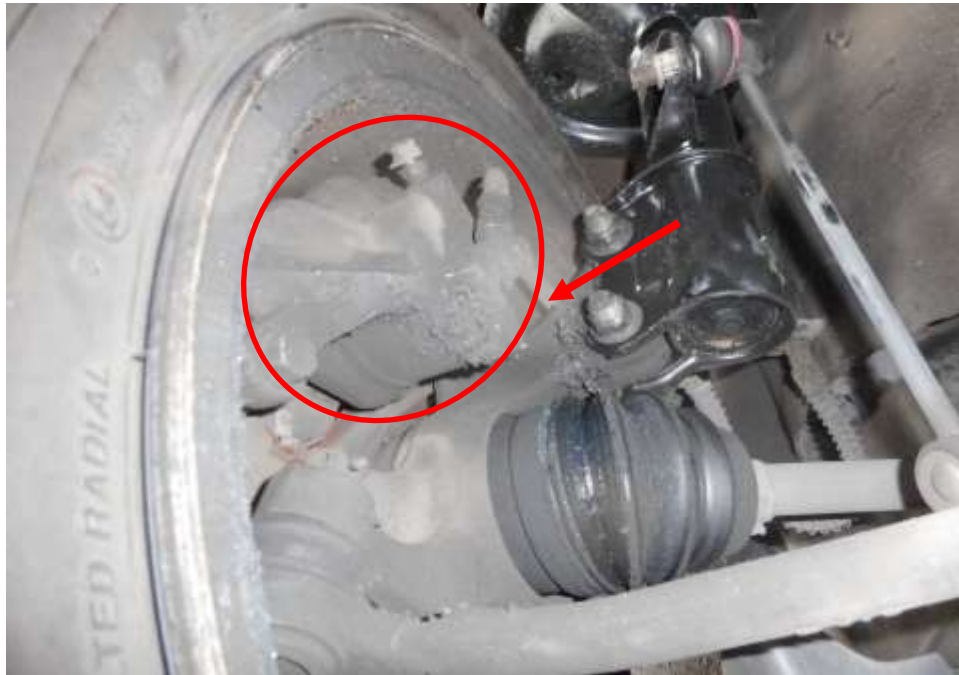
**Photo 22** shows the brake hose/pipe (arrowed) at the front left wheel of the Motor Car. No leakage of brake fluid was observed. Visual examination of the various components of the braking system like the brake caliper (circled), brake booster, brake pedal etc had revealed all to be intact and without visible damage.

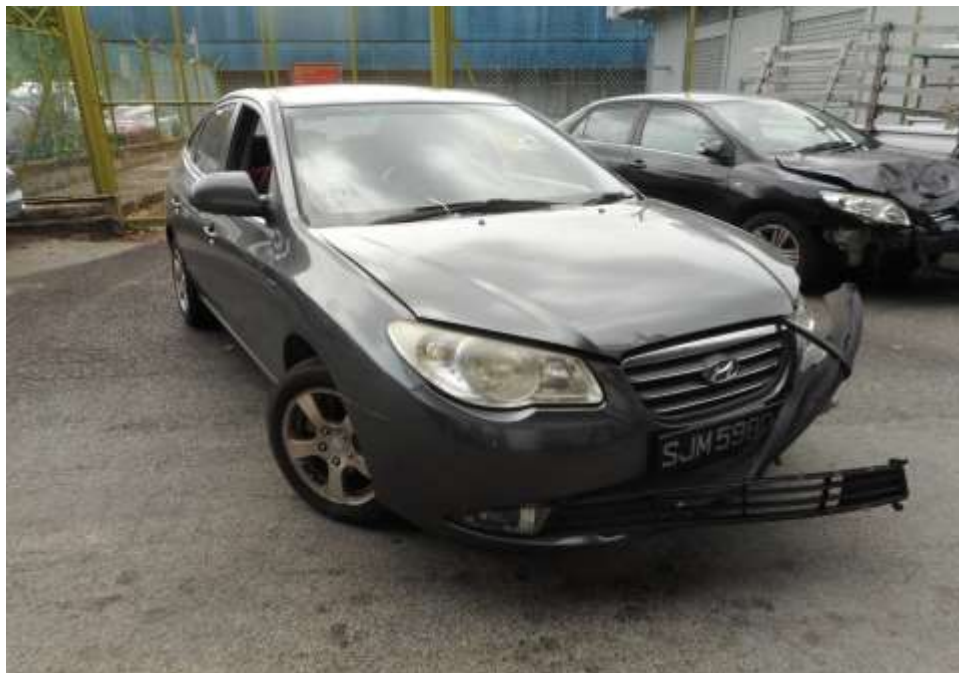
**Photo 23** shows the front right wheel of the Motor Car turned to its full left. During my steering system test, I did not experience any abnormal free play and/or resistance when I had turned the steering wheel towards the left and right. This would suggest that the steering system of the Motor Car was likely to be in serviceable condition at the material time of accident.

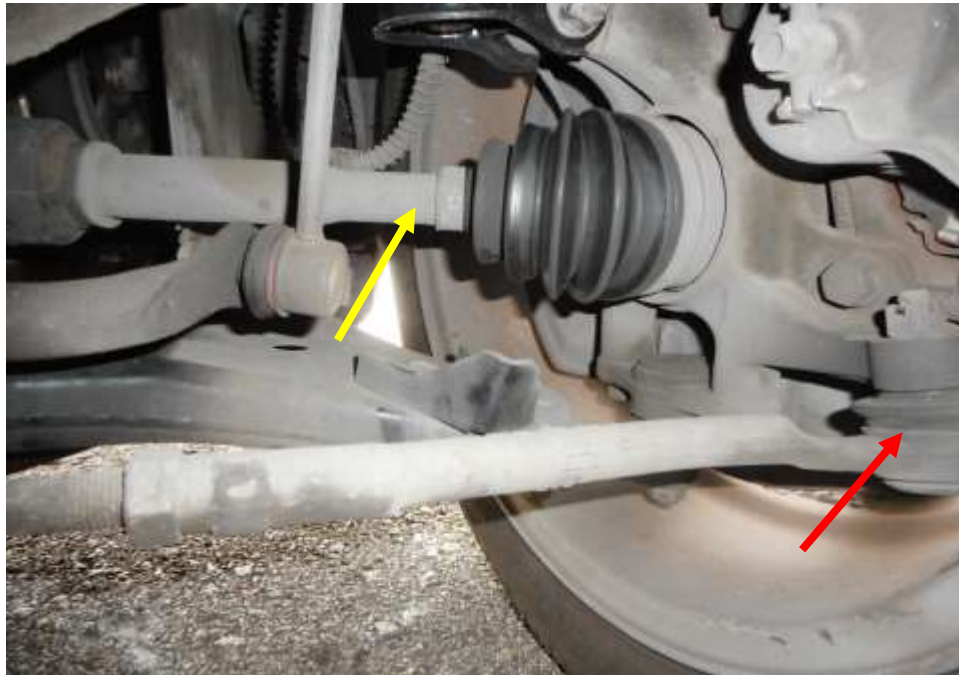
**Photo 24** shows the various undercarriage components at the front right wheel of the Motor Car, in particular the steering tie rod (red arrow) and drive shaft (yellow arrow). The various steering components were all found to be intact, suggesting that the steering system of the Motor Car was likely to be in serviceable condition at the material time of accident. There was also no sign of fluid stain observed on the various undercarriage components at the front right wheel of the Motor Car.

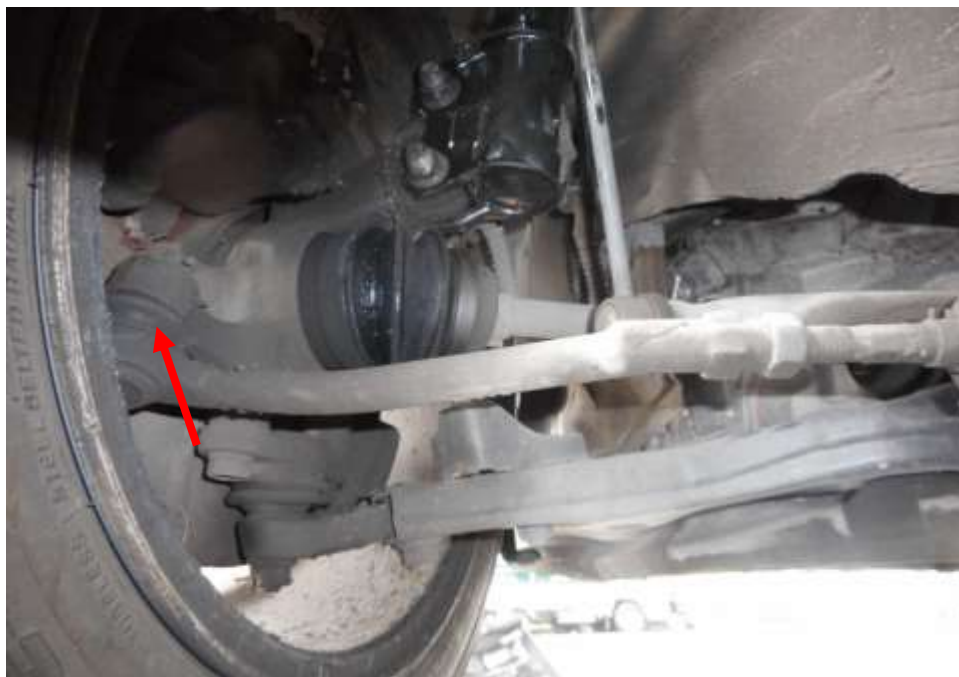
**Photo 25** shows the various undercarriage components at the front left wheel of the Motor Car, which had included the steering tie rod (red arrow). The various undercarriage components of the Motor Car were all found to be intact without any visible damage.

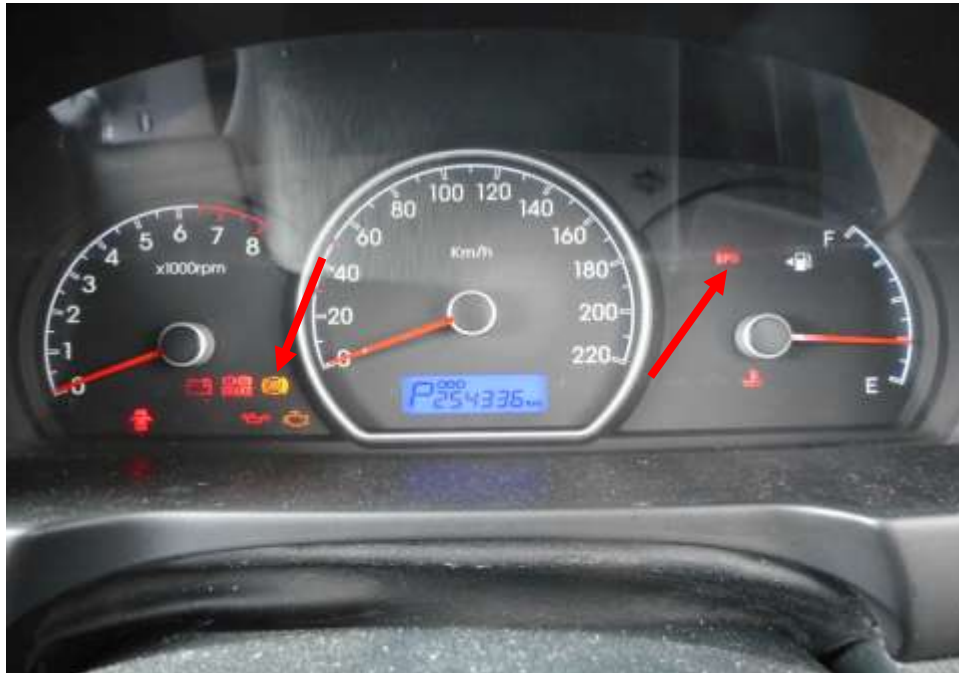
**Photo 26** shows the warning light for Anti-Lock Brake System (ABS) and Power Steering System (EPS) (arrowed) appearing on the instrument panel of the Motor Car during the self-test of its various electronic operating systems when its engine was cranked.

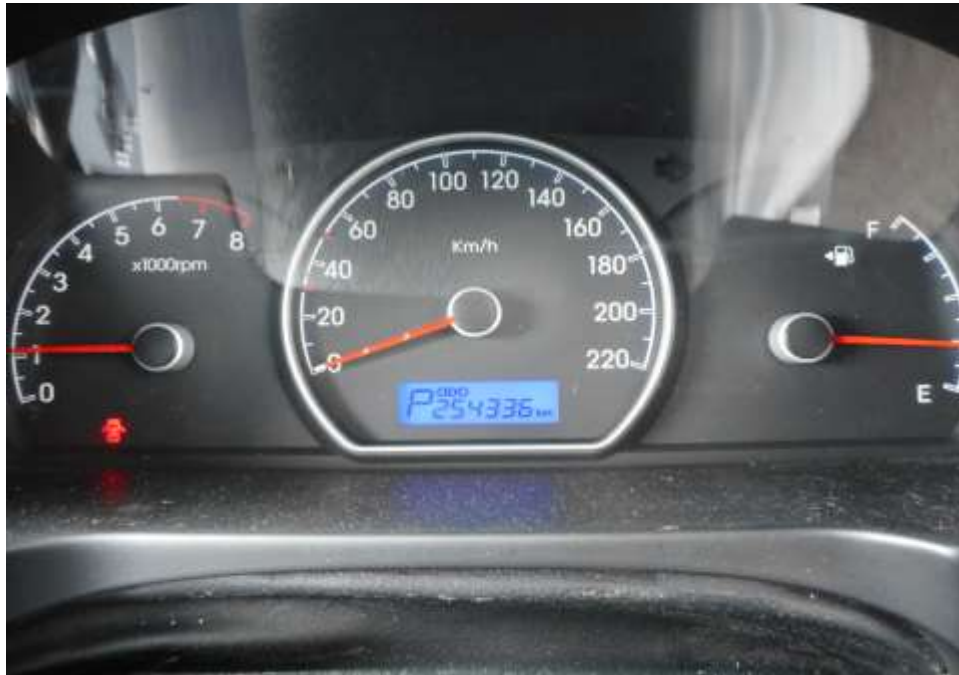
**Photo 27** shows no warning lights illuminated on the instrument panel of the Motor Car after the engine was cranked. This would suggest that there was no abnormality to the electronic operating system of the Motor Car, like the ABS and EPS etc.
