Your Ref: TP/IP/09543/2020  
Our Ref : CI/TPD20004219/P

### **Fatal Accident Investigation Team**

### **MECHANICAL INSPECTION REPORT OF MOTOR CAR SLU 7493L**

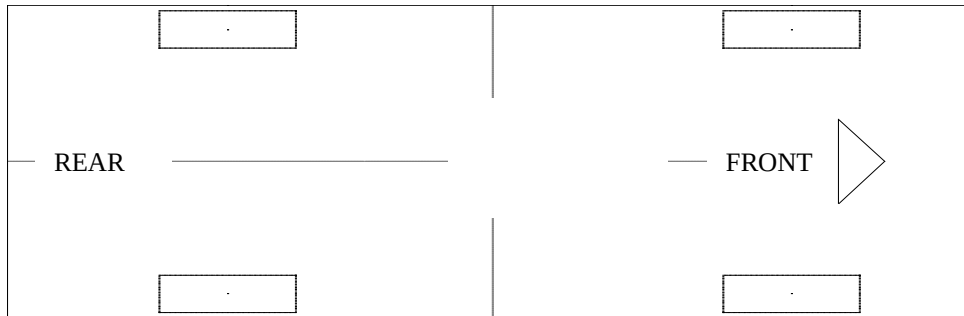
6. The condition of the Motor Car's 4 tyres was observed to be in serviceable condition. I did not find any tear, cut or burst mark(s) on the outer and the inner sidewalls as well as across the tread of the 4 tyres. The 4 tyres were also observed to be sufficiently inflated for vehicular operation. The tyre brand, tyre size and remaining tread depth of the 4 tyres were recorded as follows:-

Bilead 215/60R16 (3.9mm)

Bilead 215/60R16 (6.8mm)

Bilead 215/60R16 (4mm)

Bilead 215/60R16 (7mm)

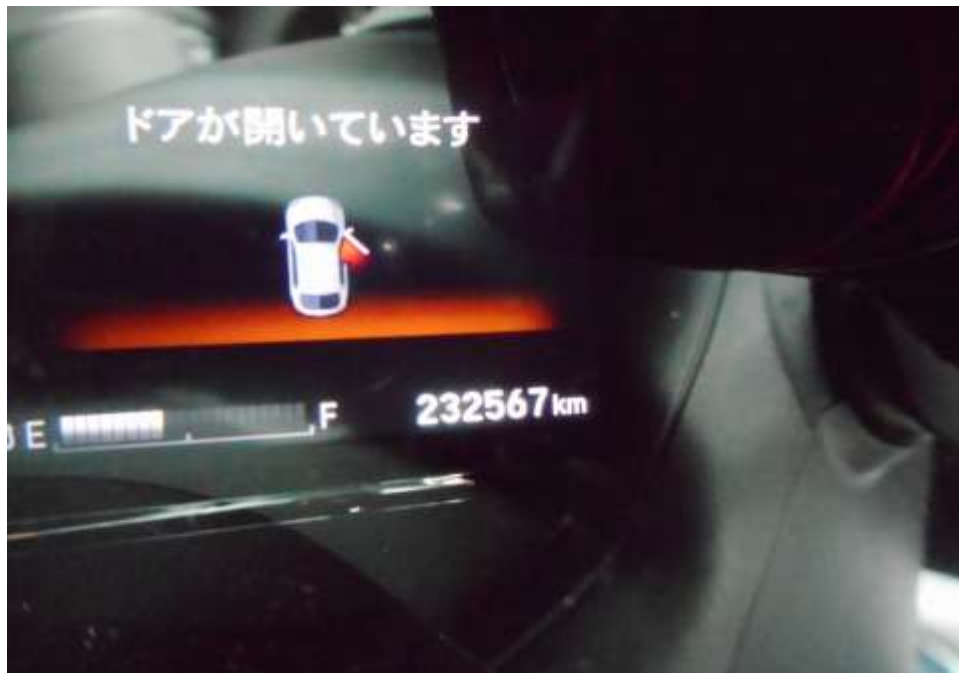
**Photo 1** shows the mileage of the Motor Car at the time of my inspection. The mileage observed was 232,567km.

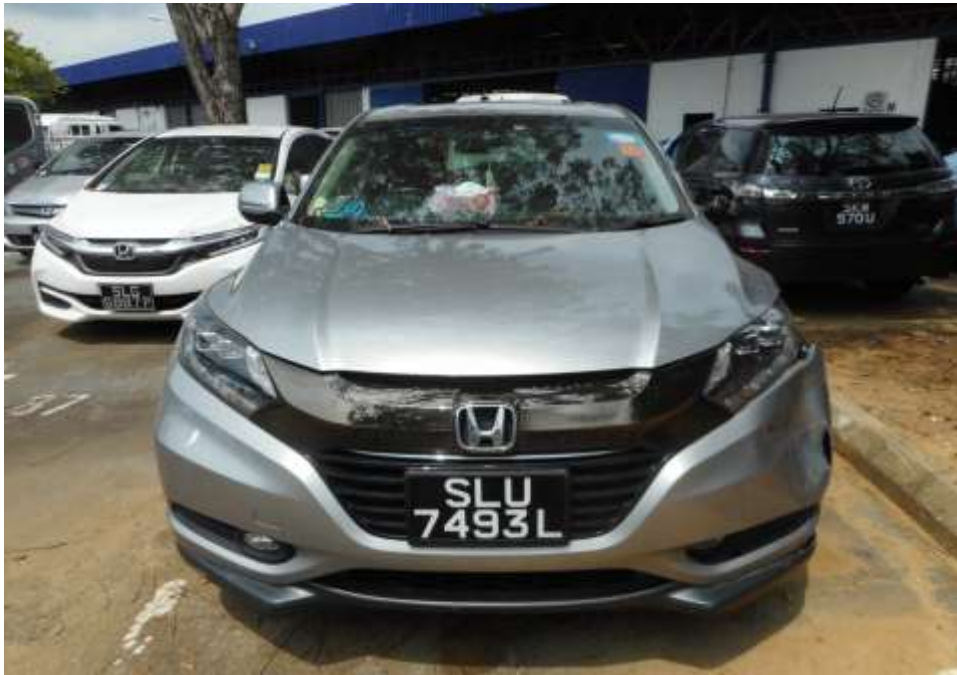
4. The mileage of the Motor Car at the time of my inspection was 232,567km.
5. The Motor Car was observed to have sustained damage at its front portion. Its front bonnet, front bumper, front left fender and the front left rear view mirror were amongst the body parts that were damaged as a result of the accident.

**Photo 2** shows a general view of the Motor Car's front body at the time of my inspection. The Motor Car was observed to have sustained damage at its frontal portion. Its front bonnet, front bumper, front left fender and the front left rear view mirror were amongst the body parts that were damaged as a result of the accident.

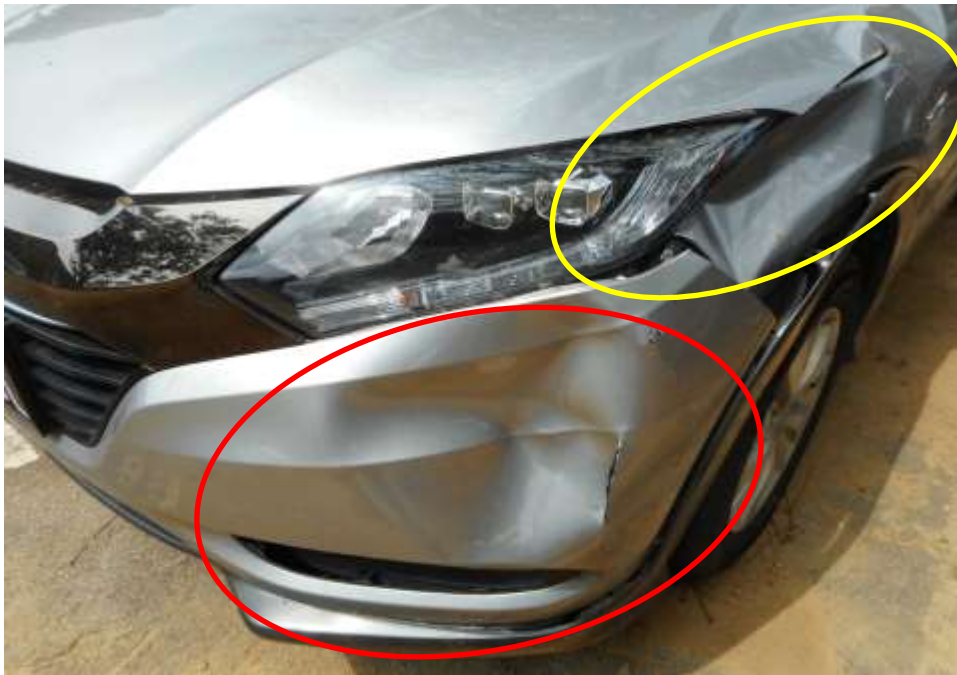
**Photo 3** shows the close up view of the Motor Car's front body at the time of my inspection. The Motor Car was observed to have sustained damage at its front bonnet and front left fender (yellow circle) and front bumper (red circle), as a result of the accident.

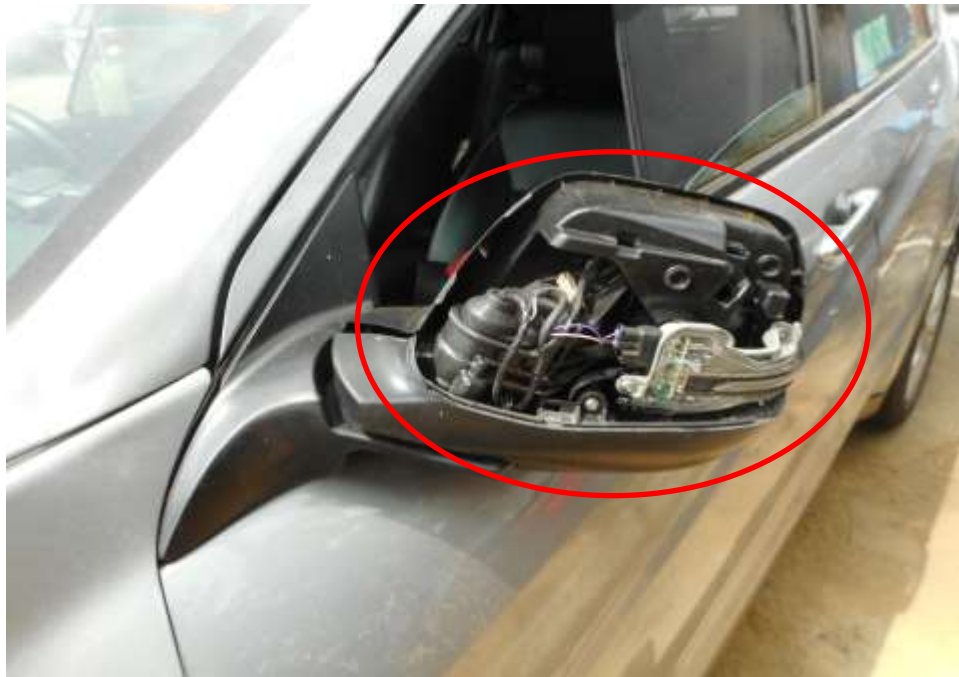
**Photo 4** shows the close up view of the Motor Car's front body at the time of my inspection. The Motor Car was observed to have sustained damage at its front left rear view mirror (circled) as a result of the accident.

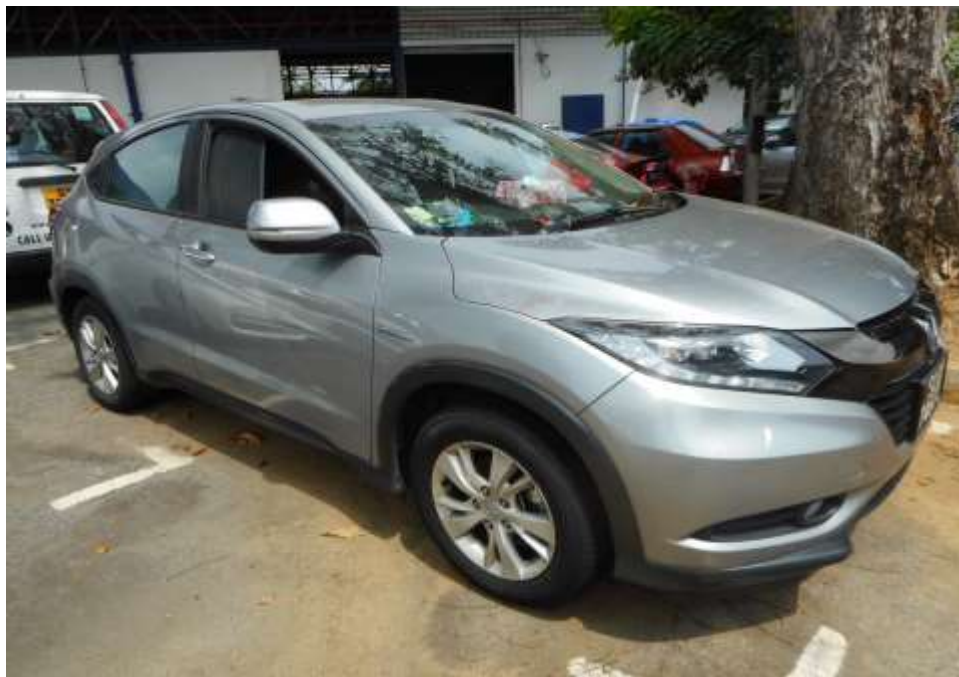
**Photo 5** shows a general view of the Motor Car's right body at the time of my inspection. The right portion of the Motor Car was observed to have been unaffected by the accident.

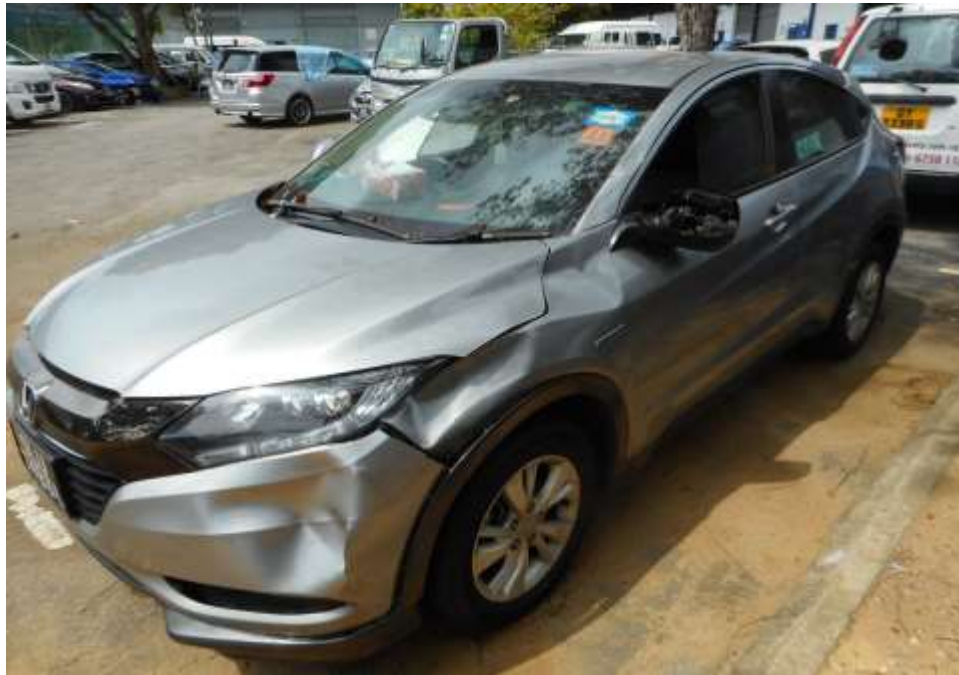
**Photo 6** shows a general view of the Motor Car's left body at the time of my inspection. The left portion of the Motor Car was observed to have been unaffected by the accident.

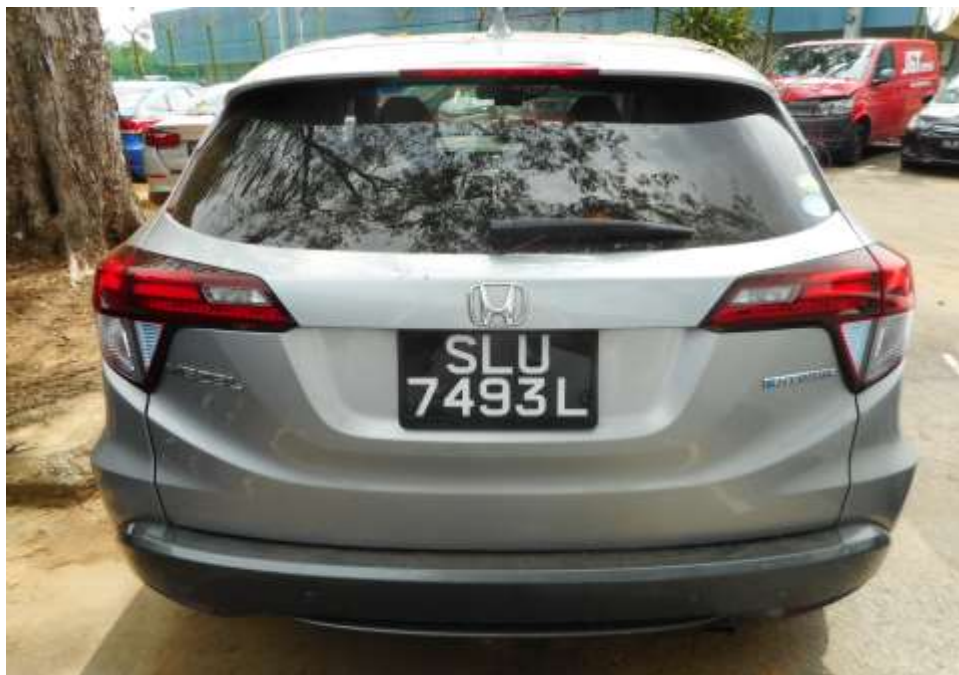
**Photo 7** shows the general view of the Motor Car's rear body at the time of my inspection. The Motor Car rear was observed to be unaffected by the accident.

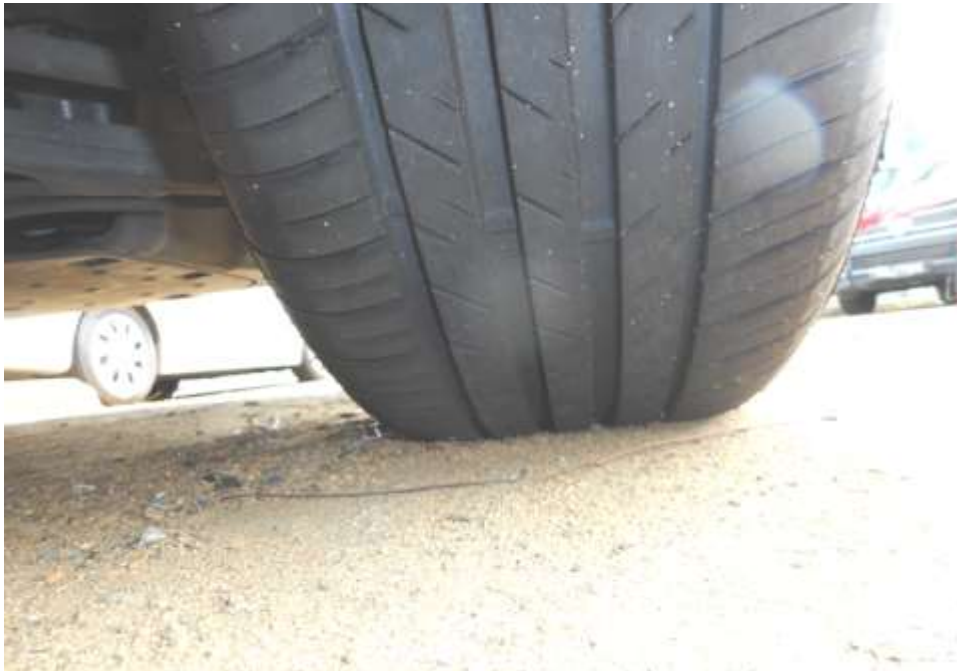
**Photo 8** shows the condition of the front right tyre of the Motor Car, which was observed to be in serviceable condition with remaining tread depth of approximately 7mm. The tyre was sufficiently inflated for vehicular operation with no tear, cut or burst mark(s) on the outer and the inner sidewalls as well as across the tread. The 4 tyres of the Motor Car were wrapped around standard steel wheel rims without any damage.

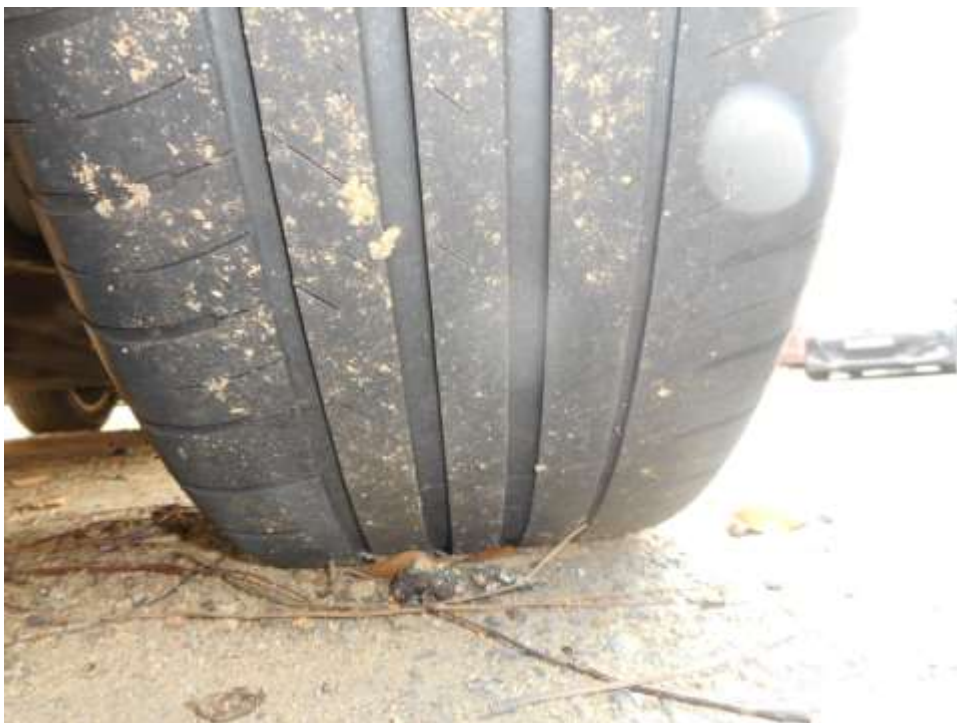
**Photo 9** shows the condition of the rear right tyre of the Motor Car, which was observed to be in serviceable condition with remaining tread depth of approximately 4mm. The tyre was also observed to be sufficiently inflated for vehicular operation with no tear, cut or burst mark(s).

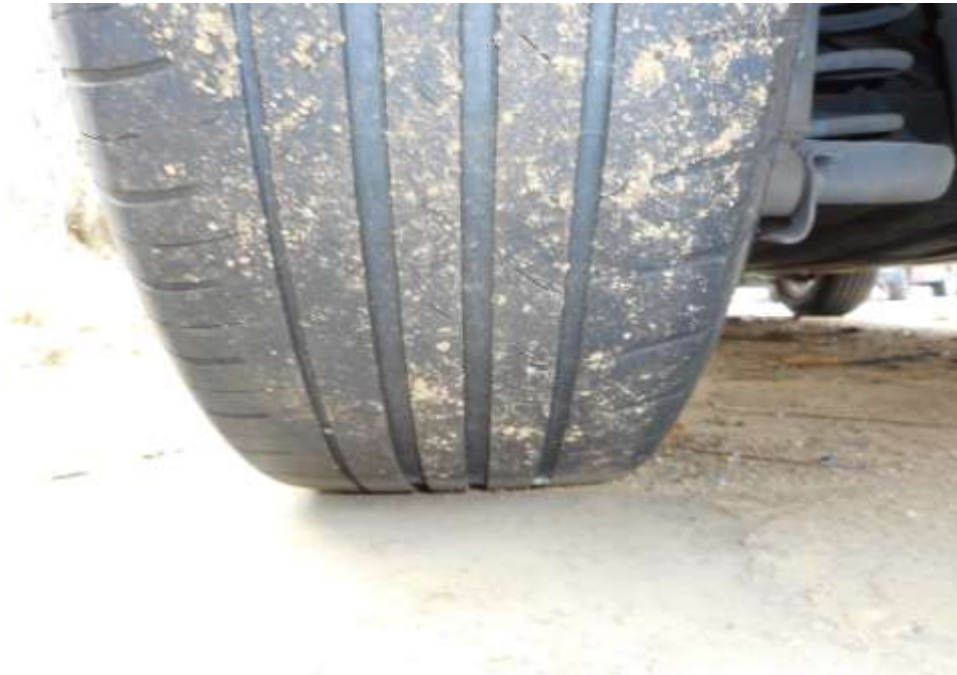
**Photo 10** shows the condition of the rear left tyre of the Motor Car, which was observed to be in serviceable condition with remaining tread depth of approximately 3.9mm. The tyre, which was wrapped around steel wheel rim, was also observed to be sufficiently inflated for vehicular operation. The 4 tyres of the Motor Car were wrapped around standard steel wheel rims.

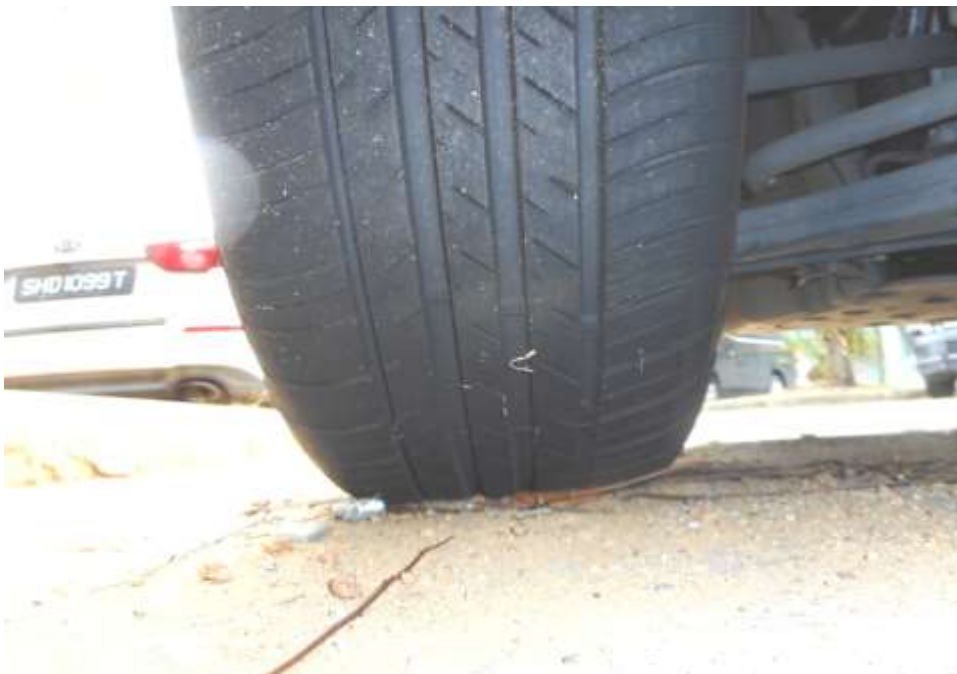
**Photo 11** shows the condition of the front left tyre of the Motor Car, which was observed to be in serviceable condition with remaining tread depth of approximately 6.8mm. There was also no tear, cut or burst mark(s) on the outer and the inner sidewalls as well as across the tread of the Motor Car's 4 tyres.

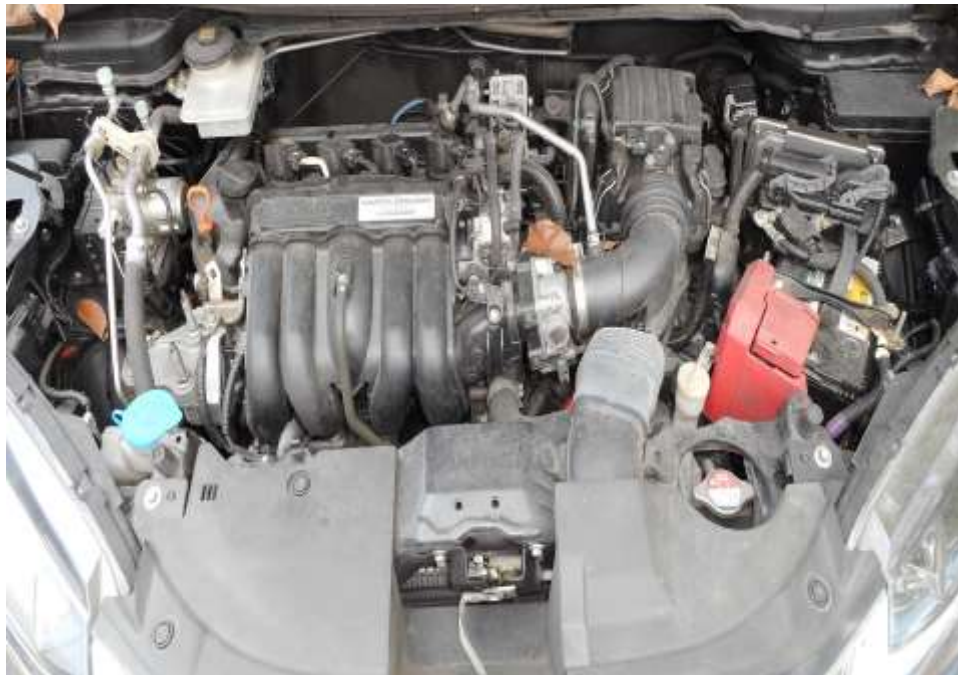
**Photo 12** shows a general view of the Motor Car's engine compartment. The various parts and components inside the engine compartment were unaffected by the accident. There was also no sign(s) or indication(s) of fluid leakage and/or fluid stain within the engine compartment.

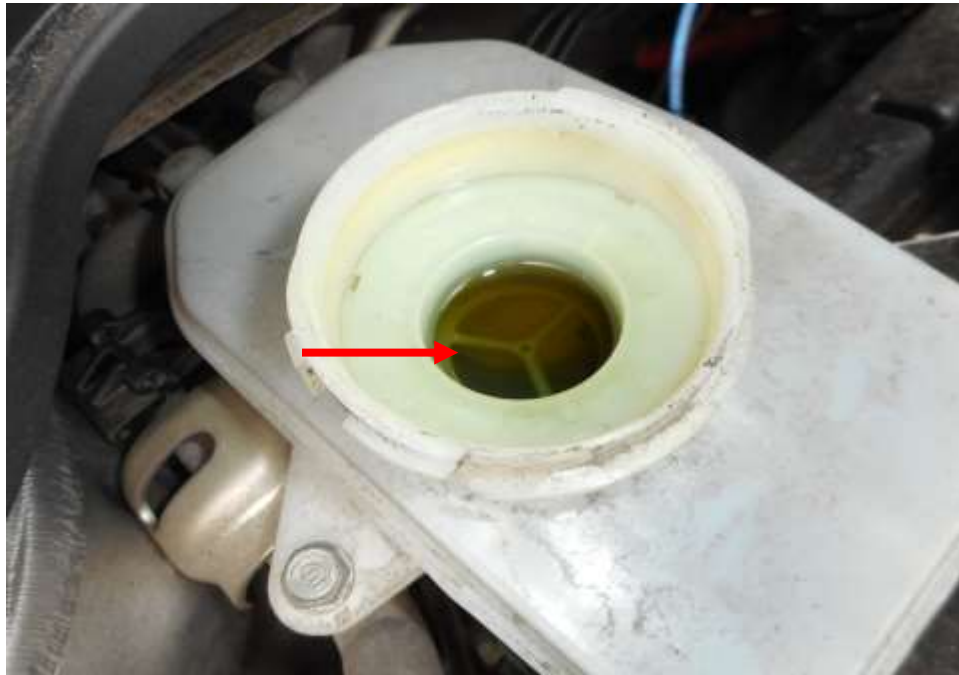
**Photo 13** shows the brake fluid reservoir of the Motor Car at the time of my inspection. The brake fluid was observed to be of sufficient level (arrowed) and without any visible contamination.

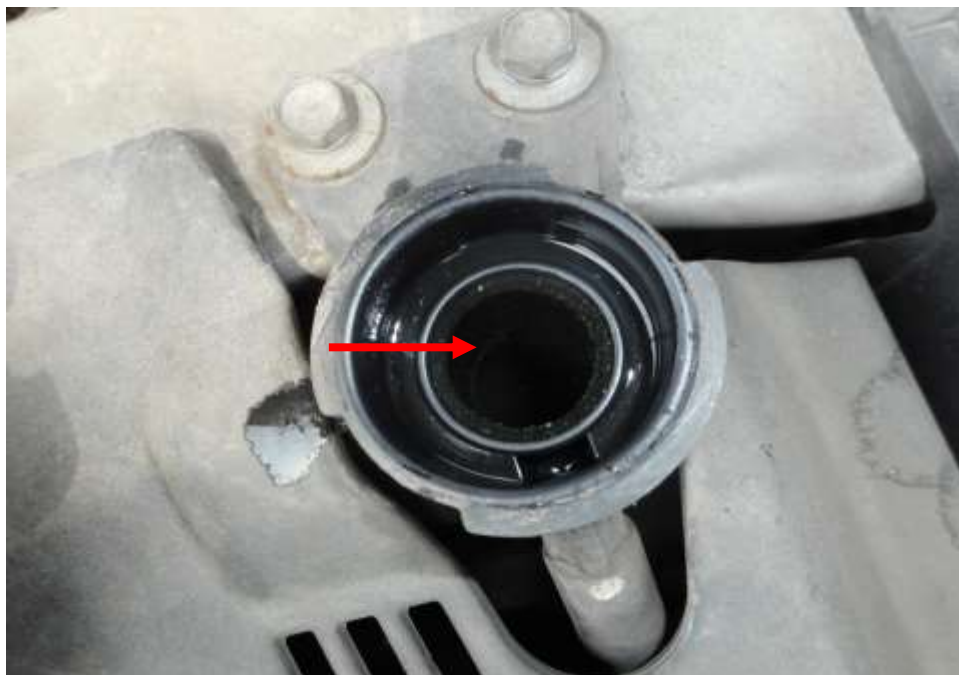
**Photo 14** shows checks being carried out to the engine coolant of the Motor Car at the time of my inspection. The engine coolant was observed to be of sufficient level (arrowed) and without any visible contamination.

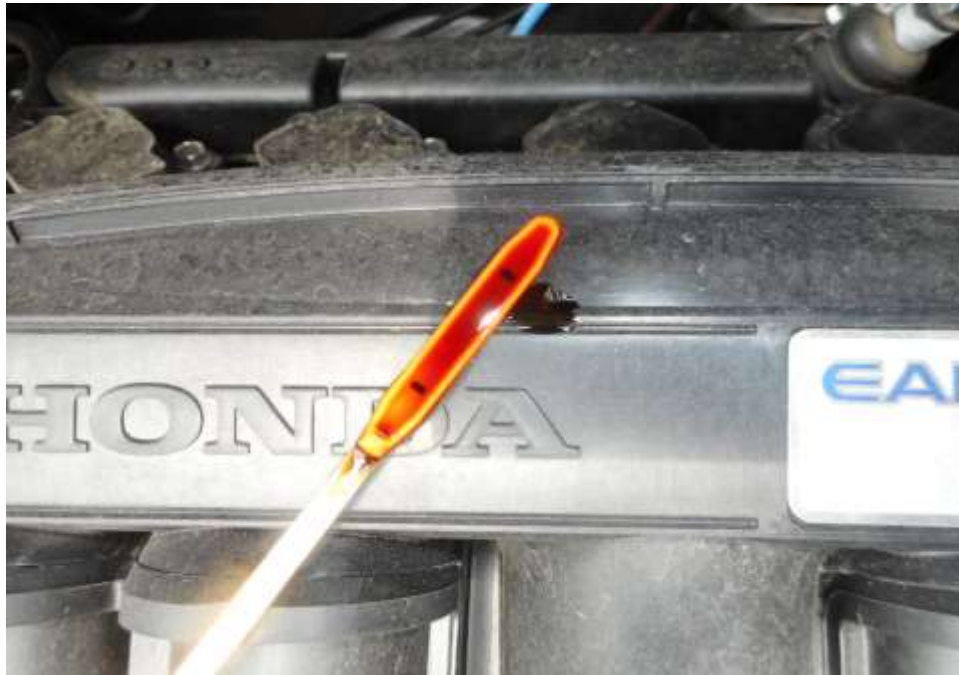
**Photo 15** shows the engine oil dip stick of the Motor Car at the time of my inspection. The engine oil was observed to be of sufficient level and without any visible contamination.

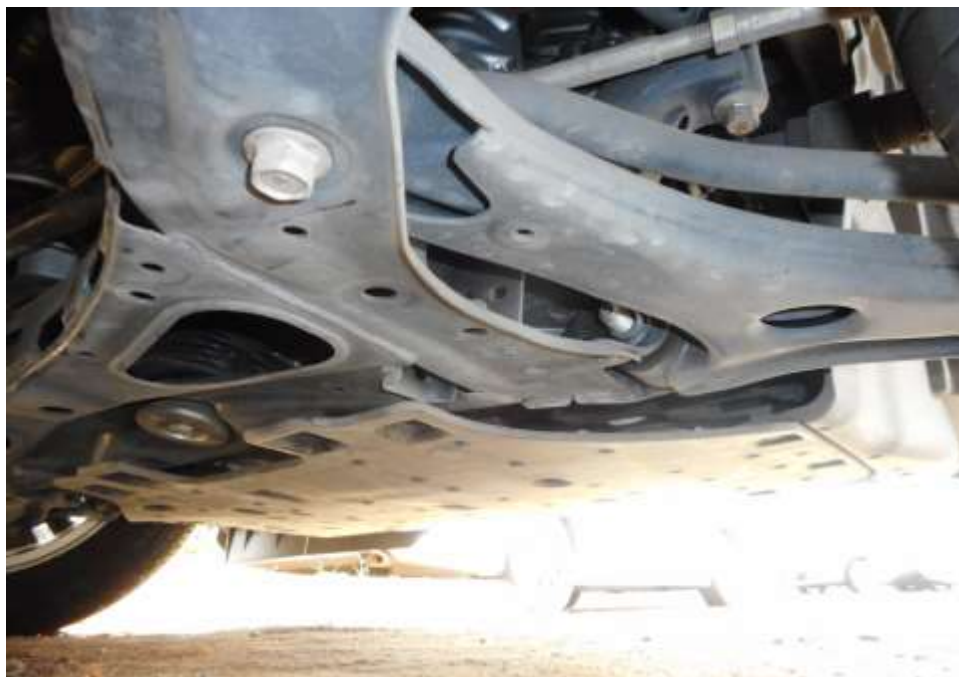
**Photo 16** shows the undercarriage of the Motor Car, at the area where the engine housing and transmission housing are located. I did not find any sign(s) or indication(s) of fluid leak and/or fluid stain(s) on the underside of the Motor Car.

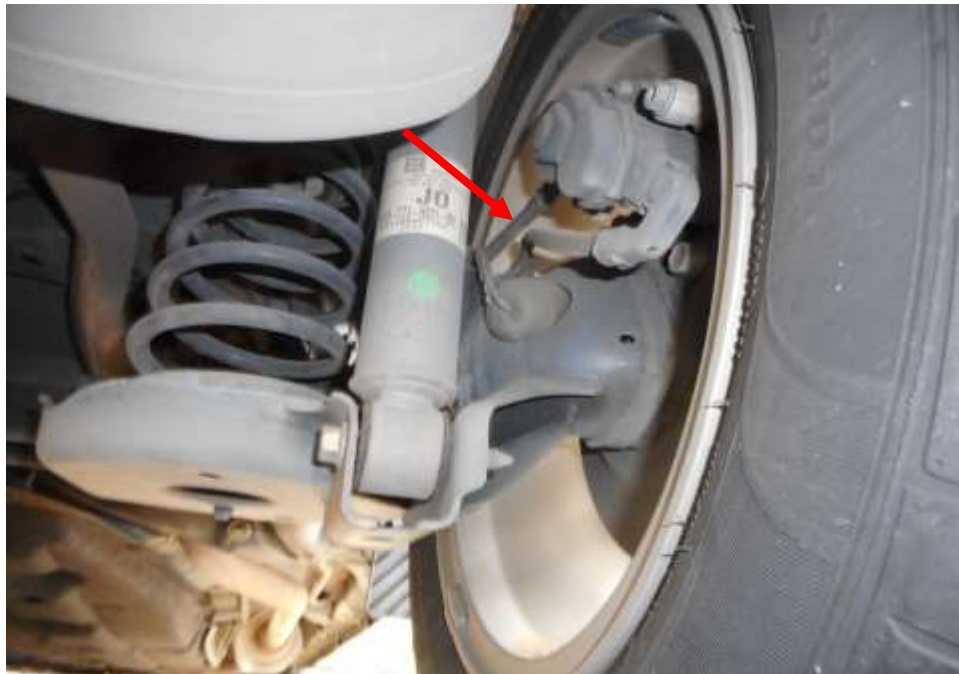
**Photo 17** shows the brake hose/pipe (arrowed) at the rear right wheel of the Motor Car. No leakage of brake fluid was observed. Visual examination of the various components of the braking system like the drum brake, brake booster, brake pedal etc. had revealed all to be intact and without visible damage.

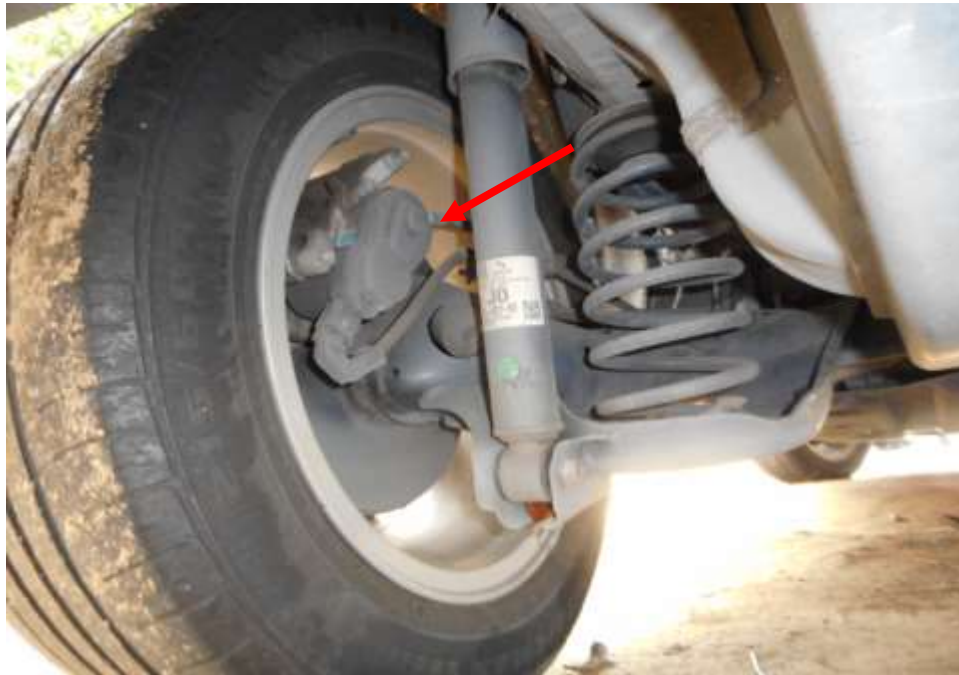
**Photo 18** shows the brake hose/pipe (arrowed) at the rear left wheel of the Motor Car. I did not observe any leakage of brake fluid at the time of my inspection of the Motor Car. Static tests of the Motor Car's braking system had indicated that there was no internal leakage of pressure/vacuum. The undercarriage components of the Motor Car were also all found to be intact and without any visible damage.

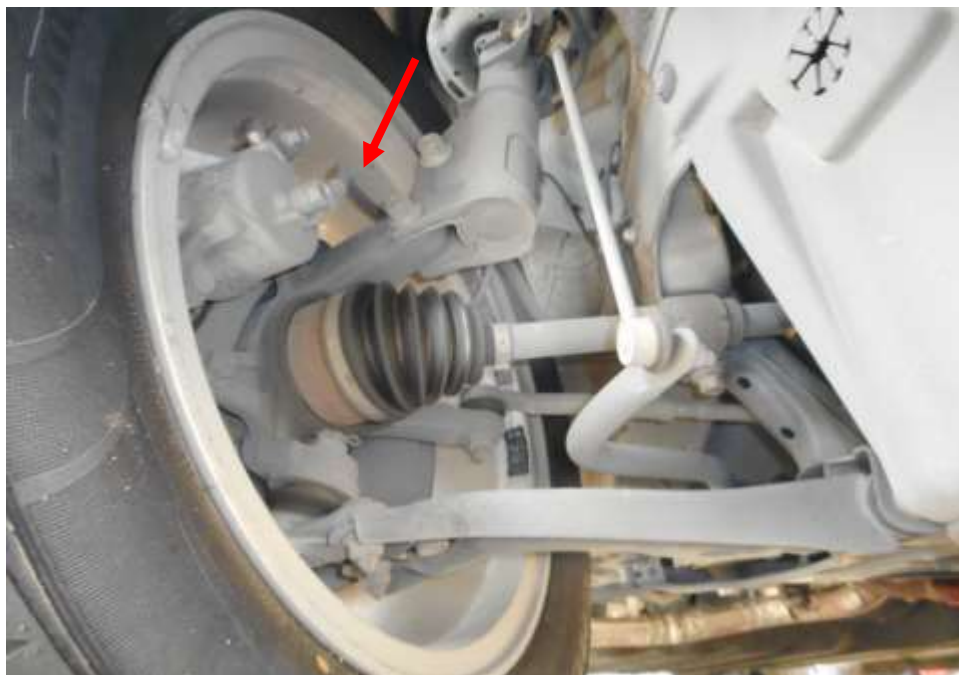
**Photo 19** shows the brake hose/pipe (arrowed) at the front right wheel of the Motor Car. I did not observe any leakage of brake fluid at the time of my inspection of the Motor Car. Static tests of the Motor Car's braking system had indicated that there was no internal leakage of pressure/vacuum. The undercarriage components of the Motor Car were also all found to be intact and without any visible damage.

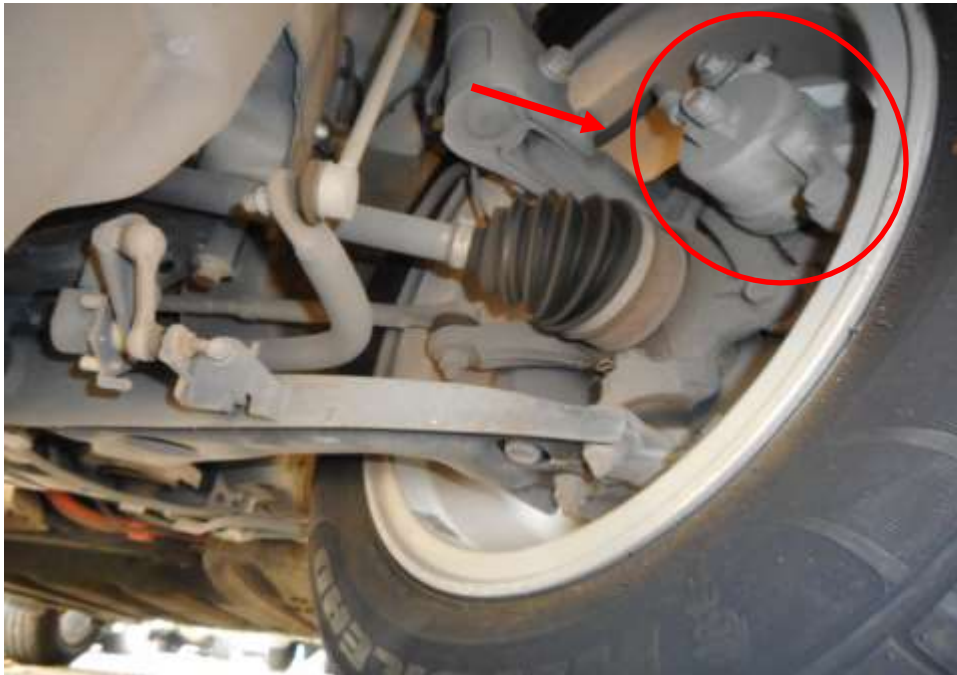
**Photo 20** shows the brake hose/pipe (arrowed) at the front left wheel of the Motor Car. No leakage of brake fluid was observed. Visual examination of the various components of the braking system like the brake caliper (circled), brake booster, brake pedal etc had revealed all to be intact and without visible damage.

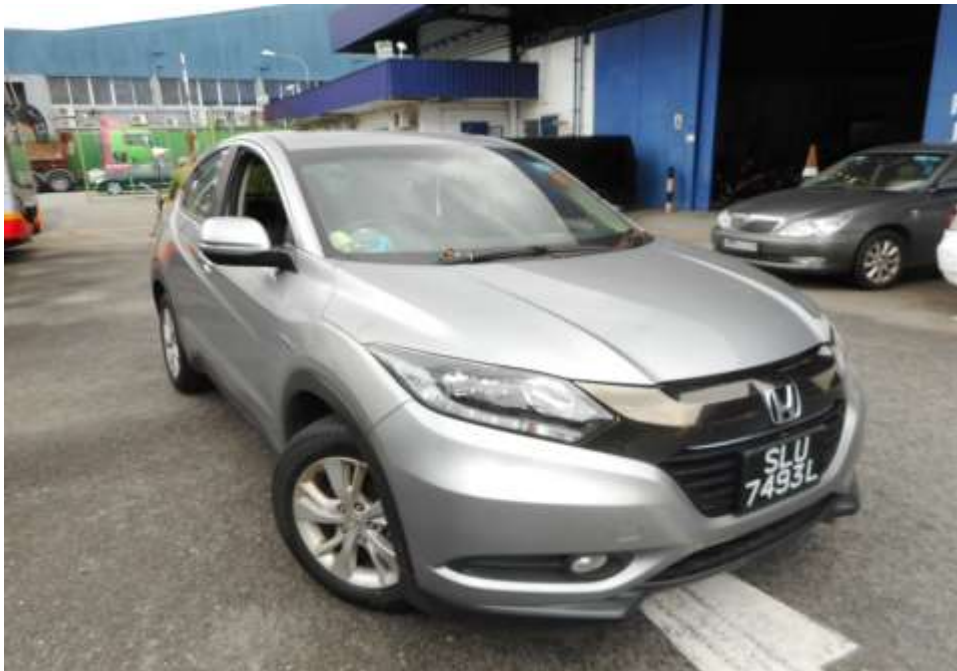
**Photo 21** shows the front right wheel of the Motor Car turned to its full left. During my steering system test, I did not experience any abnormal free play and/or resistance when I had turned the steering wheel towards the left and right. This would suggest that the steering system of the Motor Car was likely to be in serviceable condition at the material time of accident.

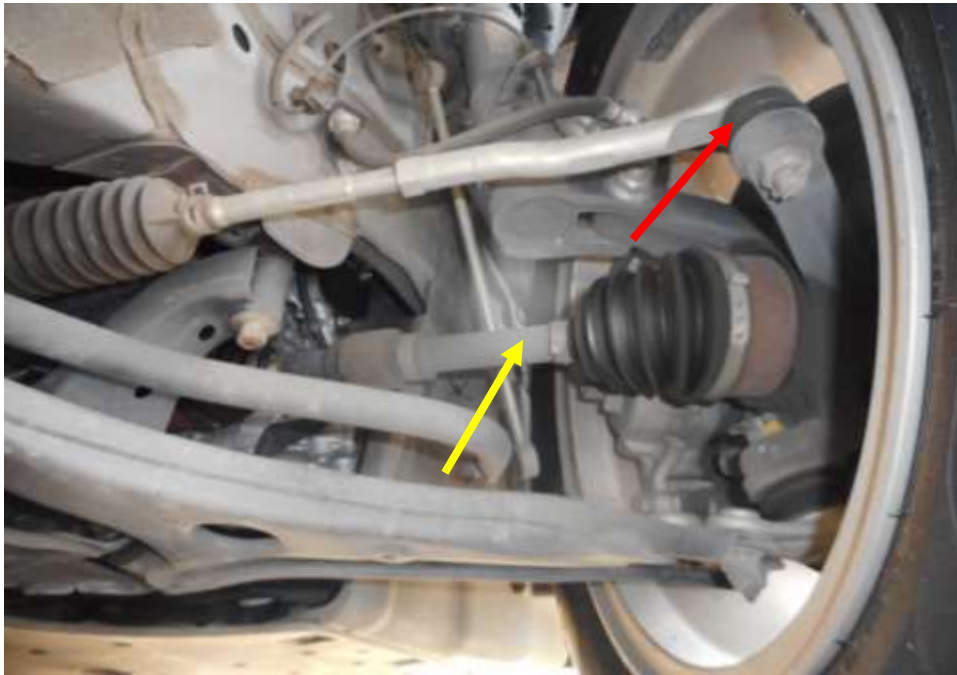
**Photo 22** shows the various undercarriage components at the front right wheel of the Motor Car, in particular the steering tie rod (red arrow) and drive shaft (yellow arrow). The various steering components were all found to be intact, suggesting that the steering system of the Motor Car was likely to be in serviceable condition at the material time of accident. There was also no sign of fluid stain observed on the various undercarriage components at the front right wheel of the Motor Car.

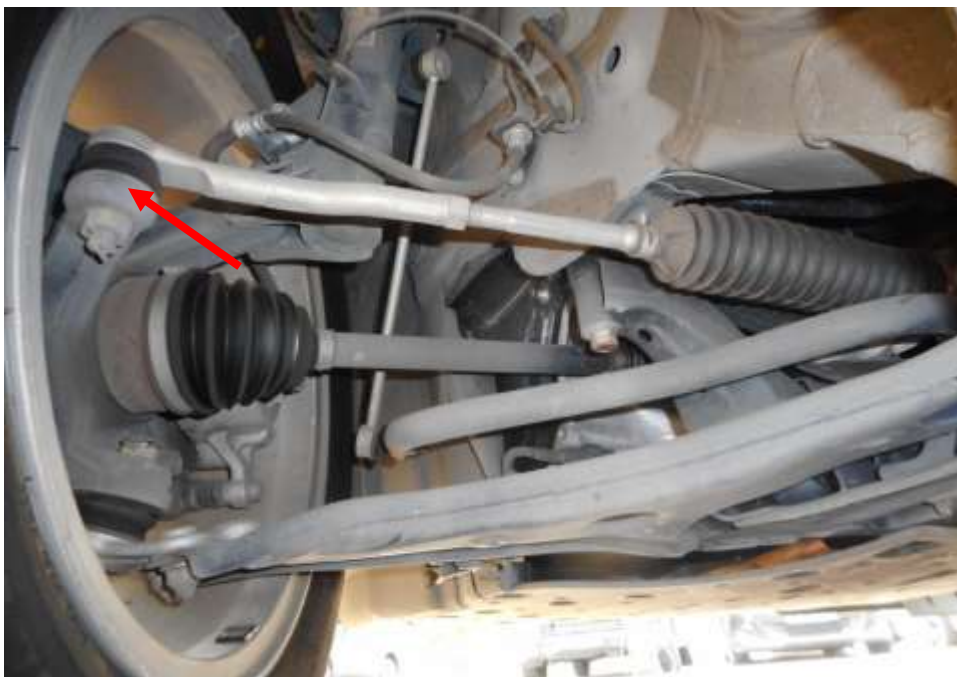
**Photo 23** shows the various undercarriage components at the front left wheel of the Motor Car, which had included the steering tie rod (red arrow). The various undercarriage components of the Motor Car were all found to be intact without any visible damage.

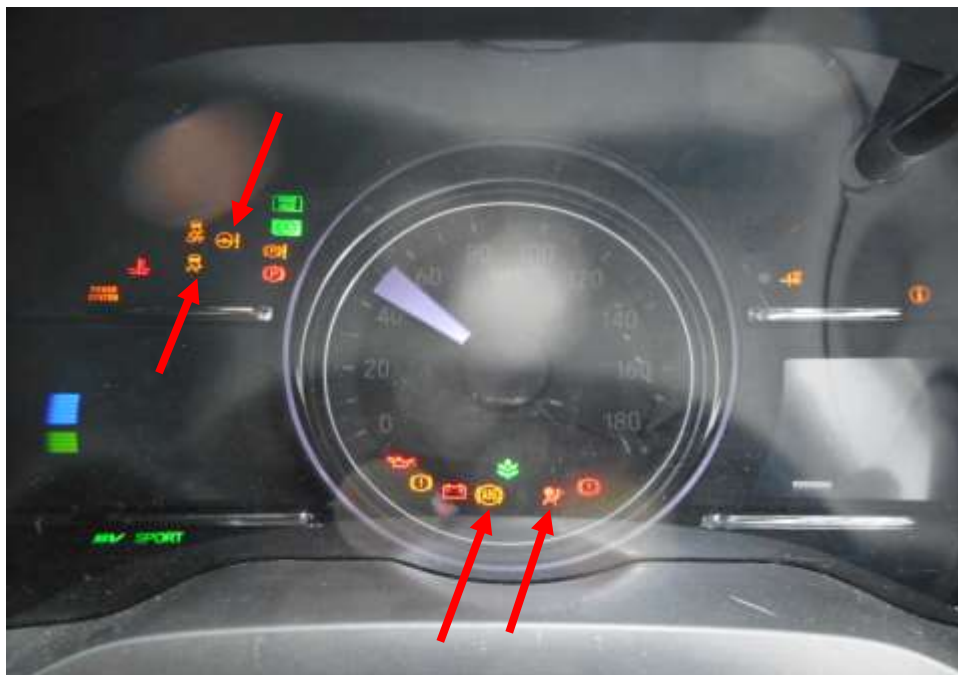
**Photo 24** shows the warning light for Anti-Lock Brake System (ABS) and Power Steering System (EPS), Supplemental Restraint System (SRS) and Traction Control (TC) (arrowed) appearing on the instrument panel of the Motor Car during the self-test of its various electronic operating systems when its engine was cranked.

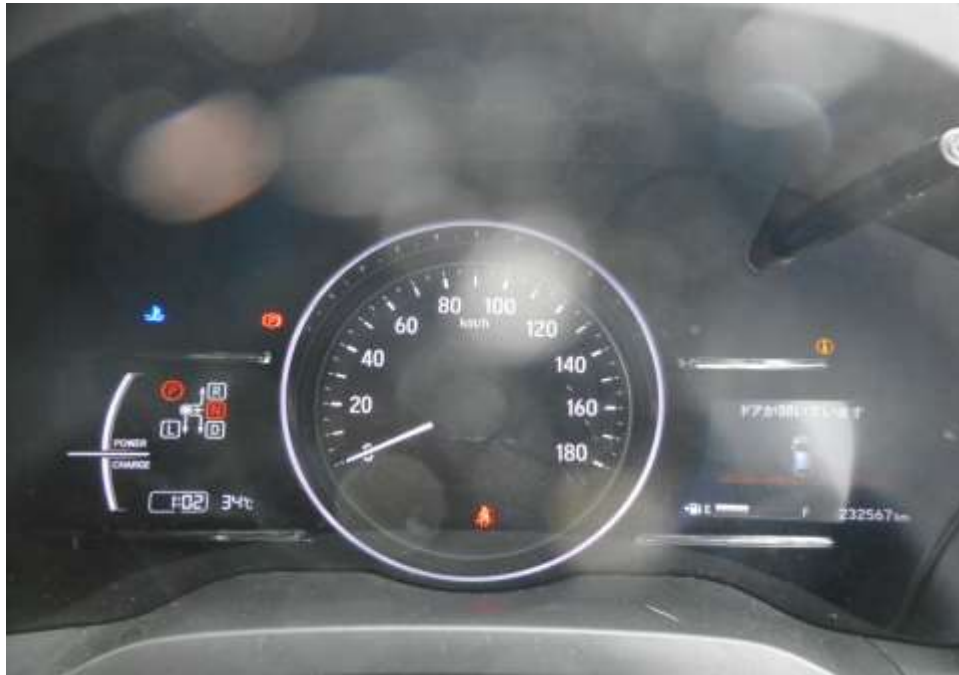
**Photo 25** shows no warning lights illuminated on the instrument panel of the Motor Car after the engine was cranked. This would suggest that there was no abnormality to the electronic operating system of the Motor Car, like the ABS, EPS, SRS, and TC etc.
