Your Ref: TP/IP/78783/2019  
Our Ref : CI/TPD20004220/P

23<sup>rd</sup> March 2020

**MECHANICAL INSPECTION REPORT OF MOTOR CAR SGU 9305T**

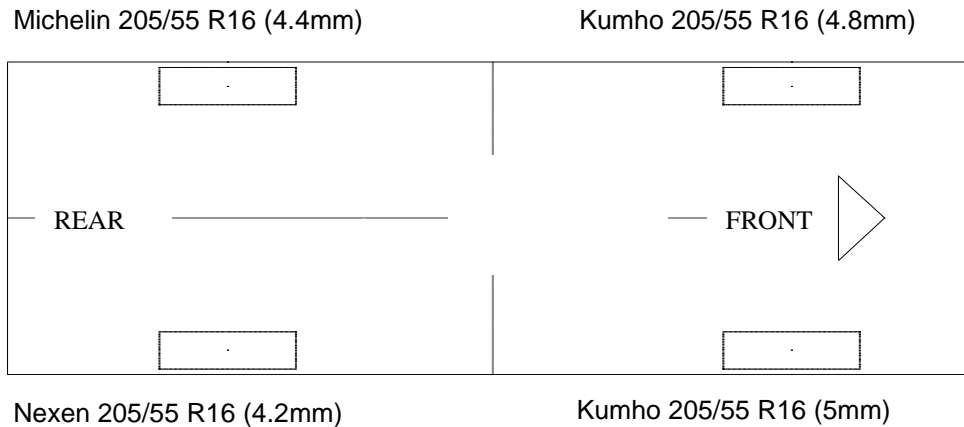
6. The condition of the Motor Car's 4 tyres was observed to be in serviceable condition. I did not find any tear, cut or burst mark(s) on the outer and the inner sidewalls as well as across the tread of the 4 tyres. The 4 tyres were also observed to be sufficiently inflated for vehicular operation. The tyre brand, tyre size and remaining tread depth of the 4 tyres were recorded as follows:-

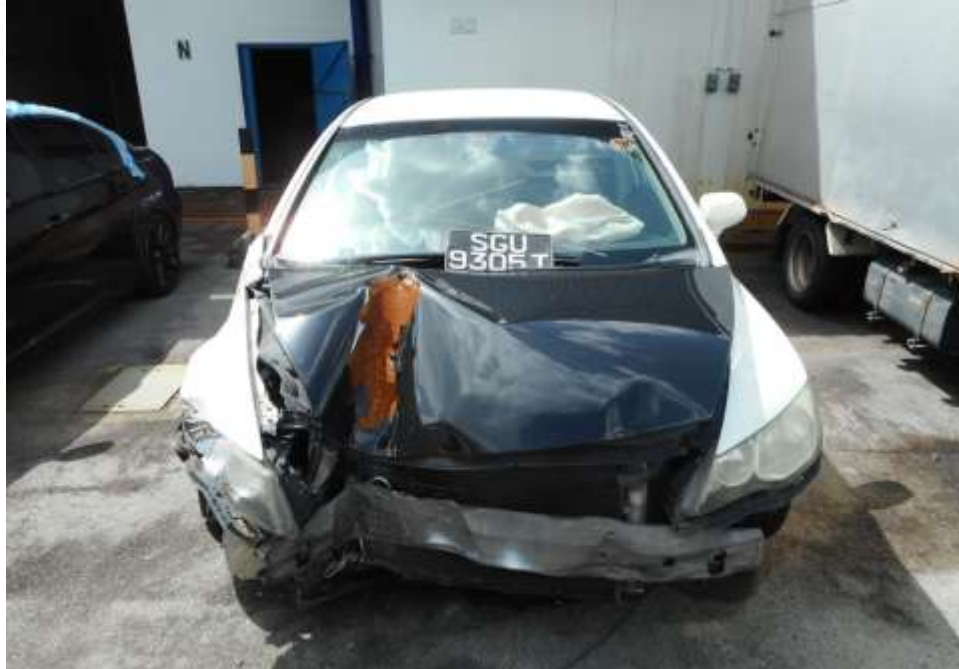
**Photo 1** shows a general view of the Motor Car's front body at the time of my inspection. The Motor car was observed to have sustained damage at its front portion. Its front bonnet, front bumper, front right fender, front right rear view mirror and front right headlamp was amongst the body parts and various components in the engine compartments were also damaged as a result of the accident. The Supplemental Restraint System (SRS) was activated as a result of the accident.

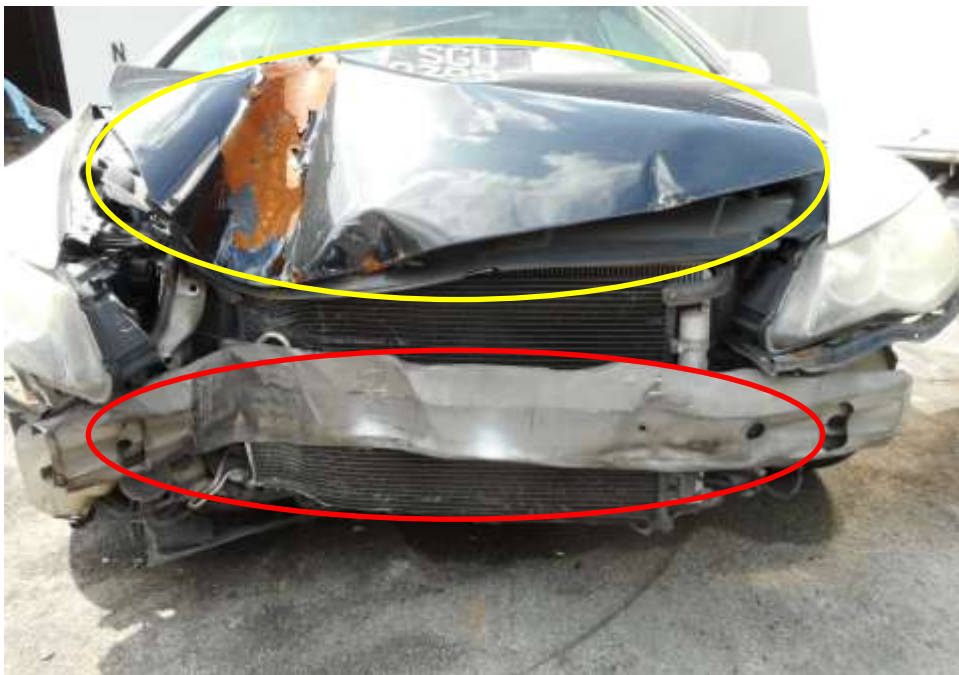
**Photo 2** shows the close up view of the Motor Car's front body at the time of my inspection. The Motor car was observed to have sustained damage at its front portion. Its front bonnet (yellow circle) and front bumper (red circle) was amongst the body parts and various components in the engine compartments were also damaged as a result of the accident.

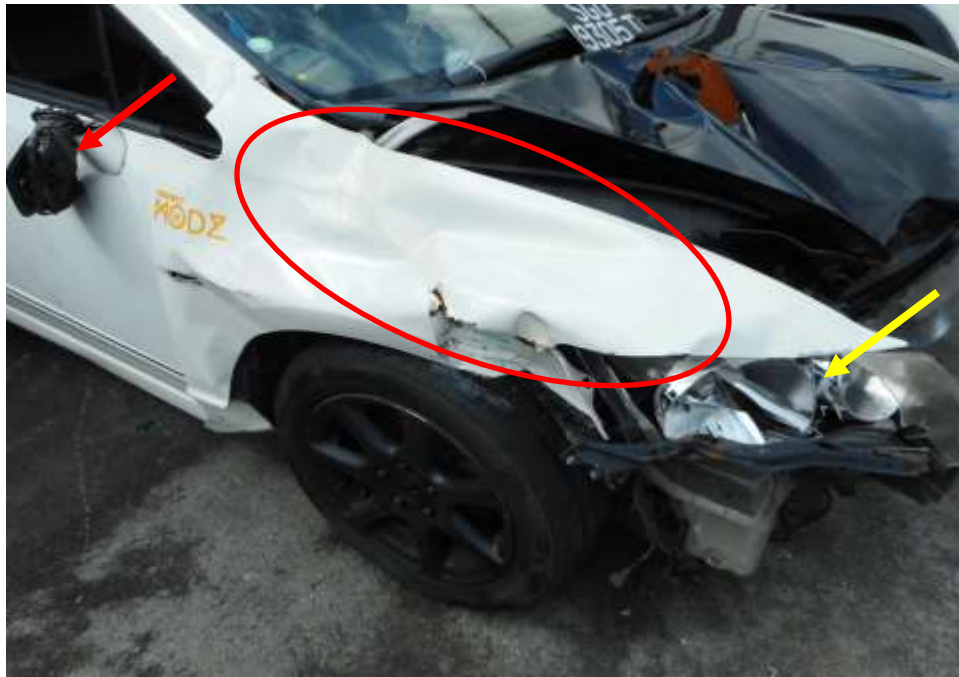
**Photo 3** shows a close up view of the Motor Car's engine compartment at the time of my inspection. The Motor car was observed to have sustained damage at its front portion. Its front right fender (red circle), front right headlamp (yellow arrow) and front right rear view mirror (red arrow) was amongst the body parts and various components in the engine compartments were also damaged as a result of the accident.

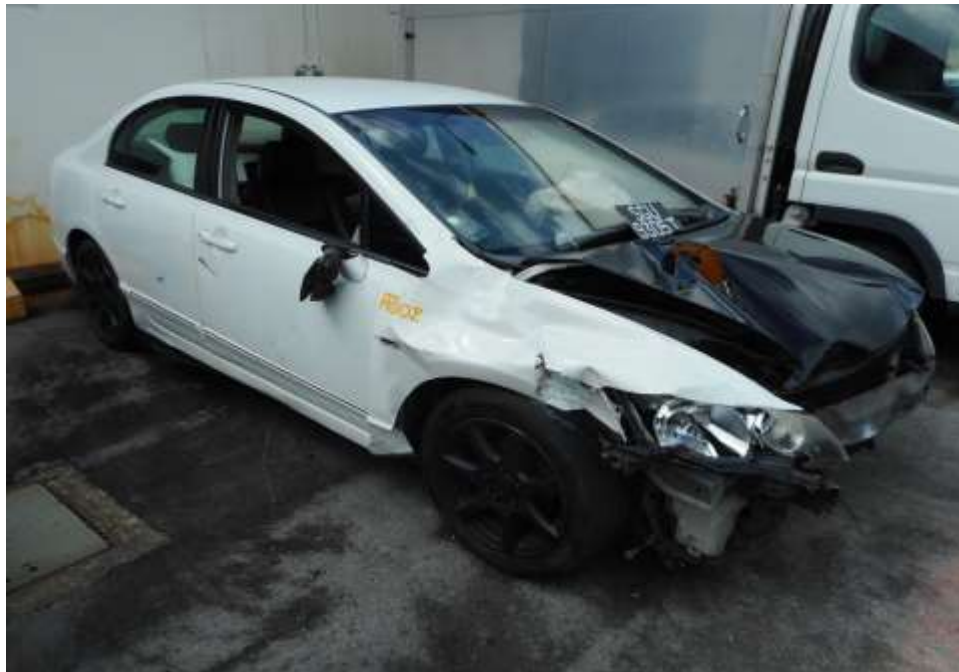
**Photo 4** shows a general view of the Motor Car's rear right body at the time of my inspection. The rear right portion of the Motor Car was observed to have been undamaged by the accident.

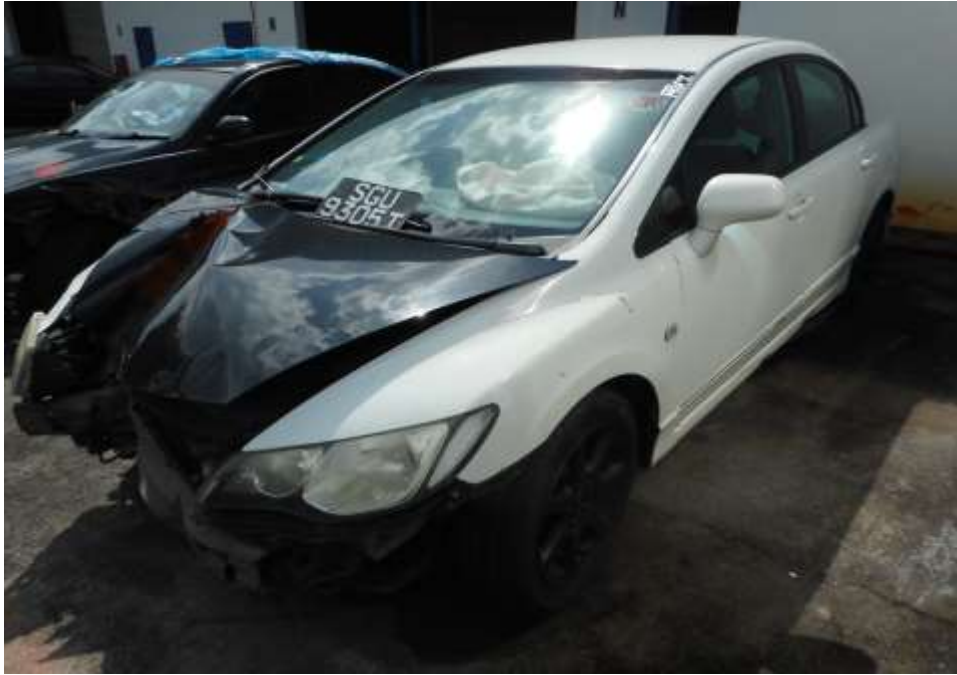
**Photo 5** shows a general view of the Motor Car's rear left body at the time of my inspection. The rear left portion of the Motor Car was observed to have been undamaged by the accident.

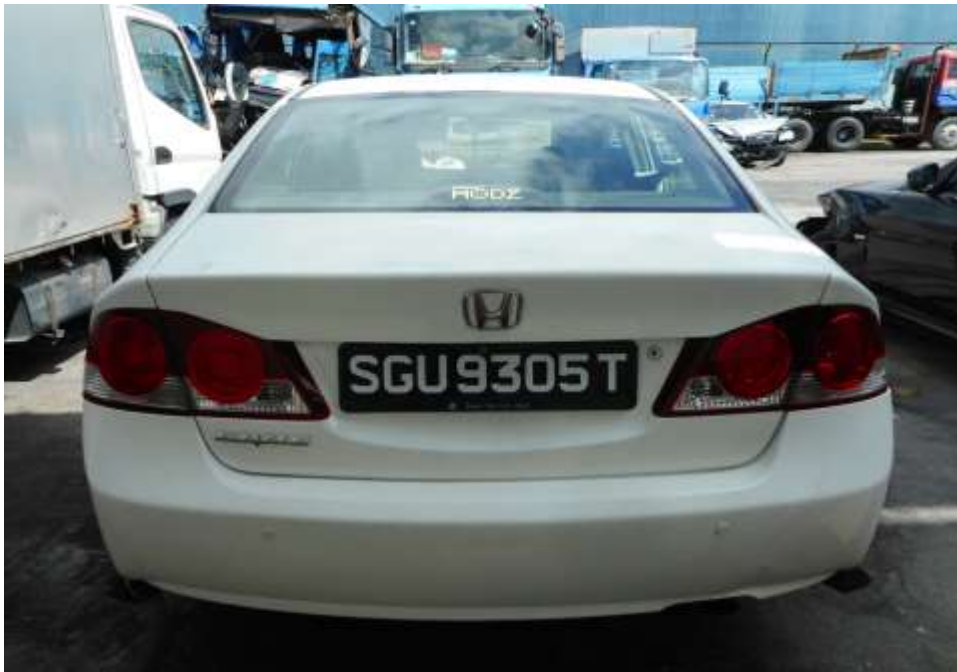
**Photo 6** shows a general view of the Motor Car's rear body at the time of my inspection. The rear portion of the Motor Car was observed to have been undamaged by the accident.

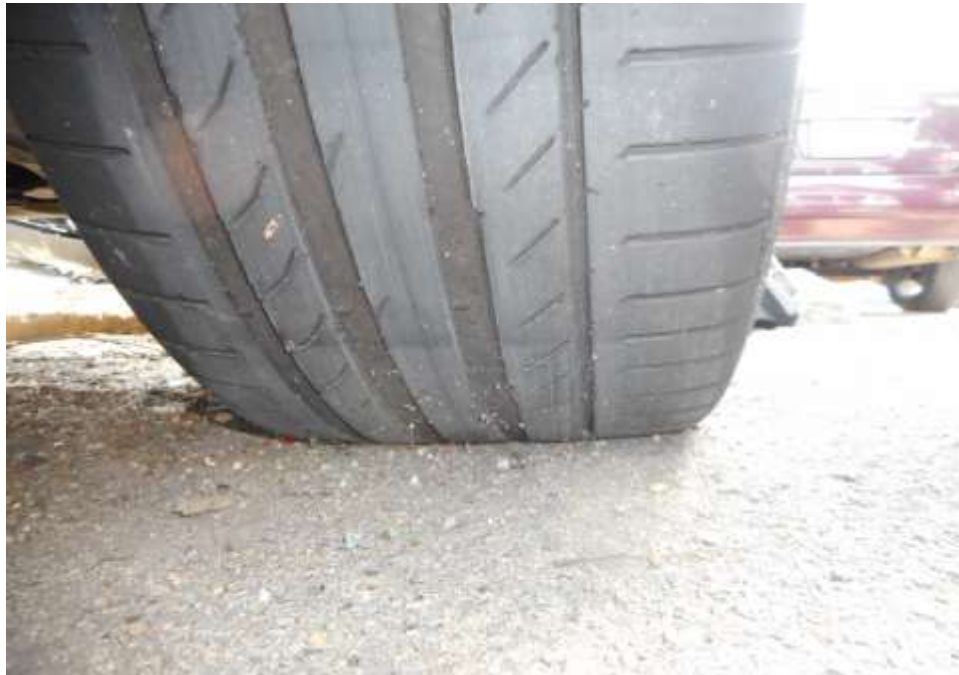
**Photo 7** shows the condition of the front right tyre of the Motor Car, which was observed to be in serviceable condition with remaining tread depth of approximately 5mm. The tyre, which was wrapped around alloy wheel rim, was also observed to be sufficiently inflated for vehicular operation.

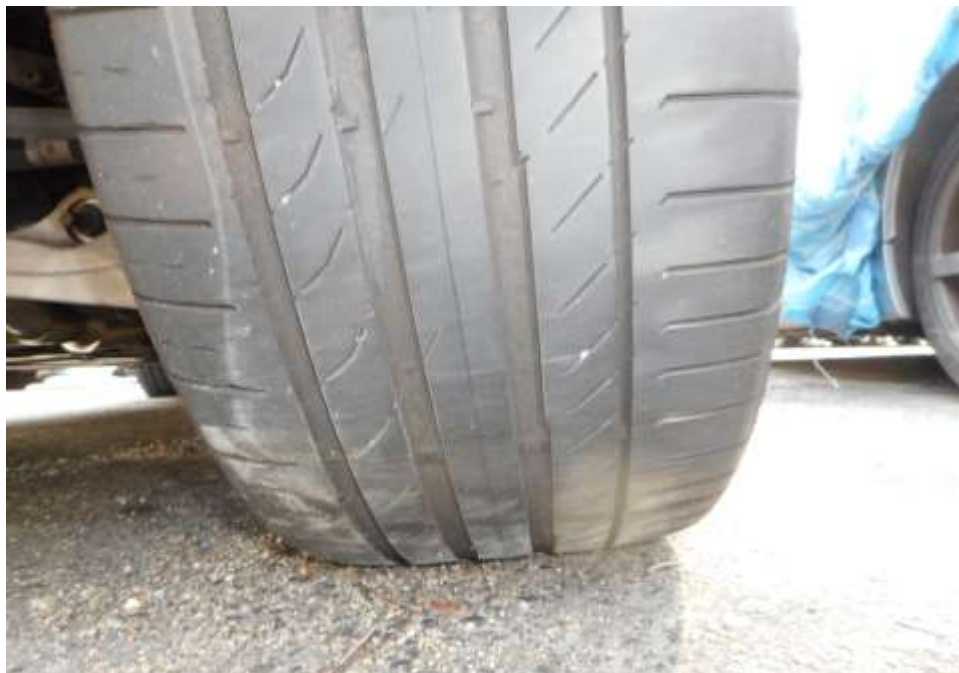
**Photo 8** shows the condition of the rear right tyre of the Motor Car, which was observed to be in serviceable condition with remaining tread depth of approximately 4.2mm. The tyre was also observed to be sufficiently inflated for vehicular operation with no tear, cut or burst mark(s).

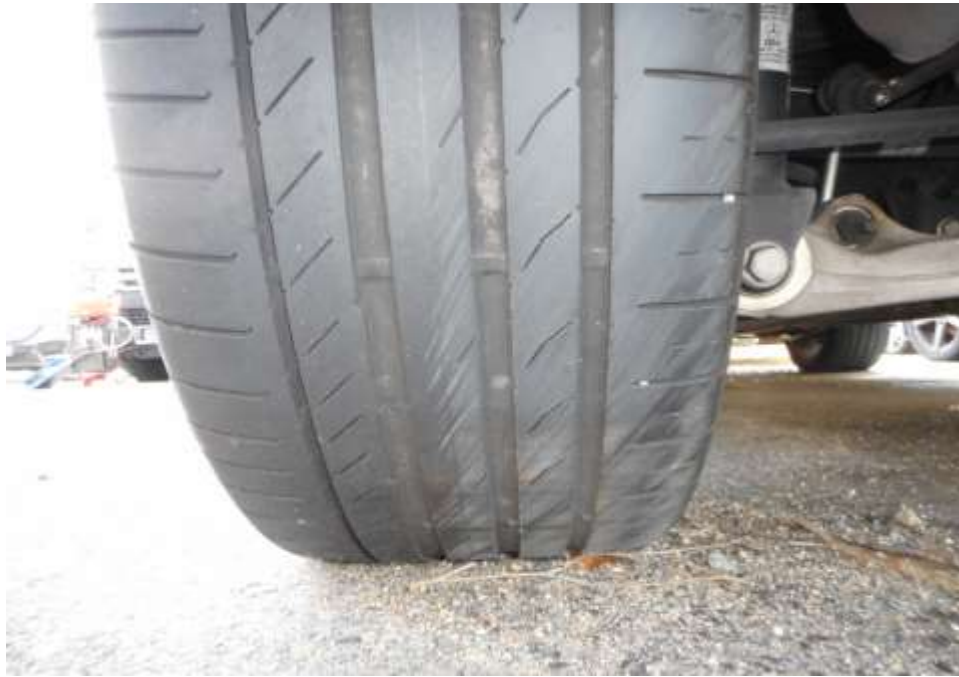
**Photo 9** shows the condition of the rear left tyre of the Motor Car, which was observed to be in serviceable condition with remaining tread depth of approximately 4.4mm. The tyre was also observed to be sufficiently inflated for vehicular operation with no tear, cut or burst mark(s).

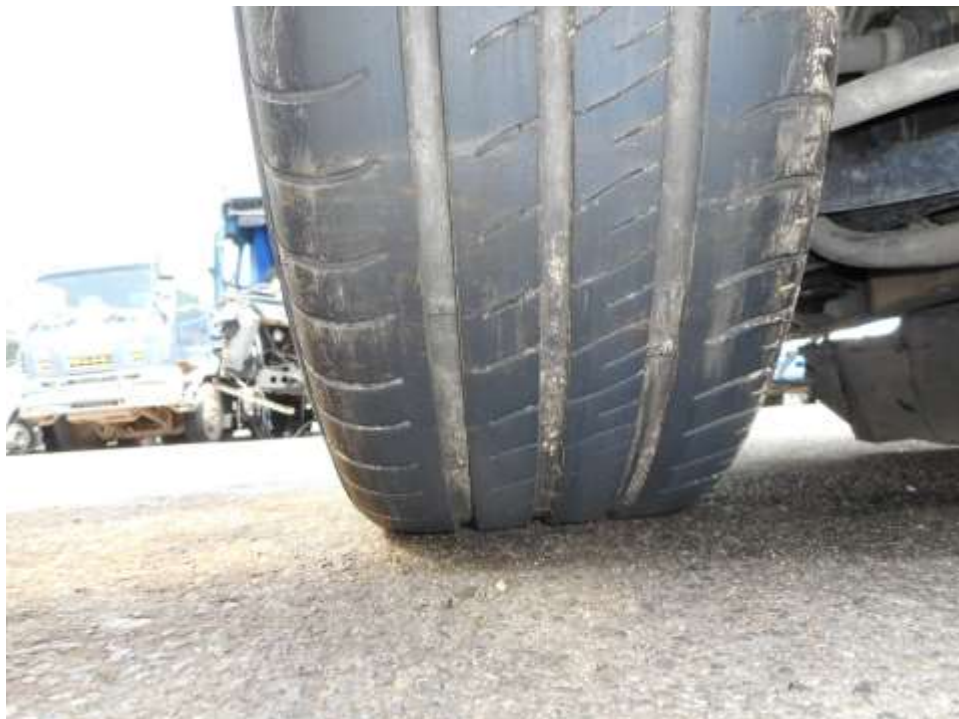
**Photo 10** shows the condition of the front left tyre of the Motor Car, which was observed to be in serviceable condition with remaining tread depth of approximately 4.8mm. The tyre was also observed to be sufficiently inflated for vehicular operation with no tear, cut or burst mark(s).

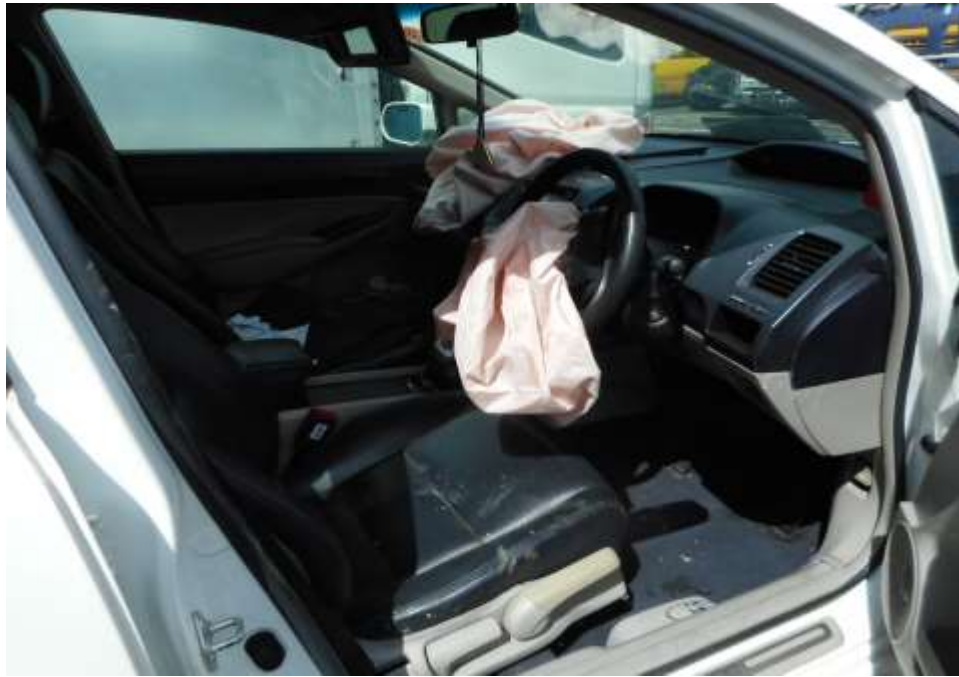
**Photo 11** shows the deployment of the Supplemental Restraint System (SRS) airbag (arrowed) in the Motor Car as a result of the accident.

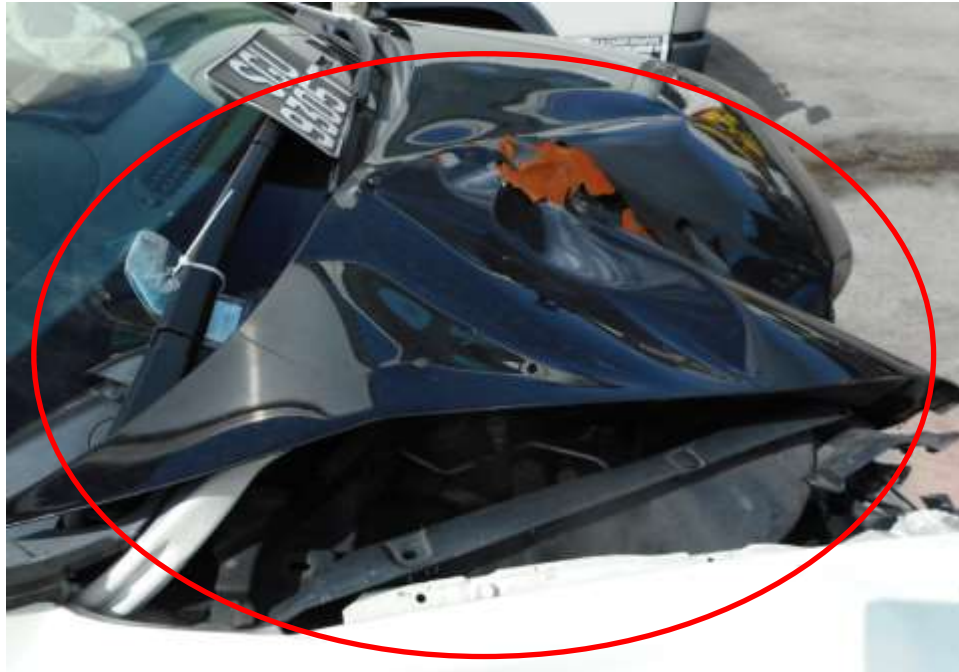
8. We were unable to raise the front bonnet of the Motor car to conduct the examination of the Motor Car's engine compartment because the damage caused by the accident had resulted in the damages to the lock mechanism of the bonnet and the structure of the engine compartment. (unable to open)  
See photo 12 below

**Photo 12** shows a close up view of the damaged front bonnet lock mechanism and the structure of the engine compartment of the Motor Car at the time of my inspection resulting it unable to open a result of the accident. (circled) (Unable to open)

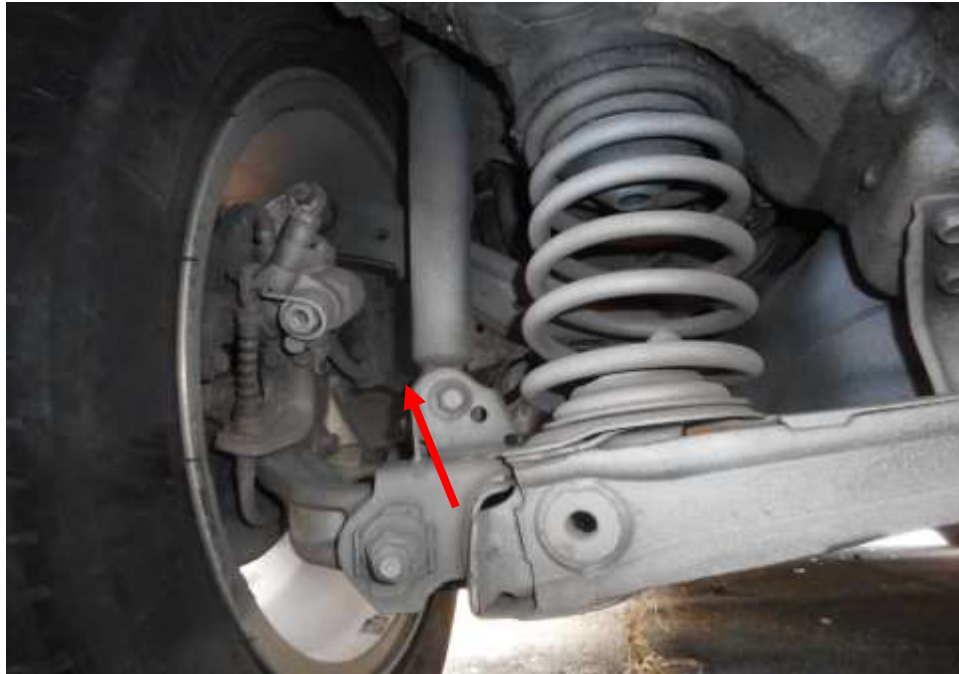
**Photo 13** shows the brake hose/pipe (arrowed) at the rear left wheel of the Motor Car. No leakage of brake fluid was observed. Visual examination of the various components of the braking system like the drum brake, brake booster, brake pedal etc. had revealed all to be intact and without visible damage.

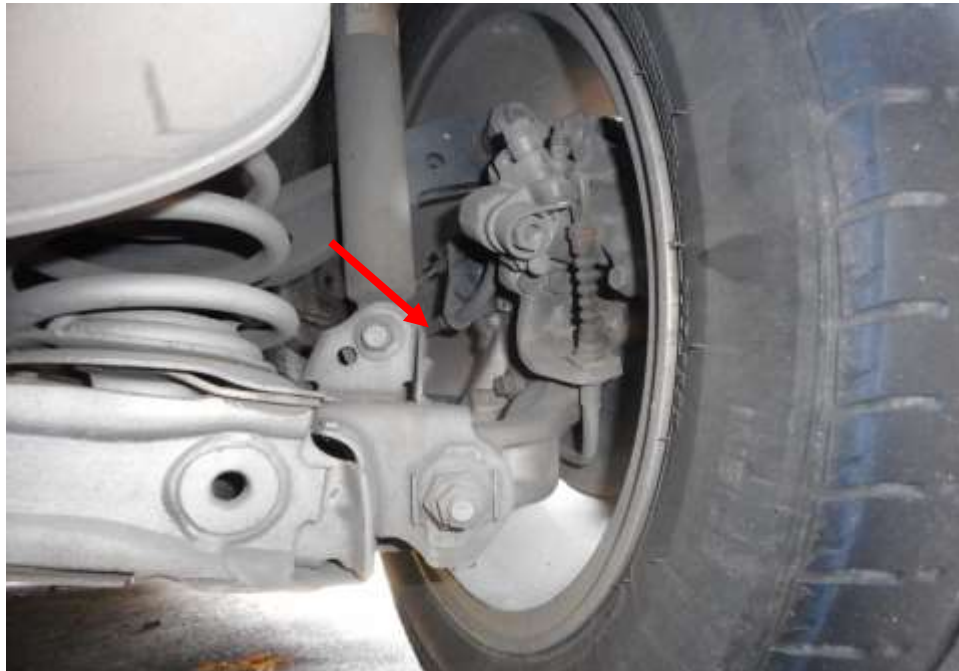
**Photo 14** shows the brake hose/pipe (arrowed) at the rear right wheel of the Motor Car. No leakage of brake fluid was observed. Visual examination of the various components of the braking system like the drum brake, brake booster, brake pedal etc. had revealed all to be intact and without visible damage.

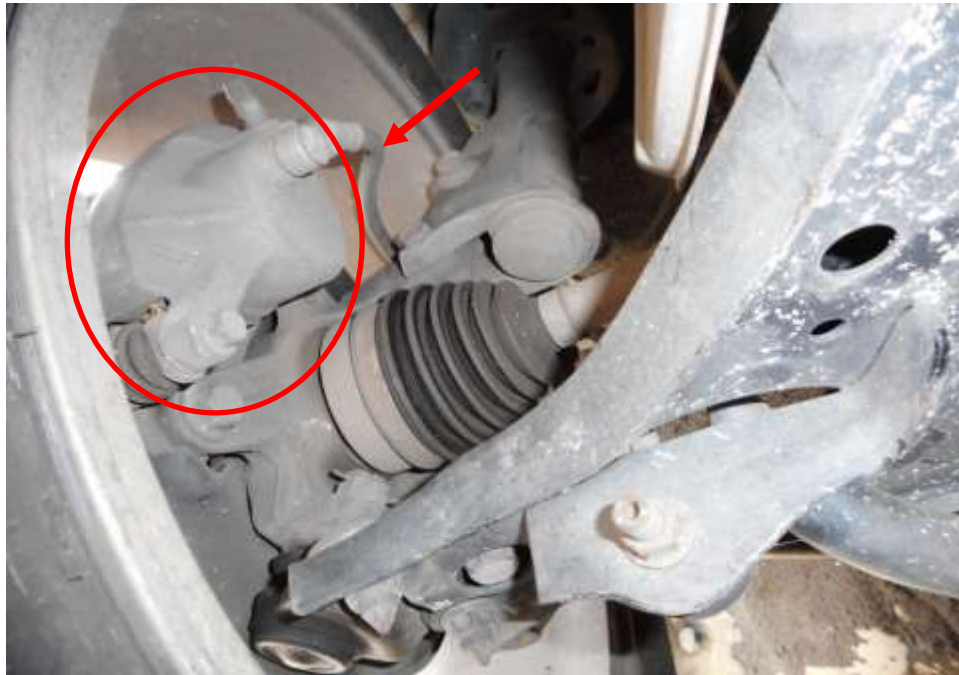
**Photo 15** shows the brake hose/pipe (arrowed) at the front right wheel of the Motor Car. No leakage of brake fluid was observed. Visual examination of the various components of the braking system like the brake caliper (circled), brake booster, brake pedal etc had revealed all to be intact and without visible damage at the time of accident. There was also no sign of fluid stain(s) observed on the various undercarriage components.

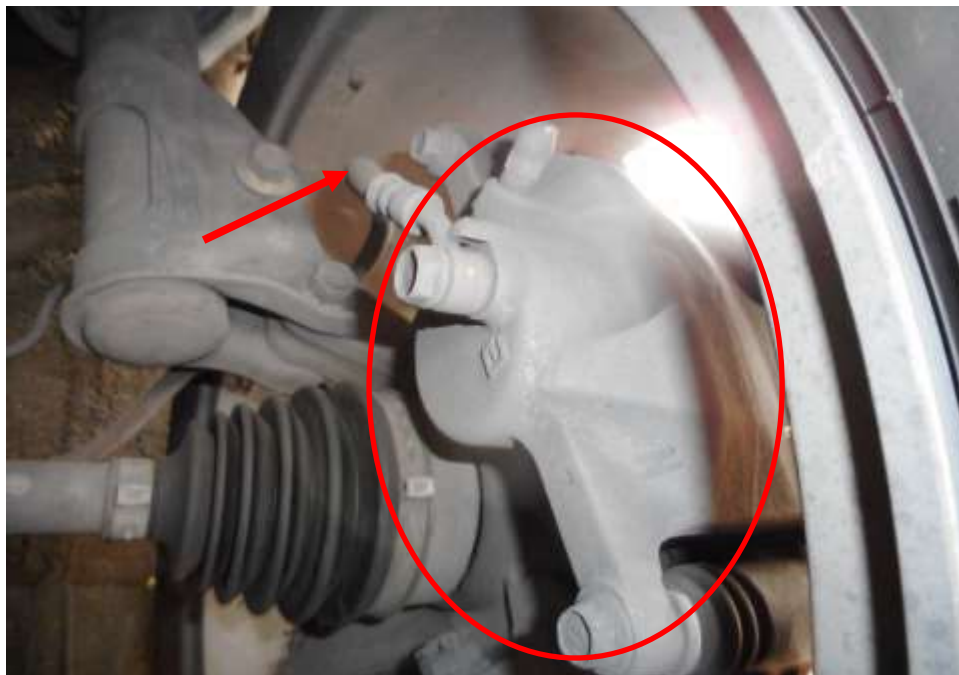
**Photo 16** shows the brake hose/pipe (arrowed) at the front left wheel of the Motor Car. No leakage of brake fluid was observed. Visual examination of the various components of the braking system like the brake caliper (circled), brake booster, brake pedal etc had revealed all to be intact and without visible damage at the time of accident. There was also no sign of fluid stain(s) observed on the various undercarriage components.

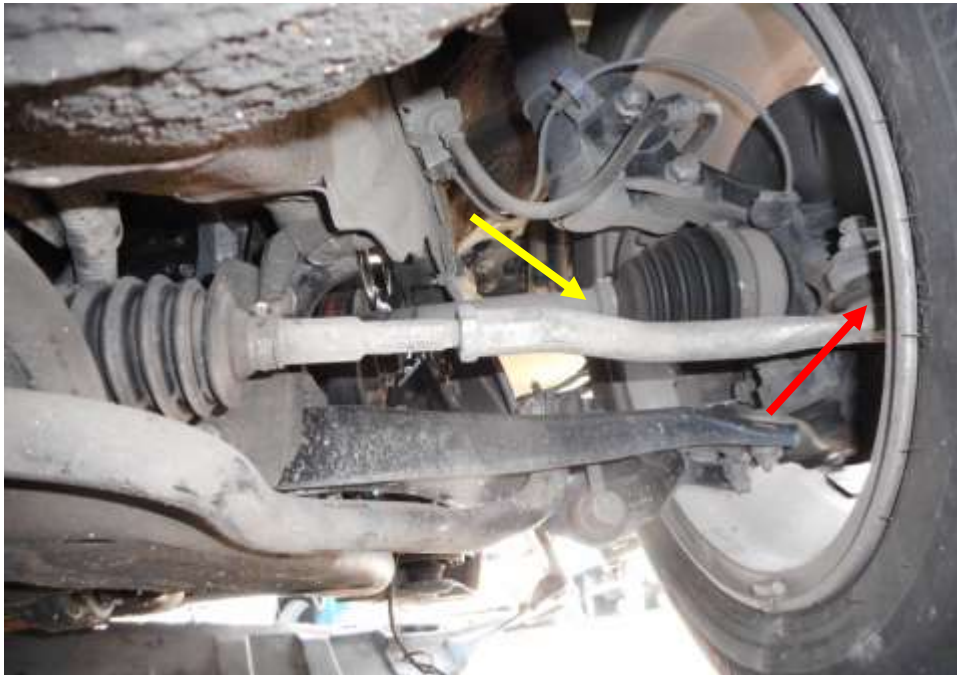
**Photo 17** shows the various undercarriage components at the front right wheel of the Motor Car, in particular the steering tie rod end (arrowed) and drive shaft (yellow arrow). The various steering components were all found to be intact, suggesting that the steering system of the Motor Car was likely to be in serviceable condition at the material time of accident. There was also no sign of fluid stain(s) observed on the various undercarriage components.

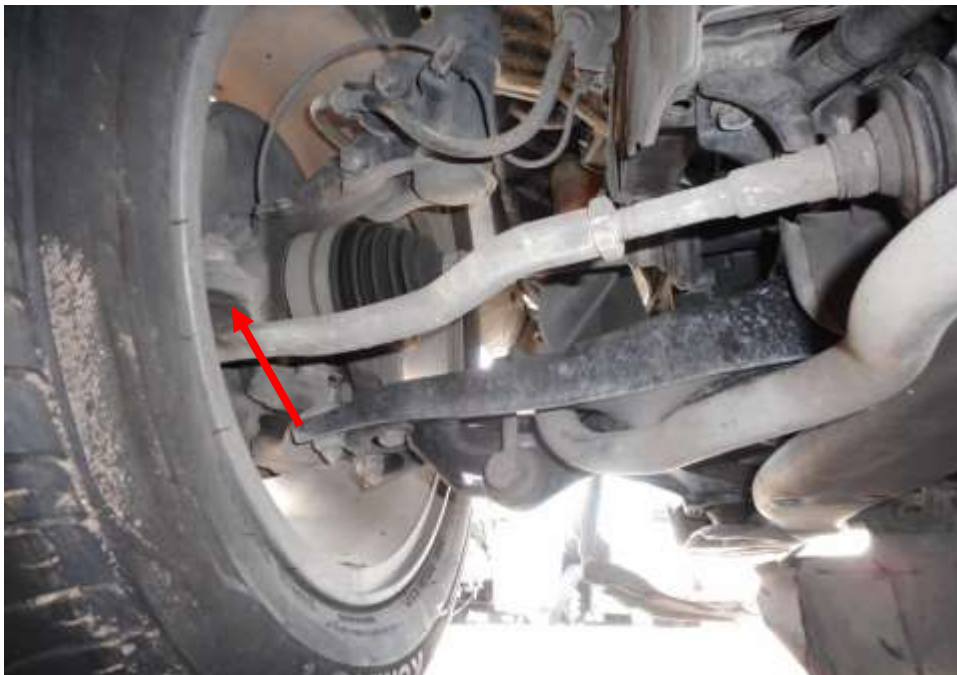
**Photo 18** shows the various undercarriage components at the front left wheel of the Motor Car, in particular the steering tie rod end (arrowed). The various Undercarriage components of the Motor Car were all found to be intact without any visible damage. There was also no sign of fluid stain(s) observed on the various undercarriage components.
