## LKK Auto Consultants Pte Ltd

### 1. Policy Particulars :- THIRD PARTY CLAIM

### ADJUSTMENT ON REPAIR COST FOR VEHICLE NO. SMJ 4913H

PHOTOGRAPHS FOR VEHICLE NO. SMJ 4913H

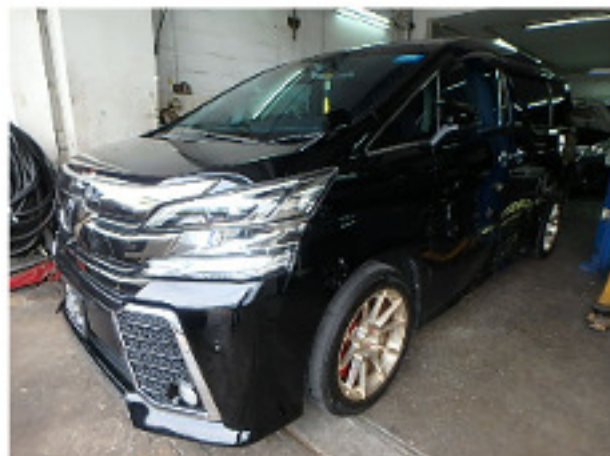
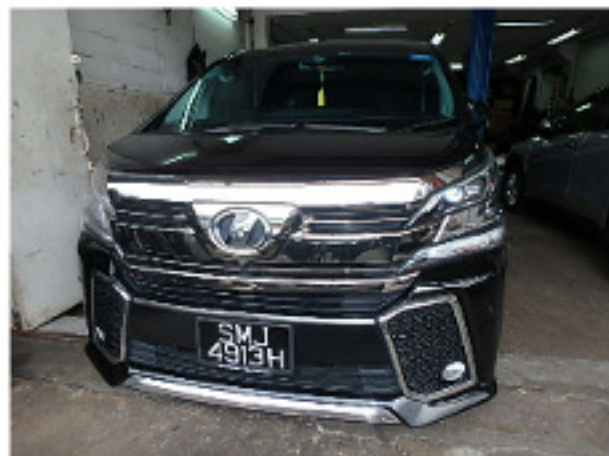
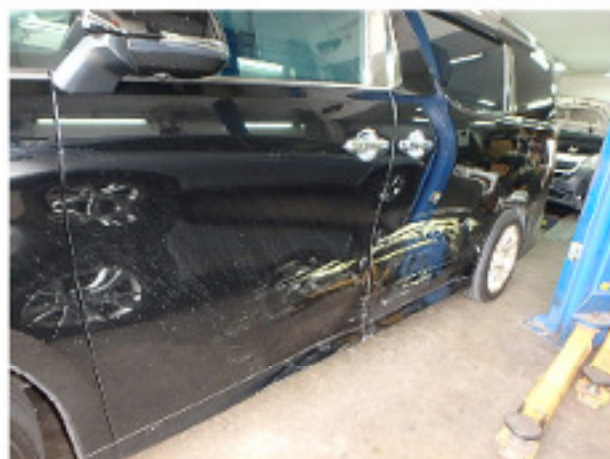
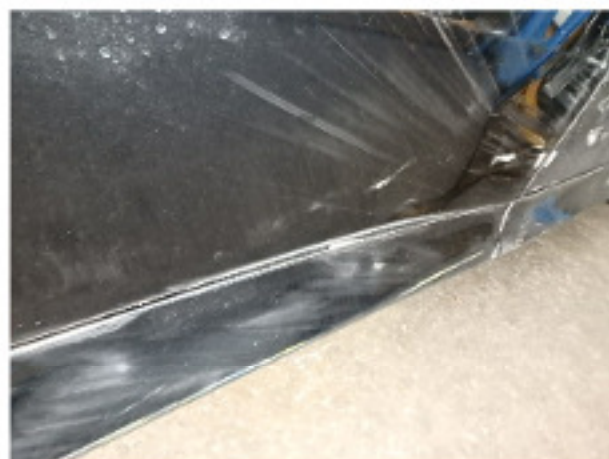
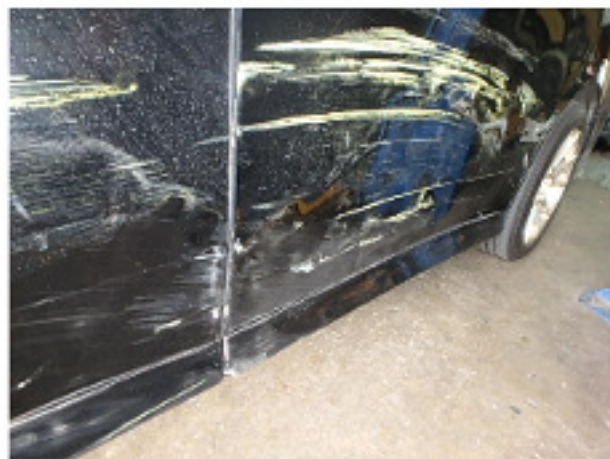
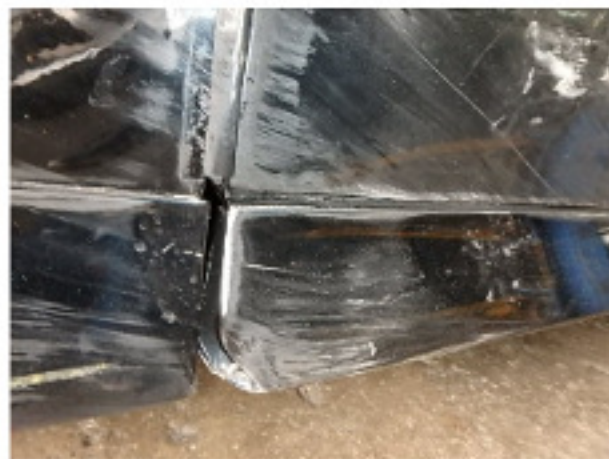
INSPECTION

THE VEHICLE SUSTAINED DAMAGES AT THE N/S BODY. DAMAGES SEE DETAILS.
--
