LKK Auto Consultants Pte Ltd

Affiliated to Federation Internationale Des Experts En Automobile				
MS FIRST CAPITAL INSURANCE LTD 36 ROBINSON ROAD #16-01 CITY HOUSESINGAPORE 068877			Ref: CC4/FCI20004307/Kea3q2	
			Date: 18/03/2021	
			Code: FCI2

ADJUSTMENT ON REPAIR COST FOR VEHICLE NO. SGV 223A

PHOTOGRAPHS FOR VEHICLE NO. SGV 223A

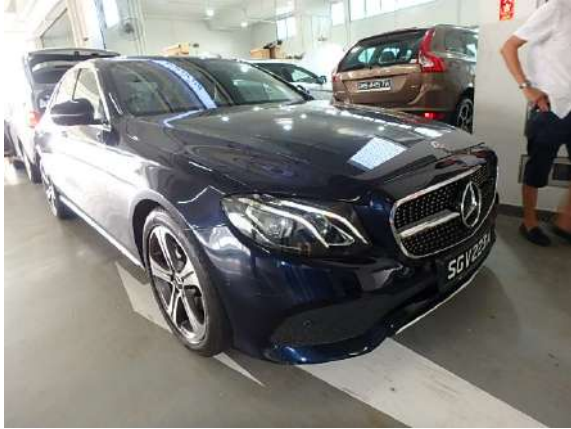
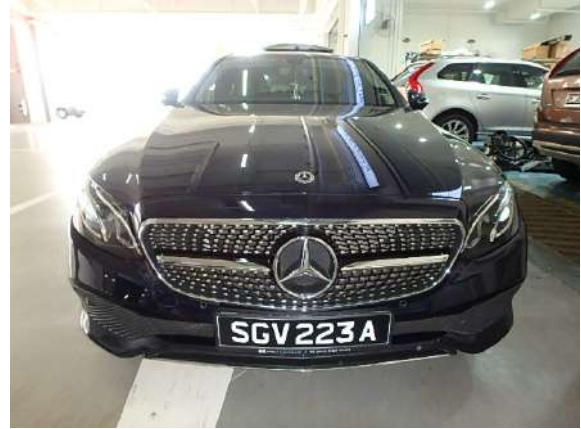
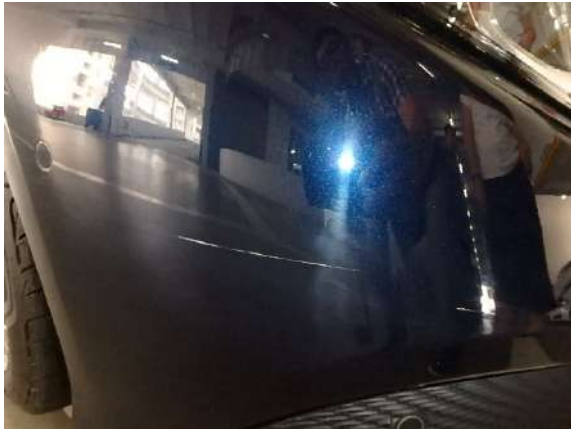
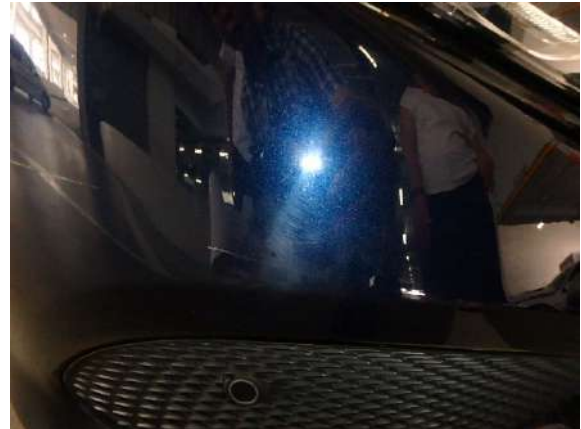
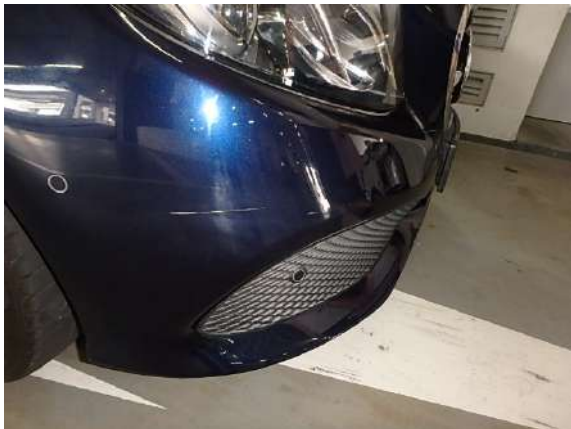
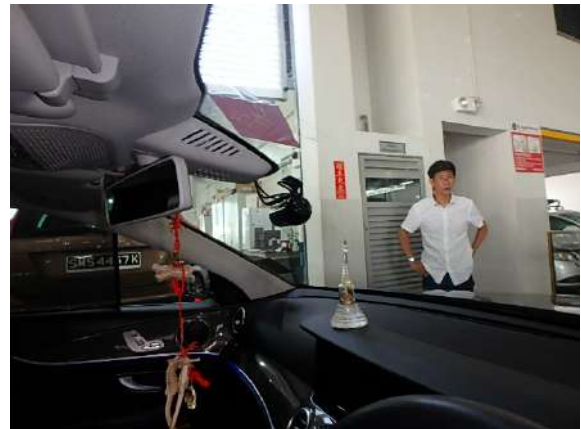
4. Description of Damages				
	THE VEHICLE SUSTAINED DAMAGES AT THE O/S FRONT PORTION. DAMAGES SEE DETAILS.			
5. General Information				
	Accident Date	14/03/2020	Inspection Date	01/04/2020
	Survey held at	LAI HUAT (MENG KEE) MOTOR PTE LTD 160 SIN MING DRIVE #04-01/02 SIN MING AUTOCITY SINGAPORE 575722		
5a. Remarks				
	A)THE INSPECTION WAS CONDUCTED ON A"WITHOUT PREJUDICE" BASIS. B)IN ACCORDANCE TO YOUR INSTRUCTIONS, WE HAVE NOT AUTHORISED REPAIRS.			
5b. Estimate Days of Repair				
	ESTIMATED NORMAL PERIOD FOR REPAIR:		1 Working Days

Qty	Description of Parts	Condition	Estimate By Workshop (\$)	Our Adjusted (\$)
	<u>LABOUR</u> TO RESPRAY FRONT BUMPER .		300.00	250.00
			300.00	250.00
	GRAND TOTAL		300.00	250.00
RECOMMENDED COST OF REPAIRS				250.00
