## LKK Auto Consultants Pte Ltd

Vehicle No. SKC 3293E  
Insured Veh. SHC 7711A  
Claim No. D20001590MFSH  
Policy No. D-20094921MFSH  
Accident Date 19/03/2020  
Inspection Date 25/03/2020

### ADJUSTMENT ON REPAIR COST FOR VEHICLE NO. SKC 3293E

PHOTOGRAPHS FOR VEHICLE NO. SKC 3293E

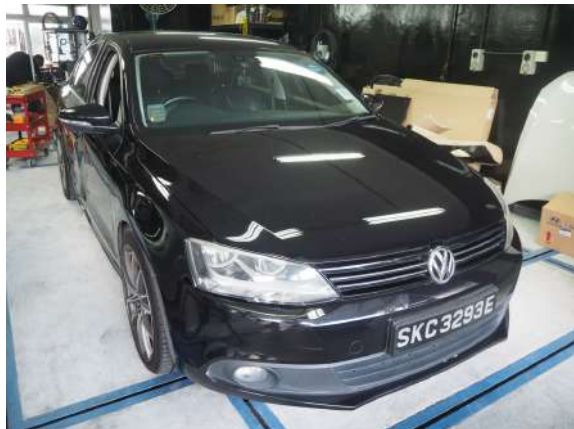
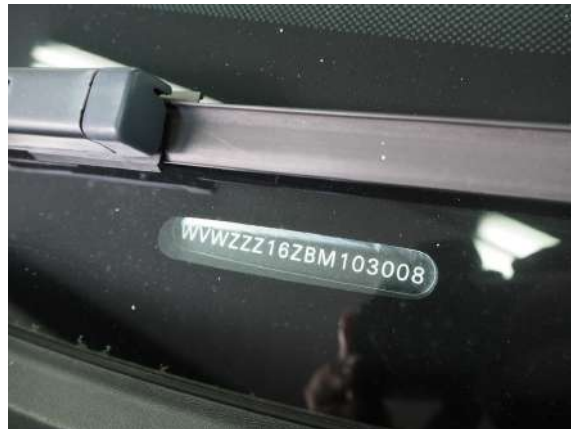
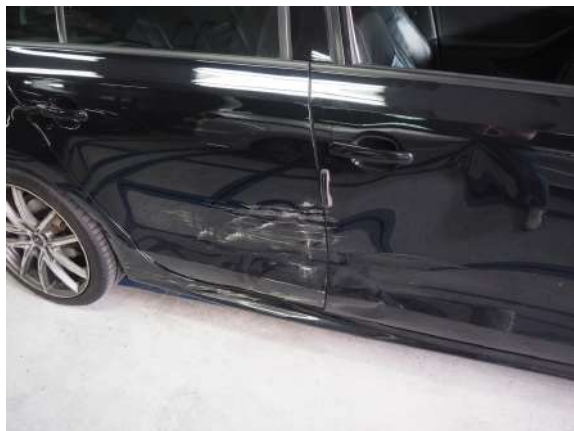
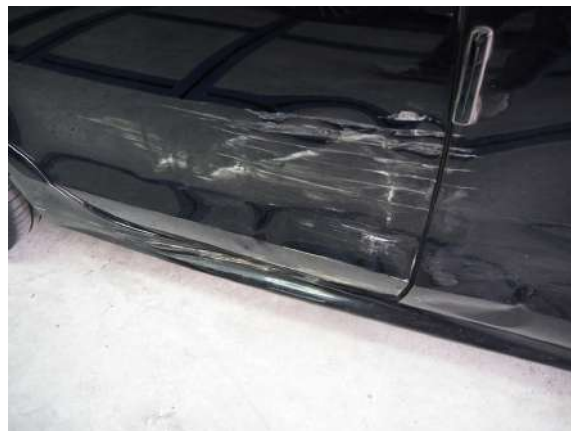
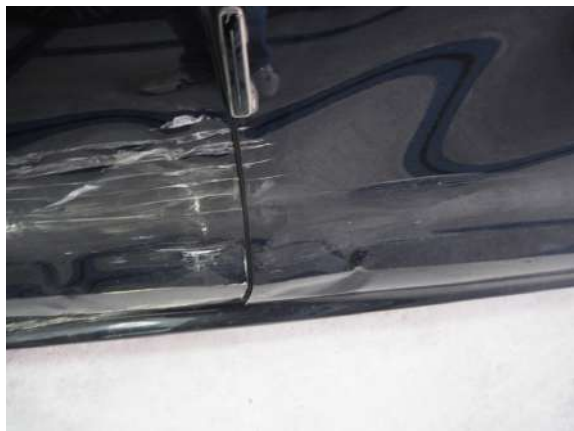
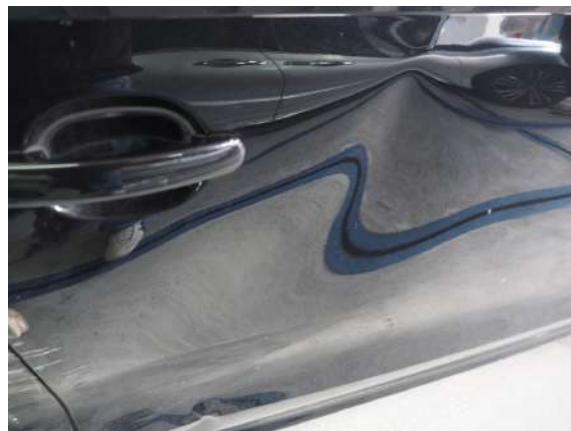
INSPECTION

| Affiliated to Federation Internationale Des Experts En Automobile | | | | |
|---|---|---|---|---|
| | THE VEHICLE SUSTAINED DAMAGES AT THE O/S BODY.<br><br>DAMAGES SEE DETAILS. | | | |
