LKK Auto Consultants Pte Ltd

Affiliated to Federation Internationale Des Experts En Automobile				
MS FIRST CAPITAL INSURANCE LTD		Ref : CC4/FCI20004553/Uba3q2		
36 ROBINSON ROAD #16-01 CITY HOUSESINGAPORE 068877		Date : 12-11-2020

ADJUSTMENT ON REPAIR COST FOR VEHICLE NO. GBB 1219X

PHOTOGRAPHS FOR VEHICLE NO. GBB 1219X

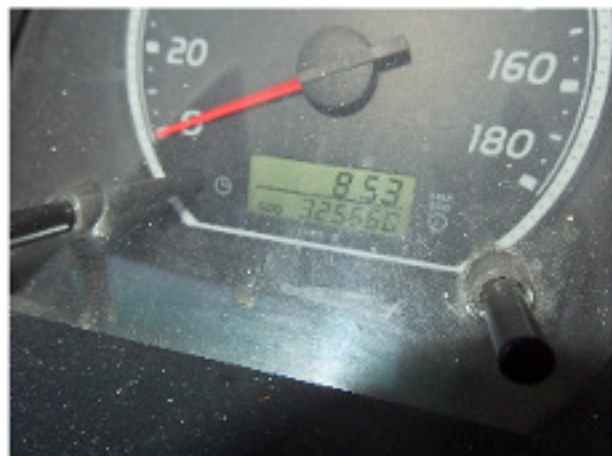
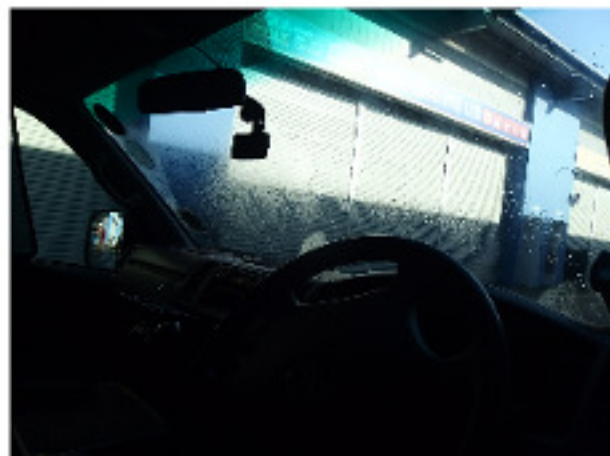
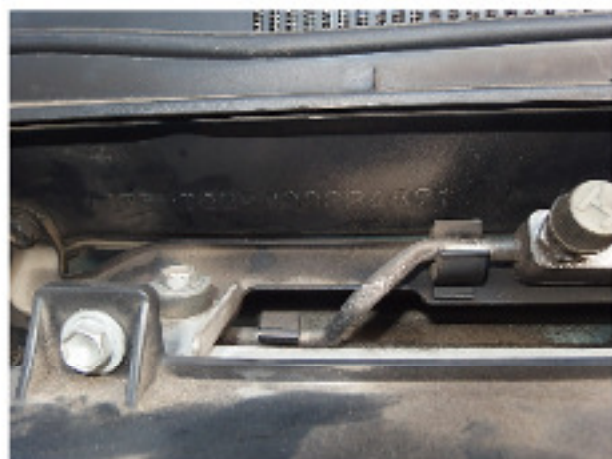
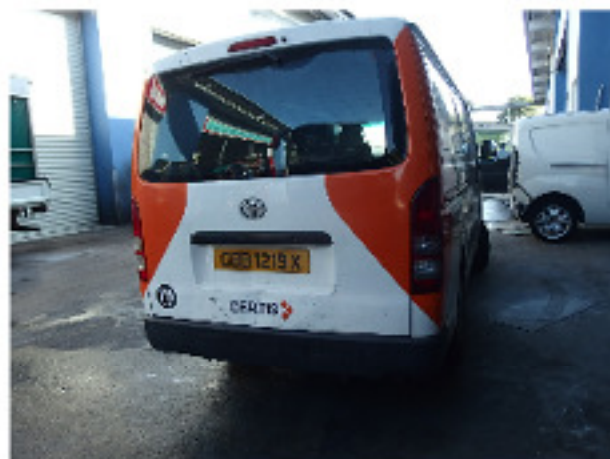
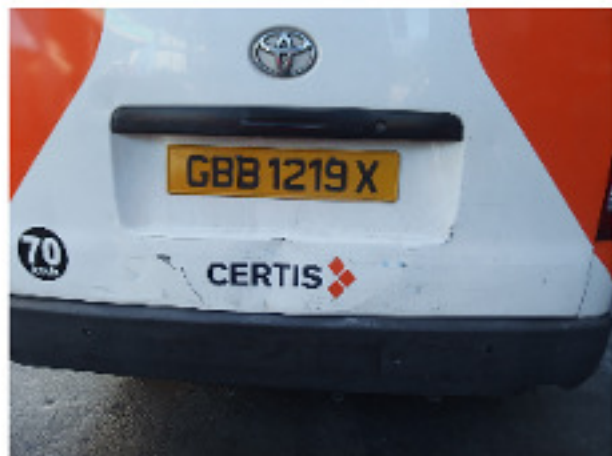
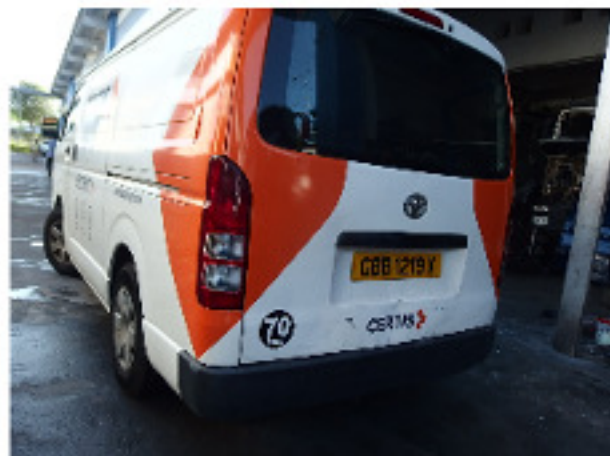
4. Description of Damages				
THE VEHICLE SUSTAINED DAMAGES AT THE REAR PORTION. DAMAGES SEE DETAILS.				
5. General Information				
Accident Date	19/03/2020	Inspection Date	25/03/2020	
Survey held at	LIU'S BROTHER AUTO ENGINEERING WORKSHOP 1 KAKI BUKIT AVENUE 6 #01-01 AUTOBAY @ KAKI BUKIT SINGAPORE 417883			
5a. Remarks				
A)THE INSPECTION WAS CONDUCTED ON A"WITHOUT PREJUDICE" BASIS. B)IN ACCORDANCE TO YOUR INSTRUCTIONS, WE HAVE NOT AUTHORISED REPAIRS.				
5b. Estimate Days of Repair				
ESTIMATED NORMAL PERIOD FOR REPAIR:		5 Working Days
