# VEHICLE CONDITION REPORT FORM / JOB RECORD

Date: 29/03/20 Time: 0630PMCustomer Name: Phyllis ChangTechnician Name: STEVEN YIPCustomer Telephone: 7345 1375Reg. No: SAR 255X Job No: V80000808Make/Model: VW GOLFOdometer Reading (Customer Vehicle): 7426Location: 46 JAN RT TO SUEE

Reason: ACCIDENT ON RHF PORTION.

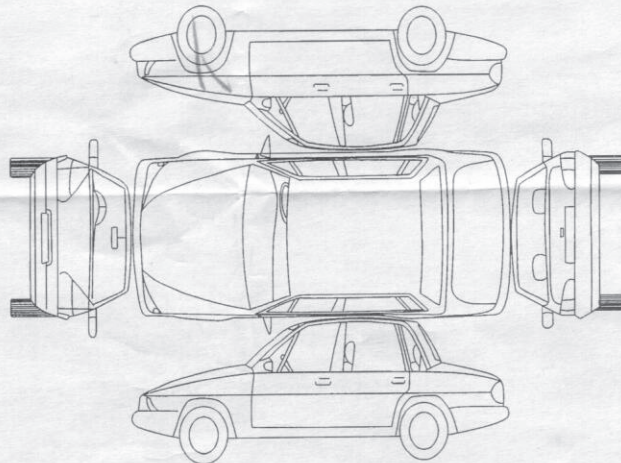
Time on Scene: 0730PMFault Reported: ACCIDENTTime Job Completed: 0730PM

Day/NightWet/DryClean/Soiled*Please circle the above as appropriate***Place X on damaged area for scratch and Y for dent**
