From: Bryan Ang (LKKAuto)
Sent: Friday, 8 January 2021 6:03 PM
To: Jasmine Lok Kheng Kwei; assignments
Cc: SUR; Rajah Kumar
Subject: RE: SHA 7209 U / DOA: 25/03/2020 / LOD 001. RE: SHA 7209 U , DOA: 25/03/2020 MSIG - LOD 003. Ref: 622444

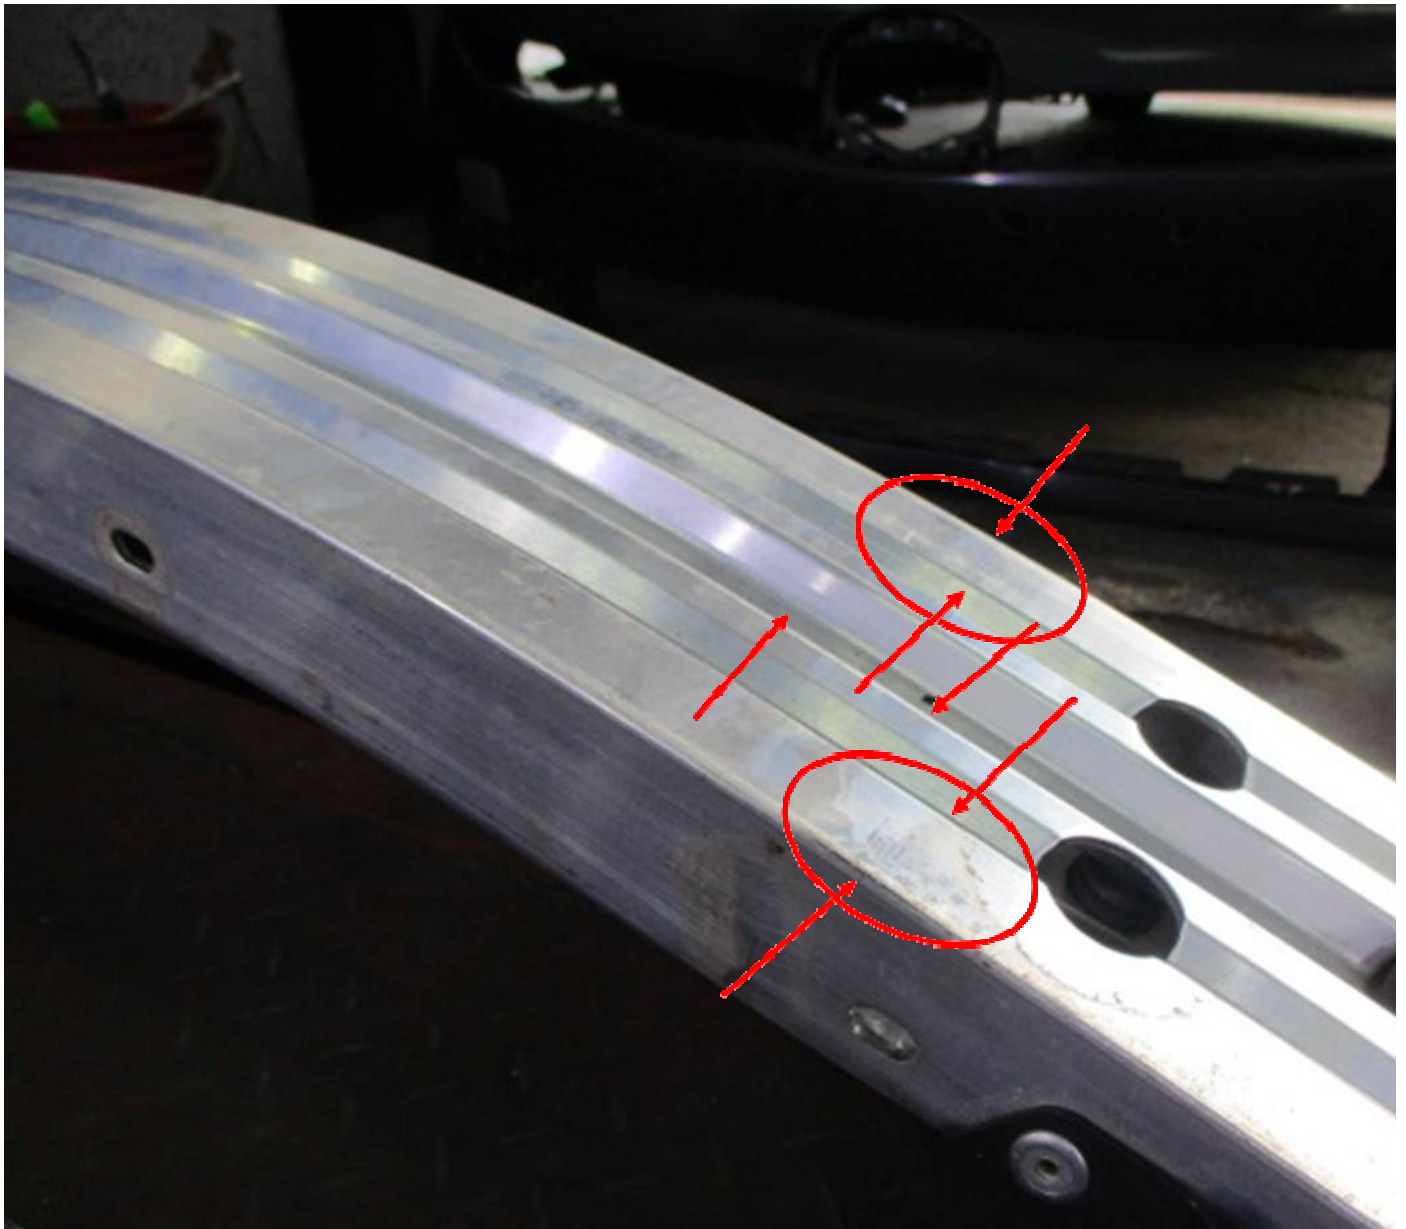
Damage to front bumper reinforcement is marked out in below photo. The circled areas are slightly dented. Because the part is chrome, the dent is difficult to see from photos. However, I have marked out the protruded edges with arrows. If you look at the arrowed location, you will see that the edges are not in a "straight line". Basing on the scene photos, the impact onto the taxi was from a left to right angled towards front direction at the front left of the taxi, which may be possible for the front bumper reinforcement to be shifted slightly towards the right. The dent could have been formed when the front bumper had shifted whilst simultaneously being anchored in place by its holding bracket.

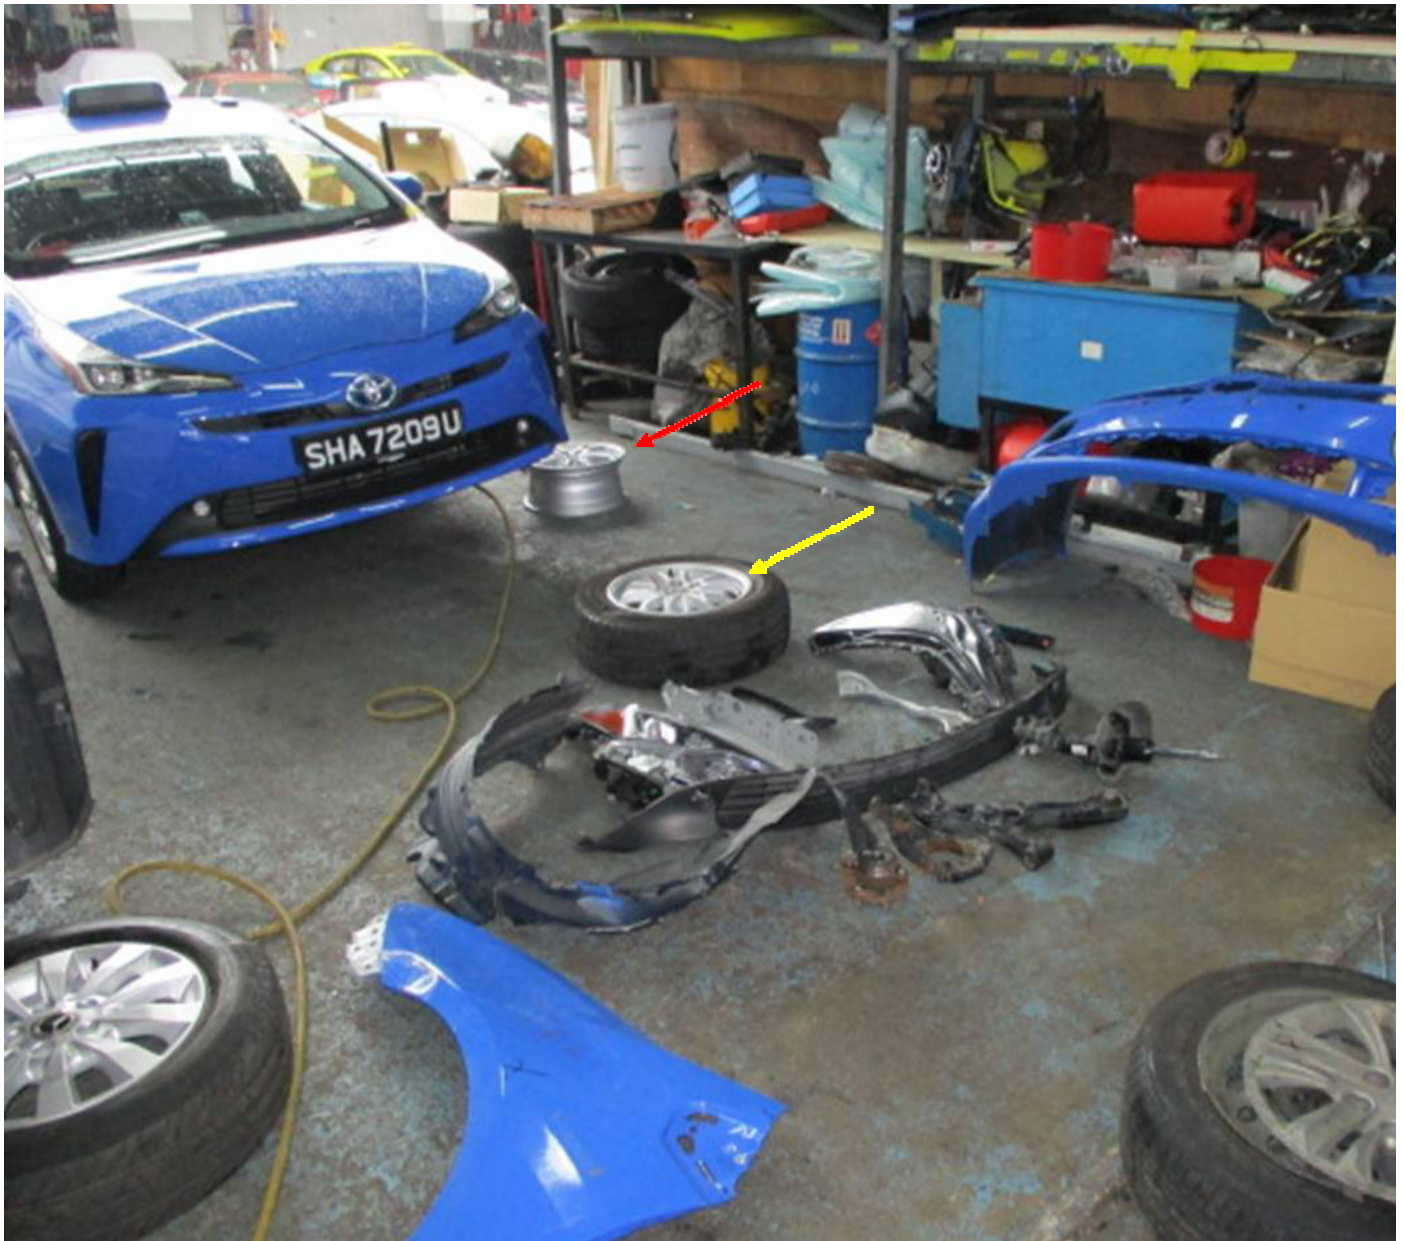
With regards to the front left wheel rim, at the time of after repair inspection, a new front left wheel rim was presented for photo taking. See photo below (more photos in Merimen), red arrow for new rim and yellow arrow for damaged rim. Part was drawn from store but taxi was not sent to external tyre shop for swapping of tyre from damaged rim to new rim when after repair inspection was called by repairer.
