**INSPECTION REPORT OF BICYCLE (GREY) - TRAFFIC POLICE POUND
REPORT NO. 4686/19**

1. We refer to your request dated 3 March 2020 to conduct a physical inspection of a Bicycle bearing Traffic Police Pound Report no. 4686/19 (herein referred to as "**Bicycle**"), which was involved in a fatal road traffic accident on 10 November 2019.
2. The purpose of this inspection is to primarily determine if there was any possible mechanical failure to the Bicycle that may have contributed to the accident.
3. Following the request, we had carried out a physical inspection of the Bicycle on 31 March 2020 at the premises of Traffic Police vehicle pound, 517 Airport Road Singapore 539942. We now set out below our observations and comments with respect to this inspection.

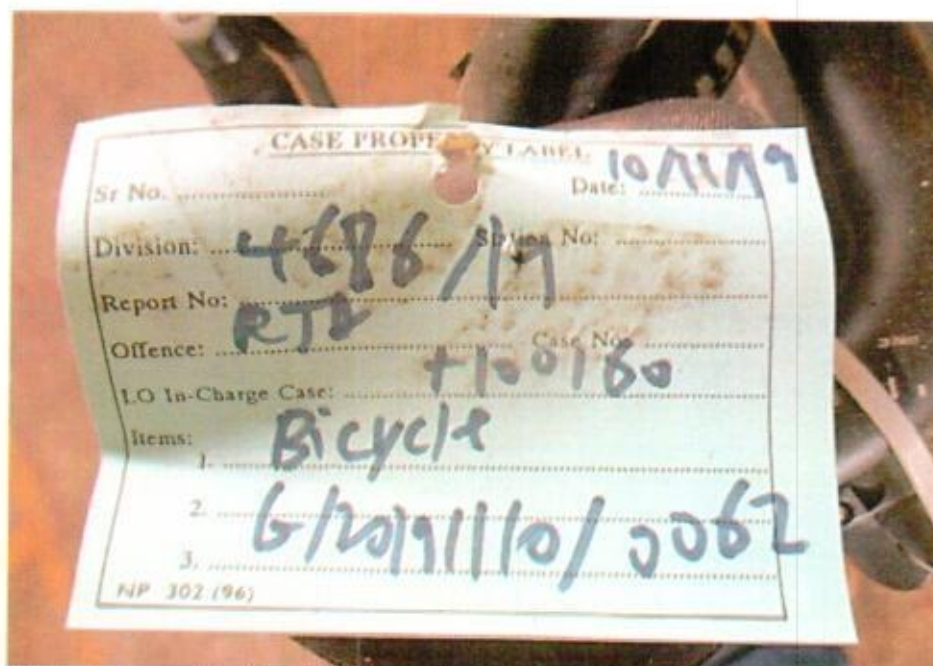
Photo 1 shows the identification of the Bicycle with reference to Traffic Police Pound Report No. 4686/19.

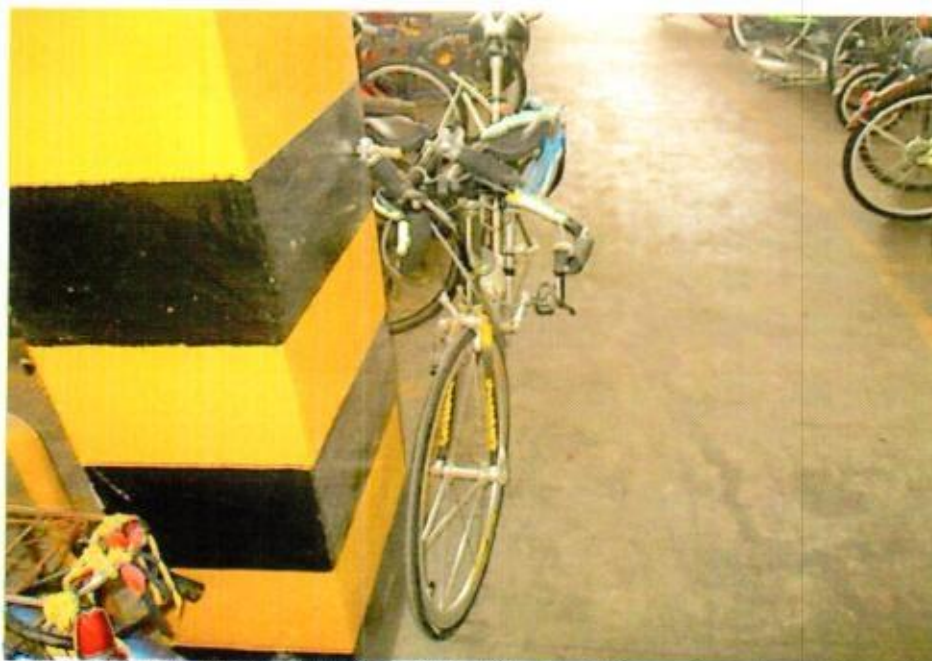
Photo 2 shows the front portion of the Bicycle at time of our inspection. The bicycle had sustained damages all around.

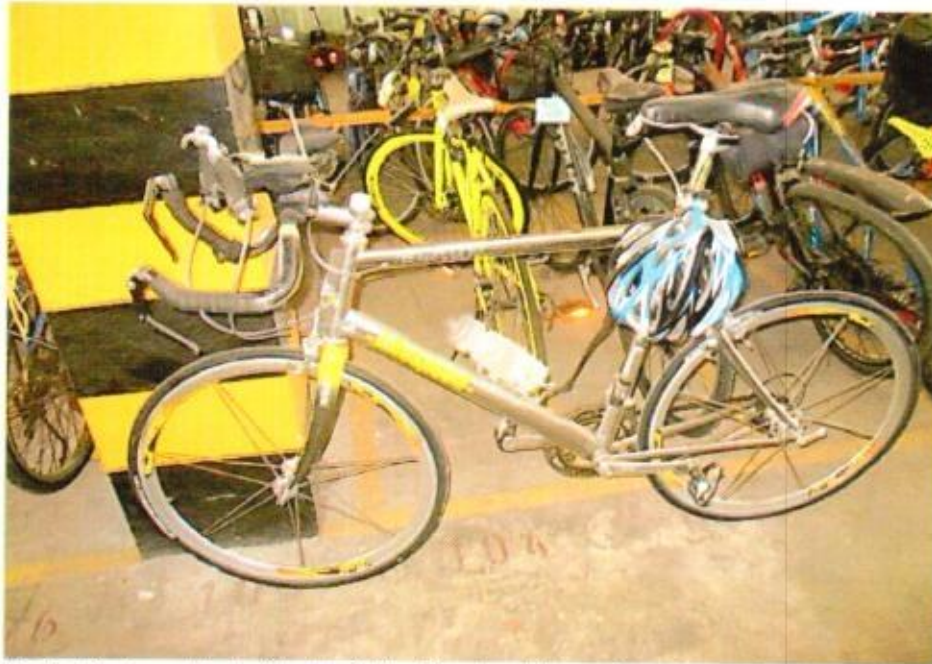
Photo 3 shows the left body of the Bicycle at time of our inspection. The bicycle had sustained damages all around.

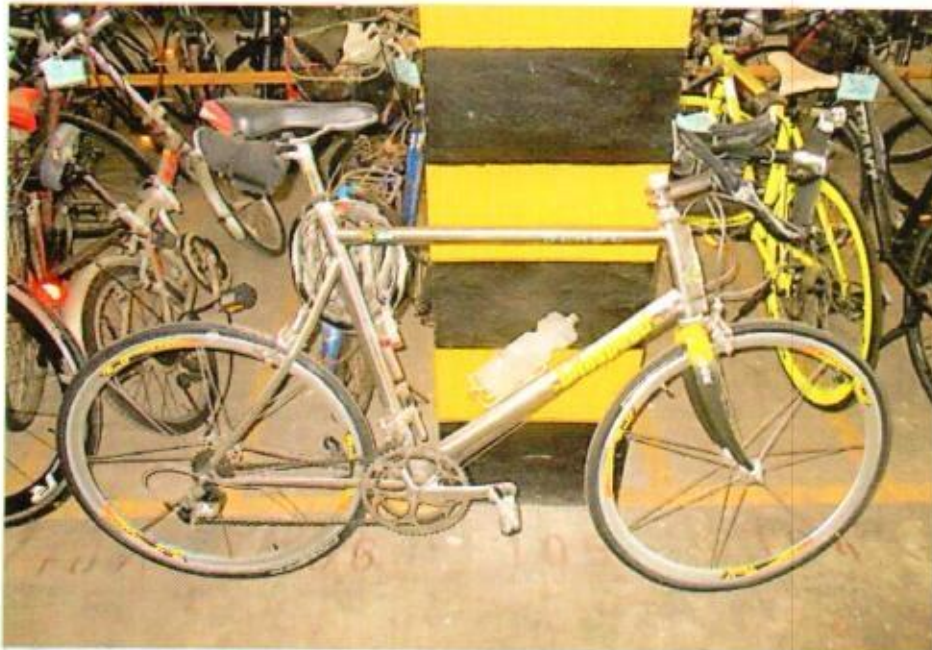
4. The Bicycle was observed to have sustained damages all around. The body parts that were found to have been damaged include its brake levers, handlebars, left pedal and seat, amongst others as a result of the accident. See photos 1 – 10 below.

Photo 4 shows the right body of the Bicycle at time of our inspection. The bicycle had sustained damages all around. The body parts that were found to have been damaged include its brake levers, handlebars, left pedal and seat, amongst others as a result of the accident.

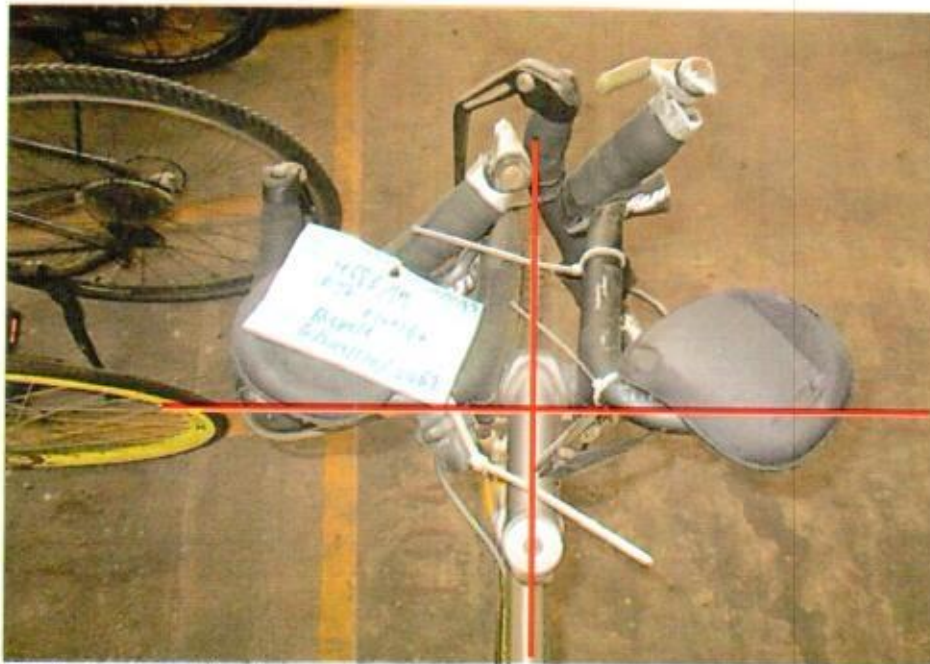
Photo 5 shows the frontal portion of the Bicycle (top view) at the time of our inspection. There was a misalignment of the handle bar & front tyre observed as a result of the accident.

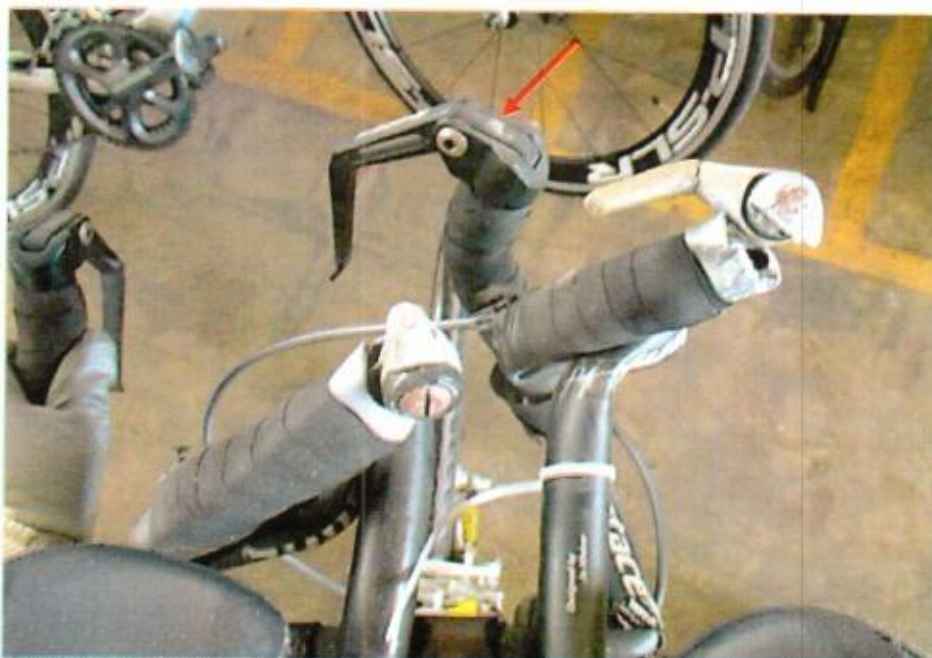
Photo 6 shows the damaged rear brake lever (arrowed) of the Bicycle at the time of our inspection.

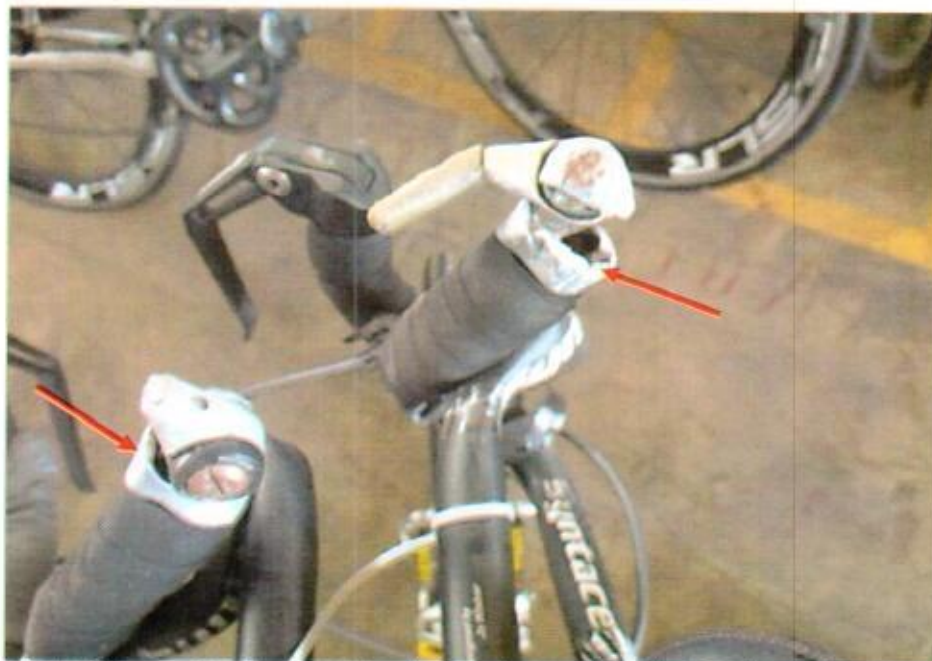
Photo 7 shows the damaged handlebars (arrowed) of the Bicycle at the time of our inspection.

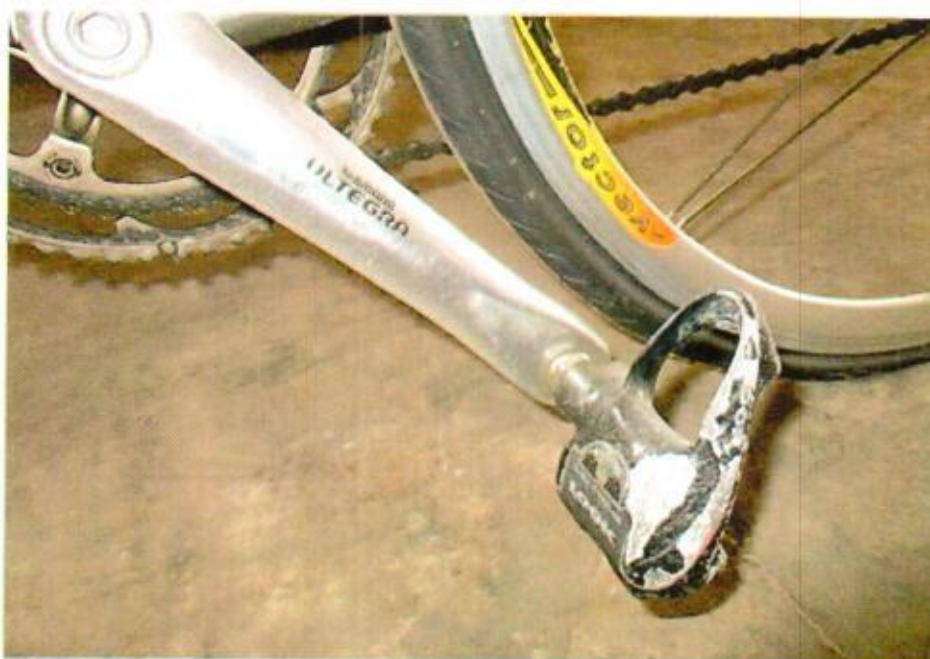
Photo 8 shows the damaged left pedal of the Bicycle at the time of our inspection.

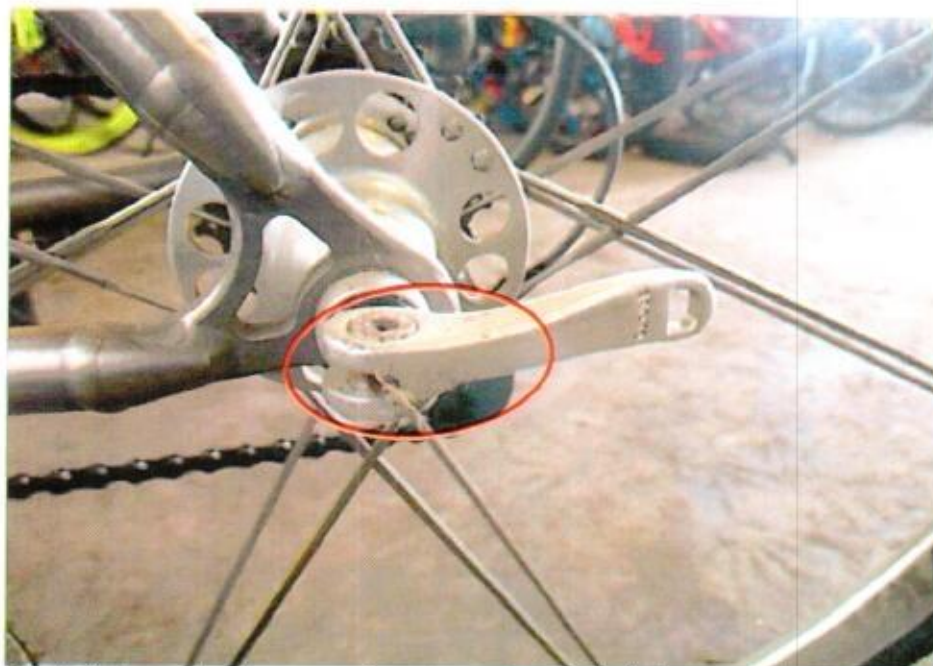
Photo 9 shows the damages of grazing nature on the left rear axle lever (circled) of the Bicycle at the time of our inspection.

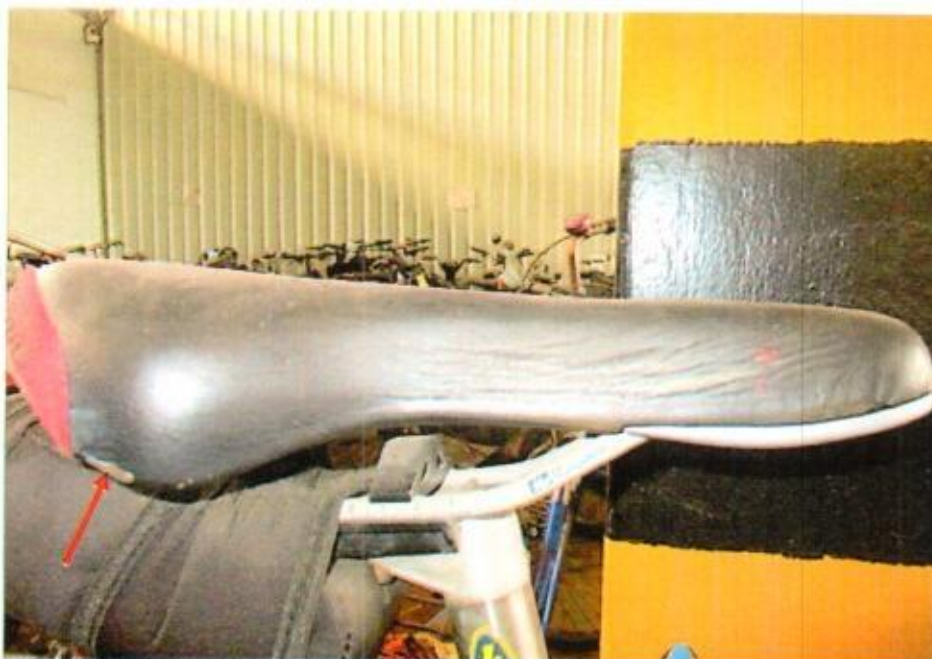
Photo 10 shows a close-up view of the damaged seat (arrowed) of the Bicycle as a result of the accident.

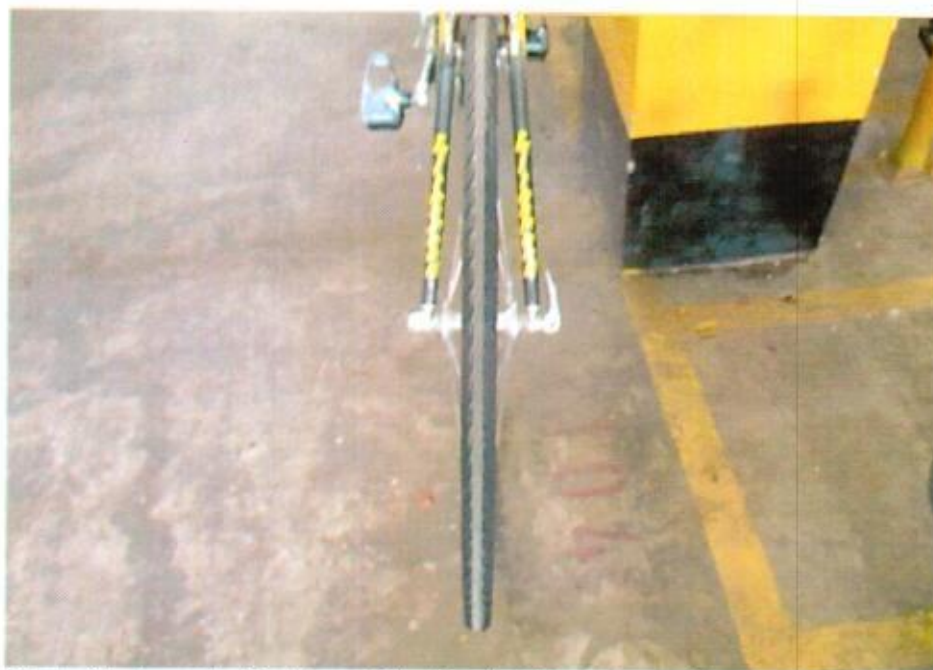
6. Both tyres were wrapped around alloy spoke wheel rims. At the time of our inspection, we did not observe any visible damage on the front and rear wheel rim of the Bicycle. See photos 11 & 12 below.

Photo 11 shows the front tyre of the Bicycle. The pattern of the tread was clearly visible. There was no tear, burst mark(s) and/or punctured hole(s) on the sidewalls as well as across the tread of the front tyre.

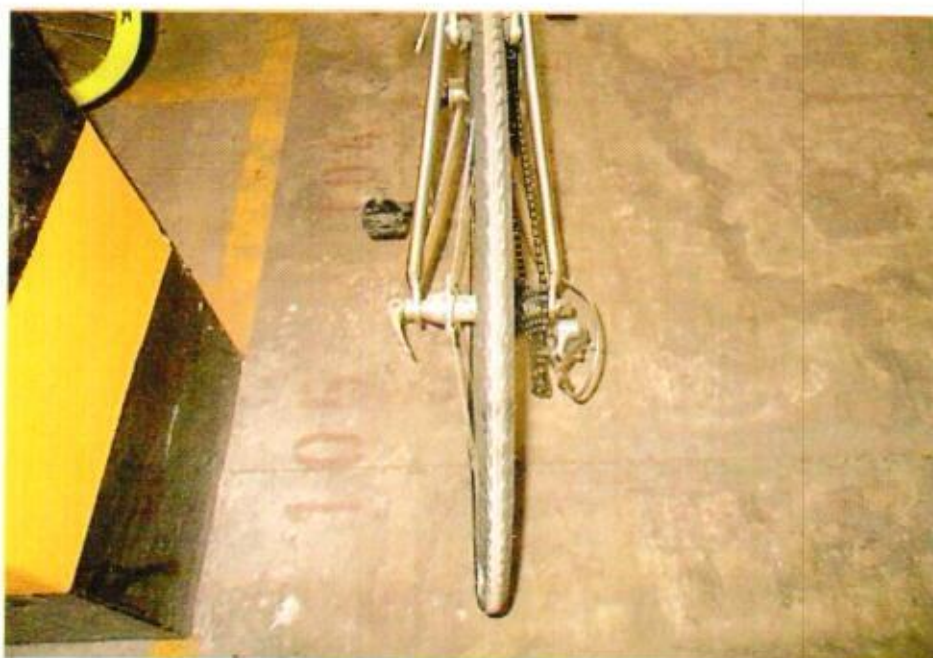
5. The condition of the Bicycle's front & rear tyres was observed to be in serviceable condition. The tread pattern of the 2 tyres was clearly visible. We did not observe any tear, burst mark(s) and/or punctured hole(s) on the sidewalls as well as across the tread of the 2 tyres. The rear tyre was observed to be deflated at the time of our inspection. The tyre brand, tyre size and remaining tread depth of the 2 tyres were recorded as follows:-

Photo 12 shows the rear tyre of the Motorcycle. The pattern of the tread was clearly visible. There was no tear, burst mark(s) and/or punctured hole(s) on the sidewalls as well as across the tread of the front tyre. However the rear tyre was observed to be deflated.

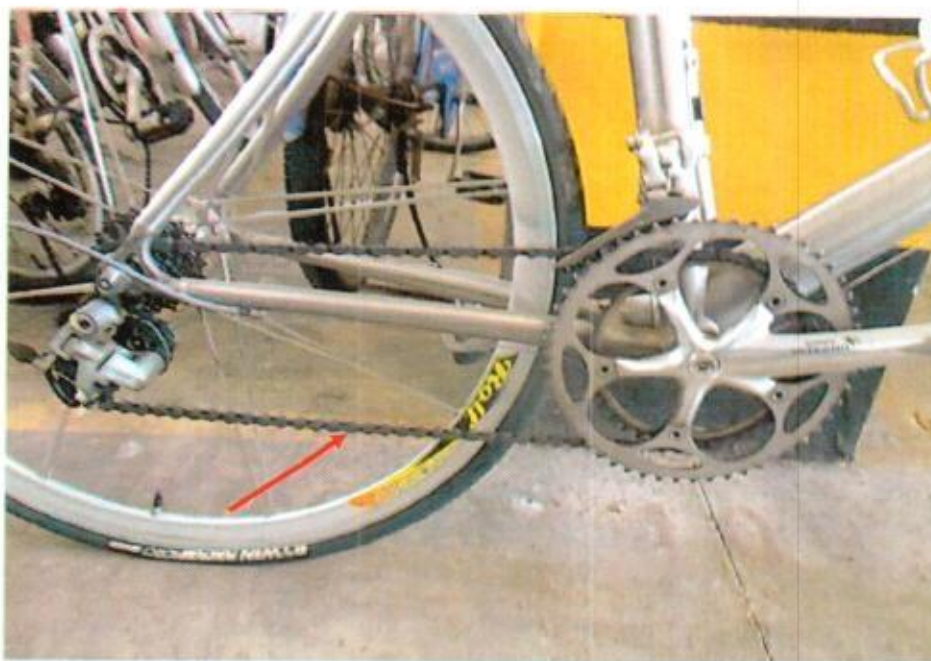
Photo 13 shows the general view of the gear train of the Bicycle, which was observed to be intact with no misalignment. It was also adequately lubricated for operating purposes (arrowed).

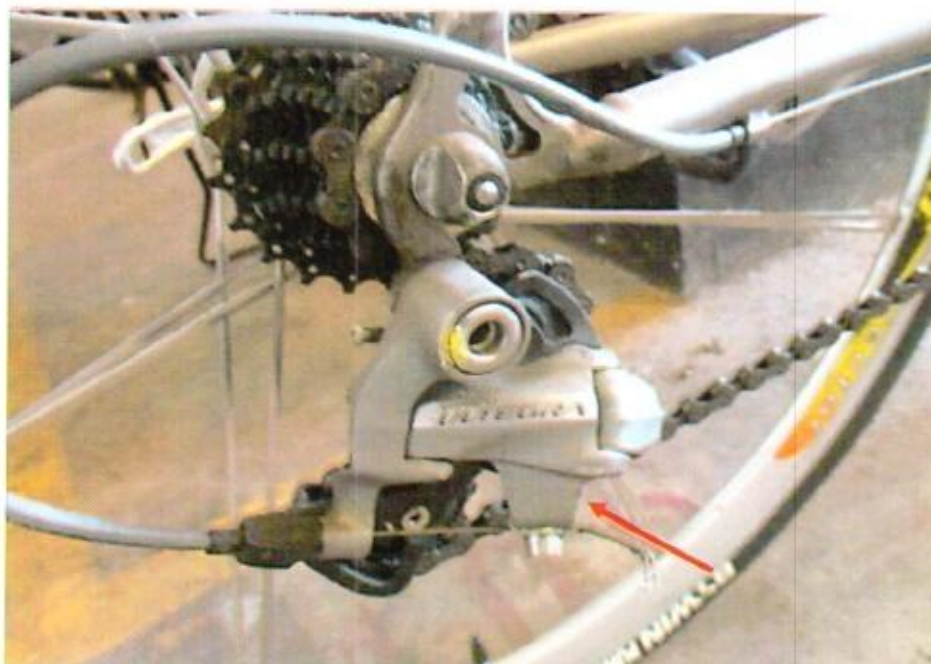
Photo 14 shows a closer view of the gear train (arrowed) of the Bicycle, which was observed to be intact with no misalignment. It was also adequately lubricated for operating purposes.

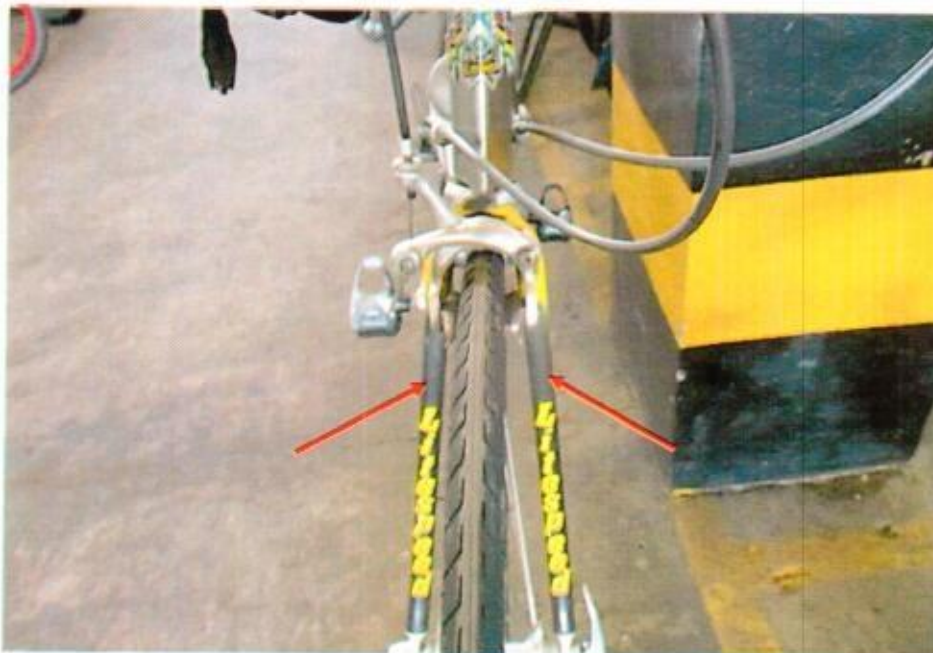
Photo 15 shows the front fork (arrowed) of the Bicycle. The front fork and fork bracket of the Bicycle were both found to be intact and undamaged. Turning the Bicycle's handle bar towards the left and right did not produce any abnormal free play. The steering system of the Bicycle was in serviceable condition at the time of our inspection.

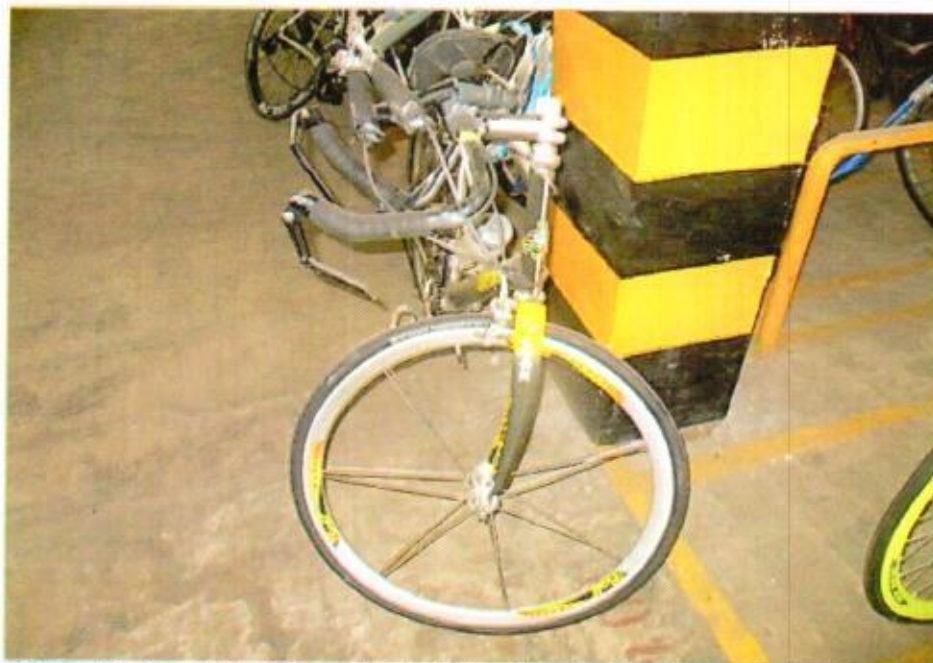
Photo 16 shows the front wheel of the Bicycle turned towards its full right. Turning the Bicycle's handle bar towards the right did not produce any abnormal free play and/or resistance. This would indicate that the steering system of the Bicycle was in serviceable condition at the time of our inspection.

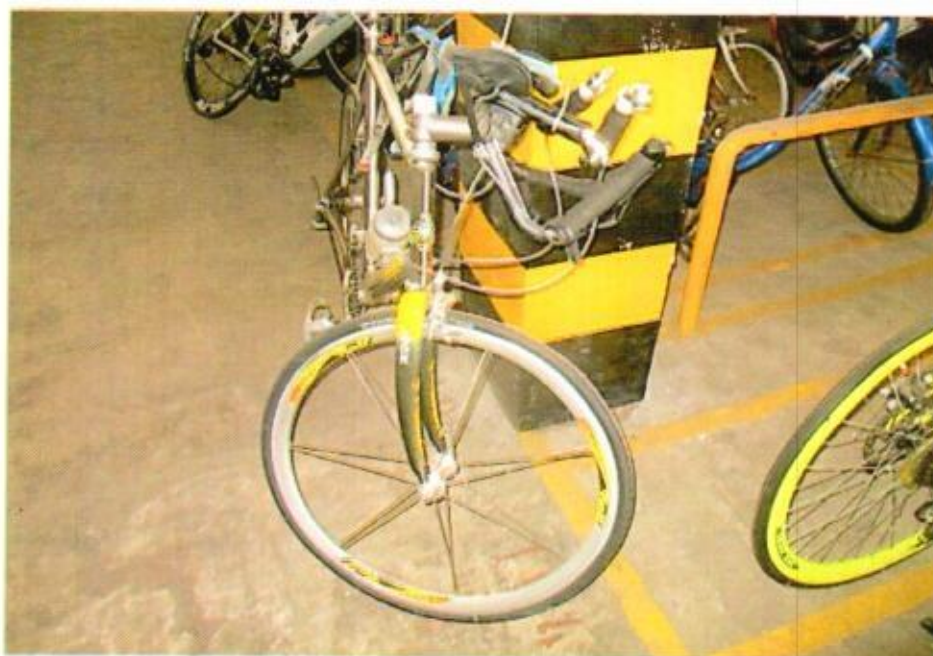
Photo 17 shows the front wheel of the Bicycle turned towards its full left. Turning the Bicycle's handle bar towards the left did not produce any abnormal free play and/or resistance. This would indicate that the steering system of the Bicycle was in serviceable condition at the time of our inspection.

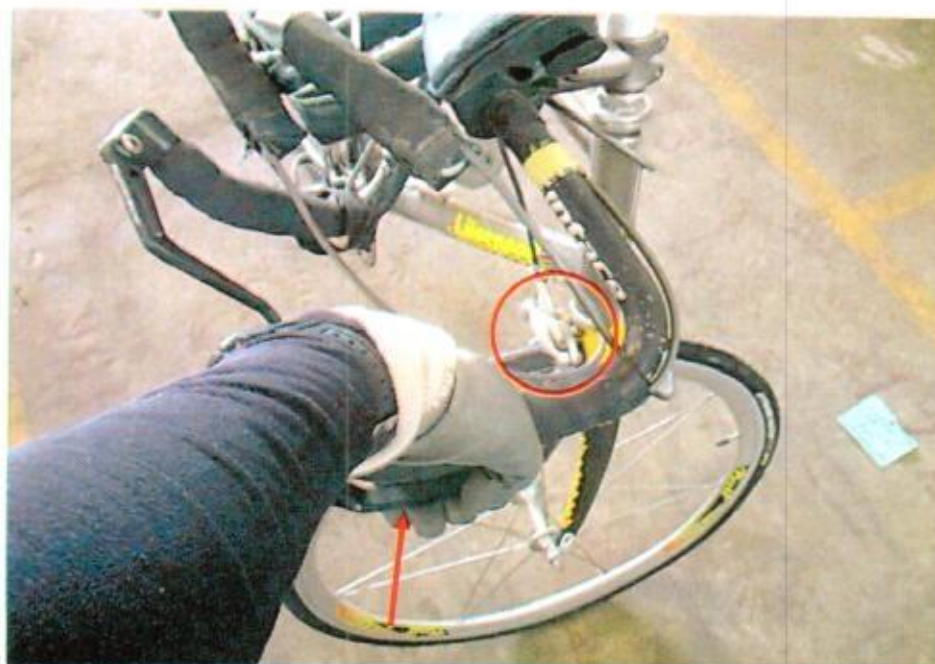
10. A static brake test was conducted on the front brake of the Bicycle. There was some resistance felt upon pressing the left hand brake lever. This was further confirmed by looking at the front brake clamps while we pressed the left hand brake lever. It shows that the front brake clamps responded to the gripping action. The rubber brake blocks pressed against the front wheel rim. This had appeared to indicate that the front brake was in serviceable condition.

Photo 18 shows a static brake test conducted on the Bicycle's front brake. There was some resistance felt upon pressing the left hand brake lever (arrowed). It also shows that the front brake clamps responded to the gripping action (circled) after depressing the left hand brake lever.

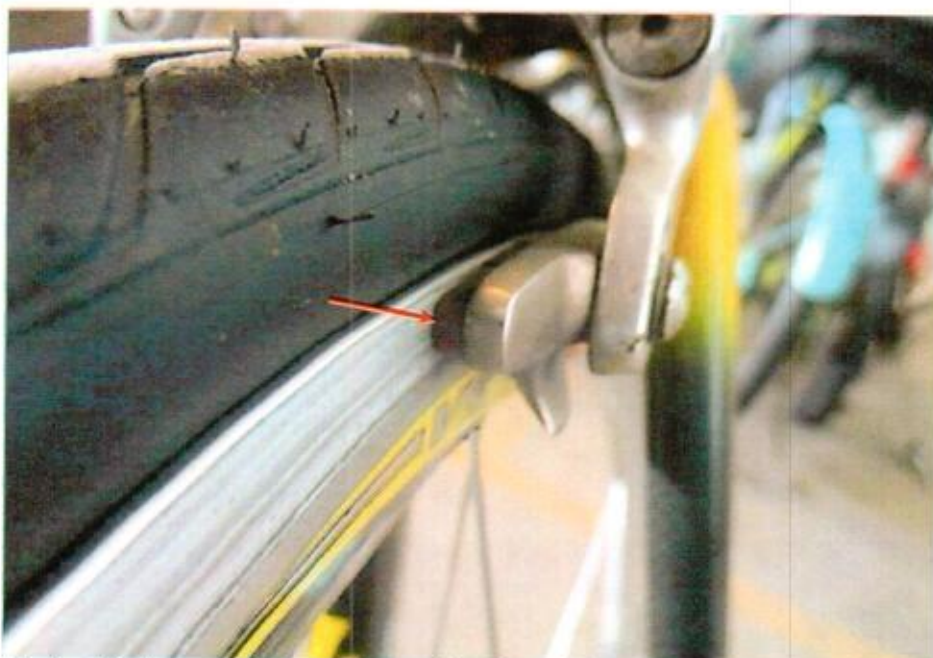
Photo 19 shows a close up view of the front brake clamps responding to the gripping action. The rubber brake blocks pressed against the front wheel rim upon depressing the left hand brake lever (arrowed). This had appeared to indicate that the front brake was in serviceable condition.

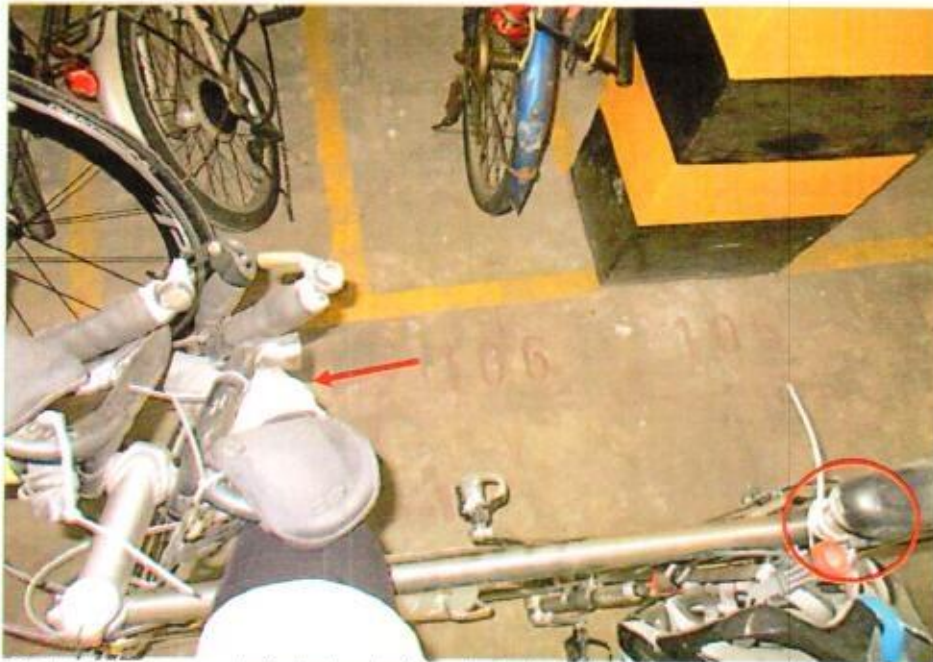
11. A static brake test was conducted on the rear brake of the Bicycle. There was some resistance felt upon pressing the right hand brake lever. This was further confirmed by looking at the rear brake clamps while we pressed the right hand brake lever. It shows that the rear brake clamps responded to the gripping action. The rubber brake blocks pressed against the rear wheel rim. This had appeared to indicate that the rear brake was in serviceable condition.

Photo 20 shows a static brake test conducted on the Bicycle's rear brake. There was some resistance felt upon pressing the right hand brake lever (arrowed). It also shows that the rear brake clamps responded to the gripping action (circled) after depressing the right hand brake lever.

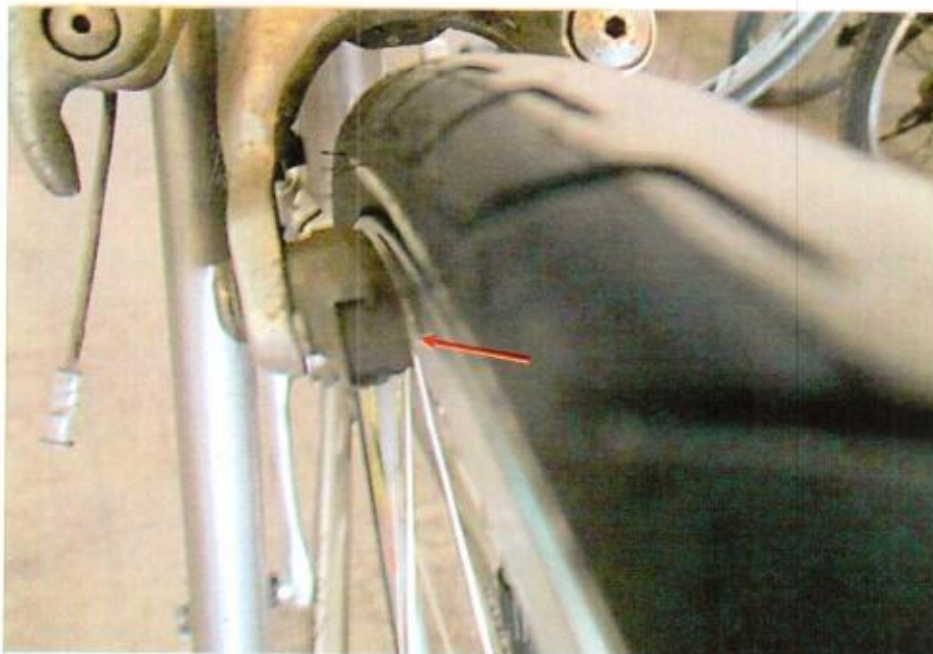
Photo 21 shows a close up view of the rear brake clamps responding to the gripping action. The rubber brake blocks pressed against the rear wheel rim upon depressing the right hand brake lever (arrowed). This had appeared to indicate that the rear brake was in serviceable condition.
