Your Ref: TP/IP/61167/2019
Our Ref : CI/TPD20004715/N

Fatal Accident Investigation Team

INSPECTION REPORT OF MOTORCYCLE FBH 9390Z

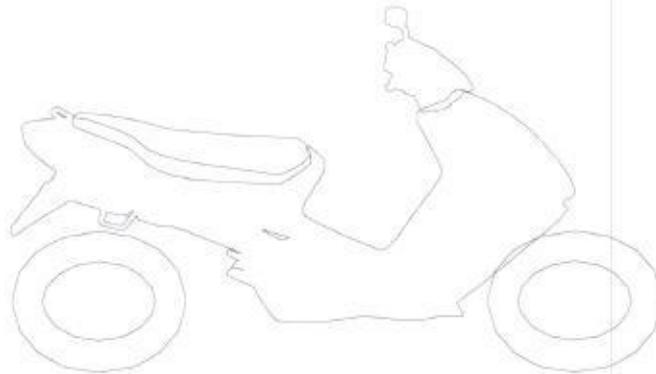
7. The tyre brand, tyre size and remaining tread depth of the 2 tyres were recorded as follows:-

Michelin 130/70 - 17 (4mm)

Michelin 100/80 - 17 (4mm)

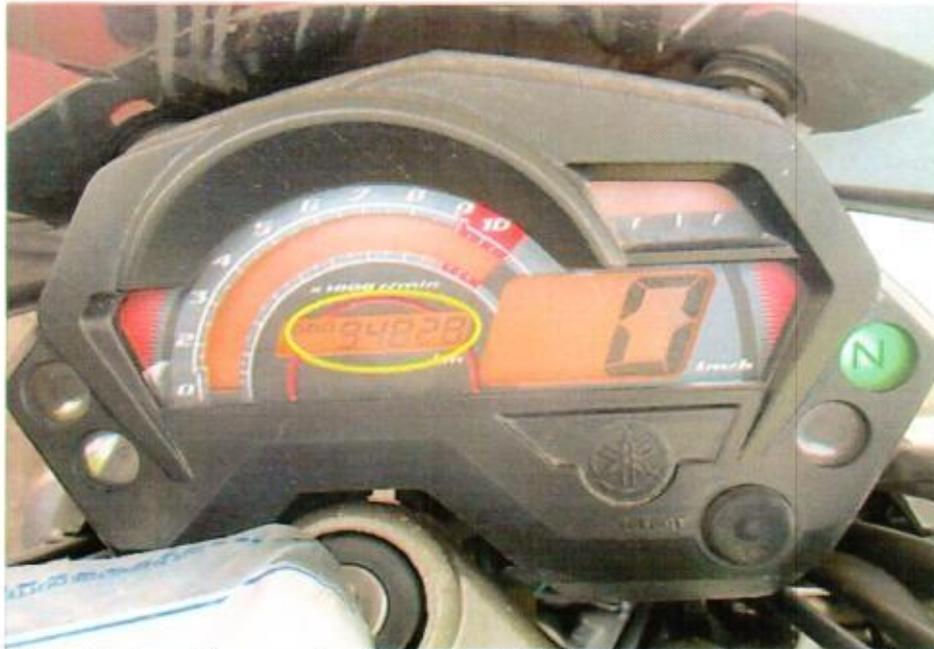
Photo 1 shows the speedometer gauge of the Motorcycle. The mileage of the Motorcycle at the time of our inspection was 94, 828km (circled).

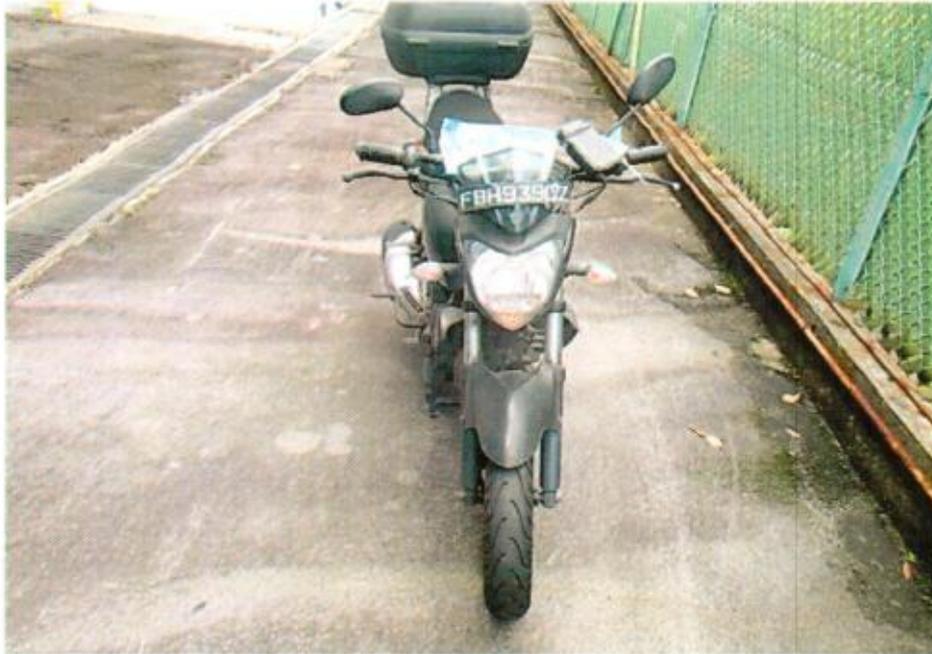
Photo 2 shows a general view of the front body of the Motorcycle at the time of our inspection. The Motorcycle was observed to have sustained damages at its frontal portion and left body.

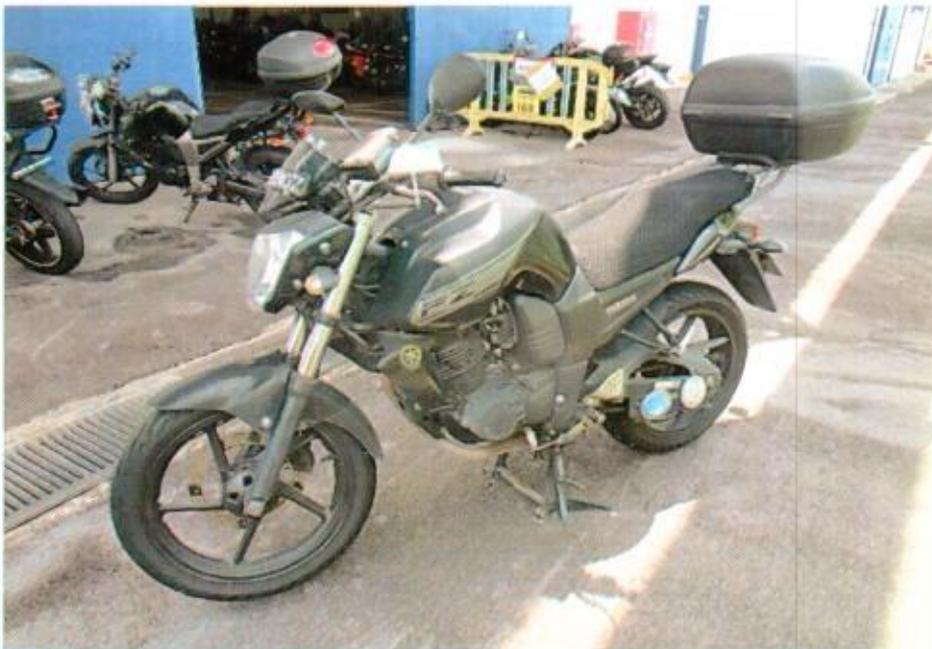
4. The mileage of the Motorcycle at the time of our inspection was 4, 295km.
5. The Motorcycle was observed to have sustained damages at the frontal portion and left body. The body parts that were found to have been damaged include its windshield, front number plate, headlight assembly, left front signal lamp, front mudguard, left side mirror, gear shift pedal, left front footrest, left pillion foot peg, left rear side cover and top box amongst others.

Photo 3 shows a general view of the left body of the Motorcycle at the time of our inspection. The Motorcycle was observed to have sustained damages at its frontal portion and left body. Amongst the body parts that were found to have been damaged include its windshield, front number plate, headlight assembly, left front signal lamp, front mudguard, left side mirror, gear shift pedal, left front footrest, left pillion foot peg, left rear side cover and top box amongst others.

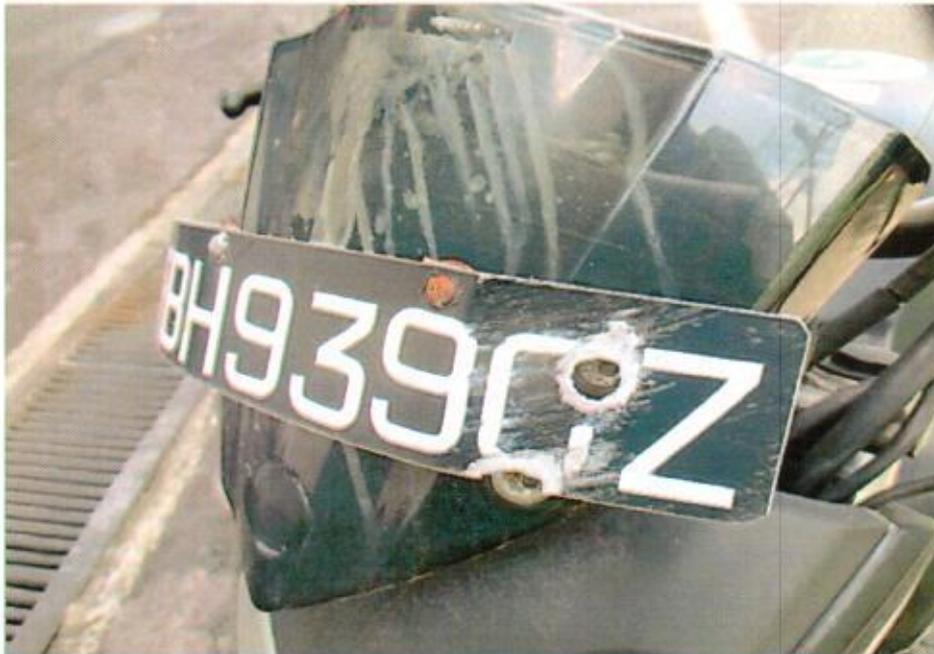
Photo 4 shows a close up view of the front number plate and windshield which were amongst the body parts at the front of the Motorcycle that had sustained damage as a result of the accident.

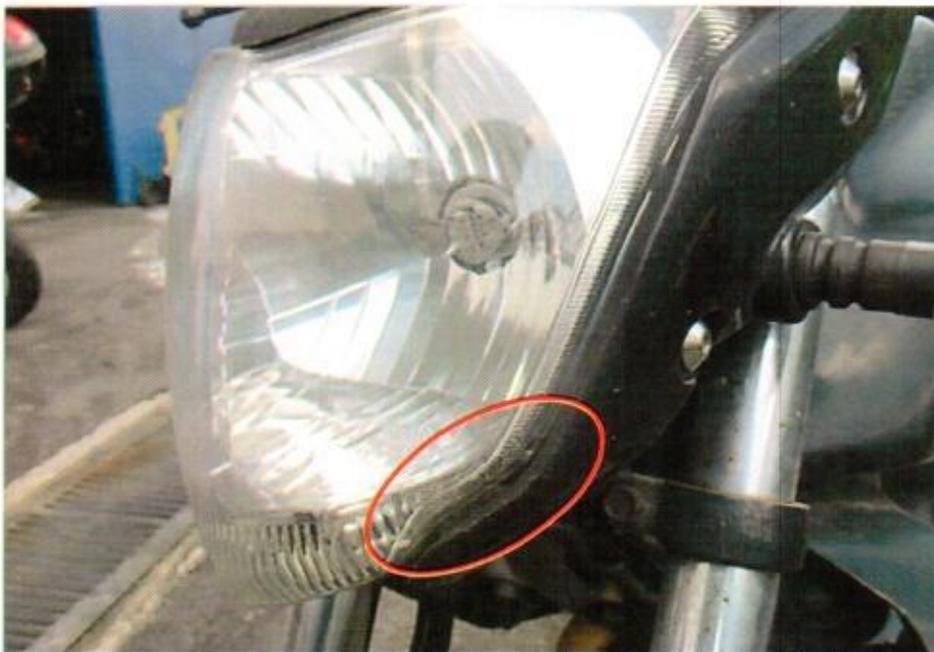
Photo 5 shows a closer view of the headlight assembly (circled) which was amongst the body parts of the Motorcycle that had sustained damage as a result of the accident.

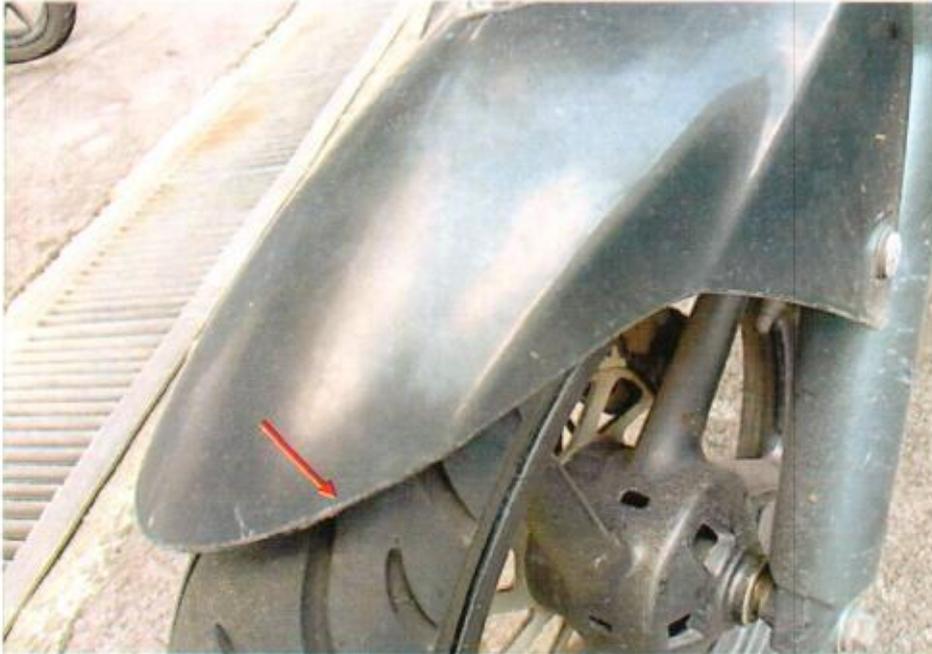
Photo 6 shows a closer view of the front mudguard (arrowed) which was amongst the body parts of the Motorcycle that had sustained damage as a result of the accident.

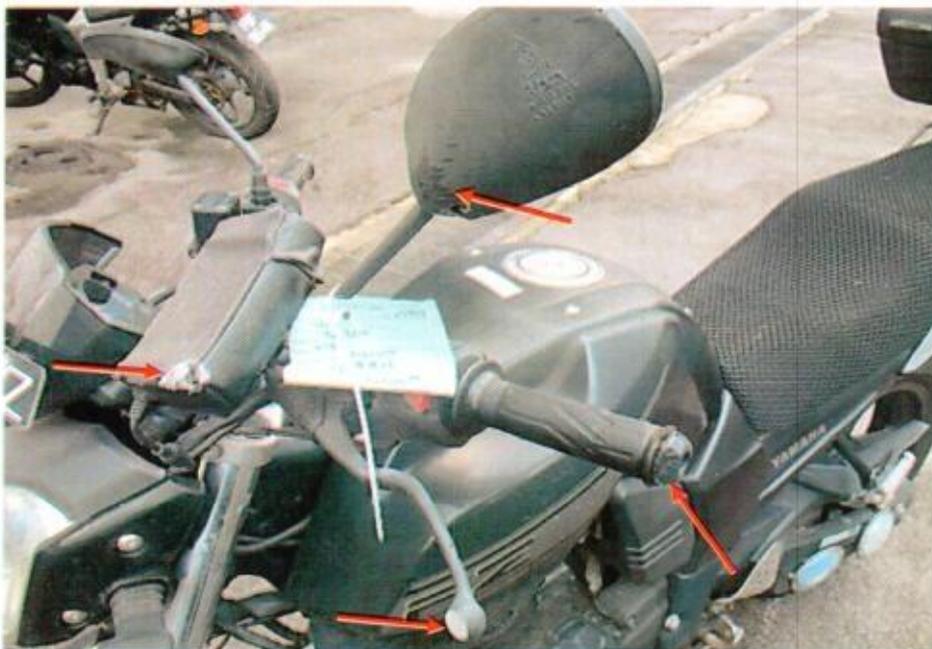
Photo 7 shows the left handlebar end, left side mirror, clutch lever and IU unit cover (arrowed), which were amongst the body parts of the Motorcycle that had sustained damage as a result of the accident.

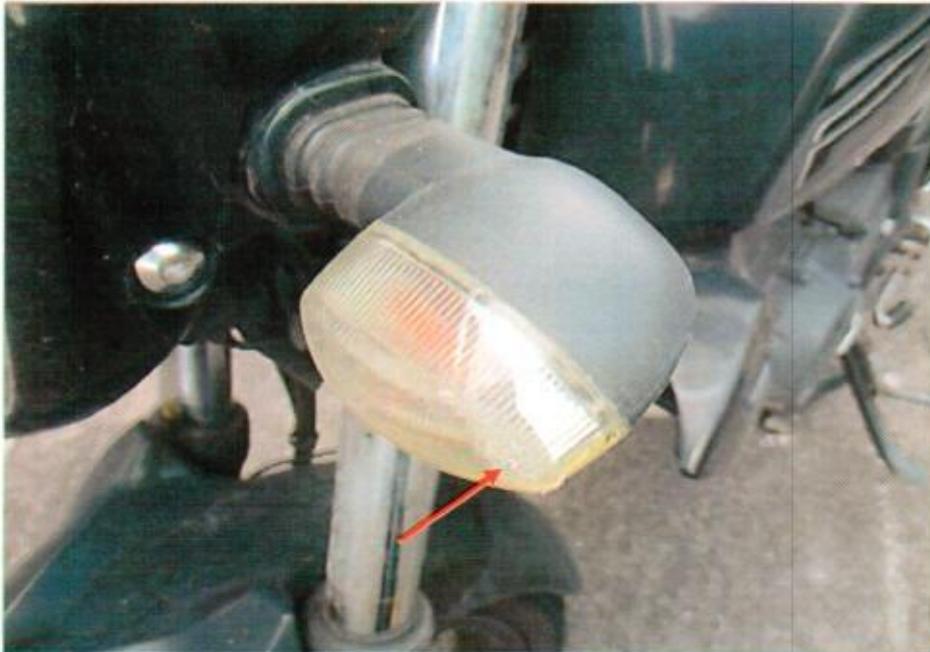
Photo 8 shows the left front signal lamp (arrowed), which was amongst the body parts of the Motorcycle that had sustained damage as a result of the accident.

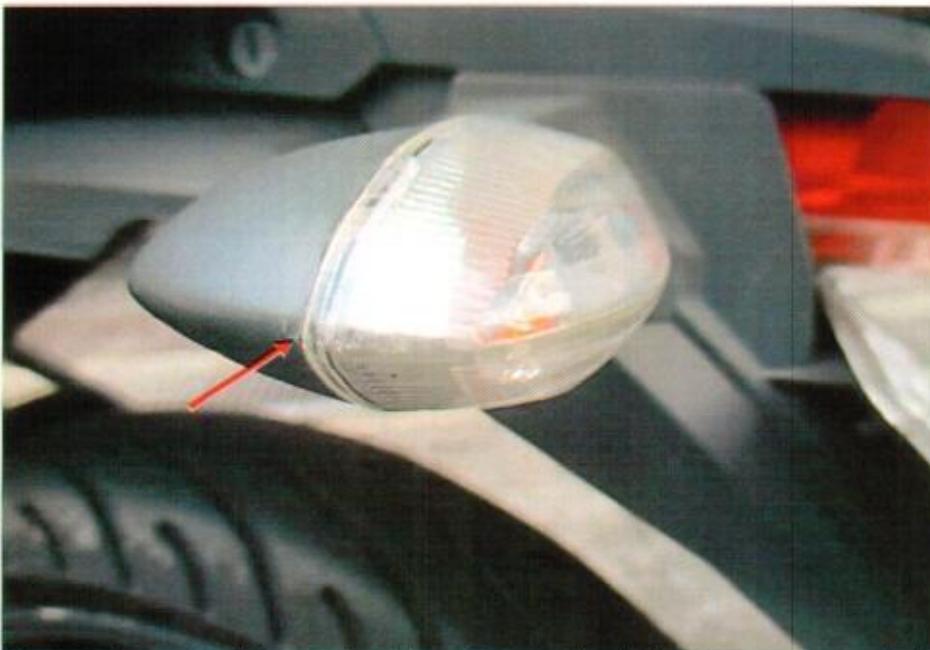
Photo 9 shows the left rear signal lamp (arrowed), which was amongst the body parts of the Motorcycle that had sustained damage as a result of the accident.

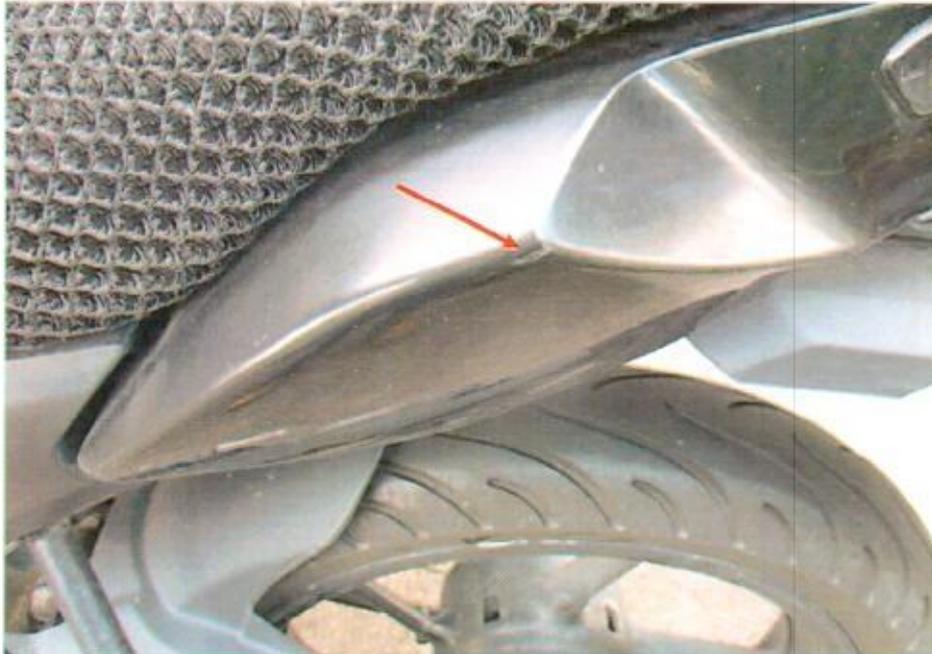
Photo 10 shows a closer view of the left rear side cover which was amongst the body parts of the Motorcycle that had sustained damages of grazing nature as a result of the accident (arrowed).

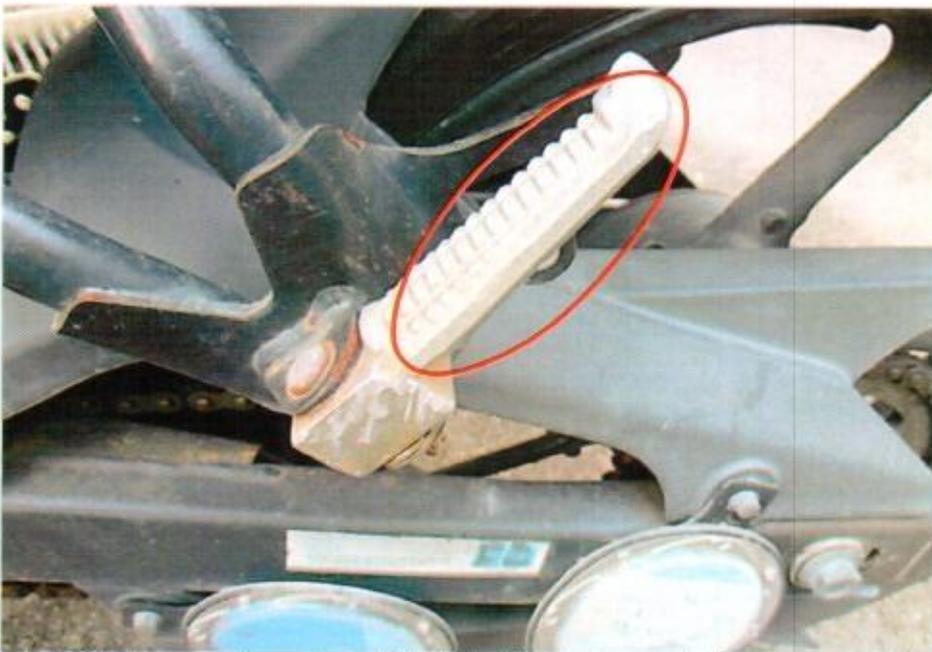
Photo 11 shows a closer view of the left pillion foot peg which was amongst the body parts of the Motorcycle that had sustained damages of grazing nature as a result of the accident (circled).

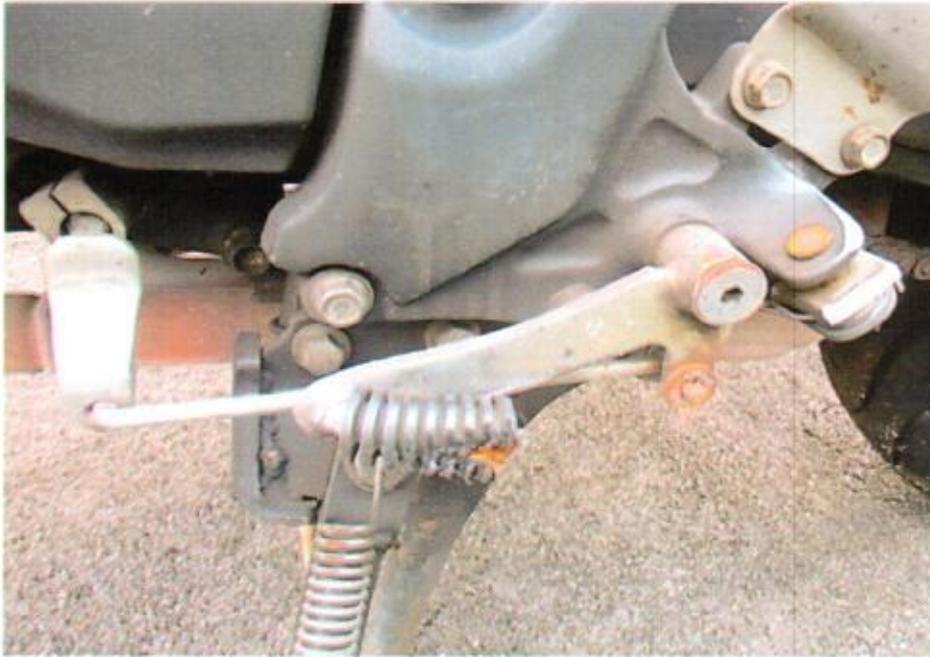
Photo 12 shows the broken gear shift pedal and left front footrest of the Motorcycle as a result of the accident.

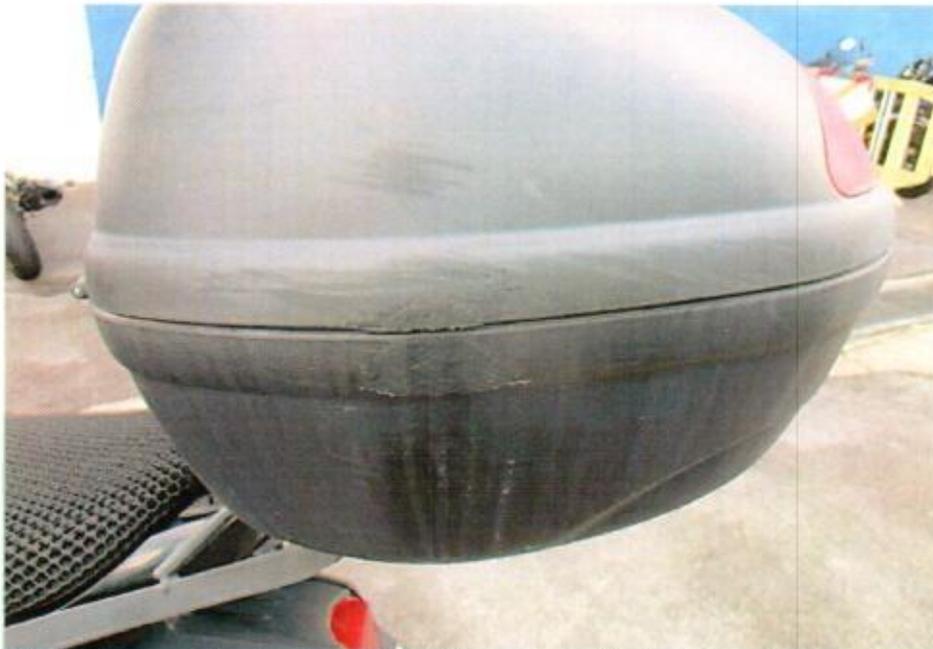
Photo 13 shows the top box of the Motorcycle that had sustained damage as a result of the accident.

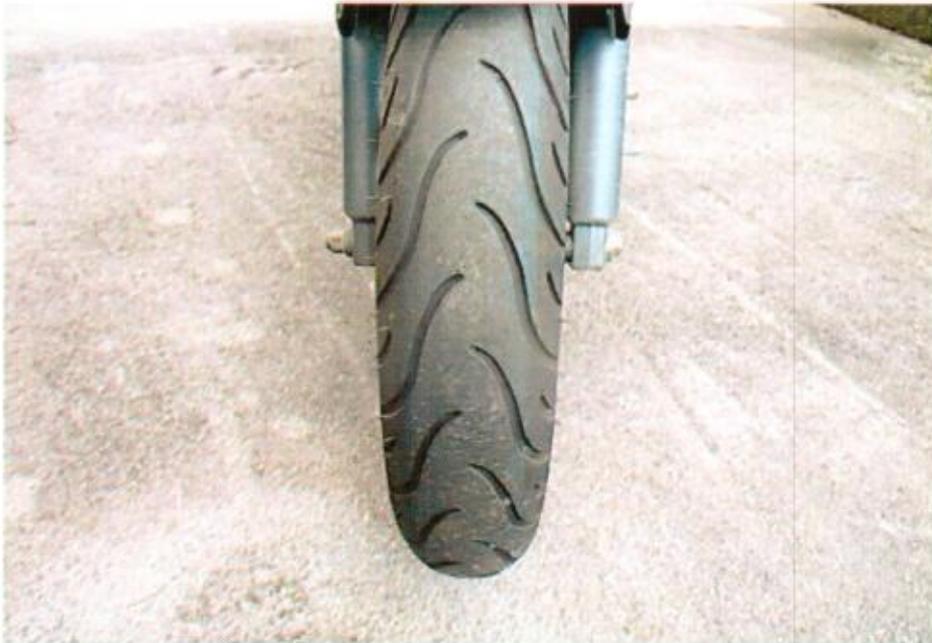
Photo 14 shows the front tyre of the Motorcycle at the time of our inspection. The front tyre was observed to be in serviceable condition with remaining tread depth of approximately 4mm. The pattern of the tread was also clearly visible. There was no tear, burst mark(s) and/or punctured hole(s) on the sidewalls as well as across the tread of the front tyre.

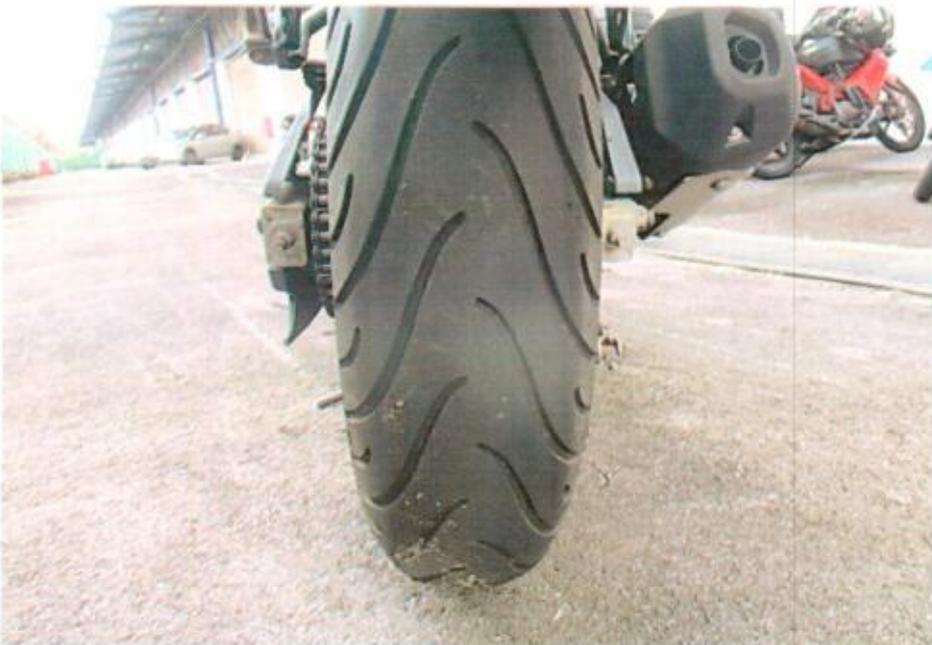
Photo 15 shows the condition of the Motorcycle's rear tyre. The rear tyre was observed to be in serviceable condition with remaining tread depth of approximately 4mm. The tyre was also observed to be sufficiently inflated for vehicular operation. We did not observe any tear, burst mark(s) and/or punctured hole(s) on the sidewalls as well as across the tread of the rear tyre.

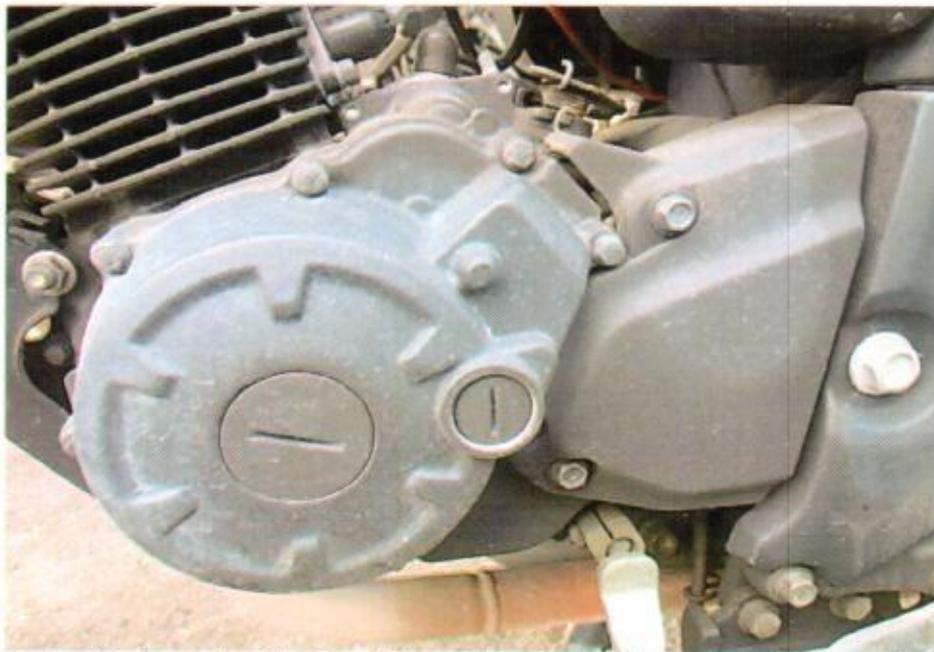
Photo 16 shows the left side of the engine of the Motorcycle at the time of our inspection. The various engine related parts and components were found to be intact with no visible damage. There was also no sign(s) or indication(s) of fluid leak observed around the left engine area of the Motorcycle.

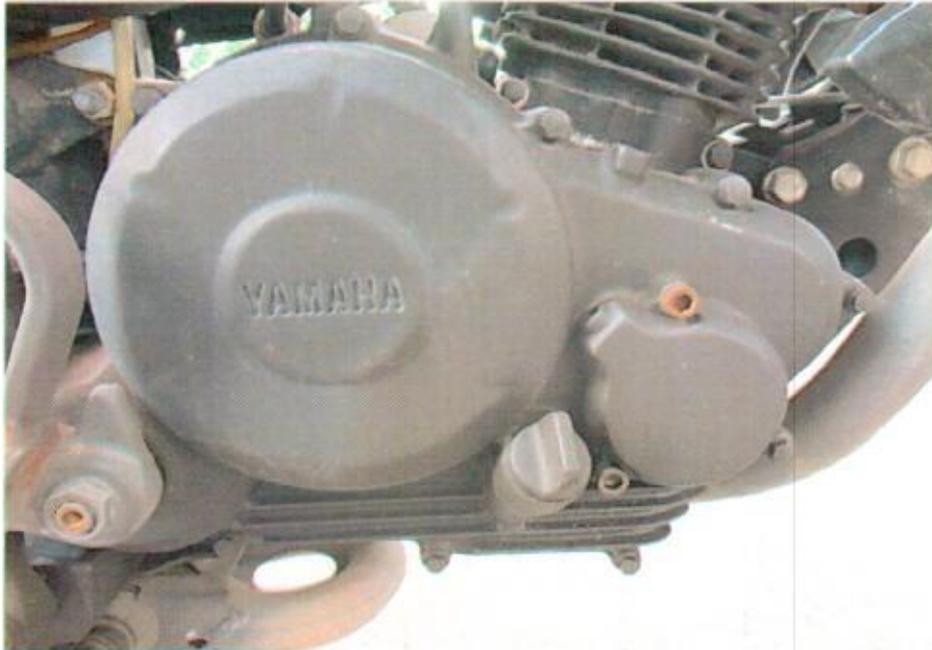
Photo 17 shows the right side of the engine of the Motorcycle at the time of our inspection. The various engine related parts and components were found to be intact with no visible damage. There was also no sign(s) or indication(s) of fluid leak observed around the right engine area of the Motorcycle.

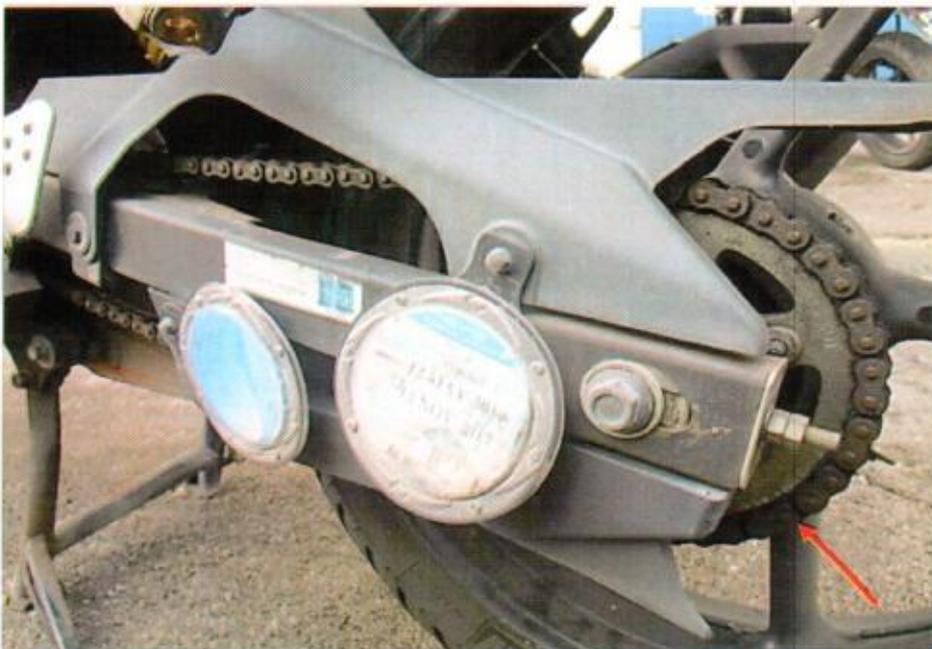
Photo 18 shows the general view of the gear train (arrowed) of the Motorcycle, which was observed to be intact with no misalignment. It was also adequately lubricated for operating purposes.

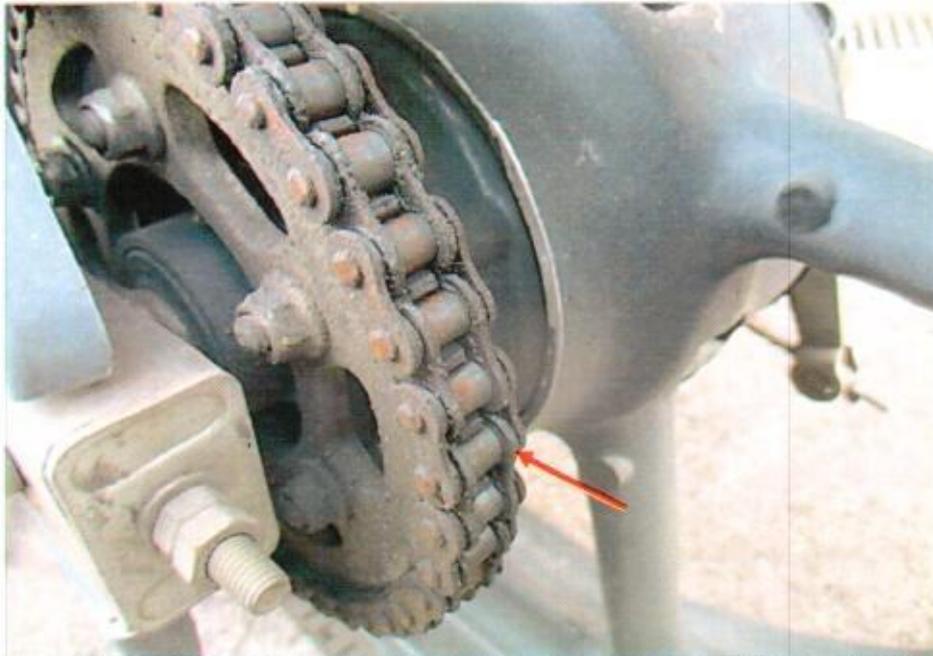
Photo 19 shows a closer view of the gear train (arrowed) of the Motorcycle, which was observed to be intact with no misalignment. It was also adequately lubricated for operating purposes.

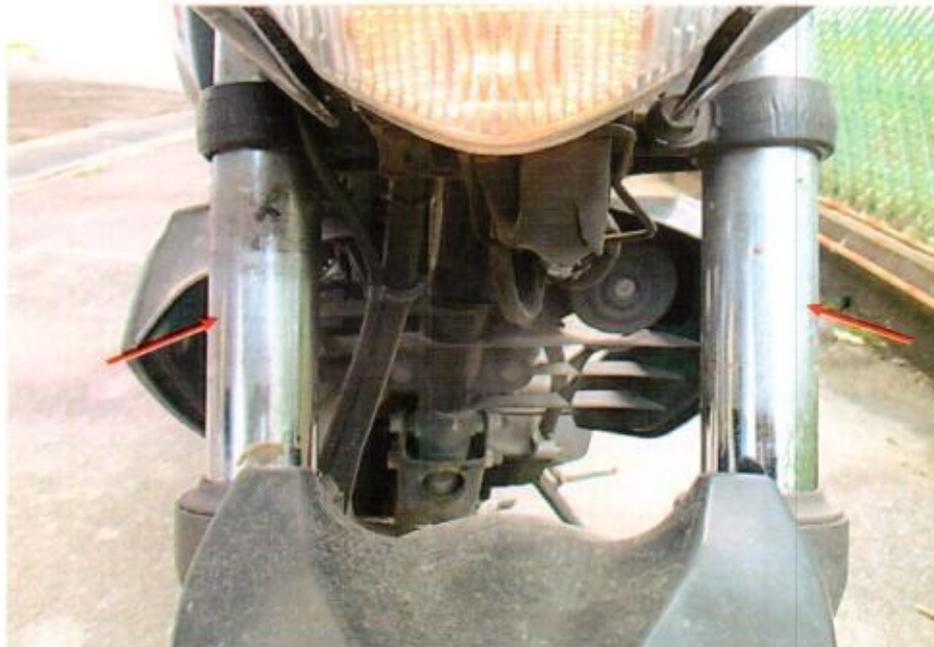
Photo 20 shows the front fork (arrowed) of the Motorcycle. The front fork and fork bracket of the Motorcycle were both found to be intact and undamaged. Turning the Motorcycle's handle bar towards the left and right did not produce any abnormal free play. The steering system of the Motorcycle was in serviceable condition at the time of our inspection.

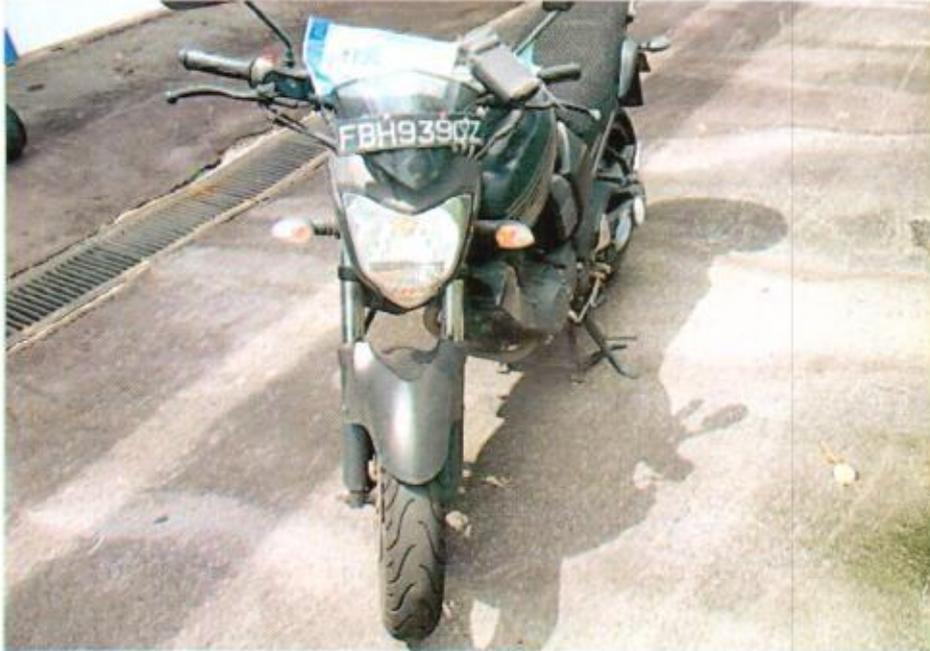
Photo 21 shows the front wheel of the Motorcycle turned towards its full left. Turning the Motorcycle's handle bar towards the left did not produce any abnormal free play and/or resistance. This would indicate that the steering system of the Motorcycle was in serviceable condition at the time of our inspection.

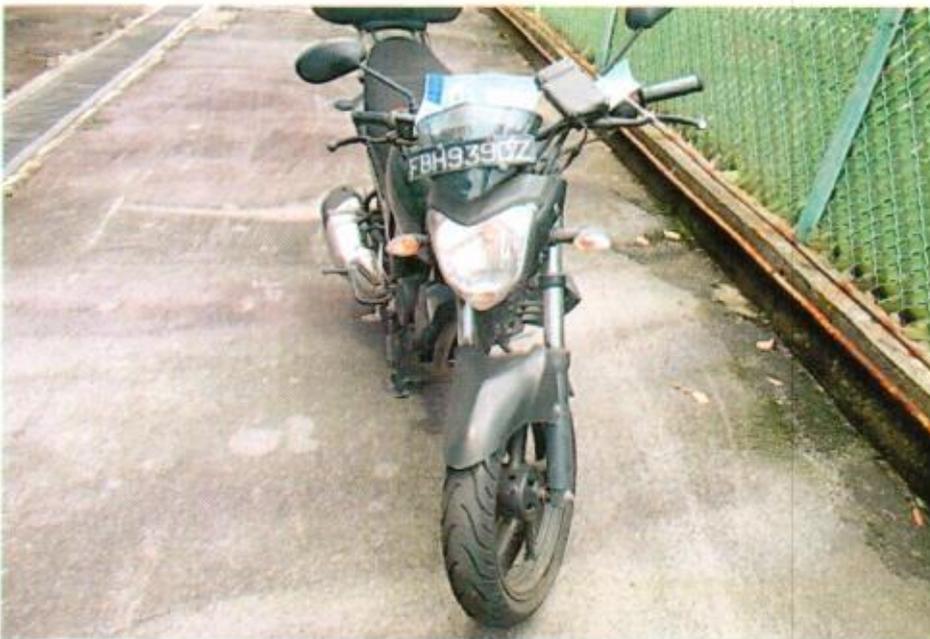
Photo 22 shows the front wheel of the Motorcycle turned towards its full right. Turning the Motorcycle's handle bar towards the right did not produce any abnormal free play and/or resistance. This would indicate that the steering system of the Motorcycle was in serviceable condition at the time of our inspection.

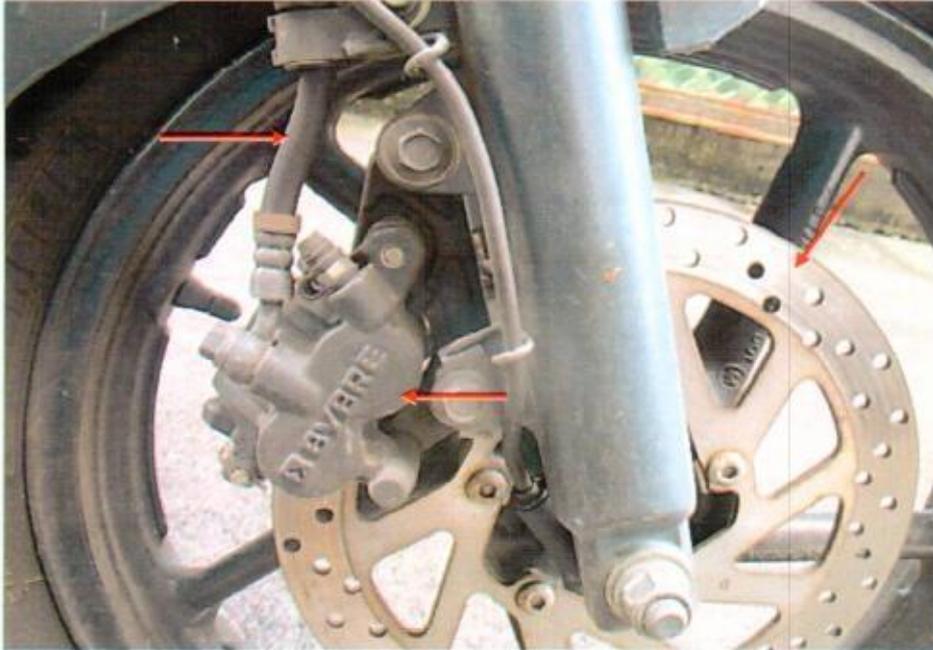
Photo 23 shows a close up view of the front brake caliper, front brake disc and front brake hose (arrowed) of the Motorcycle, which are all part of the components in the hydraulic front brake system of the Motorcycle. Our visual checks of these various components had revealed all to be intact with no visible damage. No leakage of brake fluid was also observed.

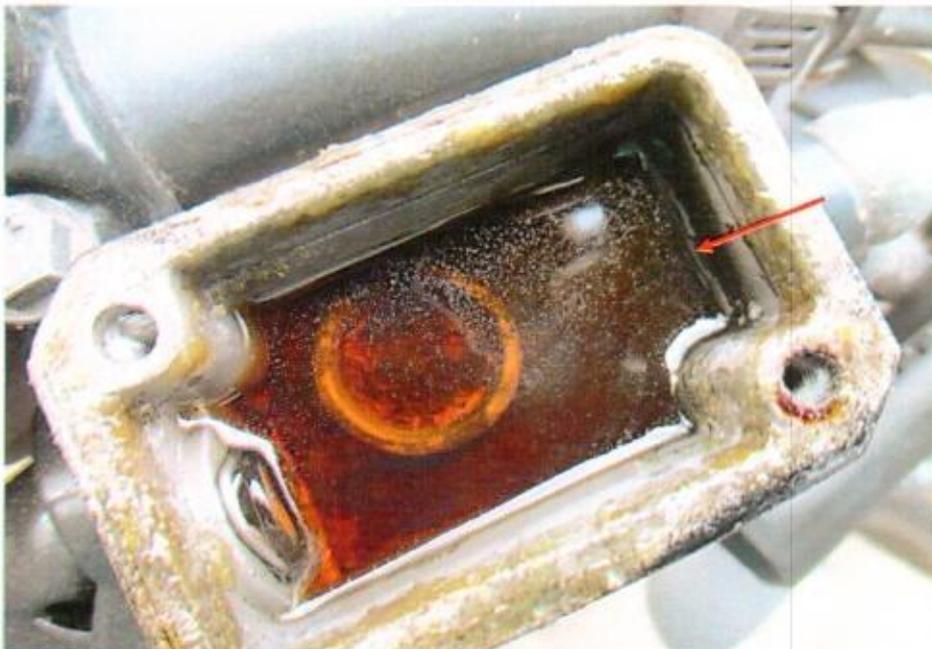
Photo 24 shows the brake fluid reservoir for the front brake of the Motorcycle. The brake fluid was found to be of sufficient level for operating purposes. However the brake fluid was found to be slightly contaminated (arrowed).

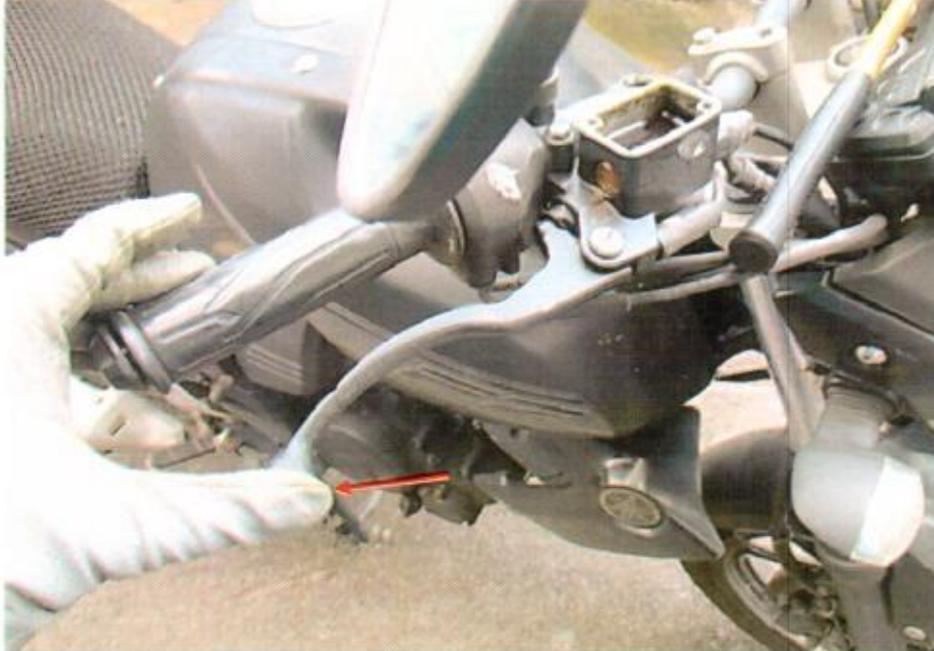
Photo 25 shows the front brake lever being depressed. There was some resistance felt (spongy like feel) upon pressing the front brake lever (arrowed). This would indicate that there is no leakage of pressure/vacuum in the brake system.

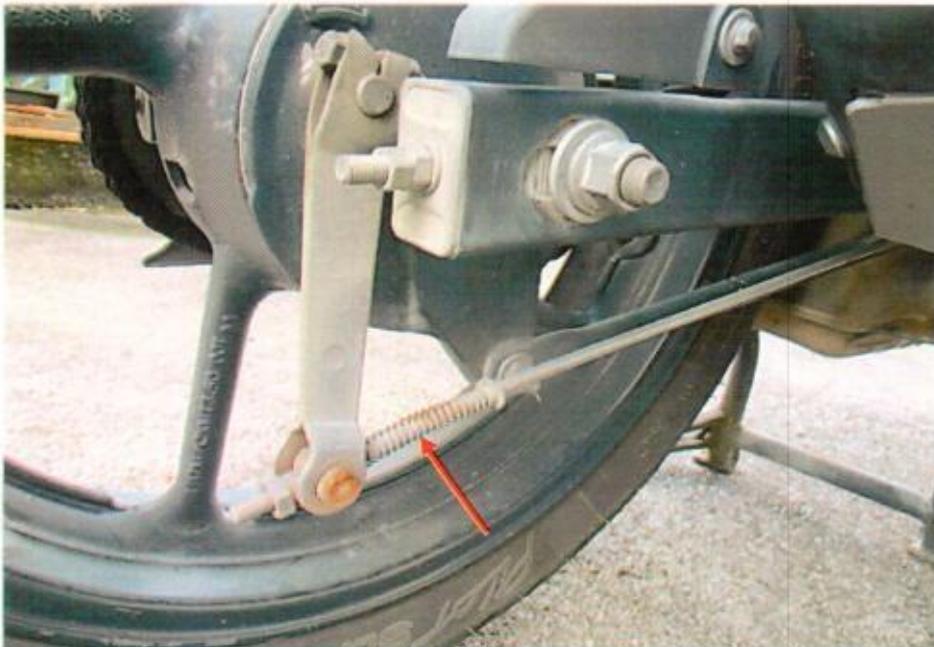
Photo 26 shows the rear wheel of the Motorcycle. The type of brake system for the rear wheel was of a mechanical type, controlled by the brake foot pedal of the Motorcycle. Our checks of the cable (arrowed), spring and drum which are all part of the components in the rear brake system of the Motorcycle reveal all to be intact and without damage.
