Your Ref: TP/IP/77337/2019
Our Ref : CI/TPD20001853/N

3 April 2020

INSPECTION REPORT OF MOTORCYCLE JPC 1091

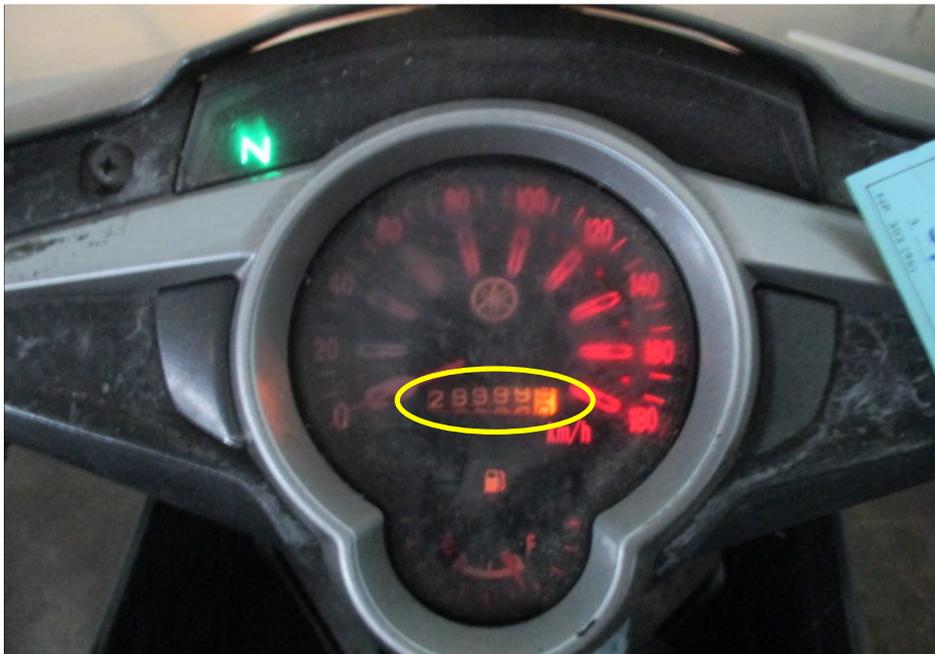
Photo 1 shows the speedometer gauge of the Motorcycle. The mileage of the Motorcycle at the time of our inspection was 29, 999km (circled).

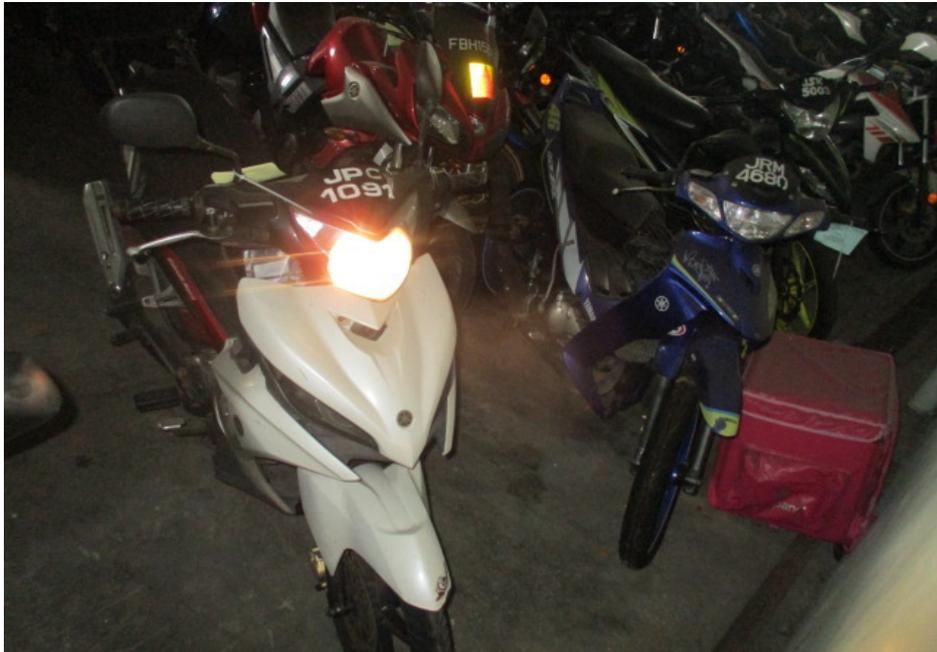
Photo 2 shows a general view of the front body of the Motorcycle at the time of our inspection. The Motorcycle was observed to have sustained damages along its frontal portion, left body and rear portion.

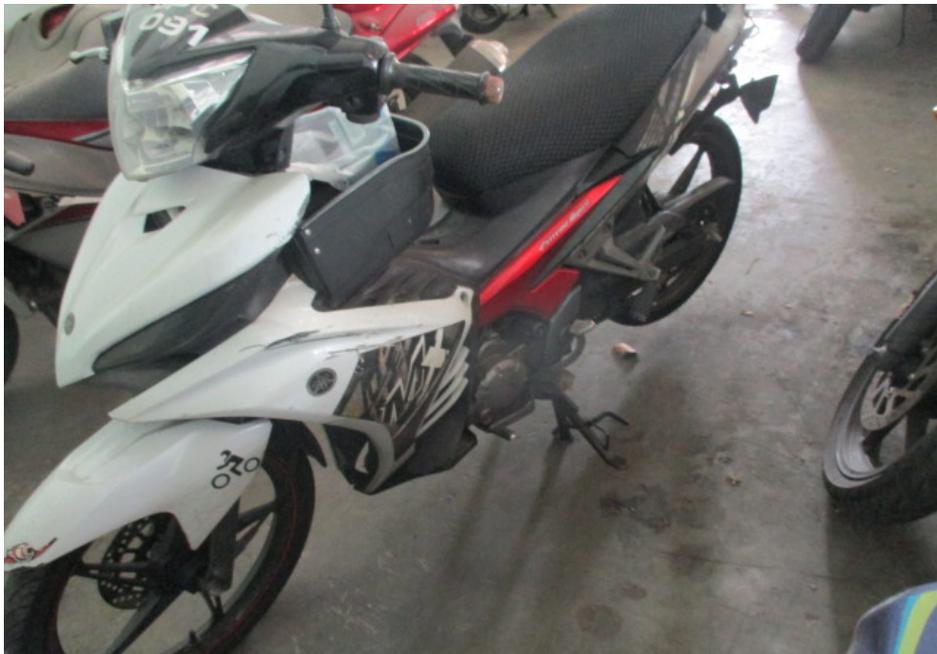
Photo 3 shows a general view of the left body of the Motorcycle at the time of our inspection. The Motorcycle was observed to have sustained damages along its frontal portion, left body and rear portion. Amongst the body parts that were found to have been damaged include its front cowling, front mudguard, left cowling, left side mirror, gear shift pedal, left front footrest, left pillion foot peg, left rear side cover, top box rack, top box and rear mudguard.

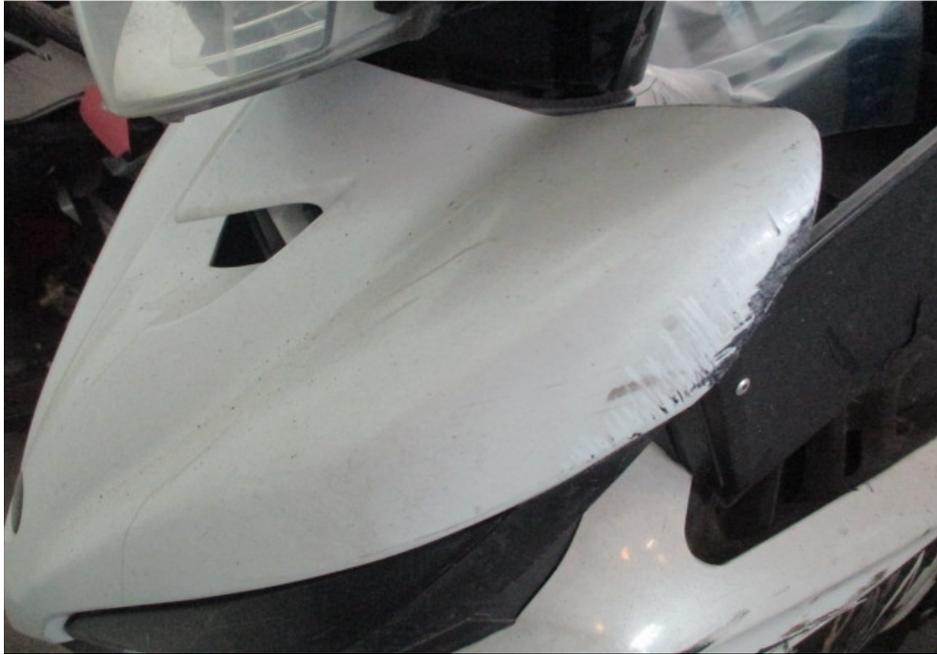
Photo 4 shows a close up view of the head cowling which was amongst the body parts at the front of the Motorcycle that had sustained damage as a result of the accident.

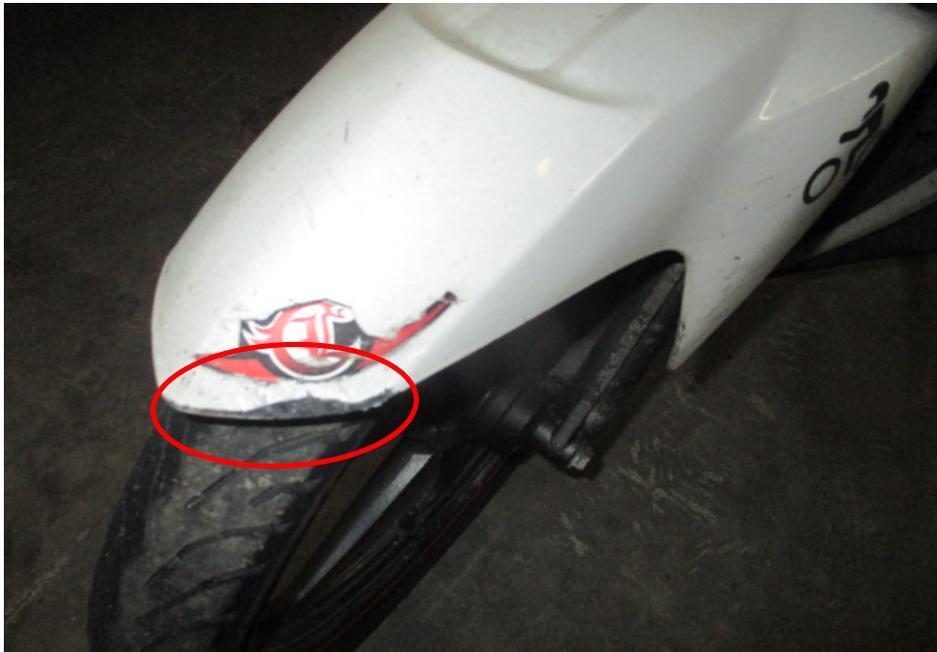
Photo 5 shows a closer view of the front mudguard (circled) which was amongst the body parts of the Motorcycle that had sustained damage as a result of the accident.

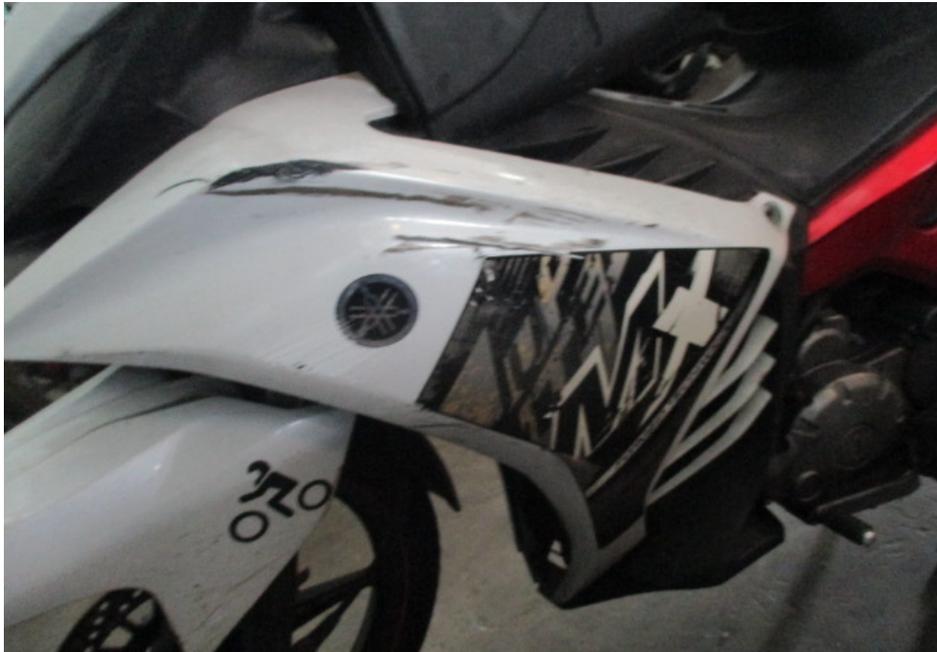
Photo 6 shows a closer view of the left cowling which was amongst the body parts of the Motorcycle that had sustained damage as a result of the accident.

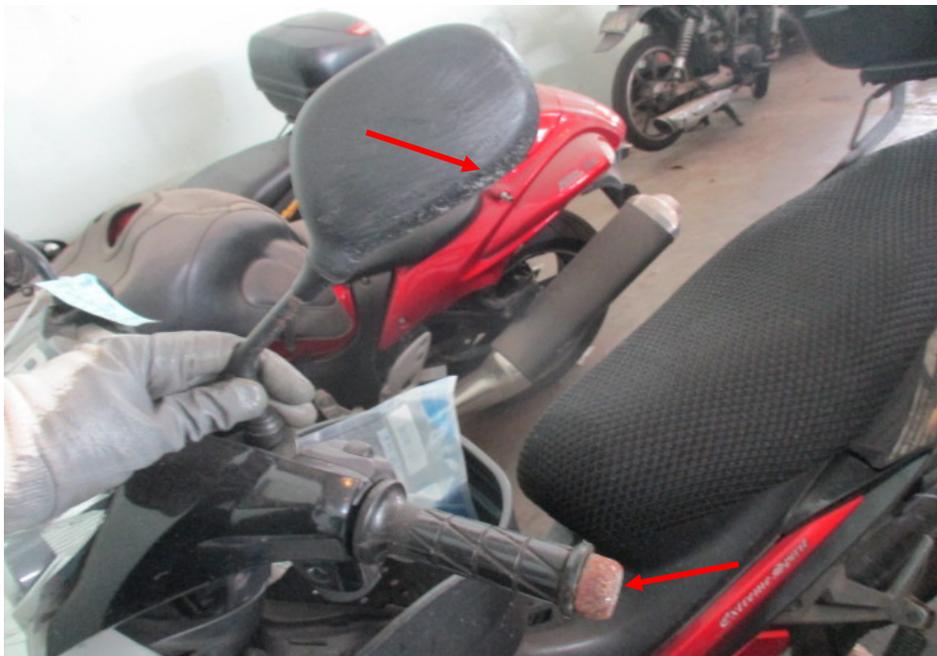
Photo 7 shows the left handlebar end and left side mirror (arrowed), which were amongst the body parts of the Motorcycle that had sustained damage as a result of the accident.

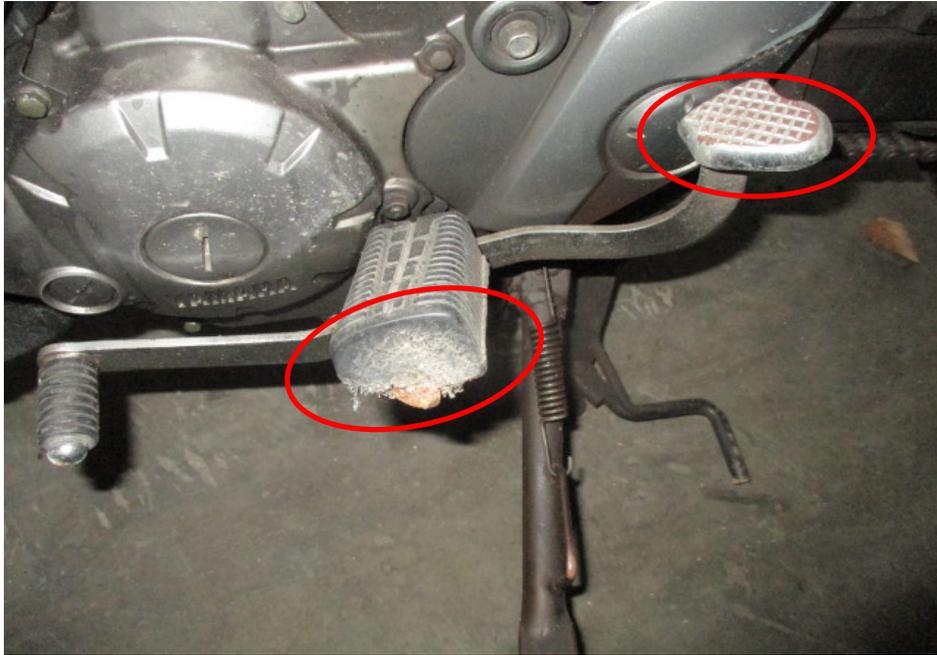
Photo 8 shows a closer view of the gear shift pedal and left front footrest (circled) which were amongst the body parts of the Motorcycle that had sustained damage as a result of the accident.

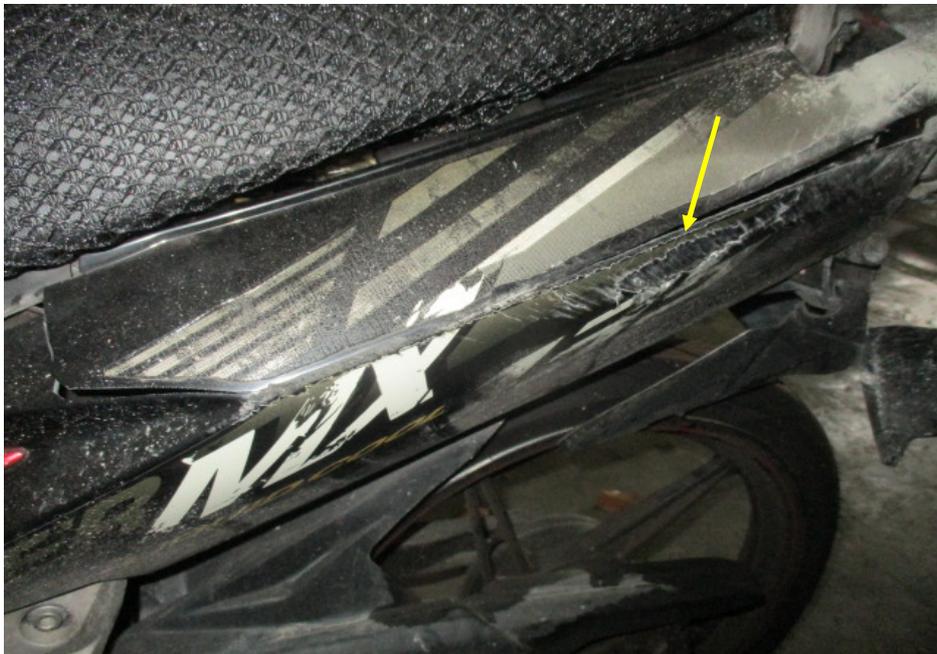
Photo 9 shows a closer view of the left rear side cover which was amongst the body parts of the Motorcycle that had sustained damages of grazing nature as a result of the accident (arrowed).

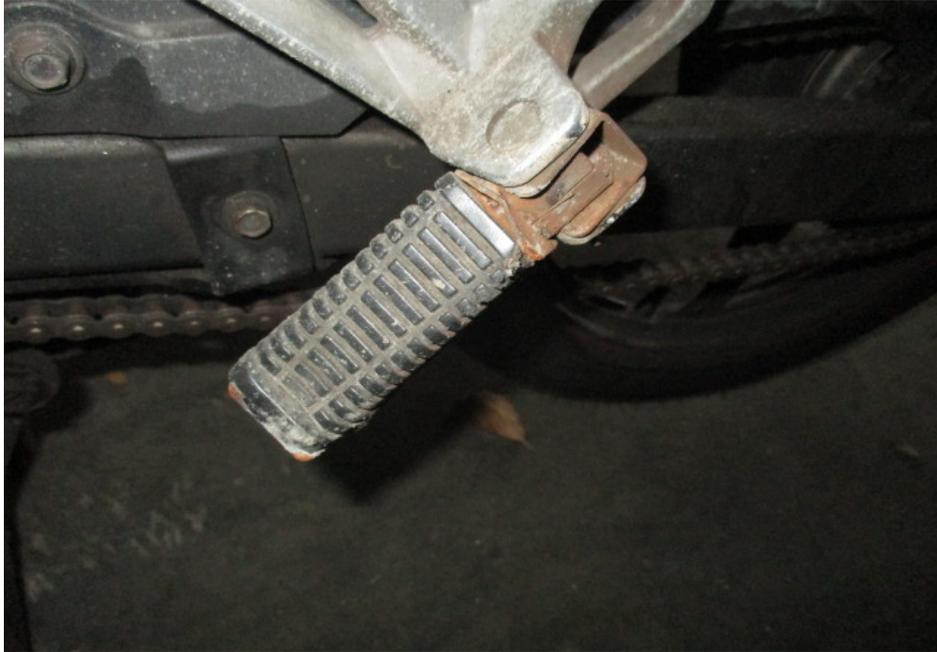
Photo 10 shows a closer view of the left pillion foot peg which was amongst the body parts of the Motorcycle that had sustained damages of grazing nature as a result of the accident.

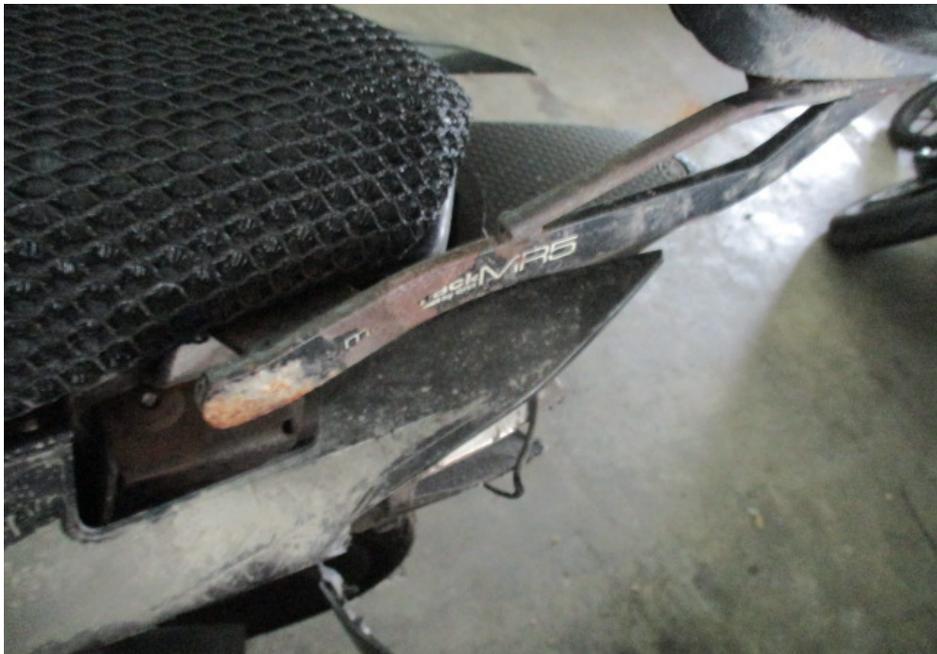
Photo 11 shows the top box rack of the Motorcycle that had sustained damage as a result of the accident.

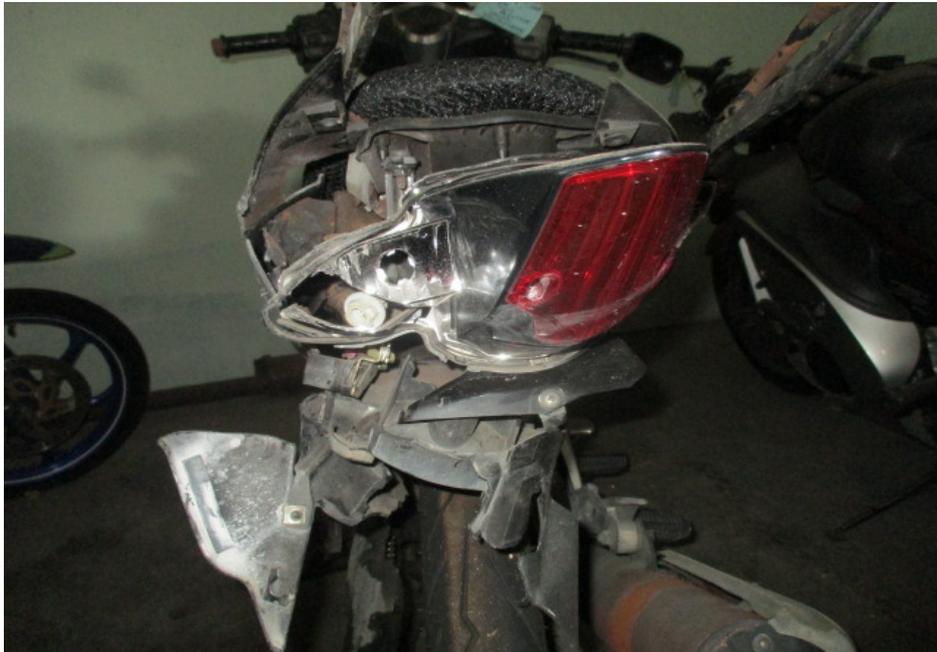
Photo 12 shows the rear mudguard, tail lamp and rear number plate of the Motorcycle that had sustained extensive damage as a result of the accident.

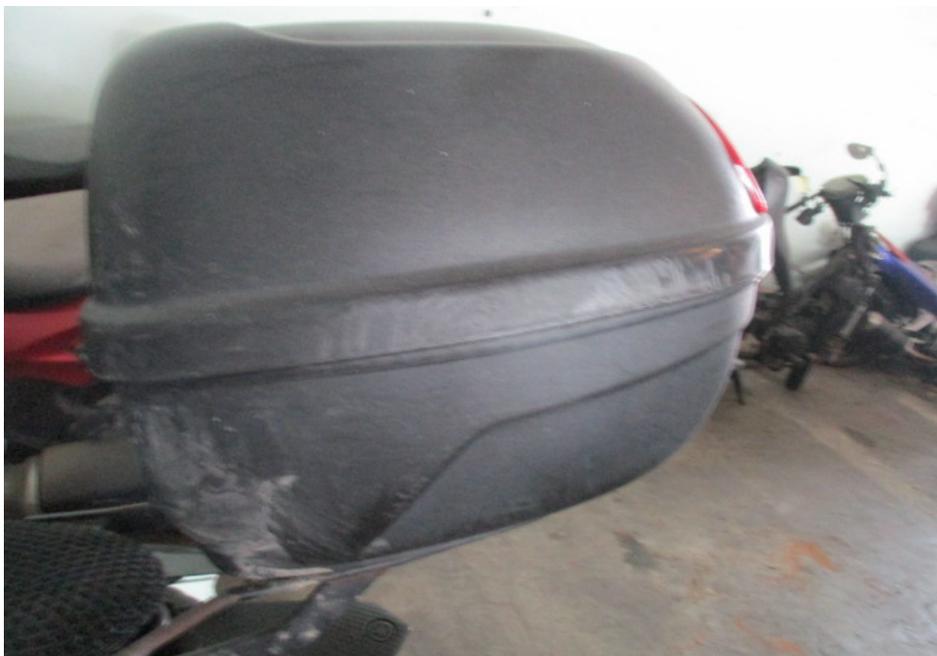
Photo 13 shows the top box of the Motorcycle that had sustained damages of grazing nature as a result of the accident.

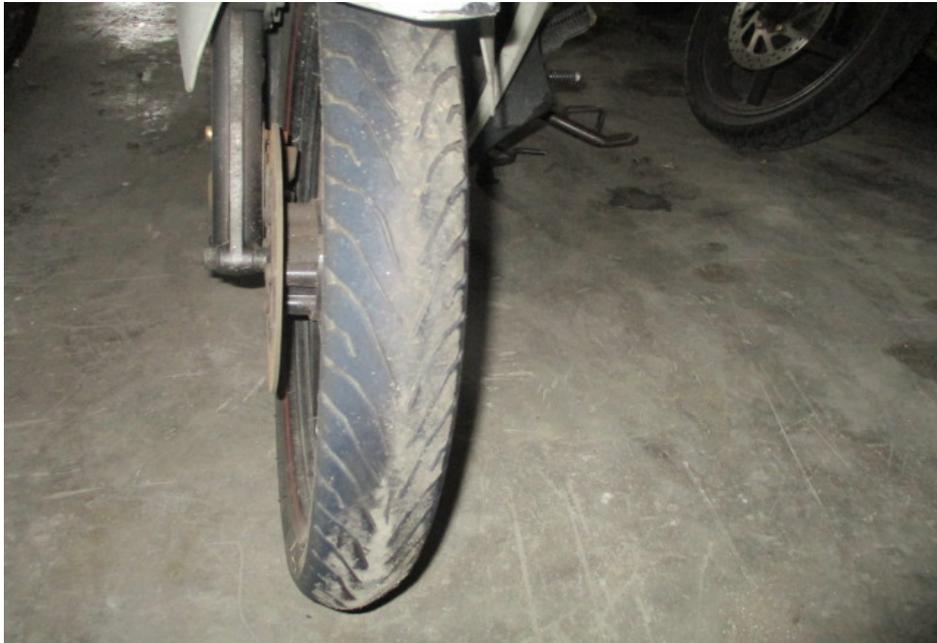
Photo 14 shows the front tyre of the Motorcycle at the time of our inspection. The front tyre was observed to be in serviceable condition with remaining tread depth of approximately 3mm. The pattern of the tread was also clearly visible. There was no tear, burst mark(s) and/or punctured hole(s) on the sidewalls as well as across the tread of the front tyre.

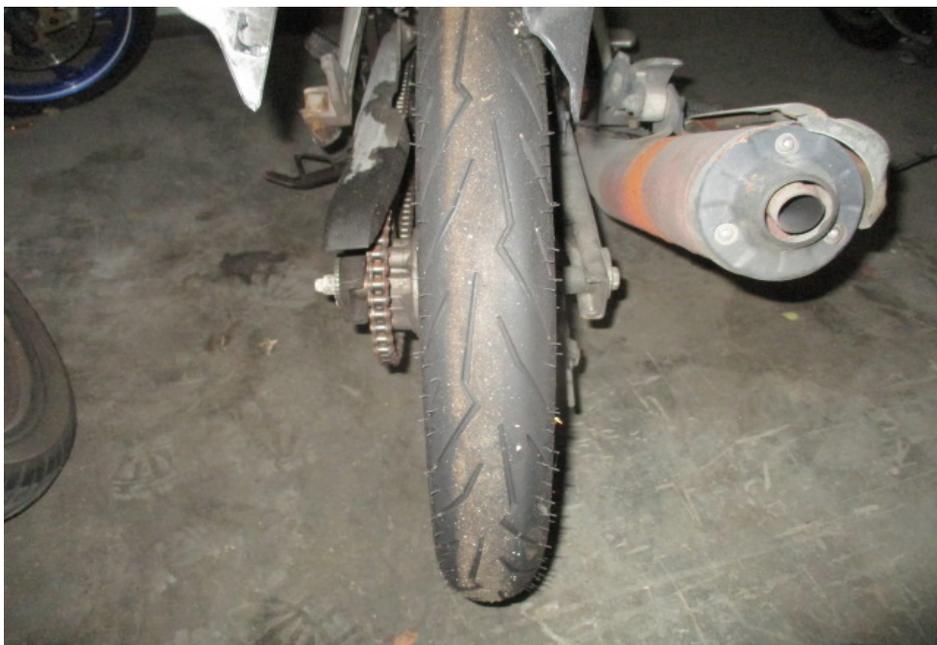
Photo 15 shows the condition of the Motorcycle's rear tyre. The rear tyre was observed to be in serviceable condition with remaining tread depth of approximately 3mm. The tyre was also observed to be sufficiently inflated for vehicular operation. We did not observe any tear, burst mark(s) and/or punctured hole(s) on the sidewalls as well as across the tread of the rear tyre.

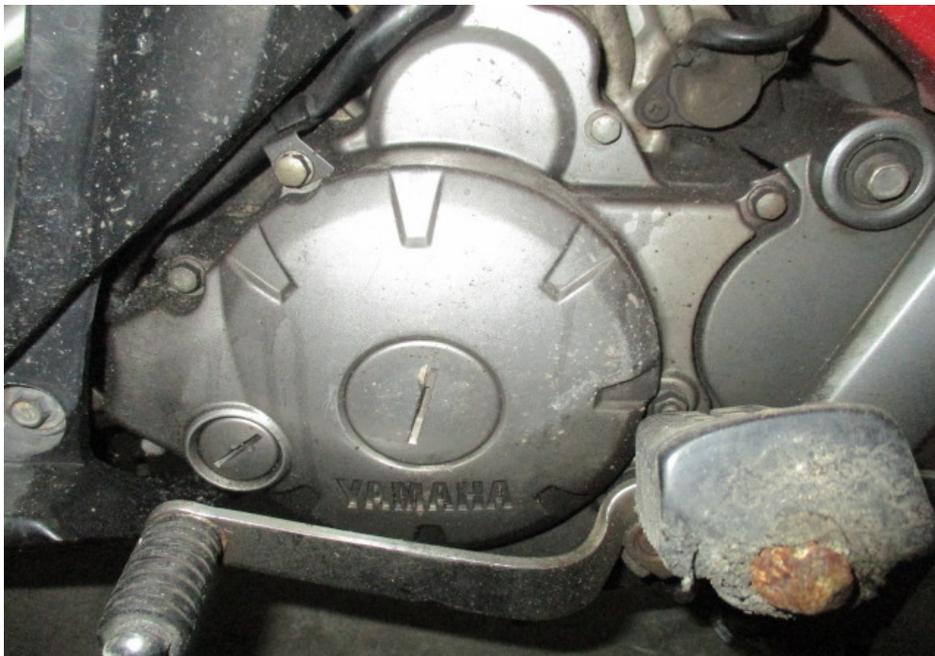
Photo 16 shows the left side of the engine of the Motorcycle at the time of our inspection. The various engine related parts and components were found to be intact with no visible damage. There was also no sign(s) or indication(s) of fluid leak observed around the left engine area of the Motorcycle.

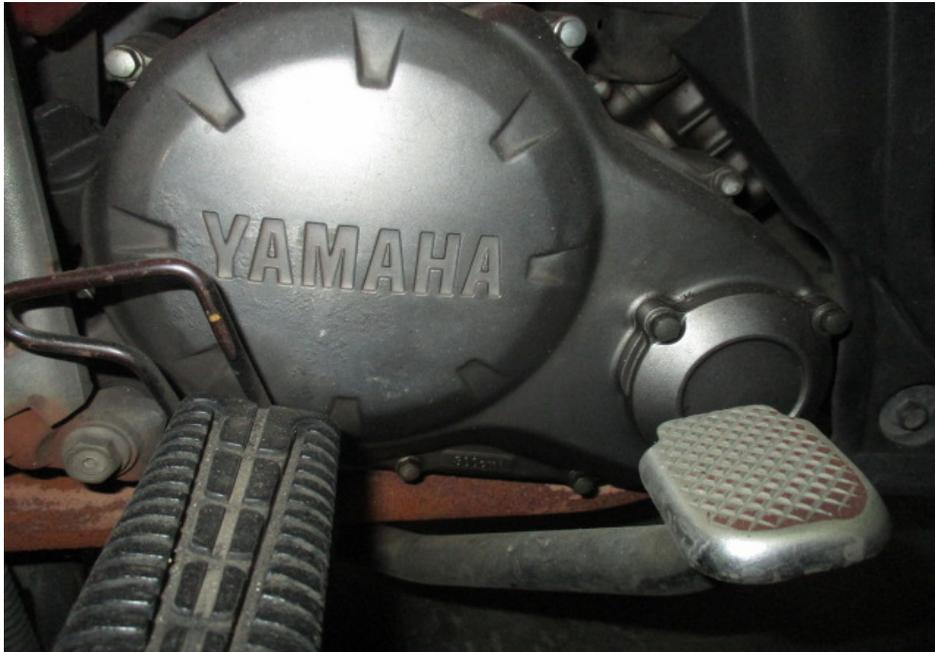
Photo 17 shows the right side of the engine of the Motorcycle at the time of our inspection. The various engine related parts and components were found to be intact with no visible damage. There was also no sign(s) or indication(s) of fluid leak observed around the right engine area of the Motorcycle.

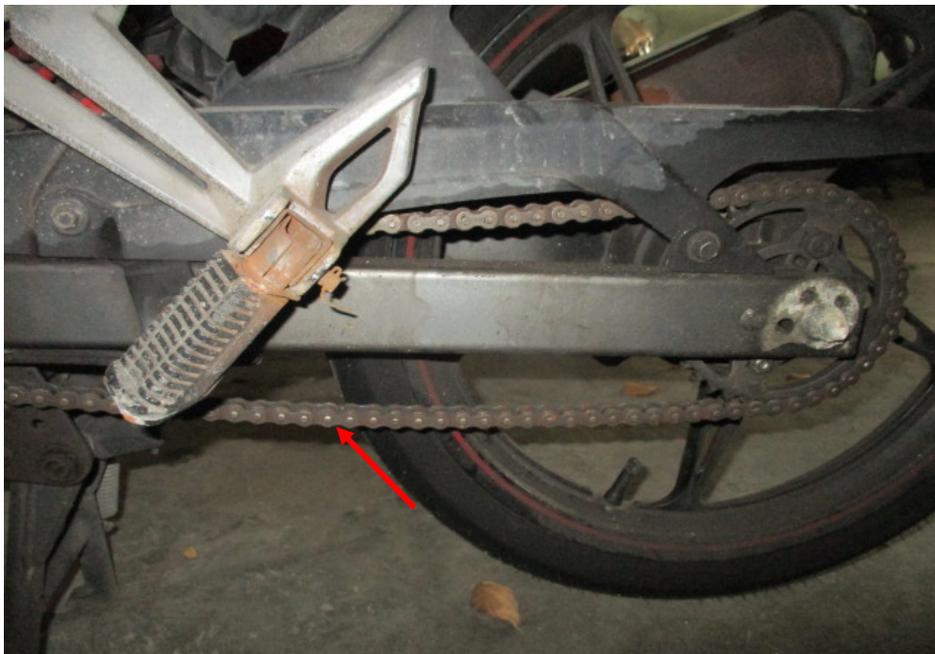
Photo 18 shows the general view of the gear train (arrowed) of the Motorcycle, which was observed to be intact with no misalignment. It was also adequately lubricated for operating purposes.

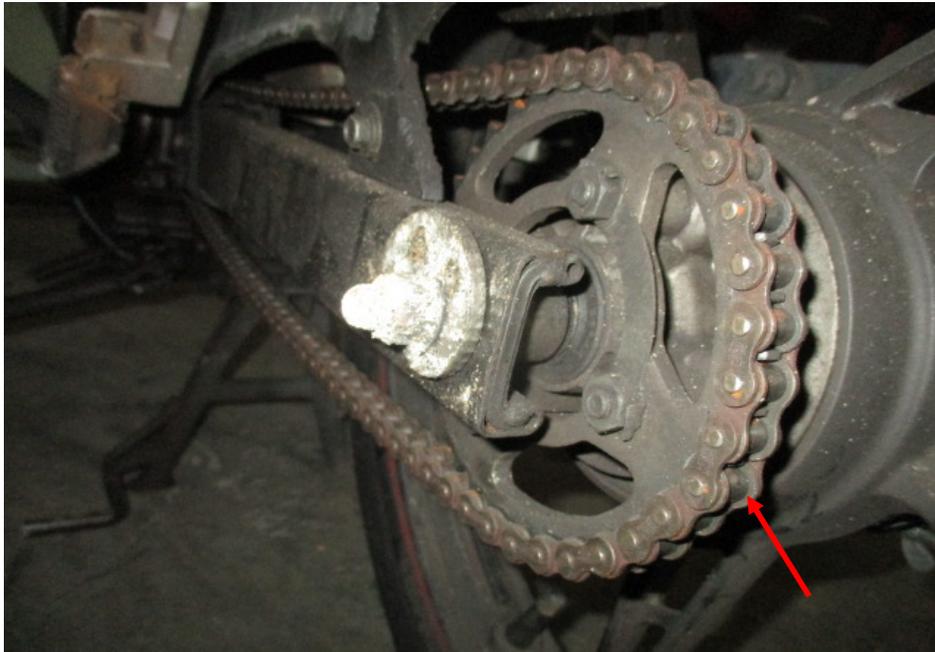
Photo 19 shows a closer view of the gear train (arrowed) of the Motorcycle, which was observed to be intact with no misalignment. It was also adequately lubricated for operating purposes.

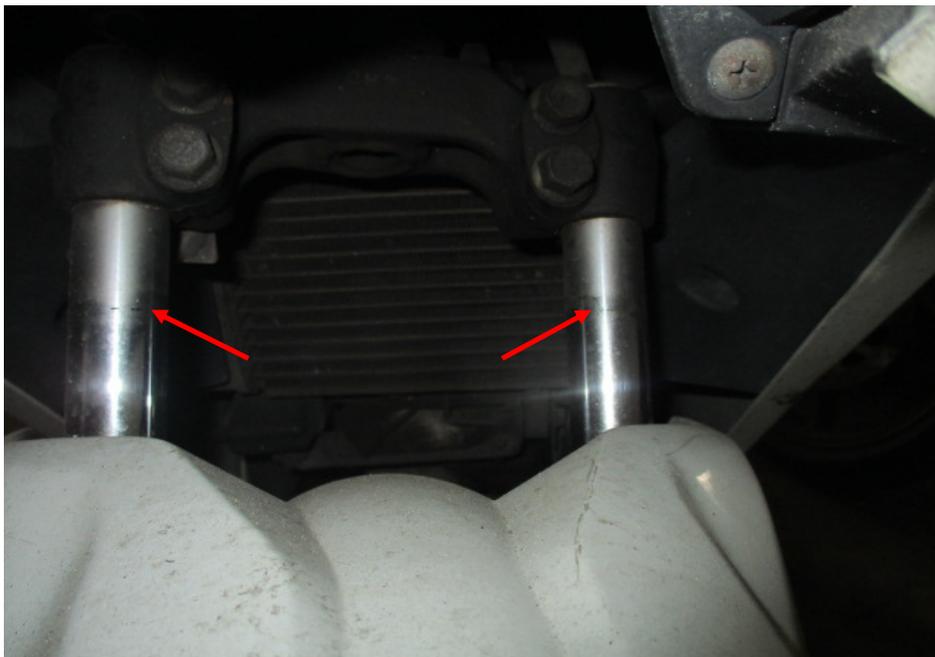
Photo 20 shows the front fork (arrowed) of the Motorcycle. The front fork and fork bracket of the Motorcycle were both found to be intact and undamaged. Turning the Motorcycle's handle bar towards the left and right did not produce any abnormal free play. The steering system of the Motorcycle was in serviceable condition at the time of our inspection.

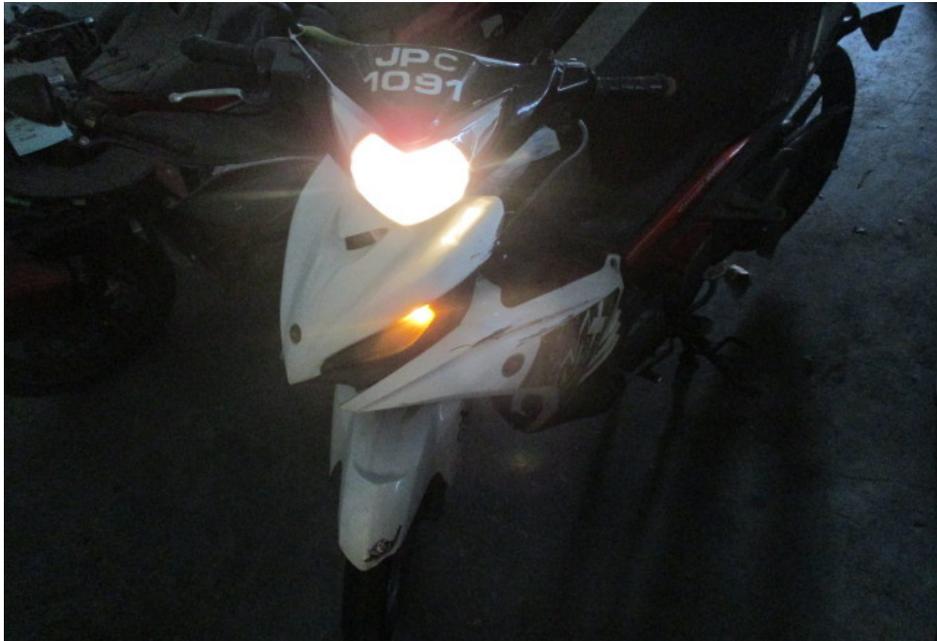
Photo 21 shows the front wheel of the Motorcycle turned towards its full left. Turning the Motorcycle's handle bar towards the left did not produce any abnormal free play and/or resistance. This would indicate that the steering system of the Motorcycle was in serviceable condition at the time of our inspection.

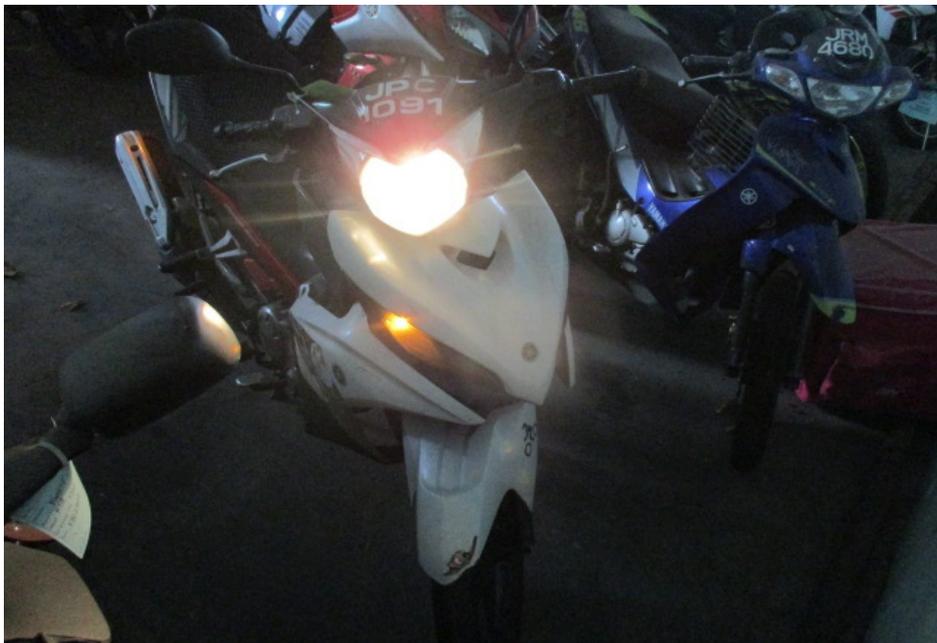
Photo 22 shows the front wheel of the Motorcycle turned towards its full right. Turning the Motorcycle's handle bar towards the right did not produce any abnormal free play and/or resistance. This would indicate that the steering system of the Motorcycle was in serviceable condition at the time of our inspection.

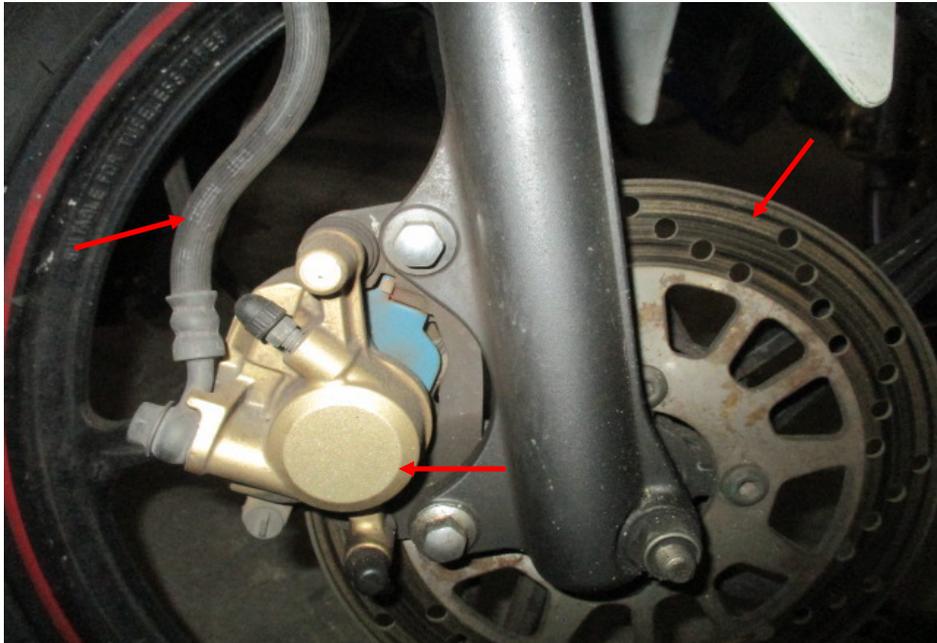
Photo 23 shows a close up view of the front brake caliper, front brake disc and front brake hose (arrowed) of the Motorcycle, which are all part of the components in the hydraulic front brake system of the Motorcycle. Our visual checks of these various components had revealed all to be intact with no visible damage. No leakage of brake fluid was also observed.

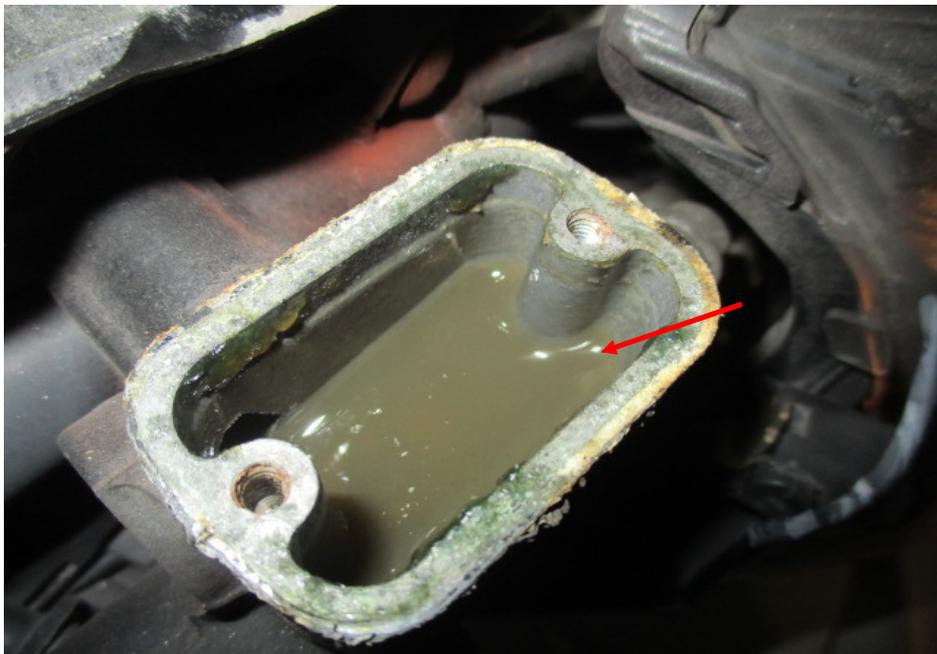
Photo 24 shows the brake fluid reservoir for the front brake of the Motorcycle. The brake fluid was found to be of sufficient level for operating purposes. However the brake fluid was found to be contaminated (arrowed).

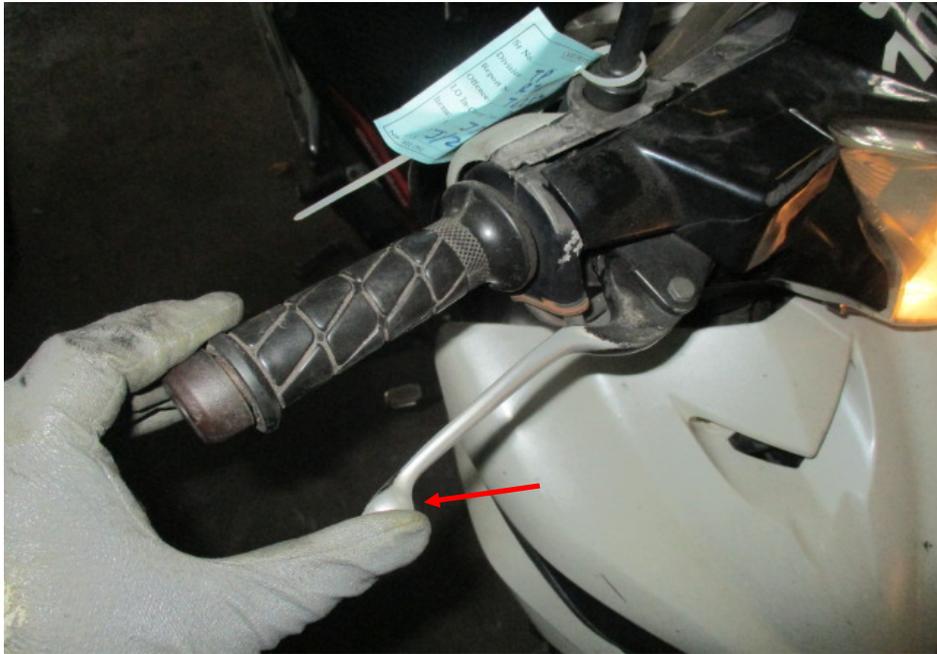
Photo 25 shows the front brake lever being depressed. There was some resistance felt (spongy like feel) upon pressing the front brake lever (arrowed). This would indicate that there is no leakage of pressure/vacuum in the brake system.

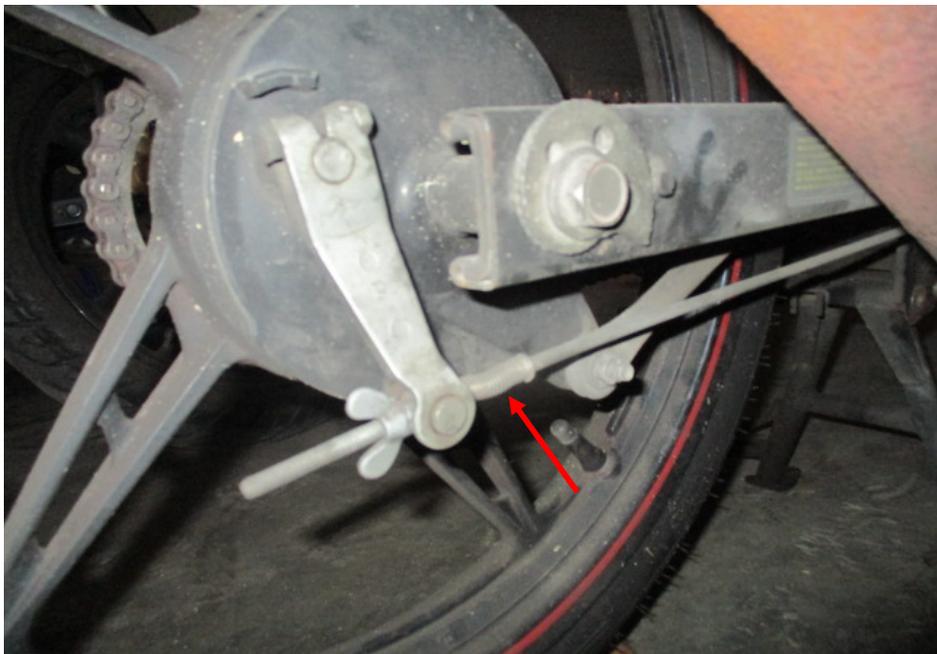
Photo 26 shows the rear wheel of the Motorcycle. The type of brake system for the rear wheel was of a mechanical type, controlled by the brake foot pedal of the Motorcycle. Our checks of the cable (arrowed), spring and drum which are all part of the components in the rear brake system of the Motorcycle reveal all to be intact and without damage.
