## LKK Auto Consultants Pte Ltd

### 1. Policy Particulars :- THIRD PARTY CLAIM

### ADJUSTMENT ON REPAIR COST FOR VEHICLE NO. GY 9999U

PHOTOGRAPHS FOR VEHICLE NO. GY 9999U

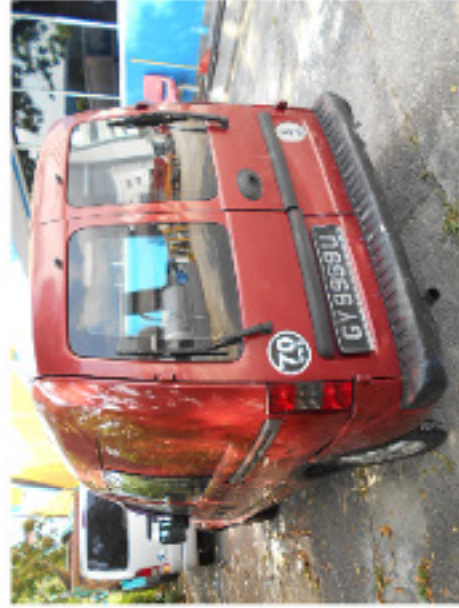
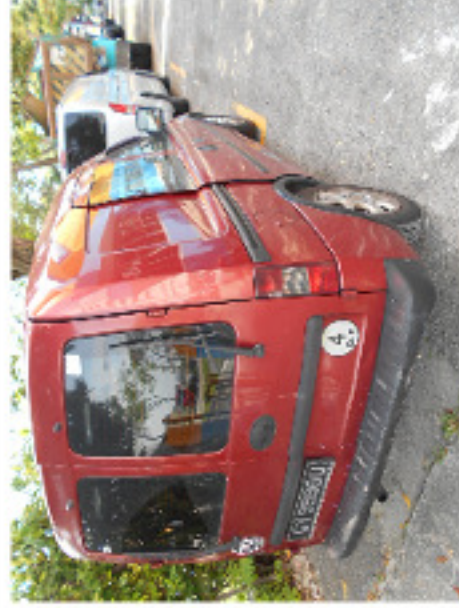
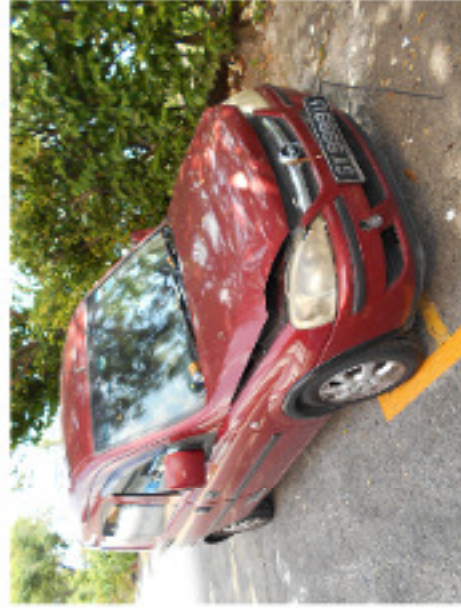
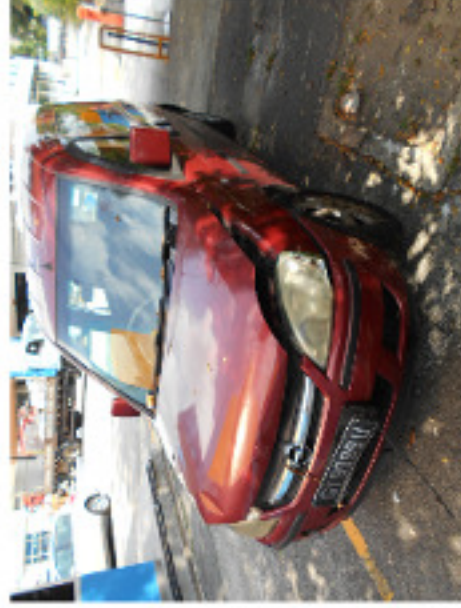
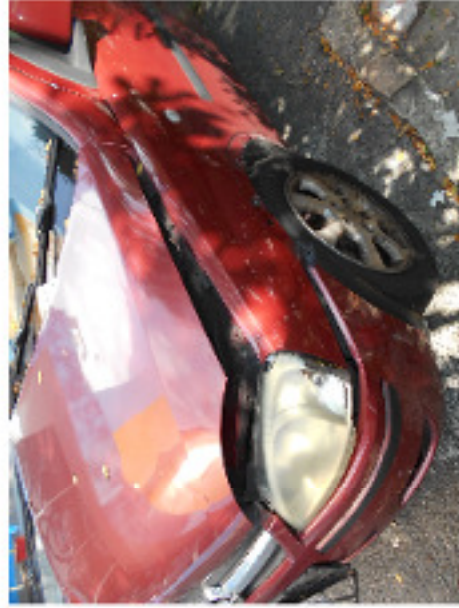
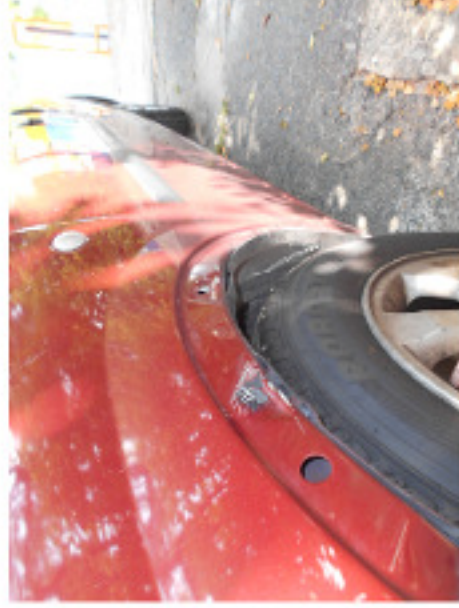
INSPECTION

THE VEHICLE SUSTAINED DAMAGES AT THE FRONT & REAR PORTION. DAMAGES SEE DETAILS.
--
